Eastern Busway EB3 Commercial and EB4 Link Road

Contaminated Land Effects Assessment

Document Number: EB-RP-3C4L-PL-000007

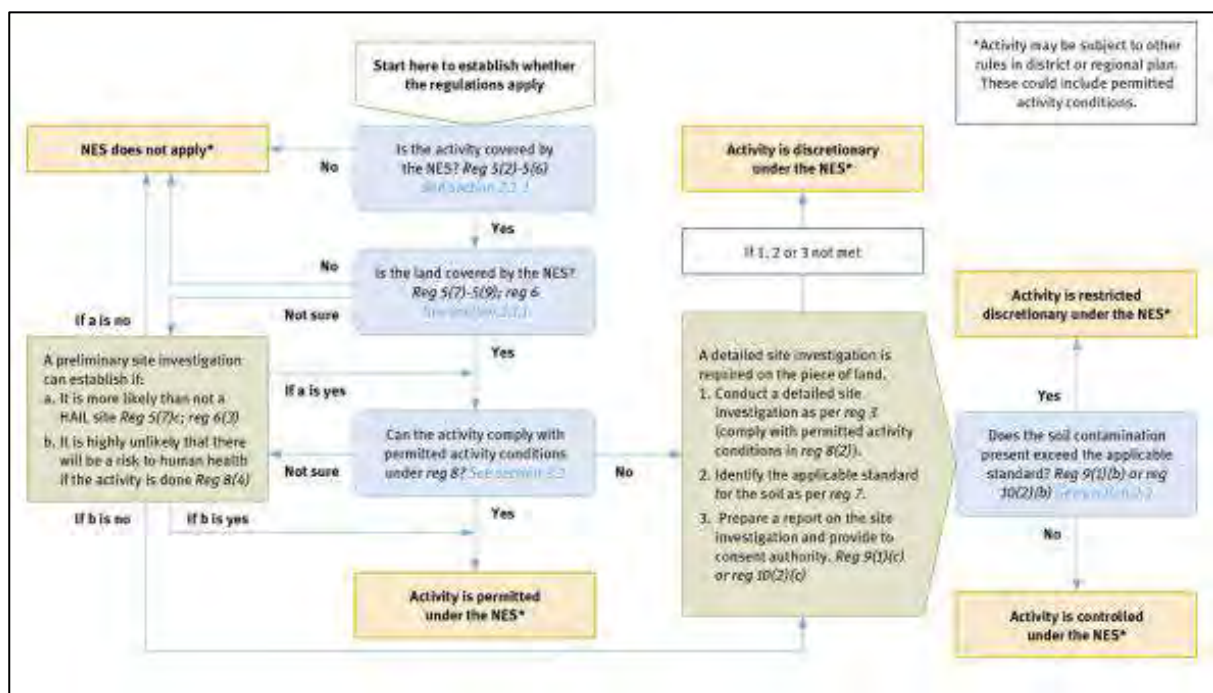
Figure 5. Process for determining resource consent requirements under the NES-CS

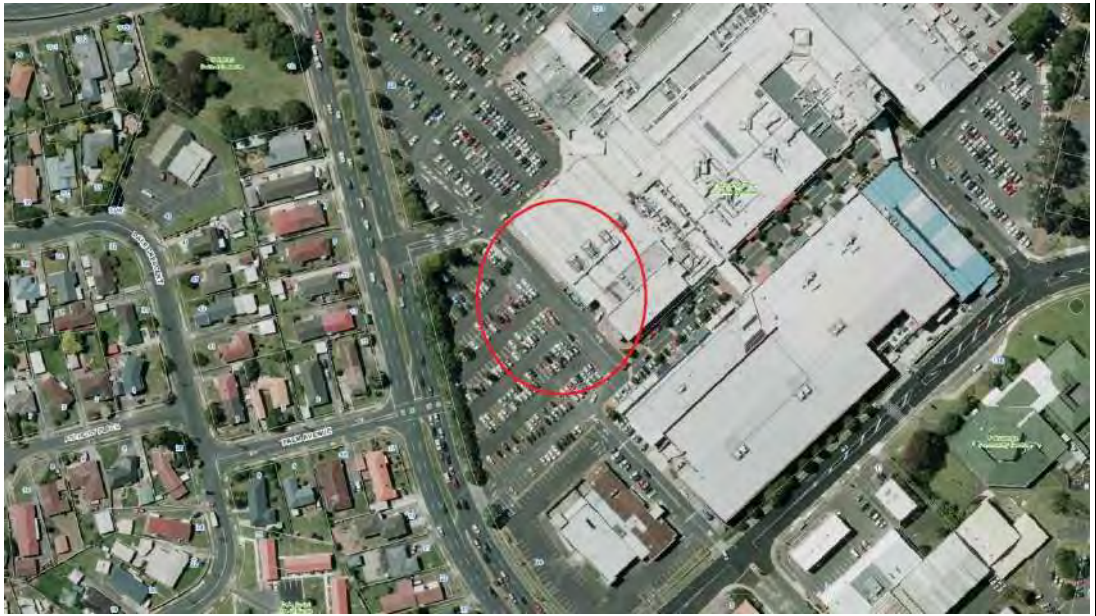
Date	Observations
2008	<p>Pakuranga Automotive (large oval) and Pakuranga Panelbeaters (circle) are located at 16 and 12 Cortina Place respectively. Pakuranga Auto Transport are located at 16D Cortina Place (small circle). These businesses may present issues to the proposed alignment with regards hydrocarbon, solvents and trace element contamination as a result of activities relating to vehicle servicing and repair.</p>

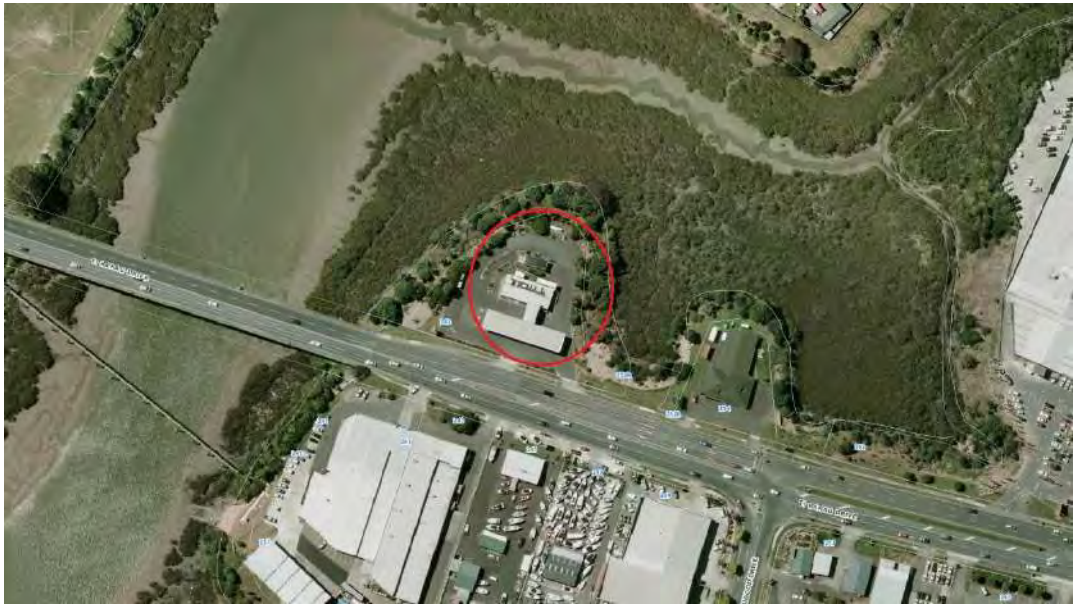
Date	Observations
2008	<p data-bbox="341 412 1385 517">Best Automotive Clinic is located at 245 Burswood Drive. This business may present issues to the proposed alignment with regards hydrocarbon, solvents and trace element contamination as a result of activities relating to vehicle servicing and repair.</p>   An aerial photograph of an industrial area. A red circle highlights a specific building in the center of the image. The area contains several large industrial buildings, parking lots with many cars, and a road. The highlighted building is a large, rectangular structure with a light-colored roof.

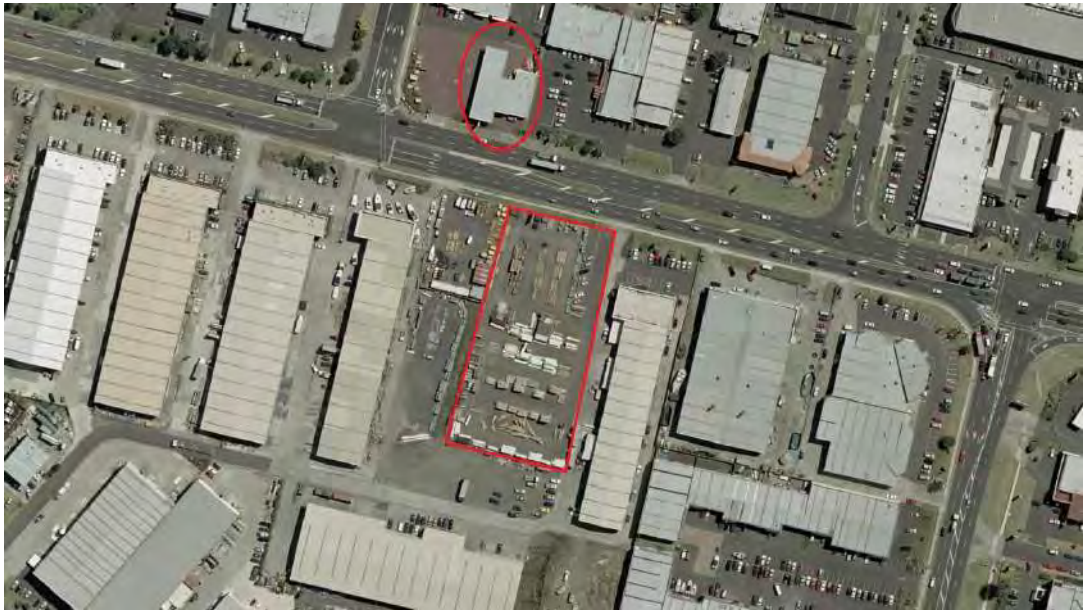
Date	Observations
2008	<p>Forging Ahead is located at 293 Ti Rakau Drive. This business may present issues to the proposed alignment with regards hydrocarbon and trace element contamination resulting from foundry operations.</p>

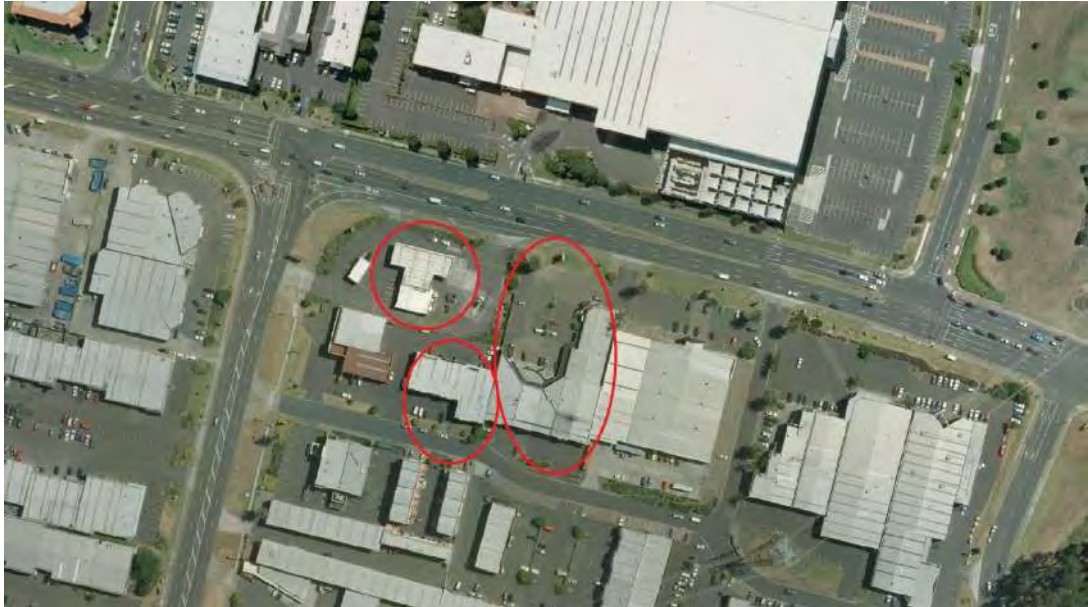
Date	Observations
2010	<p>380 Ti Rakau Drive is occupied by the Howick and Eastern Bus Company whilst next door at 384 is a Gull branded service station. Both of these sites may present issues to the construction of the alignment relating to hydrocarbon contamination as a result of fuel storage facilities at both sites. A tributary of the Pakuranga Creek flows at the back of both properties and could be considered a sensitive receptor. According to council borehole records Chevron have installed a borehole at 380 Ti Rakau Drive for monitoring purposes. A site investigation report was not available from Auckland Council. It is understood that Chevron previously operated a Caltex branded service station at 384 Ti Rakau Drive.</p>

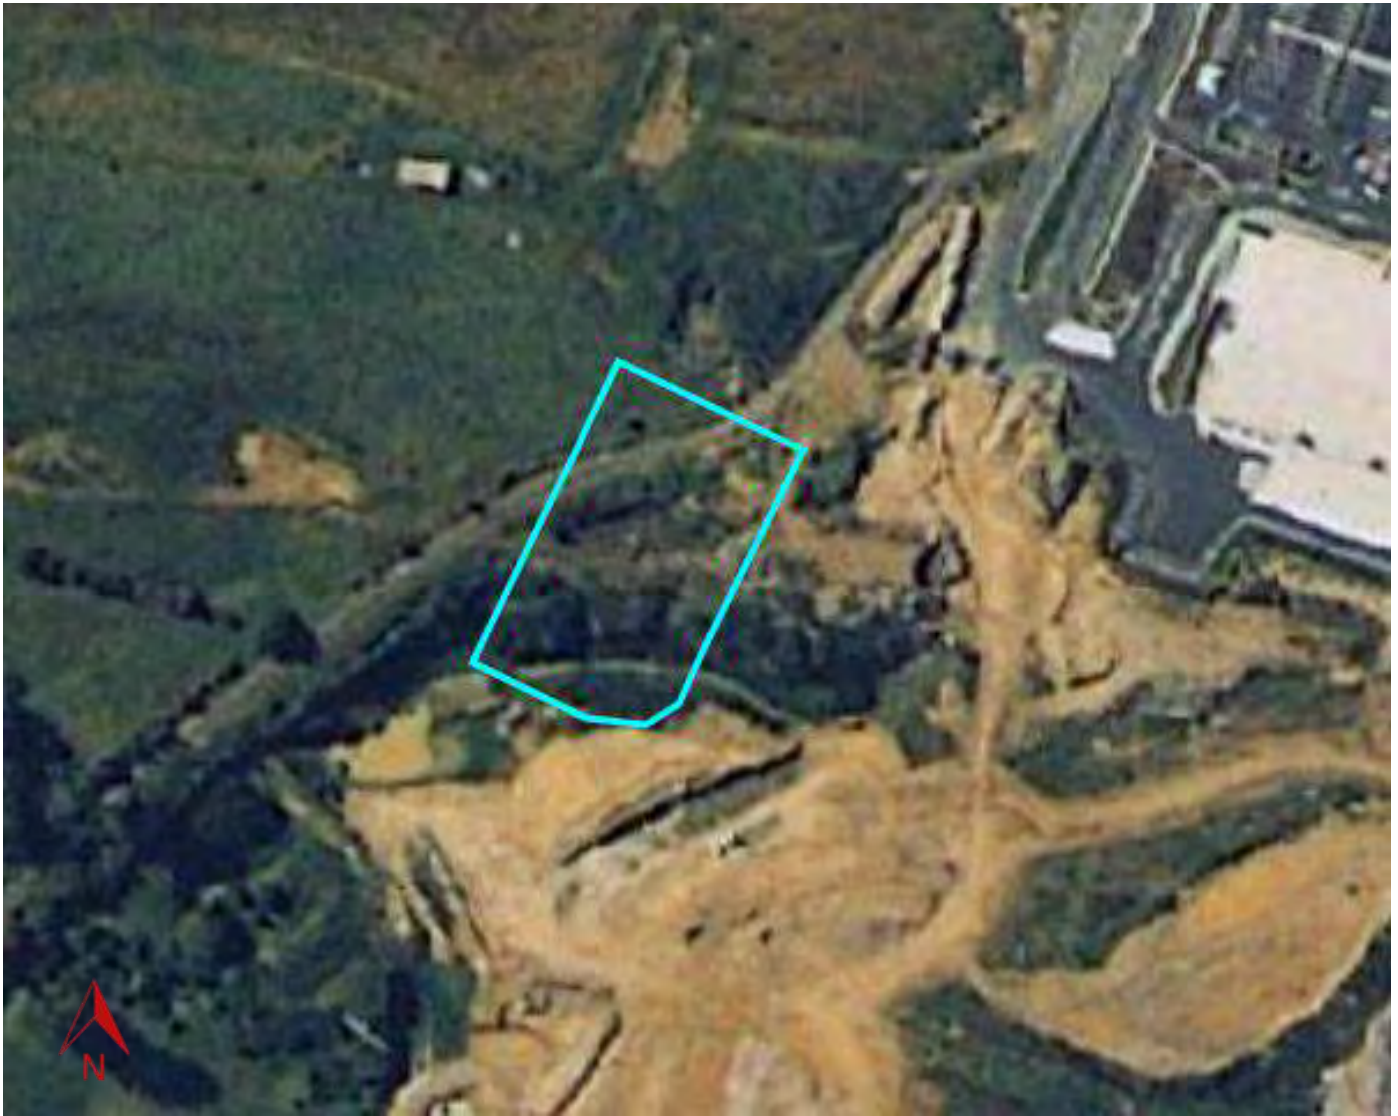
Reference	Photographs
<p data-bbox="143 229 277 255">Date: 1996</p> <p data-bbox="143 290 488 351">Source: Auckland Council Geomaps</p> <p data-bbox="143 354 488 443">https://geomapspublic.aucklandcouncil.govt.nz/viewer/index.html</p> <p data-bbox="143 475 488 536">Site: 550 Te Irirangi Drive (Z service station)</p>

An aerial photograph showing a landscape with a mix of green vegetation and brownish, cleared or excavated areas. A cyan-colored polygon is drawn over a central portion of the image, highlighting a specific site. In the bottom-left corner of the photograph, there is a red north arrow pointing upwards with the letter 'N' below it. To the right of the highlighted site, there are some buildings and structures, possibly related to the service station mentioned in the reference.
