Warkworth to Wellsford

Ecology Assessment

July 2019

Document title: Ara Tūhono Project, Warkworth to Wellsford Section; Ecology Assessment

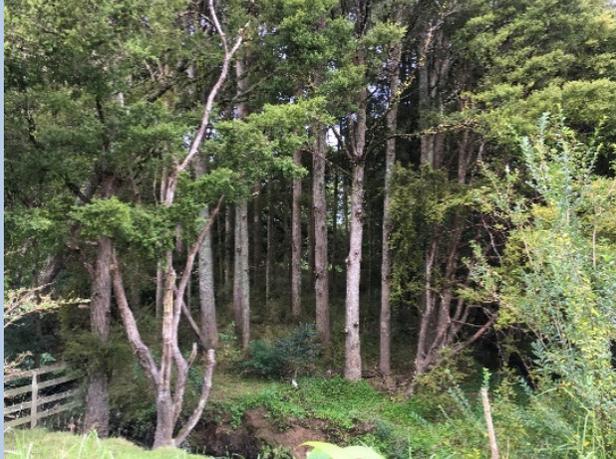
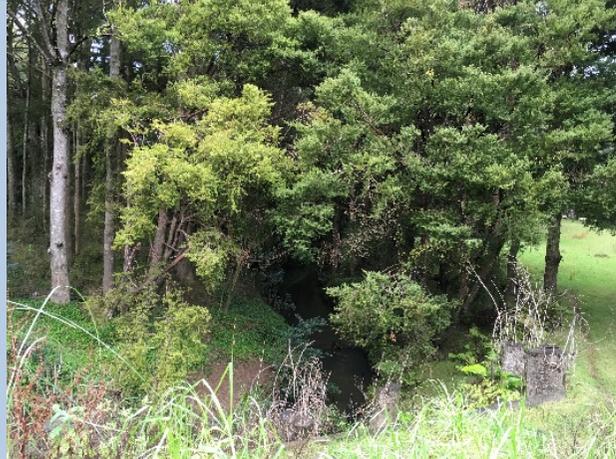
Site ID	WN_T_Mahu_02
Size (ha)	4.5
Ecosystem type and vegetation description	<p>Kauri, podocarp, broadleaved forest (WF11)</p> <p>Totara canopy interspersed with kahikatea and rimu. Canopy height is approximately 15 m and the DBH of the canopy trees ranges between approximately 40 – 60 cm. While kauri is noted as a component of ecosystem type WF11 (Singers et al., 2017), no kauri was observed during the site walkover.</p> <p>Subcanopy vegetation comprises māhoe, pūriri, ponga and kānuka. There is a dense, even-aged understorey of thin-leaved <i>Coprosma</i>, twiggy <i>Coprosma</i>, hangehange, red mapou, karamu and lancewood, with some tree privet and Chinese privet around the margin. Ground cover comprises a dense layer of various moss species as well as ferns, grasses and sedges. The ground cover species include leather-leaf fern, thread fern, basket grass, hook sedge and forest sedge. There is abundant growth of the epiphytic white rata.</p>

Habitat quality	Good. The remnant appears to have been recently fenced (within the last 10 years) and is recovering well from stock damage. Consequently, there is a very dense, even-aged, understorey comprising of broadleaved trees and shrubs, which likely persisted in the seedbank while the understorey was browsed.
Ecological Value	Moderate
Rationale	<ul style="list-style-type: none"> • The site rates as moderate for ‘diversity and pattern’ and ‘ecological context’. • Diverse vegetation assemblage but impacts of previous grazing evident. • Comparable size to nearby SEA sites.

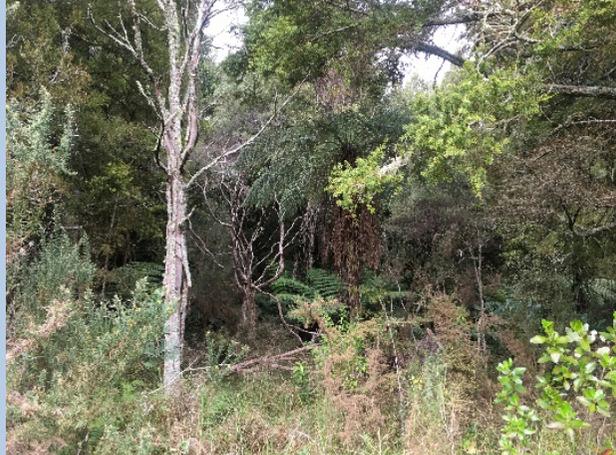
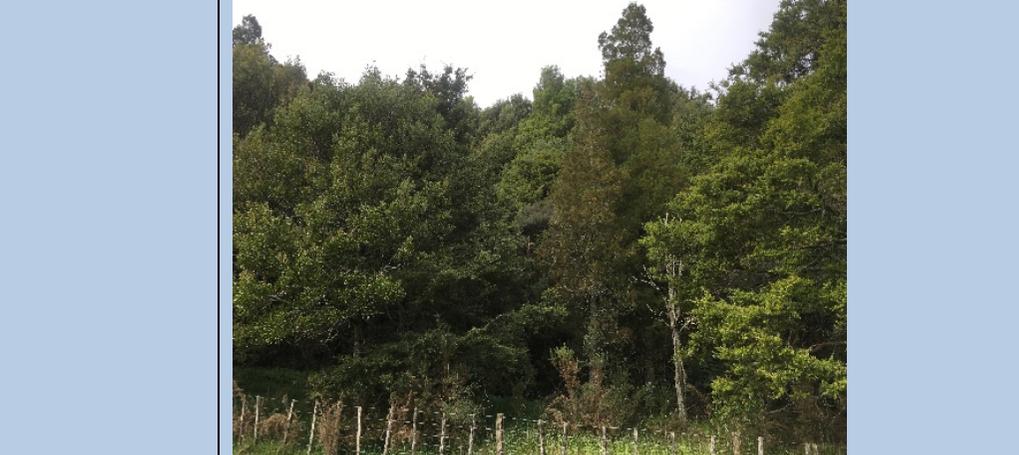
Site ID	WN_T_Koura_02	
Size (ha)	28.3	
Ecosystem type and vegetation description	<p>Kā nuka scrub/forest (VS2) Broadleaved species scrub/forest (VS5)</p> <p>Regenerating kā nuka forest grading into young treefern-dominated scrub on the upper slopes. Totara is a frequent canopy component, interspersed with young kahikatea, mā nuka, mamaku, ponga, and mature remnant pine trees. The site borders two wetland complexes, which include raupō reedland and kahikatea, pukatea forest.</p>

Habitat quality	<p>Good. A relatively large, intact example of a regenerating forest complex with community sequence from wetland through fernland on upper slopes. Some stock access evident around margins.</p> <p>Gorse dominant along old farm tracks, but has been recently controlled.</p>

Lizard species potentially present within the proposed designation boundary are habitat generalists, and are commonly found on bush margins, in rough pasture areas and in refuge habitats that are less accessible to stock. Hence, lizards may be present throughout the proposed designation. Geckos are often found occupying early successional scrub habitats such as that present in our Warkworth North site labelled WN_T_Koura_02.

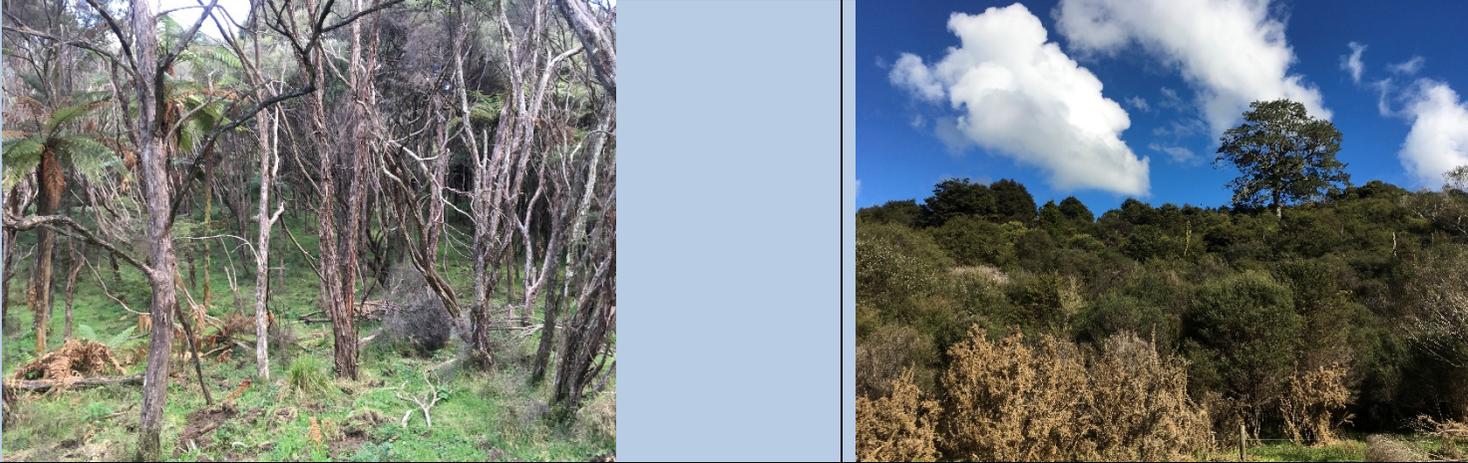
Site ID	WN_W_Koura_01
Size (ha)	1.1
Ecosystem type and vegetation description	<p>Exotic wetland (EW) Machaerina sedgeland (WL11)</p> <p>A covenanted wetland largely vegetated in exotic pasture grasses, buttercup, Mercer grass and exotic water pepper. Native wetland species (<i>Machaerina teretifolia</i>, sharp spike sedge, Edgar’s rush, leafless rush, harakeke, swamp sedge and giant umbrella sedge) are locally abundant towards the centre of the wetland. Occasional mā nuka and juvenile kahikatea are present on the wetland margin.</p>

Habitat quality	Moderate. The wetland is largely exotic. However, the assemblage of naturally occurring native wetland species indicates suitable wetland hydrological conditions. Stock are excluded.
Ecological value	Moderate
Rationale	<ul style="list-style-type: none"> • The site rates as moderate for rarity/distinctiveness, as the feature includes a component of naturally occurring native vegetation and indigenous wetlands are a LENZ IV “threatened environment” category where less than 20% indigenous vegetation remains. • However, the majority of the site is dominated by exotic vegetation. • The intact wetland hydrology and remnant indigenous wetland vegetation community indicates good restoration potential, and restoration is likely because this is a requirement of the regulatory incentive provisions under which the site was covenanted.
Site photos

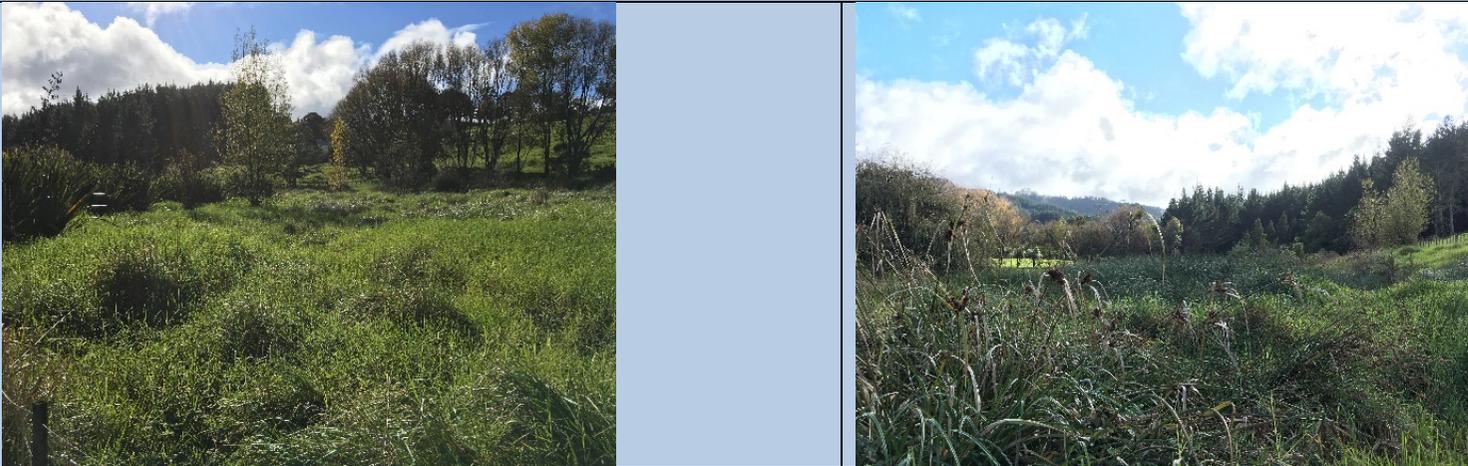
Site ID	WN_W_Koura_02
Size (ha)	0.8
Ecosystem type and vegetation description	Raupo reedland (WL19) Raupo wetland and regenerating kahikatea forest with regenerating forest and scrub surrounding upper reaches. A stand (23 stems, 8.2 cm – 40.8 cm diameter) of regionally uncommon swamp maire is present on the wetland margin.

Habitat quality	Good. Remnant wetland with intact regeneration sequence occurring in the headwaters. Stock access evident and weeds present on the margin. Lower reaches of the wetland truncated by a deep drainage ditch.

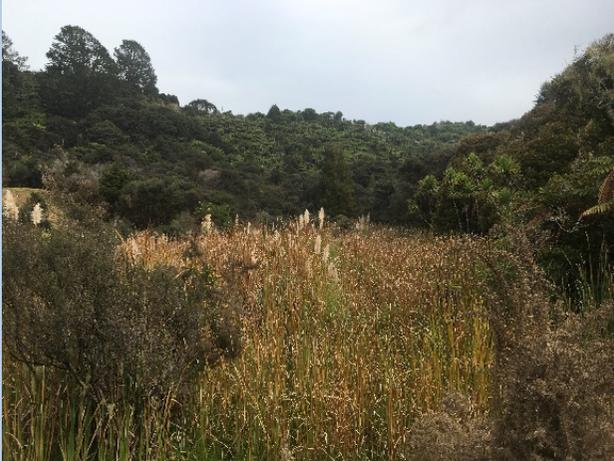
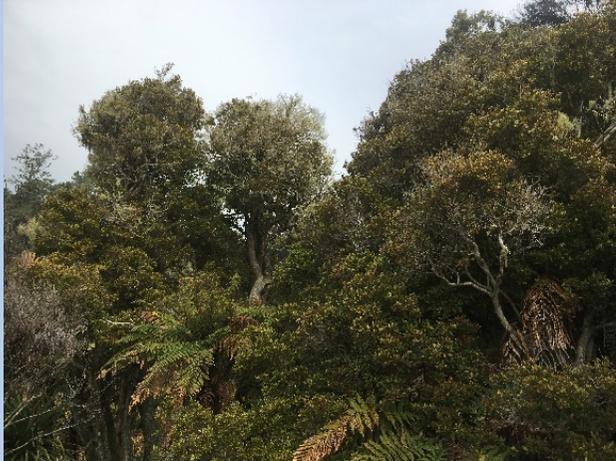
Site ID	WN_W_Koura_03	
Size (ha)	1.1	
Ecosystem type and vegetation description	<p>Raupo reedland (degraded example) (WL19)</p> <p>Wetland dominated almost entirely by <i>Isolepis prolifera</i>, a native species tolerant of grazing and disturbance, and common in nutrient rich wetlands. Mānuka, mamaku, cabbage tree, Edgar’s rush, and raupō are also sparsely present. The wetland is truncated and culverted by farm track.</p>

Habitat quality	Poor. Full stock access, hydrological modification and limited species diversity.

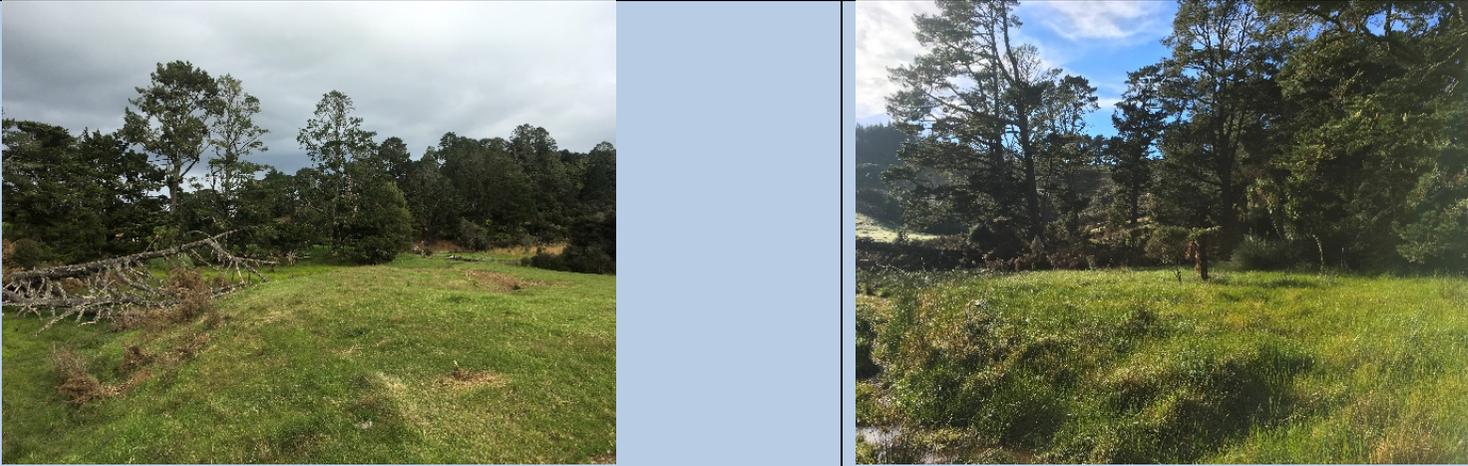
Site ID	WN_W_Koura_04
Size (ha)	0.8
Ecosystem type and vegetation description	<p>Exotic wetland (EW)</p> <p>Sits within the same valley system as wetlands WN_W_Koura_02 and WN_W_Koura_03. Like WN_W_Koura_03, it is modified by livestock grazing. Vegetation comprises marsh clubrush, swamp millet, giant rush and abundant exotic soft rush. Sparse patches of regenerating secondary scrub (mānuka, juvenile totara and kahikatea) are present around the wetland margin, interspersed with gorse that has recently been sprayed and scrubbed. Upstream the wetland grades into a 1 ha patch of “kauri, podocarp, broadleaved forest” (WF11) dominated by kahikatea and totara, with pūriri, taraire and pukatea. This remnant is outside of the proposed designation boundary.</p>

Habitat quality	Poor. Full stock access, hydrological modification and limited species diversity. With the exception of stock-related pugging, minimal hydrological modification.

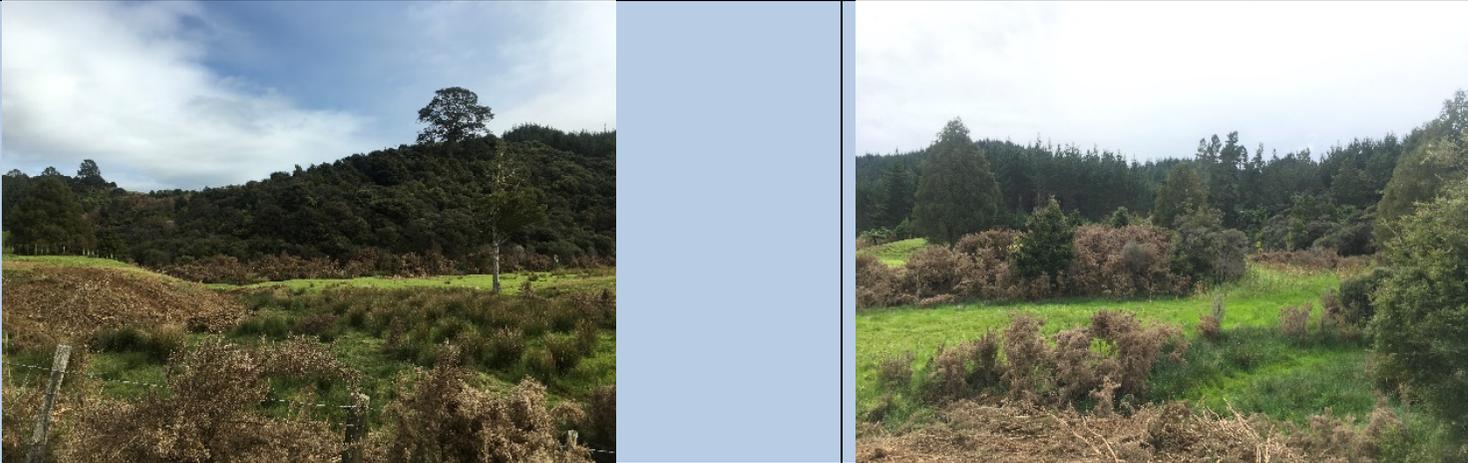
Site ID	WN_W_Koura_05
Size (ha)	0.6
Ecosystem type and vegetation description	<p>Raupo reedland (WL19)</p> <p>Sits within the same valley system as wetlands WN_W_Koura_02, WN_W_Koura_03 and WN_W_Koura_04. The feature comprises a branched raupō wetland surrounded by pines within the southern boundary of the Matariki Forest. The wetland is truncated by a drain at the southern boundary of the forest, beyond which it becomes grazed pastureland. Part of the smaller western branch of the wetland grades into WN_T_Koura_02. The remainder of the wetland remnant is surrounded by a thin strip of native riparian scrub (mā hoe, pate, mamaku, red mapou and cabbage trees, interspersed with juvenile totara and kahikatea) surrounded by plantation pines.</p>

Habitat quality	Good. Stock excluded. The upstream reach of the larger eastern branch has been modified (bisected by a forestry road and a mountain bike track).
Ecological value	High

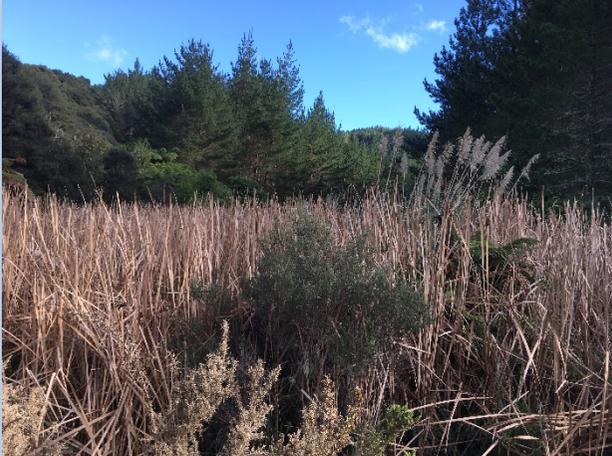
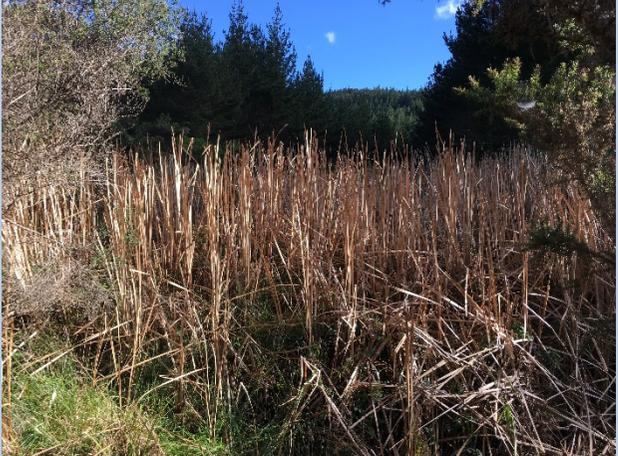
Rationale	<ul style="list-style-type: none"> • Meets rarity/distinctiveness criterion as indigenous wetlands are a LENZ IV “threatened environment” category where less than 20% indigenous vegetation remains. • Stock have been excluded from the wetland remnant. • Drains a sub catchment afforested in plantation pines. 			
Site photos

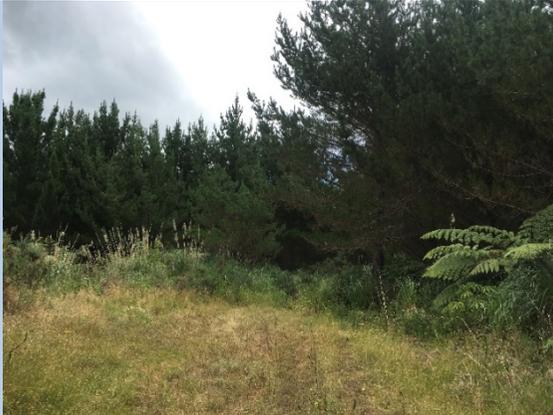
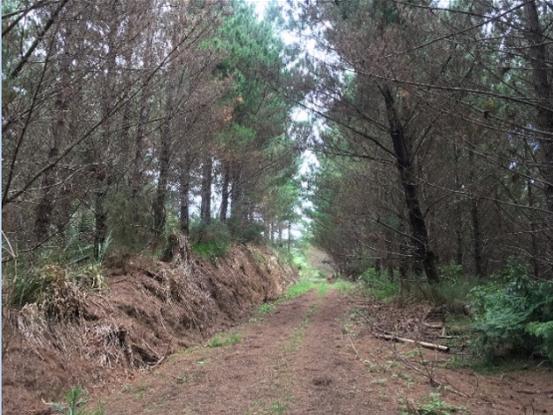
Site ID	DVF_T_Koura_01 - assessed on current ecological values	
Size (ha)	460 ha (within the proposed designation boundary), out of a total contiguous area of 3560 ha	
Ecosystem type and vegetation description	Exotic Forest Plantation forest primarily comprised of mid-cycle <i>Pinus radiata</i> trees interspersed with small areas of native scrub along the riparian margins of the tributaries dissecting the site. Stands of other exotic trees are also present including Eucalyptus species and Tasmanian blackwood.	
Habitat quality	Moderate - Low botanical value but provides habitat for a variety of Threatened and At Risk native fauna.	
Ecological value	High	
Rationale	<ul style="list-style-type: none"> The site rates high for 'rarity/distinctiveness' as Threatened and At Risk fauna are associated with the remnant including: <ul style="list-style-type: none"> Long-tailed bat (Threatened – Nationally Critical); Kauri snail (At Risk – Declining), incidentally observed during site walkovers in 2017; and Hochstetter's frog (At Risk – Declining), recorded November 2010 by Biosearches Group Ltd. in multiple tributaries within the site. The site rates high for 'ecological context'. Although it is not indigenous forest, it is a large tract of forest that used by native species during their life cycle and likely facilitates the movement of indigenous species such as long-tailed bats across the wider landscape.

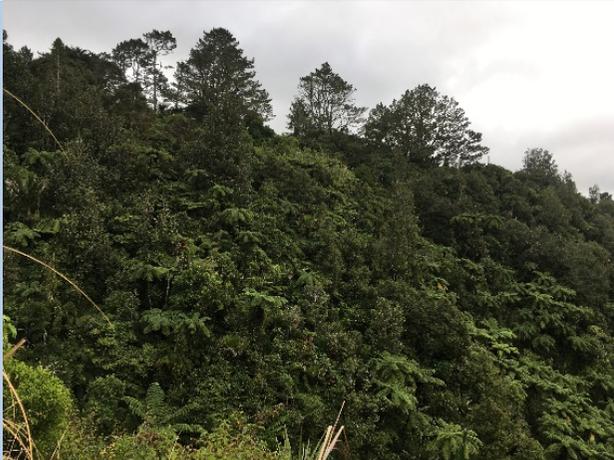
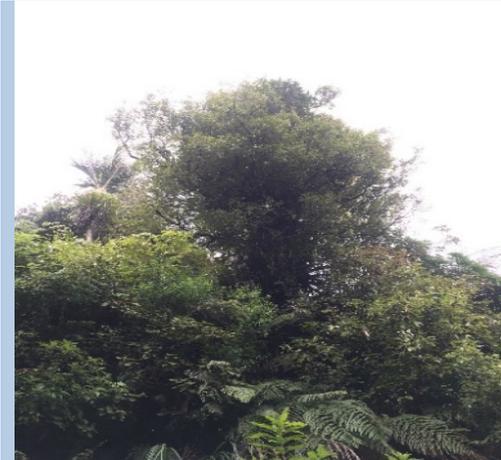
Site ID	DVF_T_Hōteao_02 (SEA_T_814)	
Size (ha)	10.4	
Ecosystem type and vegetation description	Broadleaved species scrub/forest (VS5) Common broadleaved species including kā nuka, pate and mahoe.	
Habitat quality	Moderate. Early stage of regeneration, weeds prevalent along margins including pampus, Himalayan honeysuckle and gorse.	
Ecological value	Moderate	
Rationale	<ul style="list-style-type: none"> Listed as SEA_T_814 (Chapter L, Schedule 3, AUP(OP)) on the basis of connectivity (stepping-stones, migration pathways and buffers). Although listed as significant in the AUP(OP) it does not rate highly under any ecological significance criteria as it is a small area comprising common early successional species and is impacted by weeds. One of the few ecosystem types in Auckland classified as Least Concern based on IUCN criteria (Singers et al., 2017). Part of the site located within a LENZ IV category where less than 20% indigenous vegetation remains.

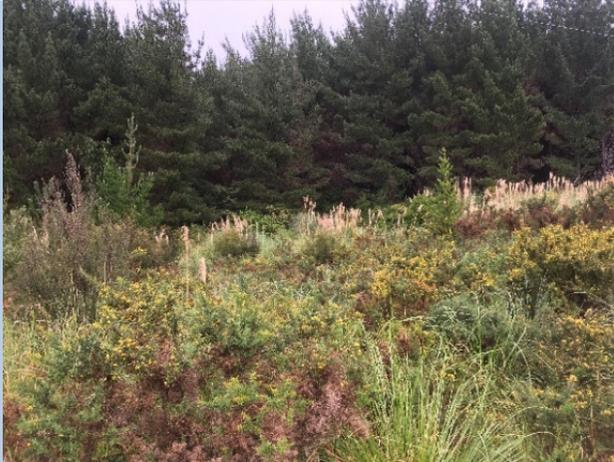
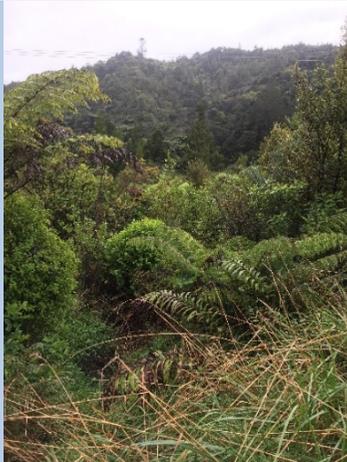
Site ID	DVF_T_Hōteao_03	
Size (ha)	4.5

Ecosystem type and vegetation description	Exotic forest (EF.1) Tall (20+ m) canopy of <i>Eucalyptus</i> with a regenerating native understorey including mā hoe, pate, karamu and mamaku.
Habitat quality	Good. Although the canopy is exotic there is dense understorey regeneration and mature <i>Eucalyptus</i> is a preferred exotic roost tree for long-tailed bats in modified landscapes.
Ecological value	Moderate.
Rationale	<ul style="list-style-type: none"> • Rates low on all ecological significance criteria due to its small size, exotic canopy, and native subcanopy and understorey of common, early successional species. • However, the emergent <i>Eucalyptus</i> trees could provide roosting habitat for Threatened long-tailed bats.
Site photos

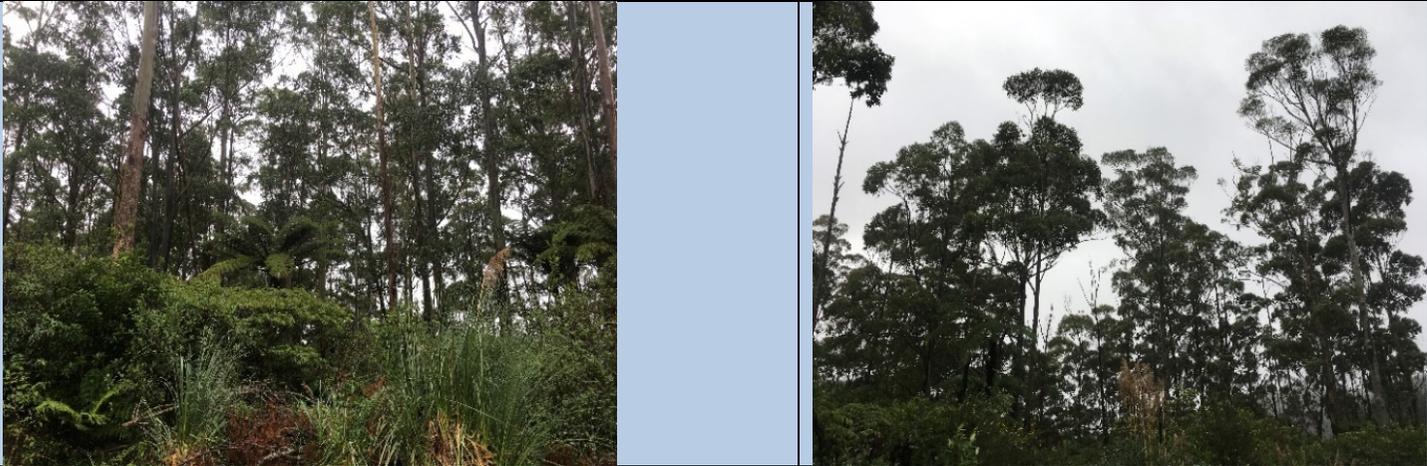
Site ID	DVF_W_Koura_01
Size (ha)	0.8
Ecosystem type and vegetation description	Exotic wetland (EW) This wetland occurs upstream of WN_W_Koura_05 described in Table 7. The two sites are contiguous but the hydrology of DVF_W_Koura_01 appears to have been modified by the construction of a forestry road through its upper reaches. Consequently, the assemblage of DVF_W_Koura_01 now differs from the raupo reedland (WN_W_Koura_05) occurring further downstream. Therefore, we have described these as separate sites. Site DVF_W_Koura_01 is surrounded by mature plantation pine, while downstream it is dominated by mercer grass and swamp millet before it grades into the raupō of WN_W_Koura_05. Upstream is transitioning into terrestrial riparian

vegetation. Pampas is prevalent along with raupo, kiokio and wheki-ponga close to the stream channel, and common riparian shrubs around the margin.	
Habitat quality	Moderate. Hydrological changes and weed species have altered the wetland community, but presence of wheki-ponga indicates remnant wetland vegetation with high restoration potential.	
Ecological value	Moderate	
Rationale	<ul style="list-style-type: none"> • Rates Low for 'rarity/distinctiveness' as the site contains some indigenous vegetation but is primarily dominated by exotic species. • Small parts of the wetland meet the rarity/distinctiveness criterion as the site sits within a LENZ IV category where less than 20% indigenous vegetation remains. Rates low or nil on all other significance criteria. • The open valley landform with surrounded mature plantation pine indicates that that the wetland could be a preferred foraging habitat for Threatened long-tailed bats.

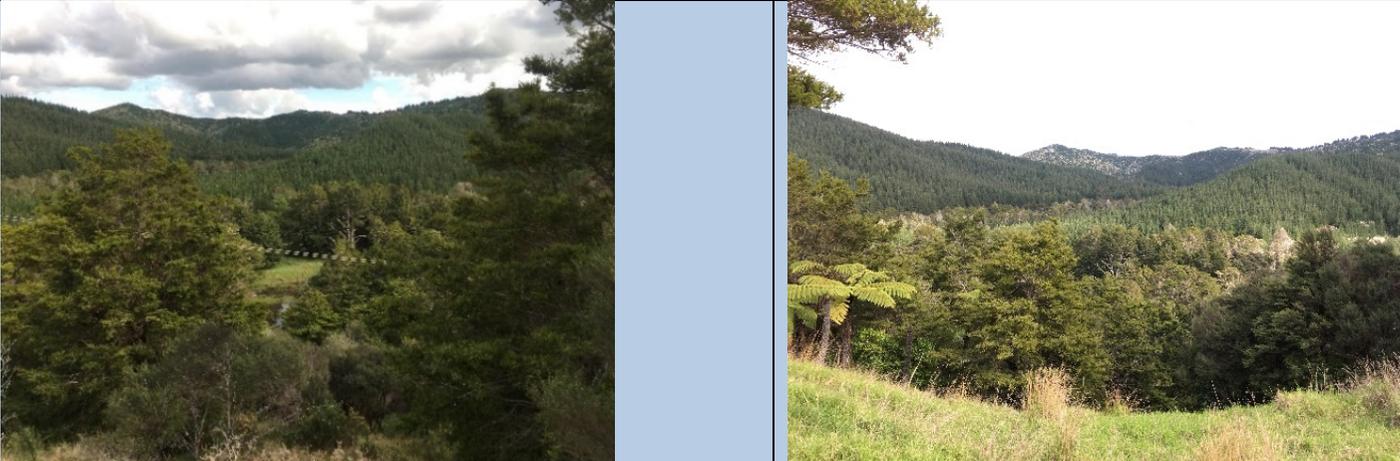
Site ID	HN_T_Hōteō_02 (SEA_T_683)
Size (ha)	11.0
Habitat type (bold) and dominant species	<p>Taraire forest</p> <p>Old growth taraire dominates the canopy along with pū riri, tī toki and pukatea. Scattered emergent trees include tō tara kahikatea and rewarewa. The regionally rare shrub kaikō mako was also recorded here.</p> <p>Riparian margin comprised largely of kā nuka, mā hoe, totara, crack willow, ribbonwood and nī kau. <i>Tradescantia</i> and rank grass dominates the groundcover along the stream margin in places where the canopy is sparse.</p> <p>The At Risk – Naturally Uncommon fern mokimoki was noted during the 2010 botanical assessments undertaken in 2011 (Bioresearches 2011).</p> <p>DOC plant records show that the At Risk – Naturally Uncommon orchid <i>Danhatchia australis</i>, which is commonly associated with taraire forest, has been identified in close proximity to the site on multiple occasions.</p>

Habitat quality	<p>Good</p> <p>Comparatively large patch of mature forest with high species diversity. The understory is largely intact although weeds are invading the margins. The stream banks are heavily scoured and lack stabilising vegetation.</p> <p>Bioresearches (2011) identified multiple <i>Amborhytida dunniæ</i> within the taraire forest comprising site HN_T_Hōteō_02. This is the location of the proposed Hōteō Viaduct (Bridge number 11).</p>

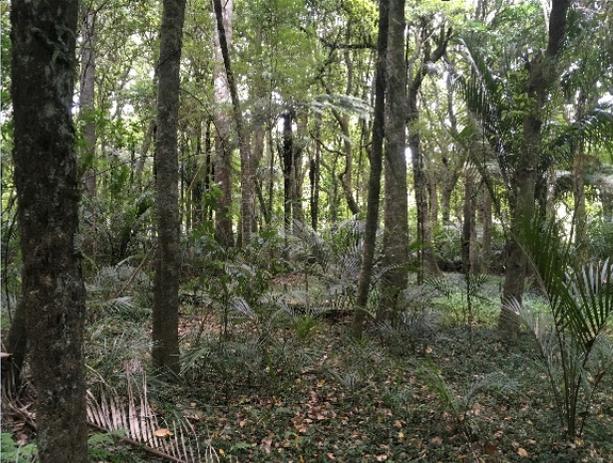
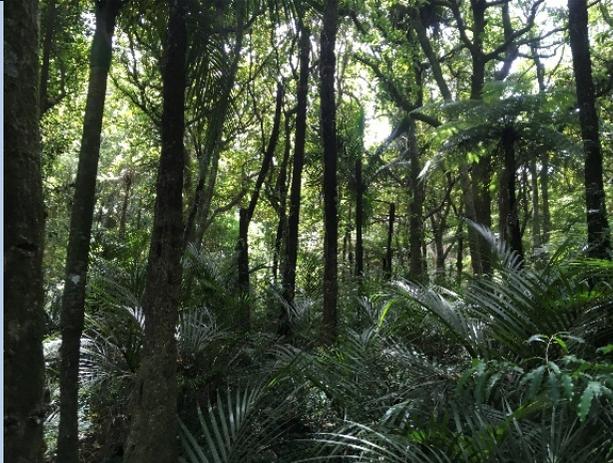
Site ID	HN_T_Hōteō_03 (SEA_T_6851)	
Size (ha)	3.0	
Habitat type (bold) and dominant species	<p>HN_T_Hōteō_03a - Kahikatea, pukatea forest (WF8) HN_T_Hōteō_03b - Machaerina sedgeland (WL11, degraded example)</p> <p>The majority (2.3 ha) of the site is kahikatea forest. The canopy is comprised of kahikatea interspersed with matai. The subcanopy/understorey is characterised by abundant kiekie as well as cabbage trees, mā hoe, and kaikomako. Tradescantia forms an almost continuous groundcover and Chinese privet dominate the margins. A group of at least 20 <i>Doodia squarrosa</i> ferns was noted during the botanical surveys undertaken to inform the SAR (Bioresearches, 2011). <i>D. squarrosa</i> is classified as At Risk – Naturally Uncommon. The sedgeland is largely dominated by exotic <i>Juncus</i> species with localised patches of flaxland with emergent cabbage trees, mā nuka and the occasional kahikatea. There are also dense patches of sharp spike sedge.</p>

Habitat quality	Moderate

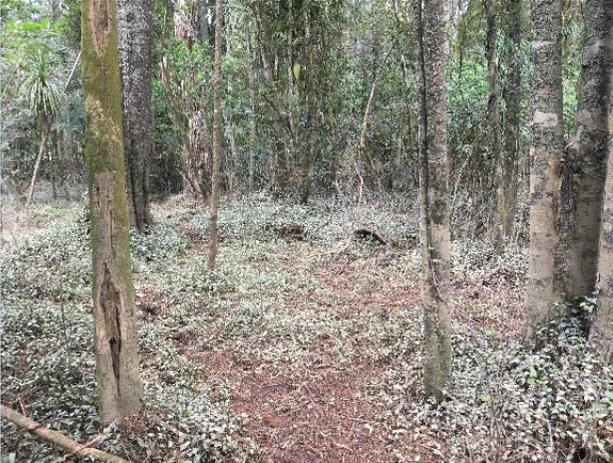
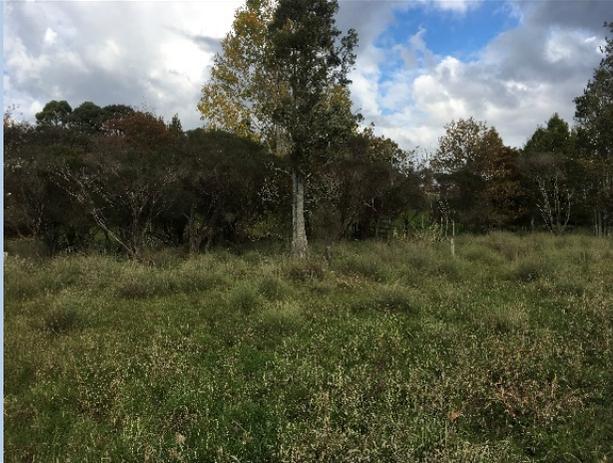
The kahikatea forest has been highly modified by deep drainage ditches and stock access. The downstream wetland also has stock access and consequently is largely dominated by exotic species that are tolerant of disturbance. The habitat condition has been assigned moderate instead of poor, due to the mature and intact kahikatea canopy and the persistence of some species diversity.	
Ecological value	Kahikatea, pukatea forest (WF8) - High Machaerina sedgeland (WL11) - Moderate	
Rationale	<ul style="list-style-type: none"> • The site is listed as SEA_T_6851 in the AUP(OP) on the basis of Representativeness', 'Threat Status and Rarity' and 'Diversity' criteria. • The Kahikatea, pukatea forest rates highly for Rarity/distinctiveness' as it supports At Risk flora and is located within a LENZ IV category where less than 20% of indigenous cover remains. • The Kahikatea, pukatea forest also rates moderately for 'Ecological context' as it provides stepping stone connectivity to other wetland and swamp forest remnants in wider landscape. • The Kahikatea, pukatea forest does not rate highly for other significance criteria as the surrounding land use has degraded the remnant and it does not reflect the biodiversity expected of this ecosystem type. The Machaerina sedgeland is also included in SEA_T_6851 but does not rate highly for any significance criteria due to the high level of degradation by stock.

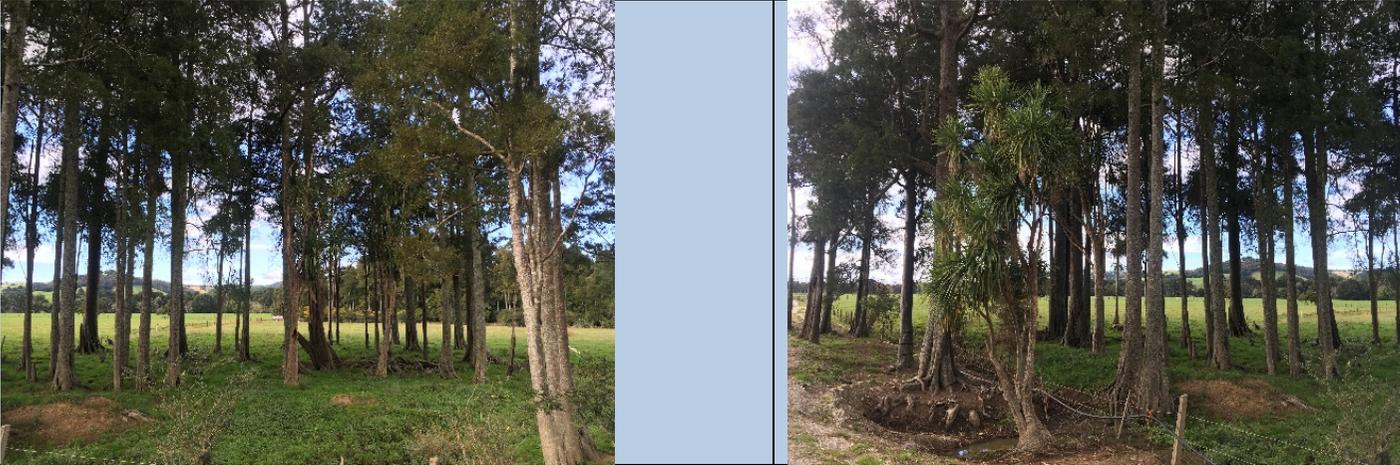
Site ID	HN_T_Hōteo_04	
Size (ha)	0.1

Habitat type (bold) and dominant species	Kahikatea treeland Kahikatea stand lacking understorey vegetation, with the exception of the occasional cabbage tree and the weed Chinese privet. The groundcover is grazed pasture grass.
Habitat quality	Poor Three very small and heavily modified stands of kahikatea trees with full stock access. Given the small total size of the stands, the benefit of restoring these stands would be limited in comparison to other modified habitats in the area.
Ecological value	Low
Rationale	<ul style="list-style-type: none"> • Rates low on all ecological significance criteria due to the site's small size and lack of diversity across all structural tiers. It should be noted that the site is located within a LENZ IV category where less than 20% of indigenous cover remains thus satisfying a single criterion of 'Rarity/distinctiveness'. • It should also be noted that the site could provide roosting habitat for Threatened long-tailed bats but the minimal habitat extent indicates that this is unlikely.

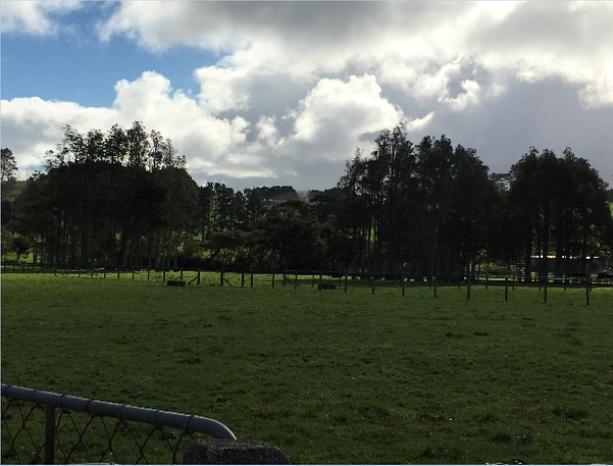
Site ID	HN_T_Hōteo_05 ⁹
Size (ha)	0.1

Habitat type (bold) and dominant species	Kahikatea treeland Three small, heavily grazed kahikatea stands. Understorey absent, and the groundcover is grazed pasture.
Habitat quality	Poor Three very small and heavily modified stands of kahikatea trees with full stock access. The small total size of the stands suggests the benefit of restoring these stands would be limited in comparison to other modified habitats in the area.
Ecological value	Low
Rationale	<ul style="list-style-type: none"> • Rates low on all ecological significance criteria due to the site's small size and lack of diversity across all structural tiers. It should be noted that the site is located within a LENZ IV category where less than 20% of indigenous cover remains thus satisfying a single subcriterion of 'Rarity/distinctiveness'. • It should also be noted that the site could provide roosting habitat for Threatened long-tailed bats but the minimal habitat extent indicates that this is unlikely.

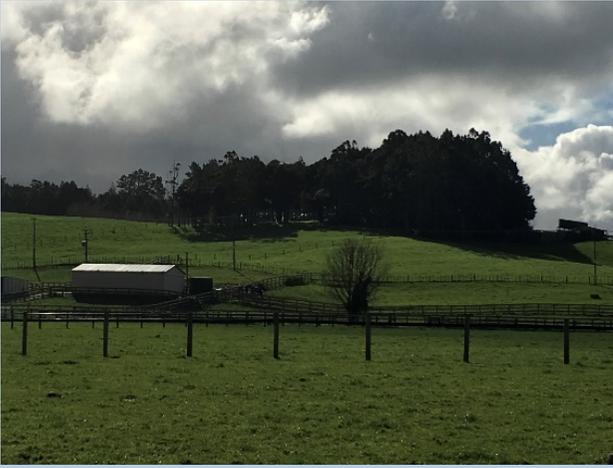
Site ID	HN_T_Hōteō_06 ¹⁰
Size (ha)	0.5

Habitat type (bold) and dominant species	Kauri, podocarp, broadleaved forest (WF11) Previous surveys (Bioresarches 2011) noted maturing totara dominates the remnant, interspersed with kauri, rimu and kahikatea. Towards the margin the podocarp canopy is replaced with mature kānuka. The understorey is modified and dominated by Chinese privet, but with a number of white maire and tītoki seedlings establishing. The structure of the remnant indicates it had been grazed until recently before the site visit in 2010.
Habitat quality	Moderate The remnant appears to be fenced with a dense understorey. However, due to access restrictions it is unknown how much of this understorey comprises native species. The site has been assessed as of 'moderate' quality due to its small size.
Ecological value	Moderate
Rationale	<ul style="list-style-type: none"> The site rates moderately for 'diversity and pattern' and 'ecological context' due to the diverse canopy tier, provision of stepping stone habitat from the Hōteoro River and the presence of native copper skink (Not Threatened; recorded by Bioresarches 2010).

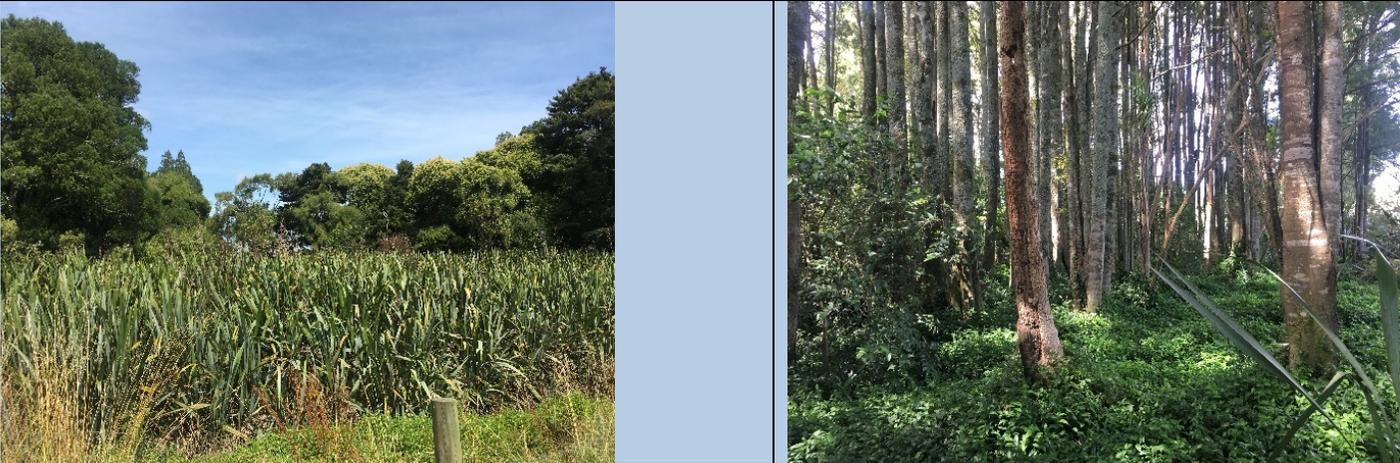
Site ID	HN_W_Hōteoro_02 (SEA_T_685)
Size (ha)	2.9
Habitat type (bold) and dominant species	Kahikatea forest (MF4)

Canopy of semi-mature kahikatea and tree privet interspersed with occasional rimu and a sparse subcanopy of Chinese privet and flax with kowhai, cabbage tree and manuka on forest margins. Tradescantia dominates the groundcover. A dense swathe of flax surrounds the margin of the stand, however the absence of seedling recruitment in the ground layer and subcanopy indicate that the remnant is impacted by stock and modifications to drainage.
Habitat quality	Moderate The native species present in the stand are indicative of a once high quality kahikatea swamp forest remnant. However, the remnant is degraded to the extent that weed species are abundant to dominant across all structural tiers. Sources of disturbance like.ly include livestock trampling and hydrological changes resulting from the surrounding agricultural land use.
Ecological value	High
Rationale	<ul style="list-style-type: none"> • The site is listed as SEA_T_685 in the AUP(OP) on the basis of ‘Representativeness’ and ‘Threat Status and Rarity’ criteria. • The site rates highly for ‘Rarity/distinctiveness’ as kahikatea forest has been classed as critically endangered in the Auckland Region (Singers et al., 2017) and this remnant represents a relatively large and intact example of this ecosystem type. The site also rates highly for ‘diversity and pattern’ and ‘ecological context’ due to the intact vegetation assemblage and its provision of ecosystem services (as an intact wetland remnant) and linkage habitat to other kahikatea forest remnants to the west of the Hōteo River.

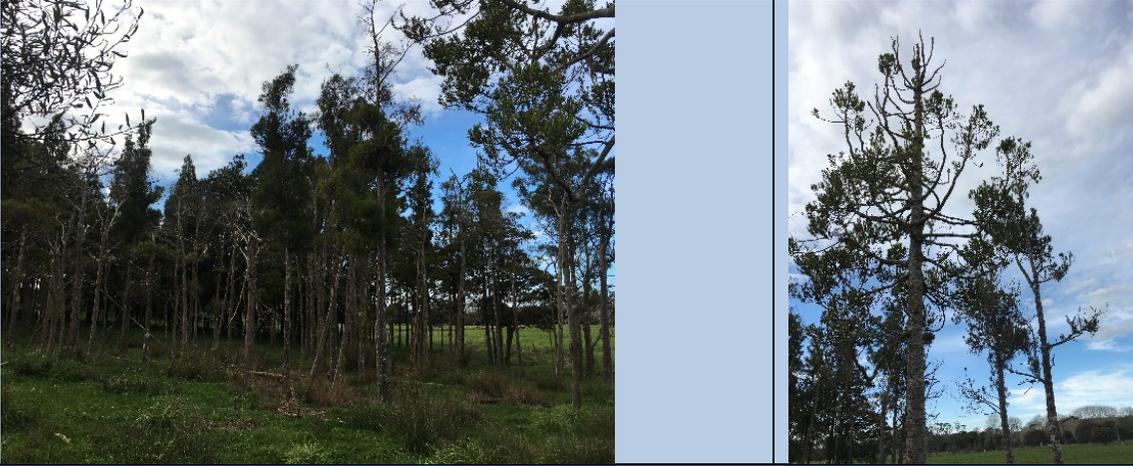
Site ID	HN_T_Hōteo_07

Size (ha)	1.5	
Habitat type (bold) and dominant species	<p>HN_T_Hōteao_07a - Kauri, podocarp, broadleaved forest (WF11) HN_T_Hōteao_07b - Anthropogenic totara forest (AVS1)</p> <p>Mixed kahikatea, rimu, totara, kauri treeland over grazed pasture grasses with Juncus tussocks in wetter areas. Little understorey vegetation due to grazing.</p> <p>Dense totara hedging on roadside with mixed broadleaved and exotic shrubs in the understorey.</p>	
Habitat quality	<p>Poor</p> <p>Heavily grazed with no native understorey. The kauri trees appear unhealthy, this may be caused by roost disturbance, wet feet, kauri dieback disease, or a combination of these factors.</p>	
Ecological value	Low	
Rationale	<ul style="list-style-type: none"> • Degraded understory and unhealthy canopy condition. • It should be noted that part of the kauri, podocarp, broadleaved forest (WF11) is located within a LENZ IV category where less than 20% of indigenous cover remains.

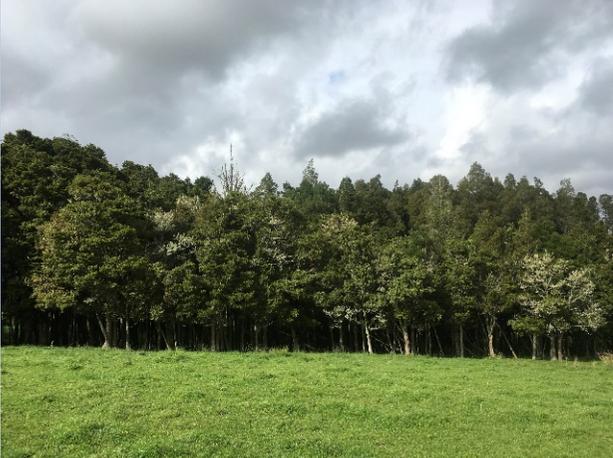
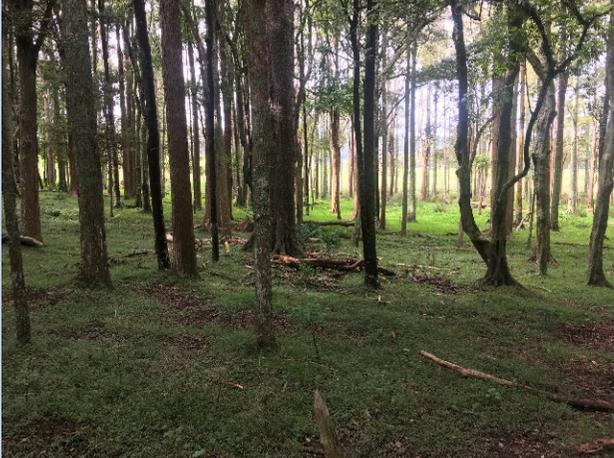
Site ID	HN_T_Hōteao_08	
Size (ha)	1.2

Habitat type (bold) and dominant species	<p>Kahikatea forest (MF4)</p> <p>Canopy of abundant kahikatea and totara with a sparse subcanopy of mā hoe, tī tōki, red mapou, cabbage tree, mamangi, kaikomako (regionally rare) and occasional Chinese privet and black maire along the margin. Groundcover comprises closely cropped native grass and a sparse assemblage of native and exotic herbs.</p> <p>A sparse rushland has also developed in the wetter pasture areas surrounding the kahikatea stand.</p>	
Habitat quality	<p>Moderate</p> <p>Tall stature podocarps that could provide roosting/nesting and foraging habitat for mobile native fauna. However full stock access has resulted in a sparse and degraded understorey. Stock were present in the remnant at the time of survey.</p>	
Ecological value	<p>High</p>	
Rationale	<ul style="list-style-type: none"> • The site rates moderate for ‘rarity/distinctiveness’ as kahikatea forest has been classed as critically endangered in the Auckland Region (Singers et al., 2017) and the site supports the regionally uncommon plant species kaikō mako. • The site rates moderately for ‘ecological context’ as the remnant provides stepping stone habitat for mobile species across the pastoral landscape. • The site is a mature forest remnant with some diversity in the canopy and subcanopy tiers. However, stock access has resulted in a degraded understorey and the ground cover layer is almost completely absent.

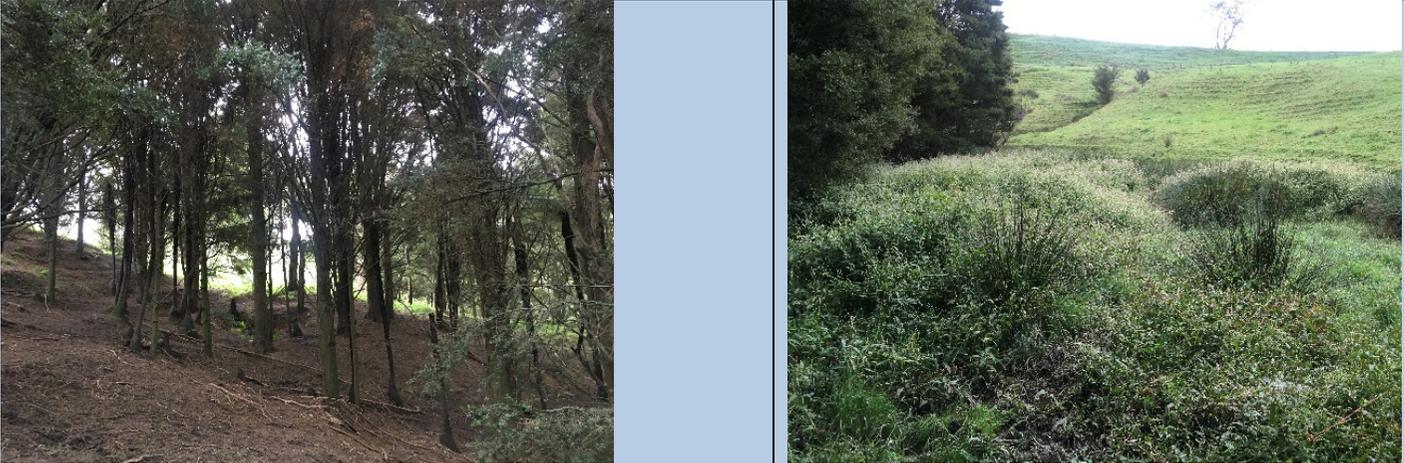
Site ID	HN_T_TeHana_01b - Exotic wetland (EW)
Size (ha)	0.6 ha
Habitat type (bold) and dominant species	This wetland extends downslope of the remnant into open pastureland. The wetland covers approximately 0.6 ha. It is pugged by stock and dominated by exotic water pepper and soft rush.
Habitat quality	Poor Wetland is degraded.
Ecological value	Exotic wetland (EW) - Low
Rationale	
Site ID	HN_W_Hōteao_01 (SEA_T_6854)
Size (ha)	0.7
Habitat type (bold) and dominant species	Flaxland (WL18) Wetland comprised of a mosaic of microhabitats each often dominated by a single species. These species include mānuka, harakeke, raupō and <i>Carex</i> species. The southern margin is fringed by exotic water pepper.
Habitat quality	Good A small but high quality wetland with a species composition that is rare in the Auckland Region.
Ecological value	High
Rationale	<ul style="list-style-type: none"> • The site is listed as SEA_T_6854 in the AUP(OP) on the basis of 'Threat Status and Rarity'. • Rates highly for 'rarity/distinctiveness' as: <ul style="list-style-type: none"> • Flaxland (WL18) ecosystems have been classified as Critically Endangered in the Auckland region using the IUCN classification system (Singers et al., 2017); • The site is located within a LENZ IV category where less than 20% indigenous vegetation remains; and • The site comprises indigenous vegetation that occurs within an indigenous wetland ecosystem. • The site rates moderately for 'diversity and pattern' as although the remnant is small (0.7 ha) it contains a variety of microhabitats with a species richness typical of Flaxland ecosystems.

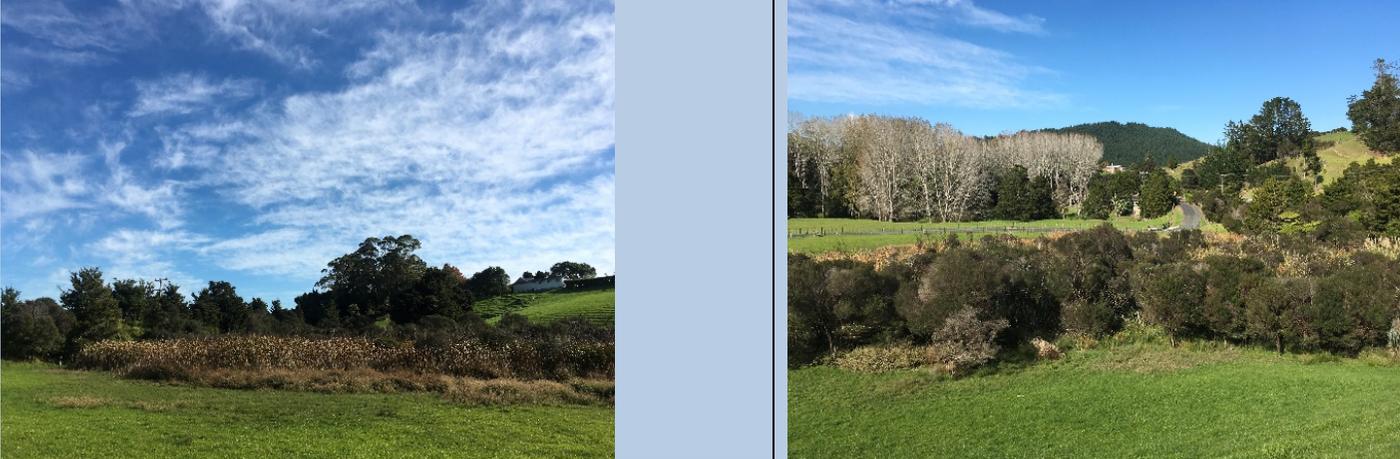
Site ID	HN_W_Hōteao_03 ¹¹
Size (ha)	0.4
Habitat type (bold) and dominant species	Exotic wetland (EW) The wetland has complete stock access and is consequently highly degraded. The vegetation assemblage is dominated by exotic species including soft rush, pasture grasses, buttercup water pepper and starwort.
Habitat quality	Poor Highly degraded wetland, dominated by exotic species and closely cropped pasture grasses.
Ecological value	Low
Rationale	<ul style="list-style-type: none"> The site rates low for all ecological significance criteria due to its small size (0.4 ha), lack of indigenous vegetation, and high level of functional degradation resulting from stock access.

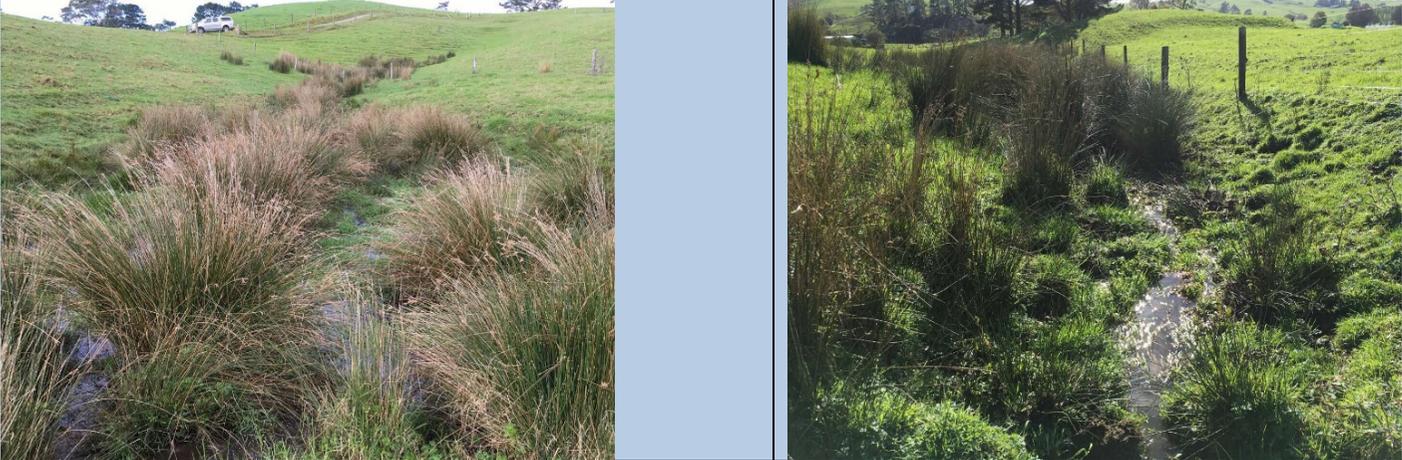
Site ID	HN_W_TeHana_01 ¹²
Size (ha)	2.1
Habitat type (bold) and dominant species	<p>Exotic wetland (EW)</p> <p>This site is relatively large (2.1 ha) comparative to other wetlands in this LCA, which are all located within an agricultural land use area. Notwithstanding its size, the wetland has complete stock access and is consequently highly degraded. The vegetation assemblage is dominated by exotic species including soft rush, pasture grasses and buttercup. There are also scattered stands of totara across the upper reaches.</p>
Habitat quality	<p>Poor</p> <p>Highly degraded wetland, dominated by exotic species and closely cropped pasture grasses.</p>
Ecological value	Low

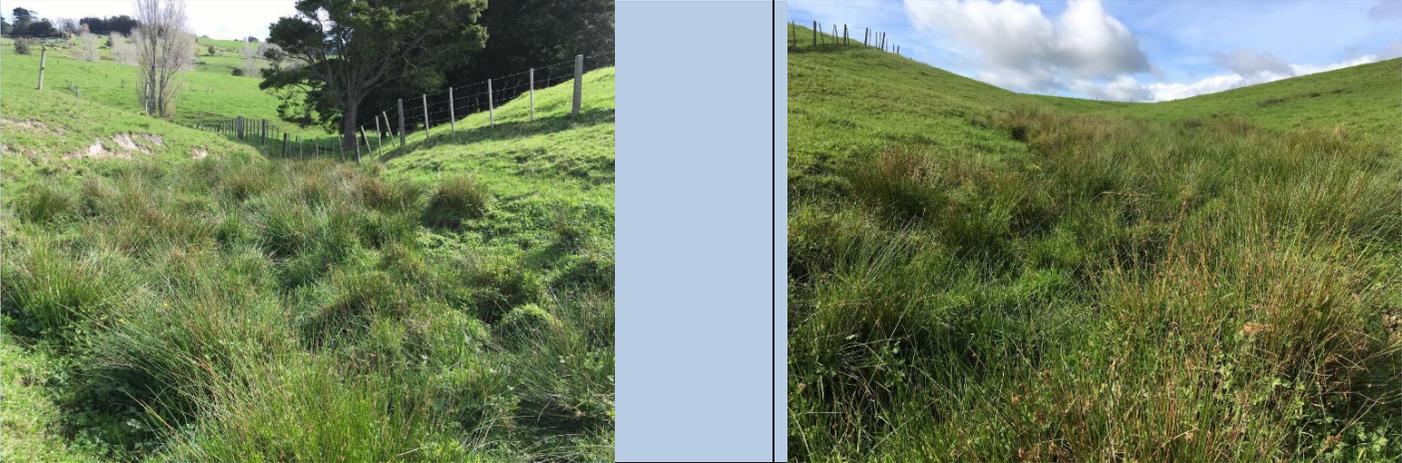
Site ID	HN_W_TeHana_02
Size (ha)	0.6
Habitat type (bold) and dominant species	<p>Exotic wetland (EW)</p> <p>Rushland with full stock access. The site is heavily pugged and contains a closely cropped flora assemblage comprising of soft rush, buttercup, Yorkshire fog, pasture grass, and patches of sphagnum moss. Water pepper was also abundant in the wetter areas. The margin of the lower reaches was lined with mature poplars (necklace and Lombardy), crack willow and the occasional juvenile kānuka.</p>
