Warkworth to Wellsford

Ecology Assessment

July 2019

Document title: Ara Tūhono Project, Warkworth to Wellsford Section; Ecology Assessment

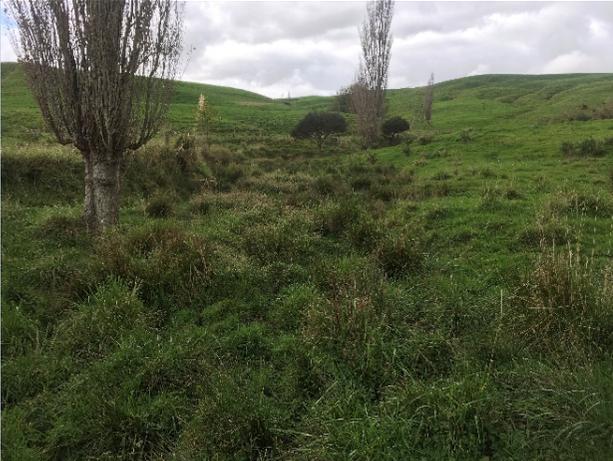
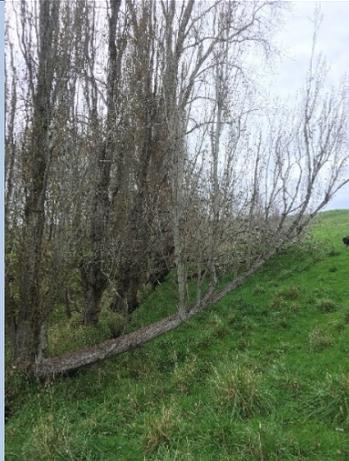
Habitat quality	<p>Poor</p> <p>Conversion to pasture and stock access has changed the hydrology and species assemblage of this wetland. Consequently, it is now dominated by exotic species and there is limited habitat for native wetland fauna.</p>
Ecological value	Low

<p>Rationale</p>	<ul style="list-style-type: none"> • The site rates low for all ecological significance criteria due to its lack of indigenous vegetation, and high level of functional degradation resulting from stock access. • Located within a LENZ IV category where more than 20% of indigenous cover remains. • The structure and quality of the wetland vegetation indicates that the site would be unlikely to be occupied by Threatened or At Risk marsh birds. • The poplars and willows on the margin of the lower reach have the capacity to provide roosting habitat for Threatened long-tailed bats. However, the lack of connectivity to large forested areas indicate that occupation by bats is unlikely. 		
<p>Site photos</p>

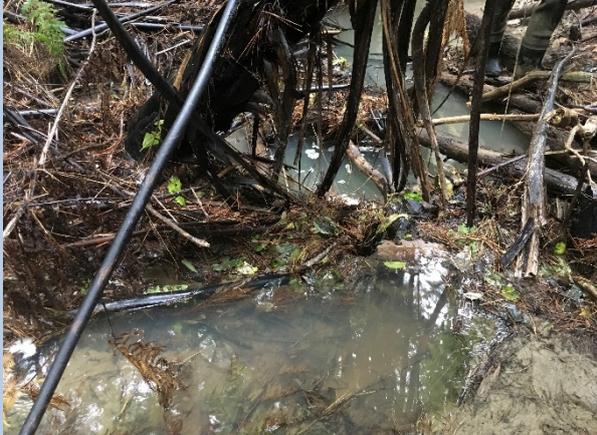
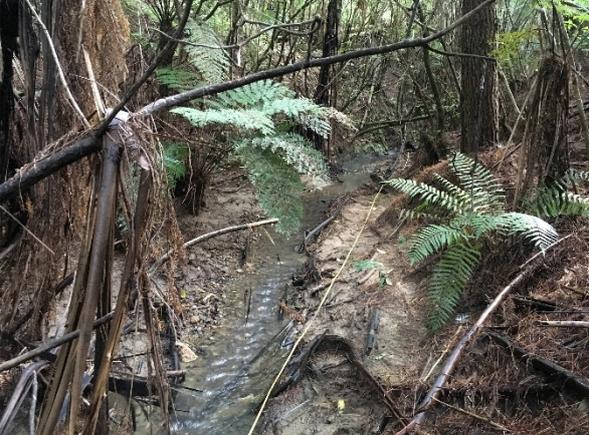
Site DVF_F_Koura_1	Site DVF_F_Koura_1
a) stream channel	b) stream channel

Figure 3 - Photos of survey sites within the Dome Valley Forest Section.

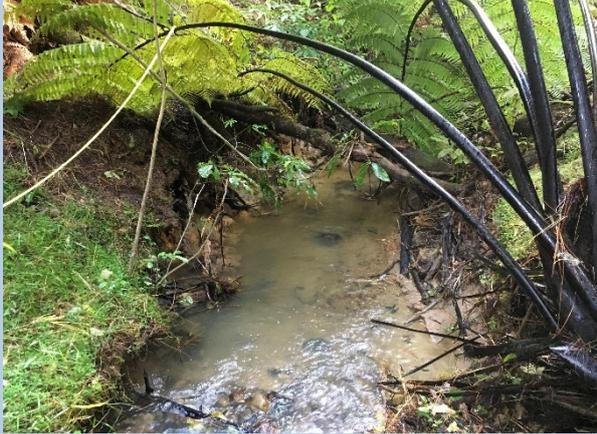
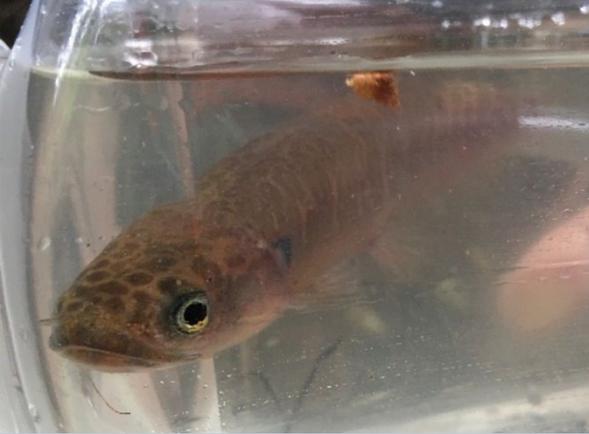
Site DVF_F_Hōteō_1	Site DVF_F_Hōteō_1
c) stream channel	d) banded kokopu

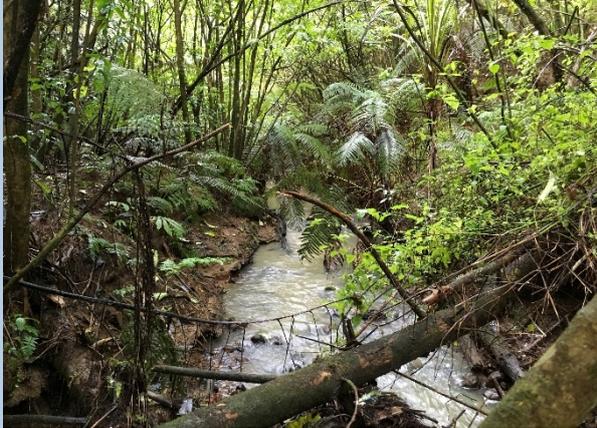
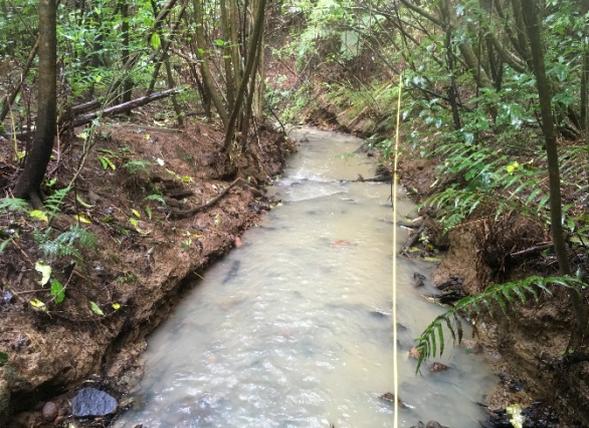
Site DVF_F_Hōteō_2-1	Site DVF_F_Hōteō_2-1
e) stream channel	f) stream channel

A tributary (DVF_F_Hōteō_2a) within the Dome Valley Forest section of the proposed designation was inspected and described, and suitable habitat (loose rocks and debris within the splash zone of the stream, and within fractures in the faces of waterfalls) were searched.
