**Ground Contamination
Assessment of
Environmental Effects**

**Ryman Village, Kohimarama Road,
Auckland**

Prepared by
Tonkin & Taylor Ltd

Date
November 2019

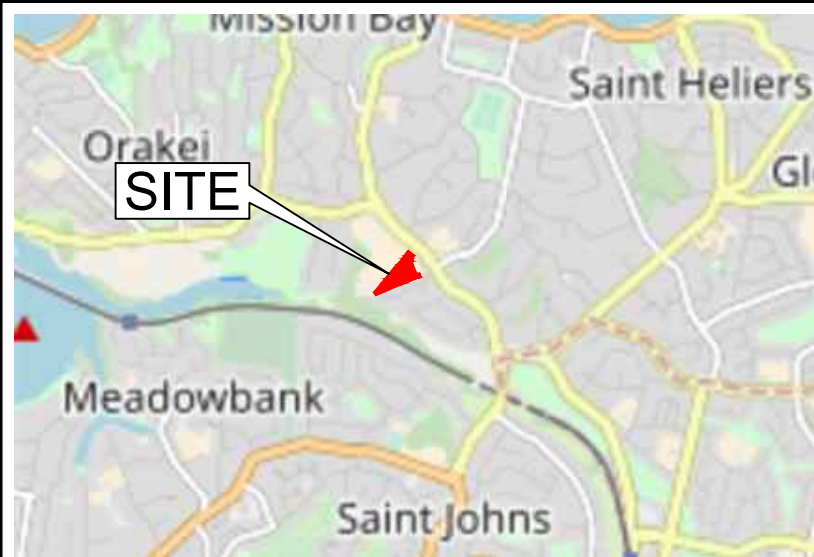
SITE LOCATION
SCALE 1:1000

Contaminant source/area of interest	Investigation scope	T+T (2018) Investigation location
Area of filling (sports field).	Collection of samples using hand augers on an approximate 20 m grid. Samples collected from 0.1 m at all locations, with additional samples collected from 0.4 m based on field observations. Samples analysed for metals, asbestos, OCPs and PAHs.	HA06-HA12
Potential historic use of persistent pesticides.	Sampling on an approximate 20 m grid across the Site (including 7 John Rymer Place). Samples collected from 0.1 m at all locations, with additional samples collected from 0.5 m and 1.0 m based on field observations to target reworked material. All samples analysed for metals and PAHs. Selected samples analysed for OCPs and asbestos.	HA1-HA5, HA13-HA24, BH1, BH2, BH5
Potential contamination associated with Selwyn College Maintenance Shed.	Surface soil sample only. Analysed for metals, PAHs and TPH.	EHA01

Fly-tipping near northern boundary.	Surface soil sample only. Analysed for metals, PAHs and TPH.	Grab01

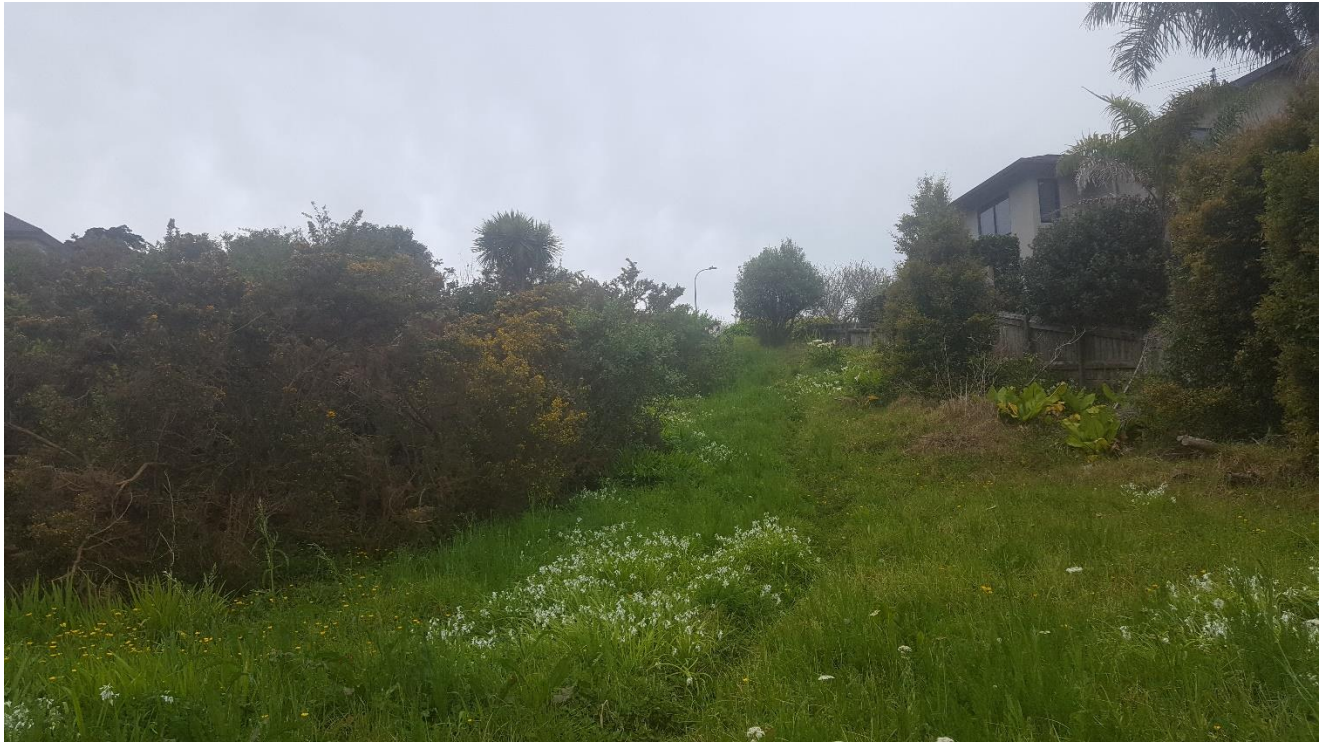
Photograph 1: View of boundary between 7 John Rymer Pace and 223 Kohimarama Road (looking north) consisting of native bush.

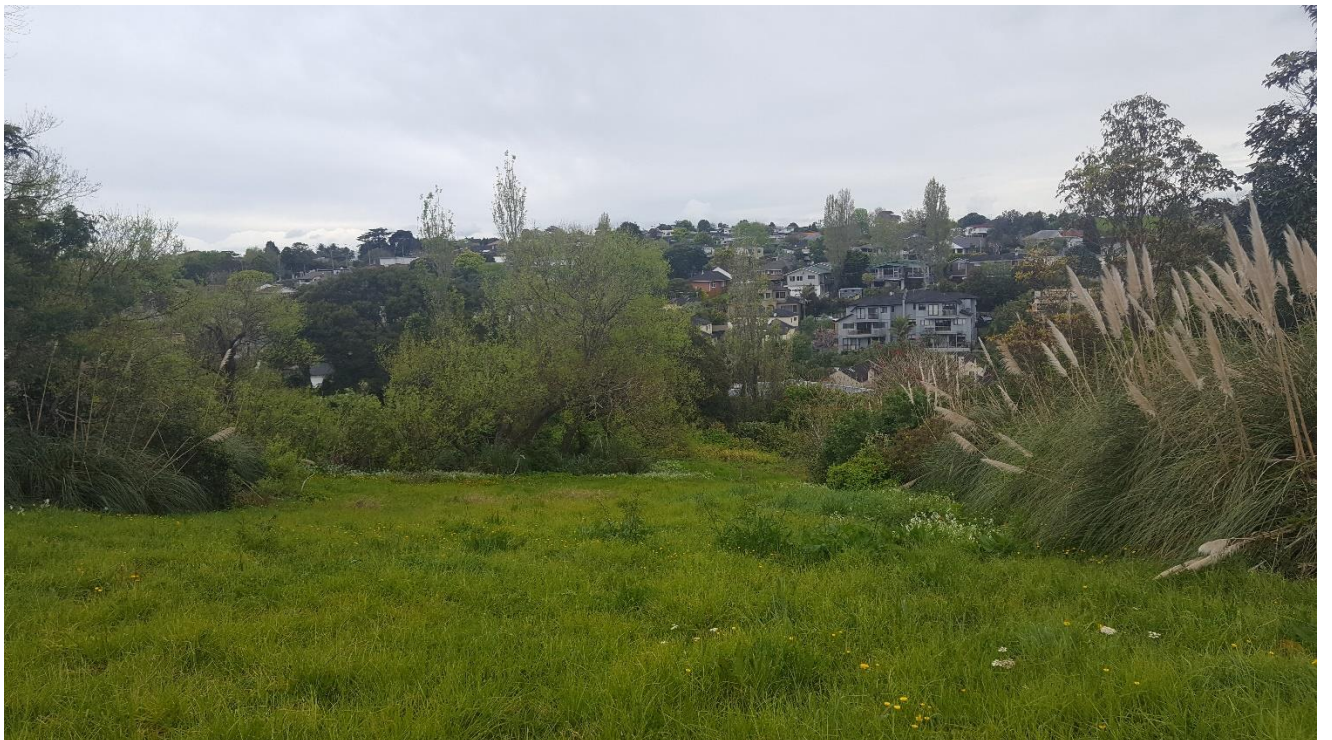
Photograph 2: Site vegetation coverage consisting of predominantly overgrown grassy areas with patches of shrubbery and native and exotic trees.

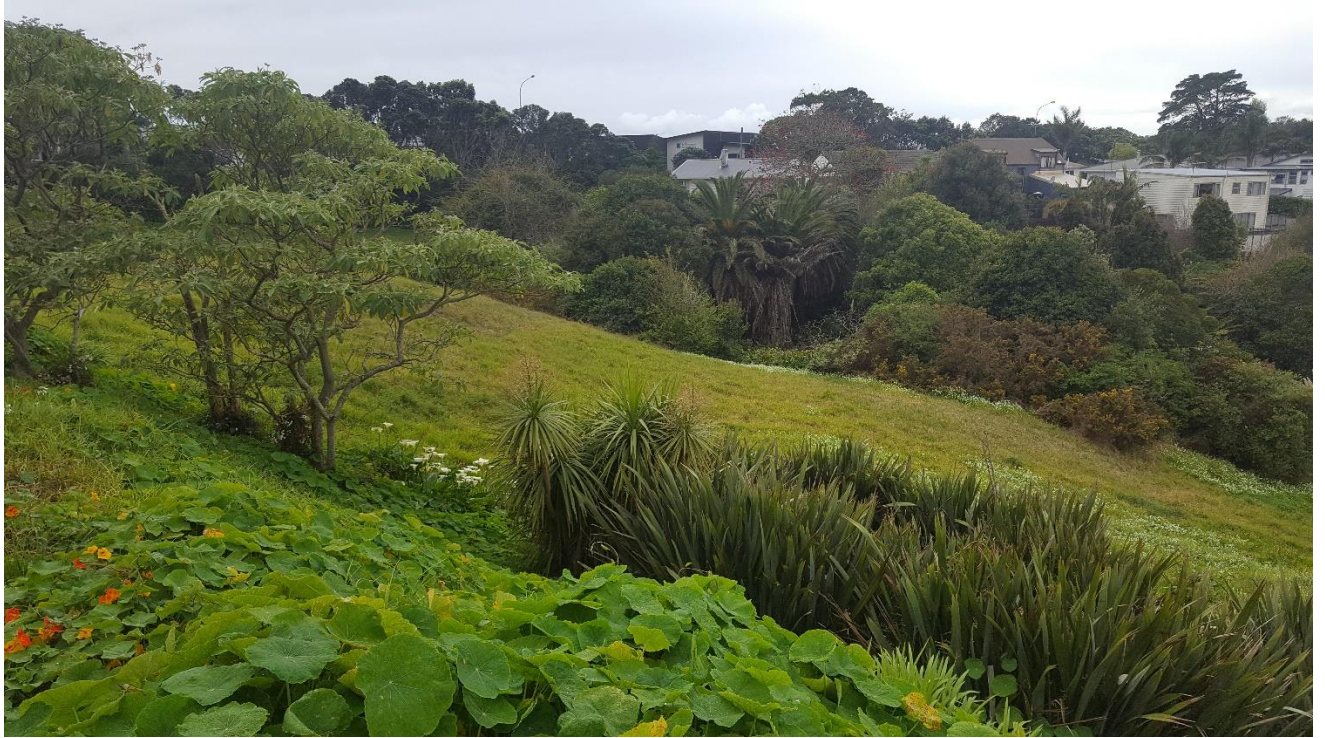
Photograph 3: Example of site vegetation consisting of native and exotic plants/trees.

- The property is currently a large vacant residential lot and is predominately covered by grass with patches of native and exotic shrubs and trees (Photographs 2 and 3).

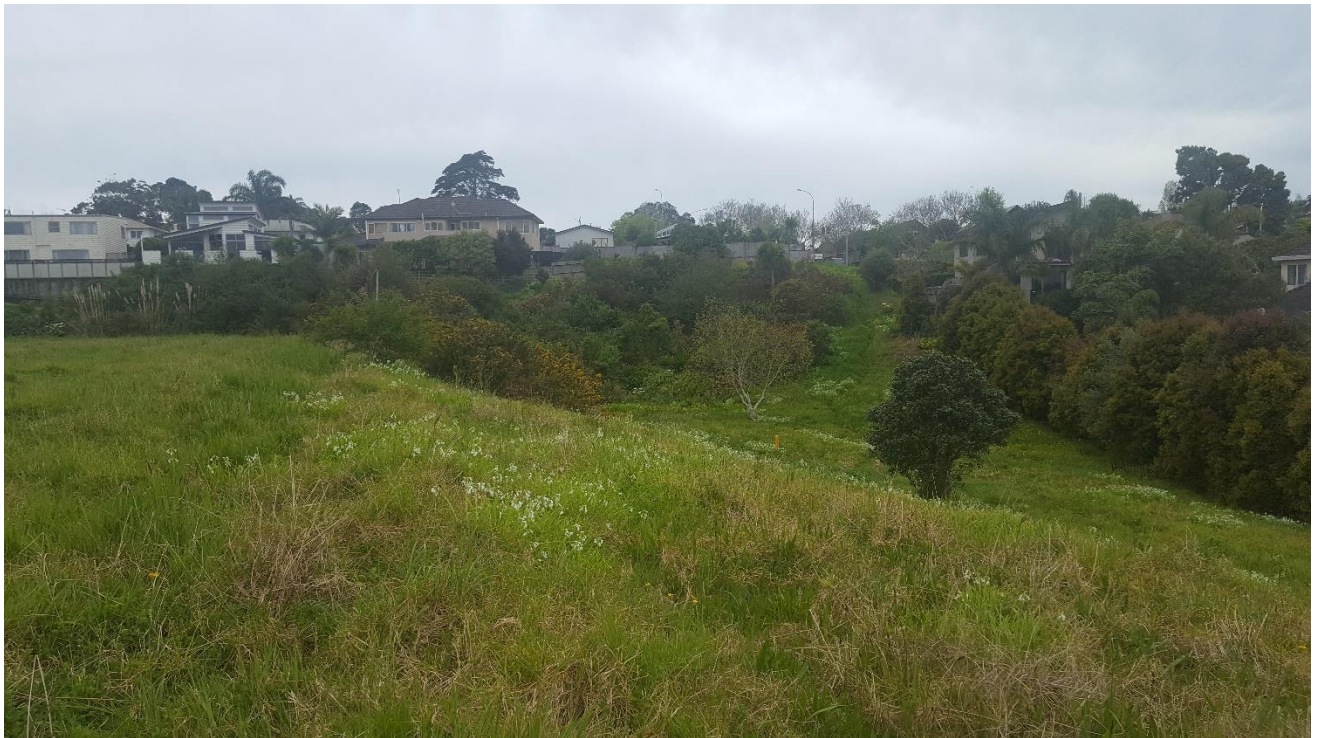
Photograph 4: Site landform looking north which slopes to the south east towards the base of the valley and residential houses.

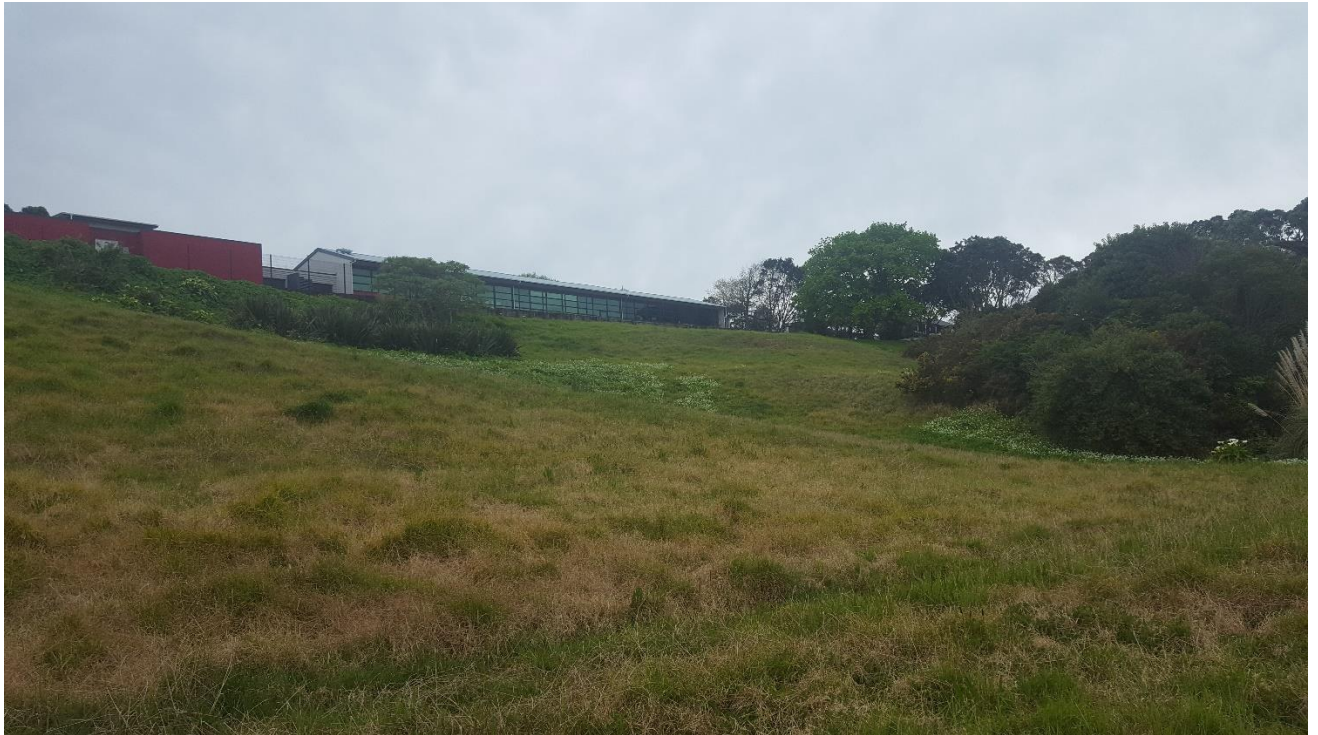
Photograph 5: Site landform looking north west which slopes to the south east. Selwyn College is present at the top of the hill.

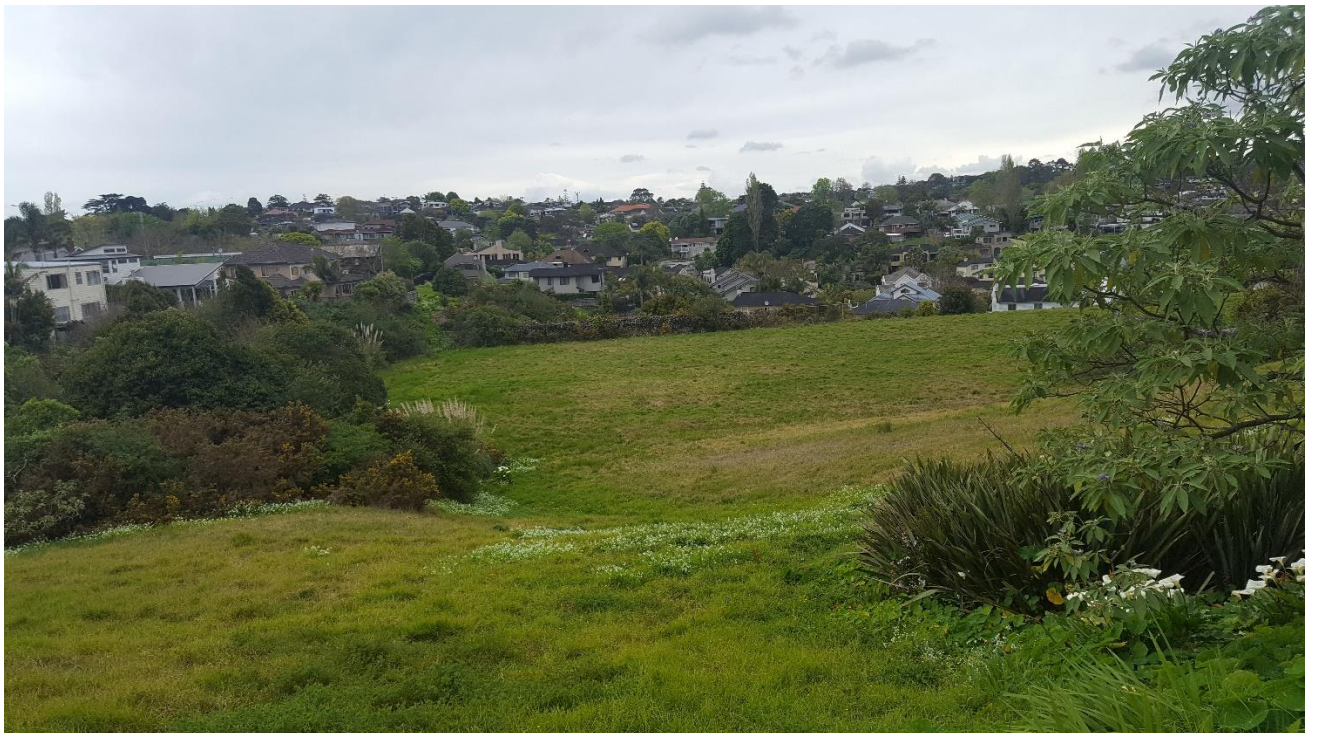
Photograph 6: North west portion of the site slopes towards levelled playing field in the south east. Levelling for the playing field has infilled former natural drainage channels / gully.

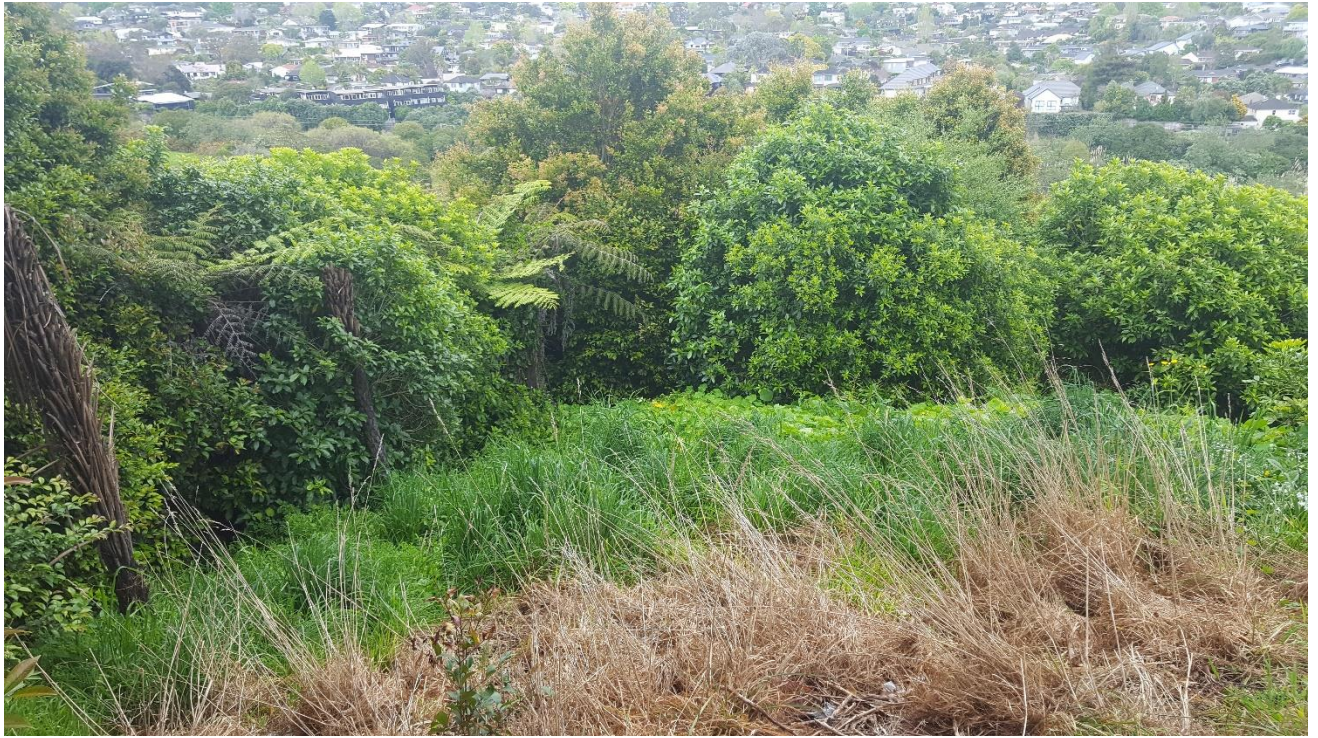
Photograph 7: Dense vegetation covering south west portion of the site.

- The south western third (approximate) of the property is largely covered with native and exotic trees and shrubs. Central and northern portions of the property are also covered with exotic trees and shrubs and grass (Photograph 7).

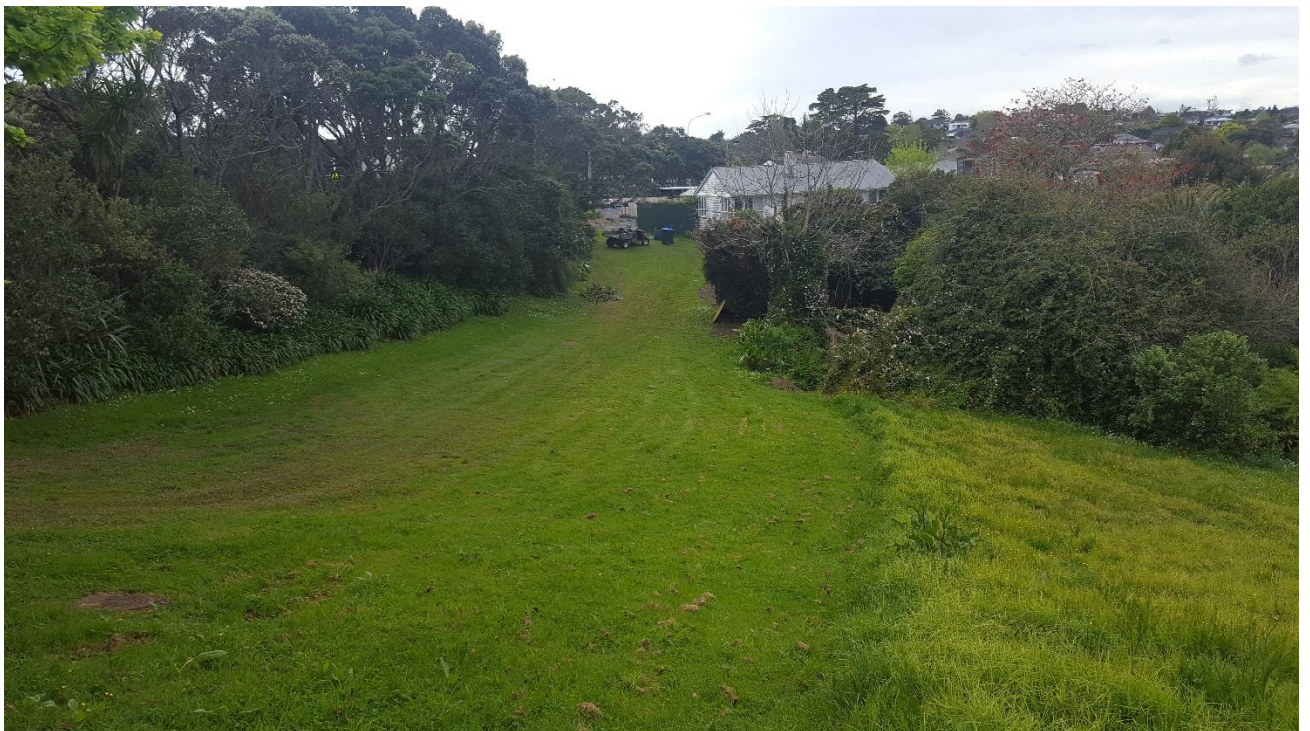
Photograph 8: Mowed area parallel to Kohimarama Road, looking east. Caretaker's property in the distance with maintenance equipment parked in the driveway.

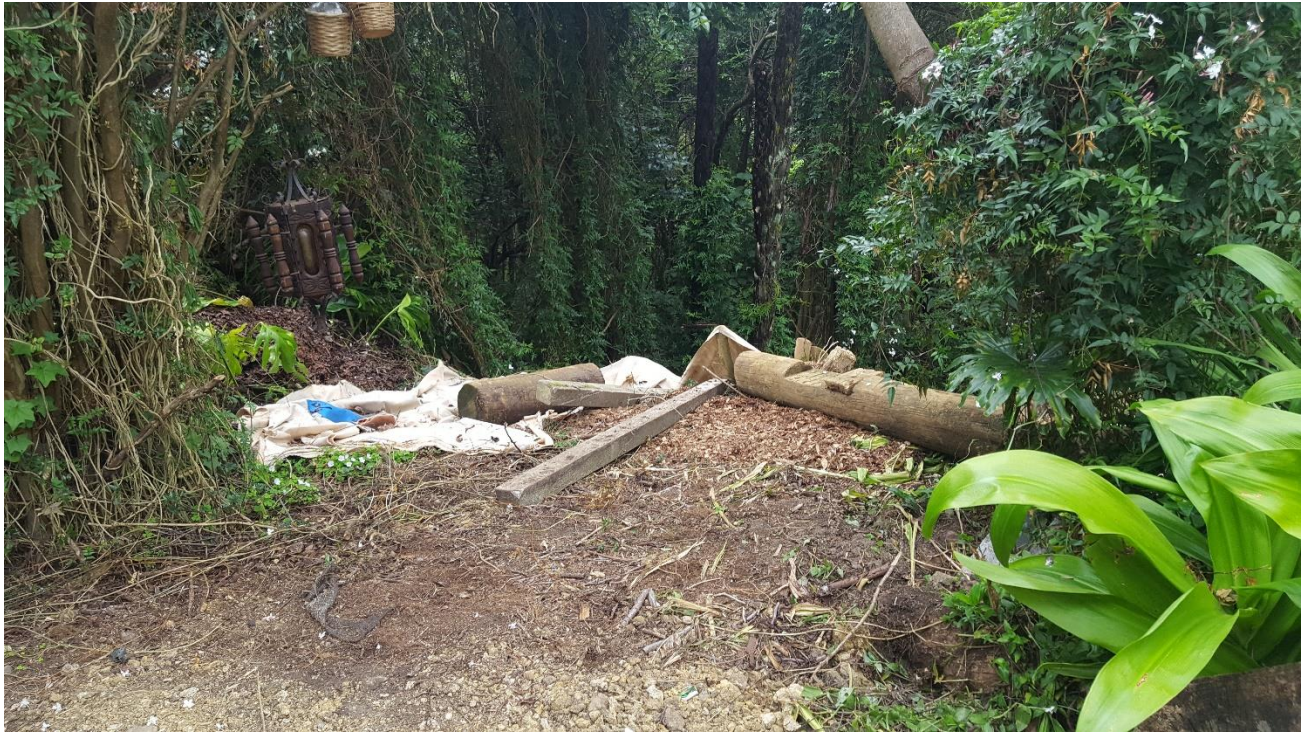
- Evidence of minor and localised (less than 1 m³) fly tipping was observed in the vegetated area in the north east corner of the property near the boundary with 245 Kohimarama Road (Photographs 9 and 10).

Photograph 9: Area of ground disturbance and apparent fly tipping next to Caretaker's residence.

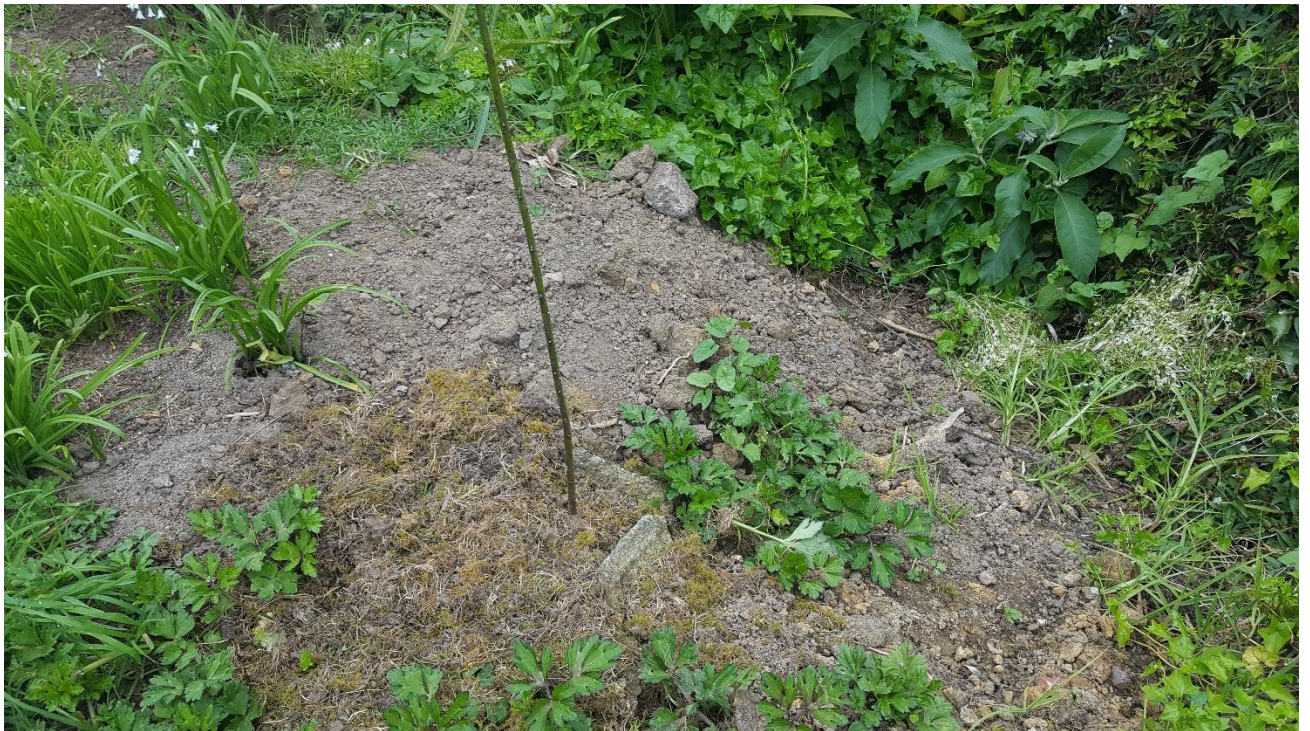
Photograph 10: Area of ground disturbance near the Caretaker's residence. Evidence of potential fly tipping.

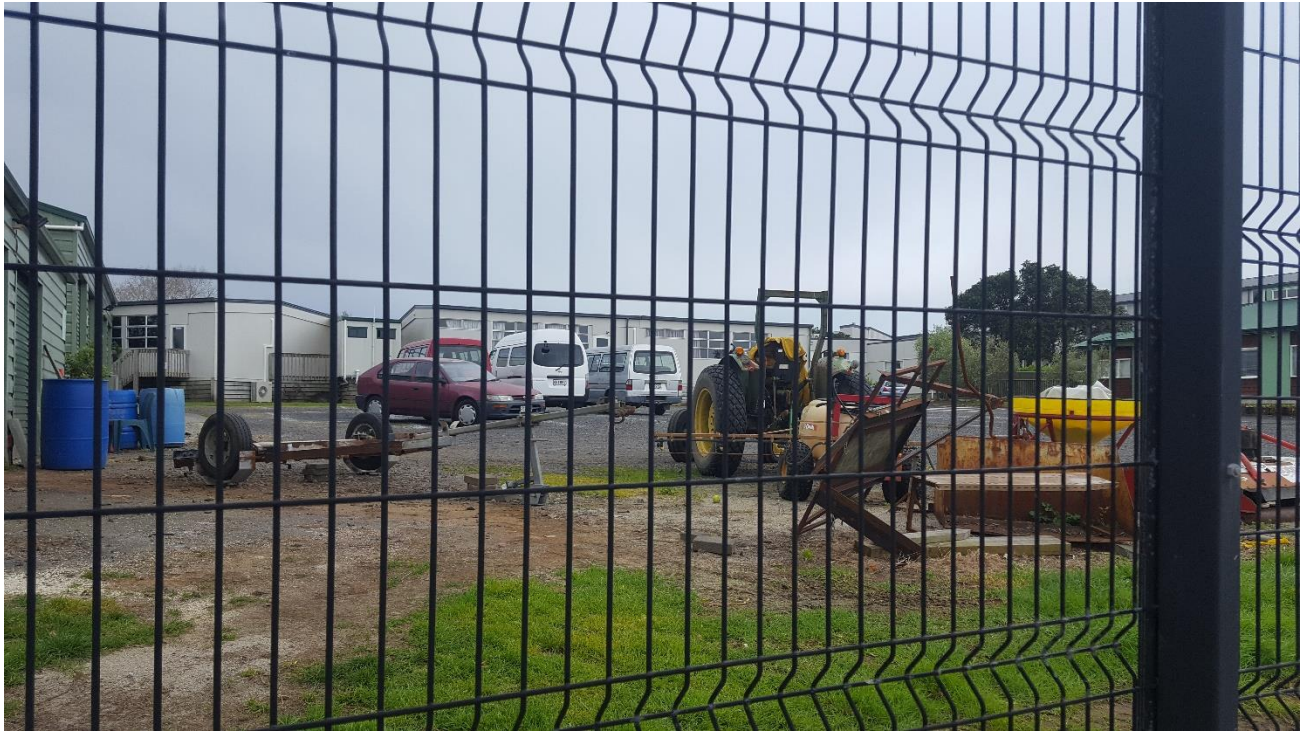
- No buildings were observed on site. However, maintenance sheds and/or workshops and a laydown area on Selwyn College were observed up against the western boundary of the site. Mowing equipment and other grounds-maintenance machinery was parked here and potential refuelling and mechanical maintenance works appear to have occurred in this area (Photograph 11).

Photograph 11: Selwyn College maintenance and laydown area.
