Appendix 28

Marine Ecology and Coastal Avifauna Effects Assessment

Eastern Busway

EB3 Commercial and EB4 Link Road

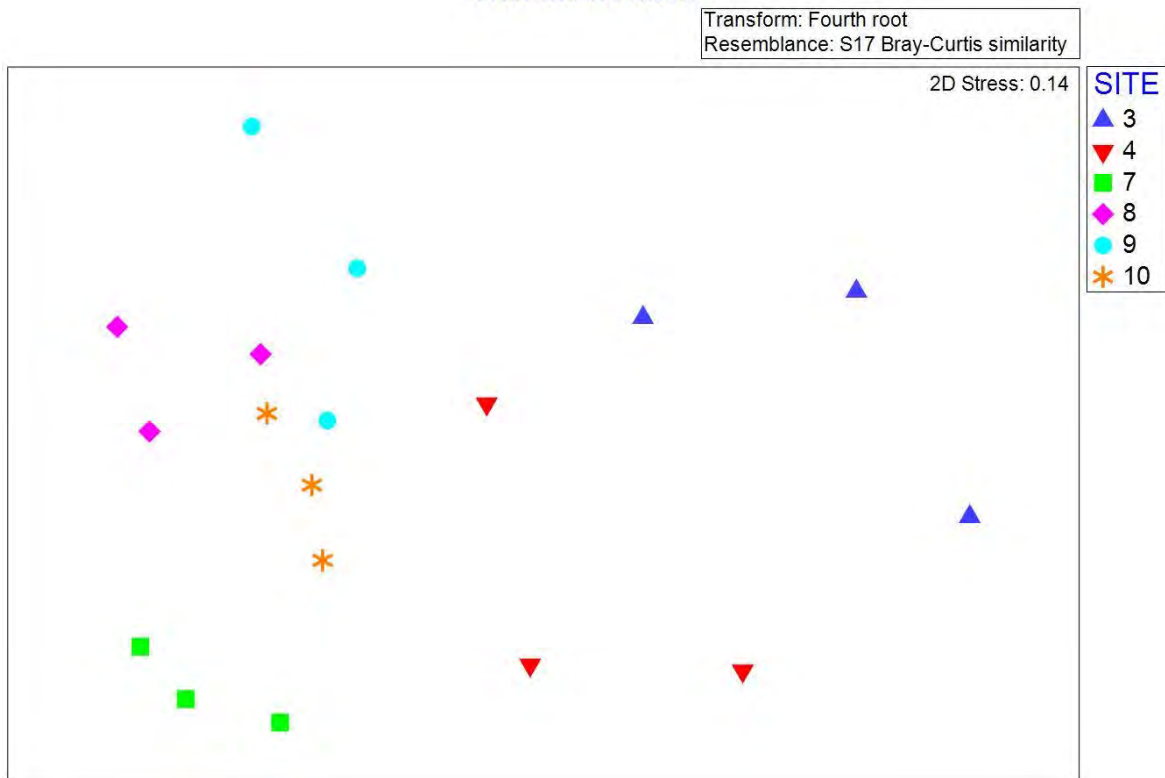
Figure 12: MDS of benthic community composition at bridge structural element sites.

The difference in benthic invertebrate assemblages at selected bridge structural elements sites is shown in the Multi-Dimensional Scaling (MDS) Plot²³ below (Figure 12), with most sites clustered separately, particularly Sites 7-10 (Figure 5) adjacent to the proposed location of Bridge B and the habitat adjacent to the existing bridge abutments over the Pakuranga Creek (near the proposed location of Bridge A).

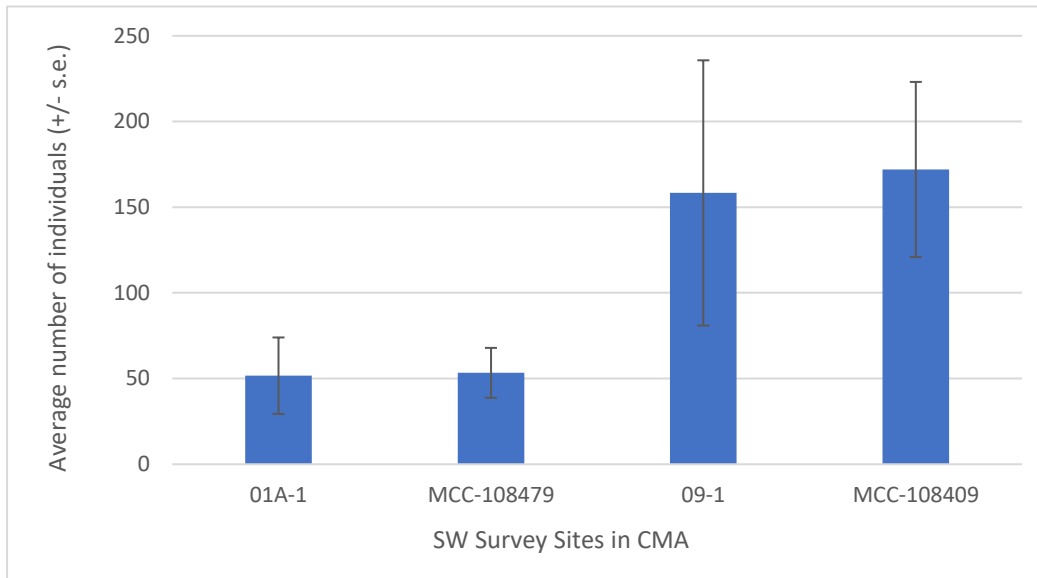
Figure 13: Average number of individuals at stormwater sites in CMA (refer to Figure 6 for site locations).

The average number of benthic invertebrate individuals ranged between approximately 50 at outfalls 01A1 and MCC-108479 (Figure 6) and approximately 150 per core at outfalls 09-1 and MCC-108409 (Figure 13). The number of taxa varied between 8 and 14 at the surveyed stormwater outfall sites (Figure 14).

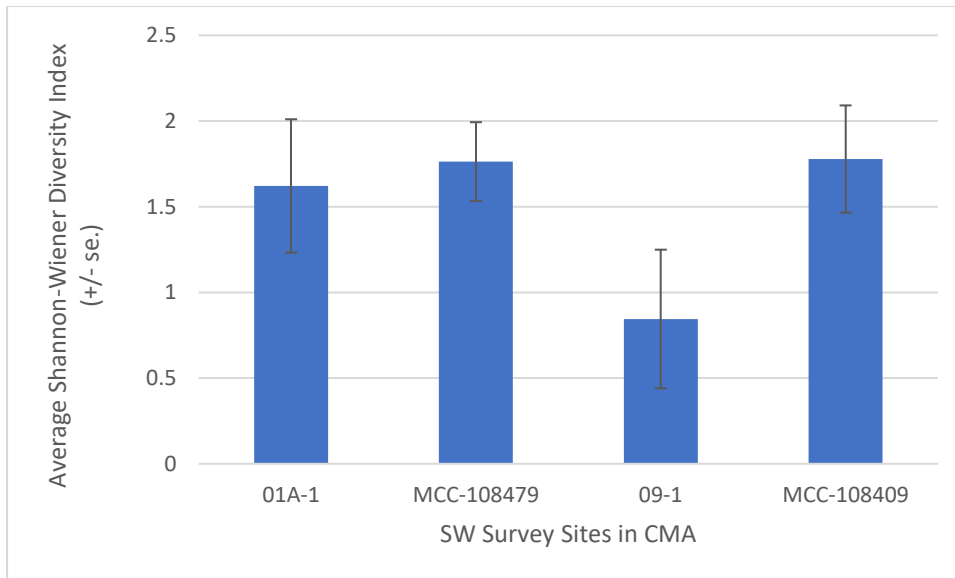
Figure 15: Average Shannon-Wiener Diversity Index at stormwater sites in CMA (refer to Figure 6 for site locations).

Shannon Wiener Diversity was lowest at outfall 09-1 (<1), with the other three sites having an index of around 1.5 (Figure 15). Most sites contained a range of gastropods, bivalves, amphipods and some oligochaete worms, whereas site 09-1 was dominated by oligochaete worms (Figure 16).

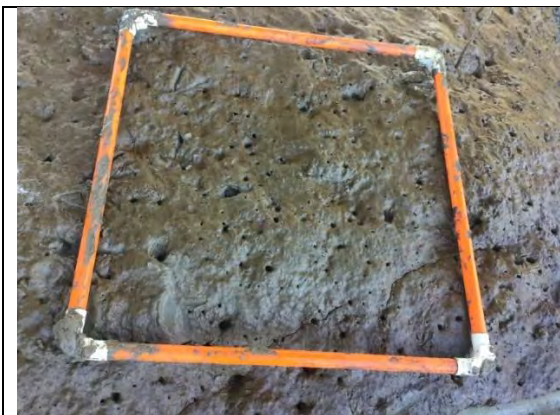
Photo 11: Site 3 – Crab and worm holes.

Representative photographs of benthic habitat at surveyed Bridge structural elements (Photo 11 to Photo 16) and new/upgraded stormwater outfall sites (Photo 17 to Photo 20) are included below. Sunlight exposed sites exhibited extensive mangrove seedling and pneumatophores and some gastropods (*Potamopyrgus estuarinus*). Although not captured in the quadrat photographs collected *Amphibola crenata* (mud snail) were present at some sites along with mangrove stands.

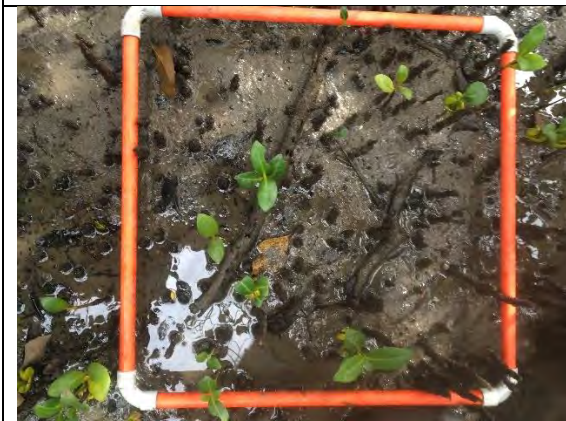
Photo 15: Site 9 – Mud crab burrows, mangrove pneumatophores and seedlings.

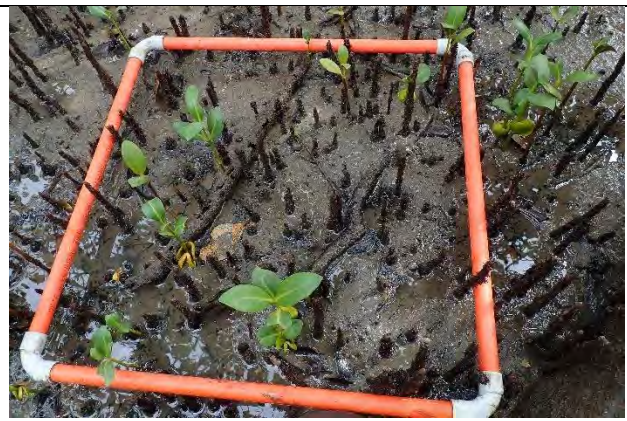
Photo 16: Site 10 – Mud crab burrows, and mangrove pneumatophores and seedlings.

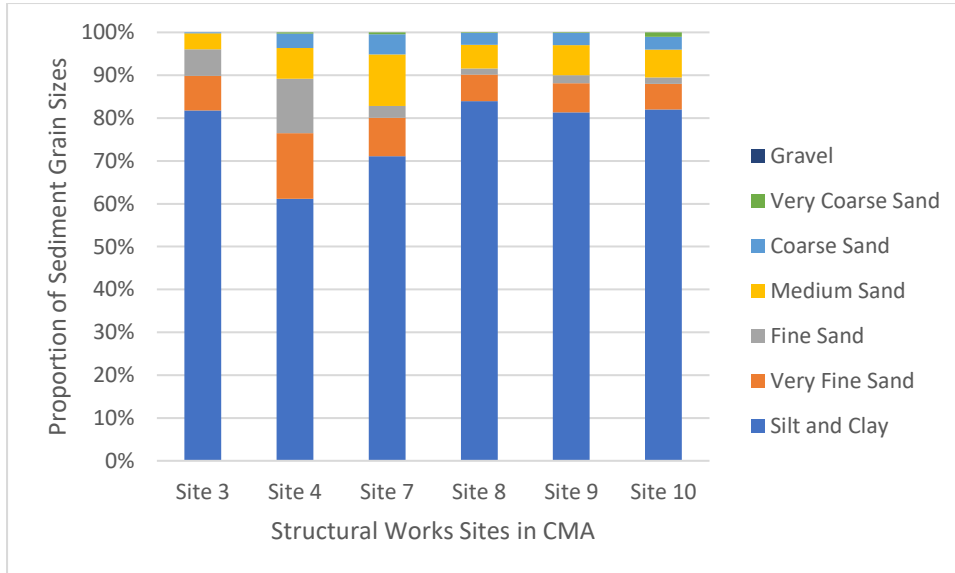
Figure 18: Proportion of sediment grain size distribution in surface sediment at structural works sites (refer to Figure 5 for site locations).

Surface sediment at all sites was dominated by silt and clay and had shallow depth of oxygenated sediment (Figure 18 and Figure 19). Silt and clay at all sites were >50% for structural works sites (Figure 18). For the stormwater sites, Site 01A-1 and MCC-108409 silt and clay was >50%, whereas Sites MCC-108479 and SW 09-1 comprised <30% and c.15% respectively (Figure 19). A high proportion of silt and clay is typical of upper estuarine depositional environments.

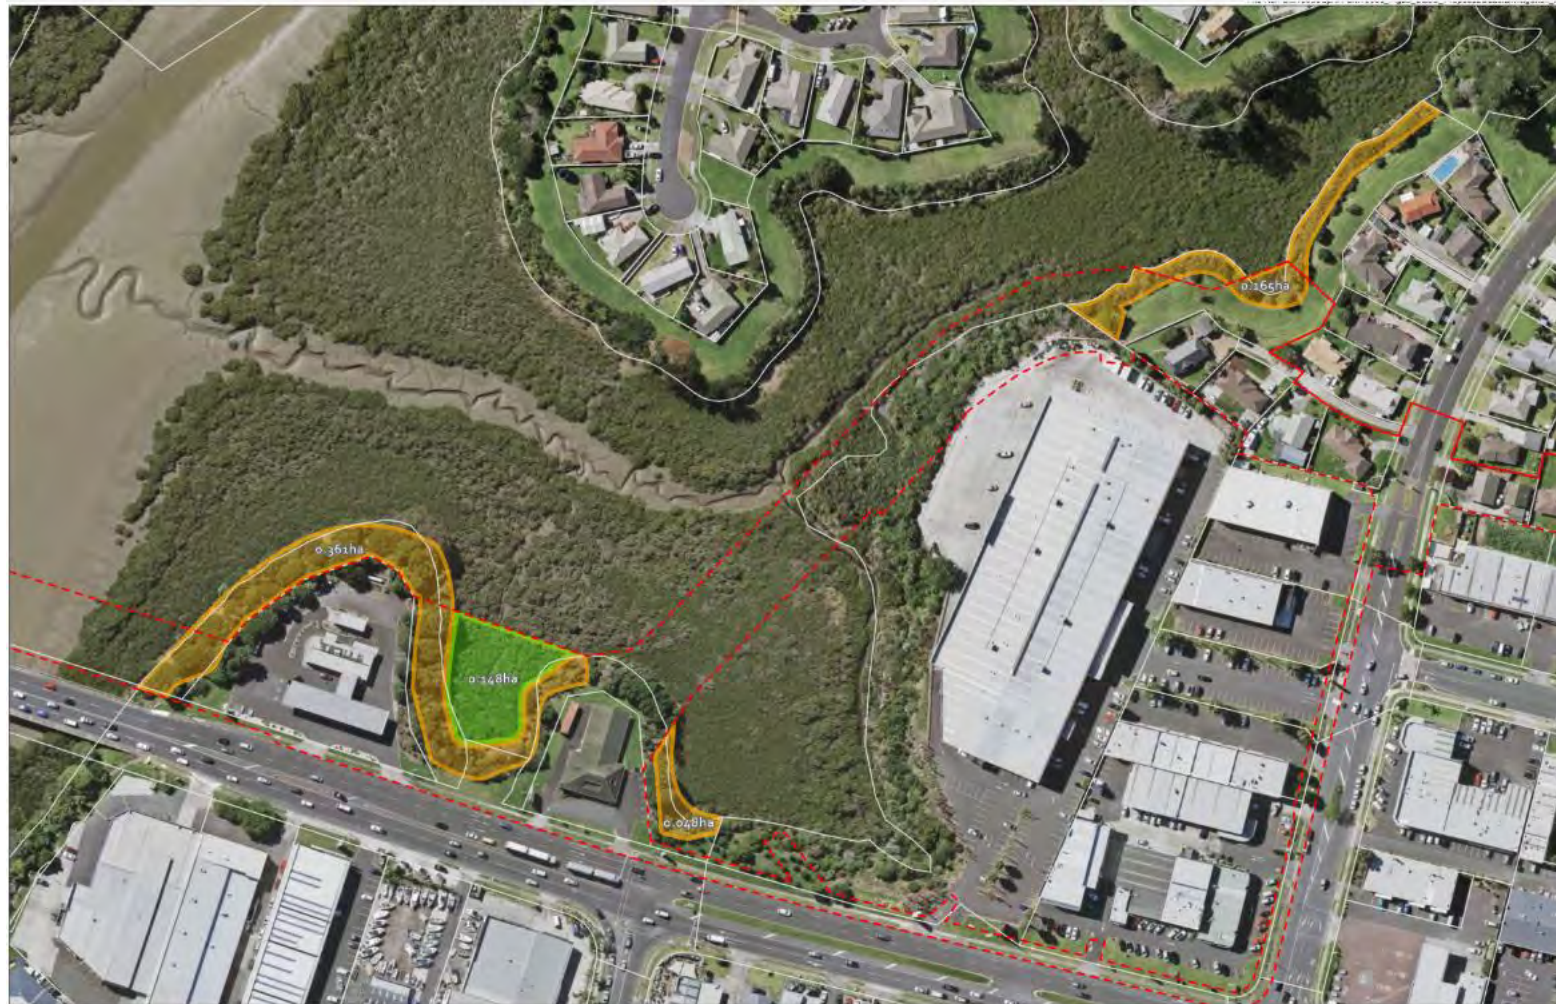
- Gather and dispose of rubbish/debris in the Pakuranga Creek within the CMA adjacent to the project (excluding private land), within an area that extends from approximately 10m above MHWS to seaward of MHWS in mangrove habitat (see Figure 20). Monitoring and repeat rubbish/debris removal should occur on an annual basis for a period of three years post construction) (approximately 1,480m² mangrove habitat and 5,740m² of coastal vegetation habitat) (see Figure 20).

- Remove/treat exotic pest vegetation species and replace with native species from the coastal margins adjacent to EB3C that are suitable for banded rail to nest in given that there is no nesting habitat currently present for them in the EB3C CMA. Removal/treatment and replacement planting to occur on an annual basis for a period of three years post construction in an area of approximately 7,600m² of coastal edge terrestrial vegetation; see Figure 20). Vegetation suitable for banded rail to nest in includes rushes and sedges (e.g. oioi (*Apodasmia similis*), sea rush (*Juncus kraussii* subsp. *australiensis*, *Carex secta*, *Carex geminata*, etc.) and coastal shrubs (e.g. saltmarsh ribbonwood (*Plagianthus divaricatus*), etc.). Rushes and sedges should be planted on the coastal edge with saltmarsh ribbonwood and other suitable shrub vegetation planted further inland.

Mitigation is not required for any of the Very Low and Low levels of adverse effects detected (on the assumption that the proposed Erosion and Sediment Control Plan and the proposed Stormwater Treatment approach are implemented in accordance with conditions). However, it is our assessment that the cumulative effects of construction on marine ecological values (a Moderate magnitude of effect) and coastal avifauna values (Low magnitude) should be mitigated even though the EIANZ assessment guidelines, indicate the overall level of effect in this situation would be Low. We recommend rubbish and debris in the CMA adjacent to EB3C is removed (and repeated annually for three years post construction) and pest plants are controlled and replaced with native vegetation along the coastal fringe of EB3C that are suitable for banded rail to nest in (continuing annually for three years post construction) (see section 7.0 and Figure 20).

- Minimise removal of coastal wetland habitat during the construction and operational stage, by complying with best practice / recommended measures.
- Mangrove Habitat - Gathering and disposal of rubbish/debris in the CMA (including repeating annually for three years post construction) (1,480 m², see Figure 20).
- Coastal Vegetation - Gathering and disposal of rubbish/debris in the CMA (including repeating annually for three years post construction) (5,740m², see Figure 20).
- Coastal Vegetation - Removal/treat exotic pest vegetation species along the EB3C coastal edge and replace with native species that are suitable for banded rail to nest in (including repeating annually for three years post construction) (5,740m², see Figure 20).
