Muriwai Downs Golf Course:

ECOLOGICAL EFFECTS ASSESSMENT

Report number: 2042

December 2021

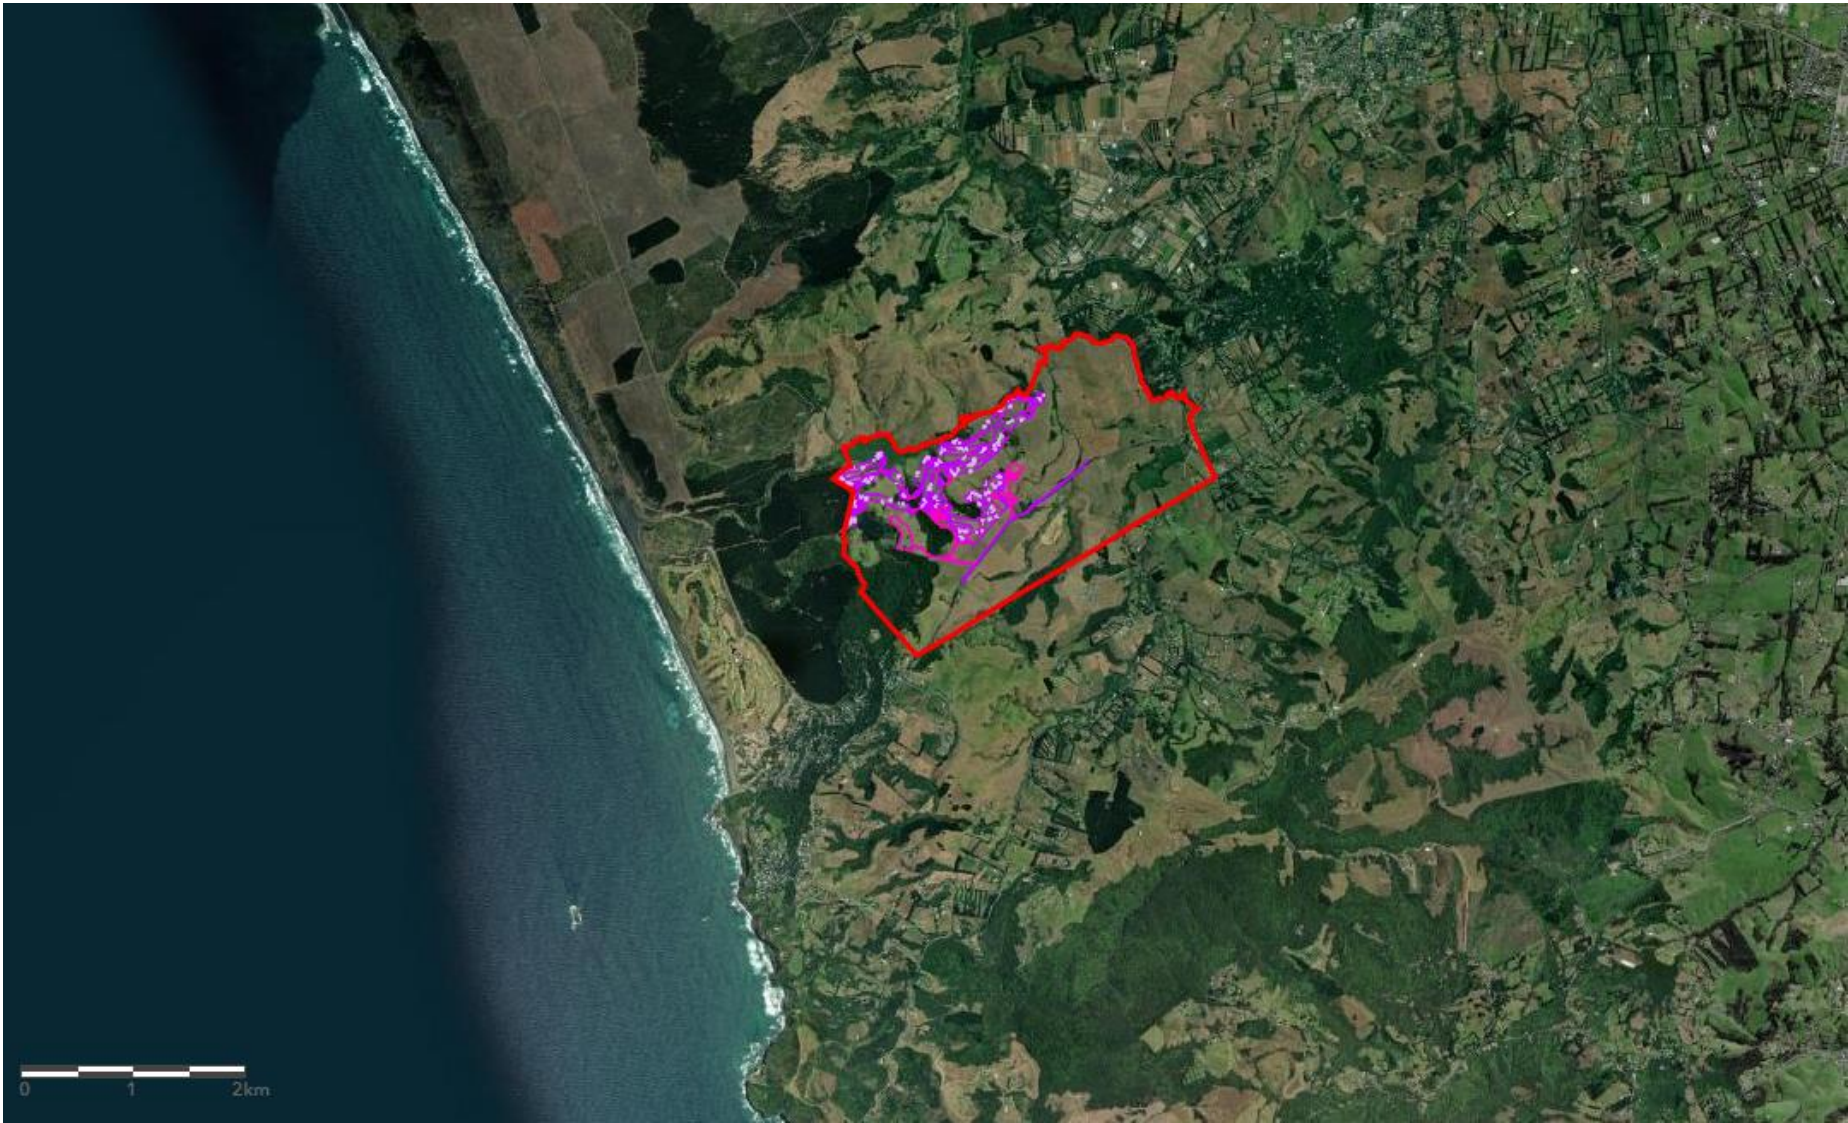
Figure 1. The Property and proposed Muriwai Downs Golf Course within the wider Muriwai landscape. The Property adjoins pine forest to the west, and mixed rural land use to the north, east and south. Proposed golf course layout and supporting infrastructure (pink/ purple features), Property boundary (red line).

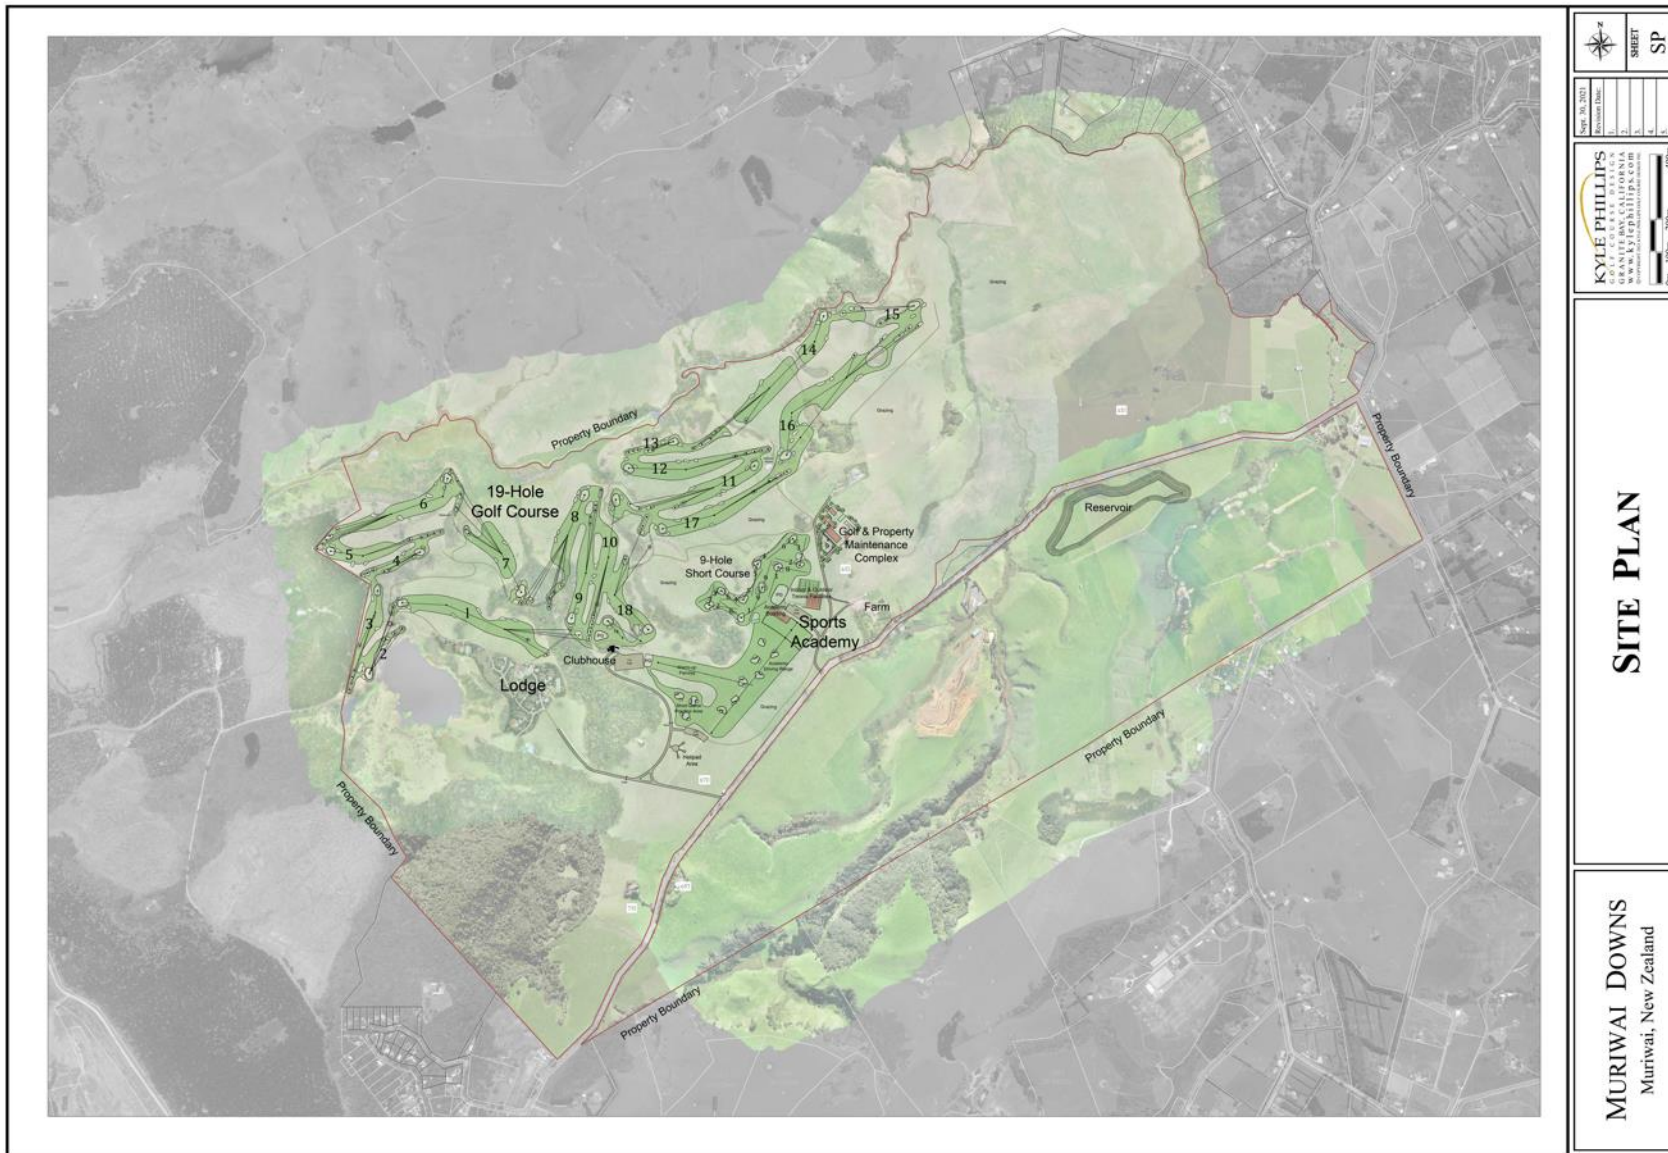
Figure 2. The proposed Muriwai Downs Golf Course site and Property. Figure supplied by Kyle Phillips.

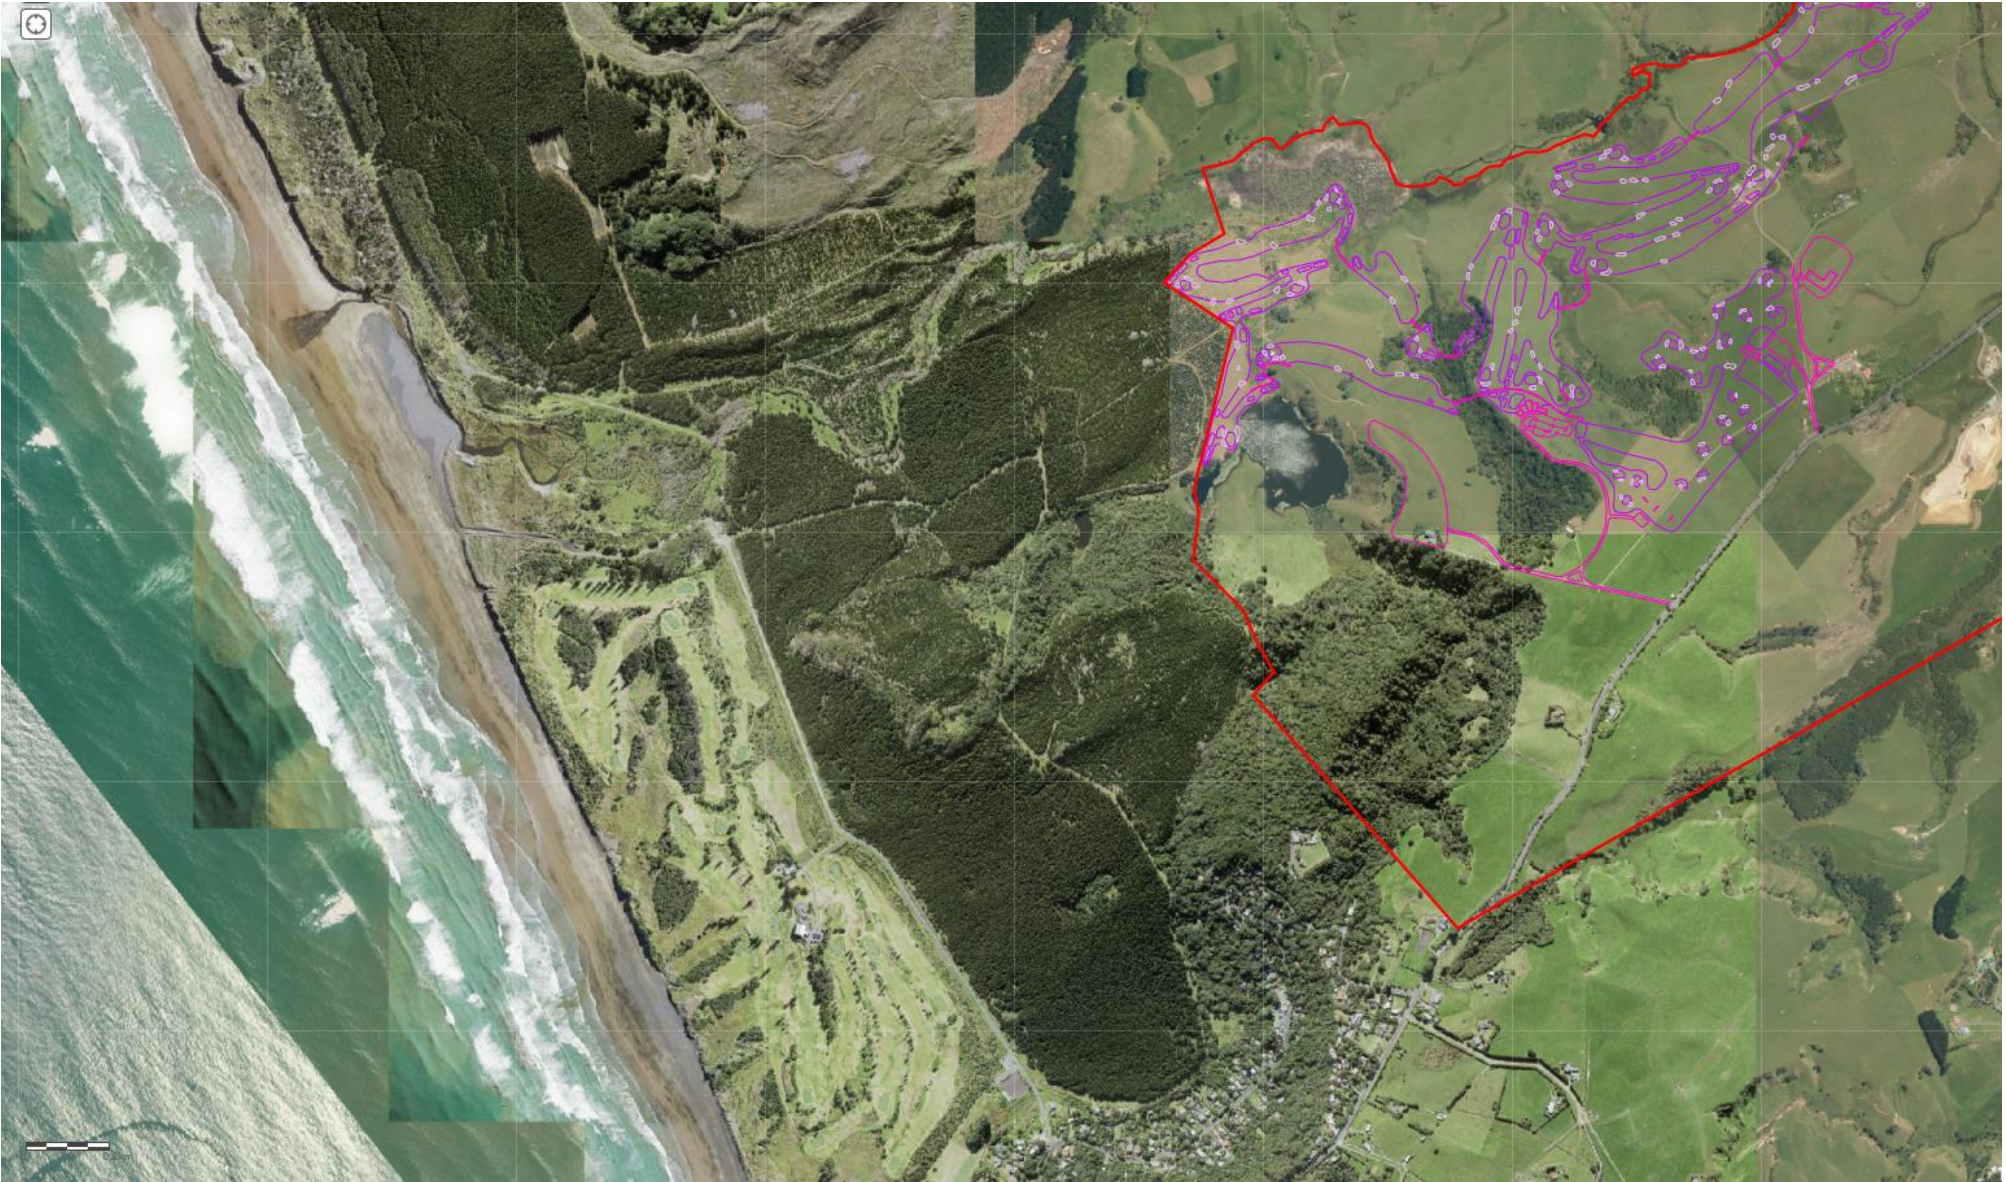
Figure 6. The Property (red boundary) and proposed course layout (purple area) relative to the Muriwai Beach coastal environment.

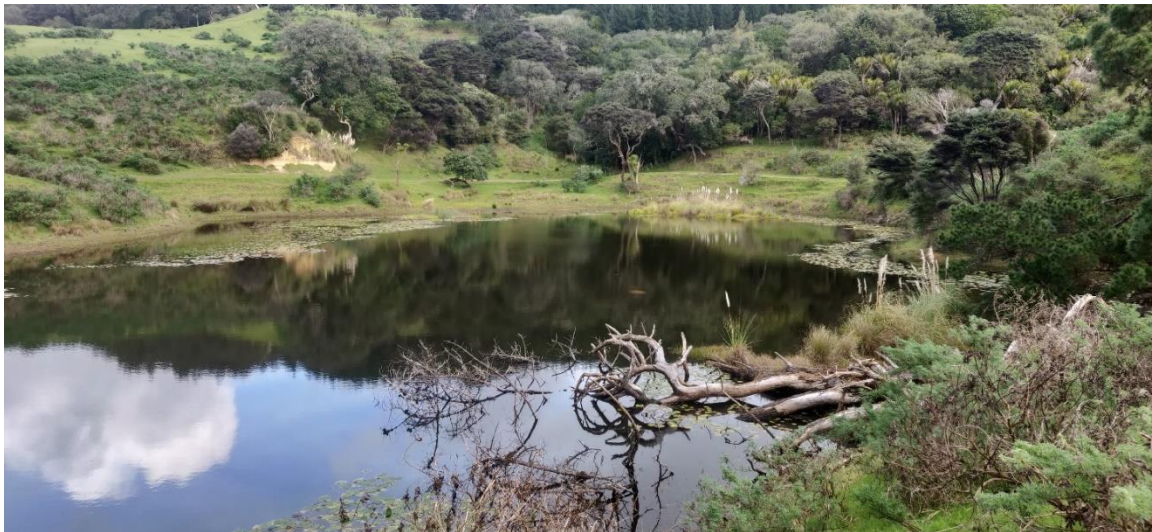
Plate 1. The northern branch of Lake Ōkaihau, photograph taken facing west.

Overall, Lake Ōkaihau has been assessed as a significant ecological feature which currently has poor ecological condition, and margins where land management could be changed to benefit lake quality. Photos of Lake Ōkaihau are provided in **Plate 1** to **Plate 3** below.

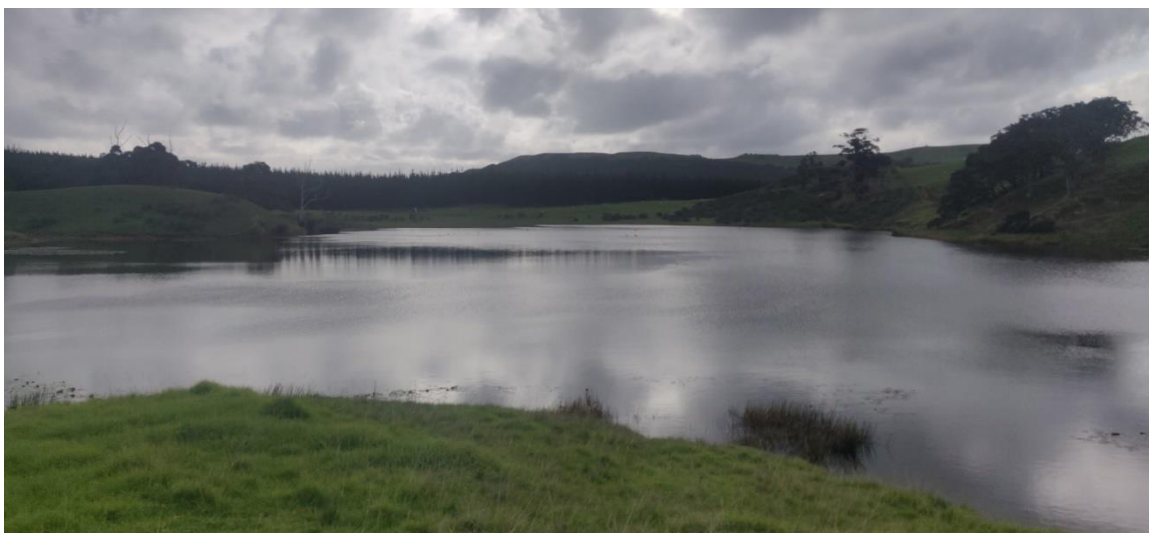
Plate 2. Lake Ōkaihau within the rural landscape, photograph taken facing north.

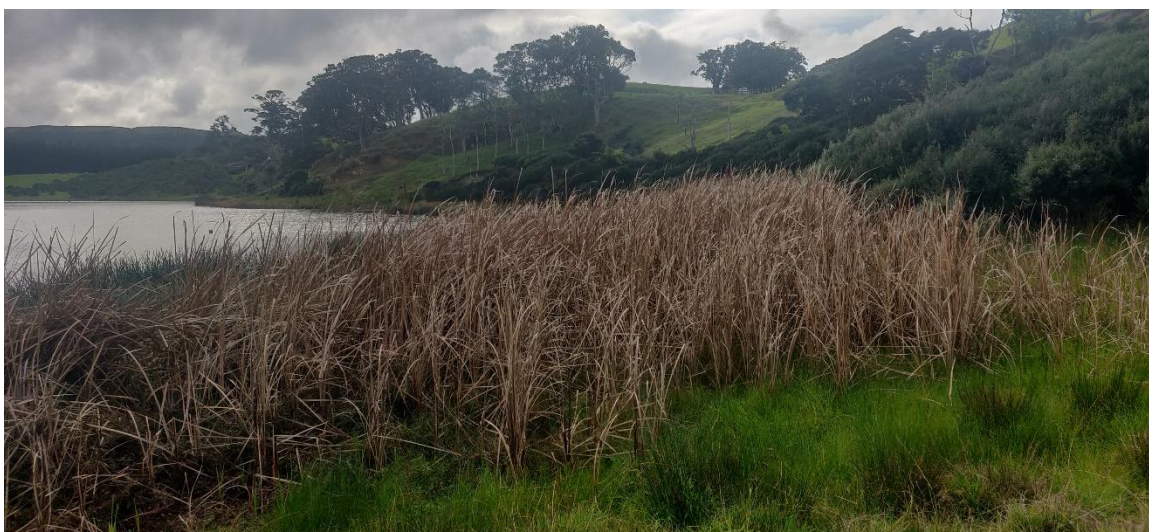
Plate 3. Native reedland on the southern margin of Lake Ōkaihau.

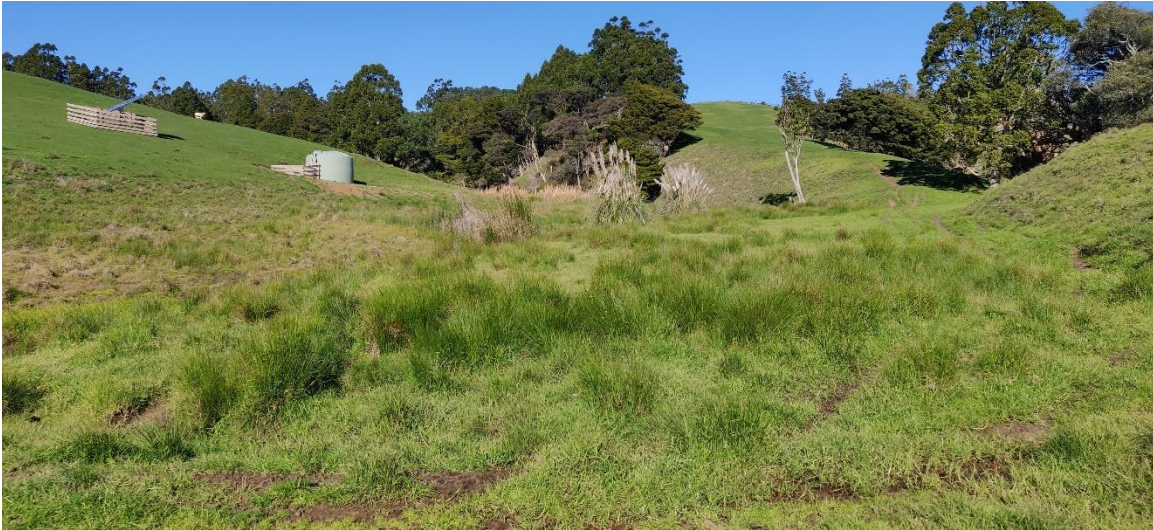
Plate 4. Wetland W9, an example of a wetland in 'poor' ecological condition.

The majority of wetlands on the Property have been degraded through historic agricultural activities, resulting in significant modification to the soils and plant communities (**Plate 4**). They are now dominated by exotic herbs and weed species (e.g. the exotic invasive reed sweet grass *Glyceria maxima*).

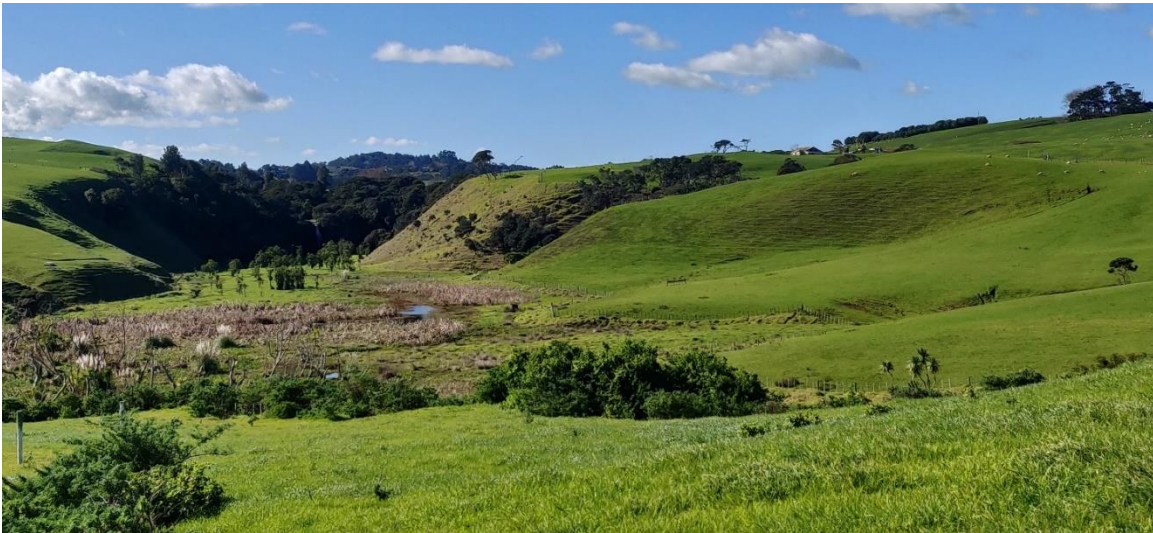
Plate 5. Wetland W7, a large contiguous wetland dominated by reed sweet grass, along the northern boundary of the Property.

The largest wetland on the Property extends from the base of the Toroānui Falls along the northern boundary of the Property, occupying ca. 12.1 ha (W7, **Plate 5**). This wetland has been degraded by weed species such as pampas (*Cortaderia selloana*) and reed sweet grass. However, despite its degraded state there are still extensive beds of raupo (*Typha orientalis*) and stands of ti kouka (*Cordyline australis*) and the wetland could provide core or important habitat for native fish and native wetland birds. Willow control several years ago is apparent with many dead standing trees and stumps.

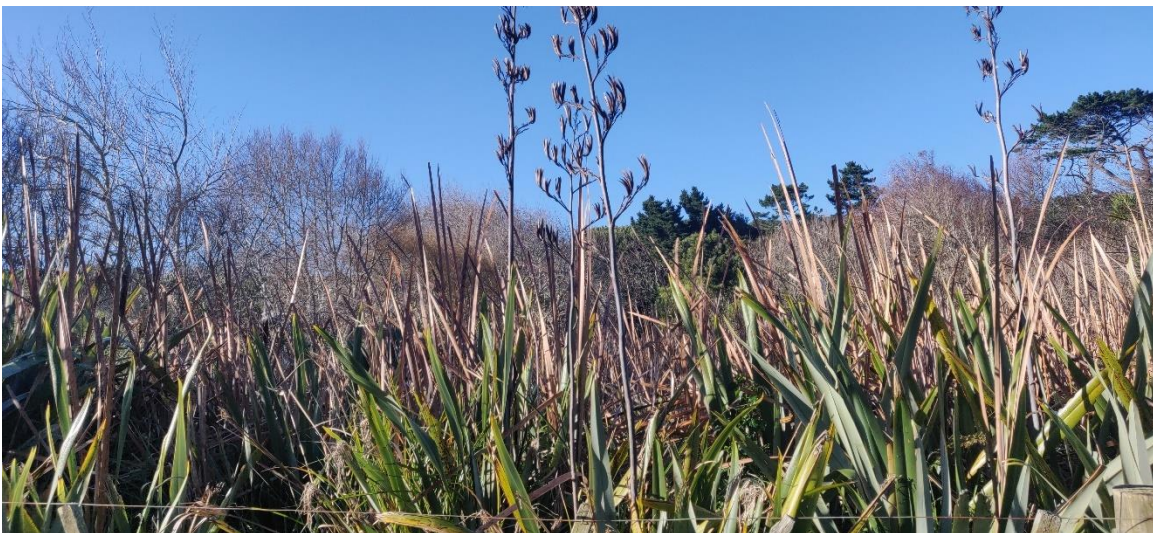
Plate 6. Wetland W6, dense raupo and harakeke provides excellent habitat for North Island fernbird.

In addition to wetland W7, wetland W6 has a large area of raupo / flaxland with scattered ti kouka which could also provide important habitat for native avifauna such as North Island fernbird (*Bowdleria punctata vealeae*) (**Plate 6**).

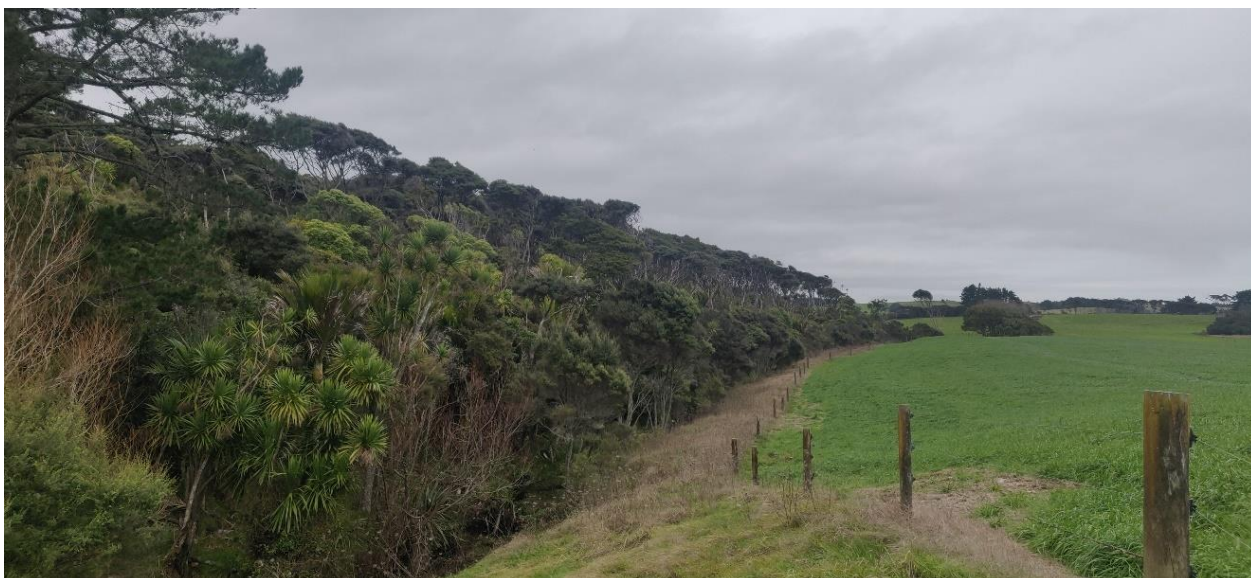
Plate 7. The Raurataua Stream upstream of Toroānui Falls. This reach of stream has little modification, high shading and bank filtering, stable banks, and excellent habitat for native fish. The ecological condition is rated as 5 = very good.

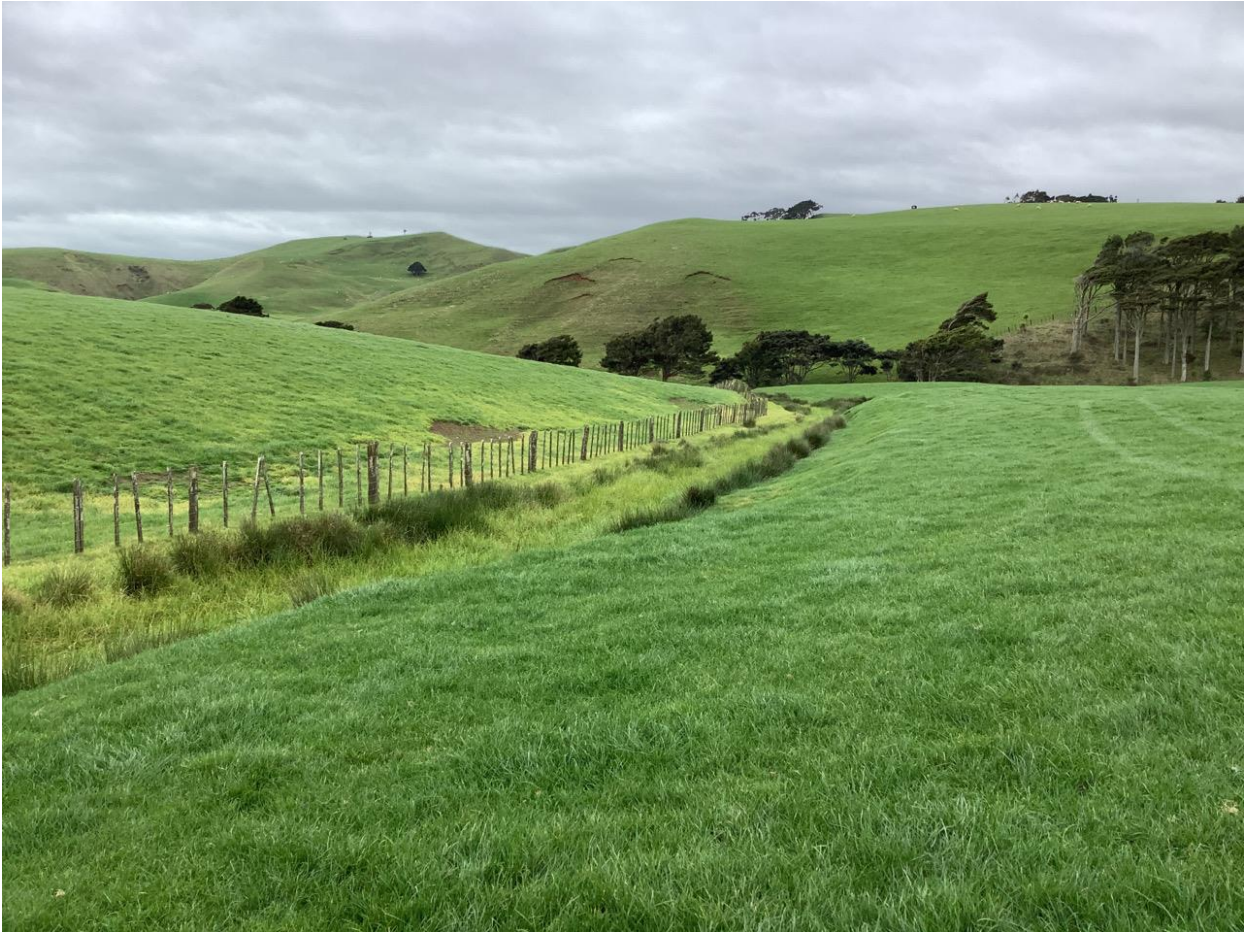
Plate 9. Stream P3, an example of stream that has been highly modified and has an ecological condition rated as 1= Very poor.

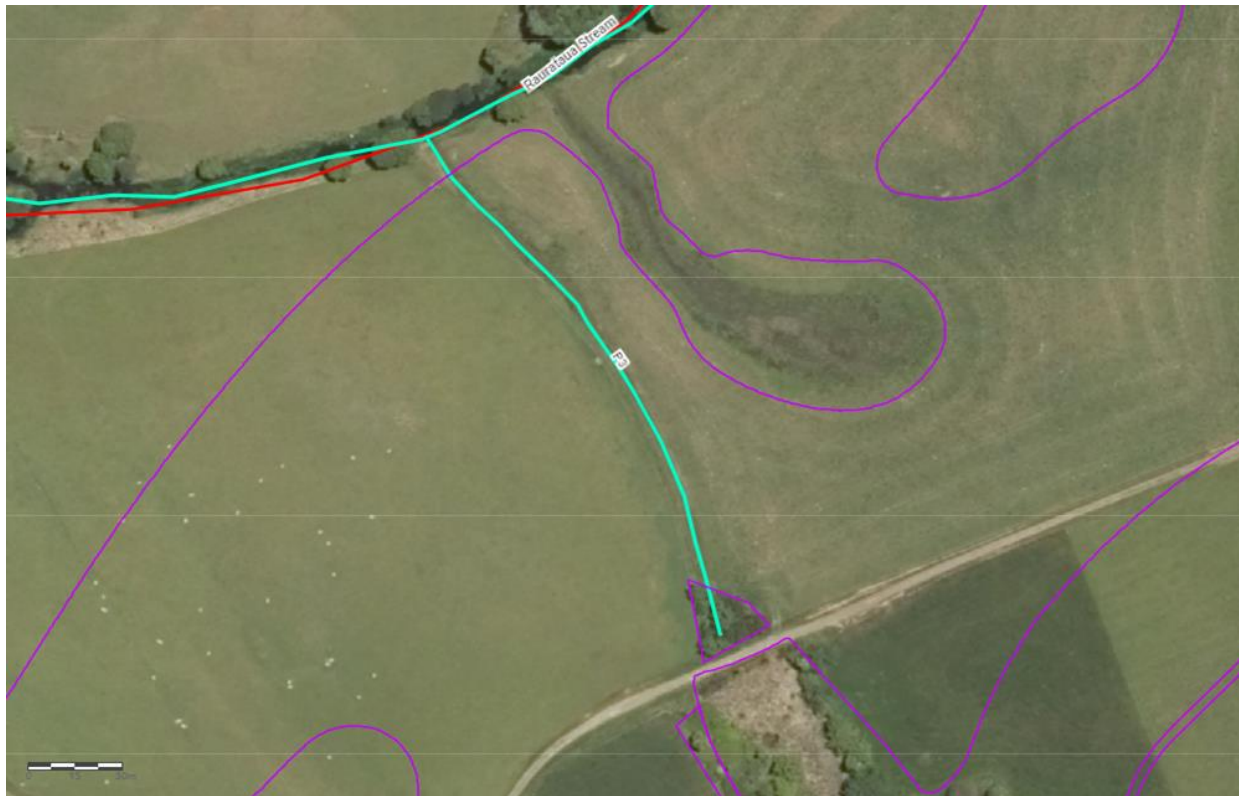
Figure 10. The reach of Stream P3 (blue line) within the proposed earthworks extent (purple lines)

For Streams P3 and I9 representative SEVs were undertaken from the most downstream extent within the proposed development footprint. For restoration Stream P2, a representative SEV was undertaken from the confluence with Stream I2. For restoration Stream I2 a representative SEV was undertaken from the confluence with Stream P2.

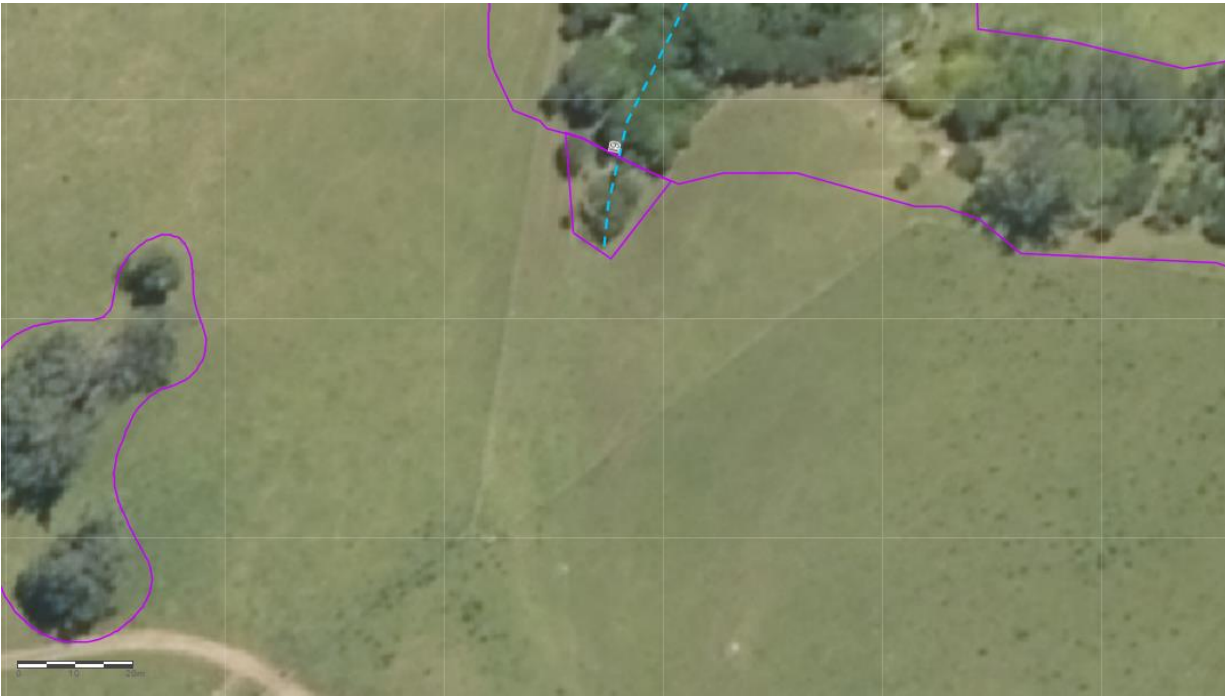
Figure 11. The reach of Stream I9 (blue dashed line) within the proposed earthworks extent (purple lines)

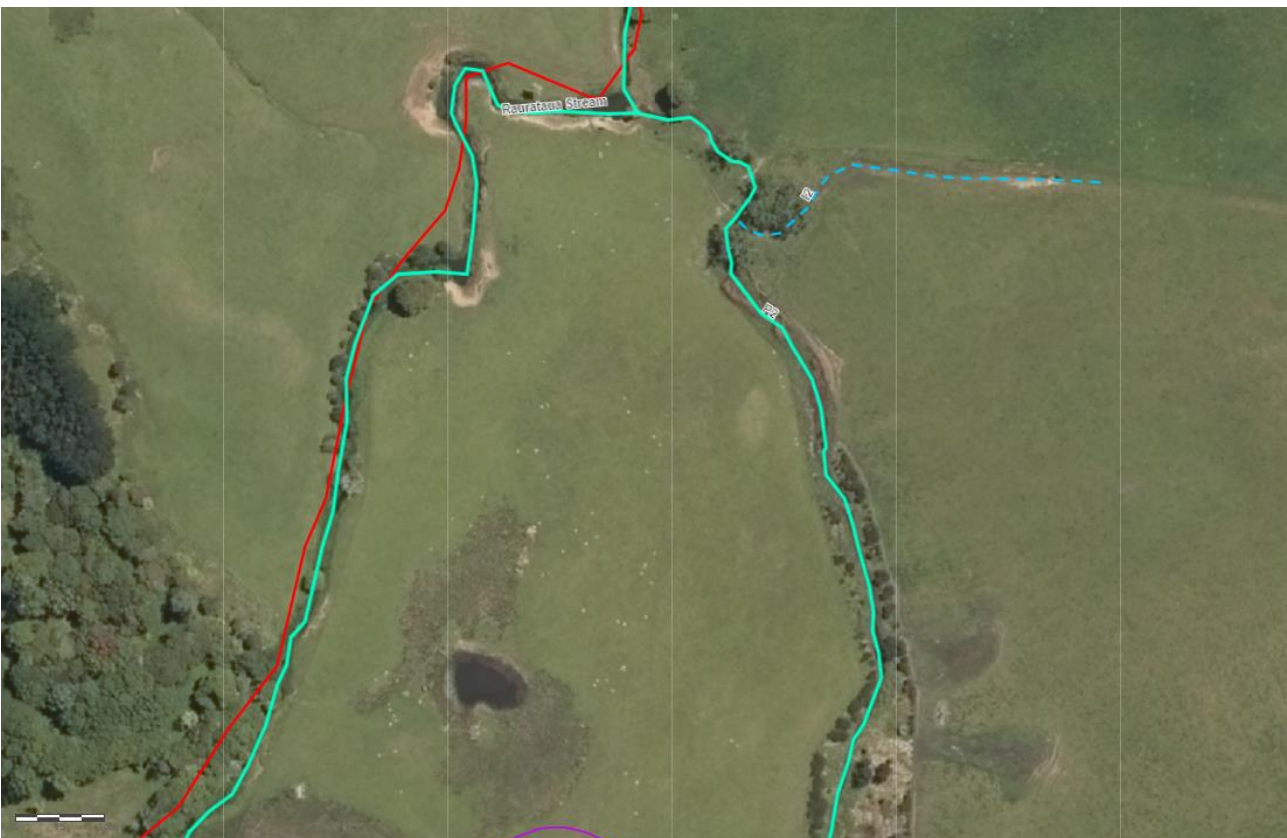
Figure 12. Stream P2 (blue line) and Stream 12 (blue dashed line) proposed for restoration.

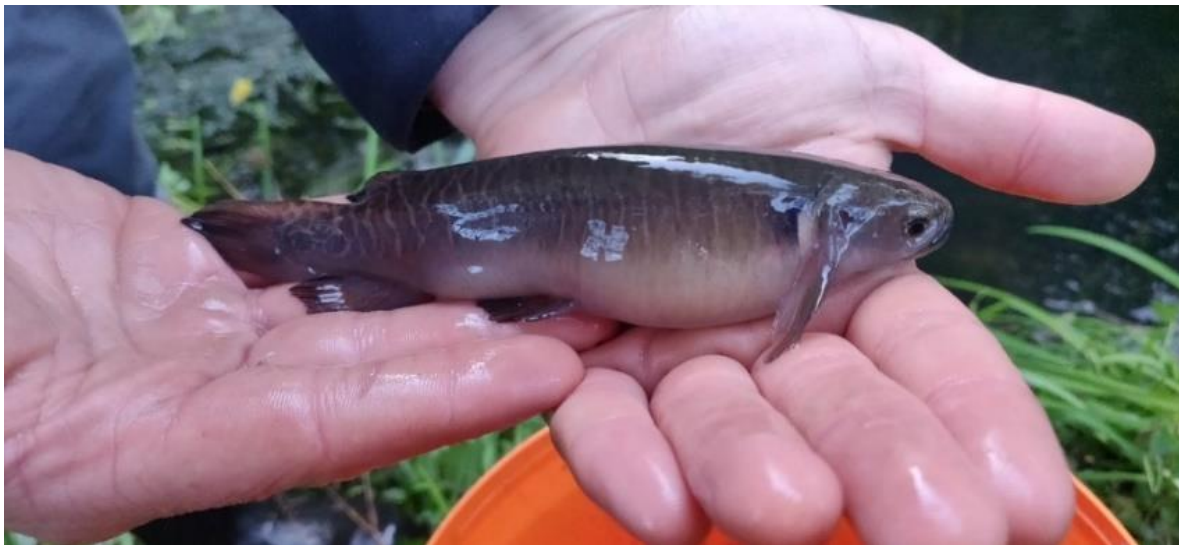
Plate 10. A gravid (egg carrying) banded kōkopu caught in the Rarautaua Stream in July 2021

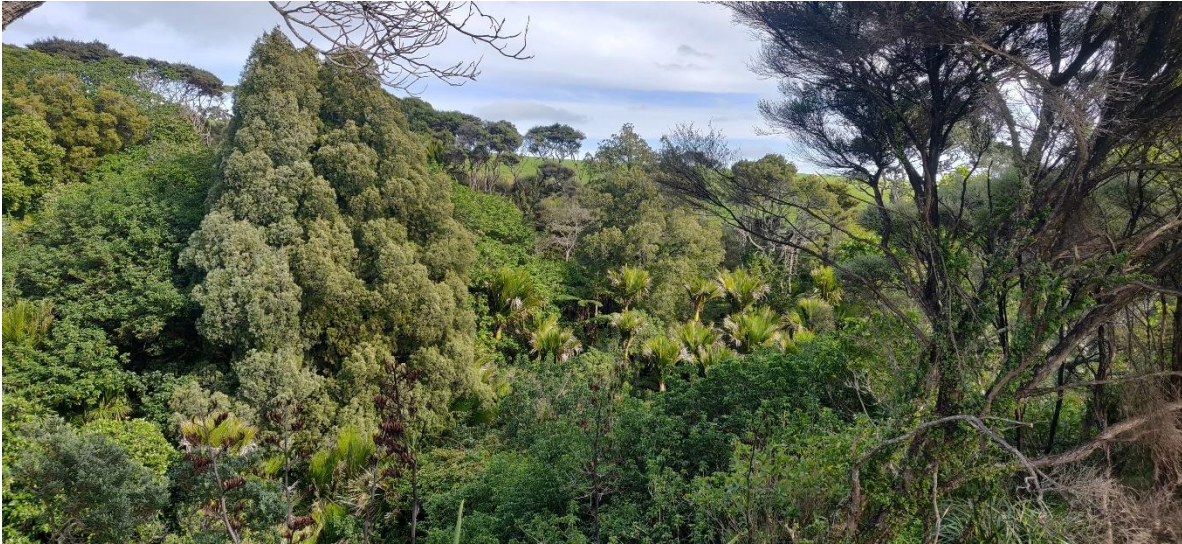
Plate 11. The canopy of mature native forest in SEA T 5525 (at the proposed hole 1 crossing).

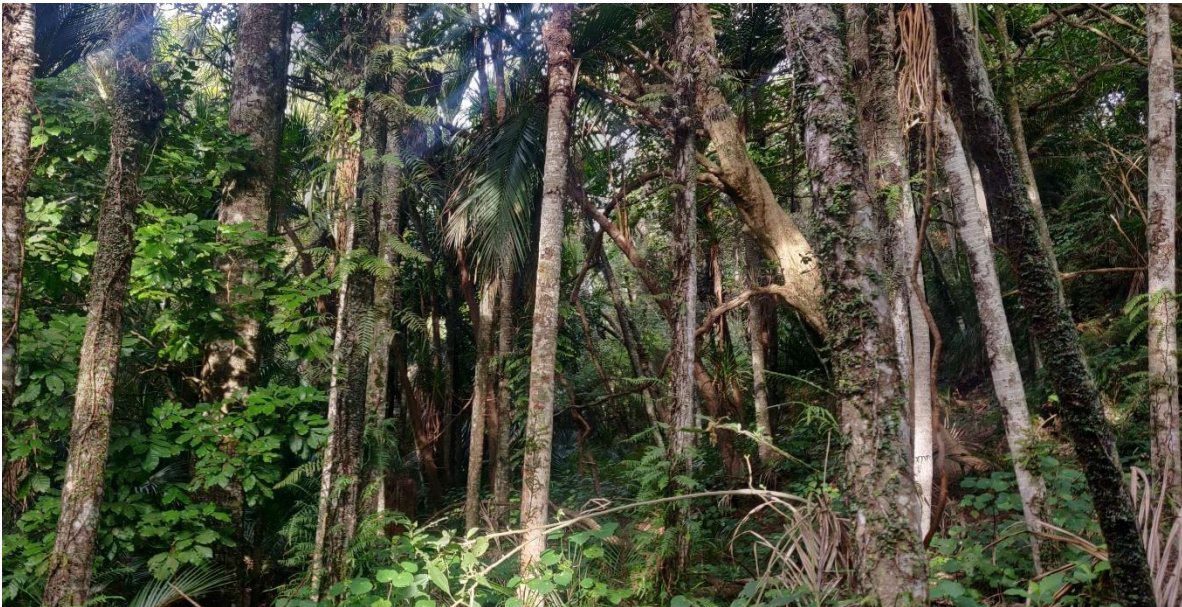
Plate 12. An example of the diverse, multi-tier indigenous forest in SEA T 5525.

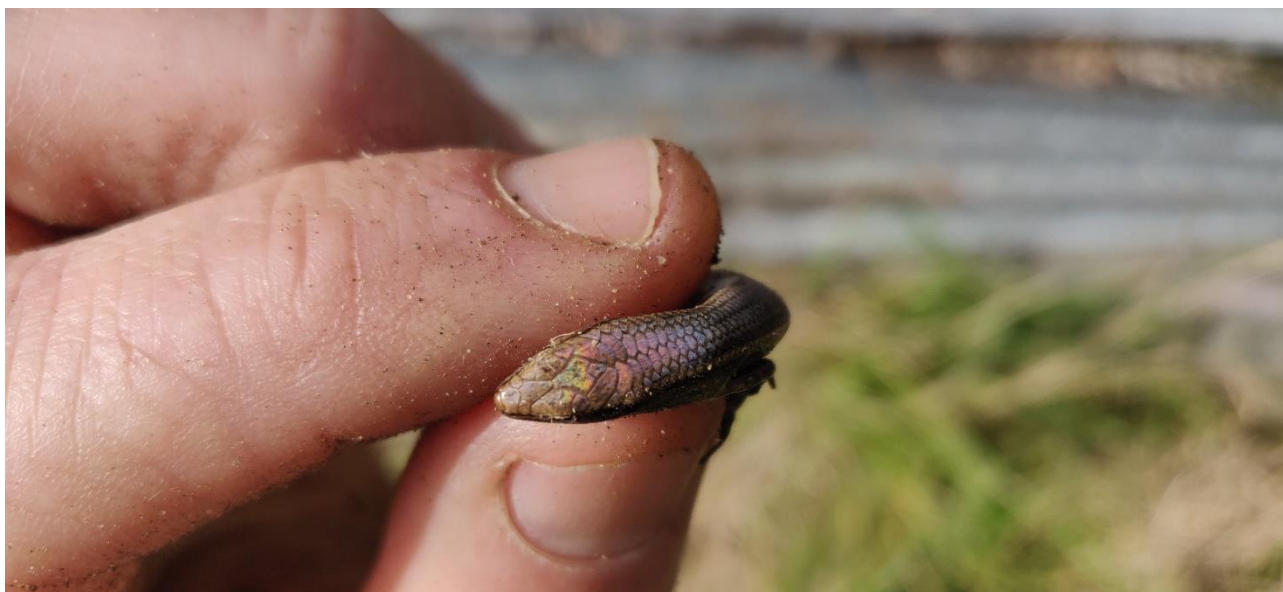
Plate 15. An exotic plague skink recorded in long grass under a pile of debris. Note fused fronto-parietal scale on top of the head, and characteristic ‘iridescent’ colour along the dorsal (back) surface – both of which are characteristic identifying features for this species.

Plague skinks are well distributed across the Property, particularly within paddocks, shelterbelts, riparian margins, and house and garden amenity areas (**Plate 15**). Copper skinks are most likely present in lower numbers and in a narrower subset of habitats including areas of rank grass, and thick weedy vegetation surrounding the edges of the wetlands, as well as thick riparian vegetation.

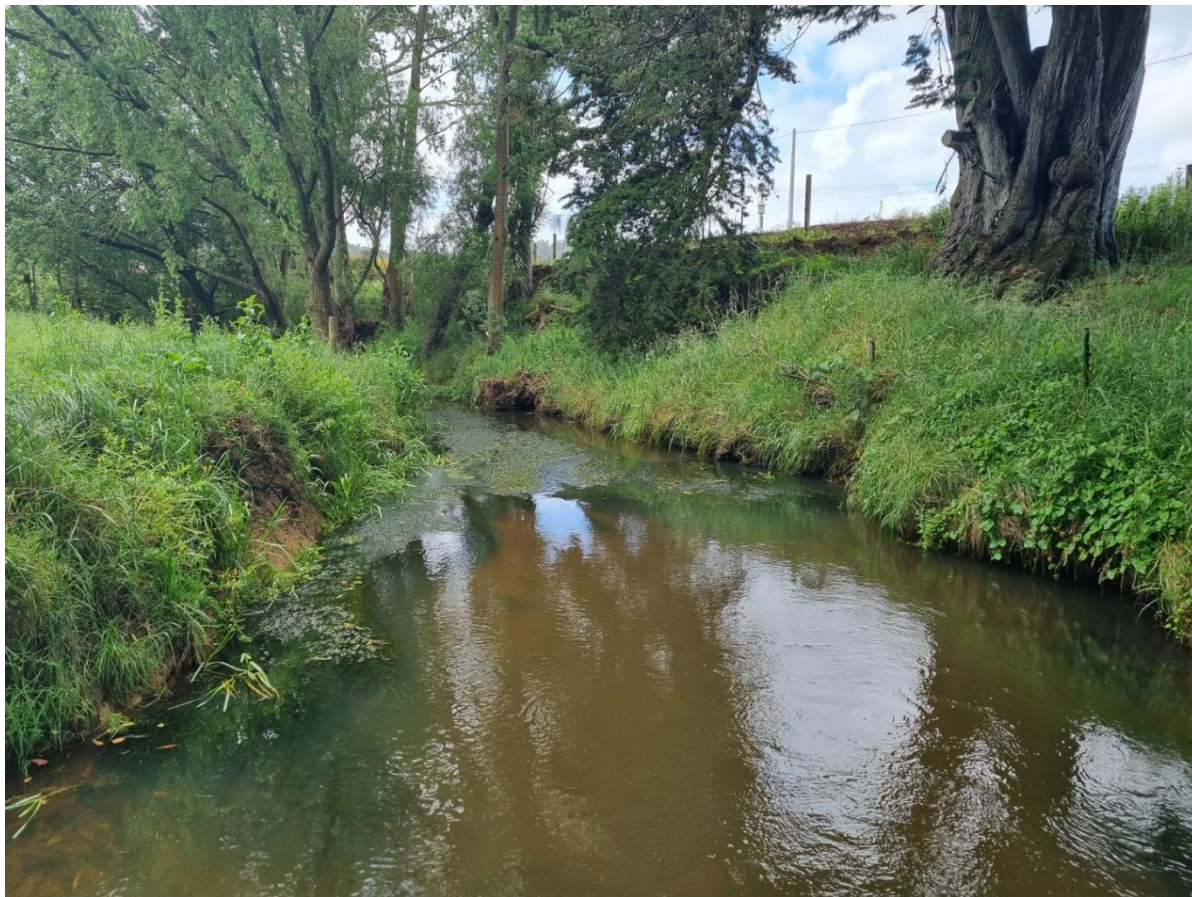
Plate 16. The Raurataua Stream at the proposed water take location. This is 220 m downstream from the closest wetland (riparian floodplain wetland associated with Raurataua Stream (northern extent of W18)).

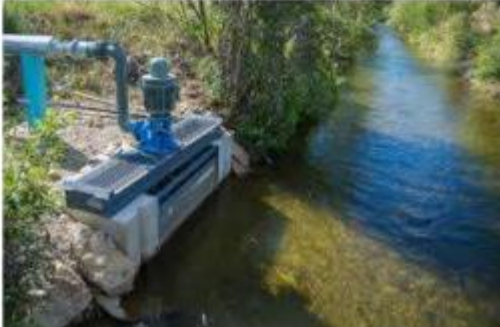
<p>Stream Bank Chamber and Pump. Consists of a pump chamber formed alongside the river with a simple overflow weir or small intake gates to allow above the median flow level into the chamber.</p>

Figure 19. Example water take options, (WWLA 2021d; see Appendix 7 to AEE).

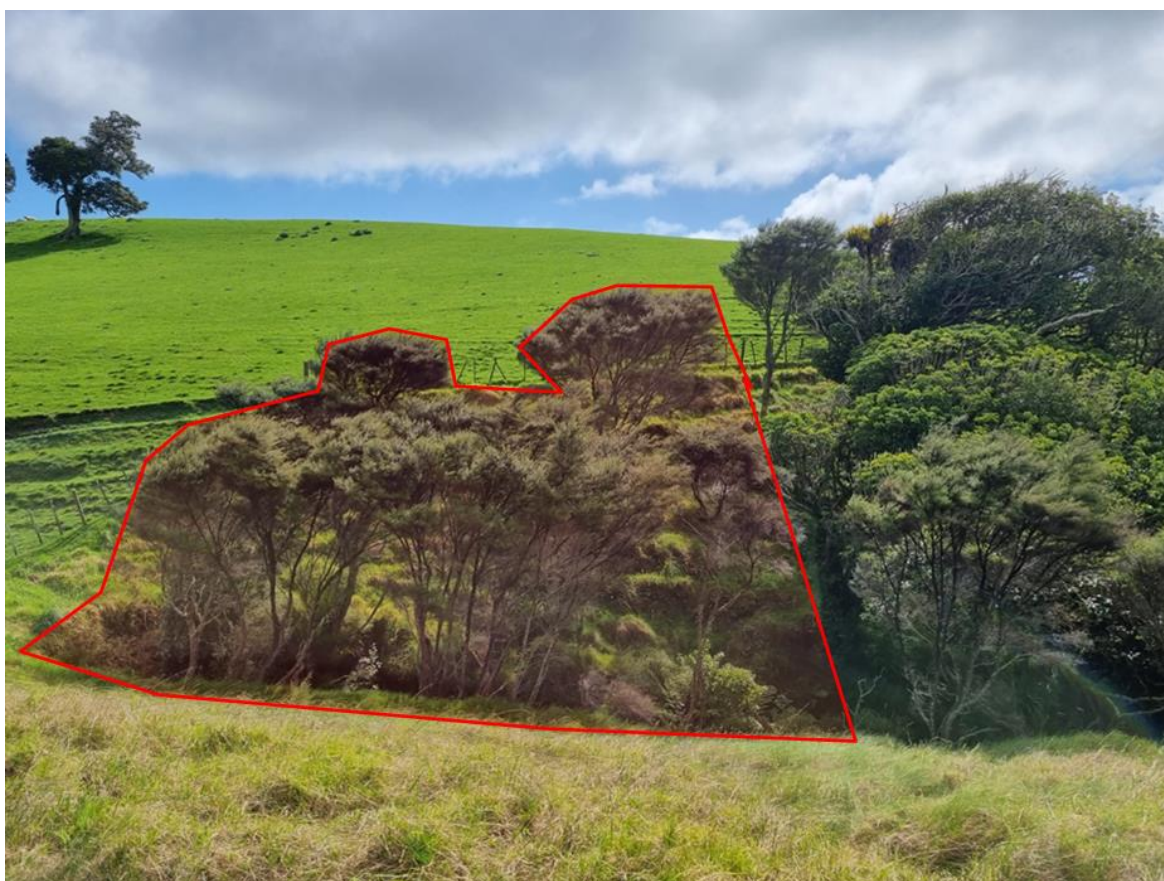
Plate 17. The proposed extent of clearance (red area) at the margin of SEA_T_5525, consisting of young kānuka and ground ferns at the head of a gully.

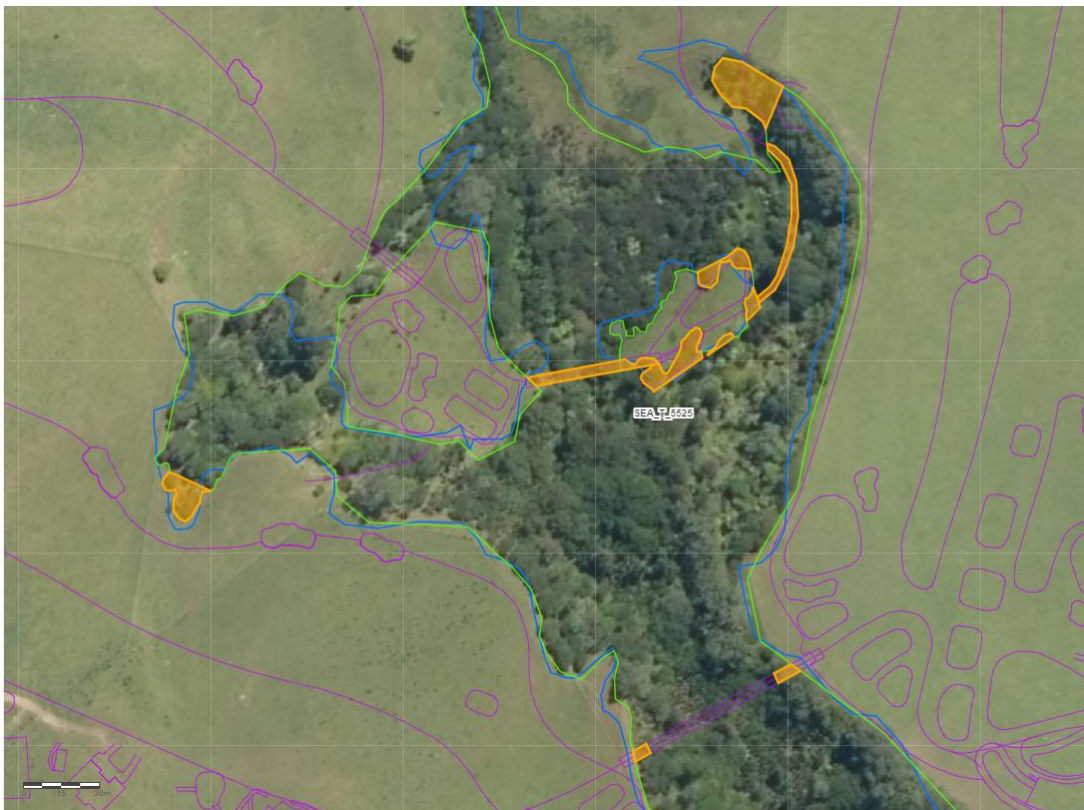
Figure 25. SEA_T_5525 boundary mapped by Auckland Council (blue line), indigenous vegetation mapped by RMA Ecology Ltd (green line), proposed extent of vegetation clearance as mapped on the ground (orange area), course layout purple line.
