Muriwai Downs Golf Course:

ECOLOGICAL EFFECTS ASSESSMENT

Report number: 2042

December 2021

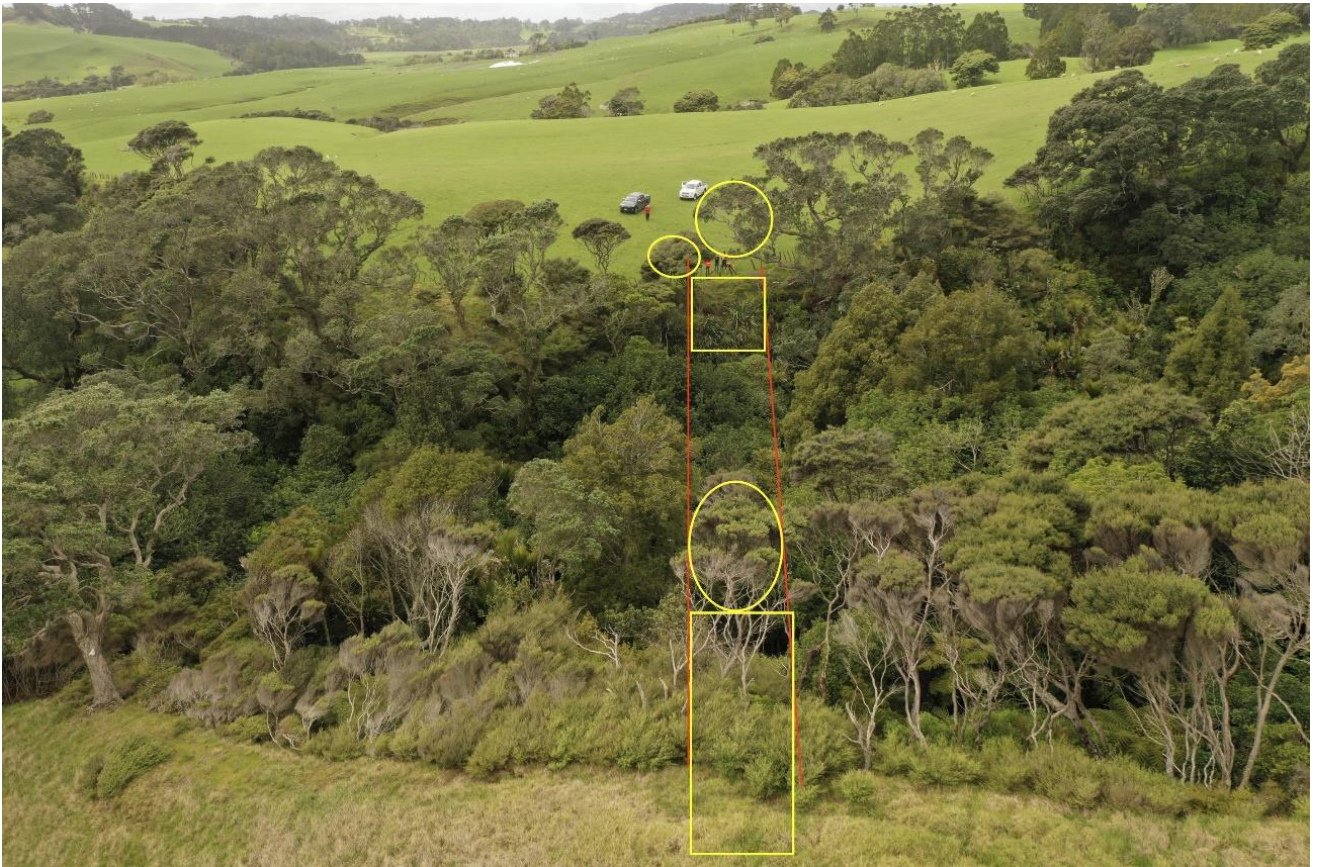
Figure 27. The proposed access bridge location between Hole 1 and Hole 9. Image supplied by Peers Brown Miller Limited.

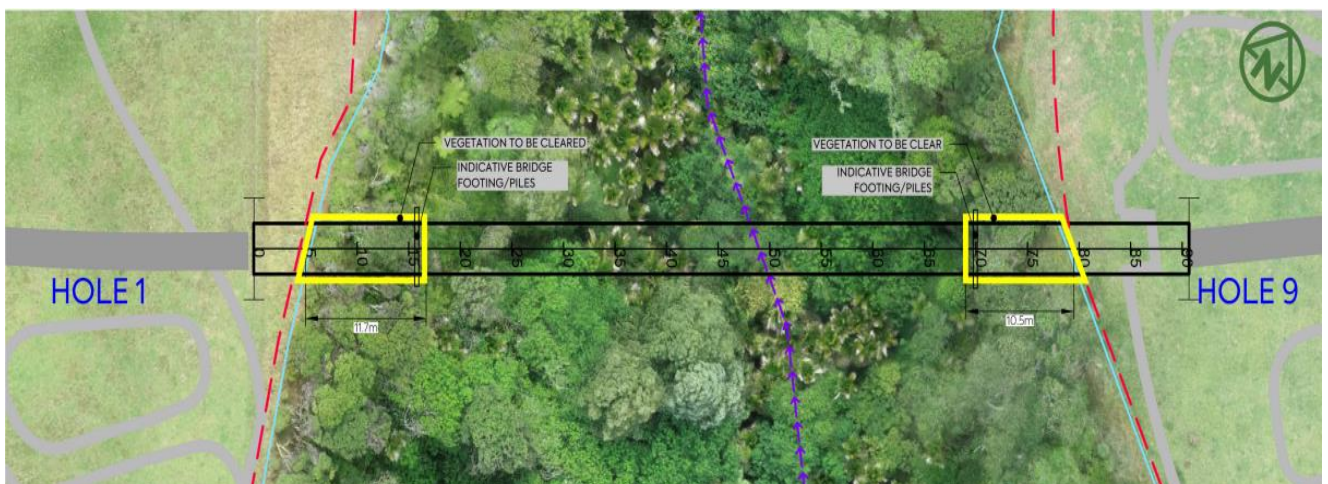
Figure 28. The proposed access bridge location between Hole 1 and Hole 9. Image supplied by Peers Brown Miller Limited.

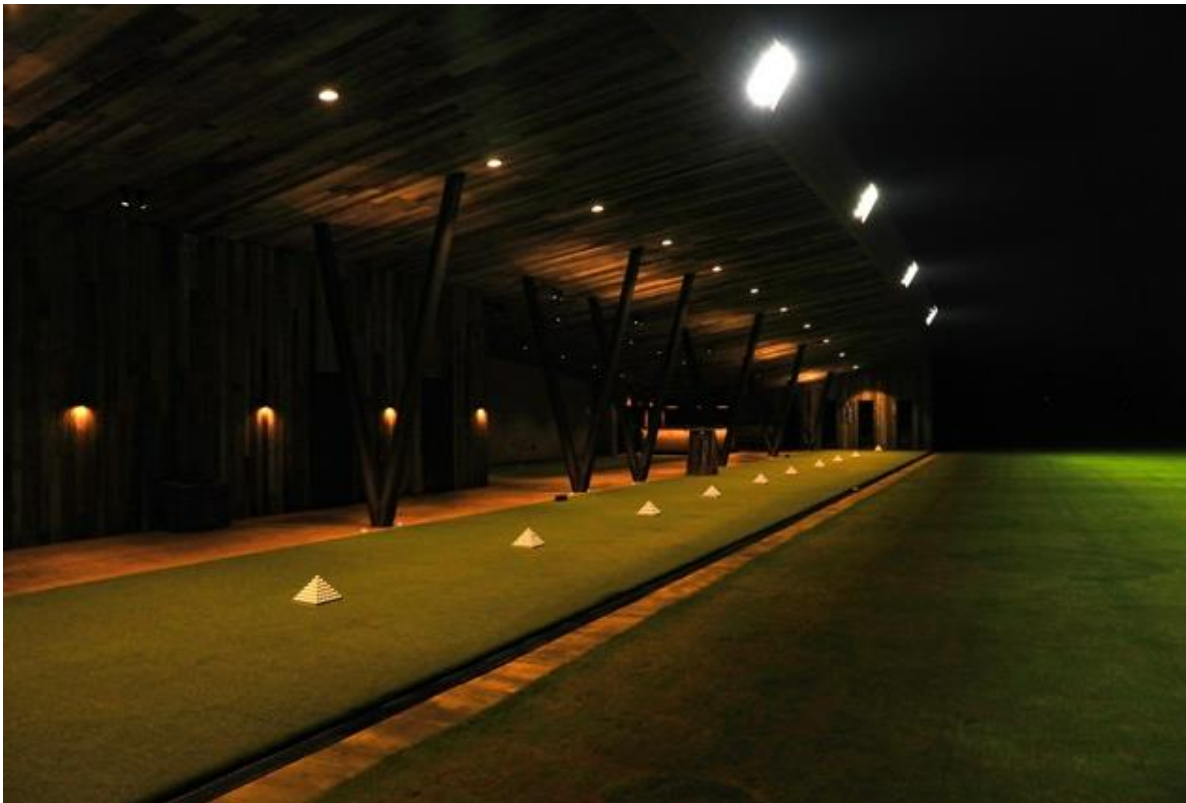
Figure 31. An indicative concept of lighting for the proposed driving range. Source Bernardus Range.

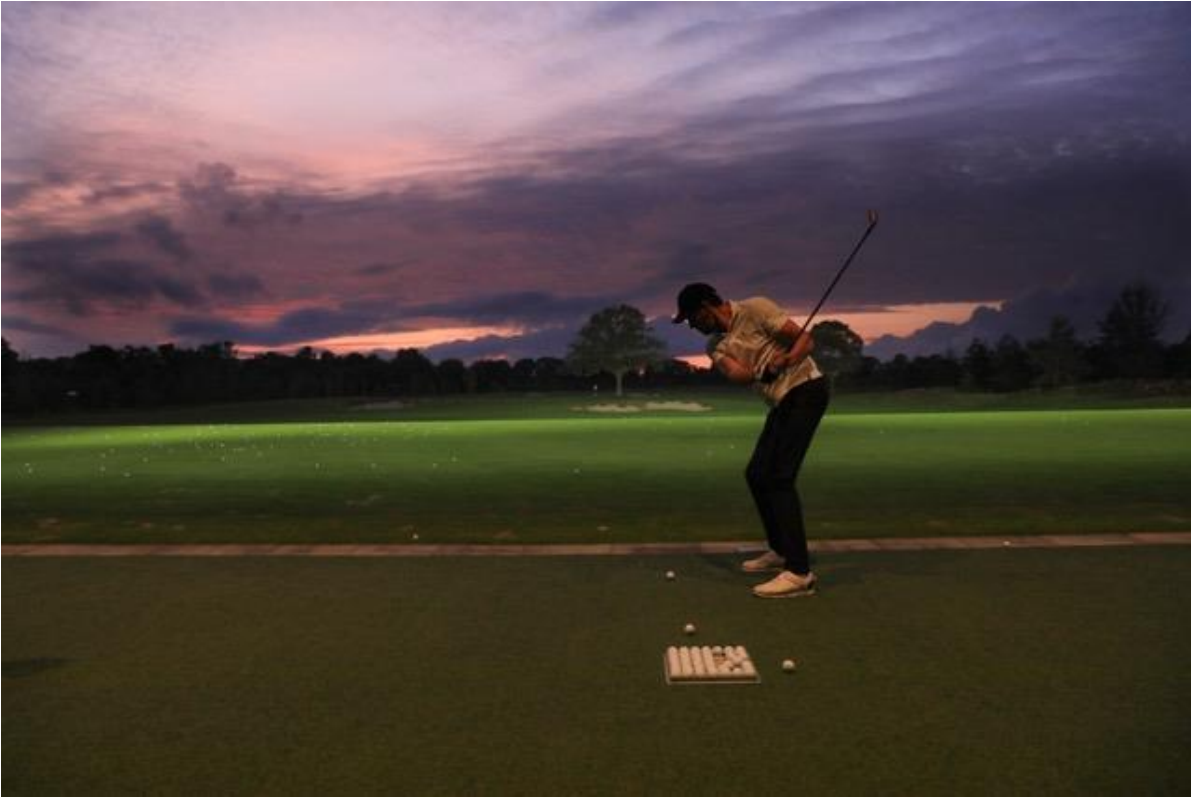
Figure 32 An indicative concept of lighting for the proposed driving range. Source Bernardus Range.

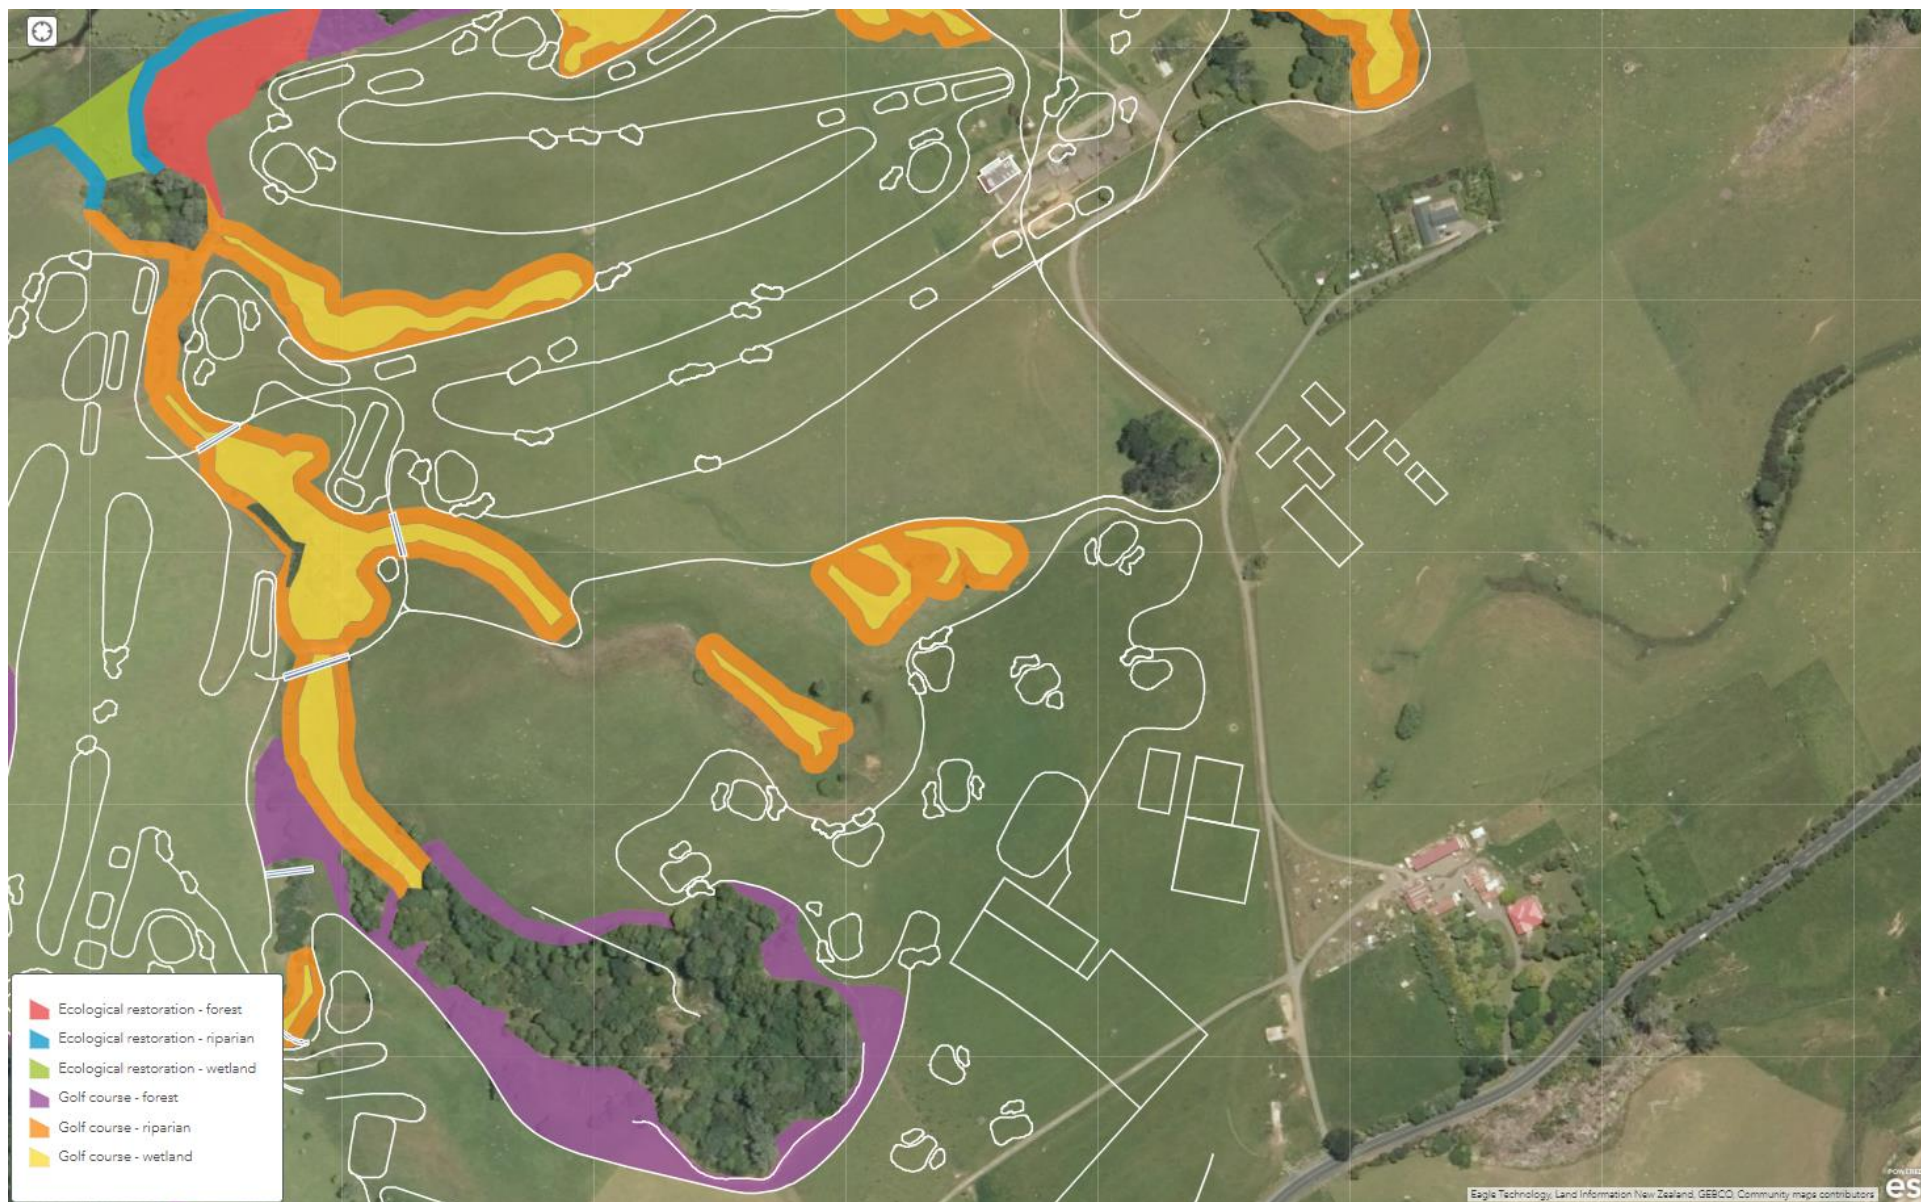
Figure 39. The proposed restoration concept (indicative) for the south-eastern extent of the project area. Development layout (white lines) restoration treatments (coloured areas), property boundary (red line).

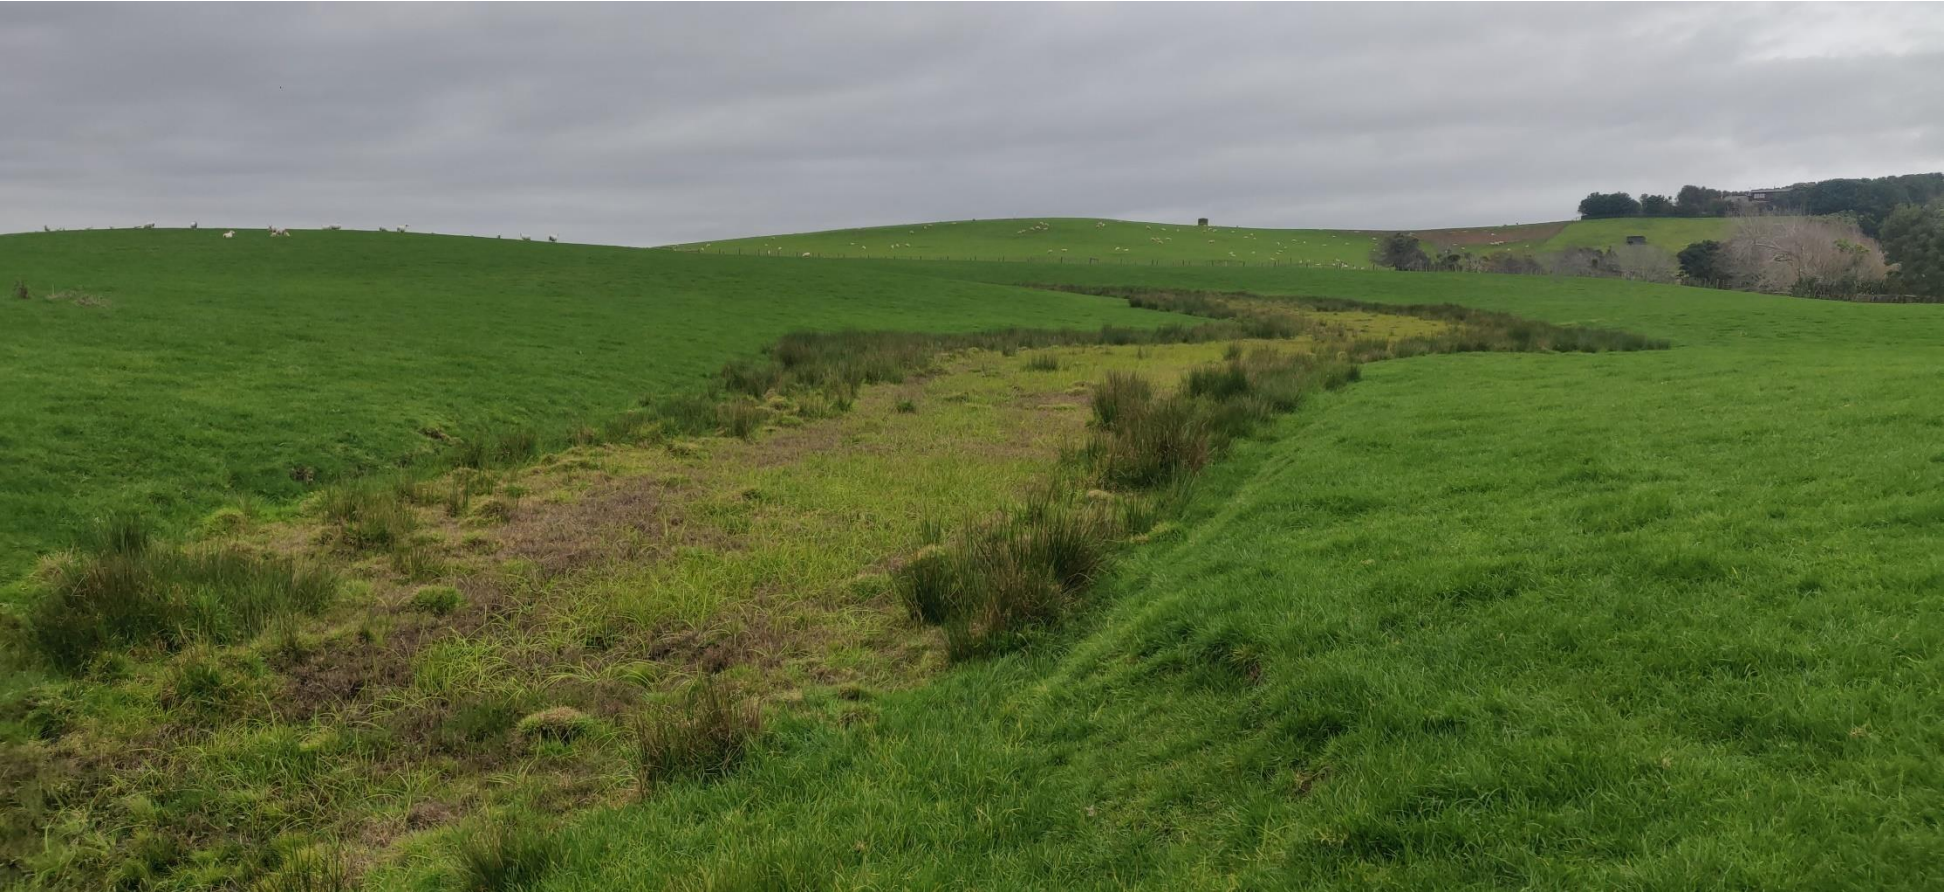
Plate D1. Wetland W5. The distinctive light green *Isolepis prolifera*, with soft rush margins (*Juncus effusus*) and immediate change in topography provides an obvious delineation between terrestrial and wetland vegetation.

In order to accurately delineate wetlands, an initial on-site assessment of wetland boundaries was undertaken by an ecologist using a GPS +/- 5 m. The wetland transition points/ boundaries at this Property were then accurately delineated assessing site data with high-resolution aerial imagery using GIS. Therefore, the boundaries of the polygons provided in this report include an element of expert judgement.

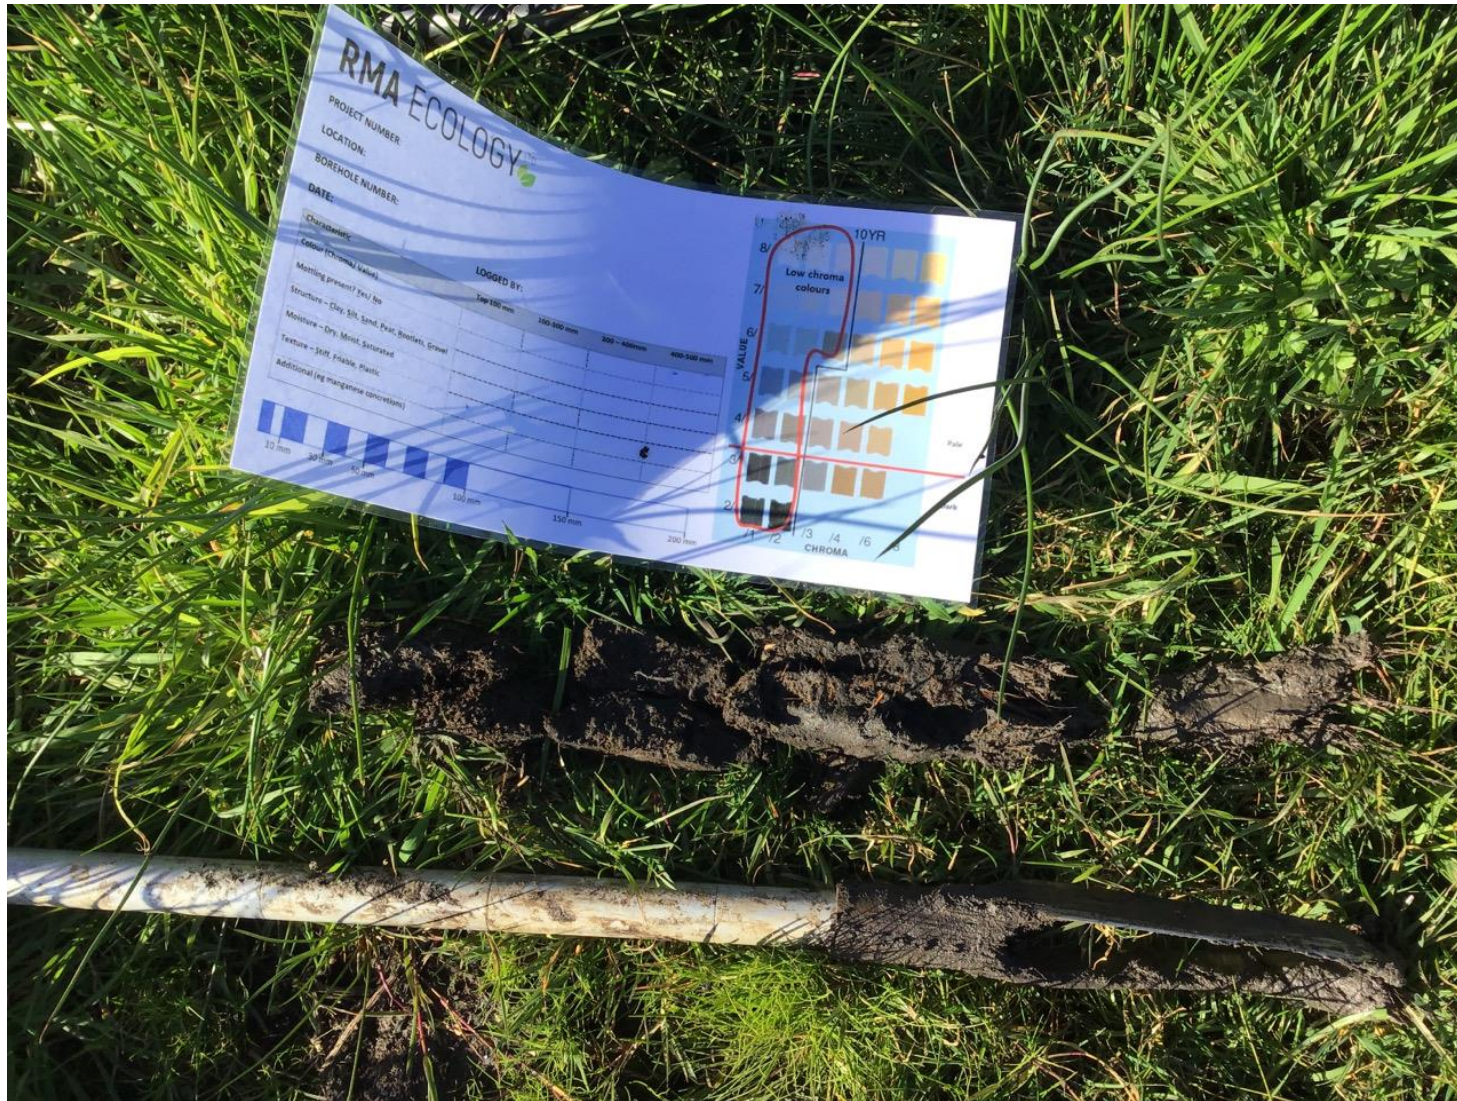
Plate D2. Soil Core W7, an example of a typical low-chroma, saturated wetland soil core which qualifies as a wetland soil.
