# **Muriwai Downs Golf Project: archaeological assessment**

**report to  
The Bears Home Project Management Ltd  
and  
Golf Strategy Group**

Date: 9 December 2021

Reference: 21-1213

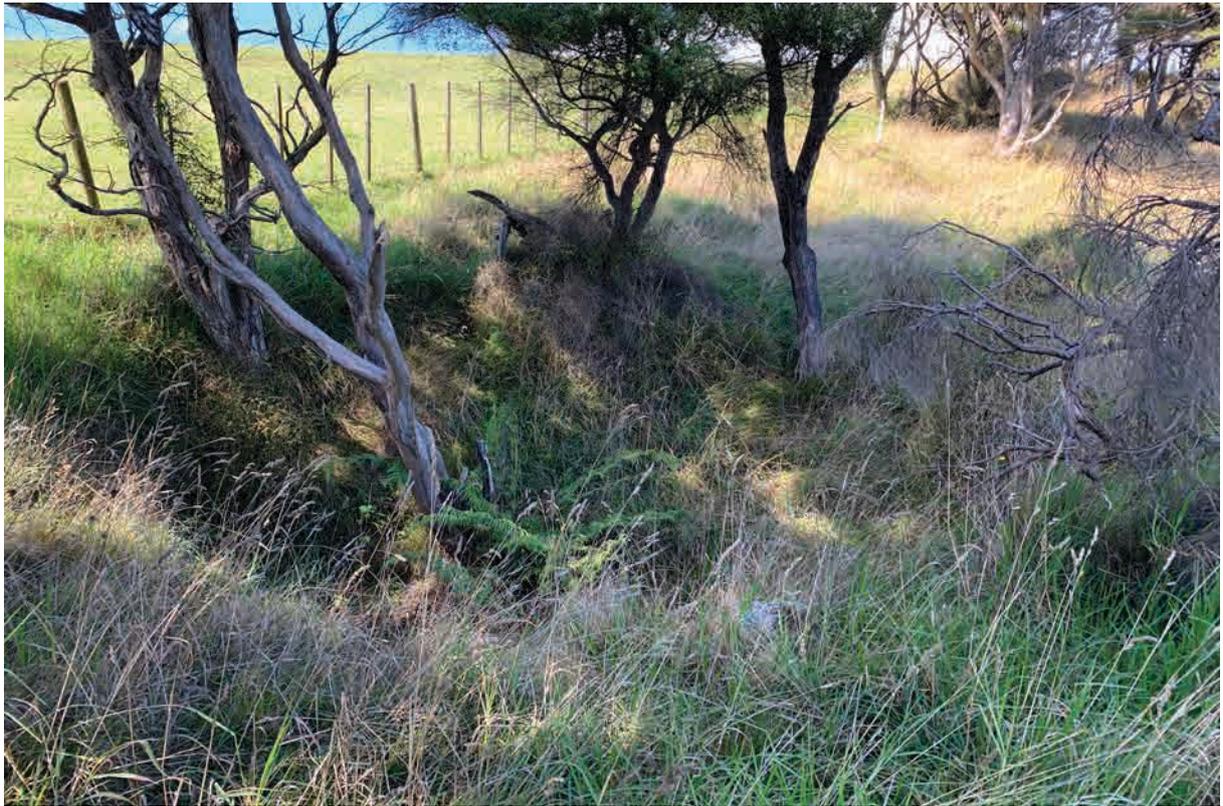
*Figure 7. View southwest of southern pit at Q11/67.*

The pits remain as recorded; the southern pit is amorphous and is approximately 4 x 3 m and is 2 m deep at the centre (Figure 7). The second pit is 4 m north of this, is more regular in form, and measures approximately 4 x 2 m x 1 m deep (Figure 8). The pits are both overgrown with long grass and manuka is growing in and around the pits.

- Protection and signage at pit sites Q11/67 and Q11/68.
- Clearing the vegetation from Foster's Mill Q11/380.
- Conserving the rock crusher at Houghton's quarry Q11/615.
- Protecting the carved face Q11/71 – this site is in a difficult to reach location and visiting it should probably not be encouraged for health and safety reasons.
- Highlighting the wider archaeological landscape, particularly to the north of the Okiritoto Stream.

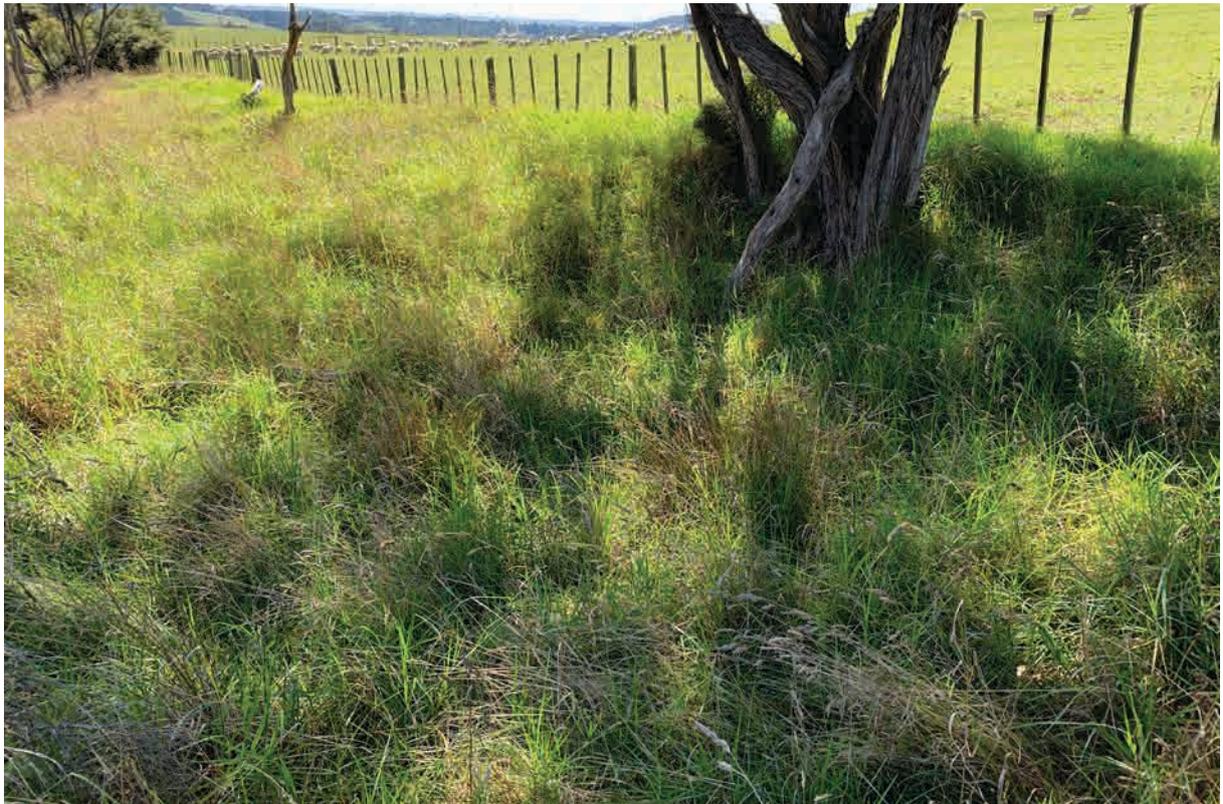
*Figure 8. View northeast of northern pit at Q11/67.*

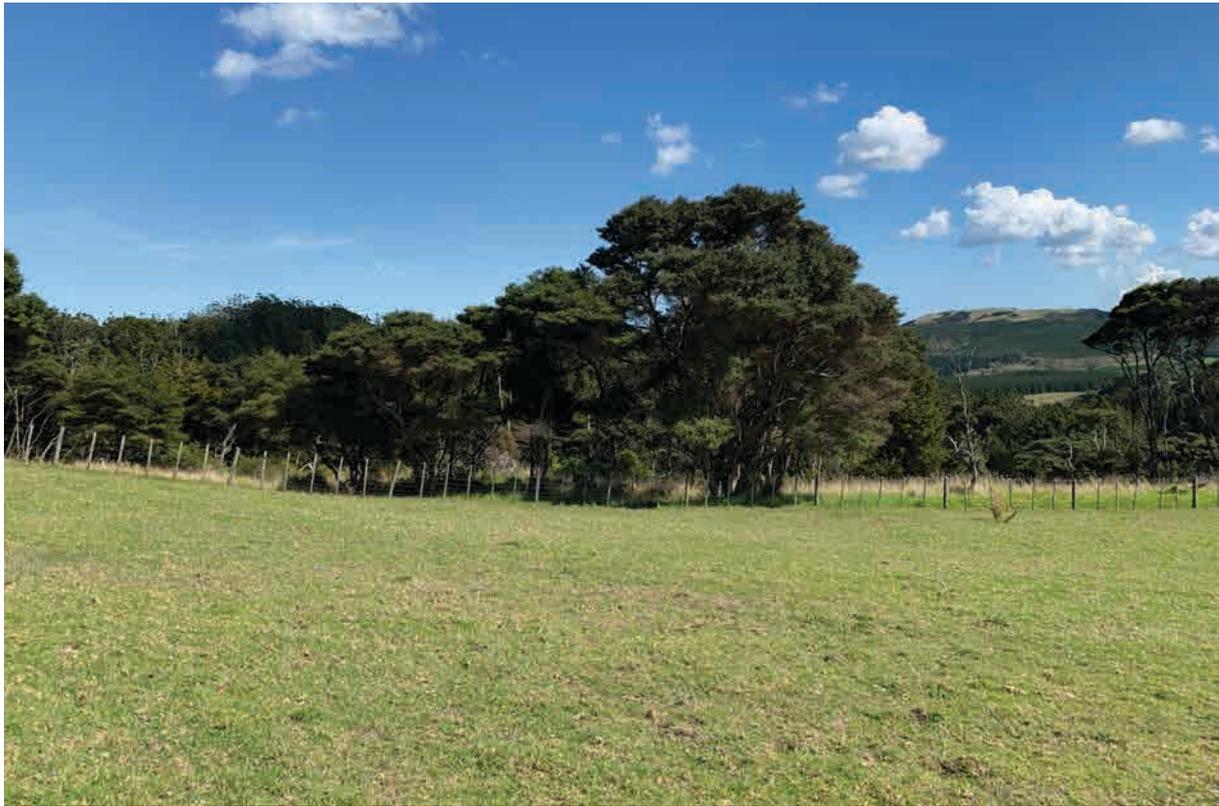
*Figure 9. View northwest of Q11/67 behind the manuka.*

Two storage pits were first recorded in 1975 by Best and relocated in 2009 by Druskovich. The pits were relocated during field assessment, located at the eastern edge of a bush filled gully, adjacent to the paddock fence.

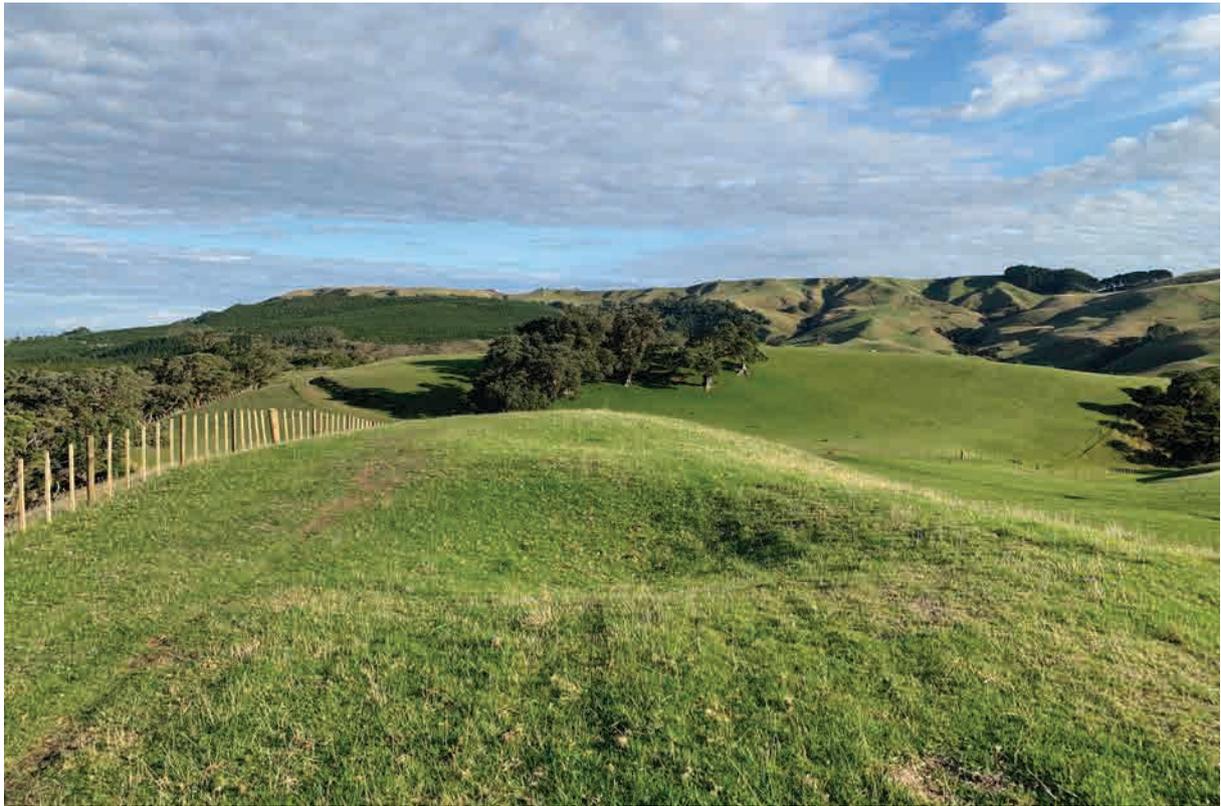
*Figure 10. View north of pits at Q11/68. Photo scale = 0.5 m.*

This site was relocated during field survey (Figure 10). The pits were originally recorded with measurements of 4 x 2 m x 0.15 m deep for the northern pit, and 6 x 3 m x 0.35 m deep for the southern pit. The southern pit was deeper than noted, being at least 0.5 m deep in the centre. 25 m north of the northern pit was a possible terrace measuring 8 x 8 m which is not noted in previous site assessments (Figure 11).

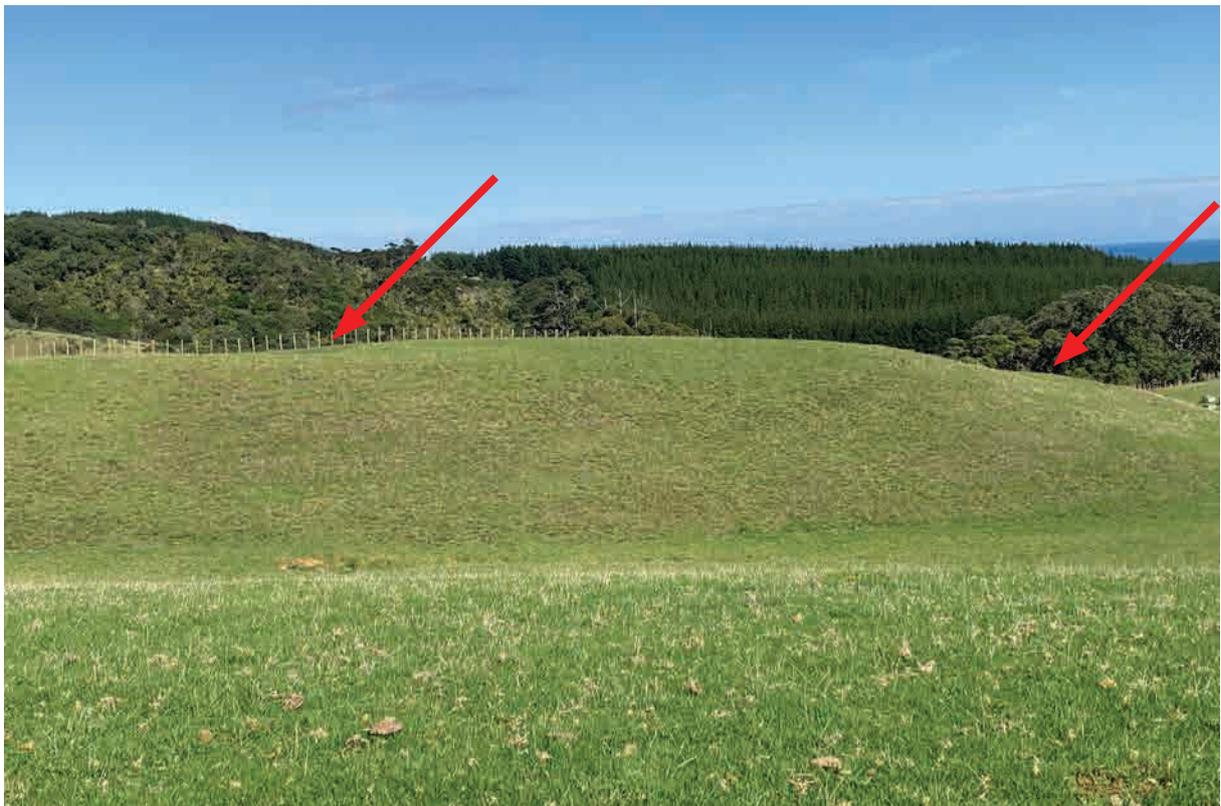
*Figure 11. View west showing the larger pit and the potential terrace (arrowed) at Q11/68.*

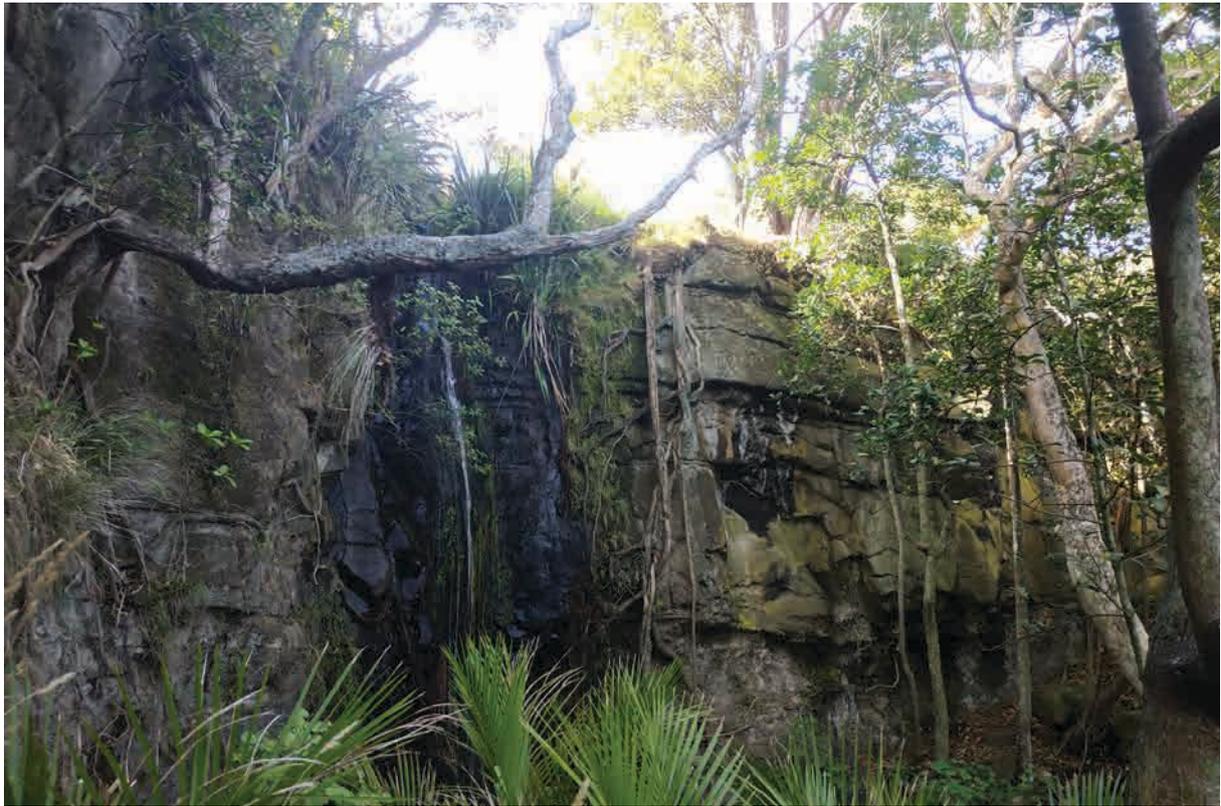
Q11/71 is a stone carving of a face recorded by Best in 1975 and relocated by Gillon in 2007. It is located on a steep rock face over which a small waterfall runs (Figure 12). The carving was relocated during the field assessment, approximately 8 m west of the waterfall. The head is about 1 m above the ground surface at that point, which slopes steeply up from the creek.

*Figure 12. Rocky outcrop on which the carving Q11/71 is located (off camera to the right).*

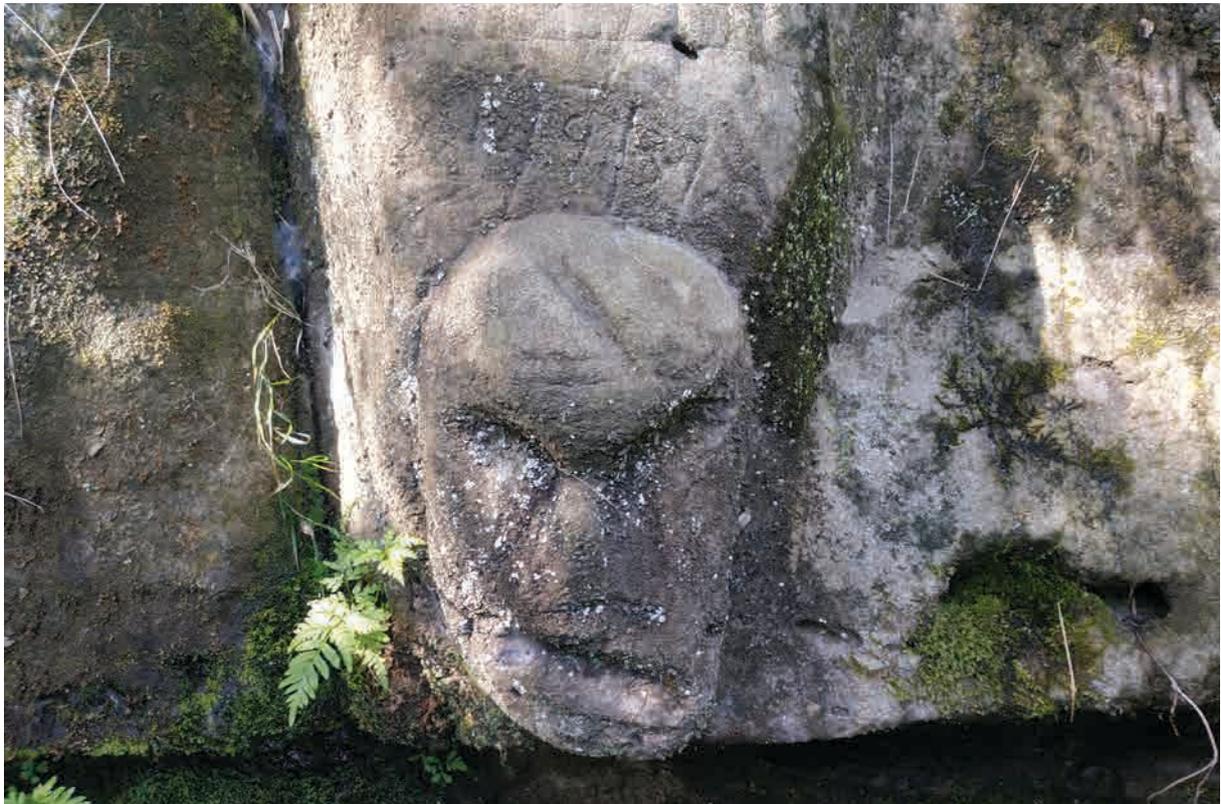
Previous site recordings note that it is unlikely the carving is pre-European Maori, due in part to its proximity to an old fence line, as well as the style. Previous recordings do not mention the date etched above the carving, which appears to read "12/9/39." This throws into question whether this date (and perhaps the face as well) was carved in 1939, and was obscured or for other reasons not recorded by Best or Gillon, or if the date was carved at some time after 2007 for an unknown reason – this latter seems unlikely.

The face carving is approximately 300 mm tall and 200 mm wide and has very deep relief, taking advantage of a natural protrusion from the surrounding rock. It has a heavy brow, large nose, and slanted mouth. There is a groove in the forehead as if it was used for grinding or sharpening (Figure 13).

*Figure 13. Stone carving of face with text above reading "12/9/39", Q11/71.*

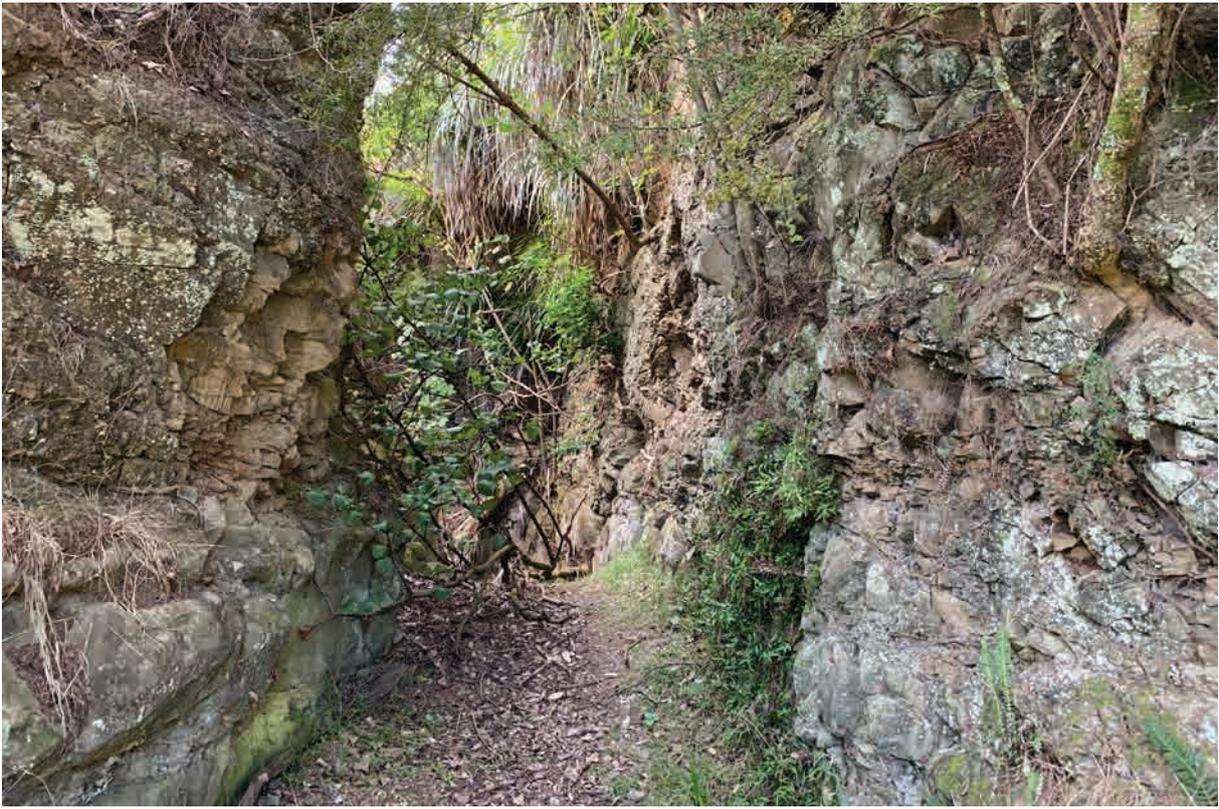
This site is the location of Foster's flax mill, on the southern bank of Okiritoto Stream at Okiritoto Falls. It was first recorded in 1981 by Renwick and revisited in 2008 and 2009 by Tanner and Druskovich, respectively. The mill was run by John Foster and dates to the 1870s. There are deep cuts in the rock approximately 7 m long, 3 m wide and 8 m deep for the wheel, with slots and buttresses, and evidence of races and slots in the bedrock above the falls. This site was relocated during the field assessment but was very overgrown (Druskovich noted that vegetation was a threat to the site), limiting access to the water wheel site (Figure 14 and Figure 15), but it remains as originally recorded.

*Figure 14. Water race at southern end of waterwheel slot, Q11/380.*

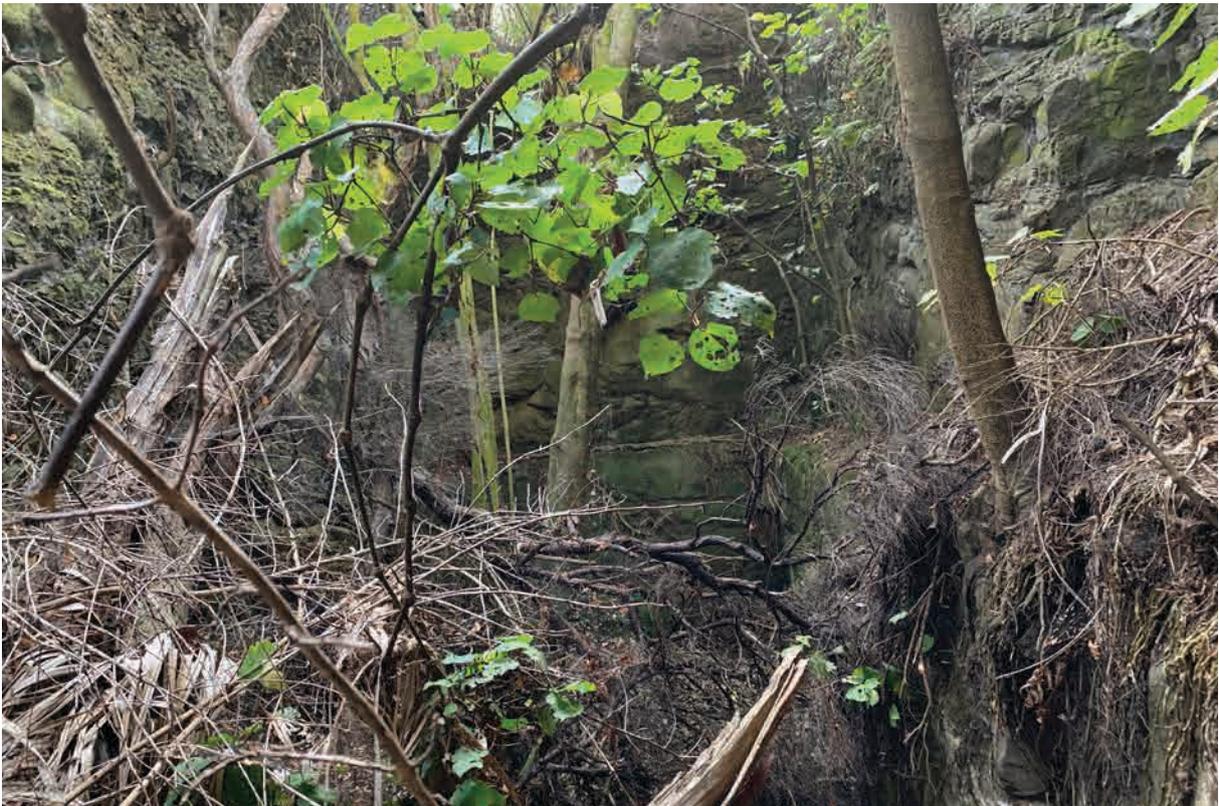
*Figure 15. Overgrown vegetation in waterwheel slot, Q11/380.*

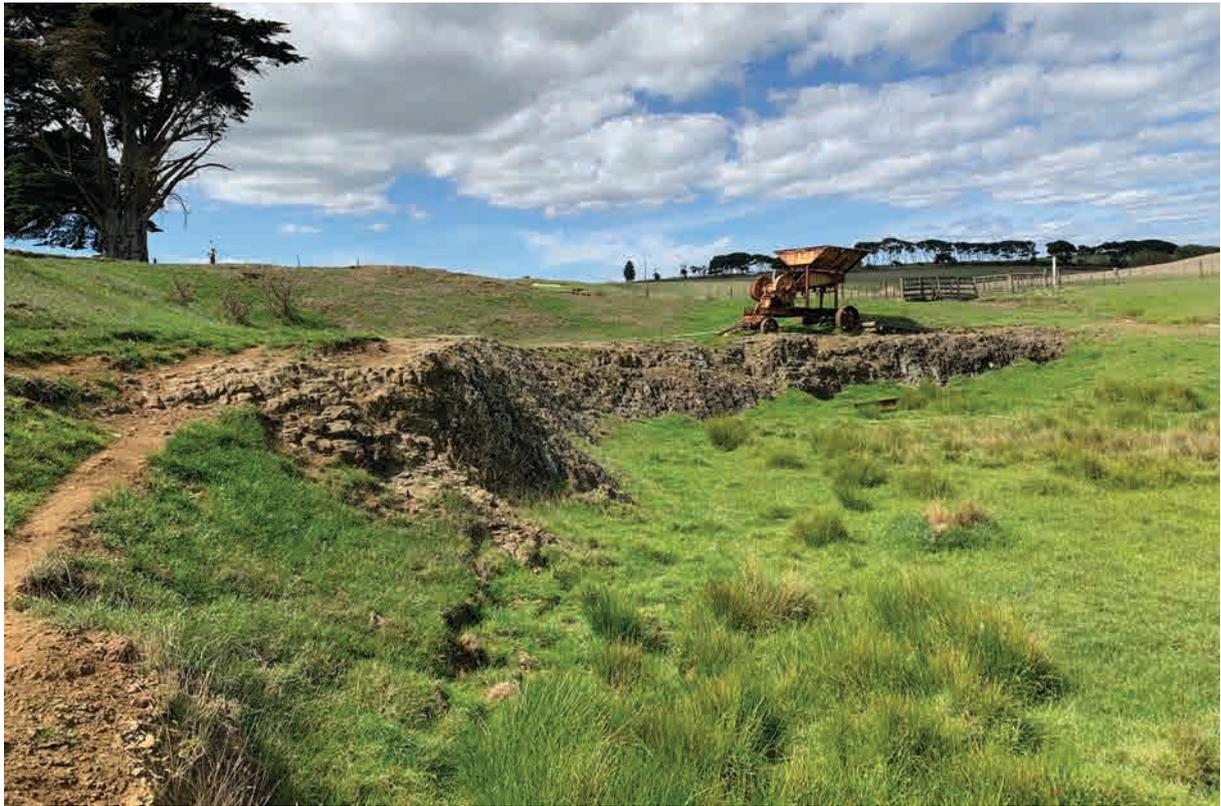
*Figure 16. View south of Houghton's quarry Q11/615.*

Houghton's andesite quarry is recorded in the CHI as item 1519. The small farm quarry was recorded by Hayward and Diamond as site O5 (1978), and was successfully relocated during field assessment on the east bank of a small tributary leading to the Okiritoto Stream. The quarry takes advantage of the underlying volcanic rock being present on the surface, and measures roughly 30 x 20 m, and is up to 2.5 m deep, and the floor of the quarry has partly infilled and become swampy. A belt driven Goodwin 15 x 7 Acme Victor rock crusher (Lee Hodges, CMS Cepercor (parent company of Goodwin Barsby), email, 23 March 2021) sits above the eastern bank of the quarry. The rock crusher is in fair condition, quite corroded underneath. Just south of the quarry by the current gate are some brick and concrete that probably relate to the quarry office or shed.

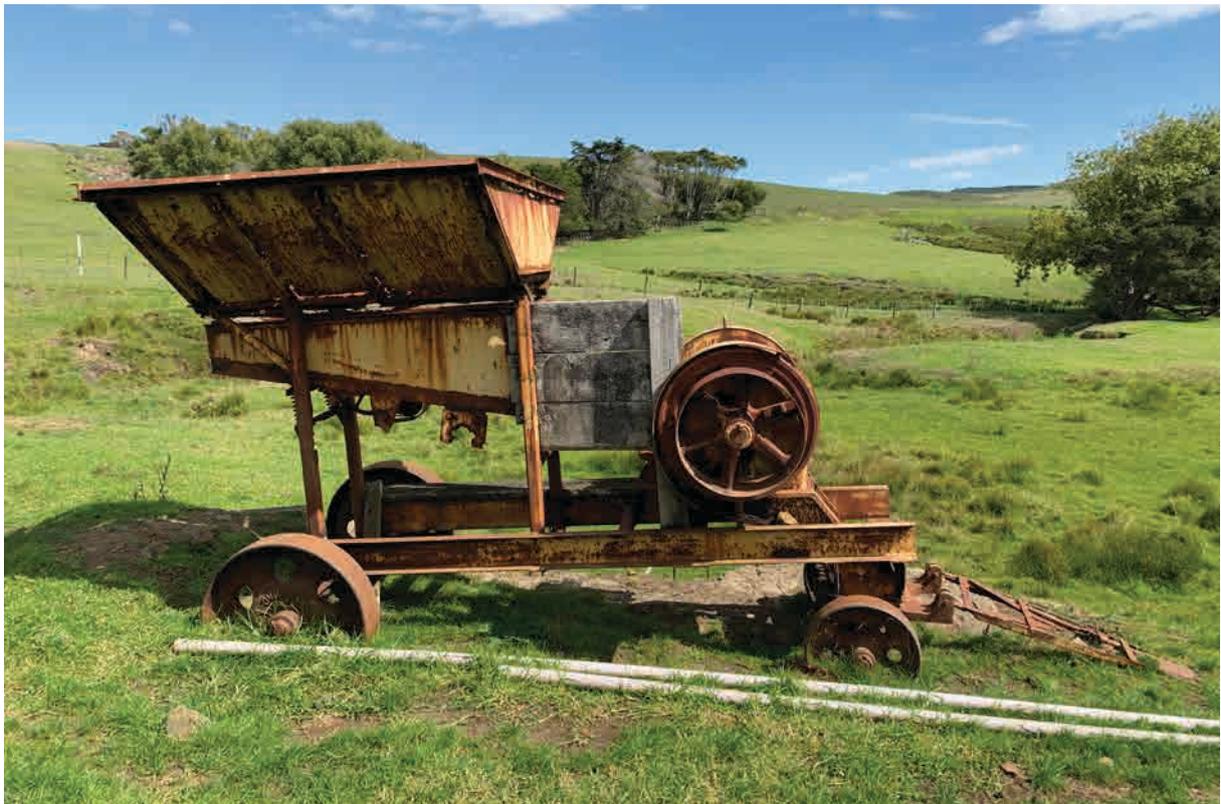
*Figure 17. Goodwin rock crusher located at the Houghton's Q11/615.*

The date of operation of the quarry is not known. The Houghton family owned the property between 1925 and 2019 and that model of rock crusher was built ca 1935–1957. The site is not visible in the earliest aerial photos (SN143, dated 1940) and is possibly visible in aerials from 1950 (SN583), but the resolution of these early images is poor. It is certainly visible in SN1392 from 1963, as is the building to the south. Houghton's Quarry has been recorded in the SRS as Q11/615.

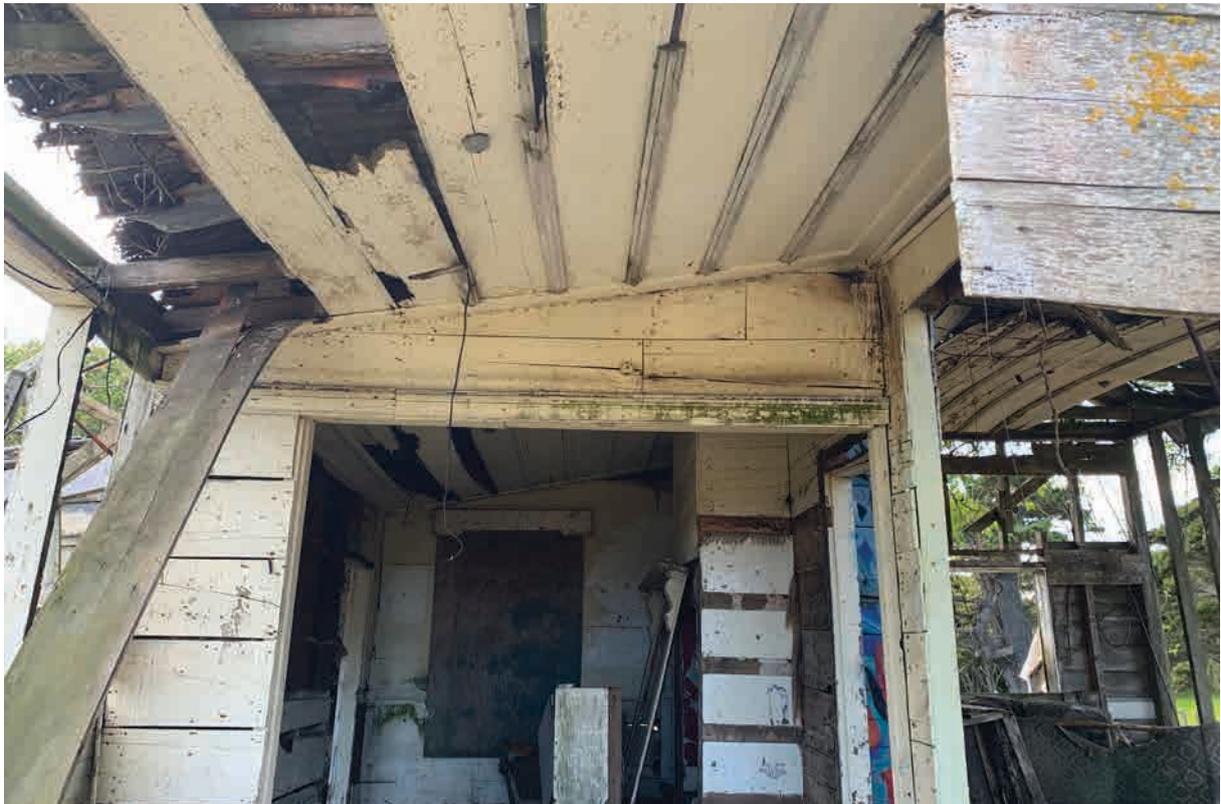
Figure 19. Horizontal sarking and board and batten ceiling in the dilapidated cottage Q11/614.

The cottage contains a main structure originally a square cottage of two rooms, with rear lean-to kitchen or laundry extension. The structural form indicates that the building was likely built before 1914, and possibly before 1910, before bevelled weatherboards became the norm (Arden and Bowman 2004). The use of what are apparently squared totara piles also is in keeping with post-1900 traditions noted by Salmond (1986). The existing chimney is likely to be early 1900s in date, based on its simple, monochromatic brick construction and use of cement-enriched mortar.

Surviving interior features included the original plan layout of the main cottage, a back-to-back chimney breast; internal stud walls, sarking, and joinery, which includes ceiling trims, door skirt-

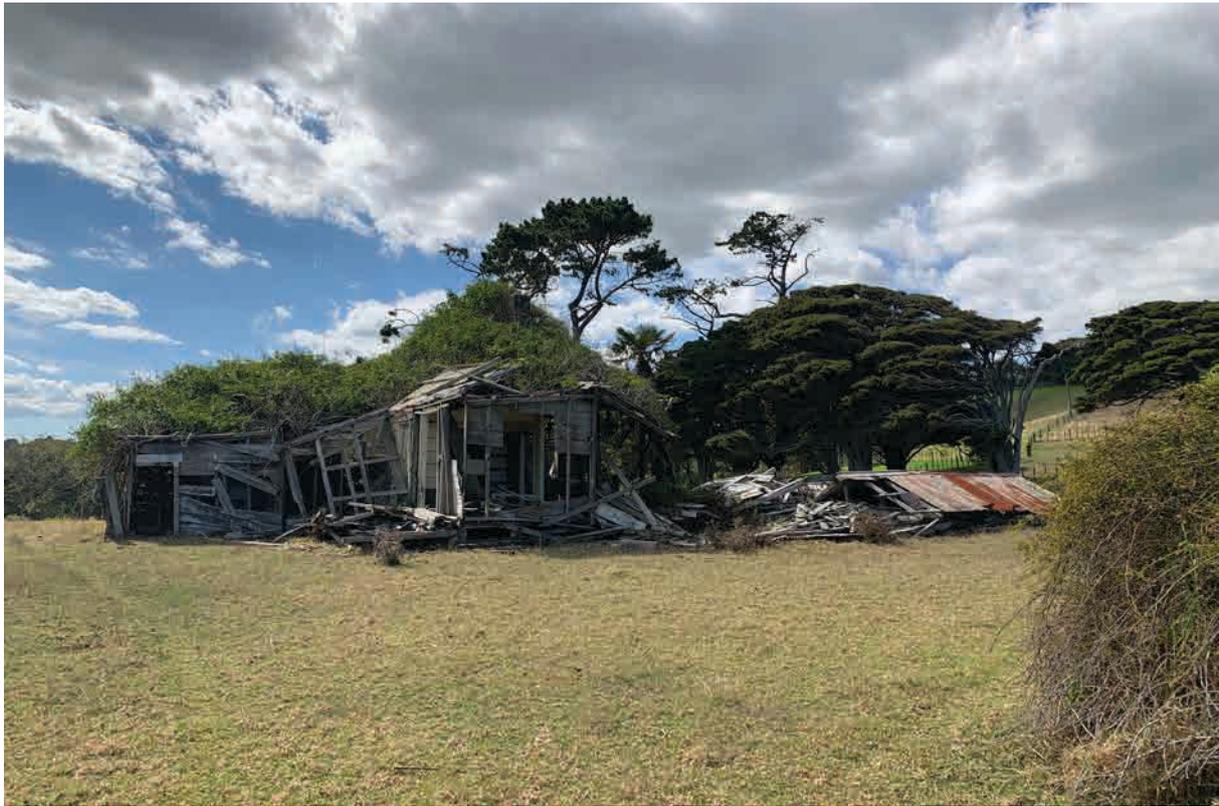
A dilapidated cottage was recorded on 614 Muriwai Road. This is the same building shown on DP 9596, dated 1914 (Figure 3). It was in an unsafe condition and was only observed from the outside. Visible elements, including horizontal 12" sarking, board and batten ceilings, tiled fire surround and a surviving 4-pane double-hung sash window indicate an early 20th century date of construction. Aerial photos from 2017 show the roof intact, but since then the front of the house has been partly demolished with the roof and ceiling structure lying on the ground. It has been recorded as site Q11/614 in the SRS.

Figure 20. General view of the dilapidated cottage Q11/614, looking north.

Modifications include a rear lean-to, which may be part of the original building form as a laundry or other ancillary space, and the extended bay to the front of the property which was probably a bedroom. The front living room chimney surround was also modified around this time, with tiling added around the grate. Some of the floor joists also appear to have been replaced.

Subsequent design has avoided most of the sites discussed in this report, apart from the dilapidated early 20th century cottage Q11/614. A 10 m buffer has been placed around pit sites Q11/67 and Q11/68 and they will not be affected. Some subsurface evidence of 20th century outbuildings associated with Q11/616 Ingram's boarding house may also be affected.

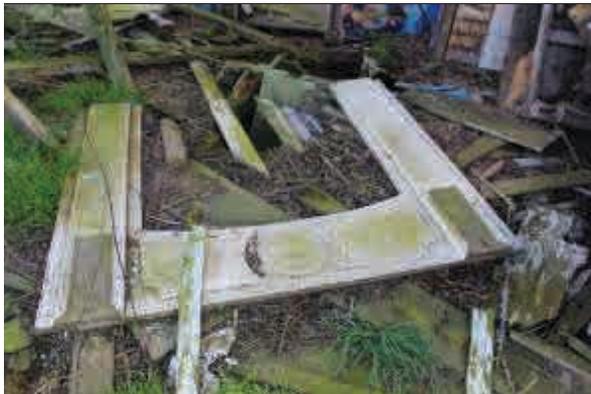
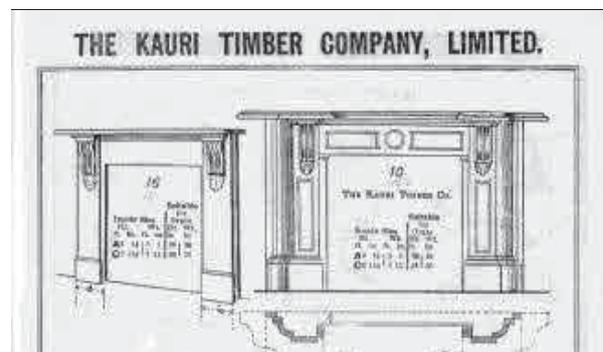
Figure 21. Comparison of the mantel with a 1906 catalogue example.

ing and architraves. It is likely, based on the combination of visible features, that the core cottage was constructed between c. 1904 and c. 1910. A good example is the comparison of a Kauri Timber Company mantel, which is a close match to a design shown in the 1906 catalogue (Figure 21).
