Client **Auckland Transport**
 Project **Eastern Busway**
 Project number **60644113**

Co-ordinates **411494.80mE 795054.36mN**
 Orientation **-90°** Elevation **8.86m**
 Location **262 Ti Rakau Drive - Chinatown**
 Feature **Bridge Abutment/Pier**

Co-ordinates 411510.79mE 795065.64mN
 Orientation -90° Elevation 8.88m
 Location 262 Ti Rakau Drive - China Town
 Feature Bridge Abutment

Co-ordinates 411582.05mE 795072.05mN
 Orientation -90° Elevation 8.195m
 Location 209 Burswood Dr, Pakuranga
 Feature Bridge/Embankment Design

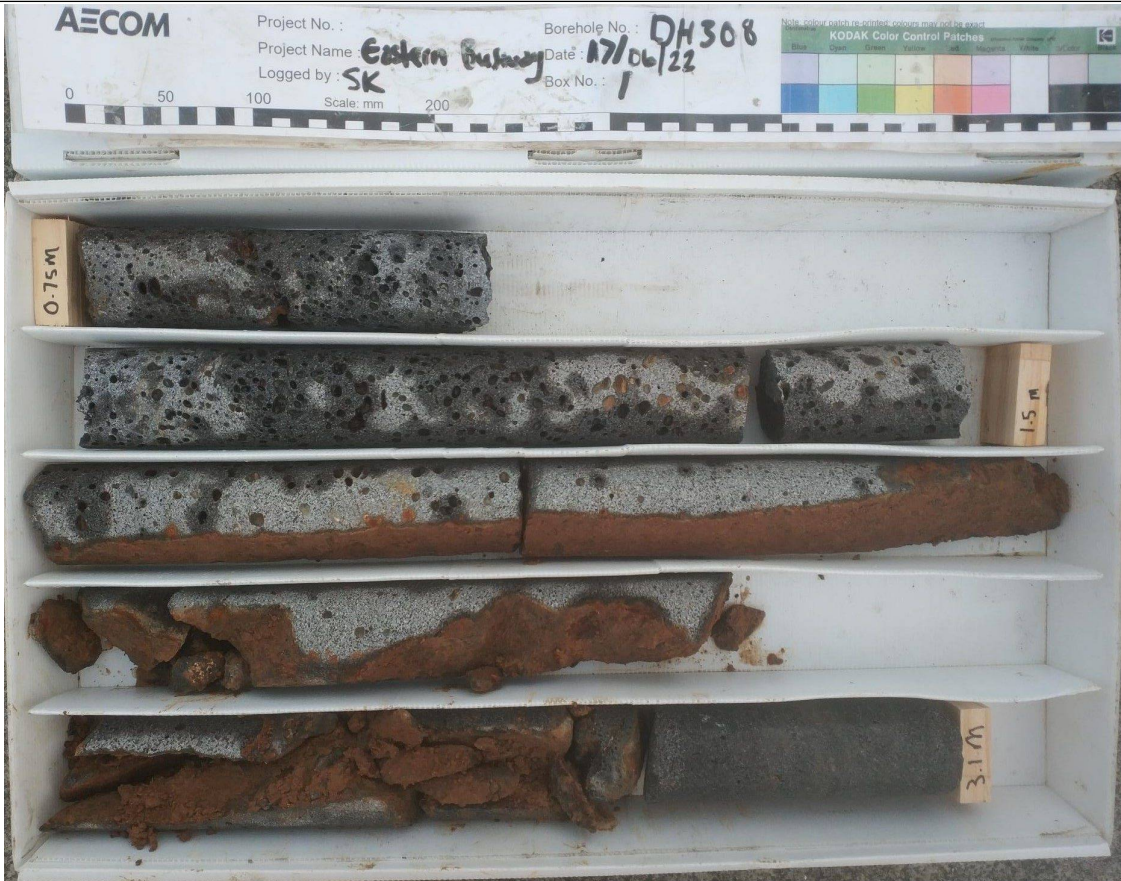
Box: 1 of 10 - Depth: 00.75m to 03.10m of 27.00m
 Date Drilled 17/06/2022 to 20/06/2022 - Date Photographed: 17/06/2022

AUCKLAND VOLCANIC FIELD				HQ3				1		100 [100]		1.5 to 2.22m: J, 80°, Ud, Ro, Sn, Fe		
0.75m: SW, dark grey, BASALT. Moderately strong. Highly vesicular (<20%), vesicles typically 5-10mm and up to 60mm. Some iron staining in vesicles.				HQ3				2		88 [59]		1.95m: 114mm diameter HWT casing to 1.95m. 2.1 to 2.16m: J, 45°, Ud, Ro, Sn, Fe 2.14 to 2.2m: J, 45°, Ud, Ro, Sn, Fe 2.14 to 2.17m: DB, 60°, Ud, Ro, Sn, Fe 2.27 to 2.46m: J, 85°, Ud, Ro, Sn, Fe 2.46 to 2.49m: J, 20°, Ud, Ro, MN, P, Cl, Stn, Fe. 2.46 to 2.78m: J, 70°, Ud, Ro, Sn, Fe		2.56

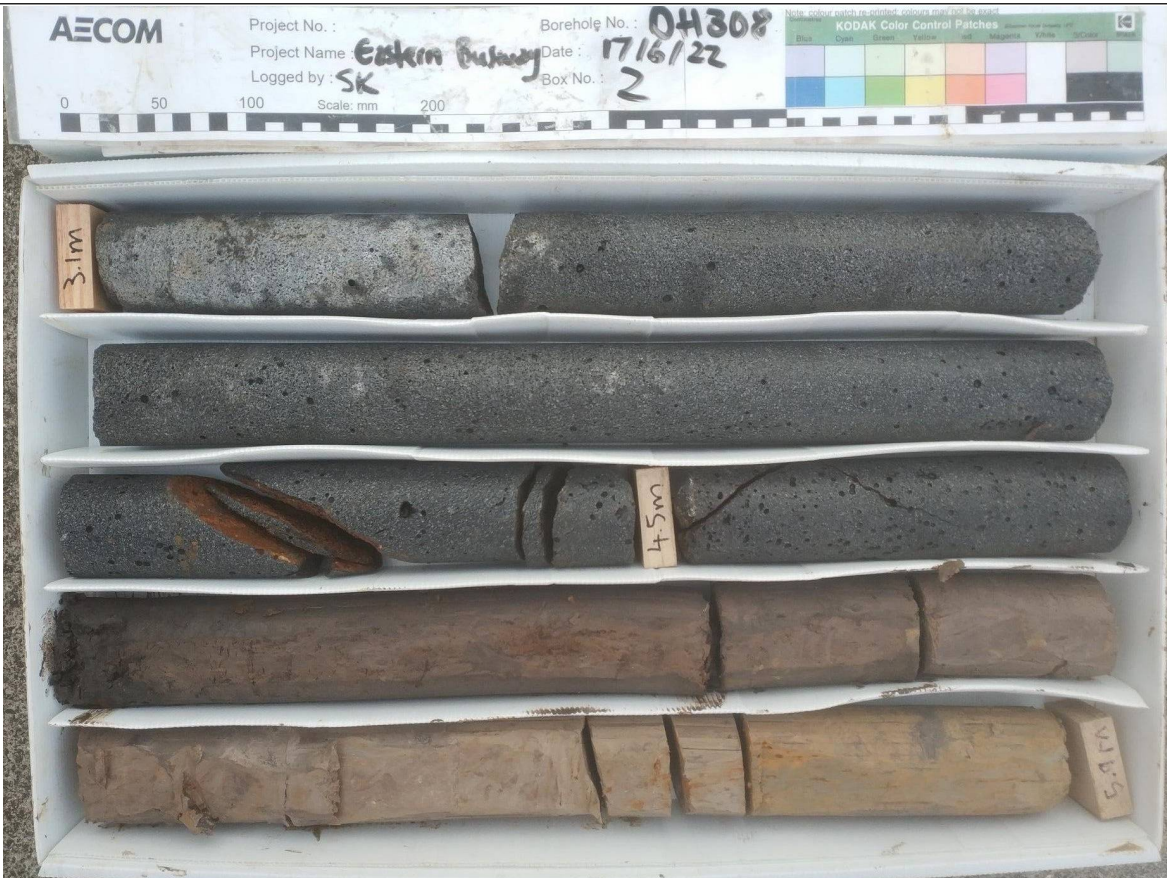
Box: 2 of 10 - Depth: 03.10m to 05.90m of 27.00m
 Date Drilled 17/06/2022 to 20/06/2022 - Date Photographed: 17/06/2022

1.7m: Slightly weathered, vesicular, dark grey, BASALT. Strong. Slightly vesicular (<2%). Vesicles up to 5mm.				HQ3				3						
4.45 to 4.75m: Slightly vesicular (<5%).				HQ3				4		100 [100]		4.23 to 4.35m: J, 60°, Ud, Ro, Sn, Fe 4.24 to 4.36m: J, 60°, Ud, Ro, Sn, Fe 4.5 to 4.58m: J, 60°, Ud, Ro, Sn, Fe 4.58 to 4.66m: J, 55°, Ud, Ro, VN, Sn, Fe		4.59
TAURANGA GROUP		UTP		HQ3				5		100 [18]		4.75m: Silty CLAY with trace organics; brown mottled orange. Very stiff, moist, high plasticity. 5.3 to 5.6m: Pinkish grey mottled orange.		5.54

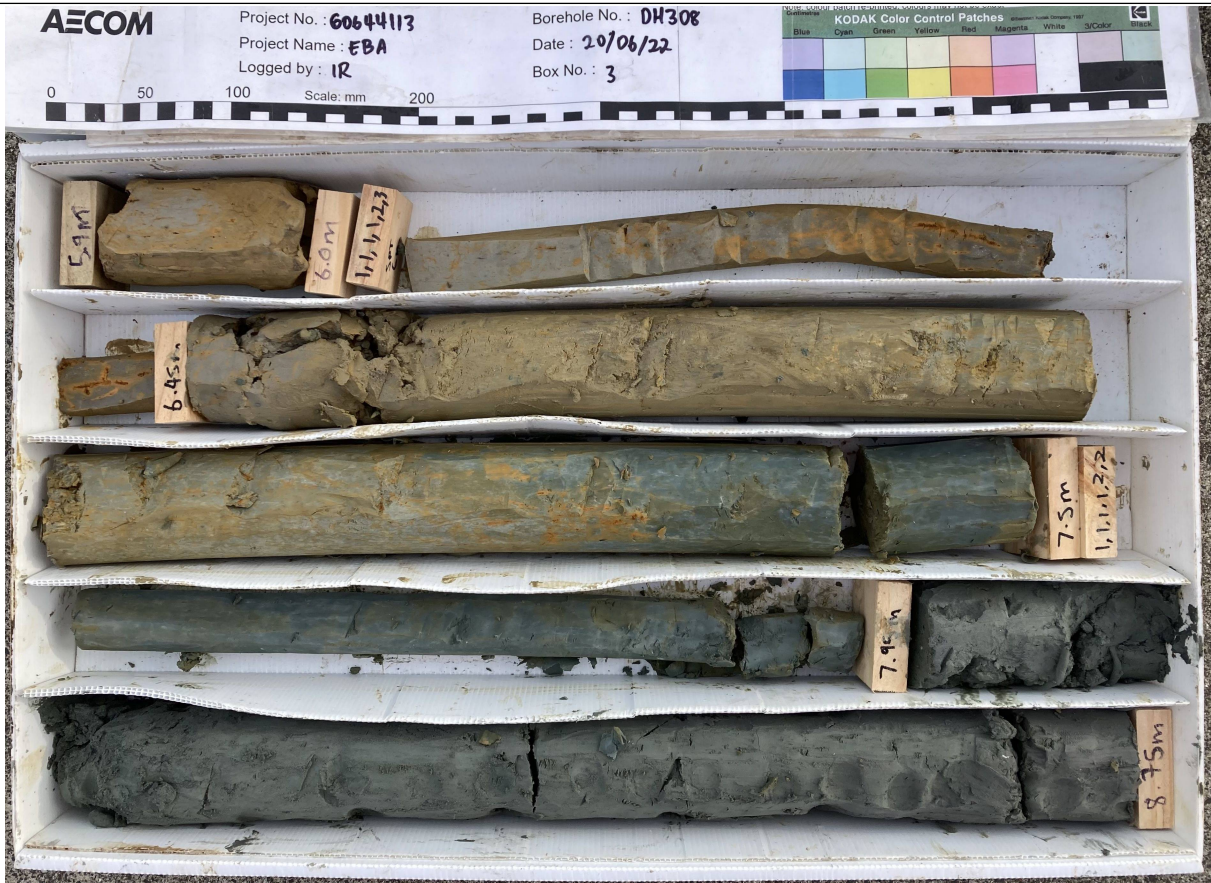
Box: 3 of 10 - Depth: 05.90m to 08.75m of 27.00m
 Date Drilled 17/06/2022 to 20/06/2022 - Date Photographed: 20/06/2022

4.75m: ALLUVIUM comprising clay, silt, peat and sand.		128/41 ss 1,1,1, 1,2,3 N=7		SPT				6		100		7.3m: CLAY; bluish grey with some orange mottling. Stiff, moist, high plasticity.		
		188/35 ss 1,1,1, 1,2,2 N=6		HQ3				7		100		8.1 to 8.15m: Clayey fine SAND. 8.15m: Silty CLAY with some fine sand; bluish grey. Firm, moist, high plasticity.		
		47/15 ss 0,0,1, 1,0,0 N=2		SPT				8		100		9.5 to 9.8m: Micaceous fine sandy SILT lenses.		
				HQ3				9		100				
				PT										
				SPT

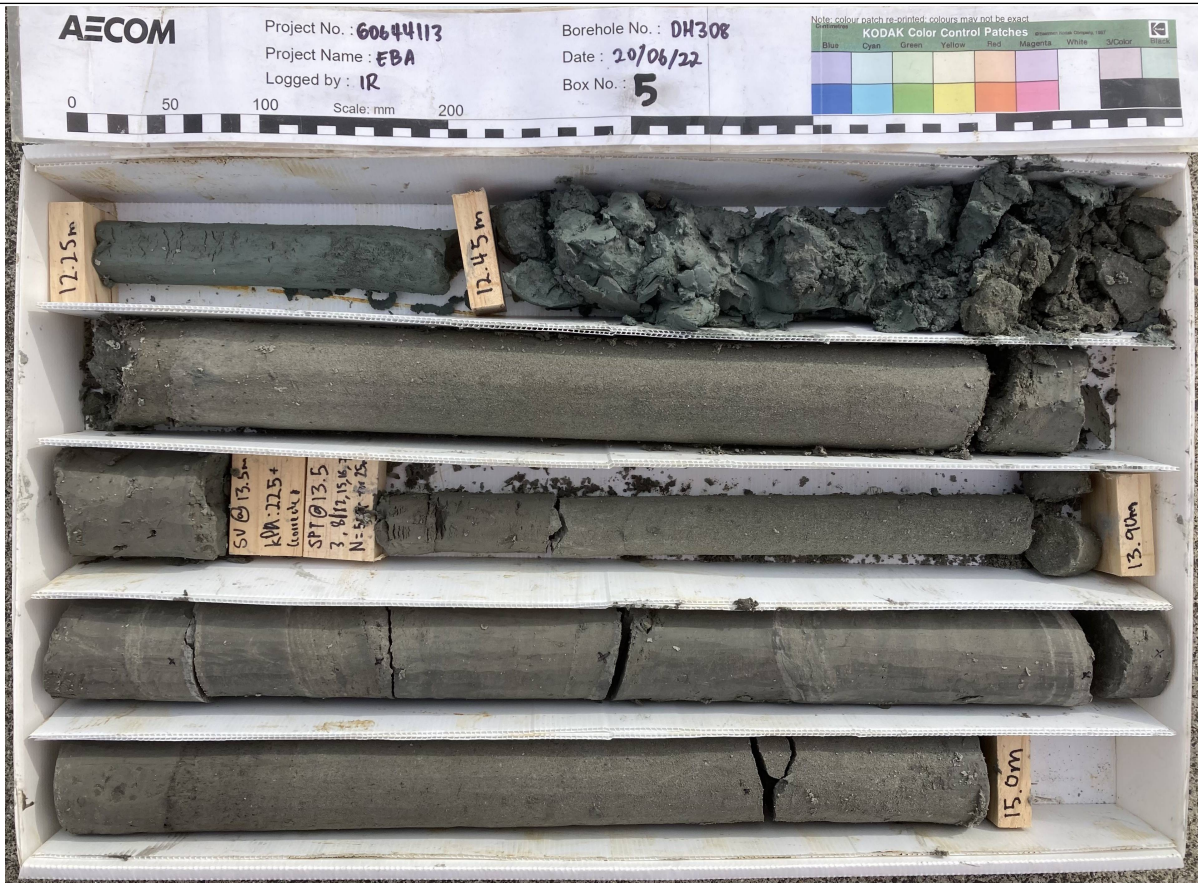
Box: 5 of 10 - Depth: 12.25m to 15.00m of 27.00m
 Date Drilled 17/06/2022 to 20/06/2022 - Date Photographed: 20/06/2022

12.6m: HW, grey, fine to medium SANDSTONE. EW. 12.8m: MW, grey, fine to medium SANDSTONE. VW.		HQ3						100		12.6m: Fine to medium SAND; grey.	
	13.35m: HW, grey, SILTSTONE. EW. 13.6m: MW, grey, fine SANDSTONE. Very weak.	225* ss 3,8,12, 15,16,7 for 25mm N>50	SPT						100		13.35m: Clayey SILT with trace fine siltstone gravel; grey

13.9m: Slightly weathered, grey, SILTSTONE. Very weak.		HQ3						100		13.9m: Gently inclined very thinly to moderately thinly bedded. 13.9 to 15m: DB, 5°, 6 No.

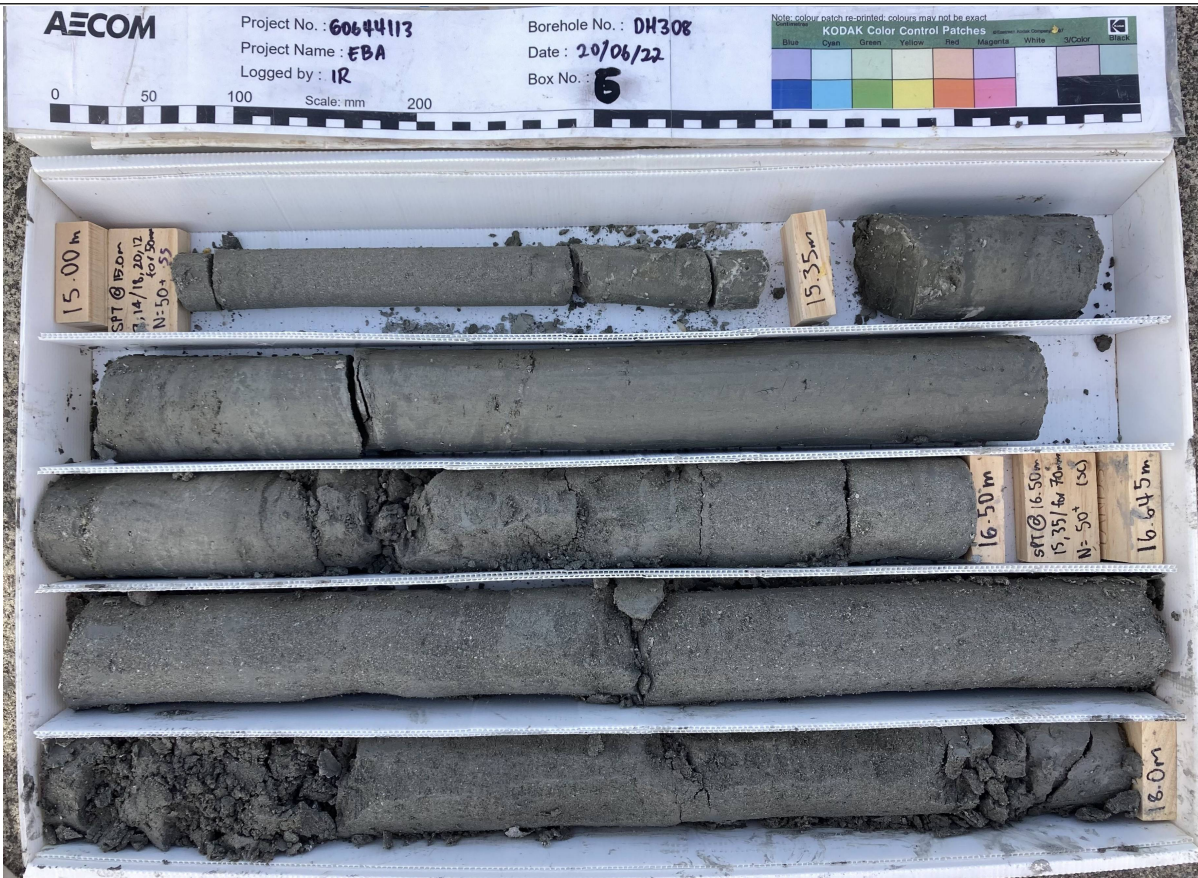
Box: 6 of 10 - Depth: 15.00m to 18.00m of 27.00m
 Date Drilled 17/06/2022 to 20/06/2022 - Date Photographed: 20/06/2022

14.53m: Slightly weathered, grey, fine SANDSTONE. Very weak.		SPT						100		15.35 to 16.5m: DB, 0°, 3 No. 15.4 to 15.5m: Fine sandy SILTSTONE.	
EAST COAST BAYS FORMATION	15.3m: Slightly weathered, grey, SILTSTONE. Very weak. Gently inclined, very to moderately thinly bedded.	9,14,18, 20,12 for 50mm N>50	SPT						100		16.02m: BP, 5°, VN, C, Slt 16.15 to 16.35m: Very thin silt beds.	[Instrumentation symbols]

16.1m: Slightly weathered, grey, thickly bedded, fine to medium SANDSTONE. Very weak.	sc 15,35 for 70mm N>50	SPT						0		17.4 to 17.55m: Recovered as silty fine to medium SAND.	
			HQ3						100	[73]	18.2 to 18.93m: Recovered as fine SAND. 19.25 to 19.5m: DB, 5°, 4 No.

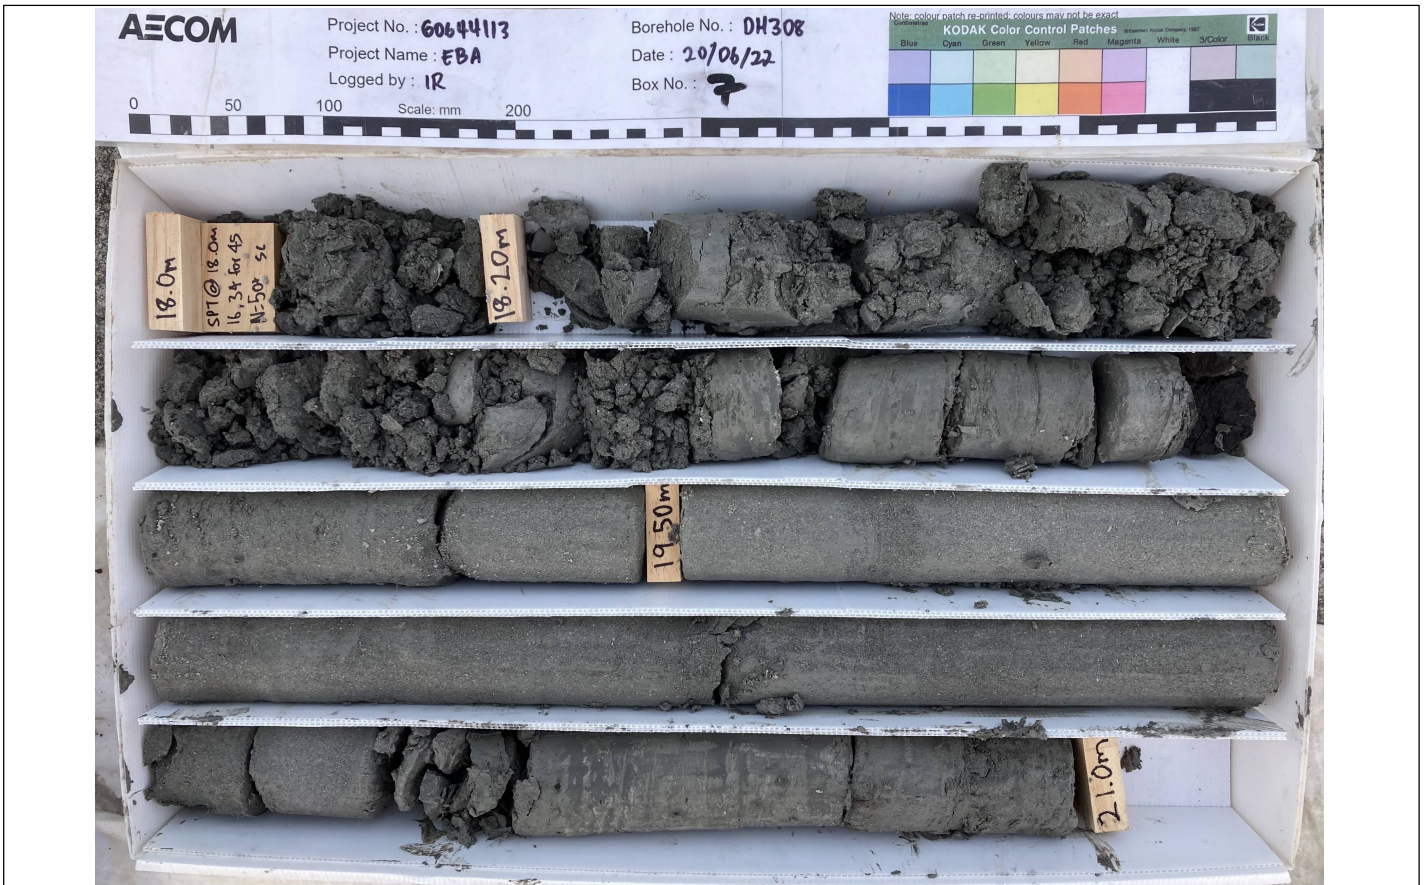
Box: 7 of 10 - Depth: 18.00m to 21.00m of 27.00m
 Date Drilled 17/06/2022 to 20/06/2022 - Date Photographed: 20/06/2022

18.2 to 18.93m: Extremely weak.	sc 16,34 for 45mm N>50	SPT						75		18.93 to 19.06m: SILTSTONE bed. 19.2m: Very thin carbonaceous bed.	
			HQ3						100	[12]		
			SPT									
			HQ3									
			SPT									
			HQ3									
For explanation of symbols and observations, see key sheet			RELATIVE STRENGTH		WEATHERING		Date logged 20/06/2022		Driller McMillan			
FLUID DEPTHS AND DRILLING PROGRESS (m) Date Time Drilled Depth Casing Depth Fluid Depth			VS - Very strong S - Strong MS - Moderately strong W - Weak VW - Very weak EW - Extremely weak		UW - Unweathered SW - Slightly weathered MW - Moderately weathered HW - Highly weathered CW - Completely weathered		Logged IR/GS Checked GP		Started 17/06/2022			
Hand Held Shear Vane DR2272: 19mm blade: Calibrated 02/22: Correction Factor = 1.595 vane shear strength per NZGS guideline			Remarks Flush 50 mm standpipe piezometer installed on completion. DR1980: 19mm blade: Calibrated Jun 2022: Correction Factor: 1.876 used for hand shear vane measurements 9.0m and deeper.						Finished 20/06/2022

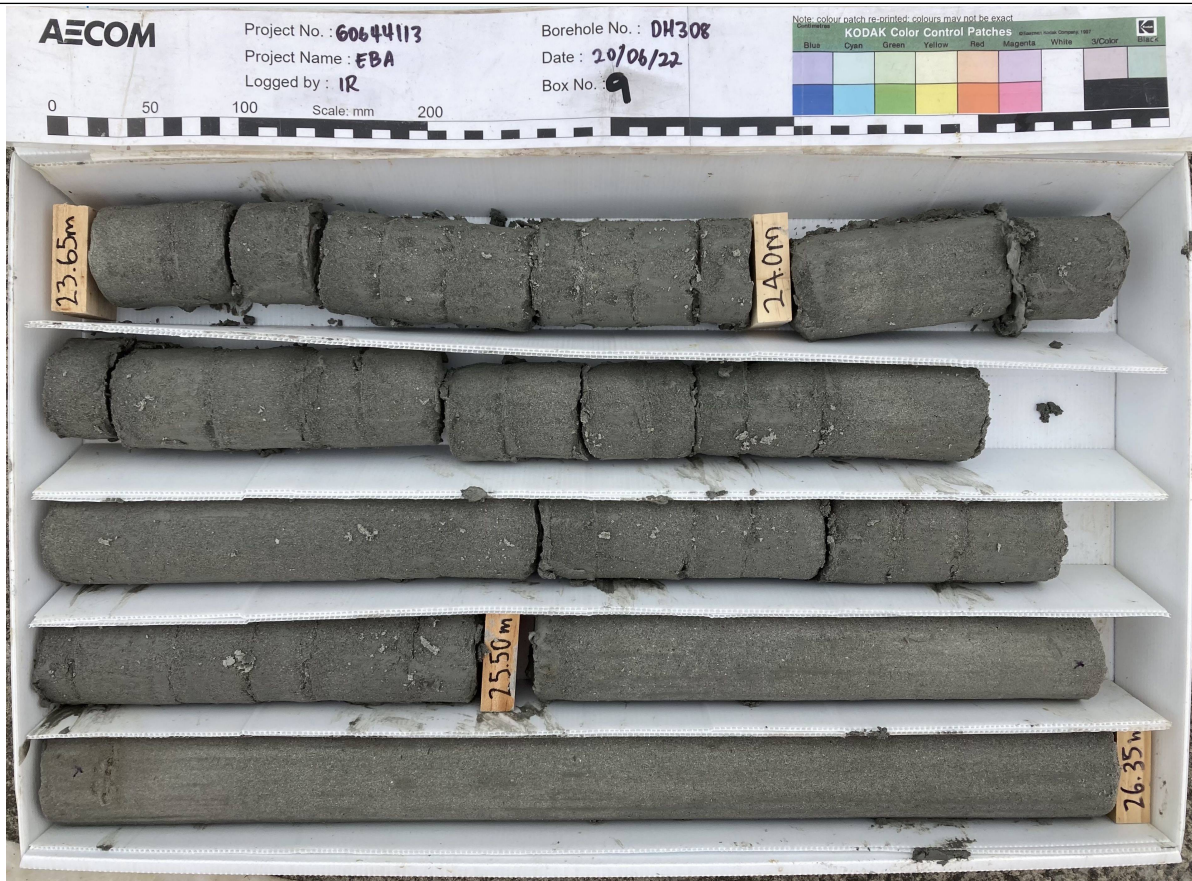
Box: 9 of 10 - Depth: 23.65m to 26.35m of 27.00m

GEOLOGICAL DESCRIPTION <small>Weathering, Colour, Fabric, ROCK NAME. Strength, Discontinuities, Lithological Features (bedding, foliation, mineralogy, cement, etc.)</small>	Test Records		Drilling Method <small>Casing remarks</small>	Core Loss/Lift	Relative Strength	Rock Weathering	Depth	Graphic Log	TCR [RQD] (%)	Spacing of Natural Defects (mm)	SOIL PROPERTIES	Instrumentation	
	Shear Vane/ SPT	SPT N Values									Subordinate MAJOR minor: colour, structure. Strength, moisture condition, grading, bedding, plasticity, sensitivity, major fraction description, subordinate fraction description, minor fraction description, additional structures, additional information, etc		
EAST COAST BAYS FORMATION 16.1m: Slightly weathered, grey, thickly bedded, fine to medium SANDSTONE. Very weak. (continued) 20.68m: SW, grey, SILTSTONE. Very weak. 20.94m: Slightly weathered, grey, fine SANDSTONE. Very weak. 22.3m: Slightly weathered, grey, SILTSTONE. Very weak. 22.67m: Slightly weathered, grey, thickly bedded, fine SANDSTONE. Very weak. 26.7 to 27.0m: Siltstone			HQ3						100 [90]		21.0 to 22.5m: DB, 0°, 2 No. 21.05 to 21.15m: Recovered as subangular SILTSTONE gravel. 21.2m: SILTSTONE clast, 50mm long. 22.3 to 22.4m: Thinly laminated. 22.5m: Subrounded SILTSTONE clast, 20mm. 23.5 to 25.5m: Subhorizontal, thinly to moderately thinly bedded with thin laminations or partings of mudstone. Drilling breaks infilled with mud. 25.5 to 27m: DB, 0°, 4 No. 26.7 to 27.0m: Thinly laminated.

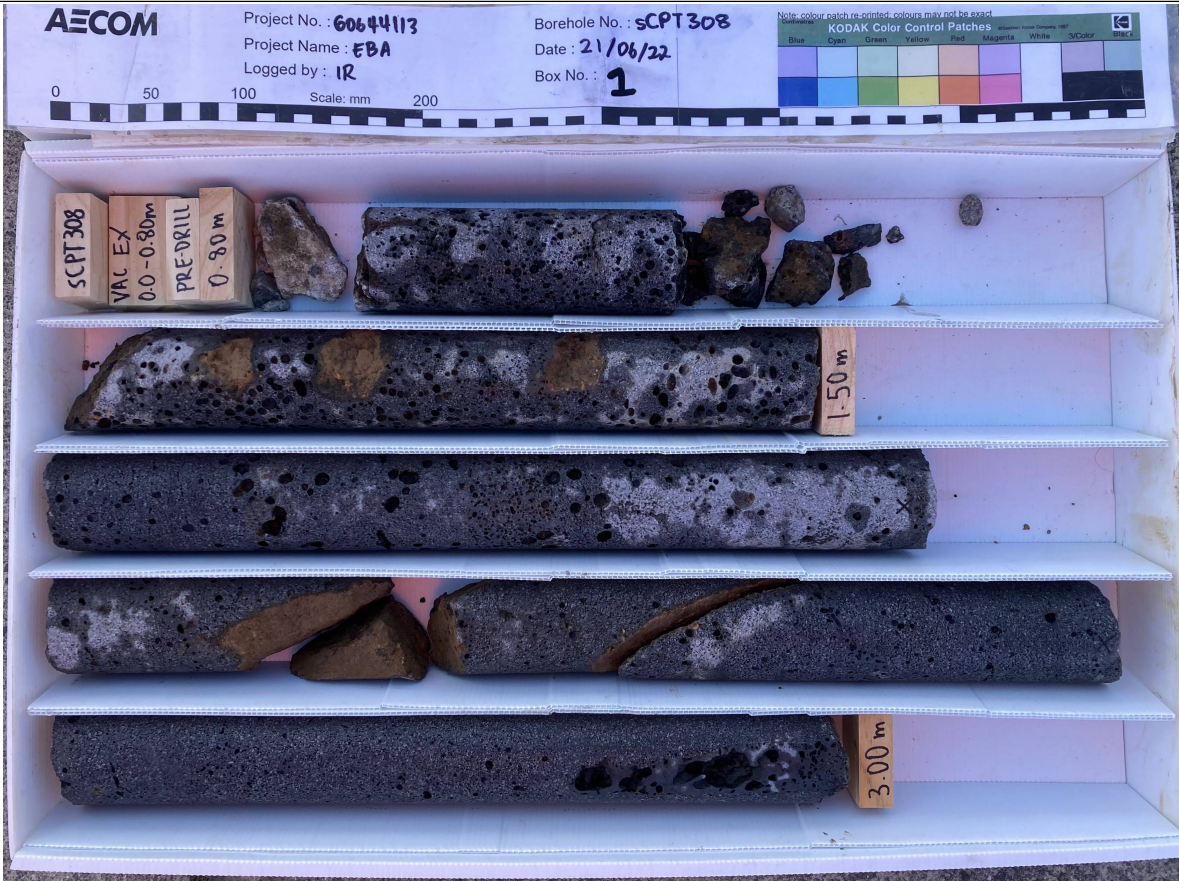
Box: 1 of 2 - Depth: 00.80m to 03.00m of 5.10m

0.8m: Slightly weathered, grey speckled light grey, BASALT. Moderately strong. Moderately vesicular, up to 50mm. Iron staining in some vesicles.			HQ3					1		100 [86]		0.8 to 5.1m: Used 2m3 of water. 1.08m: J, 52°, Ud, Ro, N, Sn, Fe & Slt

2.0m: Becomes slightly vesicular. Vesicles up to 10mm.			HQ3					2		100 [100]		2.17m: J, 10°, Ud, Ro, N, Sn, Fe & Slt 2.1 to 2.2m: J, 60°, Ud, Ro, N, Sn, Fe & Slt 2.3 to 2.4m: J, 80°, Ud, Ro, N, Sn, Fe & Slt

2.87 to 2.96m: Vesicles up to 50mm. 3.05 to 5.0m: Strong. Vesicles up to 5mm.			HQ3					3		100 [100]		3.1m: J, 45°, Ud, Ro, N, Sn, Fe 3.12 to 3.24m: J, 60°, Ud, Ro, N, Sn, Fe 3.23 to 3.36m: J, 80°, Ud, Ro, N, Sn, Fe

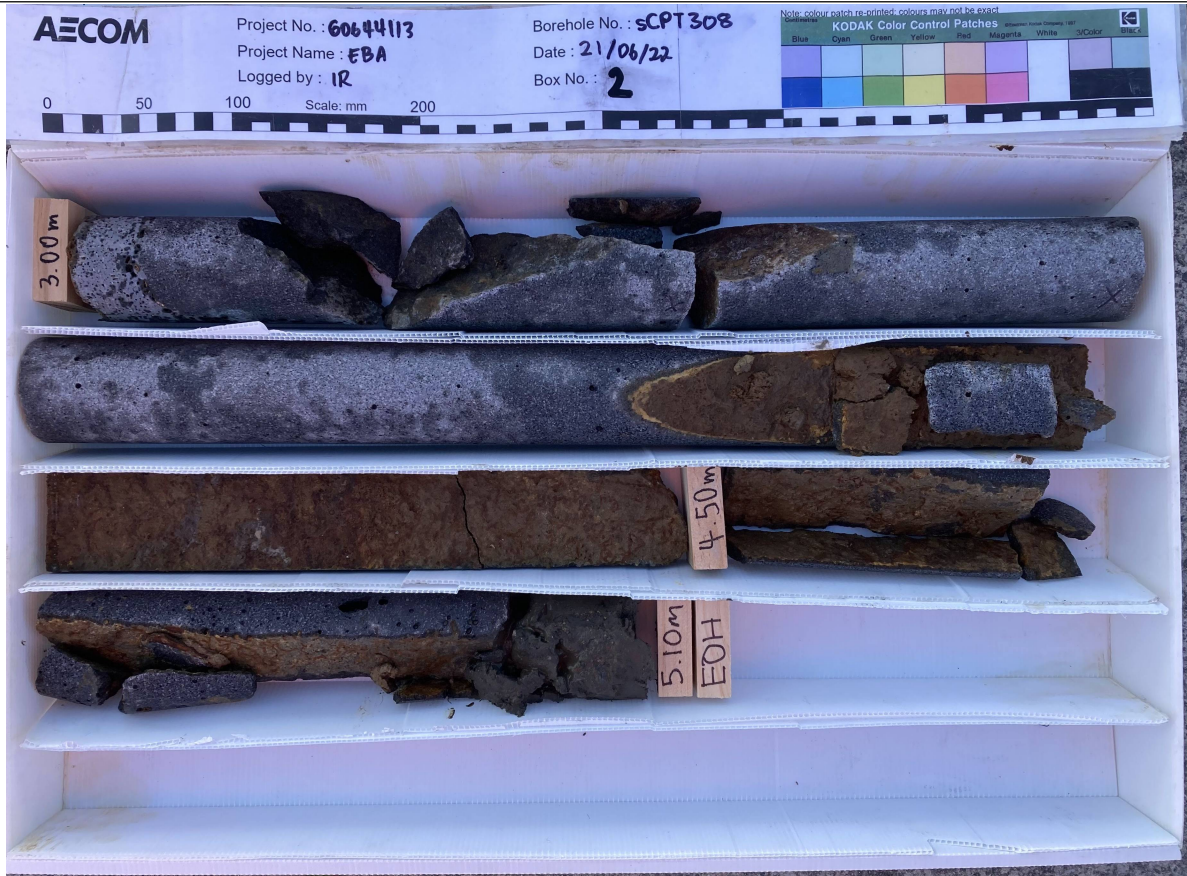
Box: 2 of 2 - Depth: 03.00m to 05.10m of 5.10m

5.0m: ALLUVIUM comprising silt and clay.			HQ3					4		100 [100]		3.9 to 5m: J, 90°, Ud, Ro, MN, C, Cl & Fe, some infill washed out.		
									5		100 [100]		5.0m: Silty CLAY; greyish brown. Moist, firm, high plasticity.		
									6				DH-sCPT308 terminated at 5.1m Depth Criteria Achieved		
									7						
									8						
									9						
For explanation of symbols and observations, see key sheet				RELATIVE STRENGTH		WEATHERING		Date logged 21/06/2022		Driller McMillan					
FLUID DEPTHS AND DRILLING PROGRESS (m) Date Time Drilled Depth Casing Depth Fluid Depth				VS - Very strong S - Strong MS - Moderately strong W - Weak VW - Very weak EW - Extremely weak		UW - Unweathered SW - Slightly weathered MW - Moderately weathered HW - Highly weathered CW - Completely weathered		Logged IR Checked GP		Started 21/06/2022		Finished 21/06/2022		Drill Rig N119	
Hand Held Shear Vane				Remarks Drilling through basalt to form starter hole; investigation continued with seismic cone penetration test. Piezometer installed upon completion of sCPT. No groundwater encountered.						Core Boxes 2

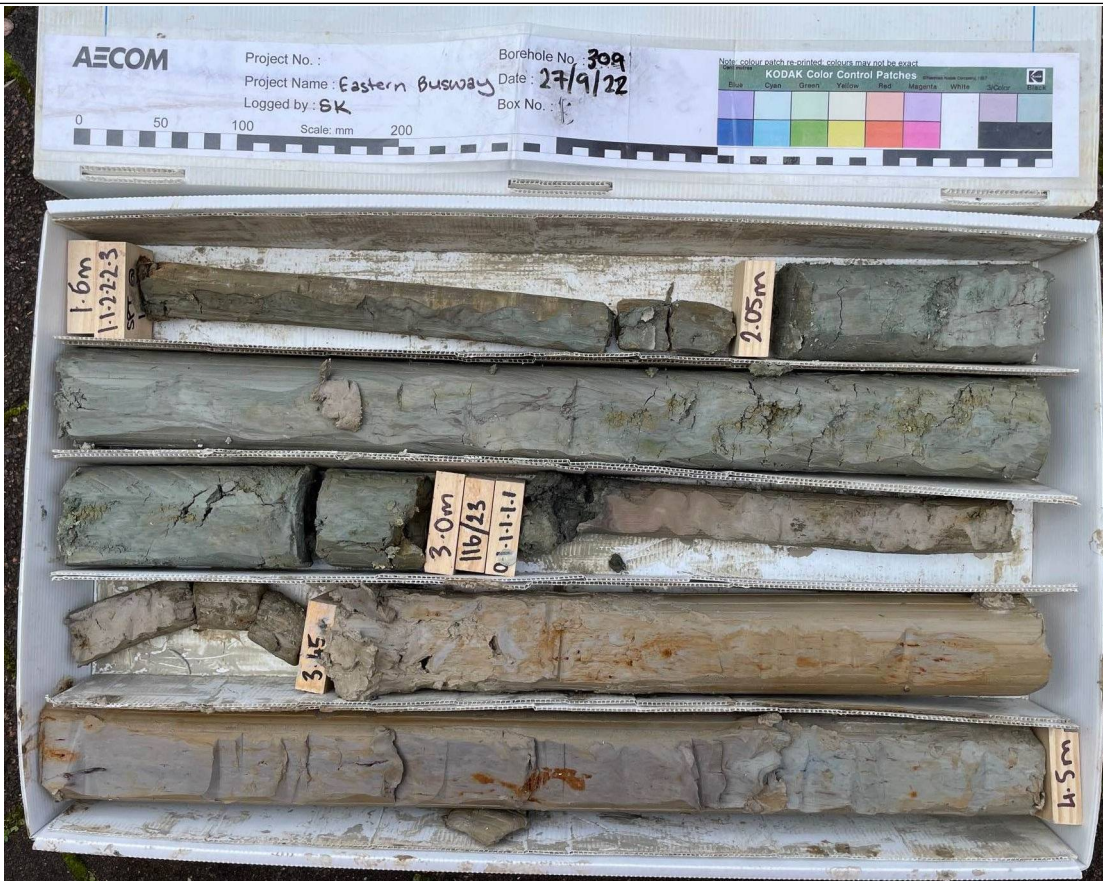
Box: 1 of 9 - Depth: P\DH309_P 00.00m to 04.50m of 30.00m
 Date Drilled 27/09/2022 to 29/09/2022 - Date Photographed: 27/09/2022

FILL 0.0m: FILL comprising clay, silt and fine to coarse gravel.	143/34		VAC EX				1		0		0.0m: Silty CLAY with some fine to coarse gravel; light brown. Very stiff, moist, high plasticity. Gravel comprises slightly weathered, subangular, BASALT. (Noted during hyro-excavation)	
	105/23											
TAURANGA GROUP 1.1m: ALLUVIUM comprising clay, silt, fine sand and organics.	111/17						1				1.1m: Silty CLAY; blueish grey. Very stiff, moist, high plasticity. 1.6 to 1.7m: Minor organic flecks, black. Becomes stiff. 2.5 to 3.05m: Some brown mottling. 3.05 to 4.95m: Greyish brown. 4.95m: Blueish grey. 7.2m: Becomes firm. 8.0m: Silty CLAY; blueish grey. Soft to very soft, moist, high plasticity.	
	158/90						2		100			
	161/21 SS 1, 1, 2 2, 2, 3 N=9		SPT				2		100			
			HQ3				3		100			
	116/23 SS 0, 1, 1, 1, 1, 1 N=4		SPT				3		100			
			HQ3				4		100			
	70/20 SS 0, 0, 1, 1, 2, 1 N=5		SPT				5		100			
			HQ3				6		100

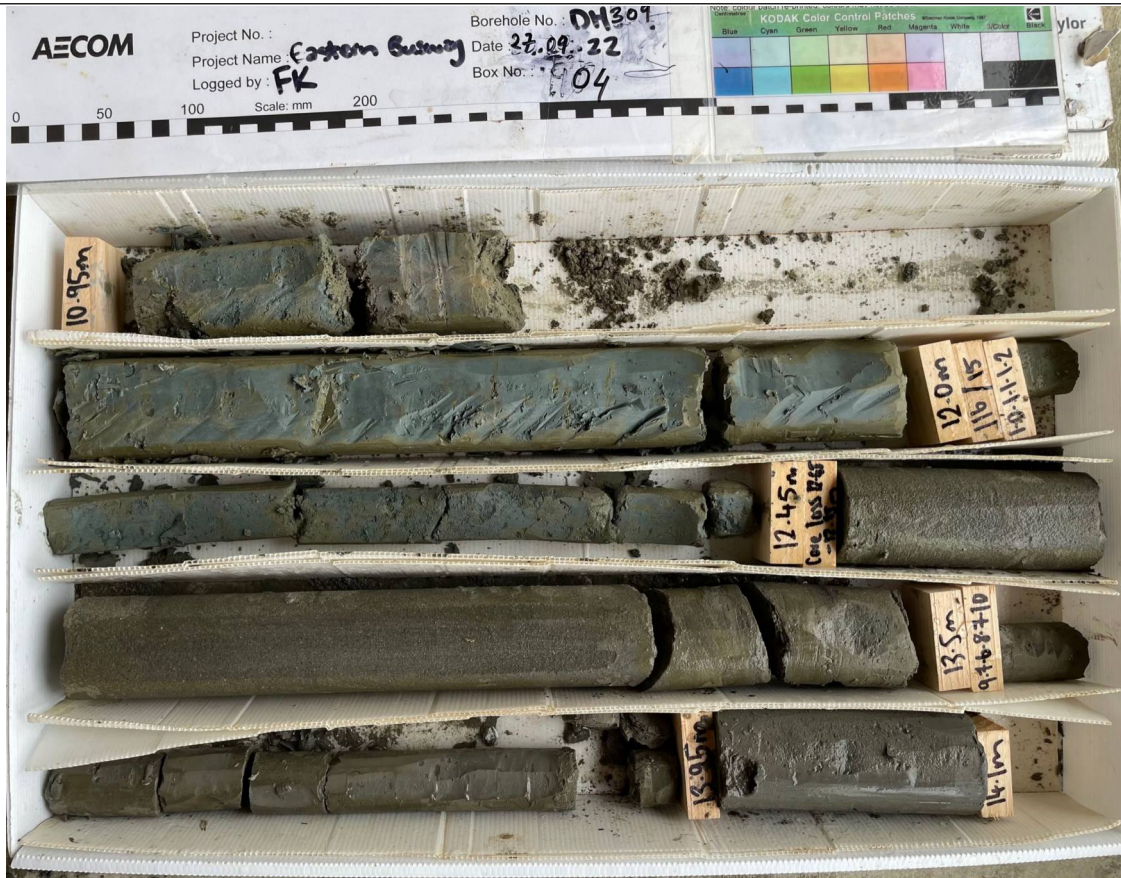
Box: 4 of 9 - Depth: P\DH309_P 10.95m to 14.10m of 30.00m
 Date Drilled 27/09/2022 to 29/09/2022 - Date Photographed: 27/09/2022

SPT					11		100	10.55m: Spongy PEAT; black. Soft, moist, high plasticity. 10.75m: Silty CLAY; brown. Stiff, moist, high plasticity. 10.95m: Becomes blueish grey.	
			HQ3					12		100		
		1,0,1, 1,1,2 N=5		SPT				12		100		
			HQ3					13		62 [62]	12.45 to 12.85m: Core Loss:	
		9,7,6, 8,7,10 N=31		SPT				13		100	13.34 to 13.37m: J, 30°, Ud, Sm, Cg	
			HQ3					14		100 [95]		
		18,12,17, 23,10 for 25mm N>50		SPT				14		100		
			HQ3					15		100 [100]		
			SPT					15		0	16.28 to 16.85m: Recovered as silty fine to medium SAND; grey. Slightly packed. 16.65m: DB, 3 No.	
	14,36 for 55mm N>50		SPT				16		22 [22]			
		HQ3					17		0			
	9,18,30, 20 for 55mm N>50		SPT				17		0	18.28m: Recovered as silty fine to medium SAND; grey. Loosely packed. 18.35 to 18.6m: Becomes very weak.		
		HQ3					18		100 [71]			
	13,37 for 65mm N>50		SPT				18		0	19.4 to 19.9m: Thin fine to medium SAND bed.		
		HQ3					19
