Client Auckland Transport
 Project Eastern Busway
 Project number 60644113

Co-ordinates 411494.80mE 795054.36mN
 Orientation -90° Elevation 8.86m
 Location 262 Ti Rakau Drive - Chinatown
 Feature Bridge Abutment/Pier

2021 EB DRILLHOLE LOG 2022-08-04 MASTER.GPJ BASE.GDT 04/08/22

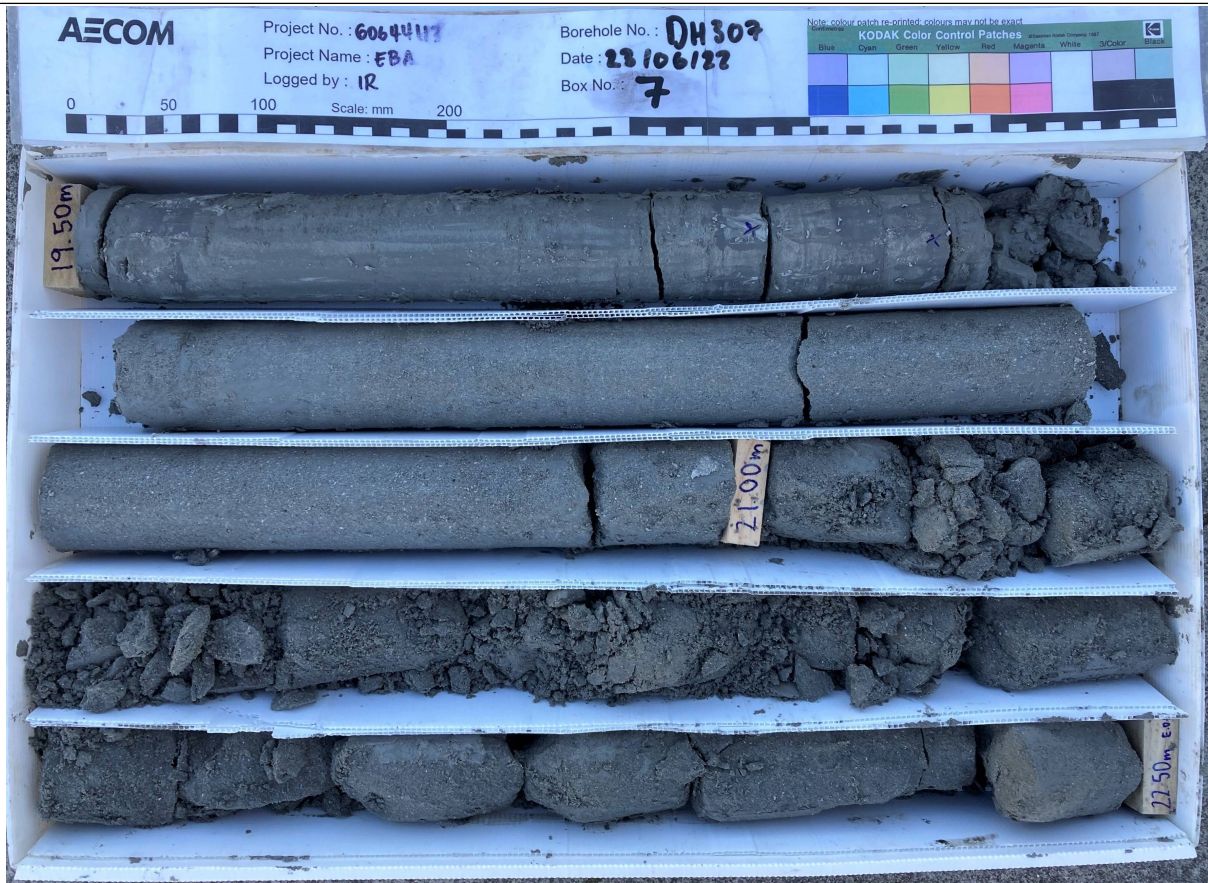
Box: 7 of 7 - Depth: 19.50m to 22.50m of 22.50m

HQ3		MS	SW	22		100 [100]		20.9m: DB, 0° 21.0 to 22.5m: Recovered as silty fine to medium SAND. Flush very silty with core stuck to the split.	
							23				DH307 terminated at 22.5m Depth Criteria Achieved	
							24					
							25					
							26					
							27					
							28					
							29					
<p><i>For explanation of symbols and observations, see key sheet</i></p> <p>FLUID DEPTHS AND DRILLING PROGRESS (m) Date Time Drilled Depth Casing Depth Fluid Depth</p>			<p>RELATIVE STRENGTH</p> <p>VS - Very strong S - Strong MS - Moderately strong W - Weak VW - Very weak EW - Extremely weak</p>		<p>WEATHERING</p> <p>UW - Unweathered SW - Slightly weathered MW - Moderately weathered HW - Highly weathered CW - Completely weathered</p>		<p>Date logged 23/06/2022 Logged IR Checked GP</p>		<p>Driller McMillan Started 23/06/2022 Finished 23/06/2022 Drill Rig N119 Core Boxes 7</p>			
<p>Hand Held Shear Vane DR1980: 19mm blade: Calibrated Jun 2022: Correction Factor: 1.876 vane shear strength per NZGS guideline</p>			<p>Remarks Hole backfilled with grout upon completion.</p> <p>Horizontal / Vertical Survey Datums: NZGD2000 - Mount Eden 2000 / New Zealand Vertical Datum 2016</p>						<p>Page 3 of 7</p>

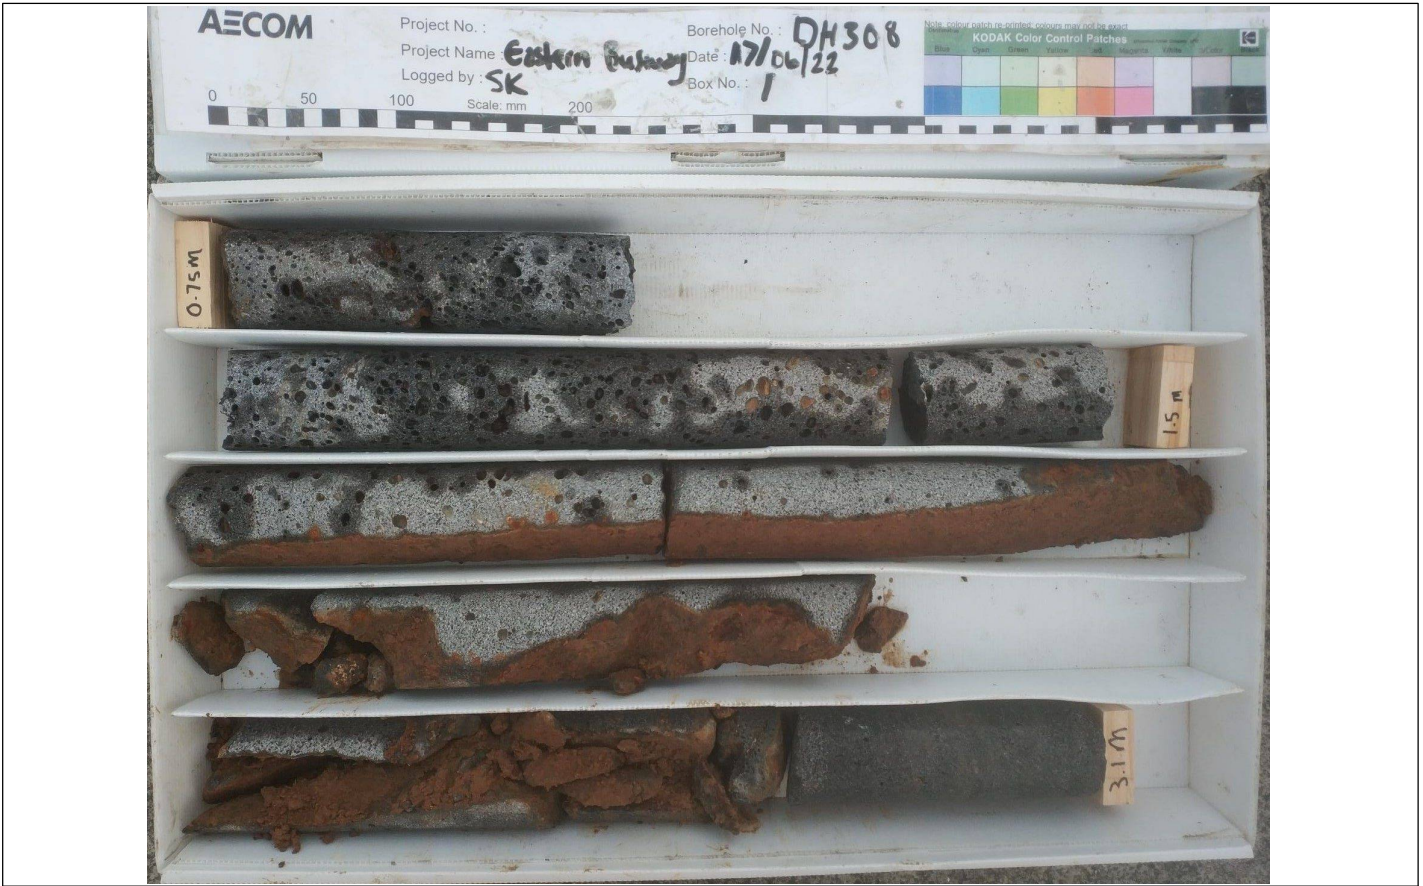
Box: 1 of 10 - Depth: 00.75m to 03.10m of 27.00m

0.0m: FILL comprising silty gravel, cobbles and boulders.			VAC EX						0		0.0m: Vacuum excavation 0.0 to 0.15m: Concrete (car park). 0.15 to 0.75m: Silty fine to coarse GRAVEL with some cobbles and boulders. Densely packed, moist. Gravel, cobbles and boulders are subangular basalt.

0.75m: SW, dark grey, BASALT. Moderately strong. Highly vesicular (<20%), vesicles typically 5-10mm and up to 60mm. Some iron staining in vesicles.			HQ3				1		100 [100]		1.5 to 2.22m: J, 80°, Ud, Ro, Sn, Fe 1.95m: 114mm diameter HWT casing to 1.95m. 2.1 to 2.16m: J, 45°, Ud, Ro, Sn, Fe 2.14 to 2.2m: J, 45°, Ud, Ro, Sn, Fe 2.14 to 2.17m: DB, 60°, Ud, Ro, Sn, Fe 2.27 to 2.46m: J, 85°, Ud, Ro, Sn, Fe 2.46 to 2.49m: J, 20°, Ud, Ro, MN, P, Cl, Stn, Fe. 2.46 to 2.78m: J, 70°, Ud, Ro, Sn, Fe

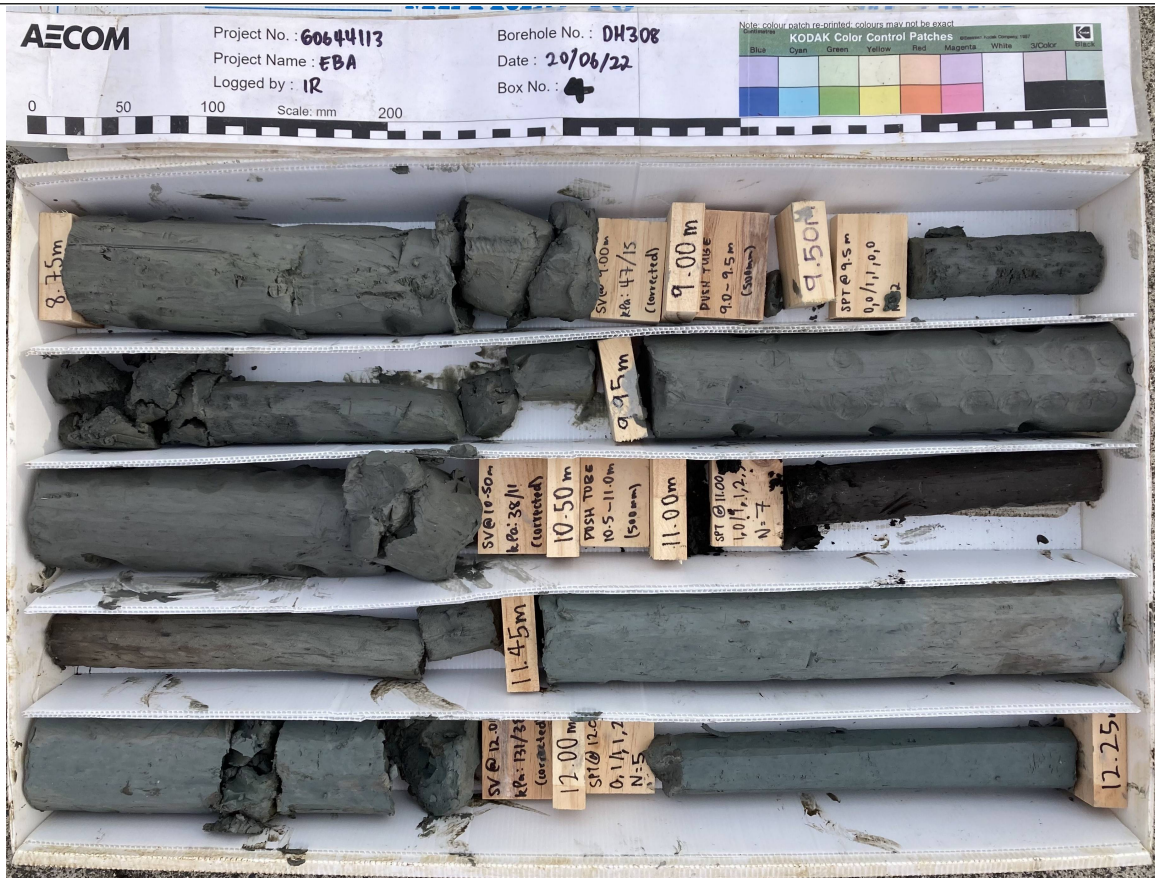
Box: 4 of 10 - Depth: 08.75m to 12.25m of 27.00m
 Date Drilled 17/06/2022 to 20/06/2022 - Date Photographed: 20/06/2022

PT						100		10.5m: Water return in basalt. No return in alluvium.	
	ss 1.0,1, 1.2,3 N=7		SPT						100		10.75m: Fibrous PEAT; black. Firm, moist, moderately decomposed wood fragments.	
			HQ3						100		11.0m: Organic CLAY; brown. Firm, moist, high plasticity.	
	131/38 ss		SPT						100		11.2m: CLAY with trace indistinct organics; light bluish grey. Very stiff, moist, high plasticity.	
	0,1,1, 1,2,1 N=5		HQ3						100		12.4m: With some fine sand.	
			SPT						100		12.6m: Fine to medium SAND; grey.	
			HQ3						100		13.35m: Clayey SILT with trace fine siltstone gravel; grey	
	225* ss 3,8,12, 15,16,7 for 25mm N>50		SPT						100		13.9m: Gently inclined very thinly to moderately thinly bedded. 13.9 to 15m: DB, 5°, 6 No.	
			HQ3						100		15.35 to 16.5m: DB, 0°, 3 No. 15.4 to 15.5m: Fine sandy SILTSTONE.	
EAST COAST BAYS FORMATION	9,14,18, 20,12 for 50mm N>50		SPT						100		16.02m: BP, 5°, VN, C, Slt 16.15 to 16.35m: Very thin silt beds.	[Instrumentation Diagram]

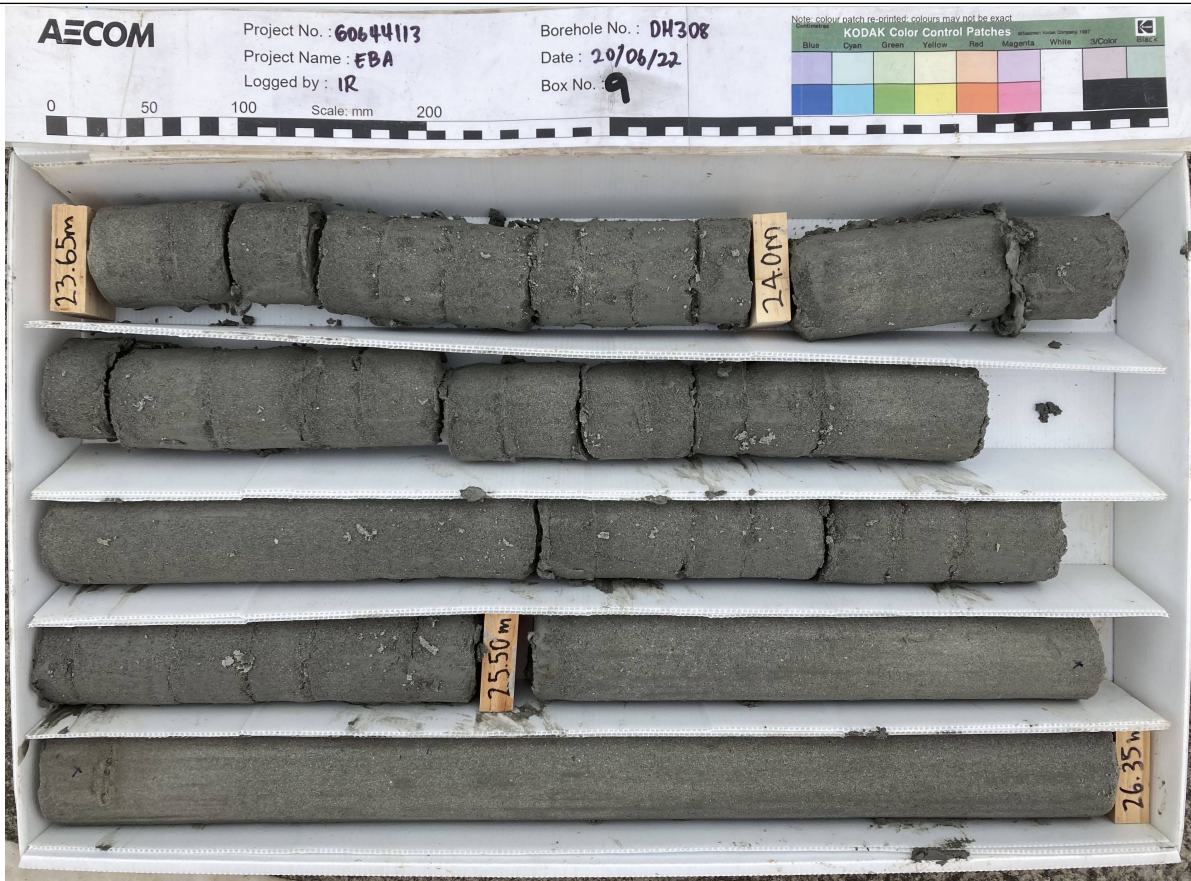
Box: 9 of 10 - Depth: 23.65m to 26.35m of 27.00m

GEOLOGICAL DESCRIPTION <small>Weathering, Colour, Fabric, ROCK NAME. Strength, Discontinuities, Lithological Features (bedding, foliation, mineralogy, cement, etc.)</small>	Test Records		Drilling Method <small>Casing remarks</small>	Core Loss/Lift	Relative Strength	Rock Weathering	Depth	Graphic Log	TCR [RQD] (%)	Spacing of Natural Defects (mm)	SOIL PROPERTIES	Instrumentation	
	Shear Vane/ SPT	SPT N Values									Subordinate MAJOR minor: colour, structure, Strength, moisture condition, grading, bedding, plasticity, sensitivity, major fraction description, subordinate fraction description, minor fraction description, additional structures, additional information, etc		
EAST COAST BAYS FORMATION 16.1m: Slightly weathered, grey, thickly bedded, fine to medium SANDSTONE. Very weak. (continued) 20.68m: SW, grey, SILTSTONE. Very weak. 20.94m: Slightly weathered, grey, fine SANDSTONE. Very weak. 22.3m: Slightly weathered, grey, SILTSTONE. Very weak. 22.67m: Slightly weathered, grey, thickly bedded, fine SANDSTONE. Very weak. 26.7 to 27.0m: Siltstone			HQ3						100 [90]		21.0 to 22.5m: DB, 0°, 2 No. 21.05 to 21.15m: Recovered as subangular SILTSTONE gravel. 21.2m: SILTSTONE clast, 50mm long. 22.3 to 22.4m: Thinly laminated. 22.5m: Subrounded SILTSTONE clast, 20mm. 23.5 to 25.5m: Subhorizontal, thinly to moderately thinly bedded with thin laminations or partings of mudstone. Drilling breaks infilled with mud. 25.5 to 27m: DB, 0°, 4 No. 26.7 to 27.0m: Thinly laminated.

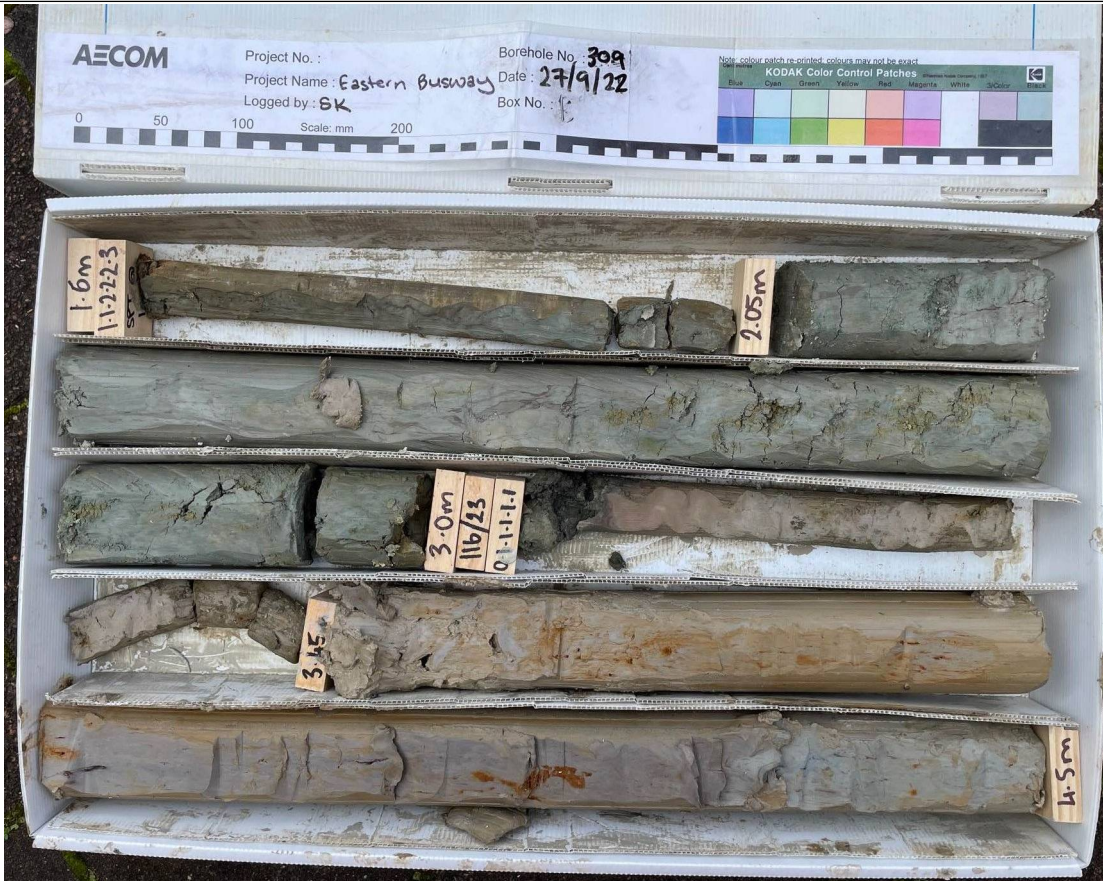
Box: 1 of 9 - Depth: P\DH309_P 00.00m to 04.50m of 30.00m
 Date Drilled 27/09/2022 to 29/09/2022 - Date Photographed: 27/09/2022

FILL 0.0m: FILL comprising clay, silt and fine to coarse gravel.	143/34		VAC EX				1		0		0.0m: Silty CLAY with some fine to coarse gravel; light brown. Very stiff, moist, high plasticity. Gravel comprises slightly weathered, subangular, BASALT. (Noted during hyro-excavation)	
	105/23											
TAURANGA GROUP 1.1m: ALLUVIUM comprising clay, silt, fine sand and organics.	111/17											
	158/90										1.1m: Silty CLAY; blueish grey. Very stiff, moist, high plasticity.	
	161/21 SS 1,1,2 2,2,3 N=9		SPT				2		100		1.6 to 1.7m: Minor organic flecks, black. Becomes stiff.	
			HQ3						100		2.5 to 3.05m: Some brown mottling.	
	116/23 SS 0,1,1, 1,1,1 N=4		SPT				3		100		3.05 to 4.95m: Greyish brown.	
			HQ3						100			
	70/20 SS 0,0,1, 1,2,1 N=5		SPT				5		100		4.95m: Blueish grey.	
			HQ3						100			
	120/26 SS 1,0,0, 0,1,1 N=2		SPT				6		100			
		HQ3						100				
		PT						100				
		SPT						100				
		HQ3						100

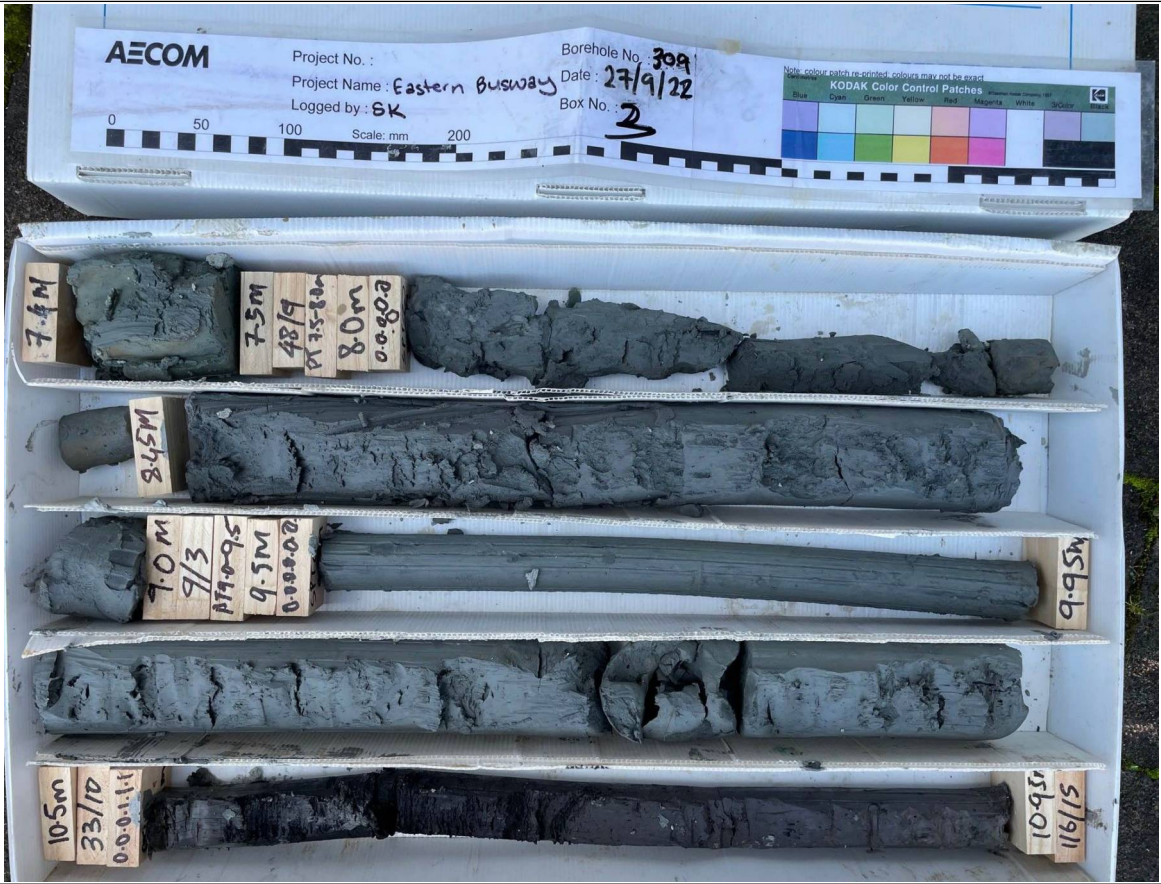
Box: 3 of 9 - Depth: P\DH309_P 07.40m to 10.95m of 30.00m
 Date Drilled 27/09/2022 to 29/09/2022 - Date Photographed: 27/09/2022

SPT				11		100	10.55m: Spongy PEAT; black. Soft, moist, high plasticity. 10.75m: Silty CLAY; brown. Stiff, moist, high plasticity. 10.95m: Becomes blueish grey.	
				HQ3				12		100		
		1,0,1, 1,1,2 N=5		SPT				12		100		
				HQ3				13		62 [62]	12.45 to 12.85m: Core Loss:	
		9,7,6, 8,7,10 N=31		SPT				14		100	13.34 to 13.37m: J, 30°, Ud, Sm, Cg	
				HQ3				15		100 [95]		
		18,12,17, 23,10 for 25mm N>50		SPT				15		100		
				HQ3				16		100 [100]		
				SPT				17		0	16.28 to 16.85m: Recovered as silty fine to medium SAND; grey. Slightly packed. 16.65m: DB, 3 No.	
	14,36 for 55mm N>50		SPT				17		22 [22]			
			HQ3				18		0			
	9,18,30, 20 for 55mm N>50		SPT				18		0	18.28m: Recovered as silty fine to medium SAND; grey. Loosely packed. 18.35 to 18.6m: Becomes very weak.		
			HQ3				19		100 [71]			
	13,37 for 65mm N>50		SPT				19		0	19.4 to 19.9m: Thin fine to medium SAND bed.		
For explanation of symbols and observations, see key sheet
