Client Auckland Transport  
 Project Eastern Busway  
 Project number 60644113

HOLE IDENTIFICATION **DH314**

HOLE IDENTIFICATION **DH315\_P**

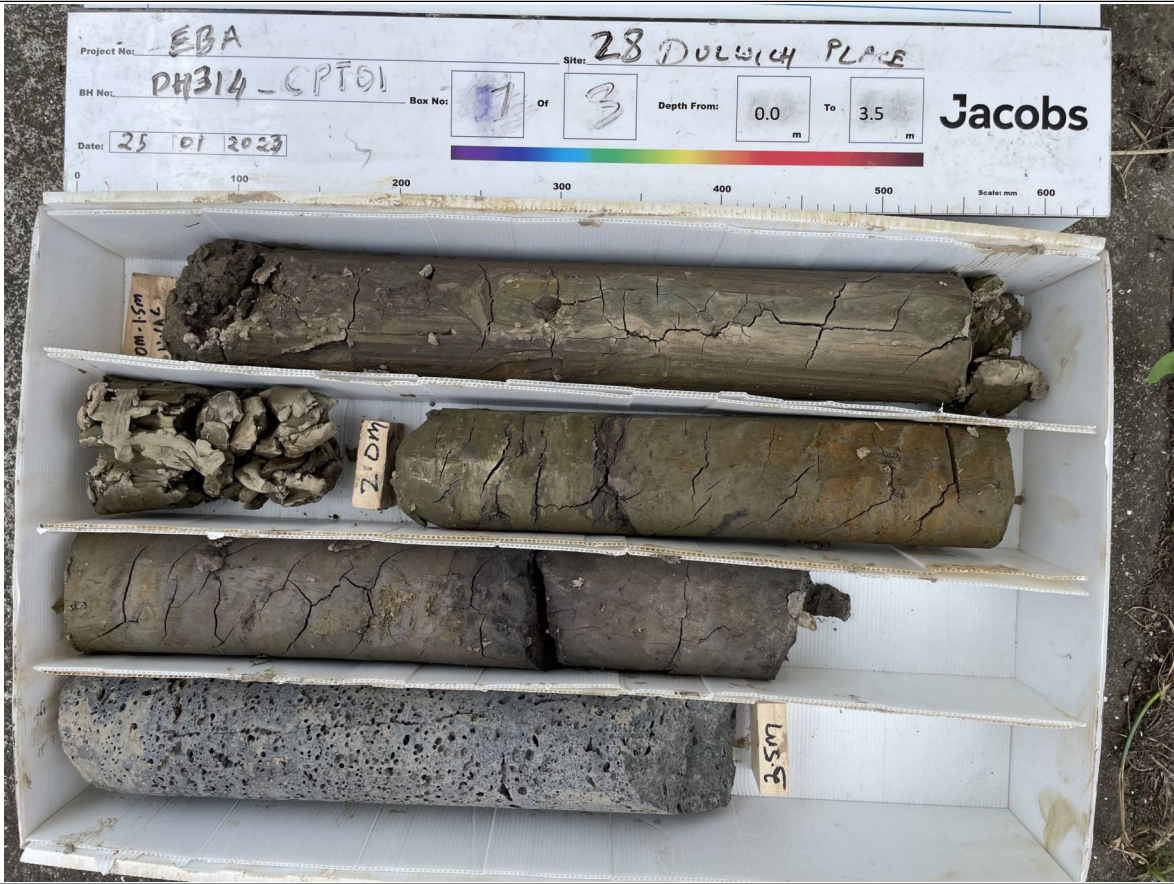
**Box: 1 of 3 - Depth: 00.00m to 03.50m of 6.00m**

0.0m: Vacuum excavated				VAC EX				1				0.0m: Vacuum excavated, not logged.		
1.5m: ALLUVIUM comprising silty clay.				HQ3				2		100 [0]		1.5m: Silty CLAY; light grey. Stiff, moist, high plasticity.

3.0m: Slightly weathered, dark grey, BASALT. Moderately strong; highly vesicular.				HQ3				3		100 [35]		3.5m: J, 45°, Pl, Ro 3.55 to 4.2m: J, Ud, Ro

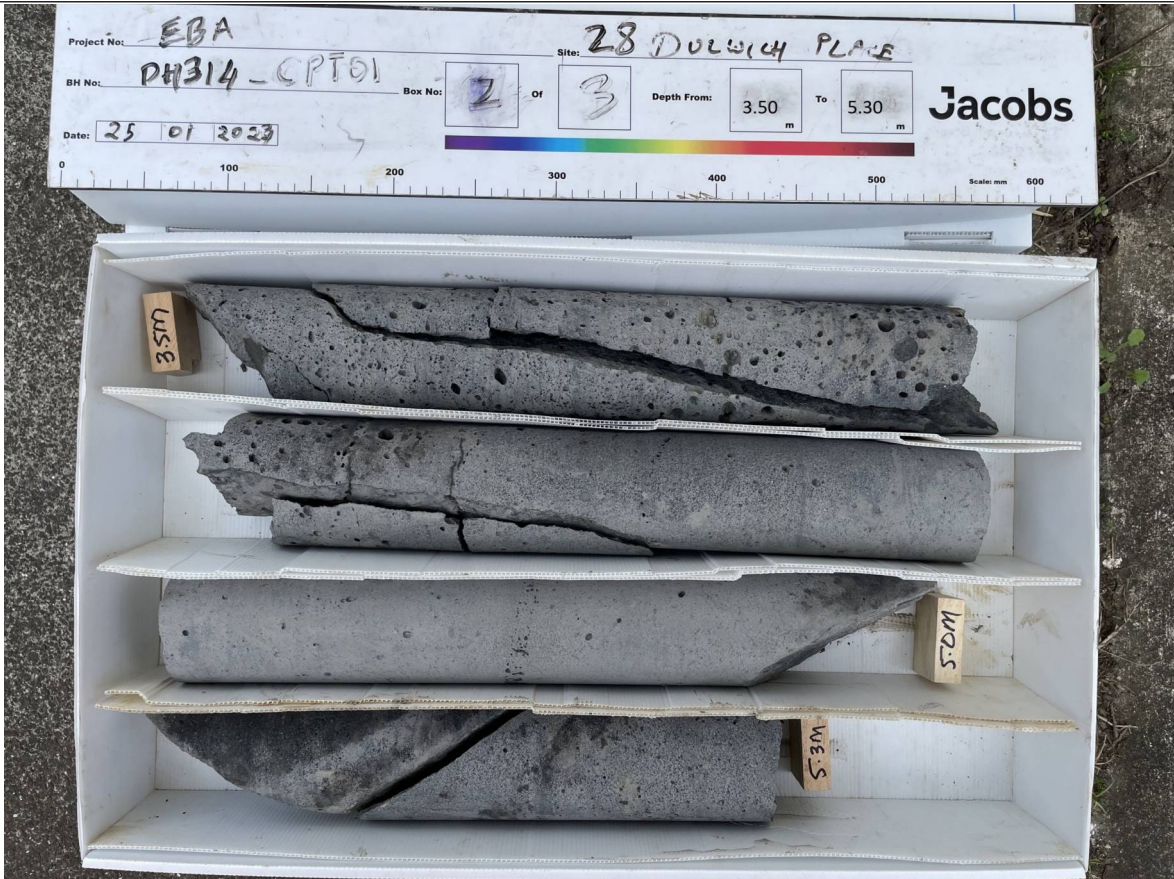
**Box: 2 of 3 - Depth: 03.50m to 05.30m of 6.00m**

4.0m: Slightly weathered, dark grey, BASALT. Strong; slightly vesicular.				HQ3				4		100 [60]				
5.9m: Highly weathered, dark grey, BASALT. Very weak.				HQ3				5		100 [85]				
								6				DH-sCPT314 terminated at 6m Depth Criteria Achieved		
								7						
								8						
								9						
<p><i>For explanation of symbols and observations, see key sheet</i></p> <p>FLUID DEPTHS AND DRILLING PROGRESS (m)                  Date Time Drilled Depth Casing Depth Fluid Depth</p>				<p>RELATIVE STRENGTH</p> <p>VS - Very strong                  S - Strong                  MS - Moderately strong                  W - Weak                  VW - Very weak                  EW - Extremely weak</p>		<p>WEATHERING</p> <p>UW - Unweathered                  SW - Slightly weathered                  MW - Moderately weathered                  HW - Highly weathered                  CW - Completely weathered</p>		<p>Date logged 25/01/2023</p> <p>Logged FK</p> <p>Checked MC</p>		<p>Driller McMillan</p> <p>Started 25/01/2023</p> <p>Finished 25/01/2023</p> <p>Drill Rig N119</p> <p>Core Boxes 3</p>

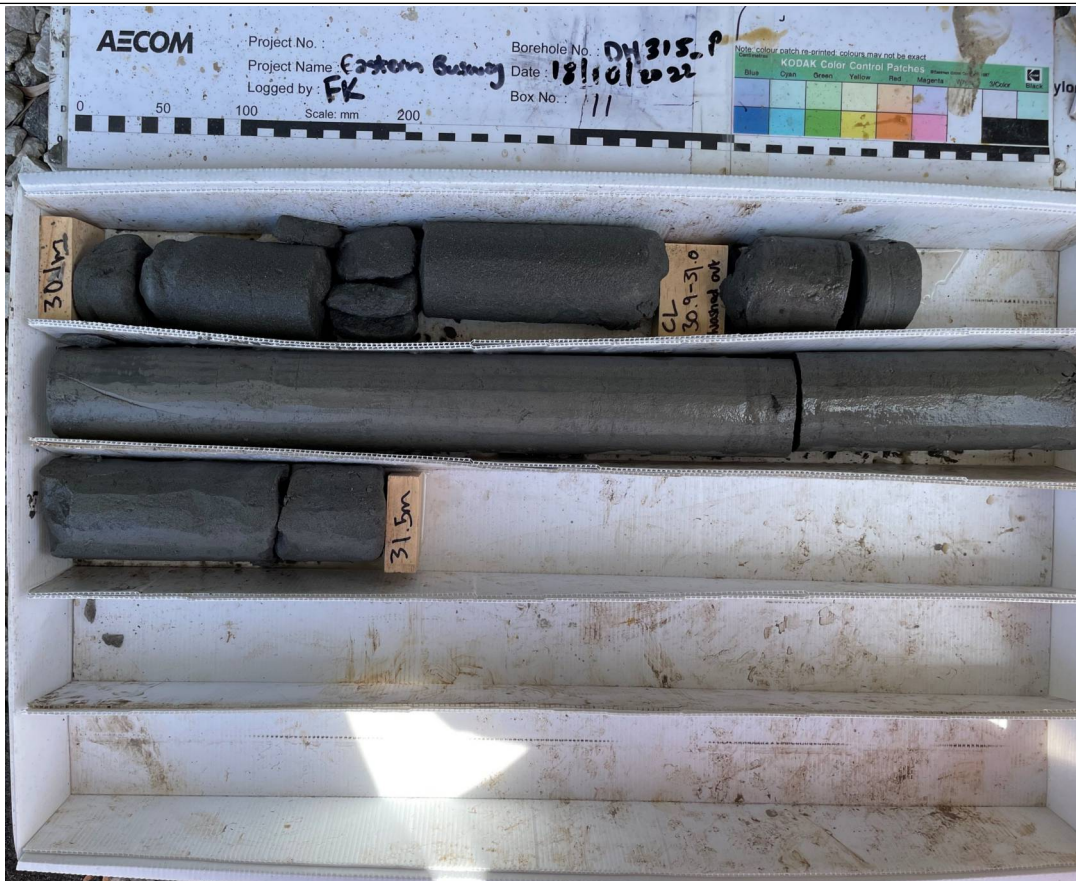
**Box: 11 of 11 - Depth: P\DH315\_P 30.1m to 31.5m of 31.50m**  
Date Drilled 18/10/2022 to 19/10/2022 - Date Photographed: 18/10/2022

29.7m: Highly weathered, light grey. Fine to medium SANDSTONE. Very weak. (continued)											
30.6m: Slightly weathered, light grey, SILTSTONE. Very weak. Thickly bedded.						31		93 [93]		30.5 to 30.6m: Core Loss: Washed out.  31.05 to 31.5m: DB, Ud, Ro, N, 2 No.

31.3m: SW, light grey, fine to medium SANDSTONE. Weak.						32				DH315_P terminated at 31.5m Depth Criteria Achieved	
						33					
						34					
						35					
						36					
						37					
						38					
						39					
<i>For explanation of symbols and observations, see key sheet</i>				RELATIVE STRENGTH		WEATHERING		Date logged 19/10/2022		Driller McMillan	
FLUID DEPTHS AND DRILLING PROGRESS (m) Date Time      Drilled Depth Casing Depth Fluid Depth				VS - Very strong S - Strong MS - Moderately strong W - Weak VW - Very weak EW - Extremely weak		UW - Unweathered SW - Slightly weathered MW - Moderately weathered HW - Highly weathered CW - Completely weathered		Logged FK Checked GP		Started 18/10/2022	
Hand Held Shear Vane DR1980: 19mm (A). Calibrated Jun 2022: Correction Factor: 1.876 <i>vane shear strength per NZGS guideline</i>				Remarks 50 mm standpipe piezometer installed on completion.  As built coordinates to come.						Finished 19/10/2022
