Client Auckland Transport
 Project Eastern Busway
 Project number 60644113

Co-ordinates 412354.13mE 794688.02mN
 Orientation -90° Elevation 4.19m
 Location Reserve: 23R Kenwick Place
 Feature Retaining Wall

HOLE IDENTIFICATION **DH320**

Co-ordinates 411731.67mE 795021.63mN
 Orientation -90° Elevation 10.99m
 Location 22 Tullis Place
 Feature Zone 5 ground conditions/Busway through burswood residential area

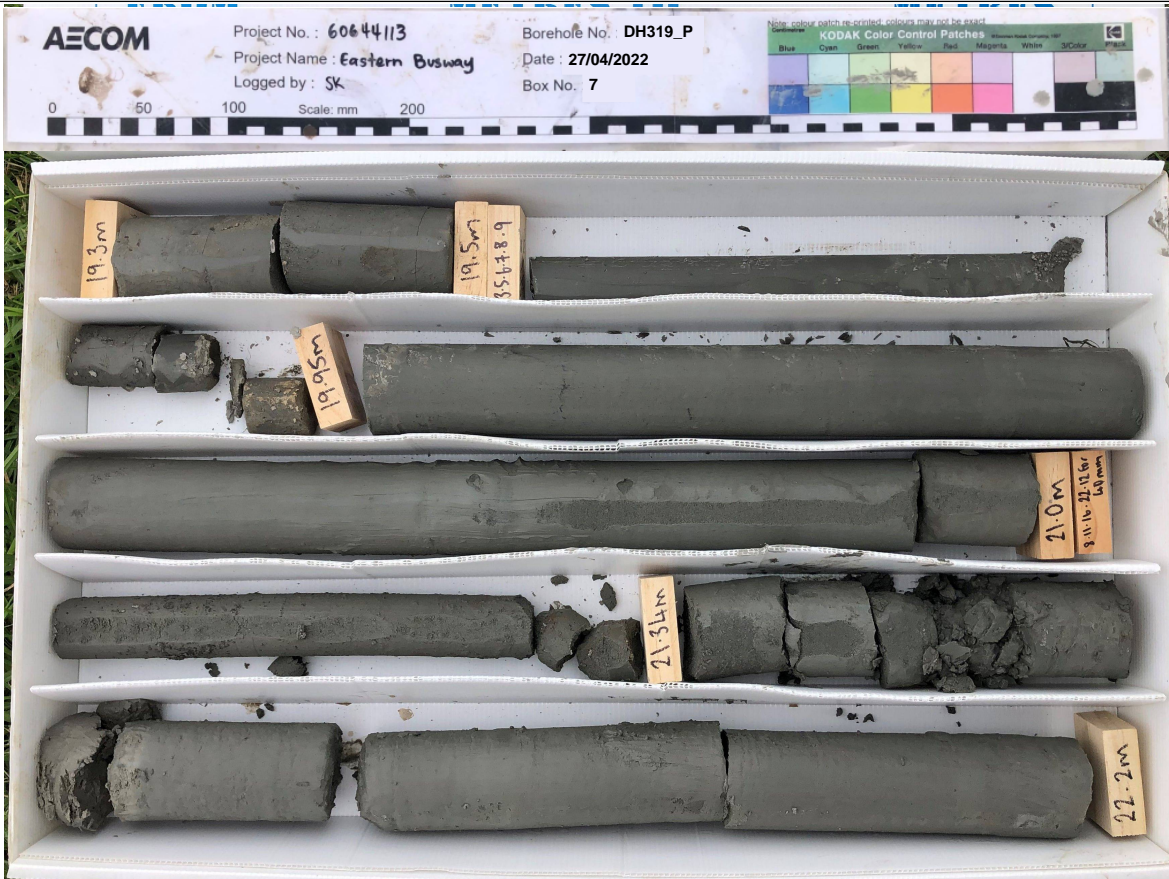
Box: 7 of 9 - Depth: 19.30m to 22.20m of 28.50m

Date Drilled 26/04/2022 to 27/04/2022 - Date Photographed: 27/04/2022

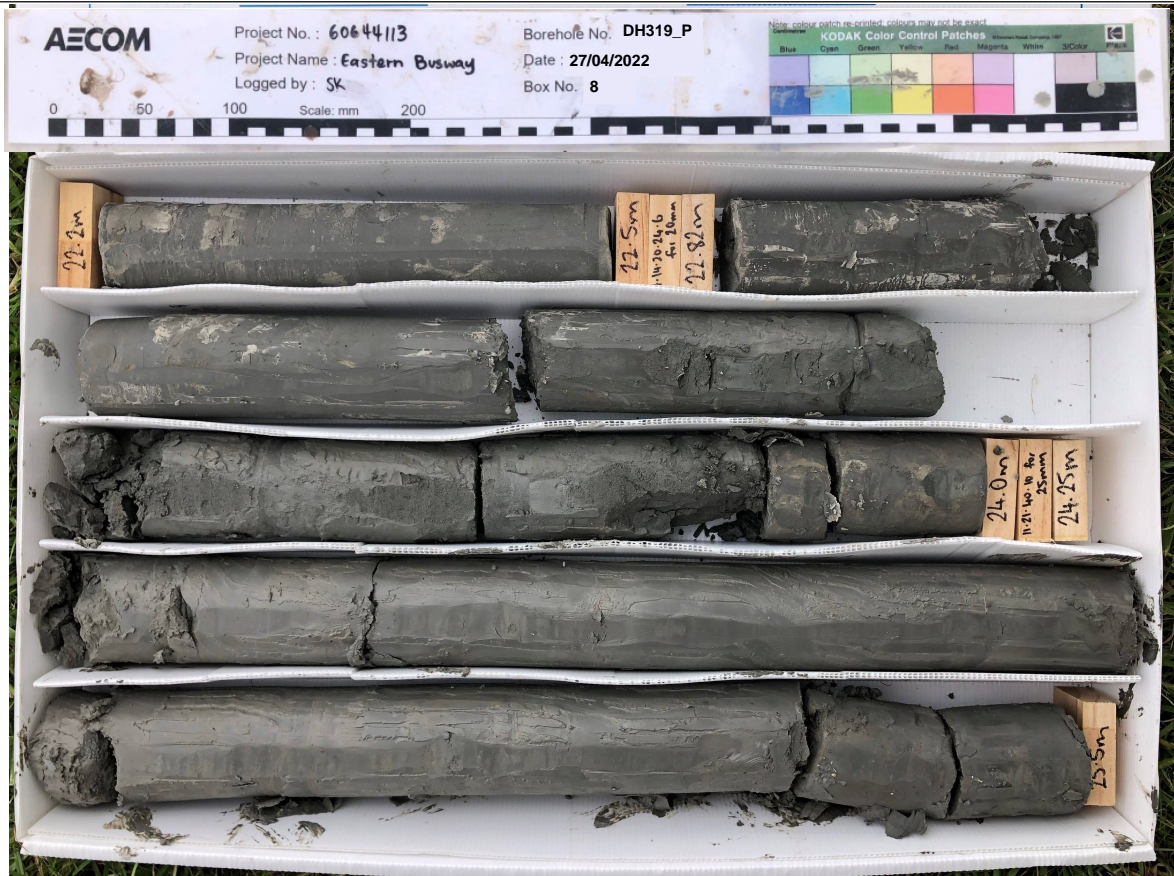
Box: 8 of 9 - Depth: 22.20m to 25.50m of 28.50m

Date Drilled 26/04/2022 to 27/04/2022 - Date Photographed: 27/04/2022

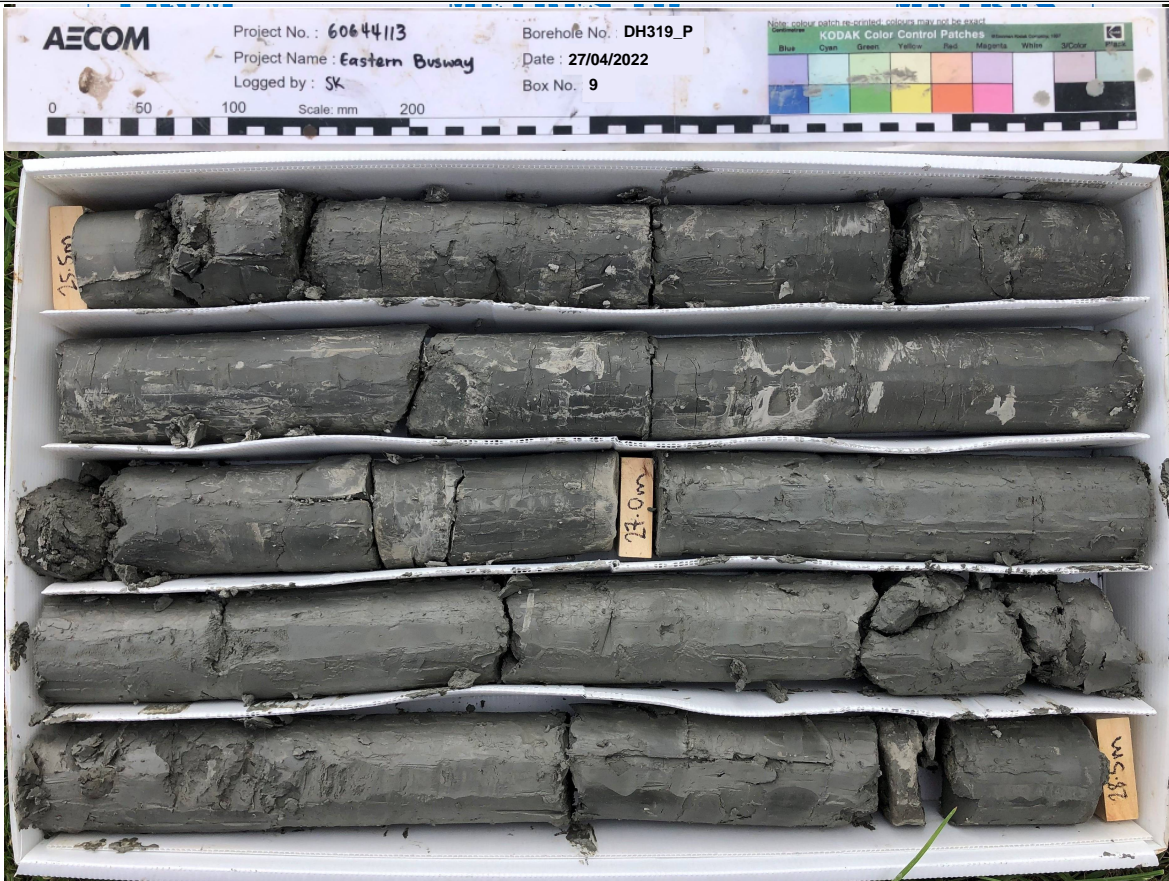
Box: 9 of 9 - Depth: 22.50m to 28.50m of 28.50m

Date Drilled 26/04/2022 to 27/04/2022 - Date Photographed: 27/04/2022

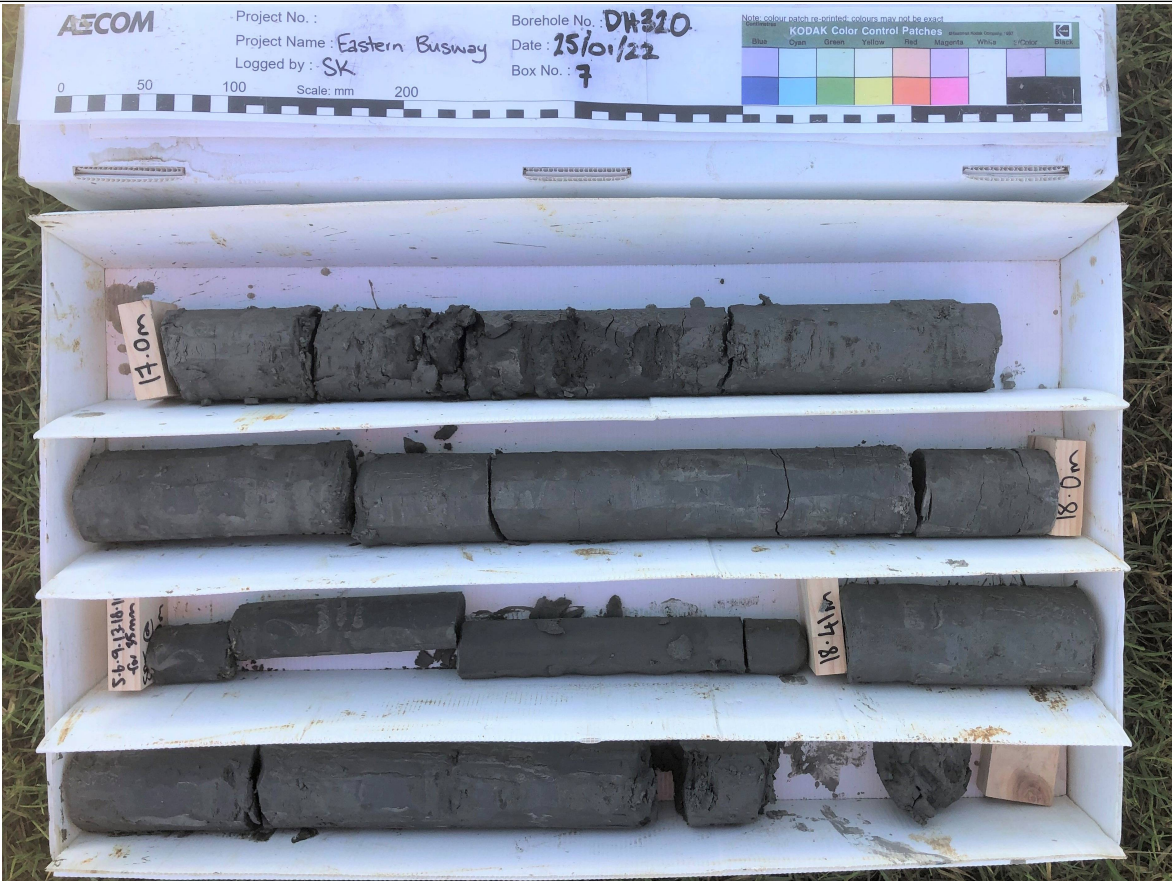
Box: 7 of 10 - Depth: 17.00m to 19.00m of 25.81m

Date Drilled 25/01/2022 to 26/01/2022 - Date Photographed: 25/01/2022

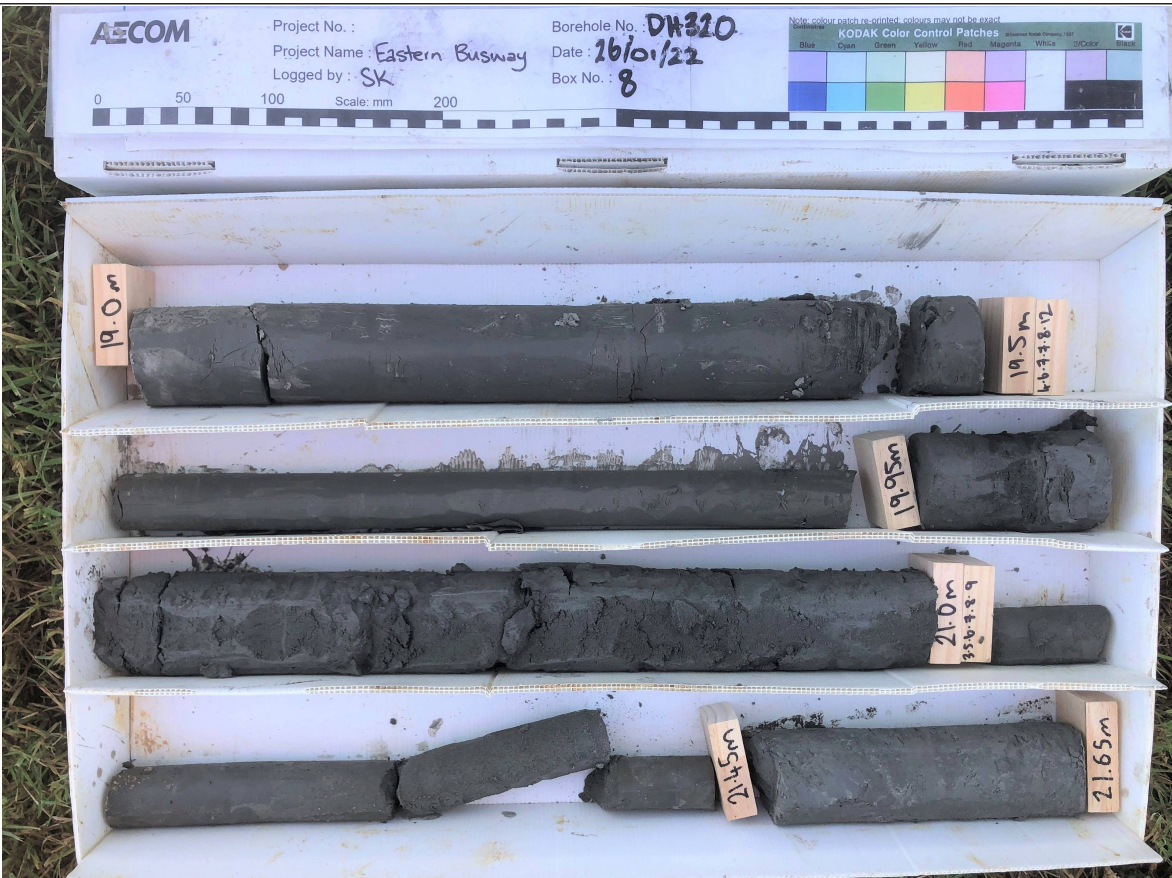
Box: 8 of 10 - Depth: 19.00m to 21.65m of 25.81m

Date Drilled 25/01/2022 to 26/01/2022 - Date Photographed: 26/01/2022

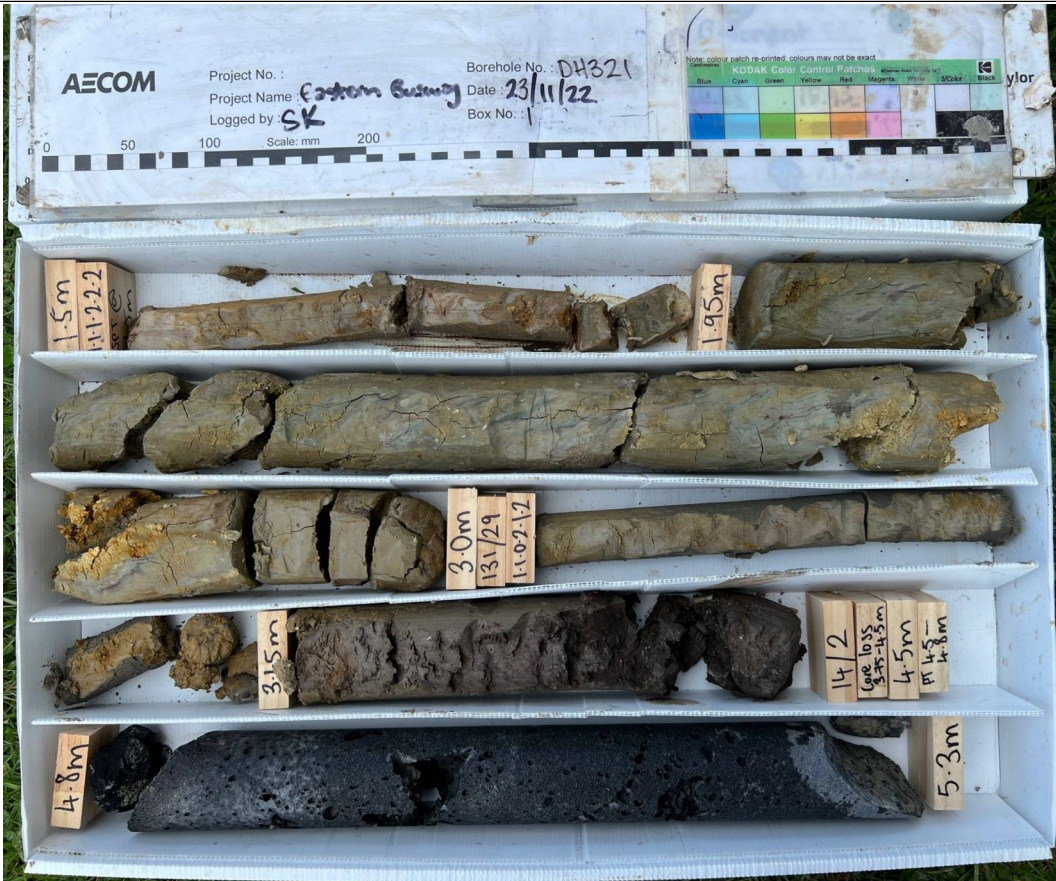
Box: 1 of 8 - Depth: 00.00m to 05.30m of 24.00m

Date Drilled 23/11/2022 to 24/11/2022 - Date Photographed: 23/11/2022

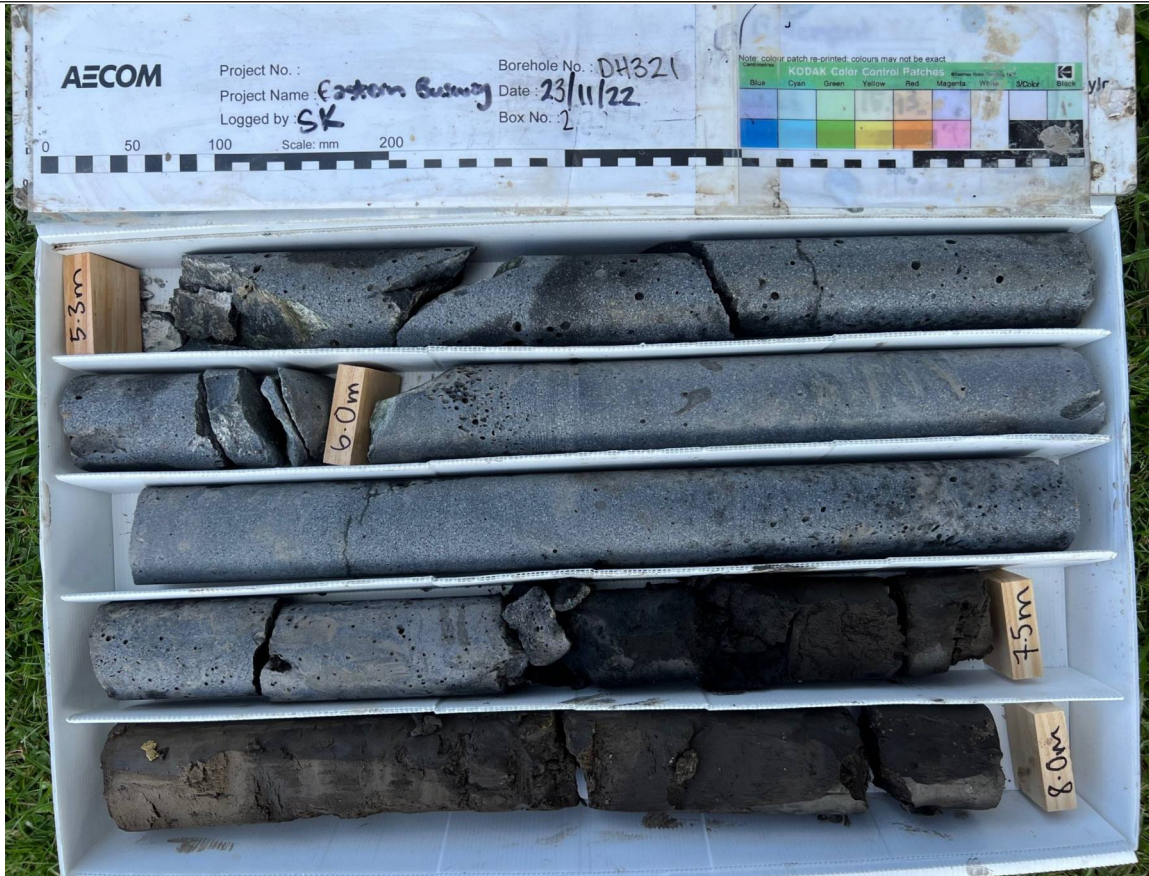
Box: 2 of 8 - Depth: 05.30m to 08.00m of 24.00m

Date Drilled 23/11/2022 to 24/11/2022 - Date Photographed: 23/11/2022

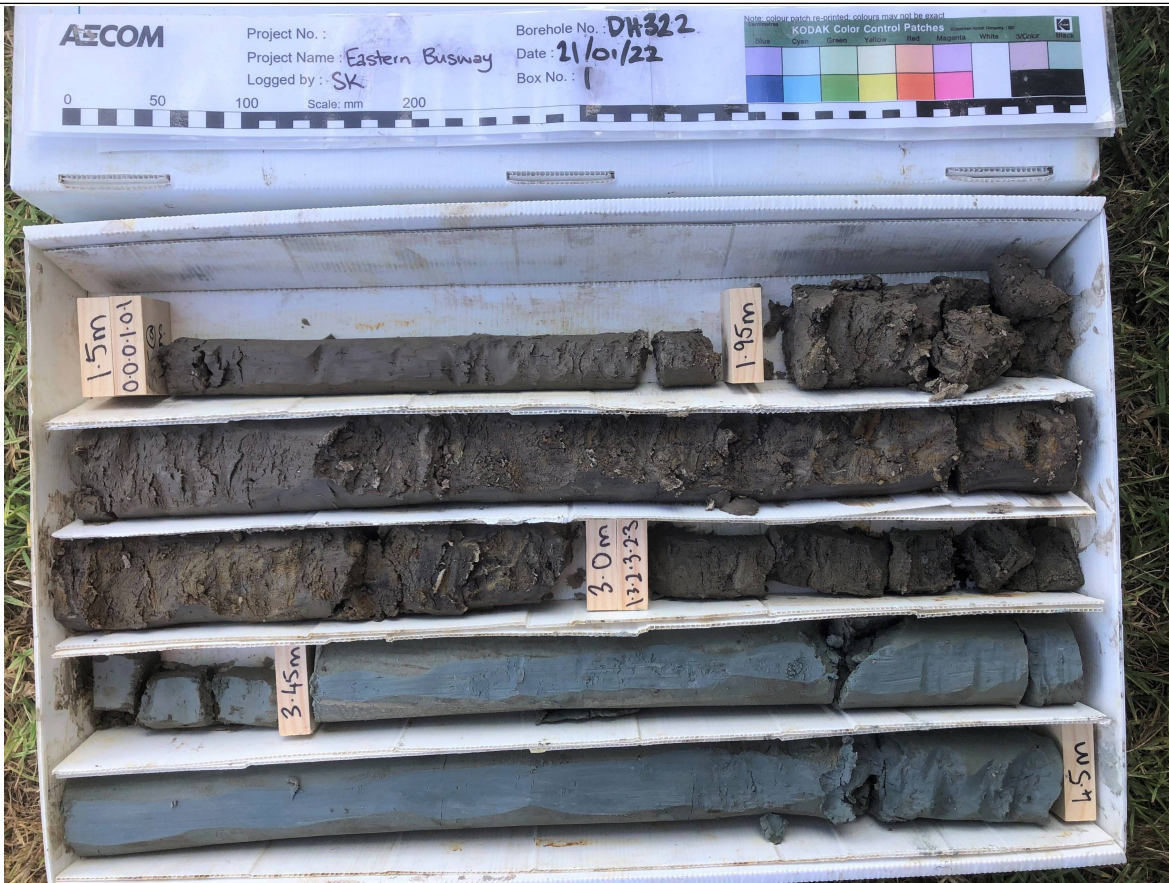
Box: 1 of 9 - Depth: 01.50m to 04.50m of 27.00m

Date Drilled 20/01/2022 to 24/01/2022 - Date Photographed: 21/01/2022

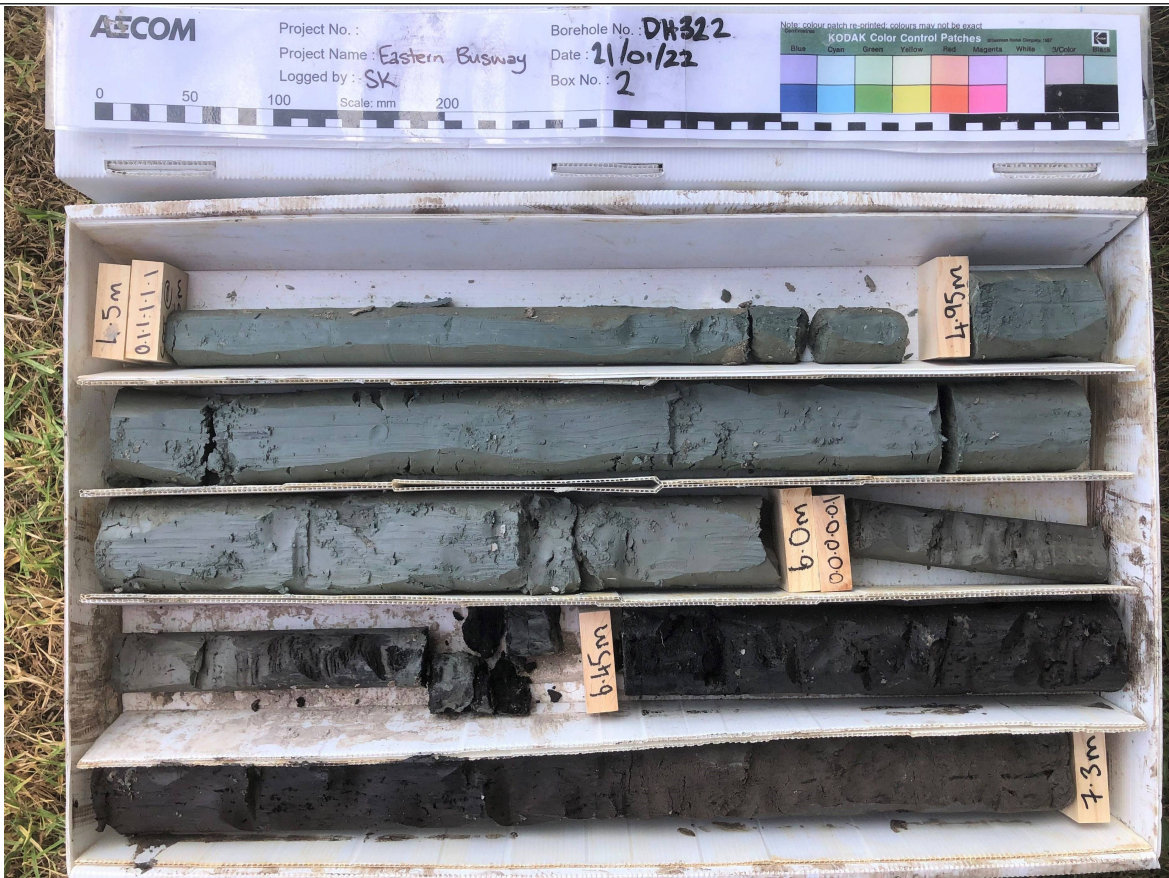
Box: 2 of 9 - Depth: 04.50m to 07.30m of 27.00m

Date Drilled 20/01/2022 to 24/01/2022 - Date Photographed: 21/01/2022

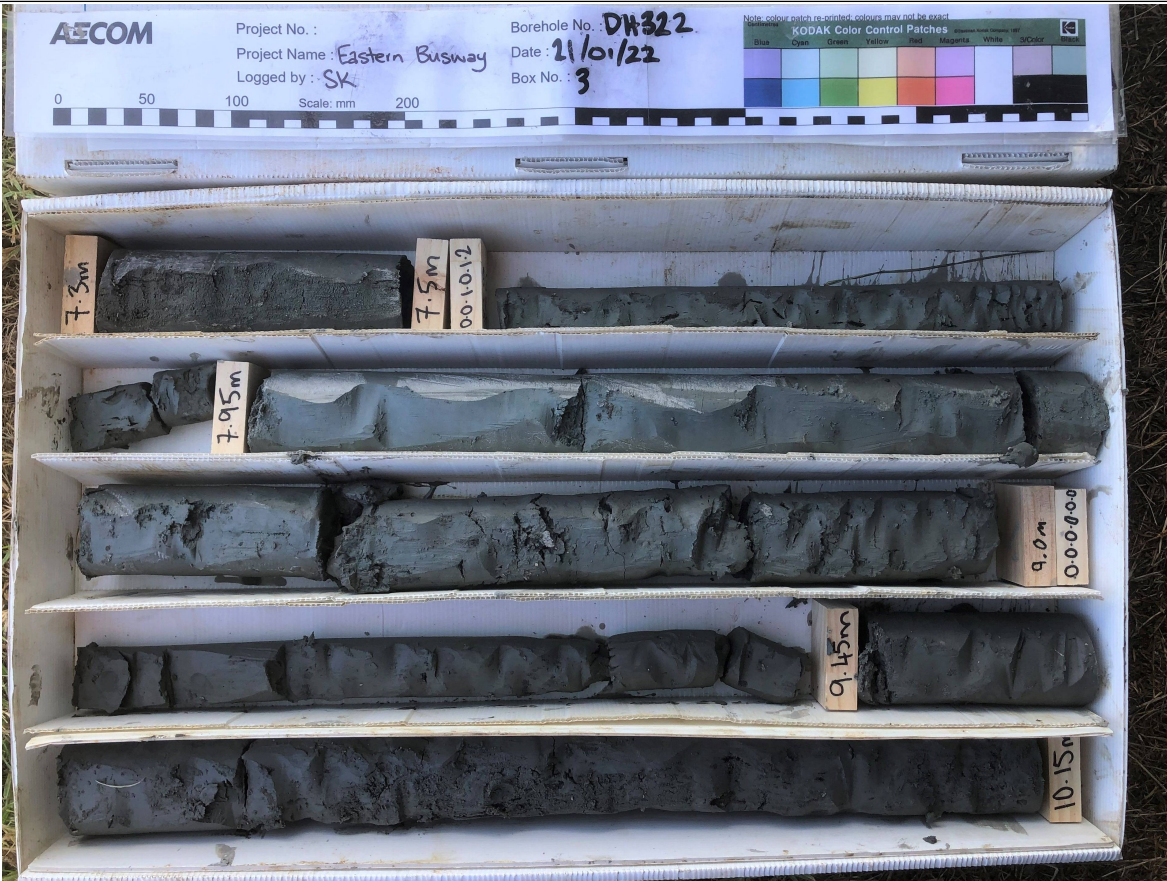
Box: 3 of 9 - Depth: 07.30m to 10.15m of 27.00m

Date Drilled 20/01/2022 to 24/01/2022 - Date Photographed: 21/01/2022

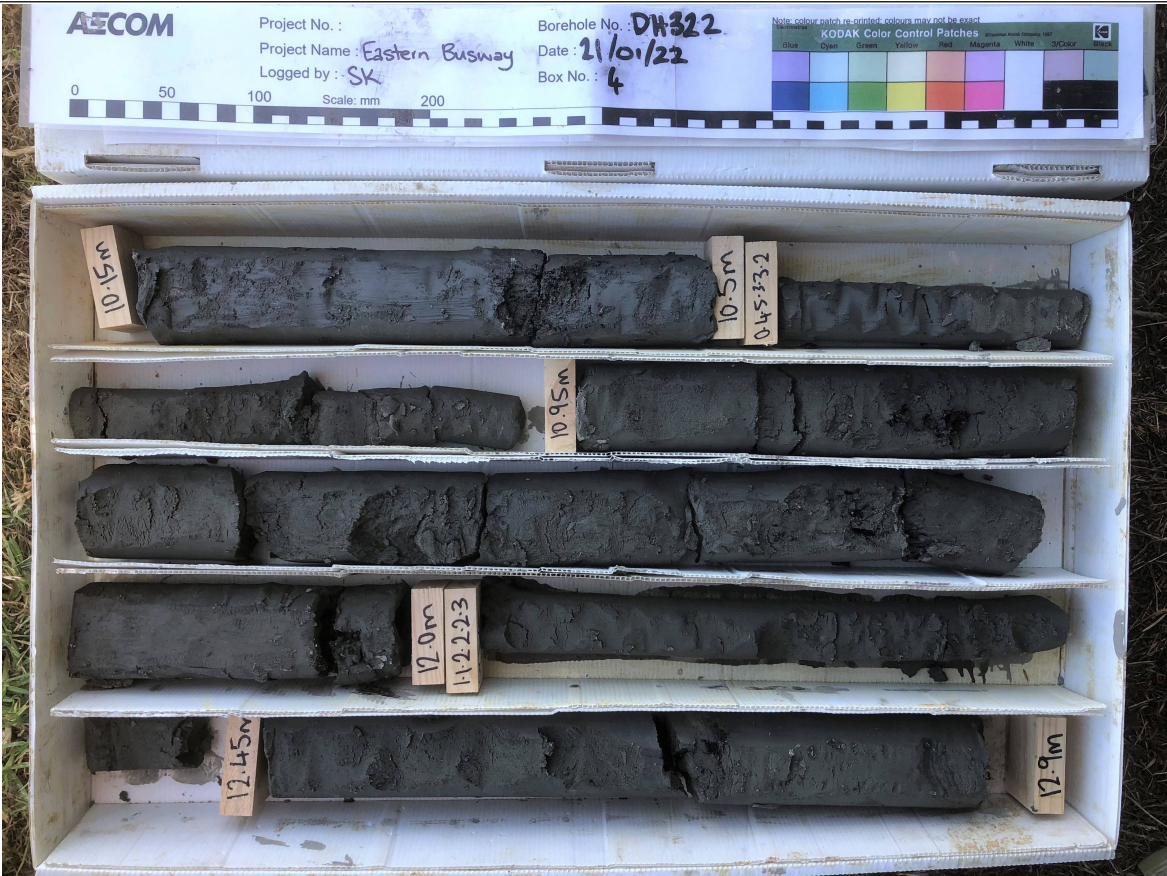
Box: 4 of 9 - Depth: 10.15m to 12.90m of 27.00m

Date Drilled 20/01/2022 to 24/01/2022 - Date Photographed: 21/01/2022
