Client Auckland Transport  
 Project Eastern Busway  
 Project number 60644113

Co-ordinates 412270.62mE 794791.97mN  
 Orientation -90° Elevation 10.02m  
 Location Reserve: 1R Burswood Drive  
 Feature Retaining wall/slope design

Co-ordinates 412274.22mE 794839.80mN  
 Orientation -90° Elevation 9.08m  
 Location Burswood Reserve  
 Feature Busway through Burswood Reserve

Co-ordinates 411888.6mE 794974.06mN  
 Orientation -90° Elevation 11.557m  
 Location 29 Dulwich Place, Pakuranga  
 Feature Ground conditions for western end of Burswood Station.

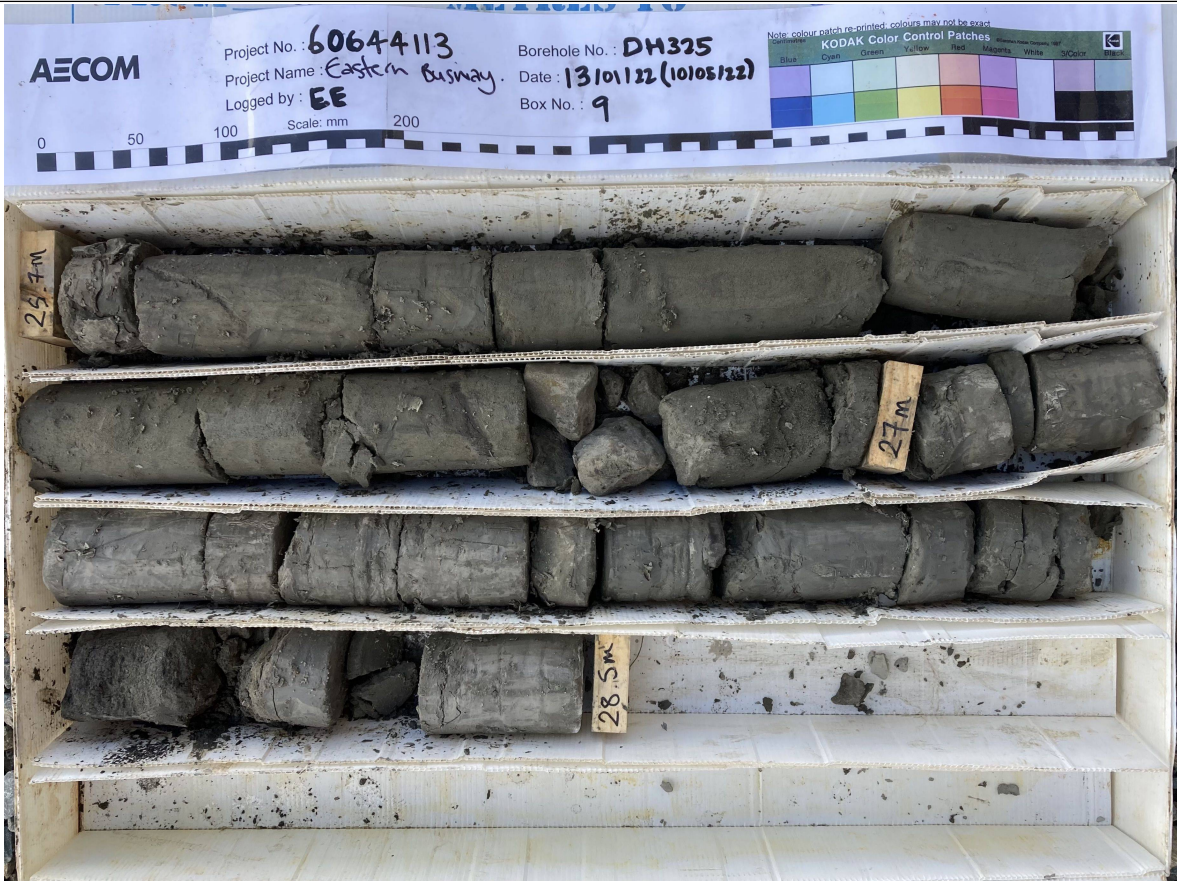
**Box: 9 of 9 - Depth: 25.70m to 28.50m of 28.50m**

Date Drilled 12/01/2022 to 14/01/2022 - Date Photographed: 10/05/2022

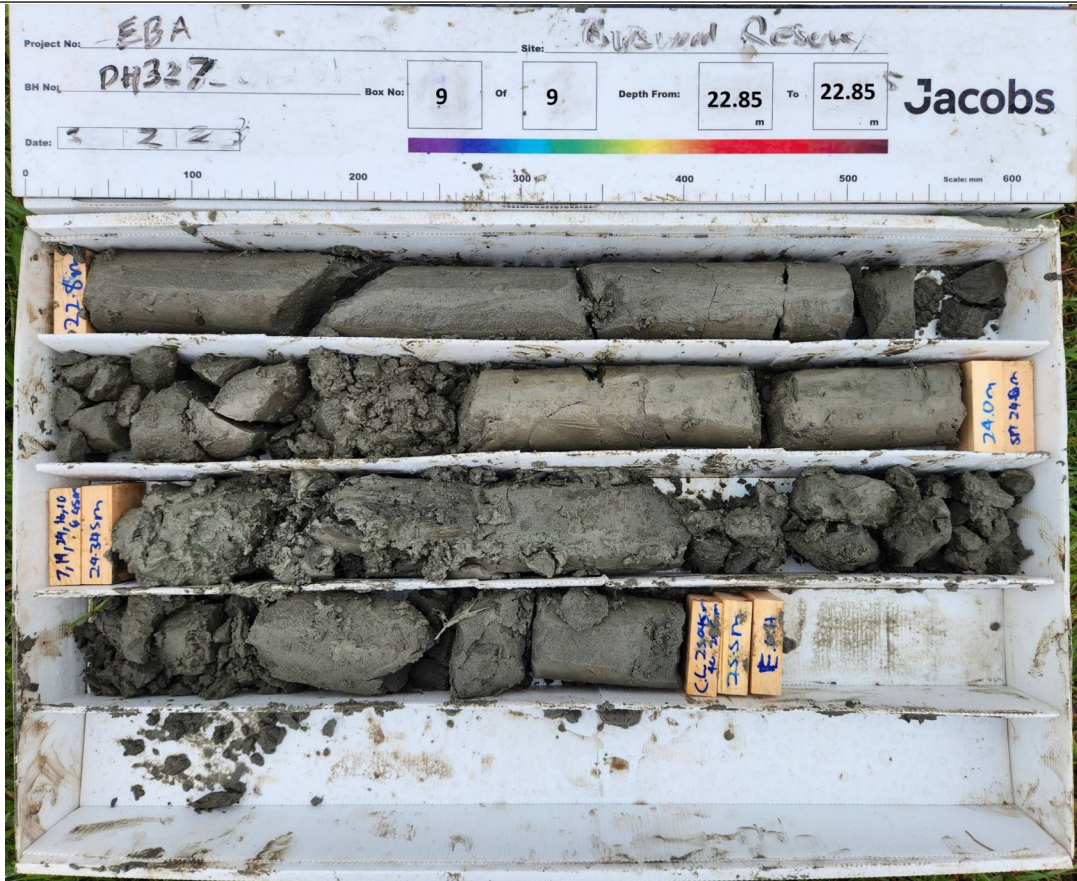
**Box: 9 of 9 - Depth: 22.85m to 25.50m of 25.50m**

Date Drilled 2/02/2023 to 2/02/2023 - Date Photographed: 3/02/2023
