Client Auckland Transport
 Project Eastern Busway
 Project number 60644113

Co-ordinates 411893.10mE 794990.00mN
 Orientation -90° Elevation 11.84m
 Location 29 Dulwich Place
 Feature Burswood Station

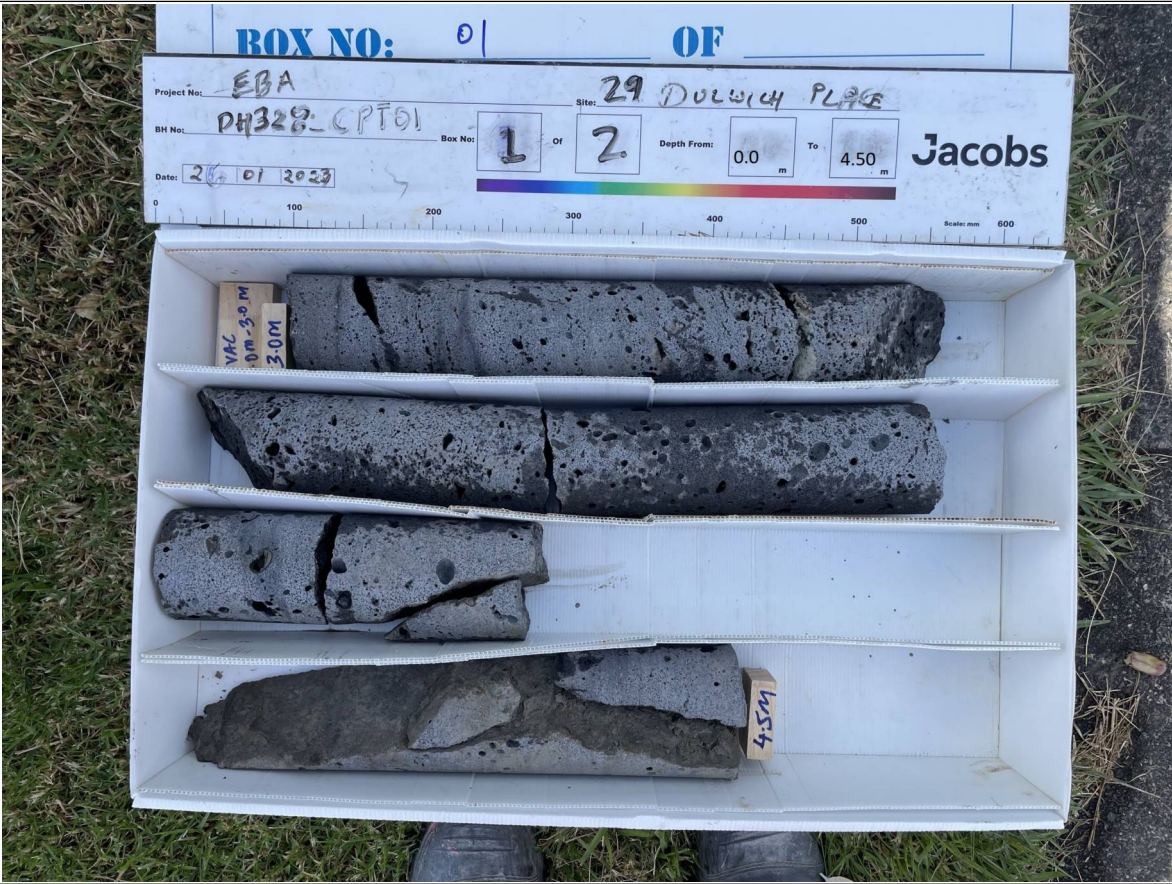
Box: 1 of 2 - Depth: 00.00m to 04.50m of 6.70m

0.0m: Vacuum excavated		0 - 50									0.0m: Vacuum excavated, not logged.	
Vacuum extraction			VAC EX									
3.0m: Slightly weathered, dark grey, BASALT. Moderately strong; highly vesicular.			HQ3						100 [67]		3.35m: J, 10°, Pl, Ro 3.45m: J, 30°, Pl, Ro 4.05m to 4.70m: J, 85°, Un, Ro 4.87m: J, 30°, Pl, Ro

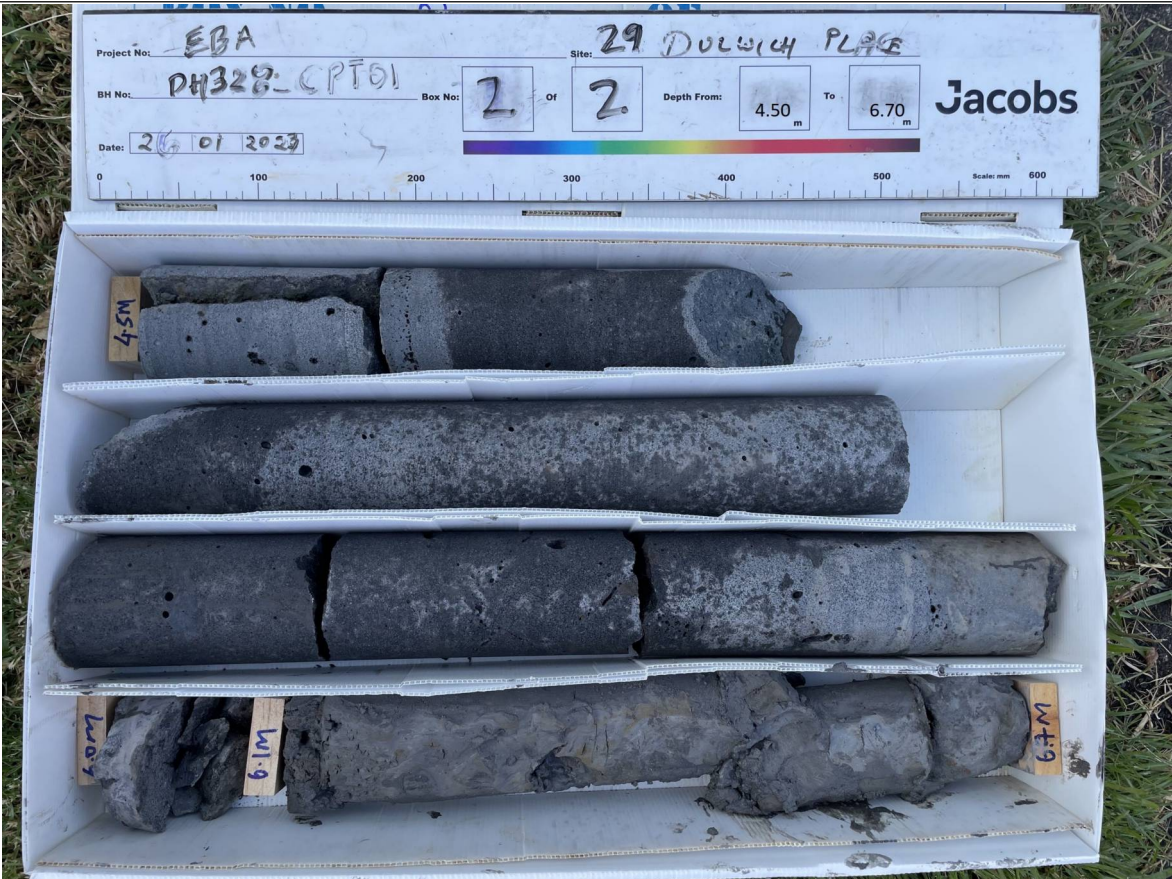
Box: 2 of 2 - Depth: 04.50m to 06.70m of 6.70m

4.7m: Slightly weathered, dark grey, BASALT. Strong; slightly vesicular.			HQ3						100 [87]			
6.0 to 6.1m: Moderately weathered, weak. 6.1m: ALLUVIUM comprised of silty clay.			HQ3						100		6.1m: Silty CLAY; light grey. Soft, moist, high plasticity.	
											DH-CPT328-D terminated at 6.7m Depth Criteria Achieved	
For explanation of symbols and observations, see key sheet			RELATIVE STRENGTH			WEATHERING			Date logged 26/01/2023		Driller McMillan	
FLUID DEPTHS AND DRILLING PROGRESS (m) Date Time Drilled Depth Casing Depth Fluid Depth			VS - Very strong S - Strong MS - Moderately strong W - Weak VW - Very weak EW - Extremely weak			UW - Unweathered SW - Slightly weathered MW - Moderately weathered HW - Highly weathered CW - Completely weathered			Logged FK Checked MC		Started 26/01/2023	
Hand Held Shear Vane			Remarks No Groundwater level recorded.			Horizontal / Vertical Survey Datums: NZGD2000 - Mount Eden 2000 / New Zealand Vertical Datum 2016					Finished 26/01/2023

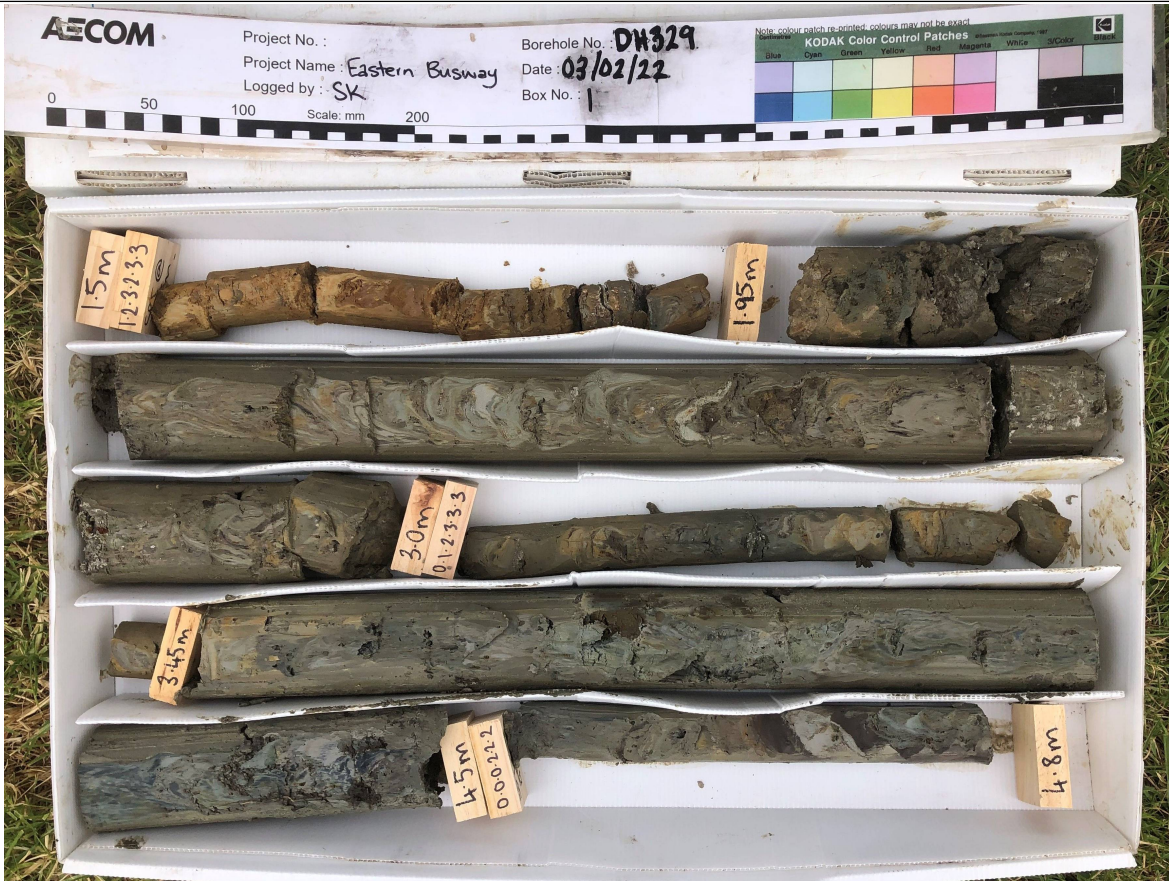
Box: 1 of 12 - Depth: 01.50m to 04.80m of 36.00m
 Date Drilled 3/02/2022 to 9/02/2022 - Date Photographed: 3/02/2022

FILL 0.0m: FILL comprising silty clay with some gravel.			HA						0		0.0m: Silty CLAY with some fine to coarse gravel (greywacke and basalt) and minor fine to coarse sand; orange. Stiff, moist, high plasticity. (Fill) 1.9m: Becomes bluish grey with light grey, dark grey and orange mottles/swirls. 3.0m: 114mm diameter HWT casing to 3.0m.	4.1 4.8 5.24
	SS 1,2,3, 2,3,3 N=11		SPT						100			
			HQ3						100			
	SS 0,2,2, 3,3,3 N=11		SPT	HWT					100			
			HQ3						100			
TAURANGA GROUP 5.4m: ALLUVIUM comprising silt, sand, clay and peat.			HQ3						100		5.4m: Fine to medium sandy SILT with some clay; brownish grey. Soft, moist, low plasticity. 5.8m: Silty fine to medium SAND; brownish grey. Loose, wet, uniformly graded. 6.45m: Becomes with some organics and fine to coarse gravel. 6.8m: Silty CLAY with trace organics; brownish grey with black specks. Firm, moist, high plasticity. 7.55m: Spongy PEAT; black. Firm, moist, high plasticity. 7.85m: Silty CLAY with trace organics; bluish grey. Firm, moist, high plasticity.	6.3

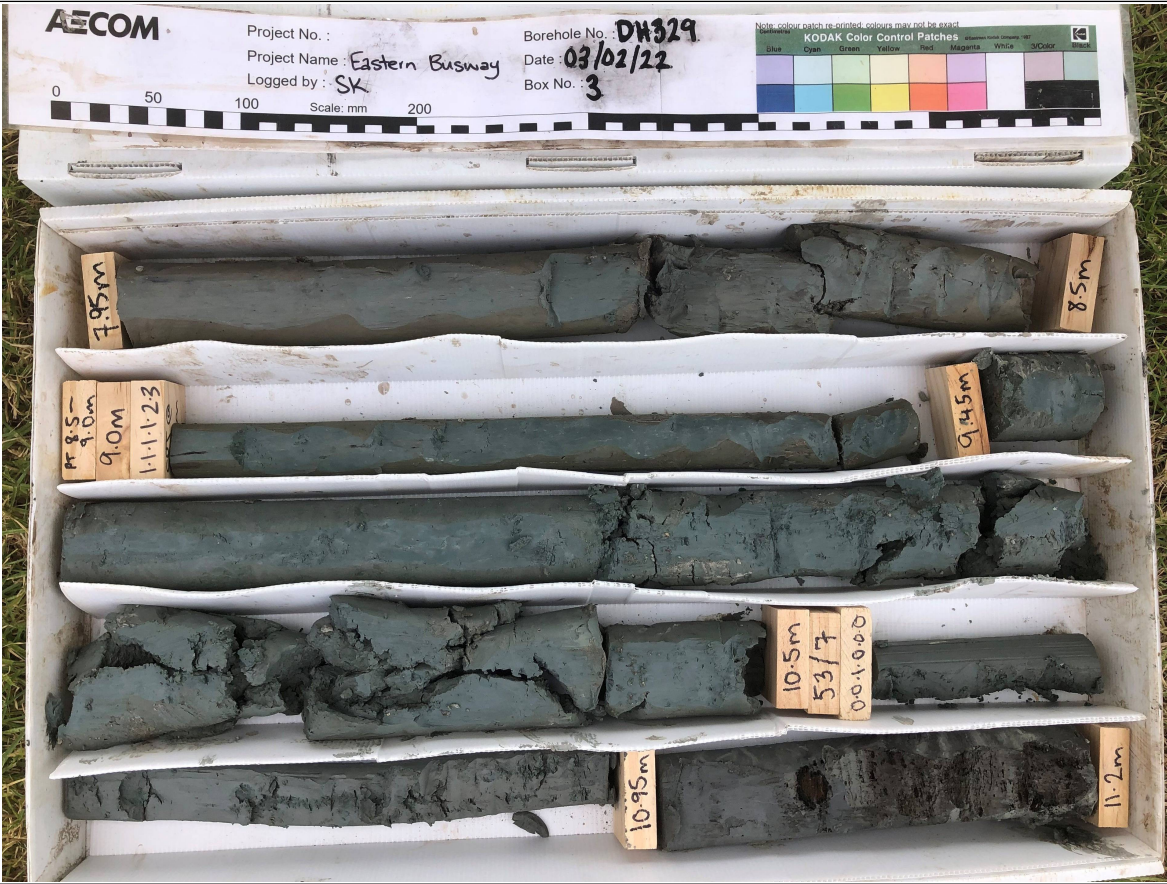
Box: 3 of 12 - Depth: 07.95m to 11.20m of 36.00m
 Date Drilled 3/02/2022 to 9/02/2022 - Date Photographed: 3/02/2022

TAURANGA GROUP	53/7 SS 0,0,1, 0,0,0 N=1	HQ3				11		100		7.85m: Silty CLAY with trace organics; bluish grey. Firm, moist, high plasticity. <i>(continued)</i> 10.6 to 11.0m: Grey, soft.	
		SPT						100		11.0m: Organic CLAY; dark brown. Soft, moist, high plasticity.	
		HQ3				12		100			
	SS 0,0,0, 0,0,0 N=0 SUOW	PT						100			
		SPT				13		100		12.8m: Silty CLAY; bluish grey with brown specks. Firm, moist, high plasticity.	
		HQ3				14		100			
	SS 0,0,1, 1,1,1 N=4	SPT						100			
		HQ3				15		100		15.1 to 15.6m: Stiff.	
	44/8 SS 1,3,2, 3,3,2 N=10	SPT						100			
		HQ3				16		100			
	SS 0,0,0, 0,1,1 N=2	SPT						100			
		HQ3				17		100		17.25m: Fine to coarse SAND, grey. Medium dense. 17.55m: Clayey SILT with trace fine sand; grey. Firm. 17.55 to 17.6m: Trace black organics.	
SS 0,0,0, 0,0,0 N=0 SUOW	SPT						100				
	HQ3				18		100				
SS 0,0,0, 0,1,1 N=2	SPT						100				
	HQ3				19		100				
	SPT						100

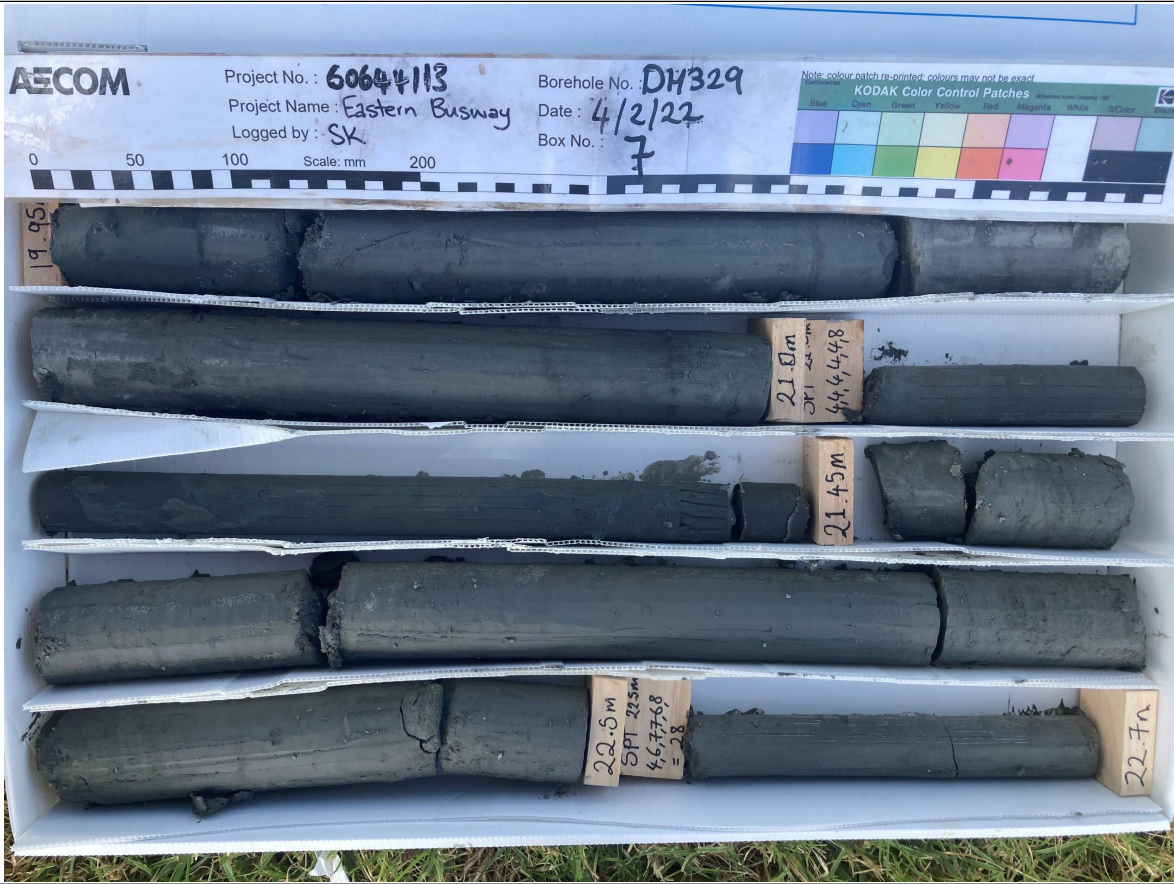
Box: 7 of 12 - Depth: 19.95m to 22.70m of 36.00m
 Date Drilled 3/02/2022 to 9/02/2022 - Date Photographed: 4/02/2022

20.5m: Highly weathered, grey, SILTSTONE. Extremely weak.	ss 4,4,4, 4,4,8 N=20	SPT				21		100		20.5m: Silty CLAY; grey. Very stiff.	
	22.1m: Highly weathered, grey, fine to coarse SANDSTONE. Extremely weak. 22.5 to 23.0m: Siltstone.	ss 4,6,7, 7,6,8 N=28	SPT				22		100		22.1m: Fine to coarse SAND. Medium dense.

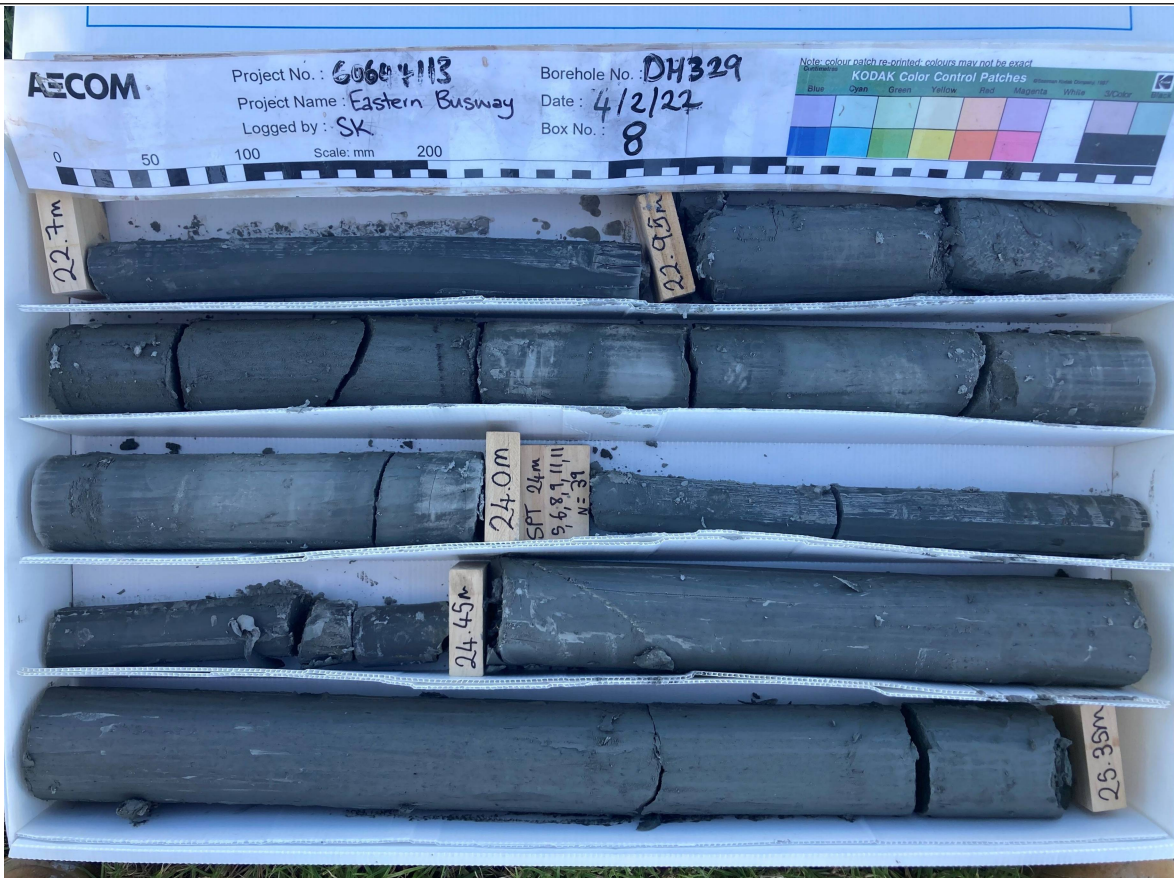
Box: 8 of 12 - Depth: 22.70m to 25.35m of 36.00m
 Date Drilled 3/02/2022 to 9/02/2022 - Date Photographed: 4/02/2022

23.0m: Moderately weathered, grey, SILTSTONE. Very weak.			HQ3			23		100		23.35m: DB, 25° 23.4m: Gently inclined, black carbonaceous lamination.	
	24.45 to 25.15m: Speckled with black organics.	ss 5,6,8, 9,11,11 N=39	SPT				24		100		24.45m: HJ, 60°

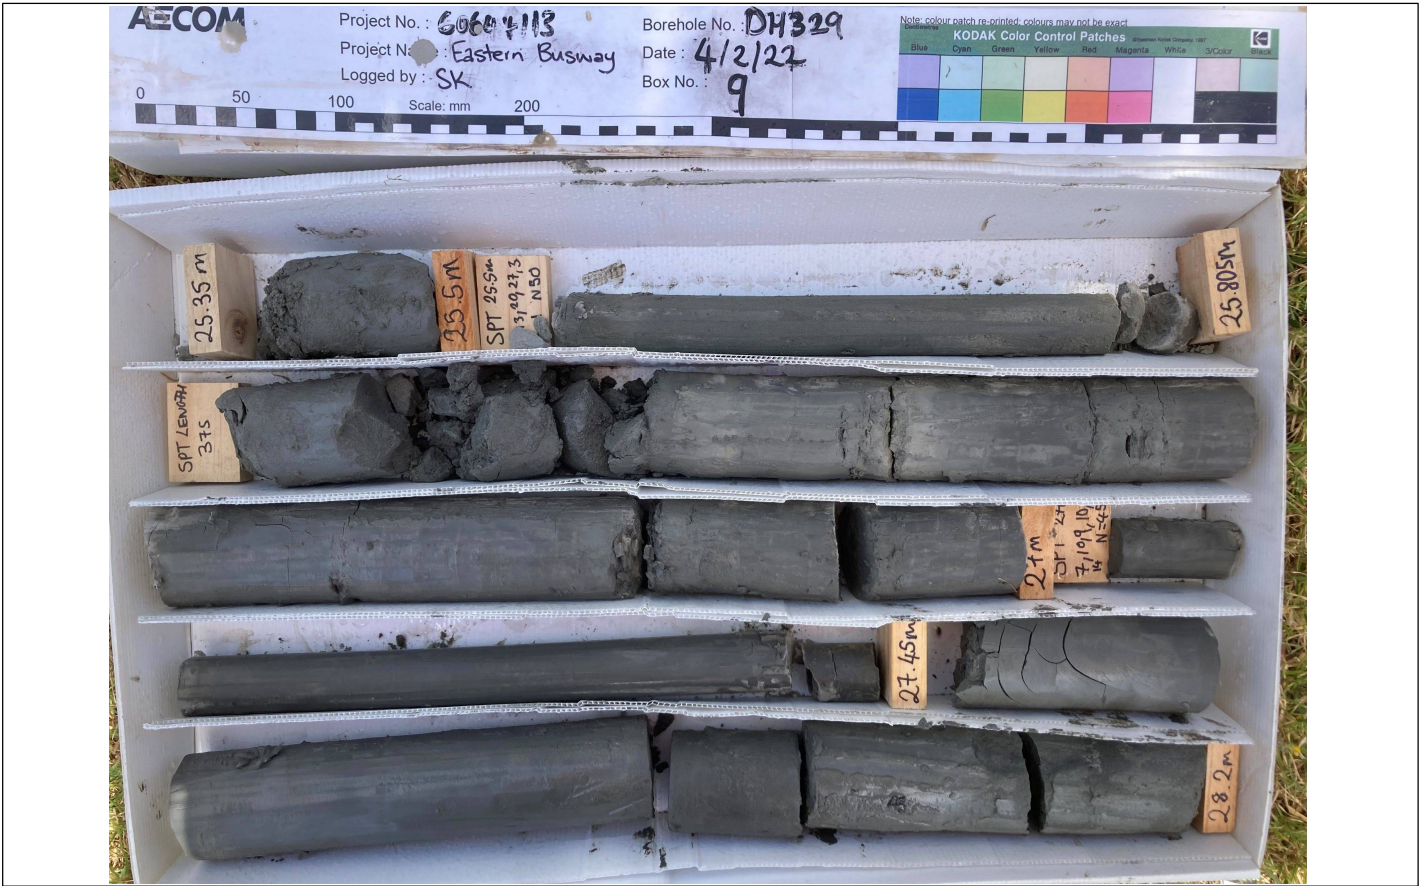
Box: 9 of 12 - Depth: 25.35m to 28.20m of 36.00m
 Date Drilled 3/02/2022 to 9/02/2022 - Date Photographed: 4/02/2022

25.15m: Moderately weathered, grey, fine SANDSTONE. Very weak.	ss 10,13,20, 27,3 for 5mm N>50	SPT				25		100			
				HQ3			26		100 [92]			
		ss 7,10,9, 10,12,14 N=45	SPT				27		100			
				HQ3			28		100 [100]

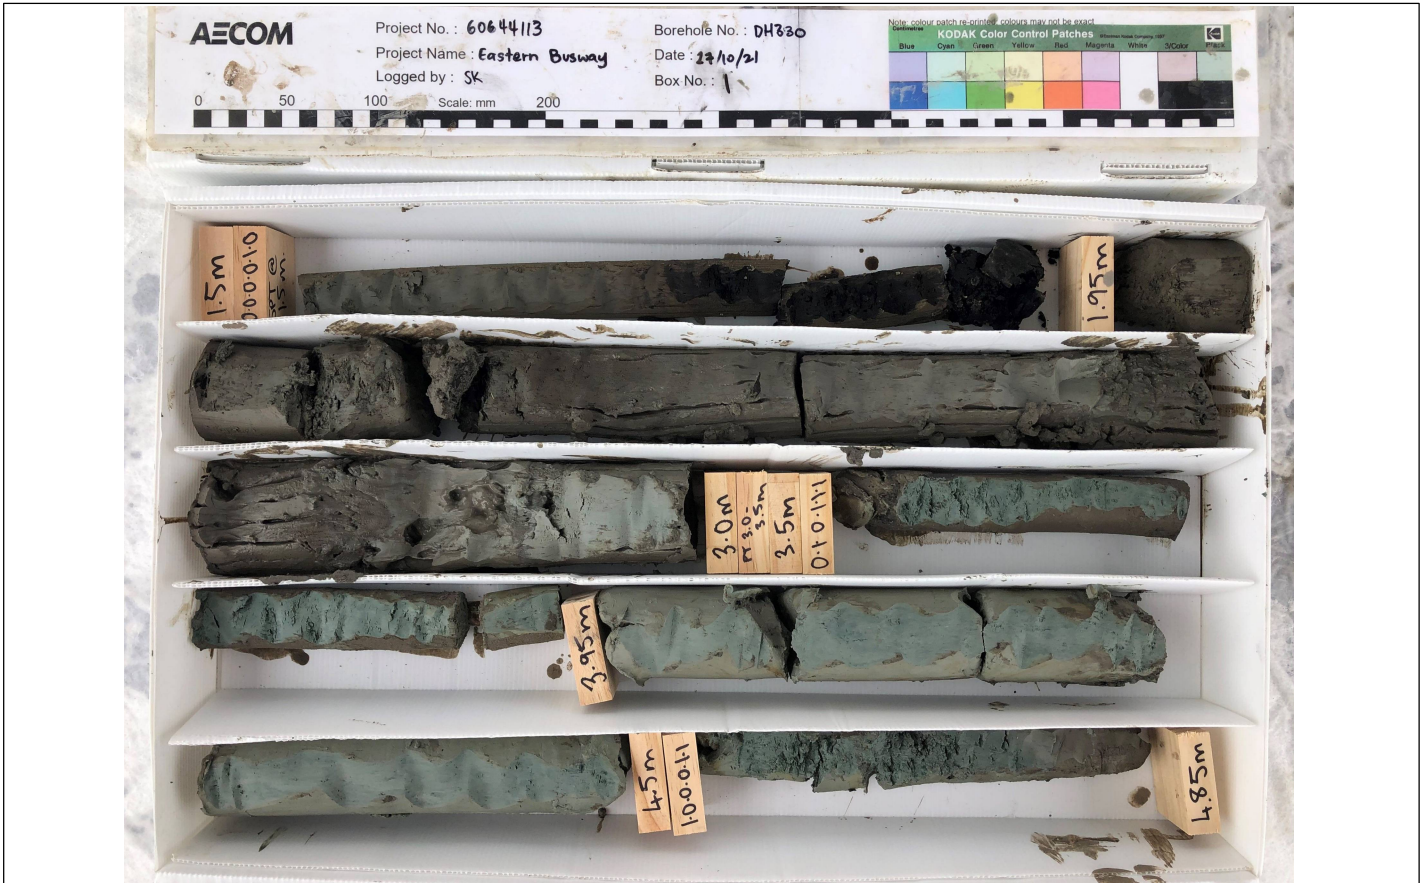
Box: 1 of 8 - Depth: 01.50m to 04.85m of 24.00m

0.0m: FILL comprising asphalt surface over sandy gravel.												0.0m: Asphalt.	
0.6m: ALLUVIUM comprising clay, silt and organic clay.		207*		VAC EX				1		0		0.05m: Sandy fine to coarse GRAVEL with some silt; dark brownish black. Tightly packed, moist. Sand is fine to coarse. Gravel is subangular basalt.	0.5
		207*										0.6m: Clayey SILT with some fine to coarse sand; light brownish grey. Hard, moist, low plasticity.	0.9
		133/30 SS		SPT				2		100		1.2m: Silty CLAY with minor fine sand; bluish grey. Stiff, moist, high plasticity.	1.5
		0,0,0, 0,1,0 N=1		HQ3						100		1.7m: Organic silty CLAY; black. Soft, moist, high plasticity.	
				PT				3		100		1.95m: Silty CLAY with trace organics; bluish grey. Firm, moist, high plasticity.	
		0,1,0, 1,1,1 N=3		SPT						100		3.0m: 114mm diameter HWT casing to 3.0m.	
				HQ3				4		100		3.6m: Trace organics cease.	
		1,0,0, 0,1,1 N=2		SPT						100		4.8m: Organic silty CLAY; blackish brown. Very soft, moist, high plasticity.

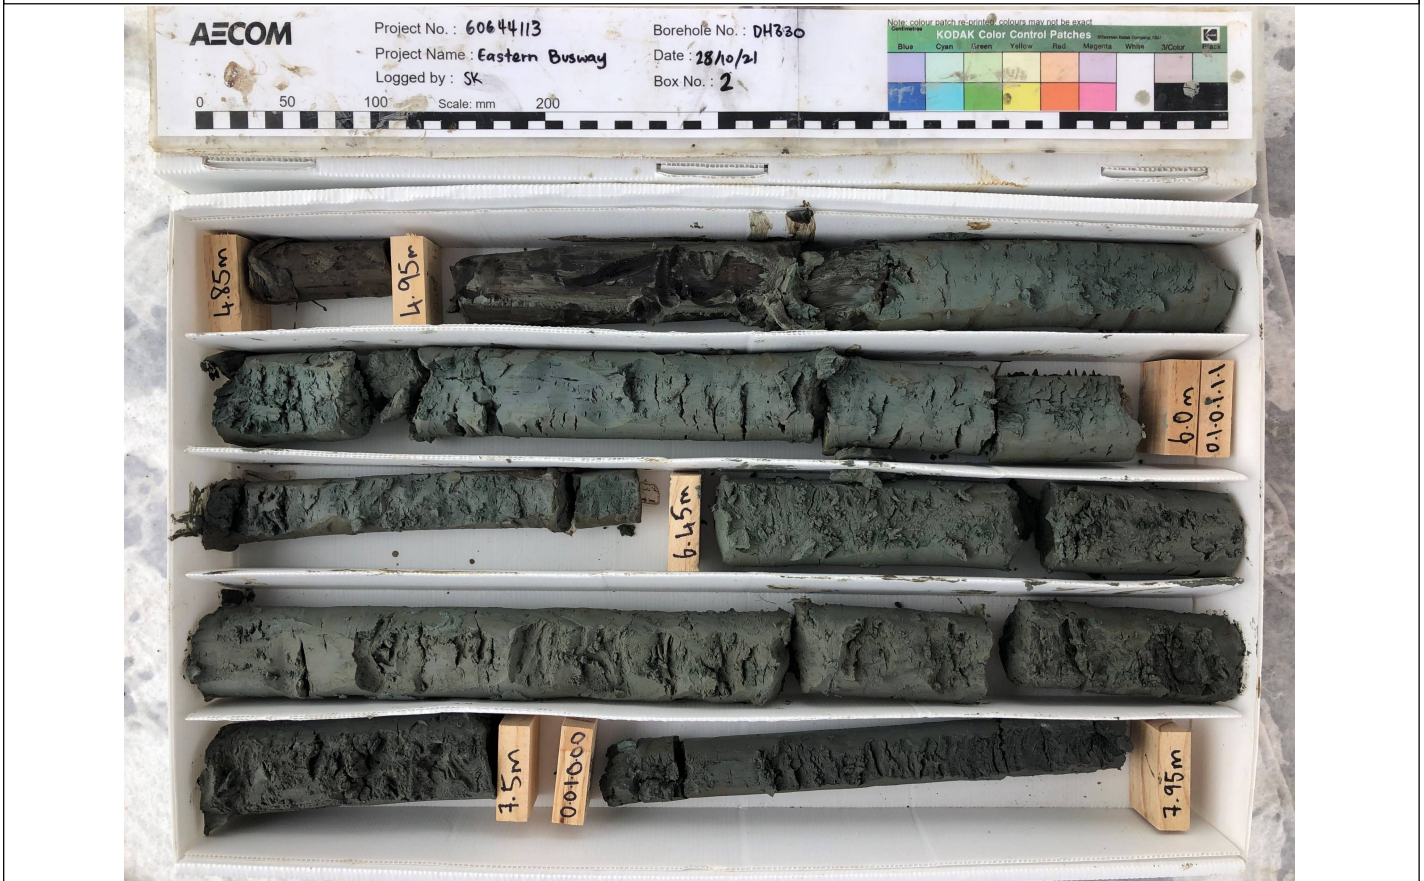
Box: 2 of 8 - Depth: 04.85m to 07.95m of 24.00m

HQ3				5		100		5.15m: Silty CLAY with trace organics; bluish grey. Firm, moist, high plasticity.	
		0,1,0, 1,1,1 N=3		SPT						100		5.9 to 8.0m: Some fine micaceous sand.	
				HQ3				6		100			
		0,0,1, 0,0,0 N=1		SPT						100		8.0 to 13.3m: Trace fine micaceous sand.	
				HQ3				7		100			
		72/13		HQ3				8		100			
				HQ3				9		100			
		44/5		PT						100

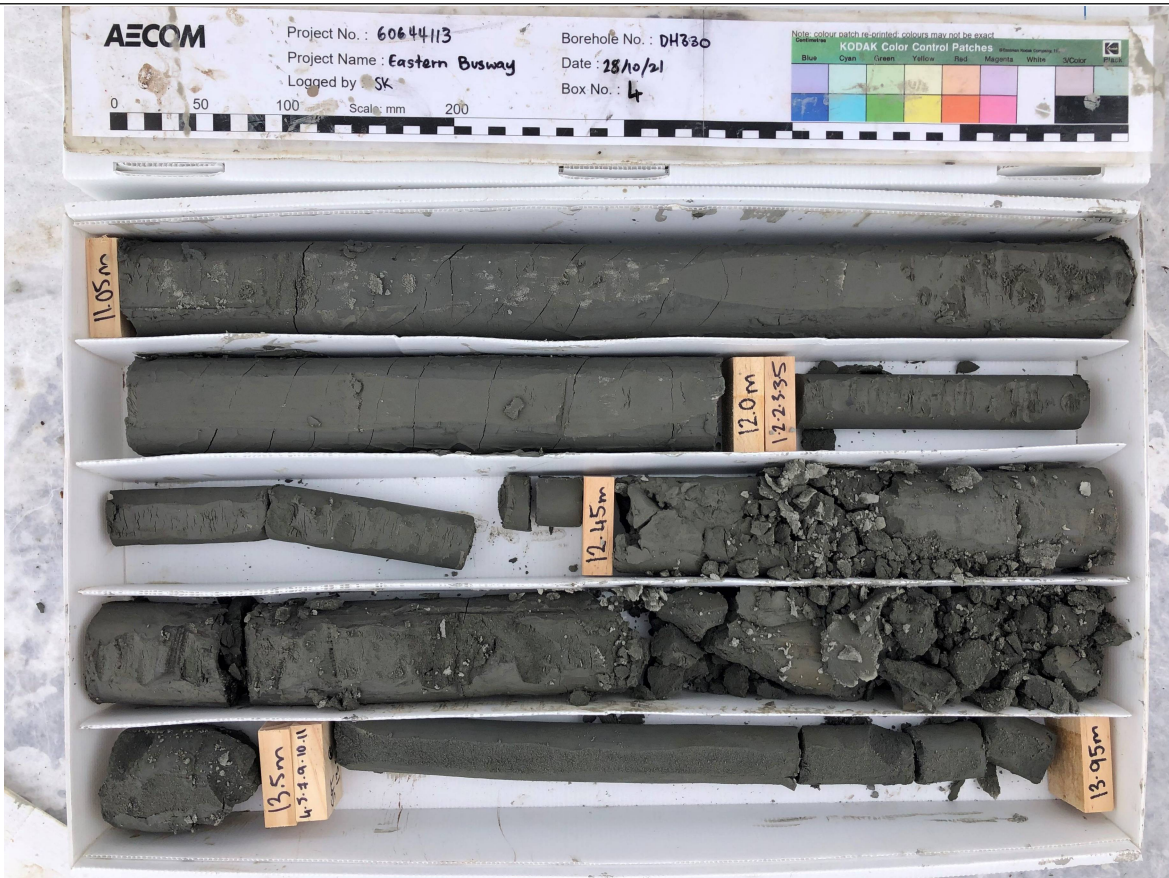
Box: 4 of 8 - Depth: 11.05m to 13.95m of 24.00m
 Date Drilled 27/10/2021 to 29/10/2021 - Date Photographed: 28/10/2021

TAURANGA GROUP	44/9 SS 0,0,1, 1,2,3 N=7	HQ3				11		100		5.15m: Silty CLAY with trace organics; bluish grey. Firm, moist, high plasticity. (continued) 11.0 to 15.45m: Stiff.		
		SPT						100				
EAST COAST BAYS FORMATION	12.6m: Highly weathered, grey, fine SANDSTONE. Extremely weak.	HQ3				12		100		12.6m: Silty fine SAND with trace clay; grey. Dense, moist. 13.3 to 15.45m: Some fine micaceous sand.		
		SPT						100

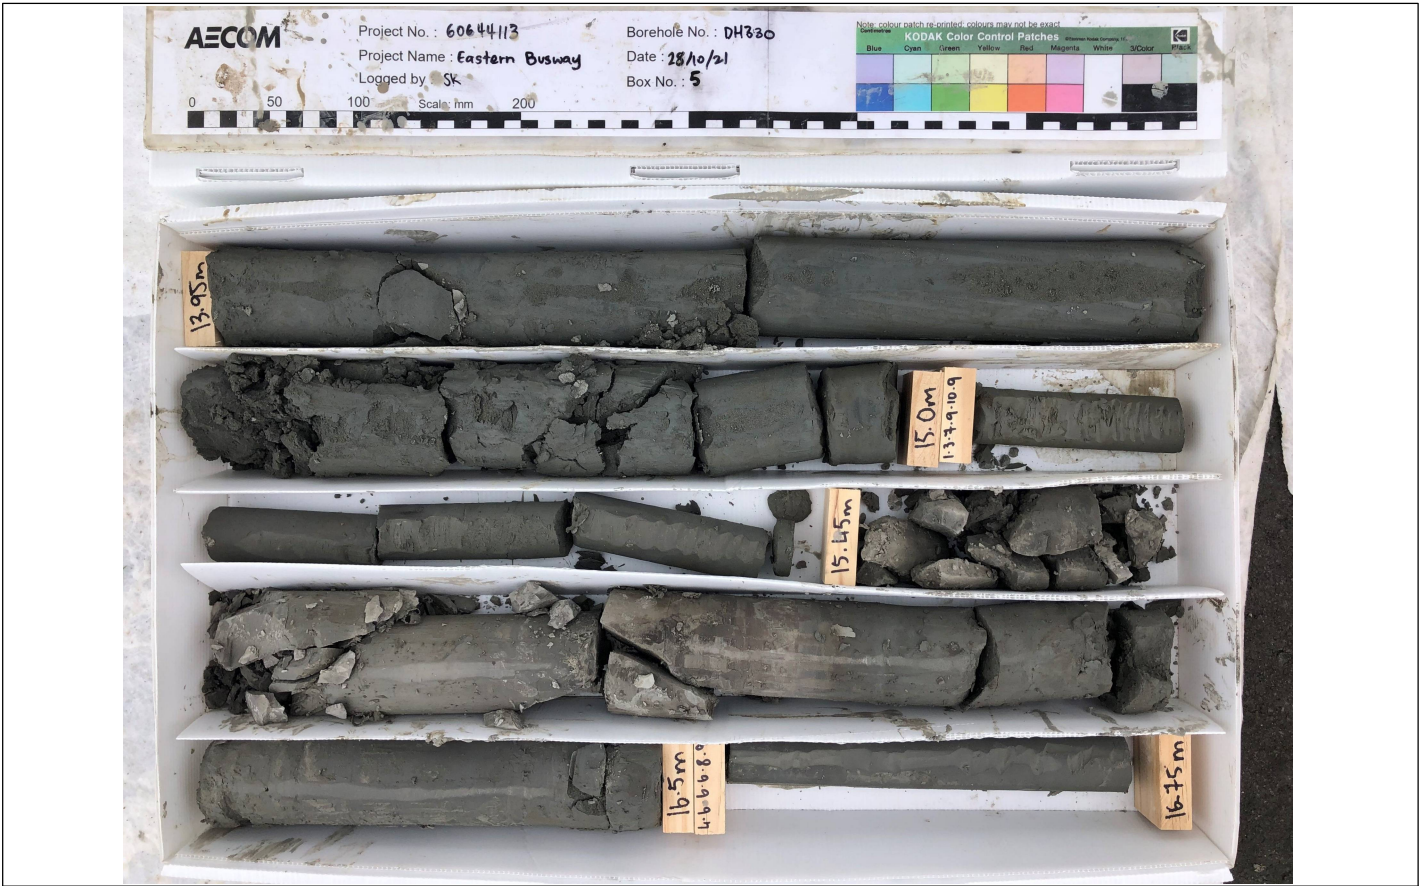
Box: 5 of 8 - Depth: 13.95m to 16.75m of 24.00m

15.45m: Moderately weathered, grey, SILTSTONE. Extremely weak.	HQ3					13		100	15.45m: Silty CLAY; grey. Very stiff. 15.45 to 15.65m: Recovered as gravel. 15.65 to 15.75m: J, 70°, Ud, Sm 15.82 to 15.88m: J, 65°, Ud, Sm 15.88 to 15.98m: J, 60°, Ud, Sm		
		SPT						100

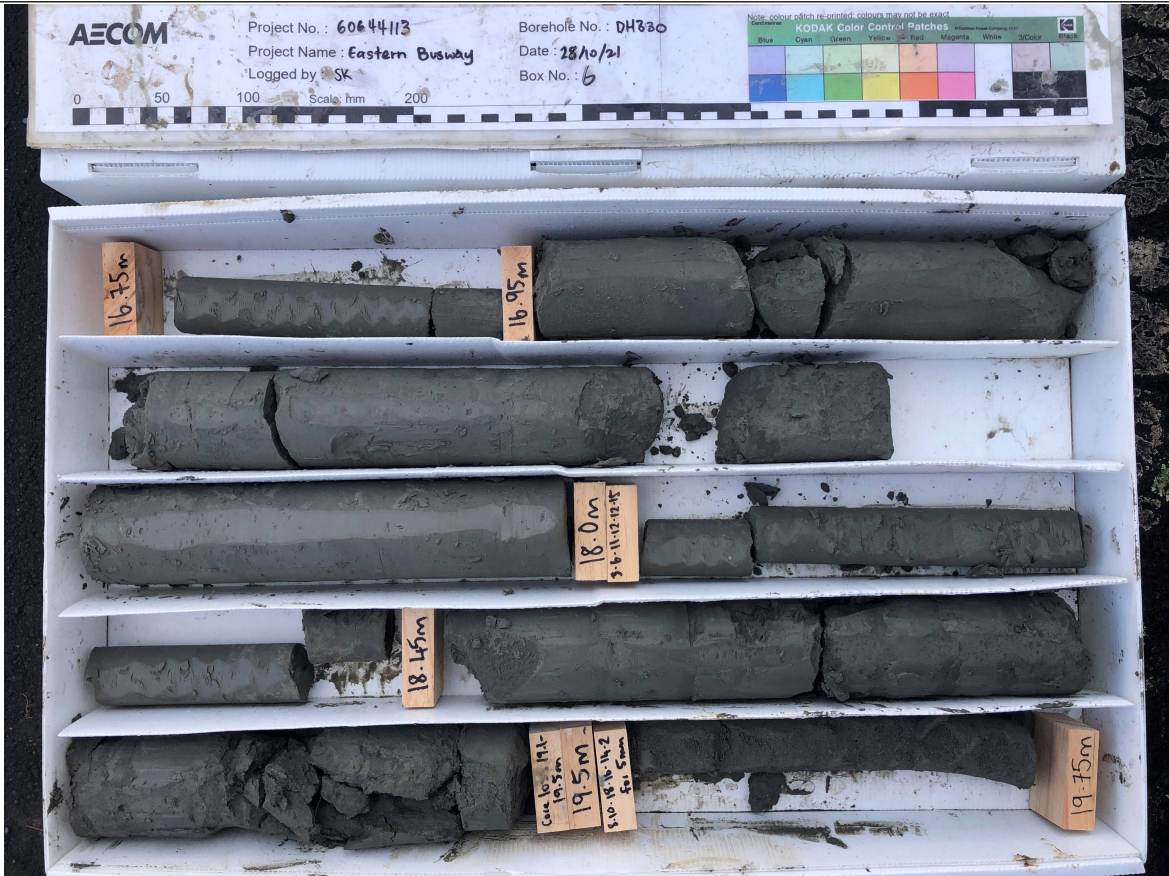
Box: 6 of 8 - Depth: 16.75m to 19.75m of 24.00m

19.0m: Moderately weathered, grey, fine to medium SANDSTONE. Extremely weak.	HQ3					14		100	19.0m: Fine to medium SAND; grey. Very dense.		
		SPT						100				
		4,5,7, 9,10,11 N=37	HQ3				15		100			
			SPT						100			
	1,3,7, 9,10,9 N=35	HQ3				16		100 [0]				
		SPT						100				
	4,6,6, 6,8,9 N=29	HQ3				17		100 [0]				
		SPT						100				
	3,6,11, 12,12,15 N=50	HQ3				18		100				
		SPT						100				
	8,10,18, 16,14,2 for 5mm	HQ3				19		100 [0]				
		SPT						100

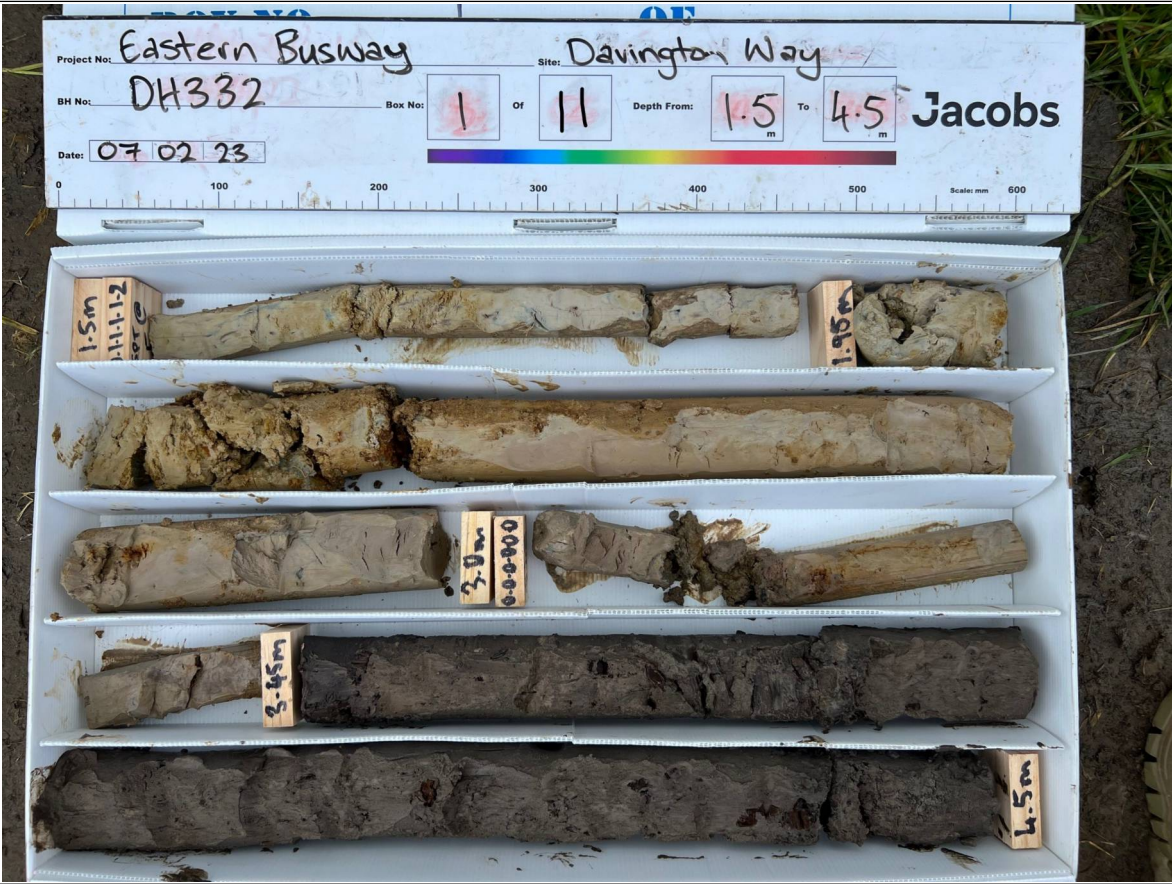
Box: 1 of 11 - Depth: 00.00m to 04.50m of 33.00m
 Date Drilled 7/02/2023 to 8/02/2023

0.0m: Hand auger clearance	84/36										0.0m: Hand auger clearance to 1.5m. Not logged. Natural ground noted.	
1.5m: Alluvium comprising Clay, silt, sand and organic soil. TAURANGA GROUP	154/45		HA				1					
	128/71											
	159/75											
	154/71											
	173/71		SPT				2		100		1.5m: Silty CLAY with trace fine sand lenses; Brownish grey with bluish grey mottling. Firm, moist, high plasticity.	
	SS 0,1,1,1,1,2 N=5		HQ3						86			
				114								
	SS 0,0,0,0,0,0 N=0 SUOW		SPT				3		100		3.5m: Organic fine to medium sandy CLAY with some bands of wood fragments; brown. Very soft, moist, high plasticity.	
			HQ3						100			
SS 0,0,0,0,0,0 N=0 SUOW		SPT				5		100		4.55m: Silty CLAY with some fine sand; bluish grey. Soft, moist, high plasticity.		
		HQ3						100				
8/3 SS 0,1,0,0,1,1,1 N=2		SPT				6		100		5.7 to 7.85m: Becomes sandy CLAY; very soft. Sand, fine to medium.		
		HQ3						100				
18/5 SS 0,0,0,0,0,0 N=0 SUOW		SPT				8		100		7.85 to 8.2m: Sand ceases. Contains trace organics.

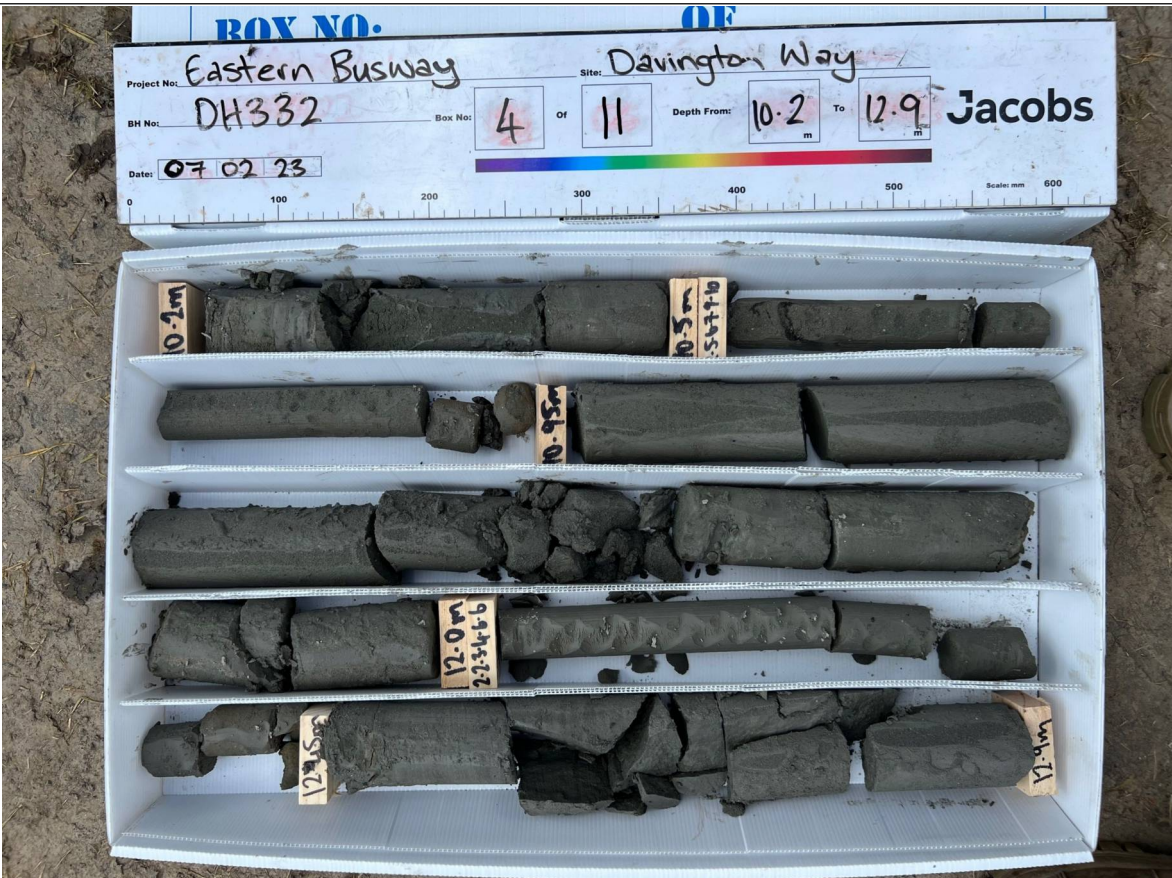
Box: 4 of 11 - Depth: 10.20m to 12.90m of 33.00m
 Date Drilled 7/02/2023 to 8/02/2023

10.25m: Highly weathered, grey, fine SANDSTONE; extremely weak.	ss 2,5,6,7,9,10 N=32	SPT				11		100		10.25m: Recovered as Silty, fine to coarse SAND; grey. Dense, moist, well graded.

11.65m: Highly weathered, bluish grey, indistinctly bedded SILTSTONE; extremely weak.	ss 2,2,3,4,6,6 N=19	SPT				12		100		11.5 to 11.65m: Recovered as sandstone gravels. 11.65m: Recovered as Silty CLAY; bluish grey. Very stiff, moist, high plasticity.

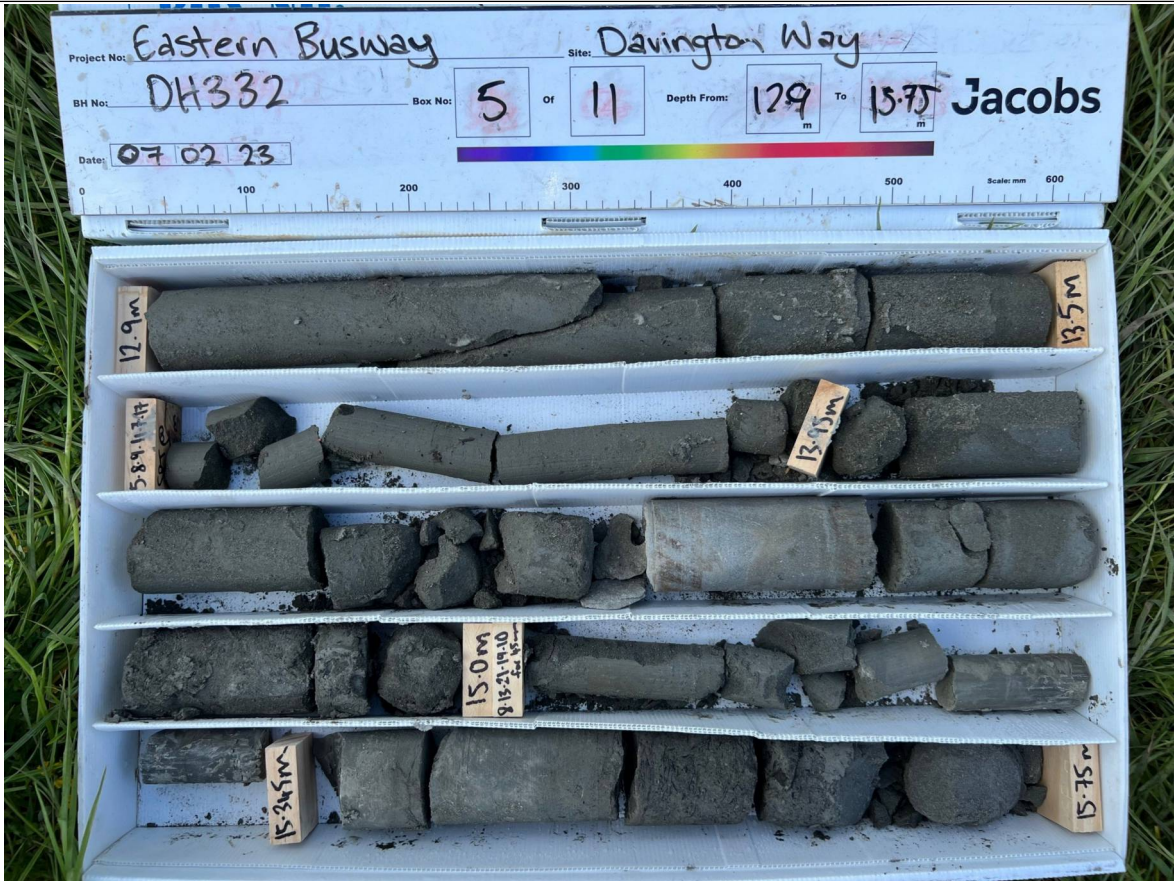
Box: 5 of 11 - Depth: 12.90m to 15.75m of 33.00m
Date Drilled 7/02/2023 to 8/02/2023

12.5m: Moderately weathered, grey, massive SANDSTONE; extremely weak.			HQ3			13		100		12.5m: Recovered as Silty fine to coarse SAND; grey. Very dense, moist, well graded.	
		ss 5,8,9,11,7,17 N=44	SPT				14		100		12.6 to 12.85m: J, 60°, Ud, Sm 13.02 to 13.3m: J, 60°, Ud, Sm	
				HQ3			15		100

14.55m: Slightly weathered, grey, fine SANDSTONE; weak. Concretion.			SPT			15		100			
	14.7m: Slightly weathered, grey, fine to coarse, SANDSTONE; very weak, weakly cemented.	ss 8,13,21,19,10 for 45mm N>50					16		100 [23]		15.85 to 16.15m: Non-intact, recovered as coarse gravel to cobble size irregular fragments

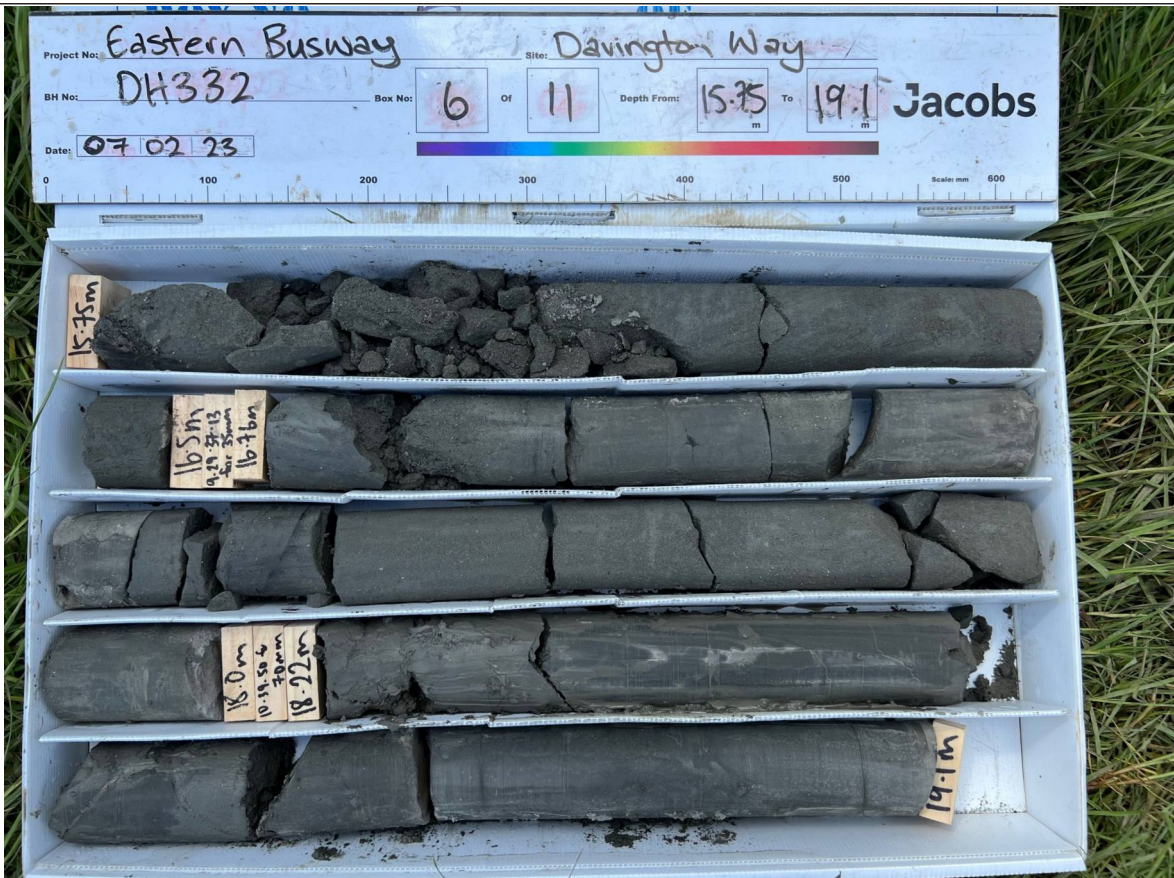
Box: 6 of 11 - Depth: 15.75m to 19.10m of 33.00m
Date Drilled 7/02/2023 to 8/02/2023

15.2m: Slightly weathered, grey, indistinctly bedded SILTSTONE; extremely weak.			HQ3			17		0			
	15.55m: Slightly weathered, grey, fine to coarse, massive SANDSTONE; very weak, weakly cemented. Trace carbonaceous material.	sc 9,29,37,13 for 35mm N>50	SPT				17		100 [100]		17.12 to 17.38m: Thin Siltstone bed; very weak

17.12 to 17.38m: SILTSTONE band.			HQ3			18		0		17.8 to 17.9m: J, 45°, Ud, Ro	
	17.9m: Slightly weathered, grey, indistinctly bedded SILTSTONE; extremely weak.	sc 10,39,50 for 70mm N>50	SPT				18		100 [91]		18.57 to 18.62m: , 30°, Ud, Sm 18.63 to 18.69m: , 45°, Ud, Sm	
				HQ3			19				19.55 to 19.7m: J, 60°, Ud, Sm	
	For explanation of symbols and observations, see key sheet			RELATIVE STRENGTH		WEATHERING		Date logged 8/02/2023		Driller McMillan		
	FLUID DEPTHS AND DRILLING PROGRESS (m) Date Time Drilled Depth Casing Depth Fluid Depth			VS - Very strong S - Strong MS - Moderately strong W - Weak VW - Very weak EW - Extremely weak		UW - Unweathered SW - Slightly weathered MW - Moderately weathered HW - Highly weathered CW - Completely weathered		Logged SK Checked GP		Started 7/02/2023 Finished 8/02/2023 Drill Rig N119 Core Boxes 11		
	Hand Held Shear Vane DR1980: 19mm (A). Calibrated Jun 2022: Correction Factor: 1.876 vane shear strength per NZGS guideline			Remarks Hole back filled with grout. 50mm PVC grouted in hole for downhole seismic testing. Shear vane readings are downhole in top 1.5m. Below 1.5m shear vanes were performed in the end of the barrel.		Horizontal / Vertical Survey Datums: NZGD2000 - Mount Eden 2000 / New Zealand Vertical Datum 2016		Page 2 of 10

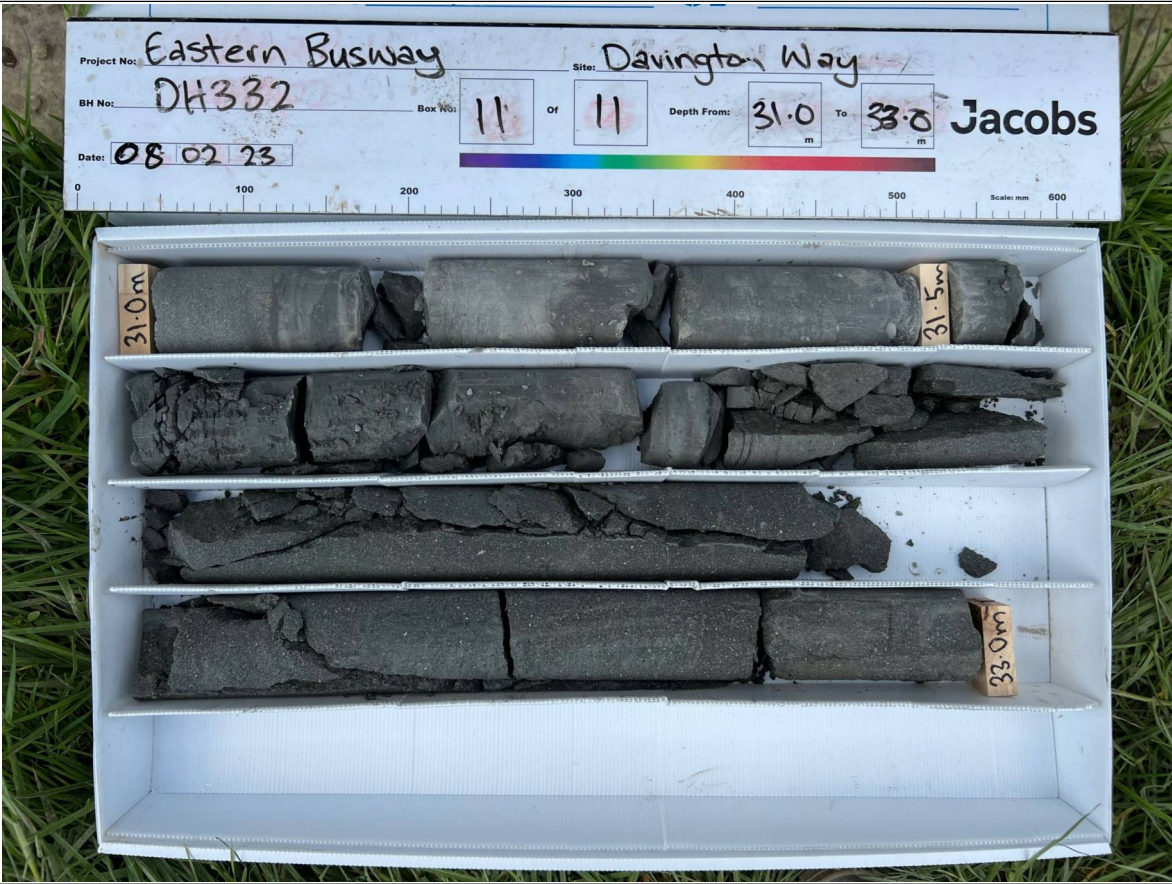
Box: 11 of 11 - Depth: 31.00m to 33.00m of 33.00m
Date Drilled 7/02/2023 to 8/02/2023

EAST COAST BAYS FORMATION 29.7m: Slightly weathered, grey indistinctly bedded SILTSTONE; extremely weak. (continued) 30.42m: Slightly weathered, grey, fine to coarse, SANDSTONE; weak. 31.1m: Slightly weathered, grey, indistinctly bedded SILTSTONE; extremely weak. Contains very thin carbonaceous beds. 31.85m: Slightly weathered, dark grey, coarse, massive VOLCANICLASTIC SANDSTONE; weak.										30.6 to 30.8m: J, 60°, Ud, Sm 30.68 to 30.71m: J, 25°, Ud, Sm	
			HQ3			31		100 [93]		31.57 to 31.67m: J, 60°, Ud, Sm 31.7 to 31.74m: J, 30°, Ud, Sm	
			HQ3			32		100 [37]		31.96 to 32.9m: J, 90°, Ud, Sm, Cl, Curved, 60 degrees at ends, 90 degrees down middle, fracture zone on one side of joint.	
						33				32.88 to 33m: J, 85°, Ud, Sm	
						34				DH332 terminated at 33m Depth Criteria Achieved	
						35					
						36					
						37					
						38					
						39
