Warkworth to Wellsford

Existing Water Quality Report

Technical Report

July 2019

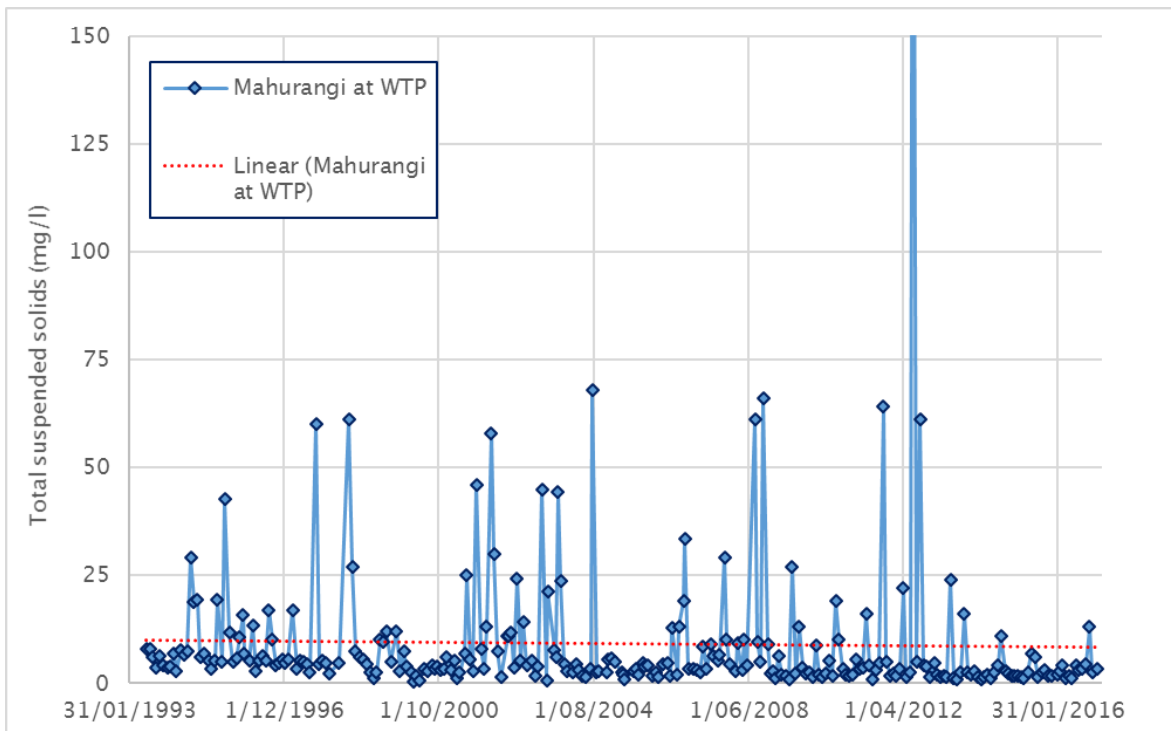
Figure 8 - Total suspended solids (mg/L) at Mahurangi at WTP from 1993 - 2016 (Note: outlier of 280 mg/L recorded on the 03/07/2012 outside of the window, this is to aid data viewing)

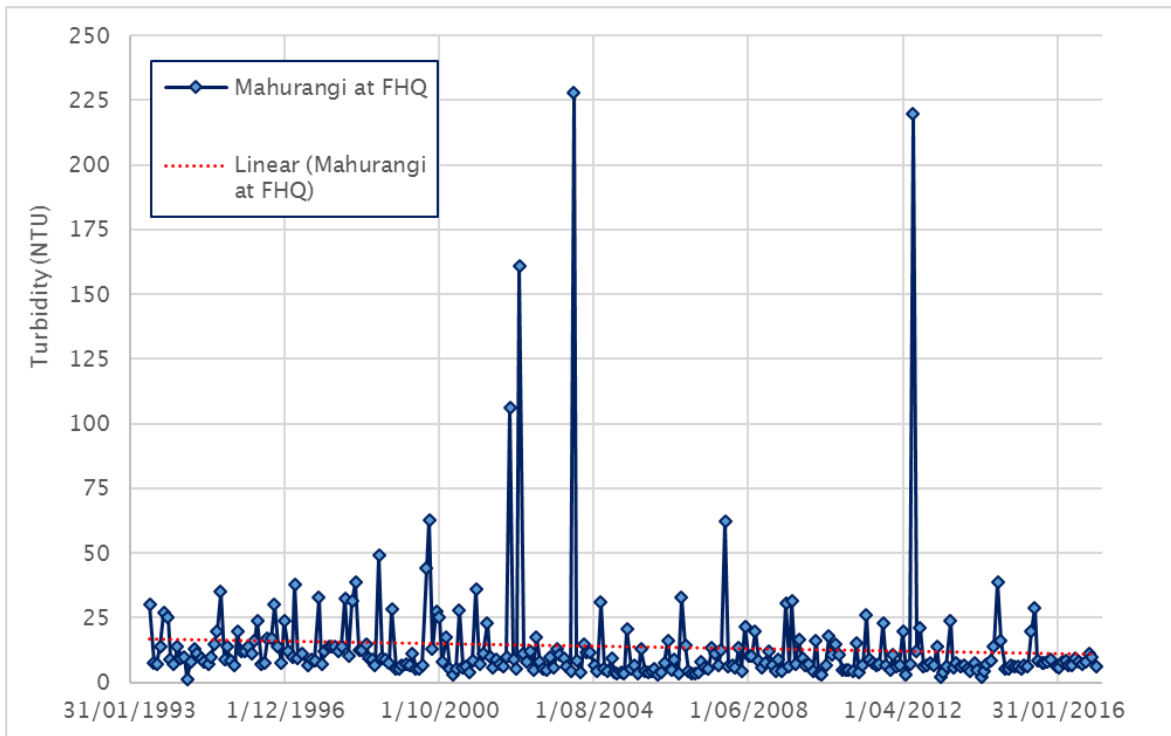
Figure 9 - Turbidity (NTU) at Mahurangi at FHQ from 1993 - 2016

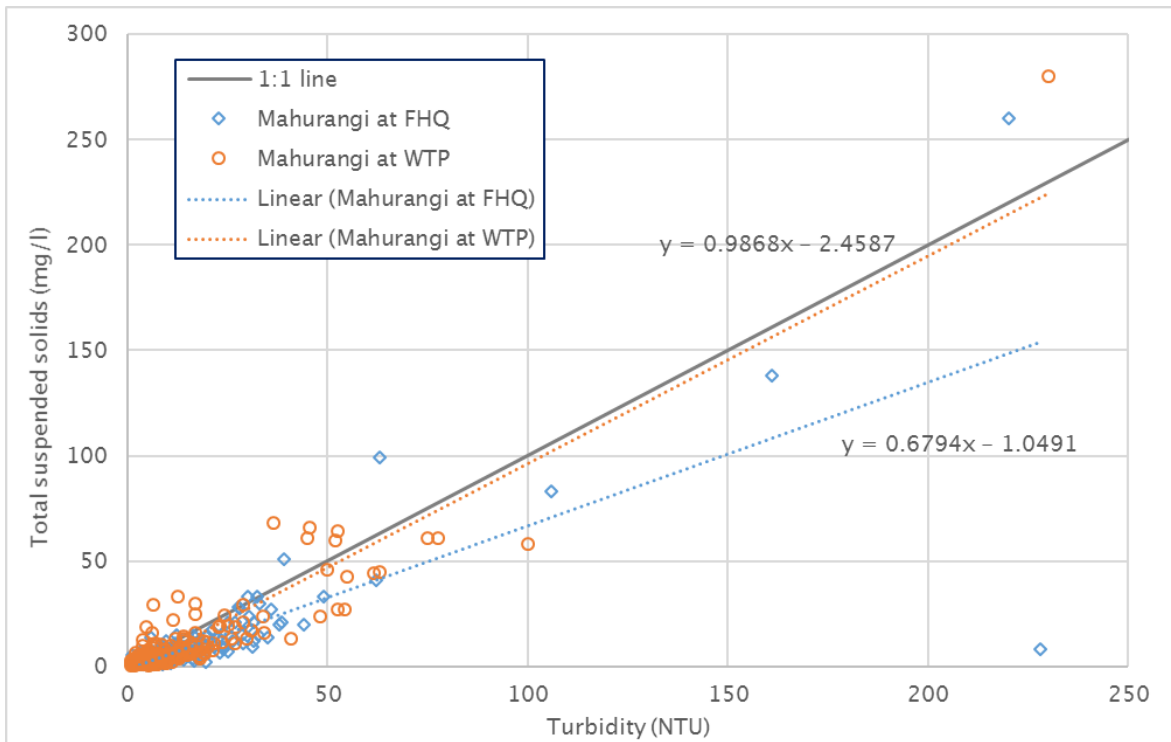
Figure 11 - Turbidity (NTU) vs total suspended solids (mg/L) for at Mahurangi at FHQ and Mahurangi at WTP

- The relationship of TSS and turbidity has been considered, and a linear relationship has been found for both the FHQ and WTP sites, which is approximately a 1:1 relationship at the WTP and 1:1.5 relationship (TSS: turbidity) at FHQ.

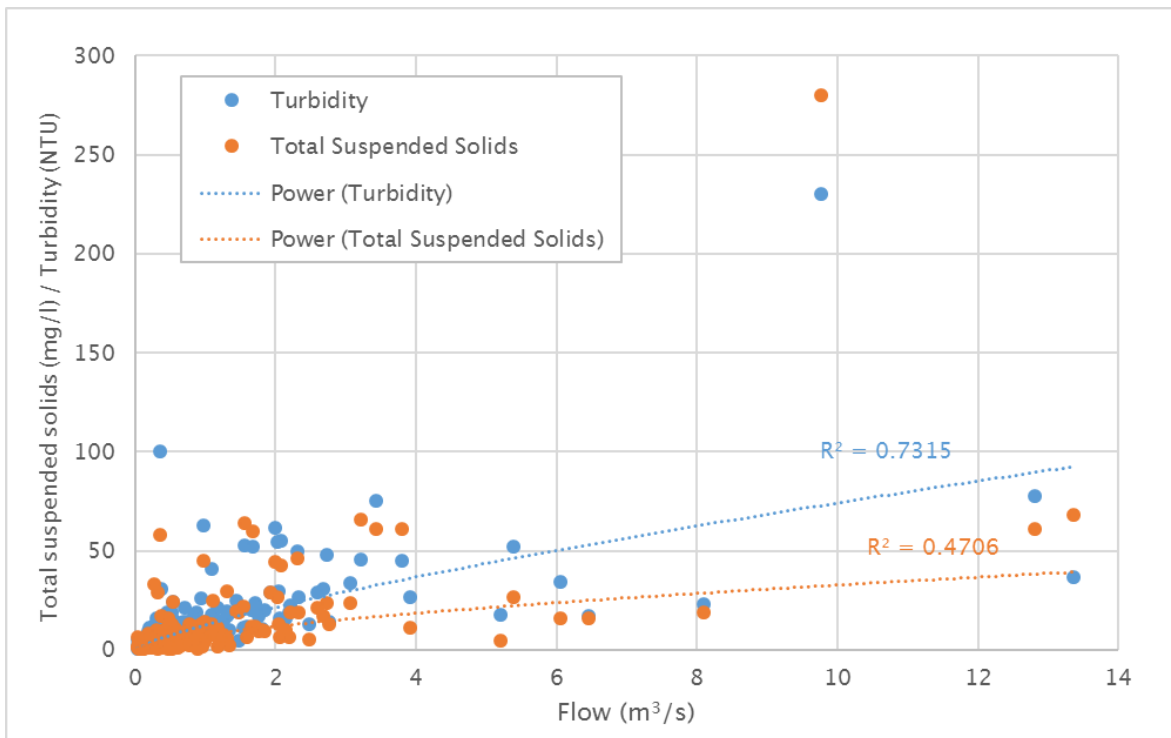
Figure 12 - Turbidity (NTU) and total suspended solids (mg/L) for at Mahurangi at WTP plotted against flow at Mahurangi at College

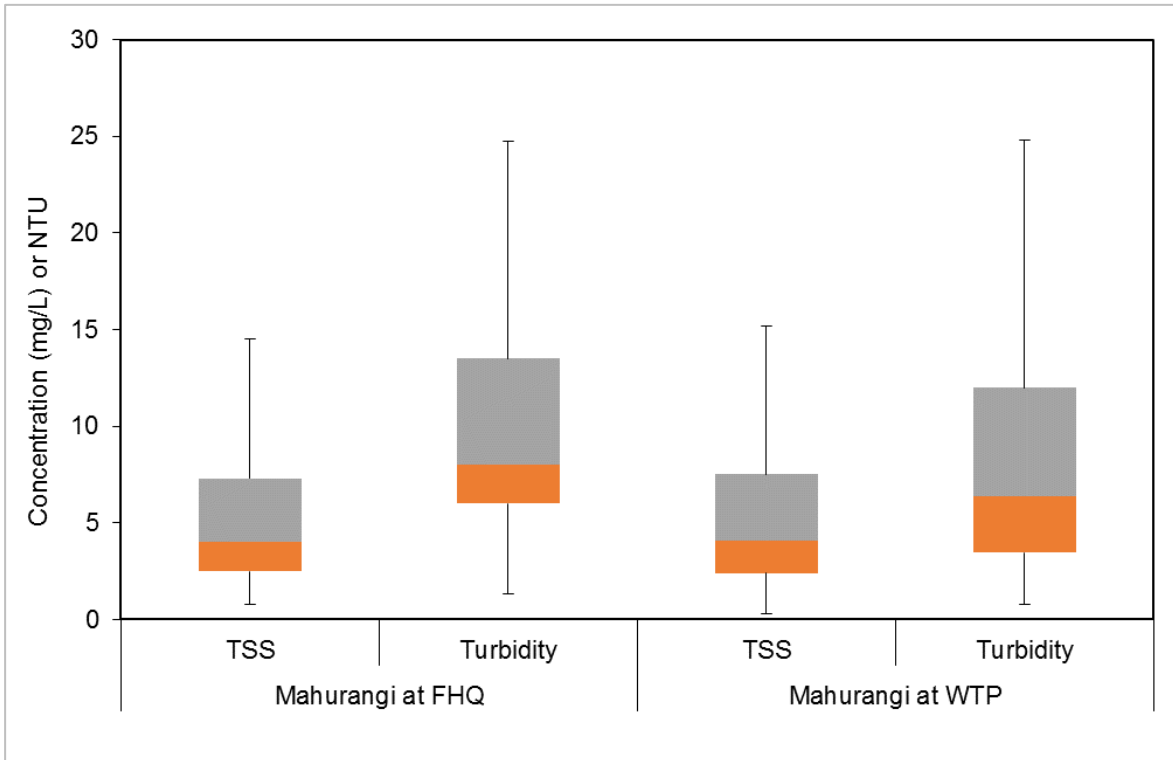
Figure 13 - Comparison of turbidity (NTU) and total suspended solids (mg/L) at Mahurangi FHQ and Mahurangi WTP

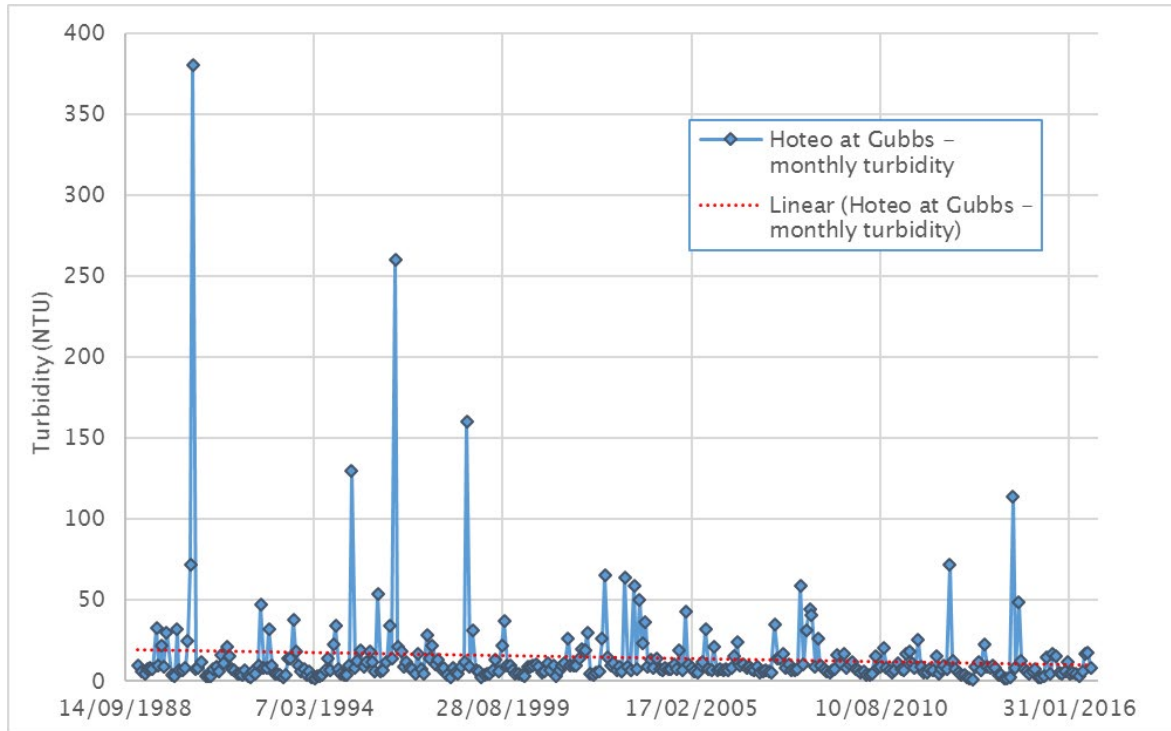
Figure 14 - Monthly turbidity (NTU) at Hōteō at Gubbs from 1989 - 2016

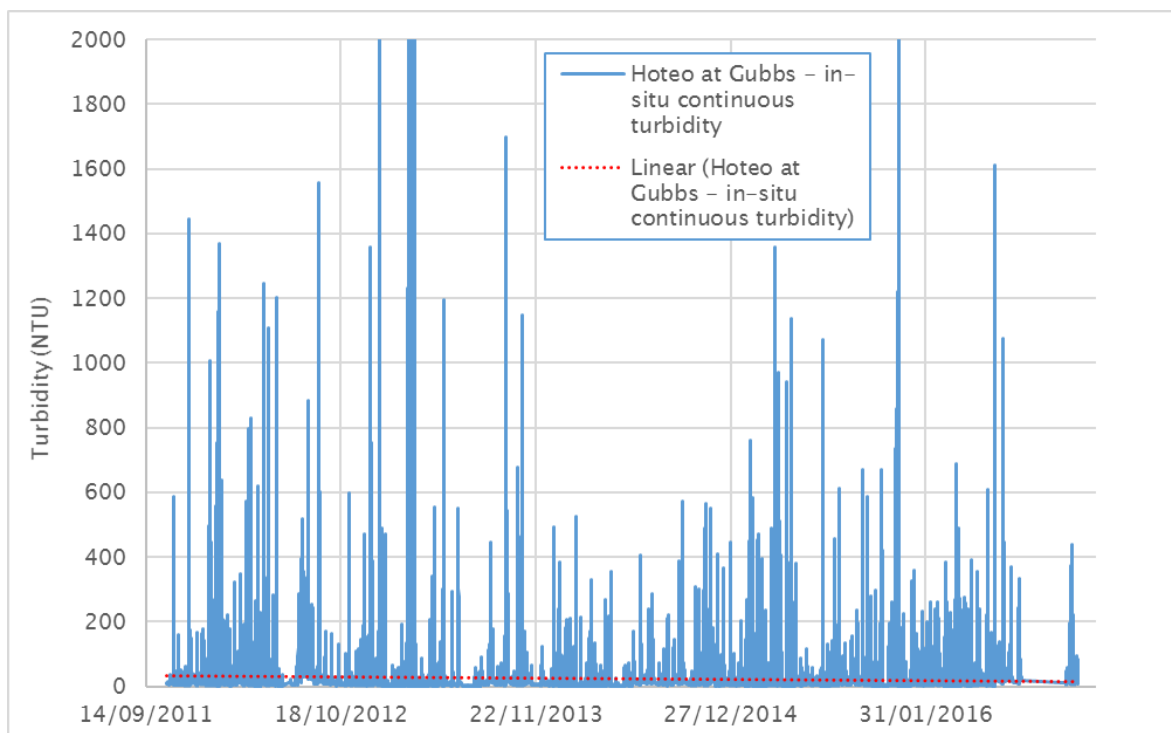
Figure 15 - Continuous in-situ turbidity (NTU) at Hōteō at Gubbs from 2011-2016 (Note: outliers above 1500NTU outside of the window, this is to aid data viewing)

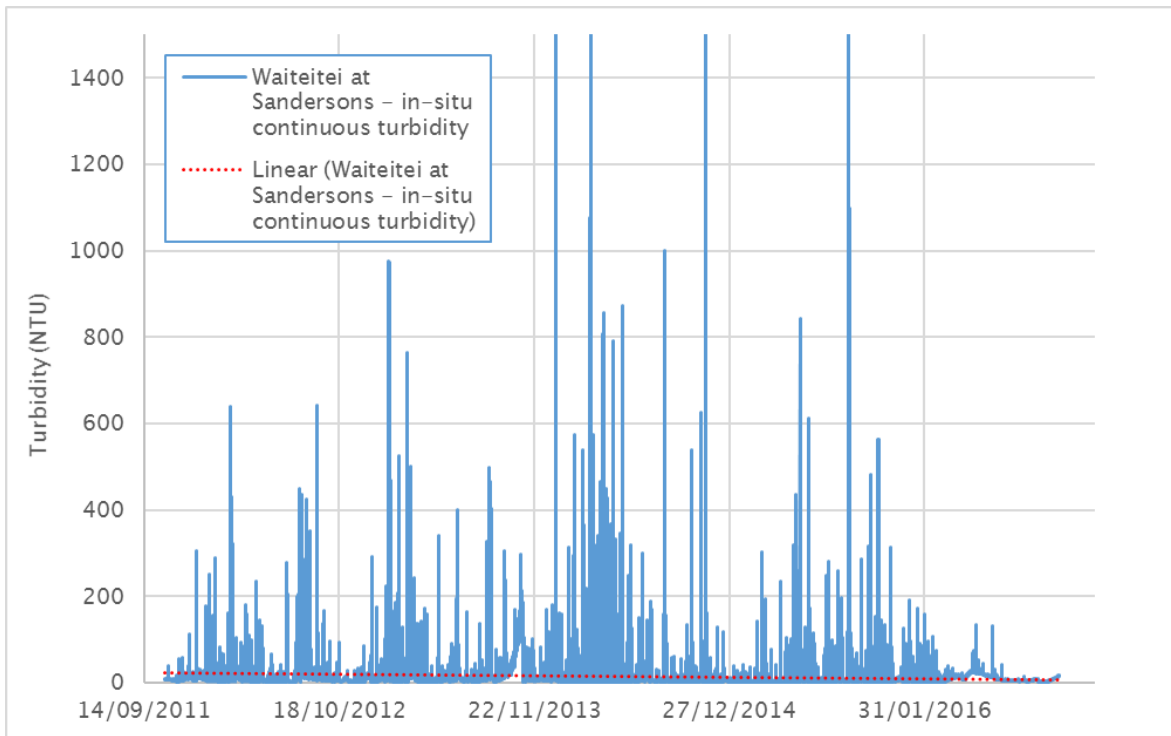
Figure 16 - Continuous in-situ turbidity (NTU) at Waiteitei at Sandersons from 2011-2016 ((Note: outliers above 1500NTU outside of the window, this is to aid data viewing)

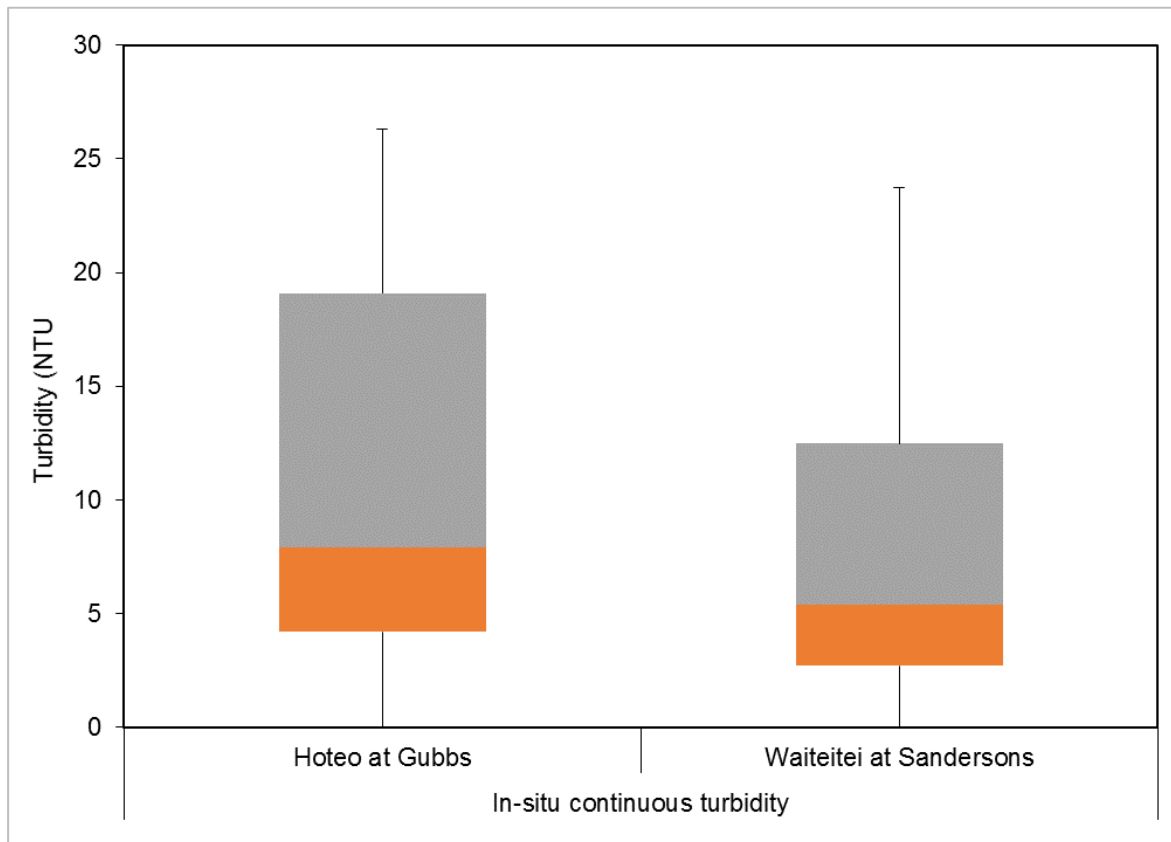
Figure 17 - Comparison of continuous in-situ turbidity (NTU) at Hōteo at Gubbs and Waiteitei at Sandersons

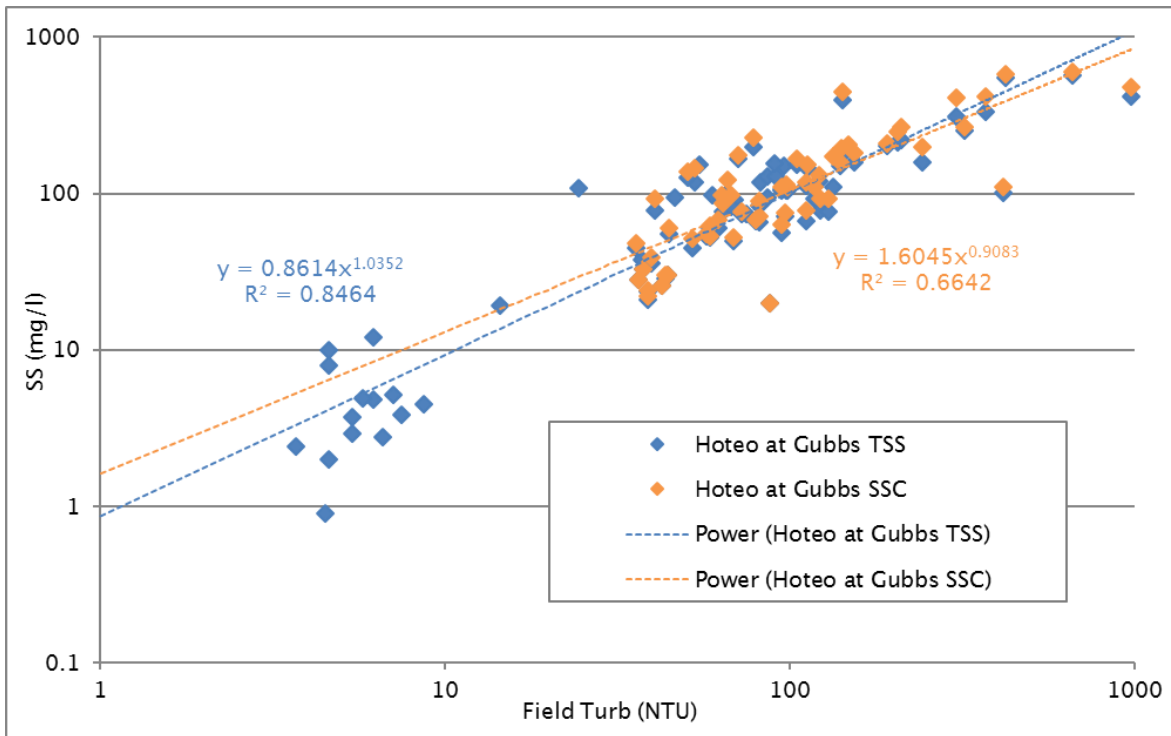
Figure 18 - Turbidity (NTU) vs total suspended solids (mg/L) and suspended sediment concentration (mg/L) for Hôteo at Gubbs (provided by NIWA 4 October 2017)

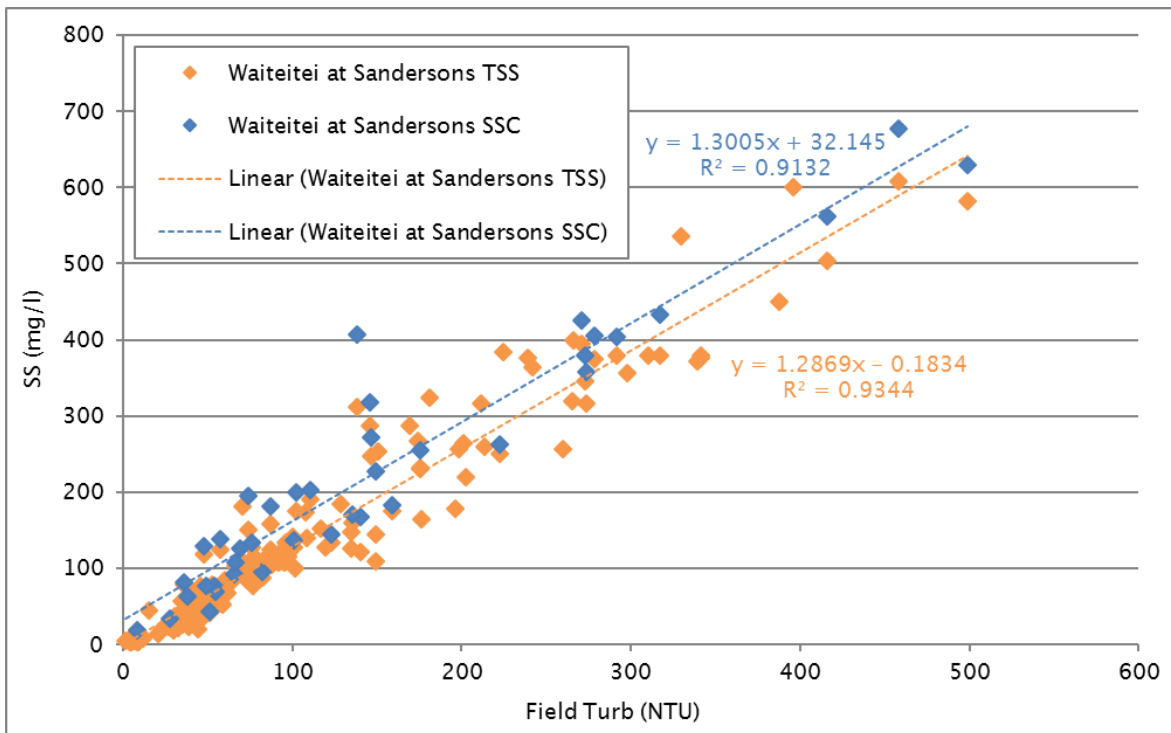
Figure 19 - Turbidity (NTU) vs total suspended solids (mg/L) and suspended sediment concentration (mg/L) for Waiteitei at Sandersons (provided by NIWA 4 October 2017)

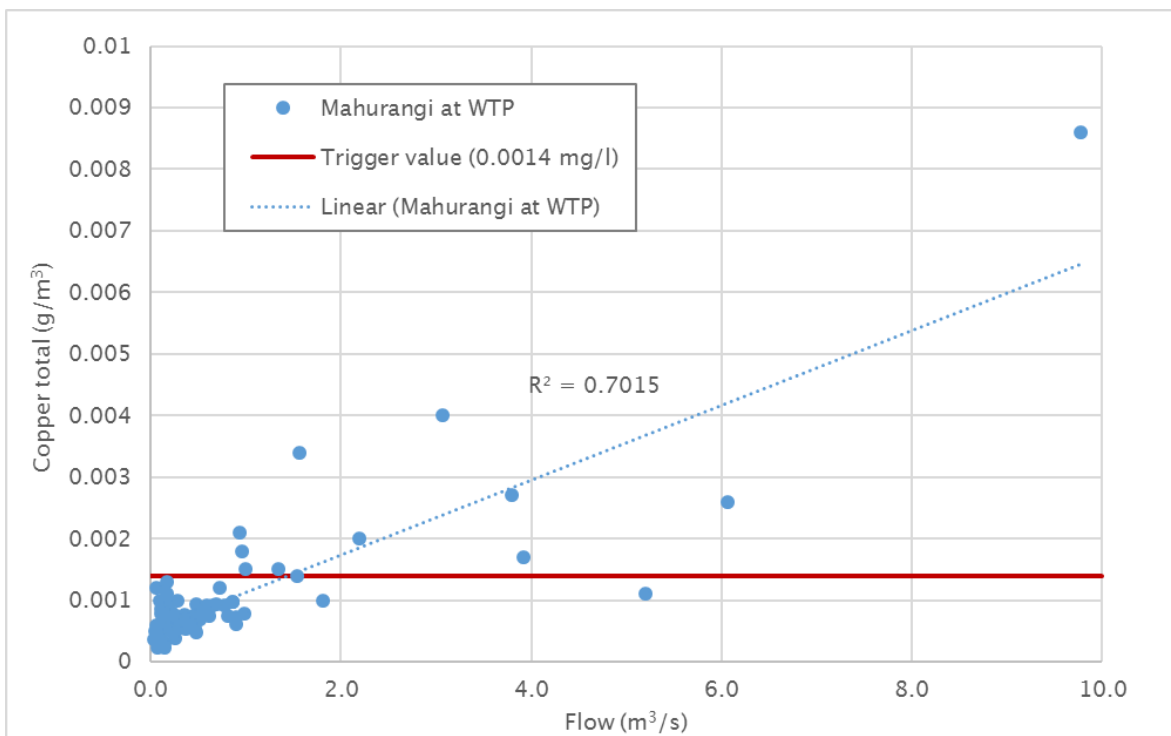
Figure 23 – Comparison of Total Copper concentration (mg/L) and daily flow (m^3/s) at Mahurangi at WTP

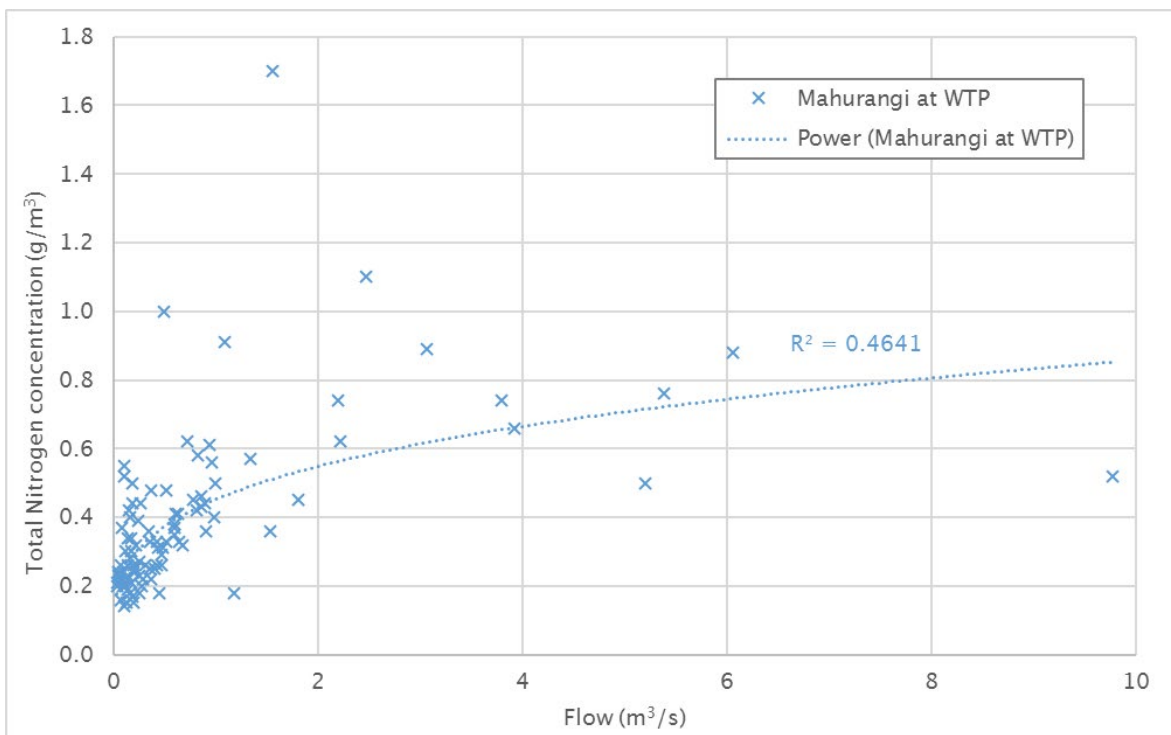
Figure 27 - Comparison of Total Nitrogen concentration (mg/L) and daily flow (m³/s) at Mahurangi at WTP

- Total nitrogen and flow were compared for Mahurangi at WTP and the Mahurangi at College site, and found that there is a weak correlation between the two ($R^2=0.464$) indicating that the concentration is likely due to land use as well as flow.

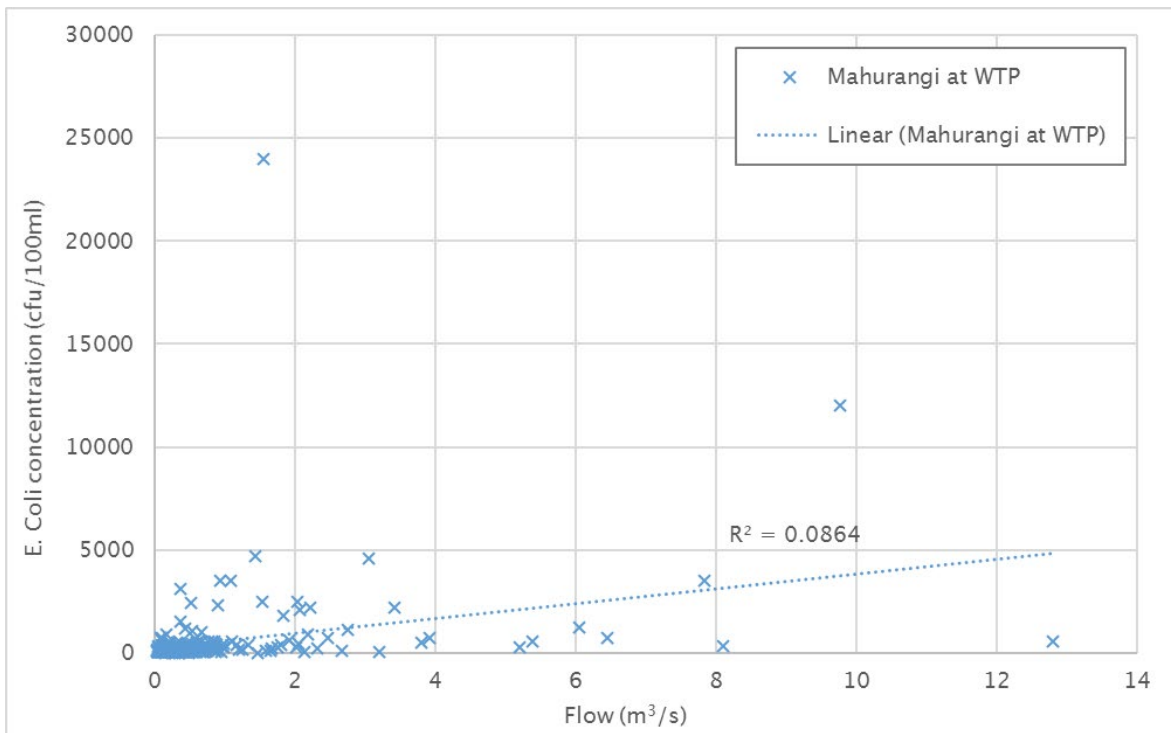
Figure 37 - Comparison of E. Coli concentration (cfu/100ml) and daily flow (m³/s) at Mahurangi at WTP

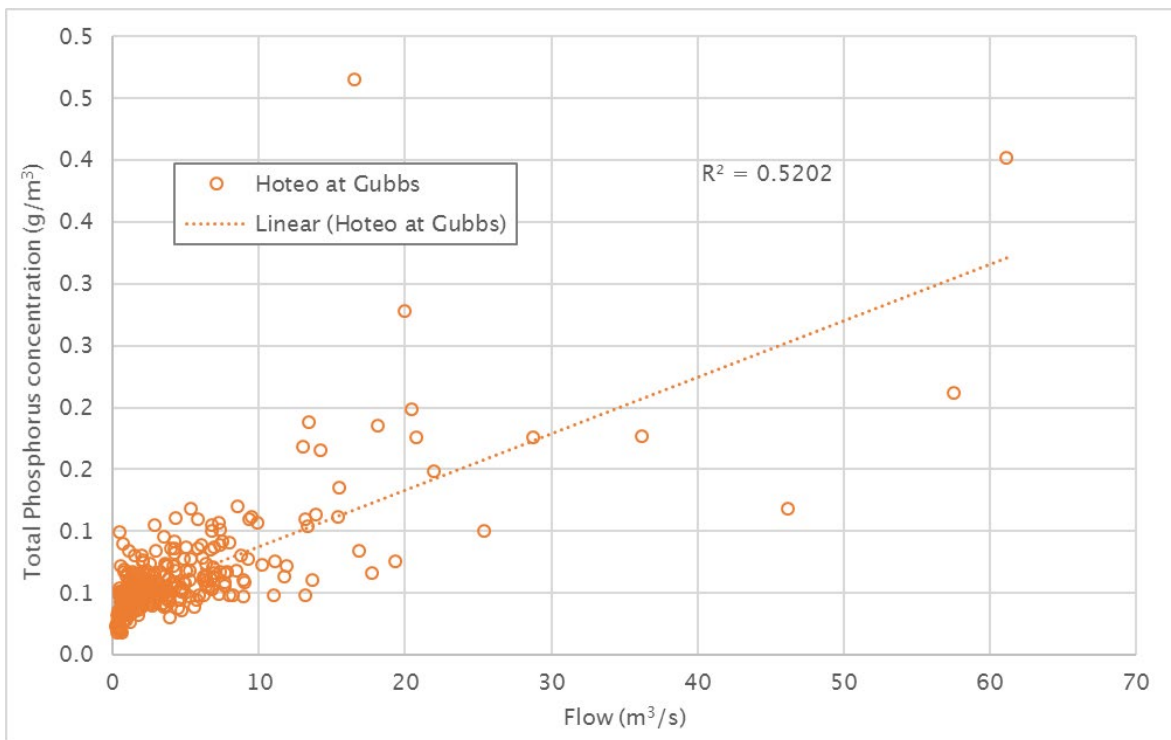
Figure 45 - Comparison of Total Phosphorus concentration (mg/L) and daily flow (m³/s) at Hōteo at Gubbs

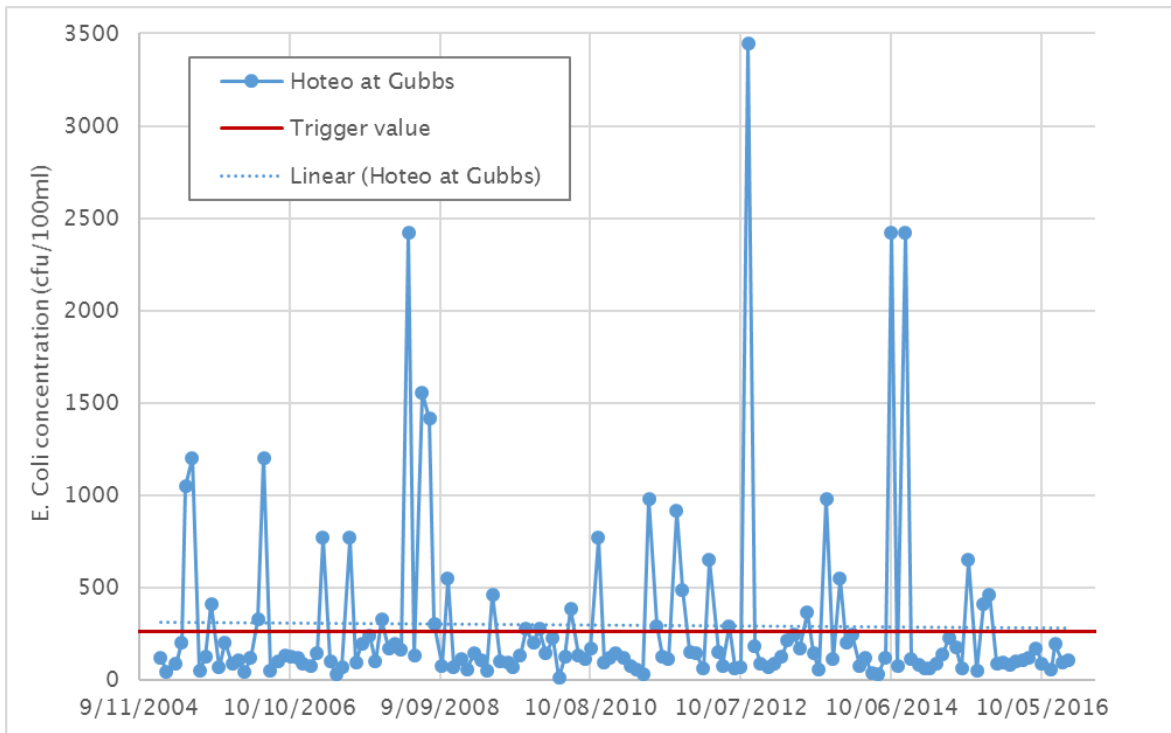
Figure 48 - E. Coli concentration (cfu/100ml) at Hôteo at Gubbs over time, including a comparison to ANZECC trigger value

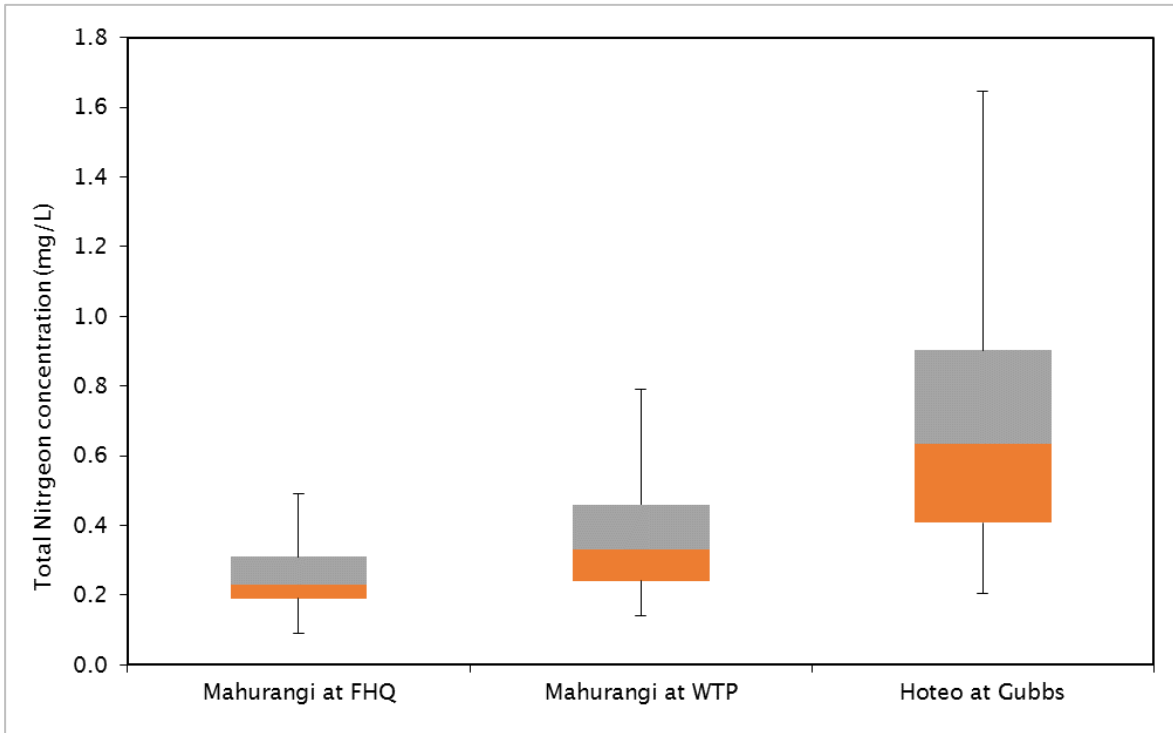
Figure 50 - Comparison of Total Nitrogen concentration (mg/L) at Mahurangi at FHQ, Mahurangi WTP and Hōteo at Gubbs

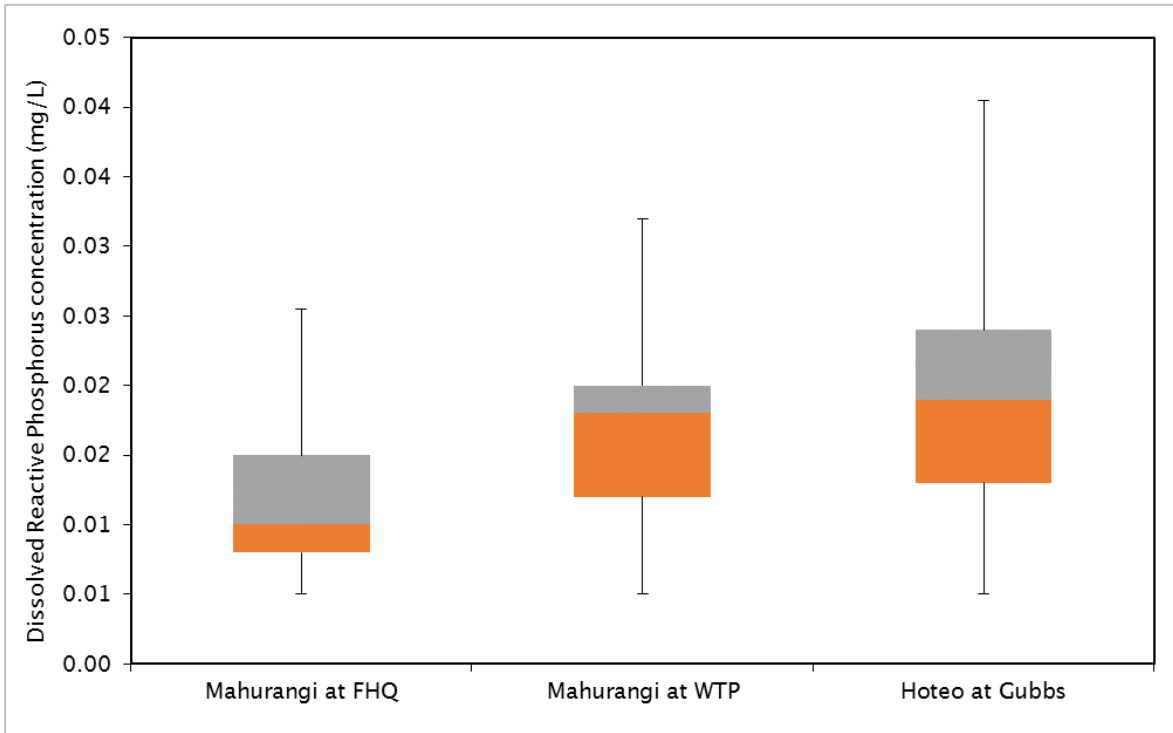
Figure 54 - Comparison of Dissolved Reactive Phosphorus concentration (mg/L) at Mahurangi at FHQ, Mahurangi WTP and Hôteo at Gubbs

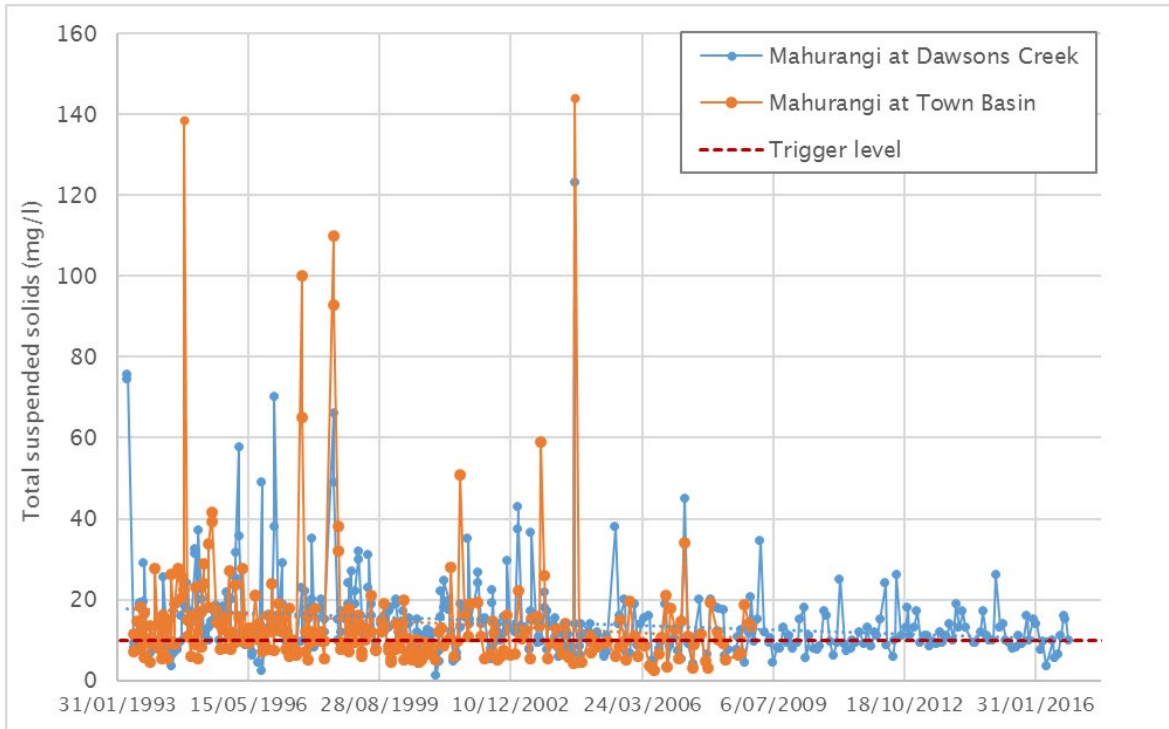
Figure 56 - Total Suspended Solids concentration (mg/L) at Mahurangi Harbour sites over time
