Client Auckland Transport
 Project Eastern Busway
 Project number 60644113

Project Eastern Busway
Location Reserve: 1R Burswood Drive

HOLE IDENTIFICATION	HA301
---------------------	--------------

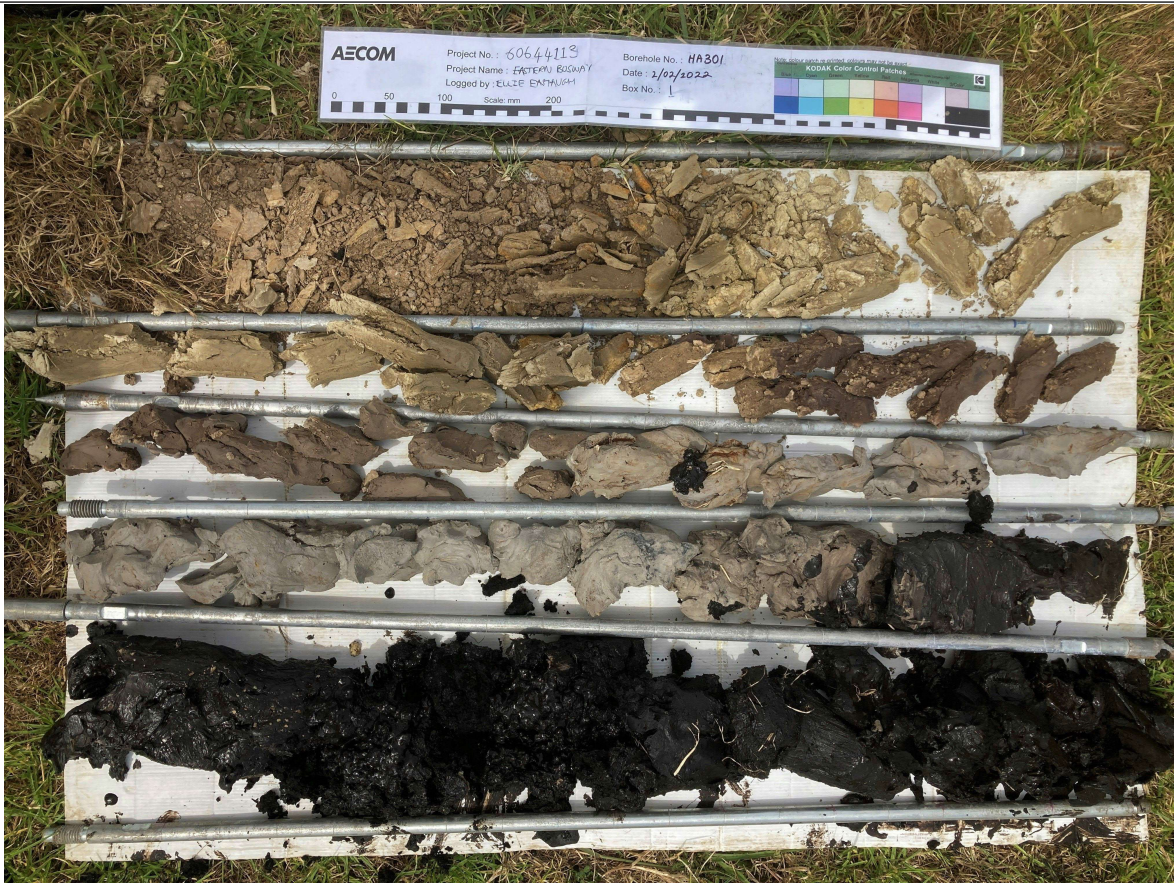
Depth: 00.00m to 05.00m
Date: 2/02/2022

0.1m: Fill comprising clay, silt and gravel.	207*			0.1m: Clayey SILT with trace fine to coarse gravel; light brownish grey. Hard, dry. Gravel is subangular basalt. 0.4 to 0.65m: Moist with orange mottling.				
1 TAURANGA GROUP	0.65m: Alluvium comprising silts, clays, organic clay and peat.	163/50		1	0.65m: Silty CLAY with trace rootlets and fine to medium gravel; light brownish grey. Very stiff, moist, moderate plasticity. Gravel is subangular basalt.				
		118/52		2					
		89/56		1	1.25 to 1.5m: Stiff.				
		109/44		2					
		118/71		2	1.6m: Silty CLAY with trace indistinct organics and rootlets; dark brownish grey. Very stiff, moist, high plasticity.				
		81/46		2					
		133/77		2	2.0 to 2.25m: Stiff.				
		103/72		2					
		2		74/59		1	2.5m: Silty CLAY; light grey streaked orange. Very stiff, moist, high plasticity.		
				59/52		2			
89/56				1	3.0 to 3.8m: Orange streaks cease.				
46/22				2

3		89/37		1	3.8 to 3.9m: Organic CLAY. Indistinct.				
		59/52		2					
		4				0	3.9m: Silty PEAT with minor clay; dark brownish black. Firm, wet, low plasticity. Amorphous.		
				0					
				0	4.2m: PEAT; black. Stiff, wet. Amorphous, plastic.				
				1					
5				1	4.5m: Silty PEAT with minor clay; black. Stiff, wet, low plasticity. Amorphous.				
				1					
				2	HA301 terminated at 5.0m				
				1					
				1					
6				1					
				1

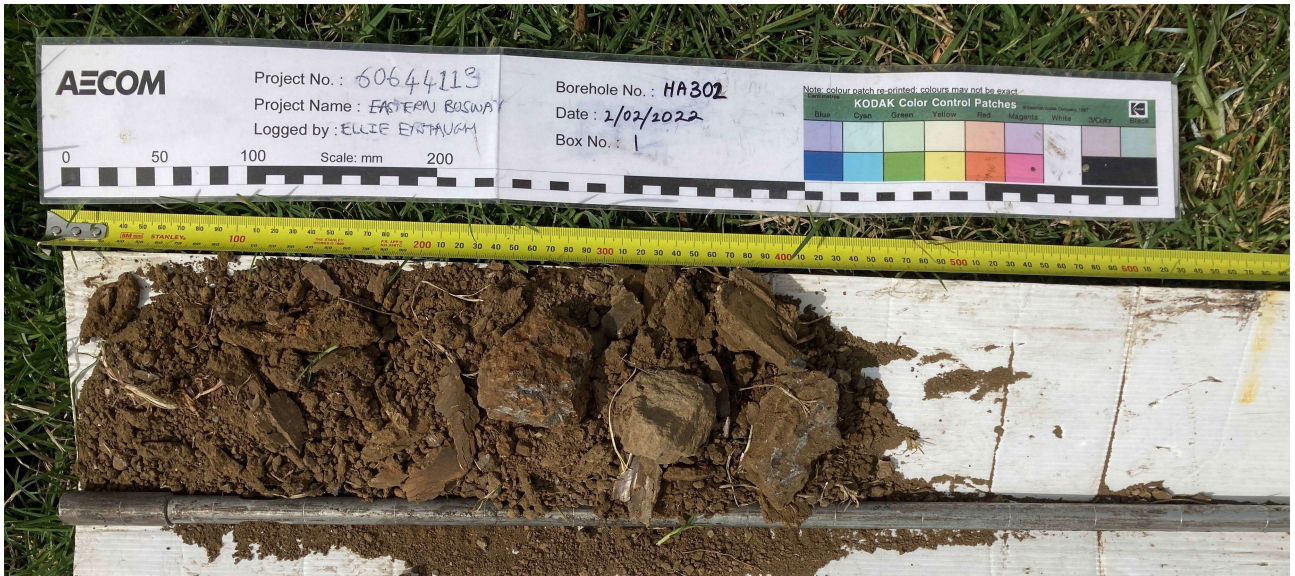
Depth: 00.00m to 00.40m
Date: 2/02/2022

Depth	GEOLOGICAL DESCRIPTION <small>Weathering, Colour, Fabric, ROCK NAME. Strength, Discontinuities, Lithological Features (bedding, foliation, mineralogy, cement, etc).</small>	Test Records		Sampling	Dynamic Cone Penetrometer (Blows per mm) 2 4 6 8	SOIL PROPERTIES <small>Subordinate MAJOR minor; colour, structure. Strength, moisture condition, grading, bedding, plasticity, sensitivity, major fraction description, subordinate fraction description, minor fraction description, additional structures, additional information, etc</small>	Graphic Log	Instrumentation	
		Shear Vane (kPa) <small>Residual - Peak</small>							Depth Related Remarks
FILL	0.0m: TOPSOIL	UTP	UTP			0.0m: Clayey SILT with minor rootlets; light brownish grey. Hard, dry, friable. 0.1m: Clayey SILT with some fine to coarse gravel and cobbles; greyish brown. Hard, moist. Gravel is subangular basalt and greywacke. HA302 terminated at 0.4m Unable to advance as too difficult to auger

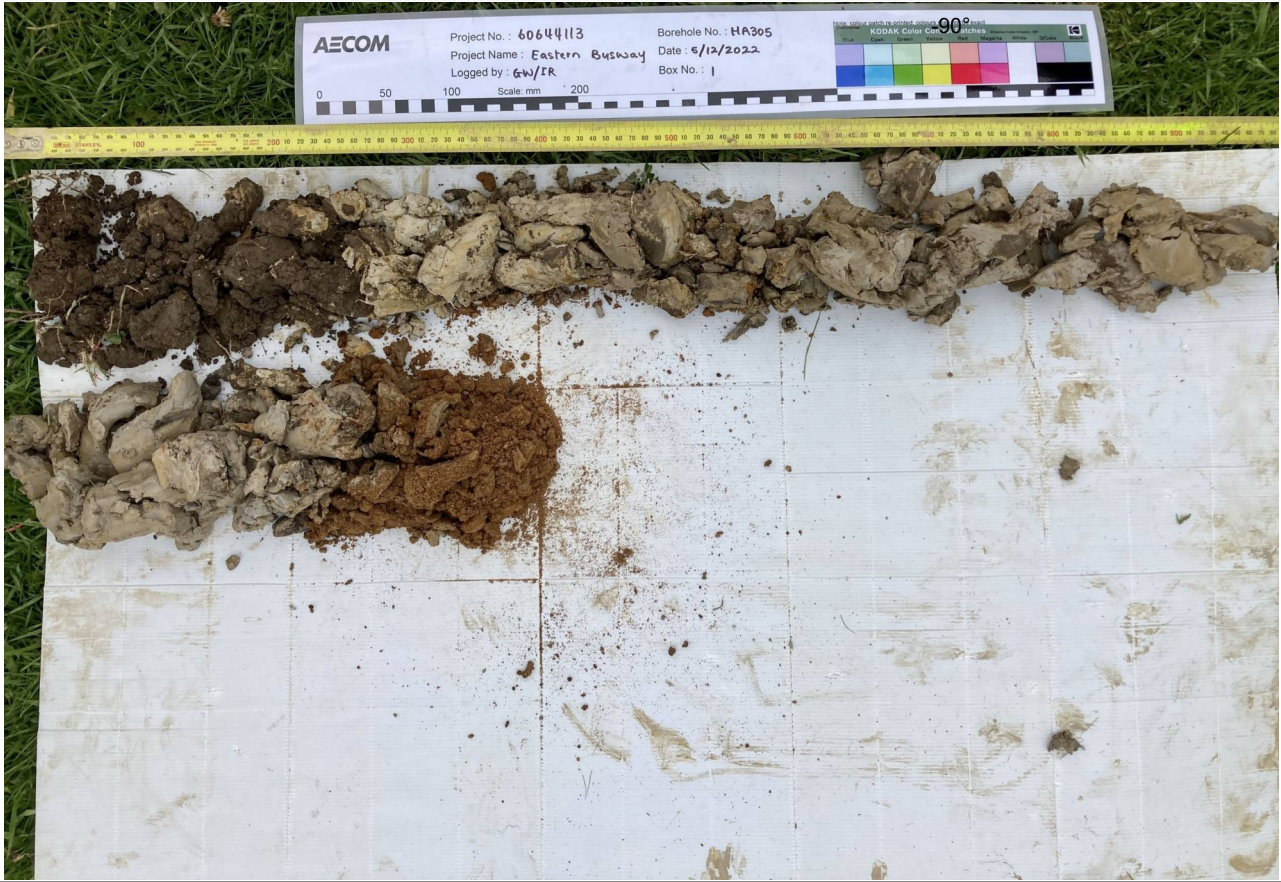
Depth: HA305 00.00m to 01.37m 0.00 to 1.37m
Date: 5/12/2022

TAURANGA GROUP	144/64		2	0.5 to 1.3m: Very stiff.

154/64		2				
		101/41		3				
		UTP		3	1.3 to 1.37m: Silty fine SAND with minor clay; reddish brown. Densely packed, moist. Slow dilatancy when water applied.

4	HA305 terminated at 1.37m Unable to advance due to an obstruction			
2				8				
3				6				
4								
<p><i>For explanation of symbols and observations, see key sheet</i></p> <p>GROUNDWATER OBSERVATIONS (m) Date Time Drilled Depth Casing Depth Fluid Depth</p> <p>Hand Held Shear Vane DR1980: 19mm (A). Calibrated Jun 2022: Correction Factor: 1.876 Vane shear strength per NZGS guideline</p>					<p>Remarks Obstruction at base of hole interpreted as basalt. Backfilled with cuttings upon completion. DCP undertaken in adjacent hole. No groundwater encountered. 225 kPa is the shear vane limit Horizontal / Vertical Survey Datums: NZGD2000 / Mount Eden 2000 / New Zealand Vertical Datum 2016</p>		<p>Started 05/12/2022 Finished 05/12/2022 Date logged 05/12/2022 Logged GS Checked GP</p>

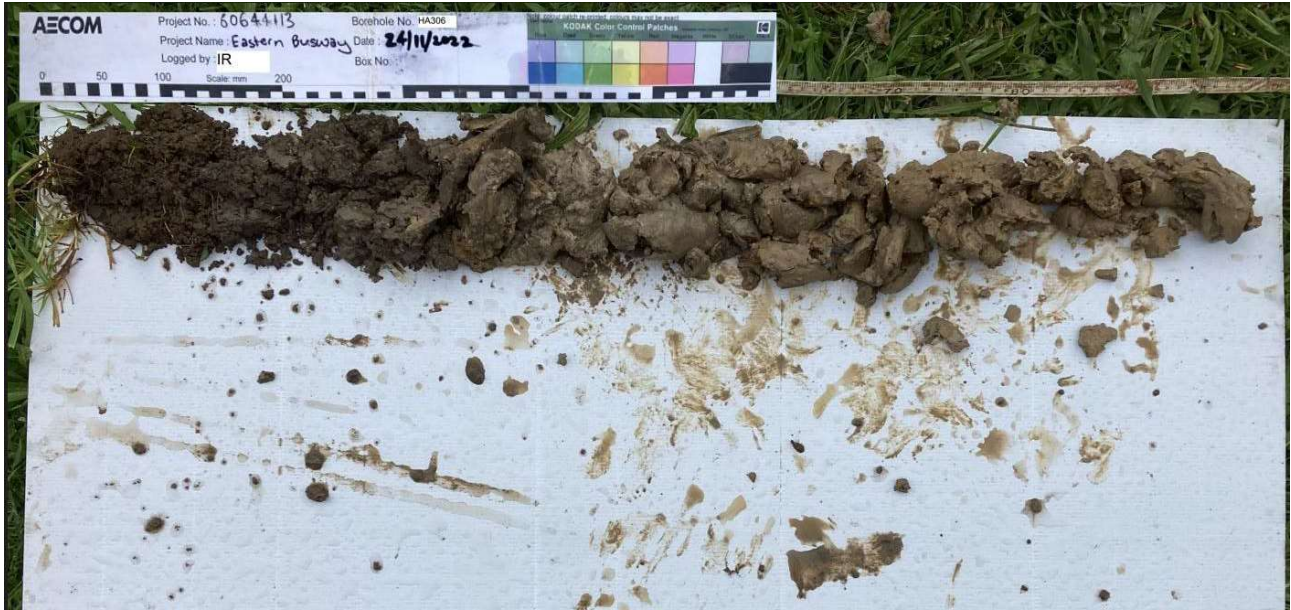
Box: 1 of 1 - Depth: 00.00m to 00.90m of 0.90m

0.3m: Alluvium comprising clay and silt.	98/15 165/49 191/109			0.3m: Silty CLAY; bluish light grey mottled orange. Stiff, wet, moderate plasticity. 0.5m: Becomes very stiff.		
	UTP				0.7m: Silty CLAY; bluish grey heavily mottled orangey brown. Very stiff, moist, high plasticity. 0.8 to 0.9m: Micaceous specks HA306 terminated at 0.9m Unable to advance due to practical refusal		
2							
3							
4							
<p><i>For explanation of symbols and observations, see key sheet</i></p> <p>GROUNDWATER OBSERVATIONS (m) Date Time Drilled Depth Casing Depth Fluid Depth 22/11/2022 15:08 00.90 - 0.74</p> <p>Hand Held Shear Vane DR1980: 19mm (A). Calibrated Jun 2022: Correction Factor: 1.876 <i>Vane shear strength per NZGS guideline</i></p>					<p>Remarks Termination due to practical refusal. Interpreted as being due to basalt lying beneath.</p> <p>Horizontal / Vertical Survey Datums: NZGD2000 - Mount Eden 2000 / New Zealand Vertical Datum 2016</p>		<p>Started 22/11/2022 Finished 22/11/2022 Date logged 22/11/2022 Logged IR Checked GP</p>
