Muriwai Downs: information request regarding Stream P3

We refer to the Section 92 letter dated 24 February 2022 from Auckland Council requesting further information on the Muriwai Golf Project at 670 Muriwai Road, Muriwai.

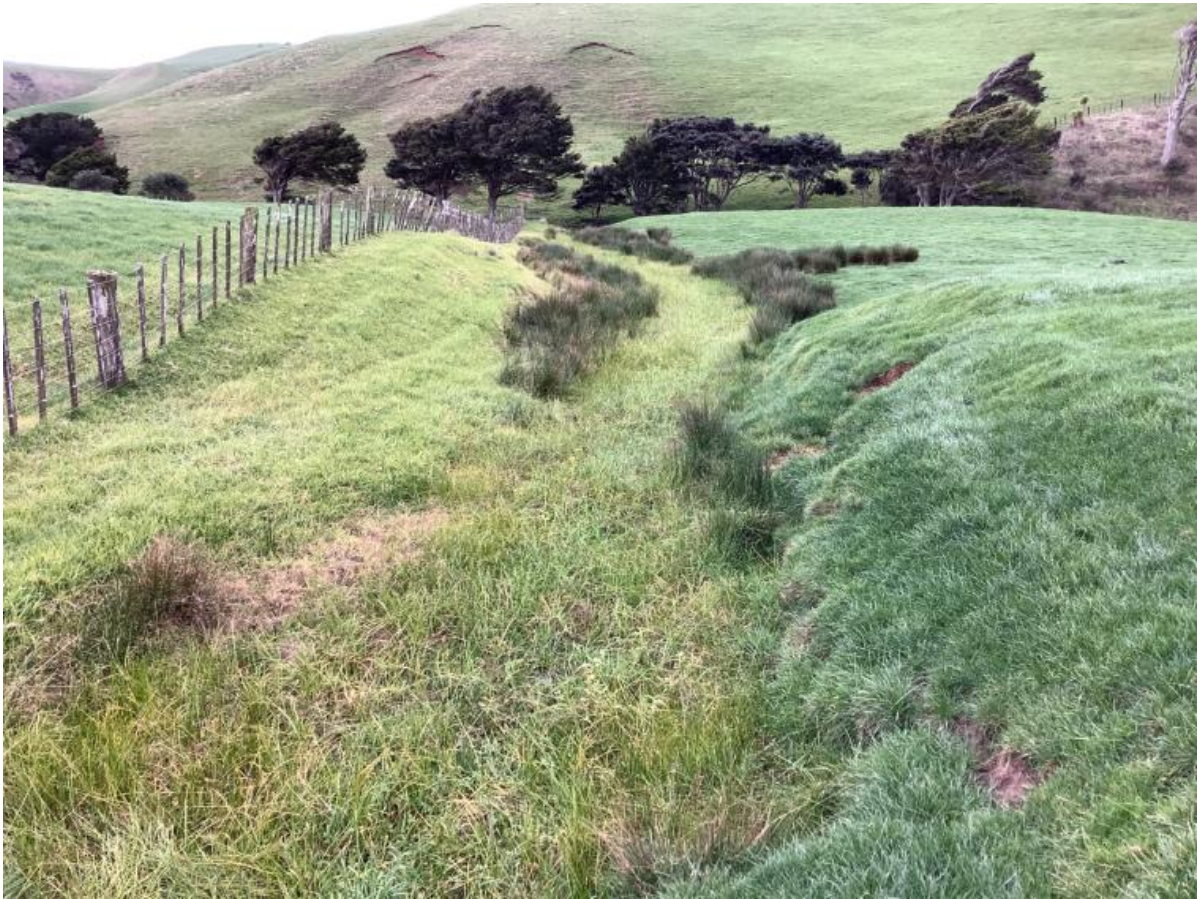
Plate 1. Stream P3 looking downstream. Photo taken July 2021 when *Isolepis* is dominant in the channel.

The stream channel currently supports a sediment/water slurry with flow paths through it. The banks are vertical and the margins support a narrow, 1-plant wide edge of soft rush and pasture grasses, before abruptly changing to ryegrass-clover dryland pasture grasses (**Plates 1 and 2**).

The vegetated margin supports a narrow band of soft rush and dryland pasture grasses (**Plates 1 and 2**). This band of vegetation is where we consider that a wetland could occur – in keeping with the composition of stream margins across most of the site. The margins of Stream P3 cannot be sampled using the NPS-FM stipulated methodology as a 2m x 2 m quadrat does not fit within the distinct community (it would spill over into dryland pasture community and stream channel). The stream margin comprises around 60 % soft rush with the balance as sweet vernal, ryegrass, Yorkshire fog, lotus and clover (i.e. a mix of facultative upland and facultative plant species).

This is not correct. There are parts of tributary streams where the stream margin vegetation that would qualify as a wetland is so narrow that it cannot meet the definition, or where qualifying wetland vegetation (and soils) are absent. Stream P3 does have wetland vegetation (as shown in **Plates 1 and 2**), however as discussed above, the soils do not qualify and the narrow form of the margin also does not qualify this as wetland. Other streams on the site have a mix of riverine qualifying wetlands, narrow non-qualifying wetland plants and pasture margins – Stream P3 is not special or different, apart from the degree of modification that it has experienced, and continues to experience from stock impacts.

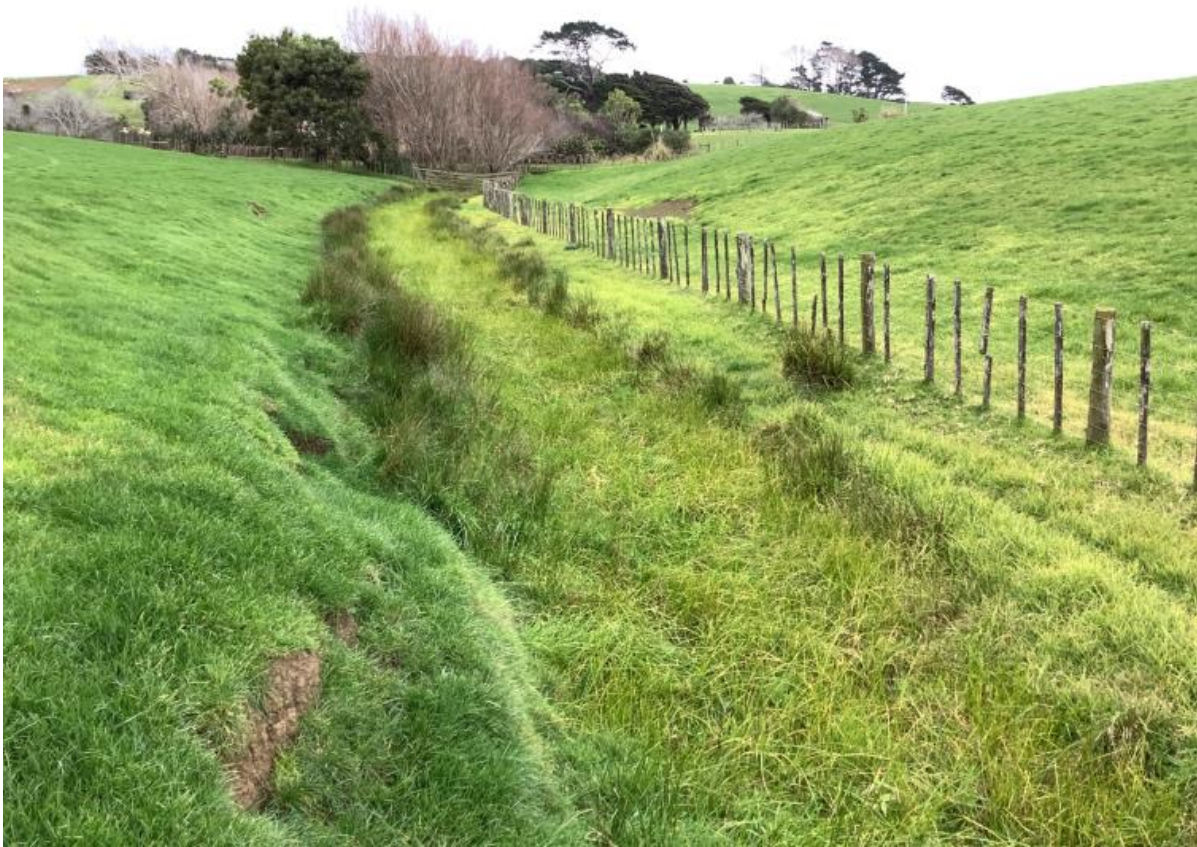
Plate 2. Stream P3 looking upstream. Photo taken July 2021 when *Isolepis* is dominant in the channel.
