Determination of Solid Density of Medium & Fine Soils - NZS 4402:1986 Test 2.7.2 (Vacuum)

Determination of the Particle Size Distribution

Determination of the Particle Size Distribution - NZS 4402:1986 Test 2.8.1 (Wet Sieve Method)
Determination of the Particle Size Distribution - NZS 4402:1986 Test 2.8.4 (Hydrometer Method)

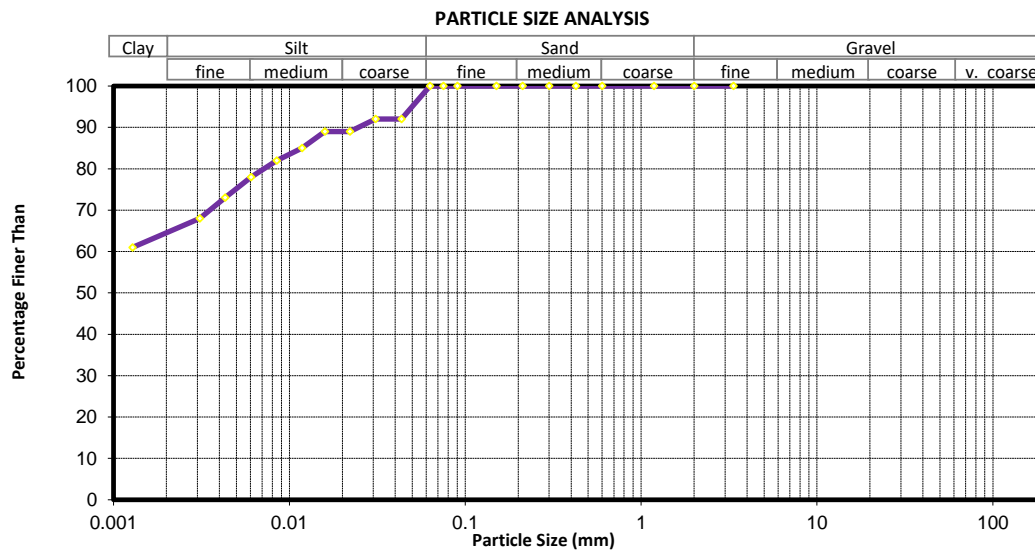
LOCATION	ID	DH306		
	Description	Eastern Busway 12		
	Data	N/A		
SAMPLE	Geotechnics ID	AKL377.1		
	Reference	-	Depth	6.0-6.5 m
	Description	silty CLAY with trace of sand and gravel, light orange brown with orange; soft, moist, high plasticity		
SPECIMEN	Reference	-	Depth	-
	Description	-

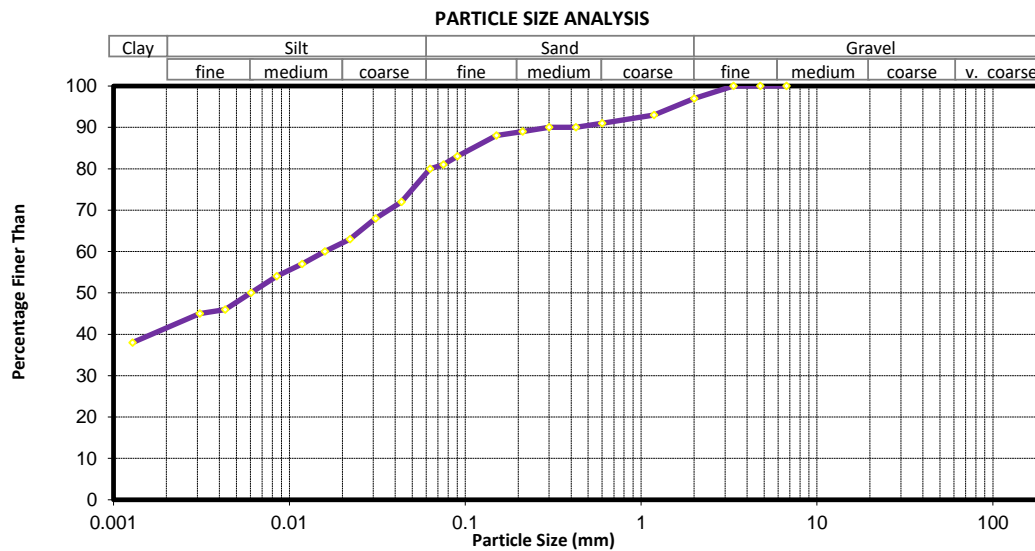
LOCATION	ID	DH314	
	Description	Eastern Busway 12	
	Data	N/A	
SAMPLE	Geotechnics ID	AKL377.4	
	Reference	-	Depth 1.75-2.25 m
	Description	silty CLAY with some sand and trace of gravel, dark orange brown with black; soft, moist, high plasticity	
SPECIMEN	Reference	-	Depth -
	Description	-

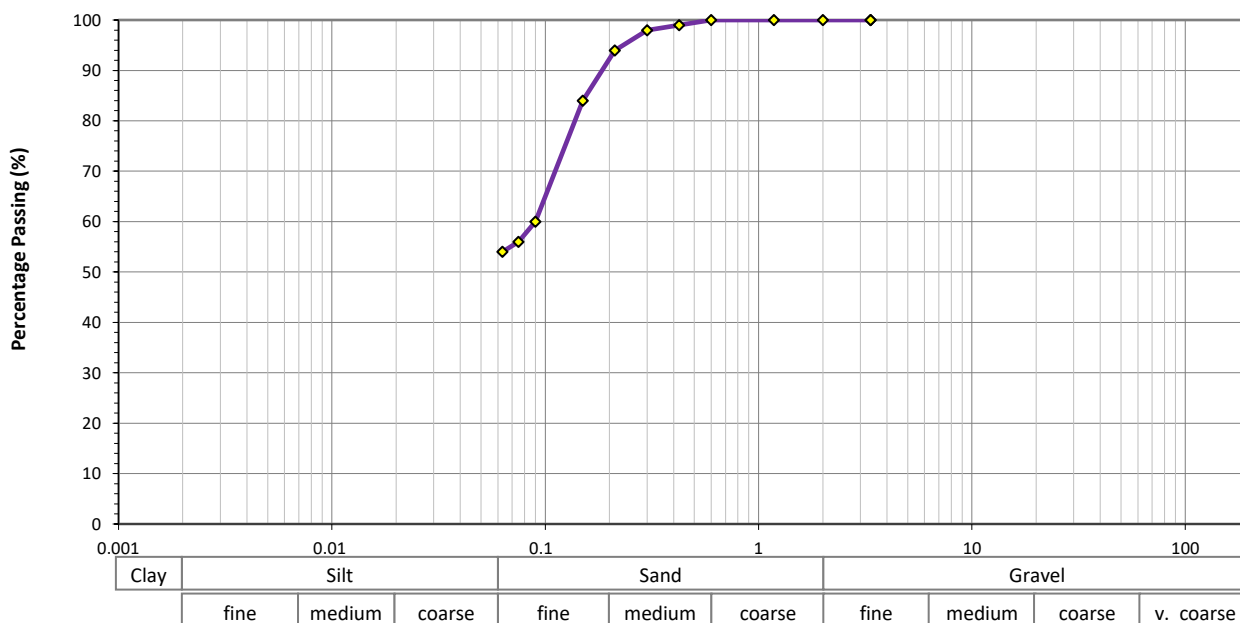
LOCATION	ID	DH325		
	Description	ALCOE-103		
	Data	N/A		
SAMPLE	Geotechnics ID	AKL106.1		
	Reference	-	Depth	4-4.5 m
	Description	silty SAND minor clay, light greyish brown; soft, moist, low plasticity		
SPECIMEN	Reference	-	Depth	-
	Description	-

Sample history : Tested as Received
Description: silty SAND minor clay, light greyish brown, soft, moist, low plasticity

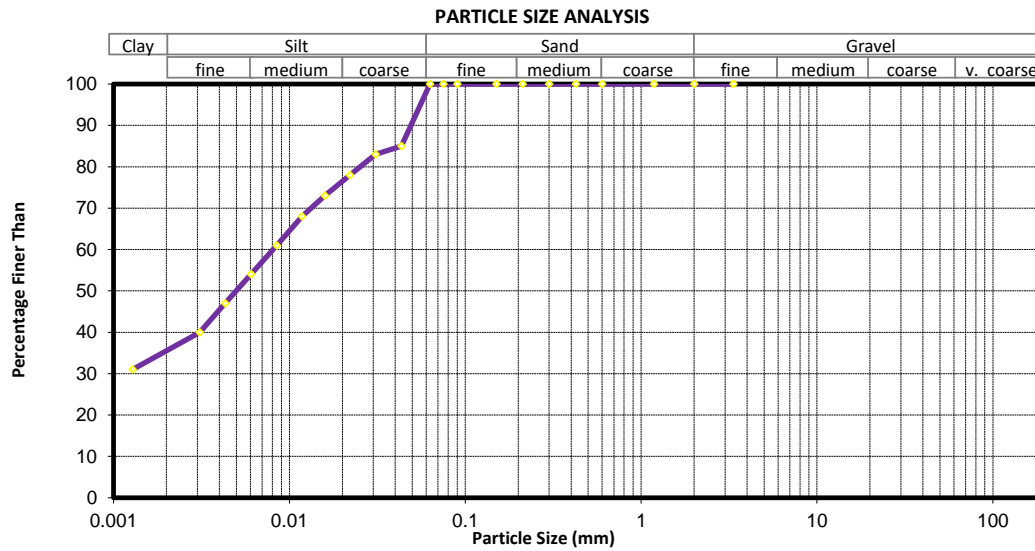
LOCATION	ID	DH329_P		
	Description	Eastern Busway 11		
	Data	N/A		
SAMPLE	Geotechnics ID	AKL371.6		
	Reference	-	Depth	7.0-7.5 m
	Description	clayey SILT with trace of sand and gravel, dark brownish grey with orange; firm, moist, high plasticity		
SPECIMEN	Reference	-	Depth	-
	Description	-

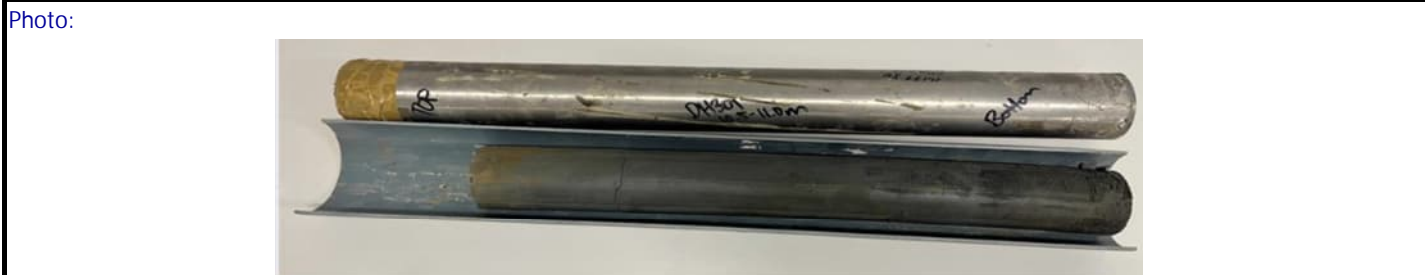
Location ID	Sample Reference	Depth (m)	Sampling tube		Vane Shear Strength (kPa)	
			Type	Diameter (mm)	Peak	Residual
DH301	--	10.56	Push tube	55	150	93

Soil description:
 10.56-10.90m: clayey SILT with a trace of sand, firm, dark grey with some brown; moist, high plasticity
 10.90-10.98m: clayey SILT with minor sand, firm, dark grey; moist, high plasticity

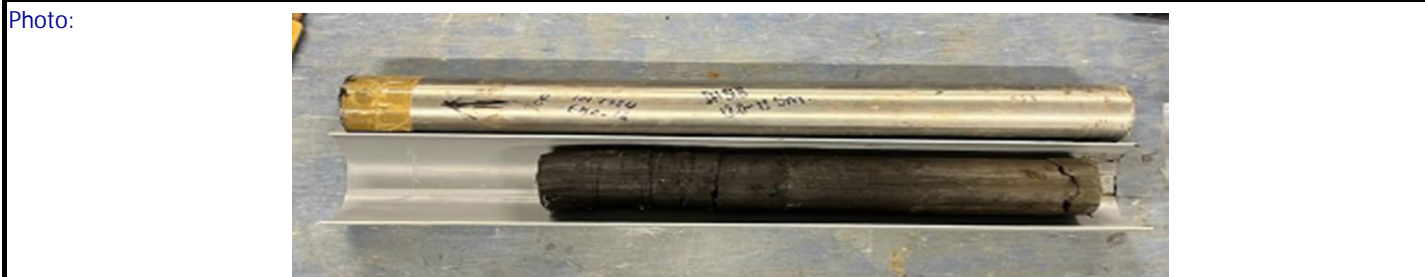
Location ID	Sample Reference	Depth (m)	Sampling tube		Vane Shear Strength (kPa)	
			Type	Diameter (mm)	Peak	Residual
DH318_P	--	12.4	Push tube	55	57	11

Soil description:
 12.34-12.46m: silty CLAY with some organics, soft, dark brownish grey; moist, high plasticity

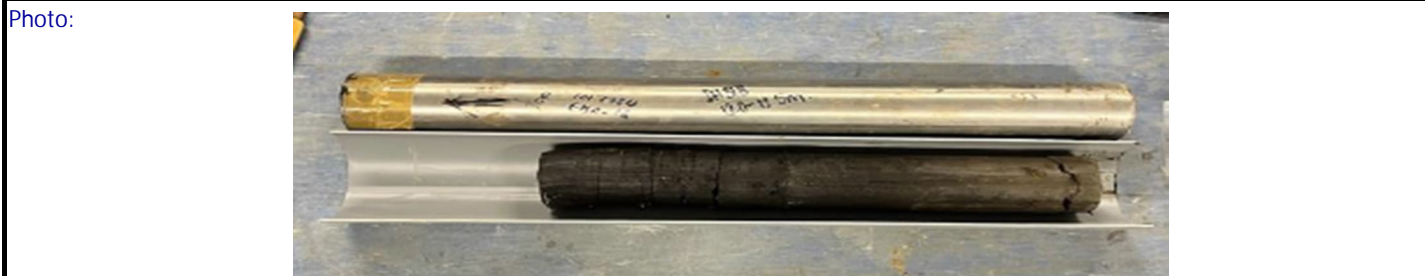
Location ID	Sample Reference	Depth (m)	Sampling tube		Vane Shear Strength (kPa)	
			Type	Diameter (mm)	Peak	Residual
DH318_P	--	12.08	Push tube	55	45	9.9

Soil description:
 12.04-12.34m: Organic silty CLAY, soft, black; moist, high plasticity

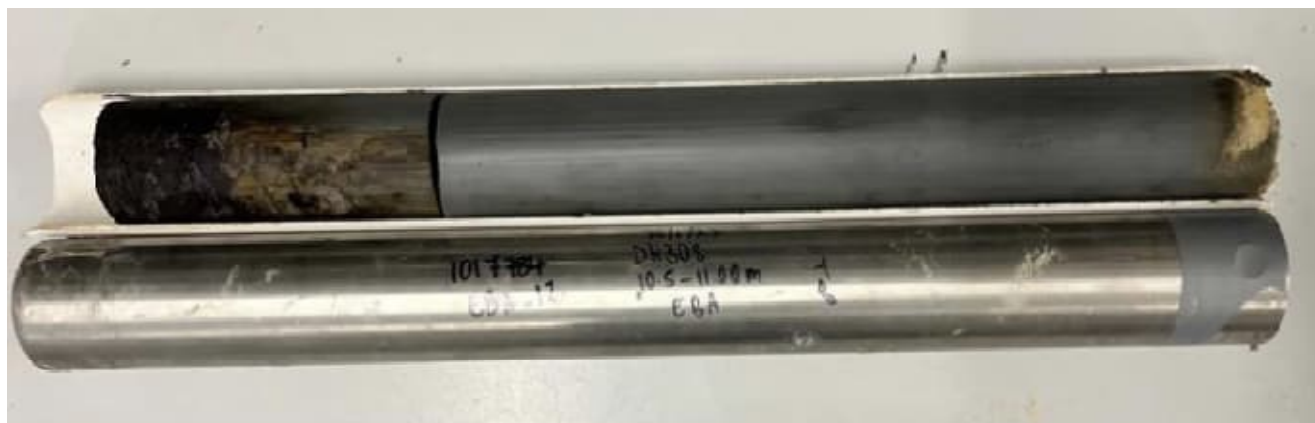
DH No.:		DH308
Depth	(m)	10.96m
Peak vane shear strength	(kPa)	149
Residual vane shear strength	(kPa)	22

10.5-10.83m: silty CLAY, firm to soft, blueish dark grey; moist, extremely high plasticity

10.83-10.93: Clayey SILT with minor organic inclusions, firm, brown with grey; moist, high plasticity

10.93-10.99m: Organic clayey SILT, firm, black; high plasticity, moist

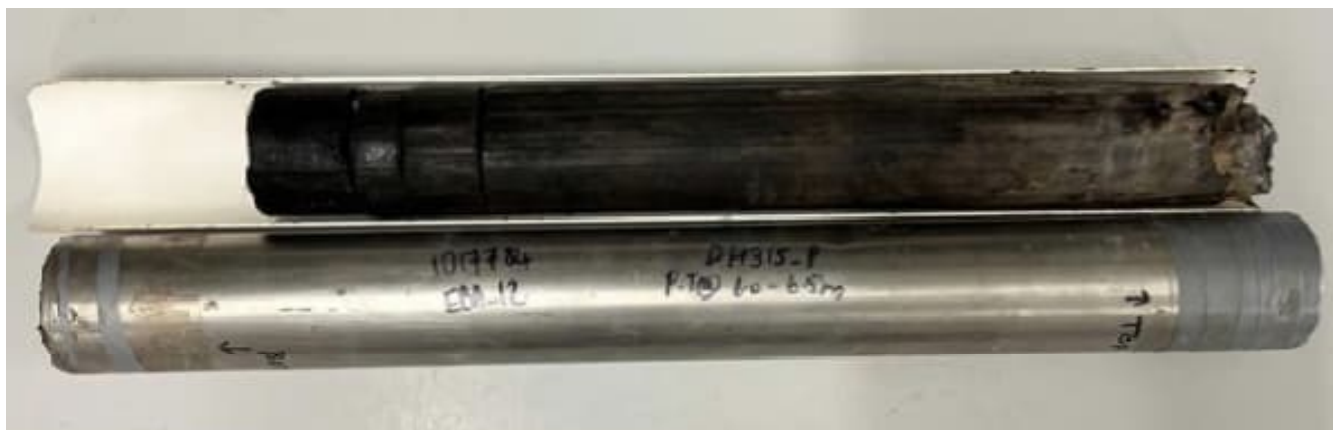
DH No.:		DH315_P
Depth	(m)	6.36m
Peak vane shear strength	(kPa)	56
Residual vane shear strength	(kPa)	12

6.0-6.22m: Clayey SILT with minor sand, soft, mottled grey and black with orange; moist, high plasticity

6.22-6.50m: Organic clayey SILT, soft, blackish brown; moist, extremely high plasticity

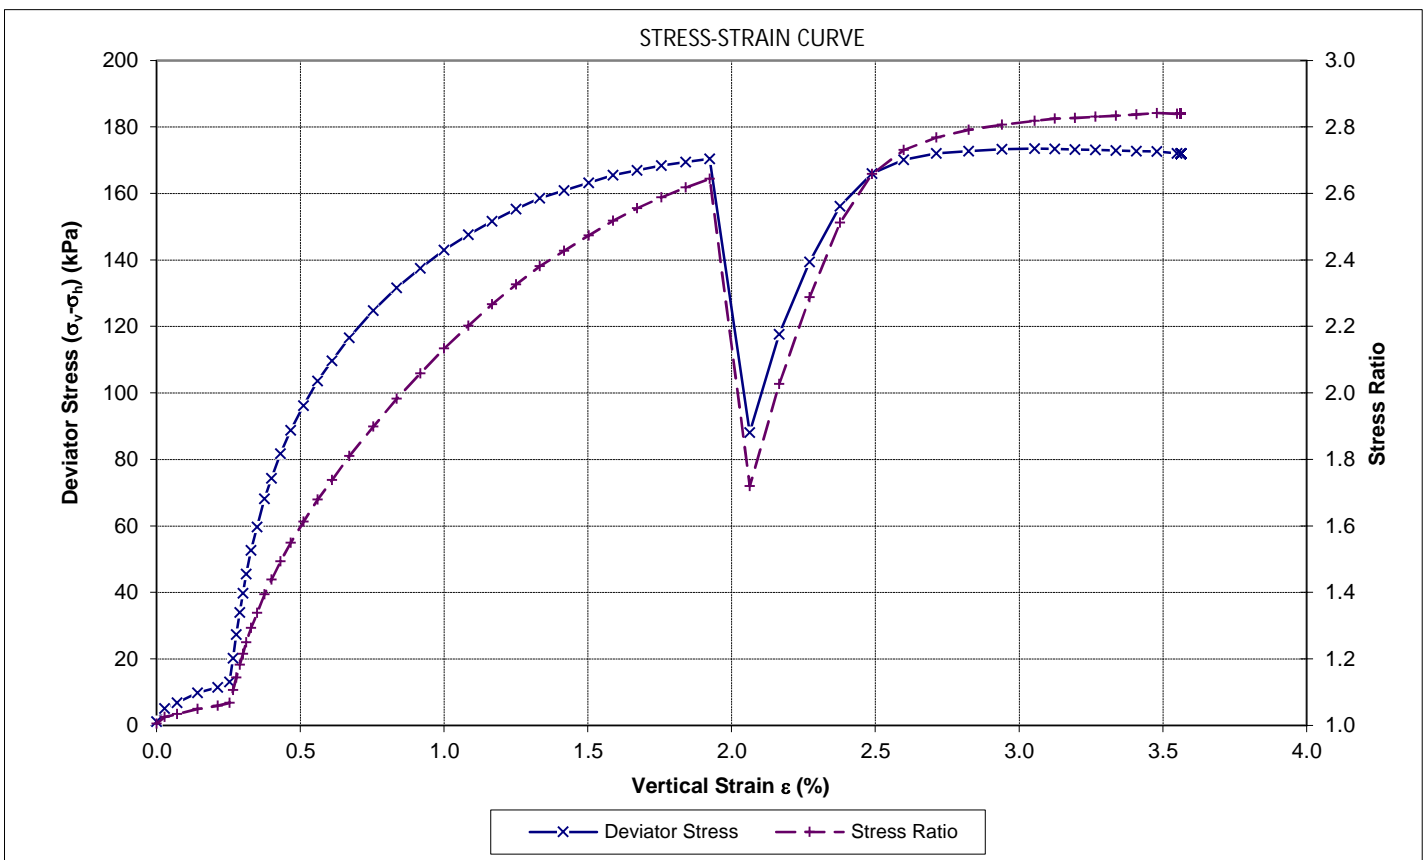
STAGE 3 GRAPHS

Site: Eastern Busway Location ID: DH301
 Sample Ref.: -- Depth: 4.89-4.99 (m)
 Test method used: ISO 17892-9:2018 Part 9 Isotropic consolidated-undrained triaxial compression test on water saturated soils (CIU)
 NZS 4402:1986 Test 2.1 Determination of Water Content

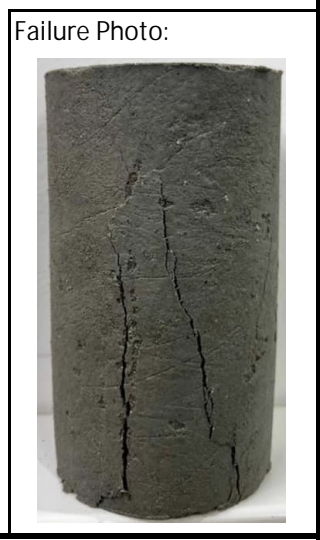
Soil Description: SILTSTONE, extremely weak, dark brownish grey

Test Remarks: Unconfined Compressive Strength reported to the nearest 1 kPa.
 The test is not IANZ accredited.

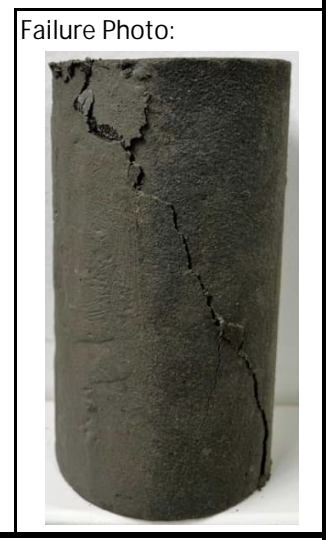
Soil Description: SANDSTONE, very weak, dark grey

Test Remarks: Unconfined Compressive Strength reported to the nearest 1 kPa.
The test is not IANZ accredited.

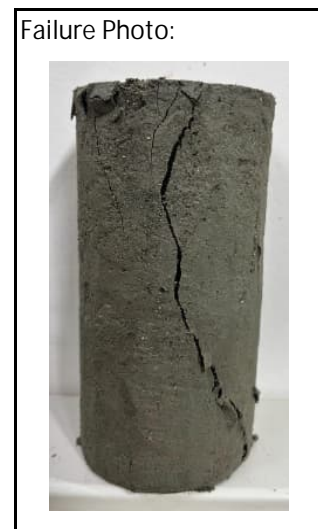
Soil Description: slightly weathered SANDSTONE, very weak, dark brownish grey.

Test Remarks: Unconfined Compressive Strength reported to the nearest 1 kPa.
 The test is not IANZ accredited.

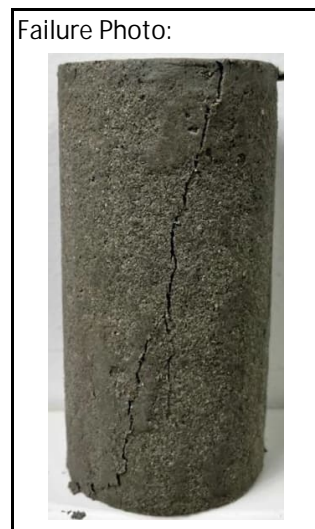
Soil Description: SANDSTONE, very weak, dark grey

Test Remarks: Unconfined Compressive Strength reported to the nearest 1 kPa.
The test is not IANZ accredited.

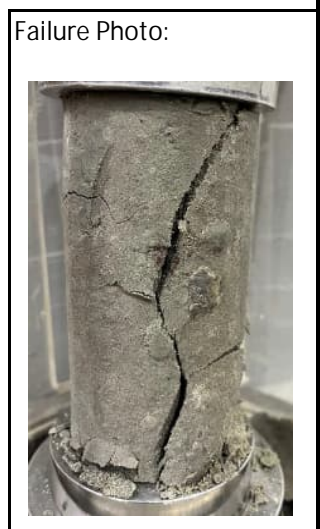
Soil Description: SANDSTONE, very weak, light grey.

Test Remarks: Unconfined Compressive Strength reported to the nearest 1 kPa.
The test is not IANZ accredited.

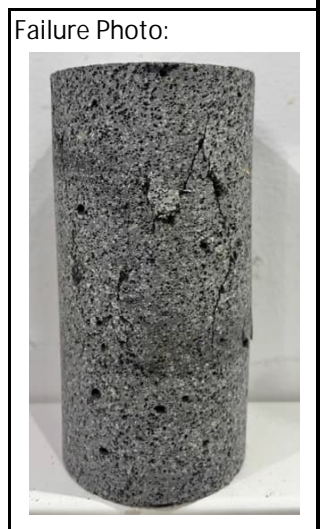
Soil Description: BASALT, slightly weathered, strong, light grey and black; highly vesicular.

Test Remarks: Unconfined Compressive Strength reported to the nearest 1 kPa.
 The test is not IANZ accredited.

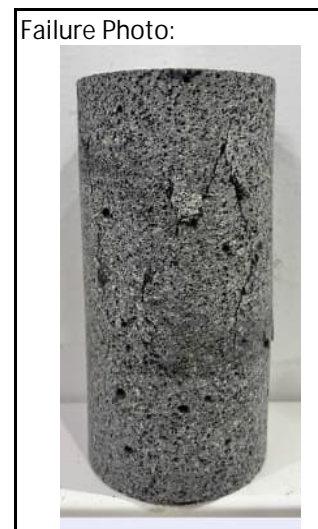
Soil Description: slightly weathered BASALT, strong, light grey; slightly vesicular.

Test Remarks: Unconfined Compressive Strength reported to the nearest 1 kPa.
The test is not IANZ accredited.

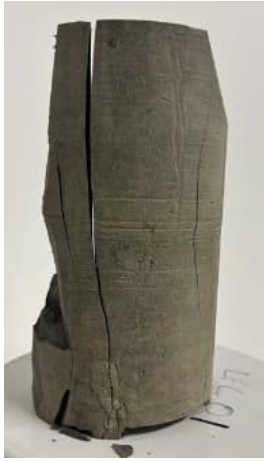
Failure Photo:

Test Remarks: Unconfined Compressive Strength reported to the nearest 1 kPa. The test is not IANZ accredited.

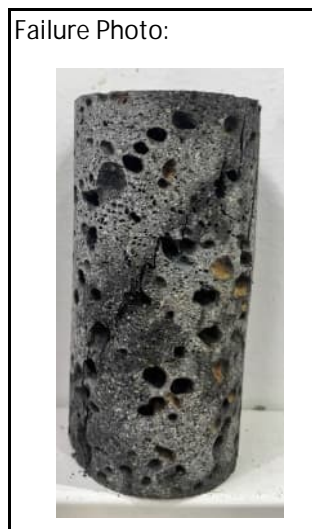
Soil Description: slightly weathered BASALT, strong, light grey with black; vesicular.

Test Remarks: Unconfined Compressive Strength reported to the nearest 1 kPa.
The test is not IANZ accredited.
