Prepared for Auckland Transport | 15-Apr-2019

## Draft Environmental Assessment (Contamination)

**PROJECT**  
 AUCKLAND TRANSPORT  
 AMETI EASTERN BUSWAY 2 AND 3

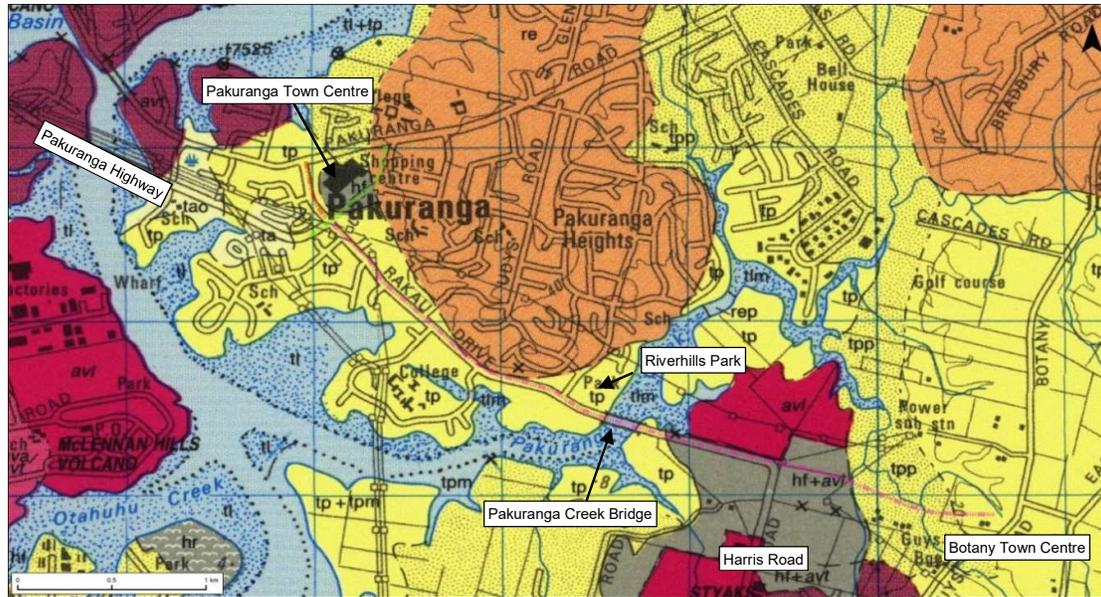
Figure 2 Geological Map Extract 1:50,000 (Kermode, 1992)

Strata Map Code	Strata Name	Strata Description	Approximate Locations
hf+avl	Construction Fill & Basalt Lava	Construction fill: re-compacted clay to gravel sized materials may include demolition debris. Basalt lava: grey, dense, fine grained lava	Ti Rakau Drive between Trugood Drive and Greenmount Drive, and around Pakuranga Town Centre
tIm	Intertidal Mud	Grey to black, indistinctly bedded	Beneath Pakuranga Creek Bridge
ta	Undifferentiated Alluvium	Mud, sand and gravel	Pakuranga Highway
avl	Basalt & Basanite Lava	Grey, dense, fine grained lava	North of Ti Rakau Drive between Burswood Drive and Harris Road
tp	Puketoka Formation	Pumiceous deposits: light grey to orange brown, pumiceous mud, sand and gravel with black muddy peat lignite	Pakuranga Highway, southern end of Reeves Road, Ti Rakau Drive between Pakuranga Town Centre and Trugood Drive
tpp	Puketoka Formation	Rhyolite pumice: light grey, massive to finely laminated, mud to sand sized pumice, includes non-welded ignimbrite, tephra and alluvial pumice deposits	Ti Rakau Drive between Greenmount Drive and Botany Town Centre

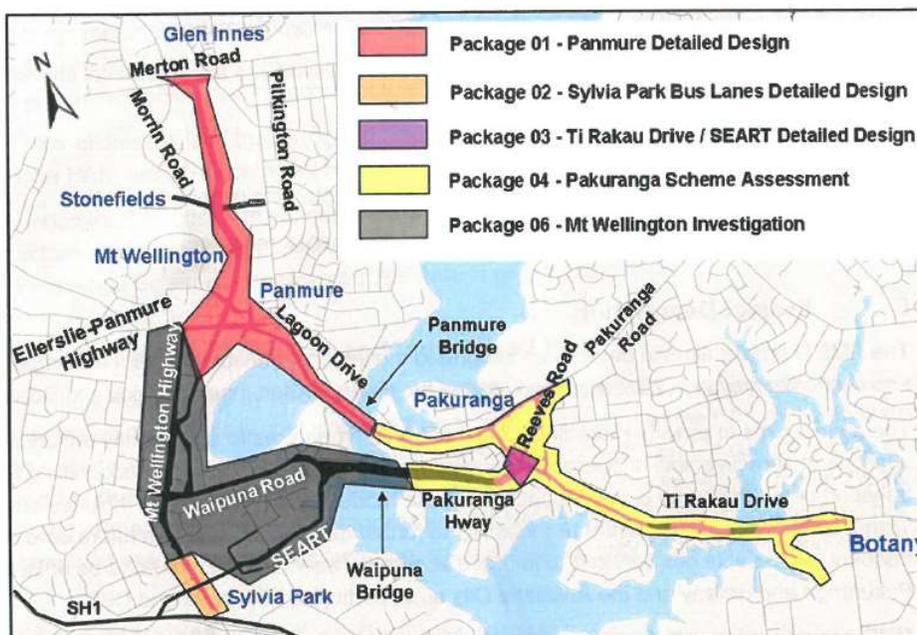
**Figure 3 AMETI Alignment Entire Scheme Assessment**

Segment	Description
One	Pakuranga Road between the eastern abutment of the Panmure Bridge and Ti Rakau Drive.
Two	Pakuranga Town Centre and immediate surrounding corridors. These include Pakuranga Road, between Ti Rakau Drive (including the Pakuranga Road intersection) and St Kentigerns signalised entrance; Ti Rakau Drive, between Pakuranga Road and Reeves Road (including the Reeves Road intersection); and Reeves Road, between William Roberts Road and Ti Rakau Drive.
Three	Ti Rakau Drive between Reeves Road and Gossamer Drive.
Four	Ti Rakau Drive between Gossamer Drive and Greenmount Drive.
Five	Ti Rakau Drive between Greenmount Drive and Botany Road.

The Package 4 Scheme Assessment is noted to comprise five segments, and these are summarised in **Table 2** Error! Reference source not found.. The entire Package 4 Scheme (including each of the five segments) forms the subject of the GHD PSI and encompasses packages EB2 and EB3 (which are the focus of this environmental assessment). The review of the GHD PSI indicates that Package 4 appears to generally align with packages EB2 and EB3 of the current AMETI programme.

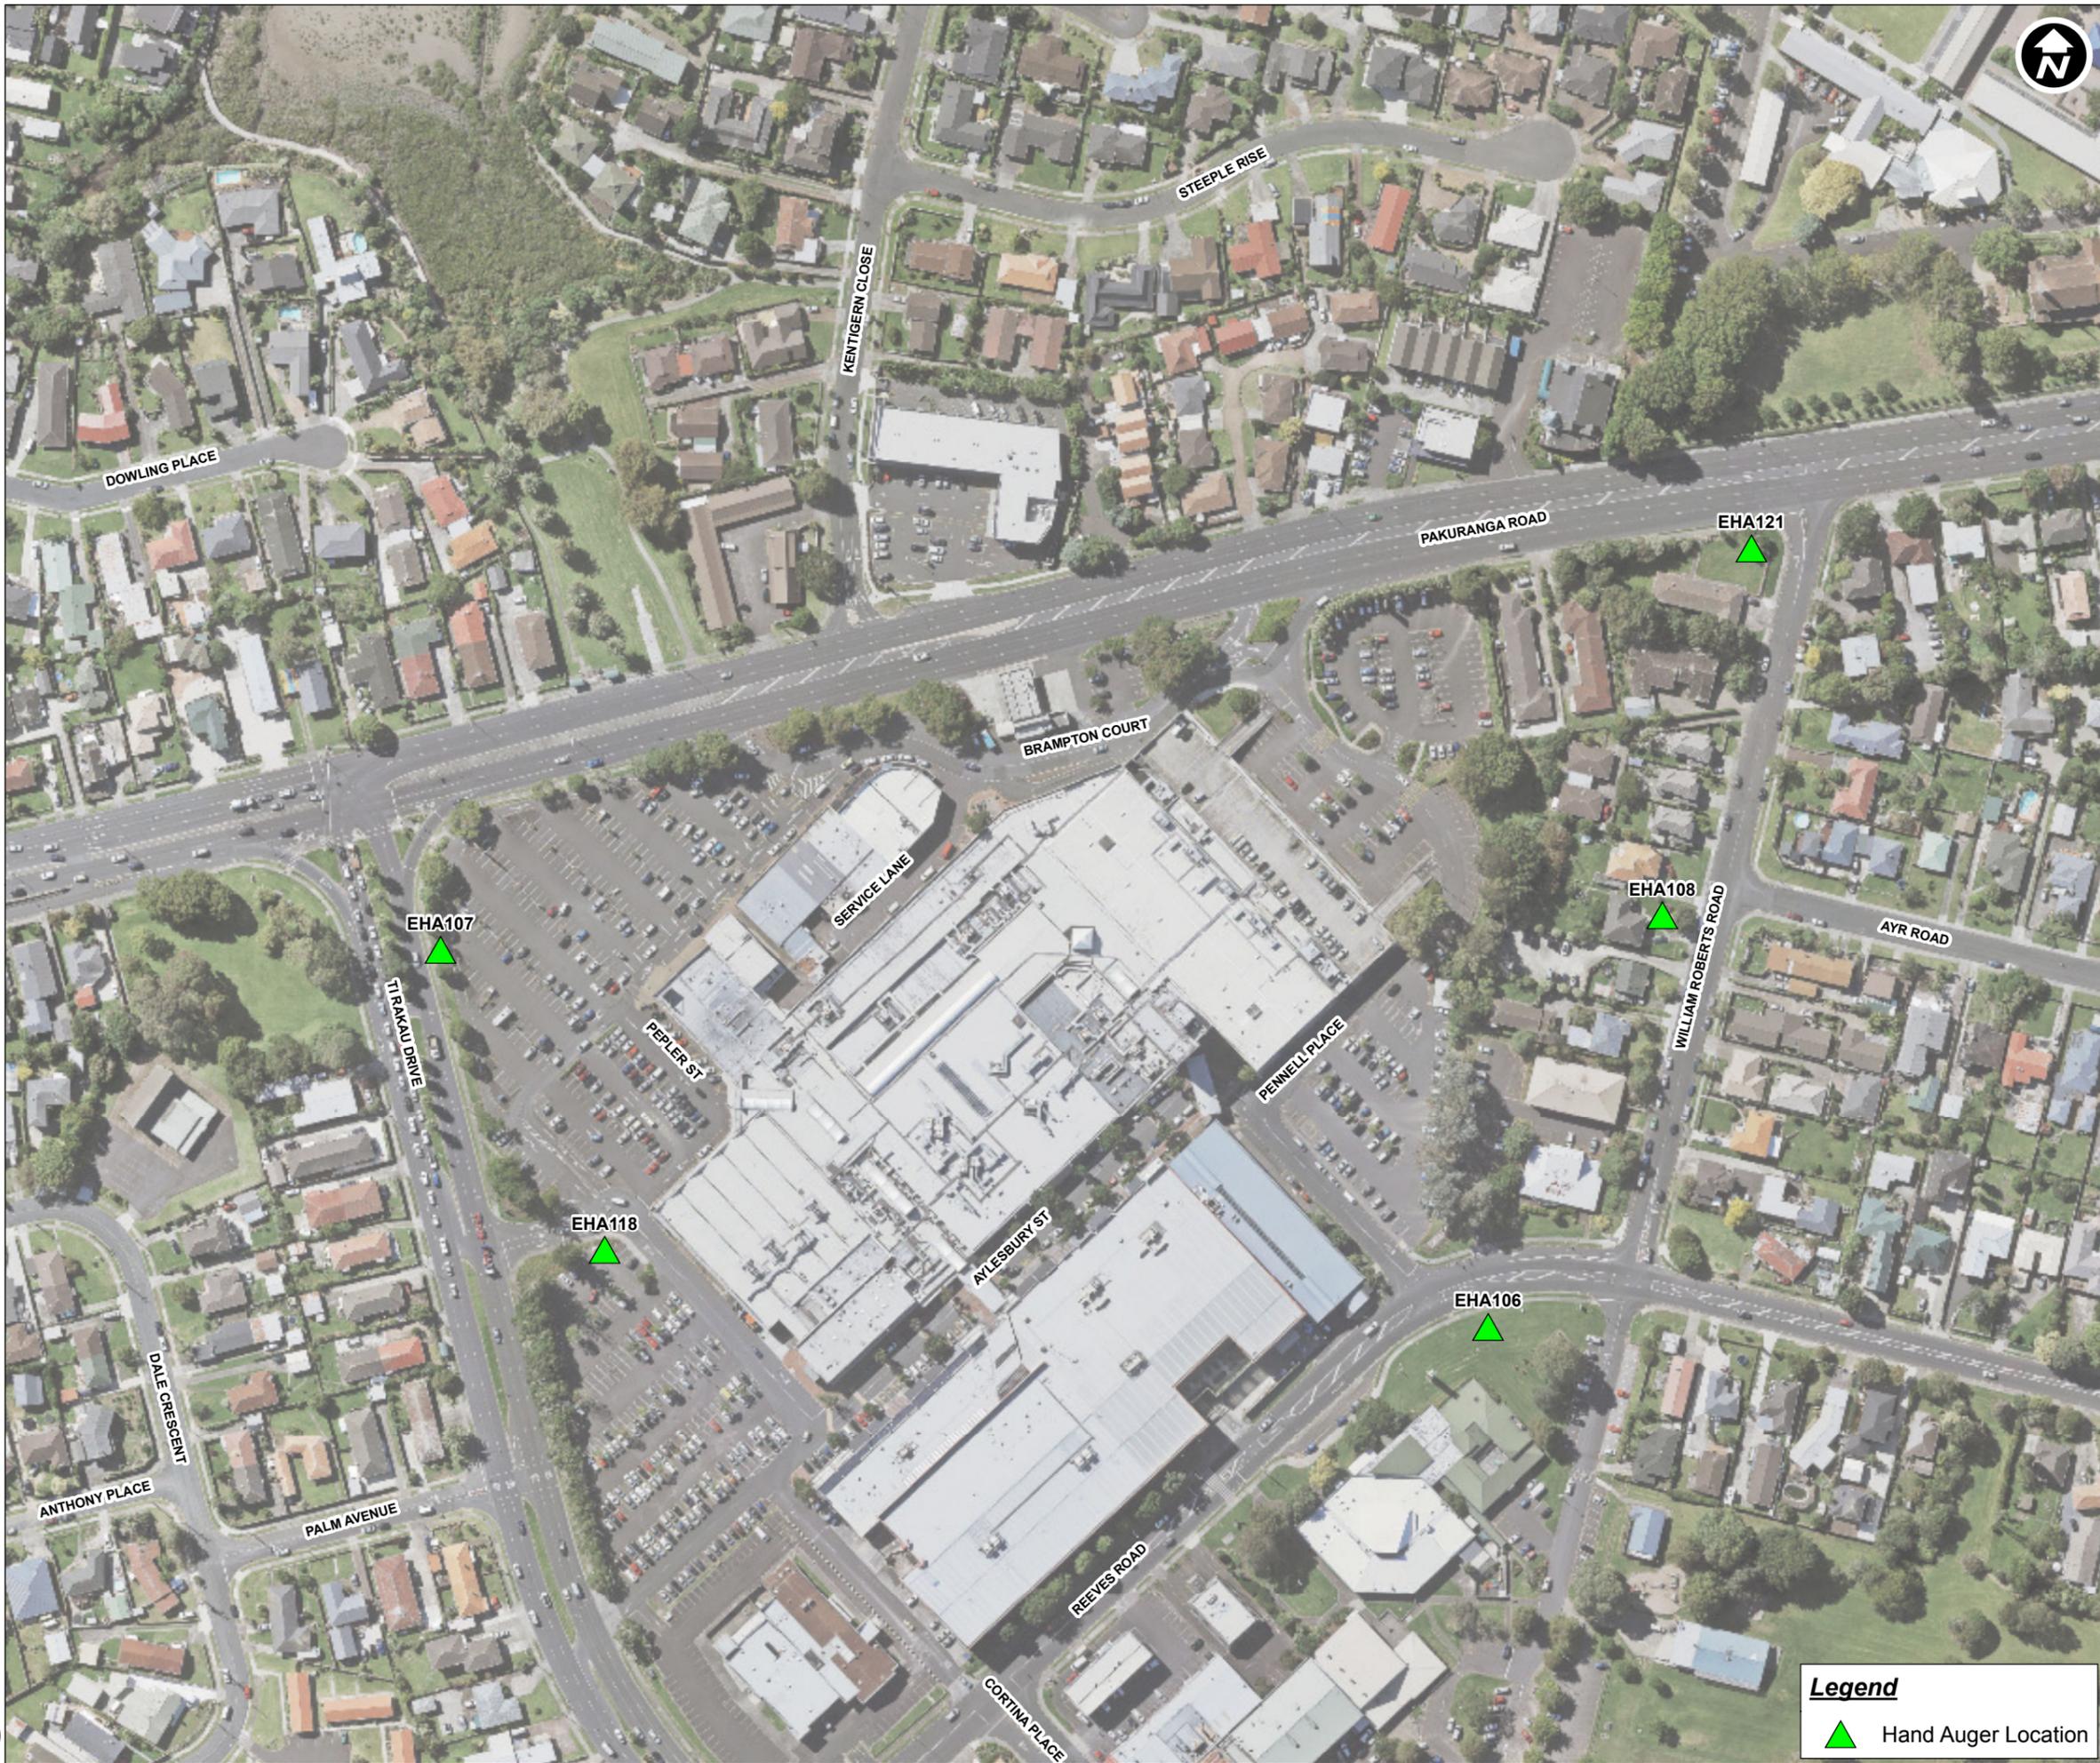
FIGURE 4A

**Table 4** presents a summary of the works completed between April and August 2019 and in February 2019. Investigation locations are presented on **Figure 4** in **Appendix A**.

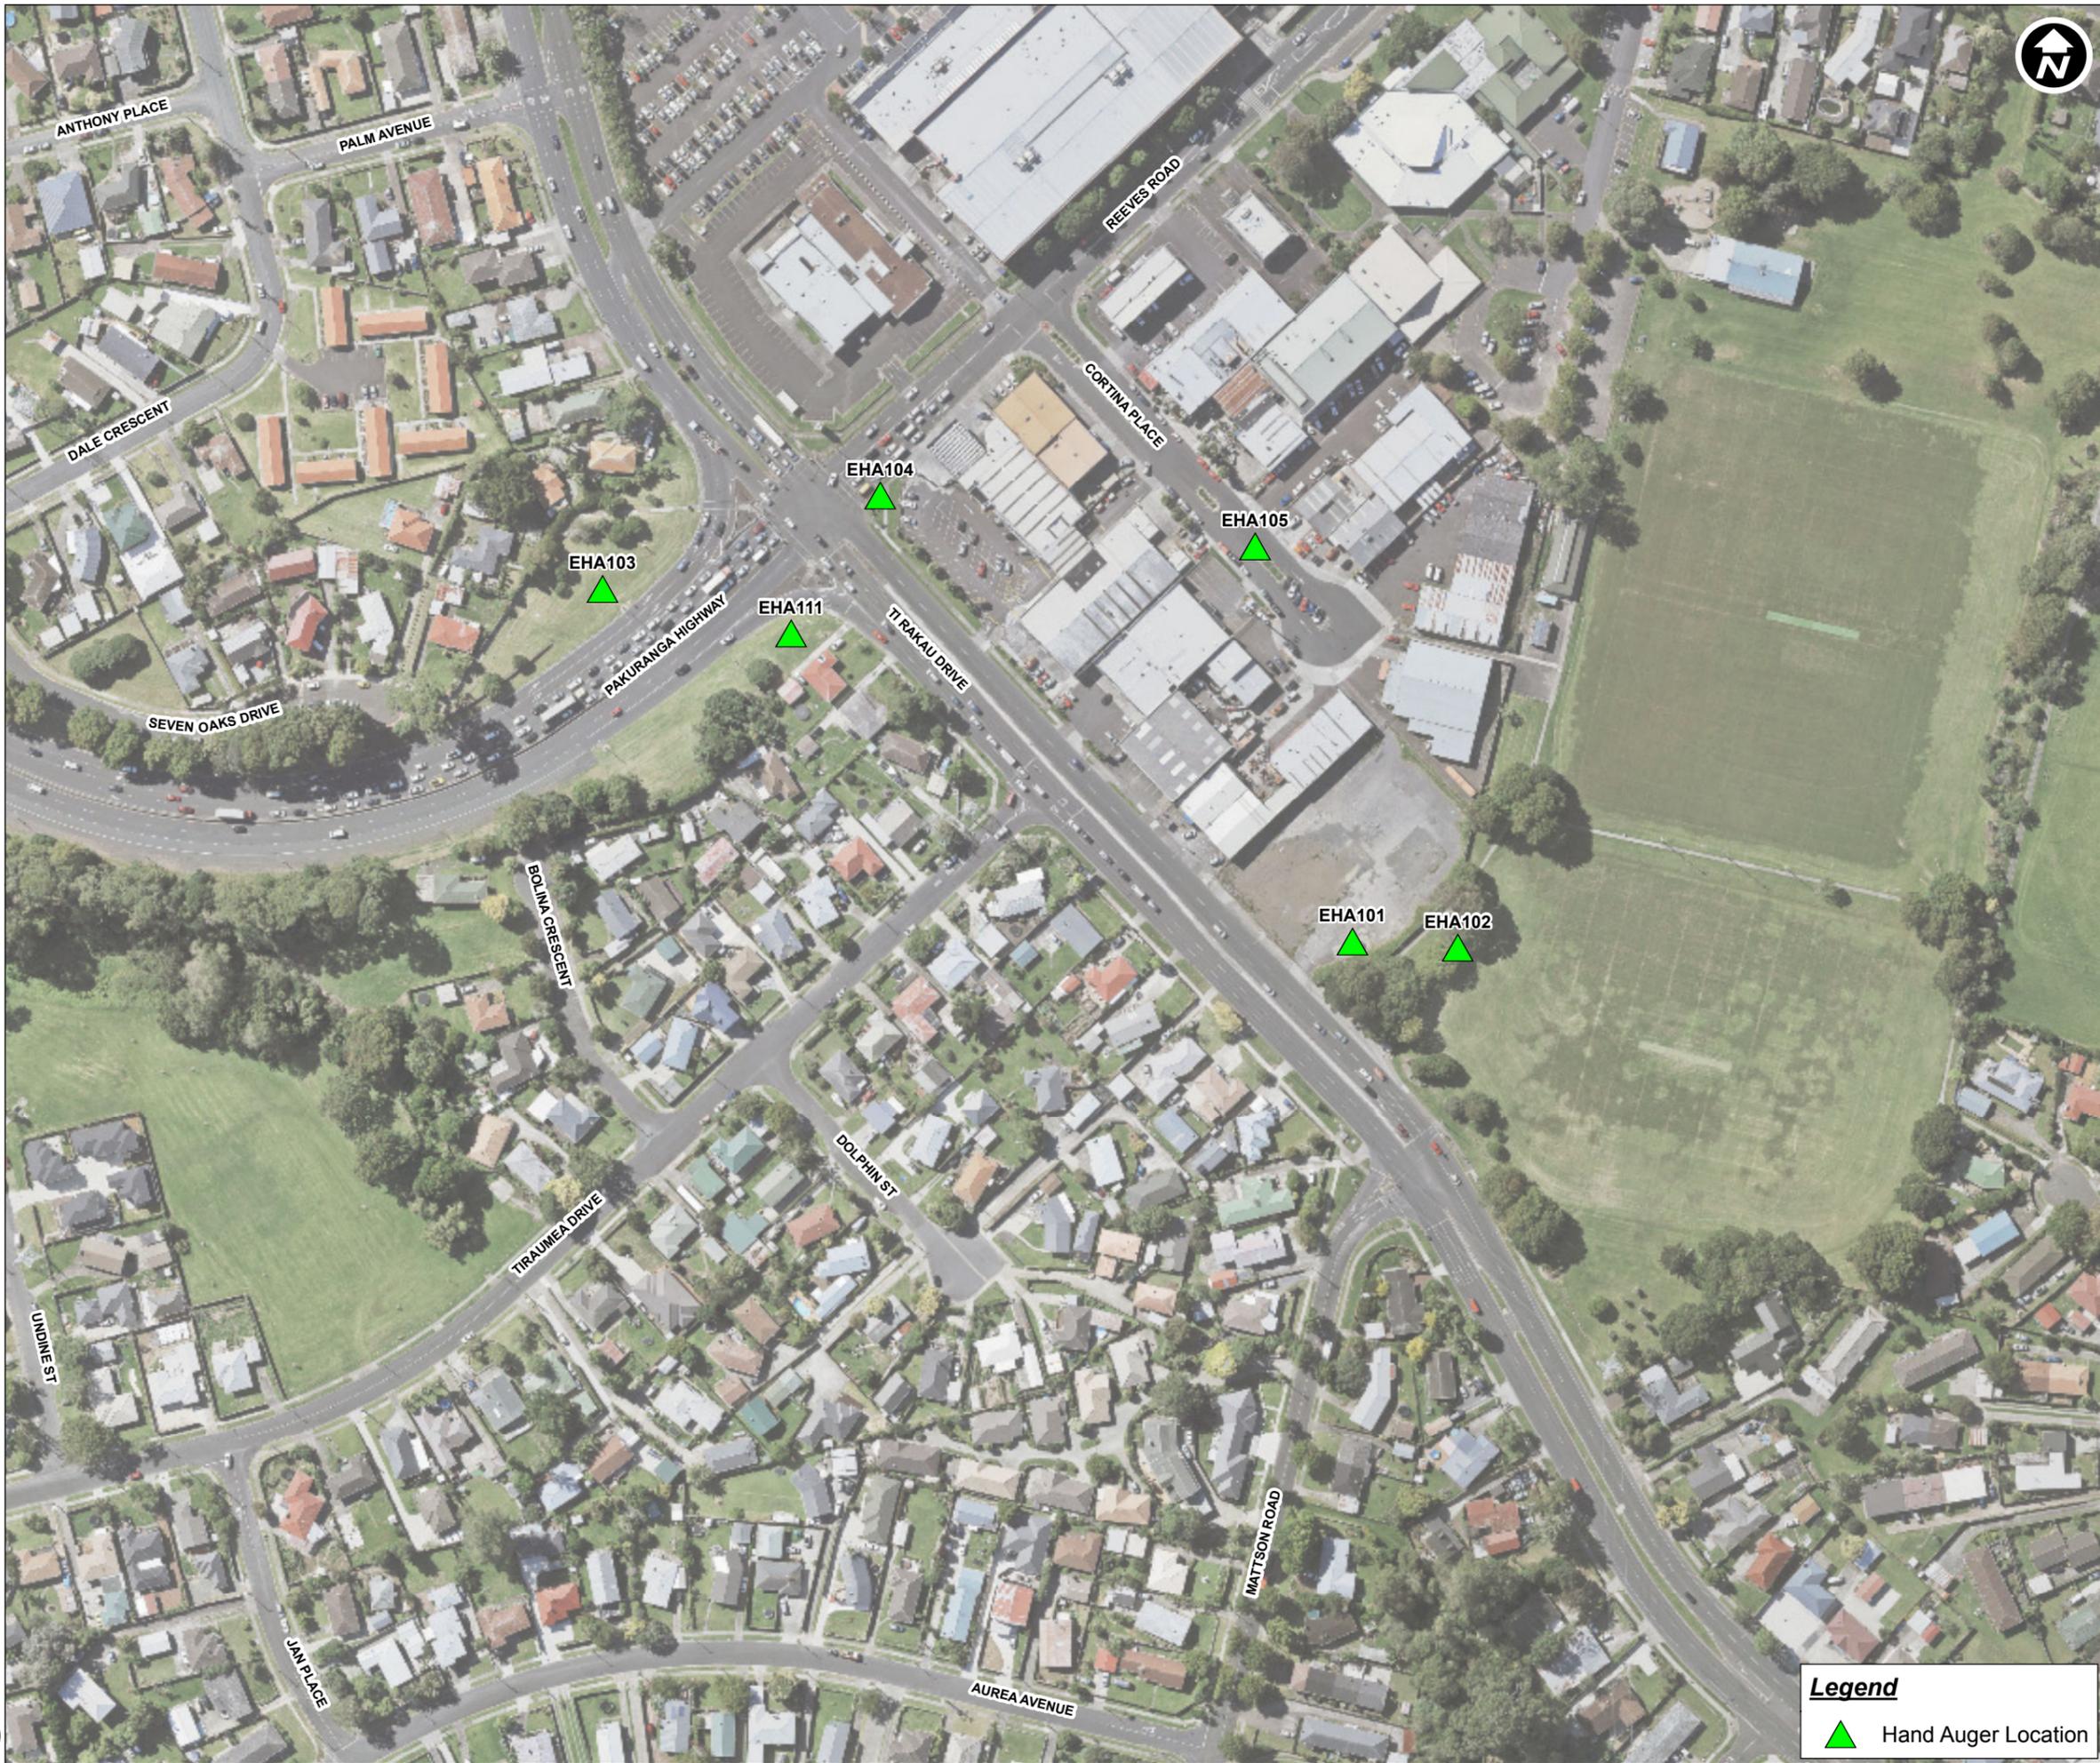
**MAP NUMBER**  
 FIGURE 4C

▲ Hand Auger Location

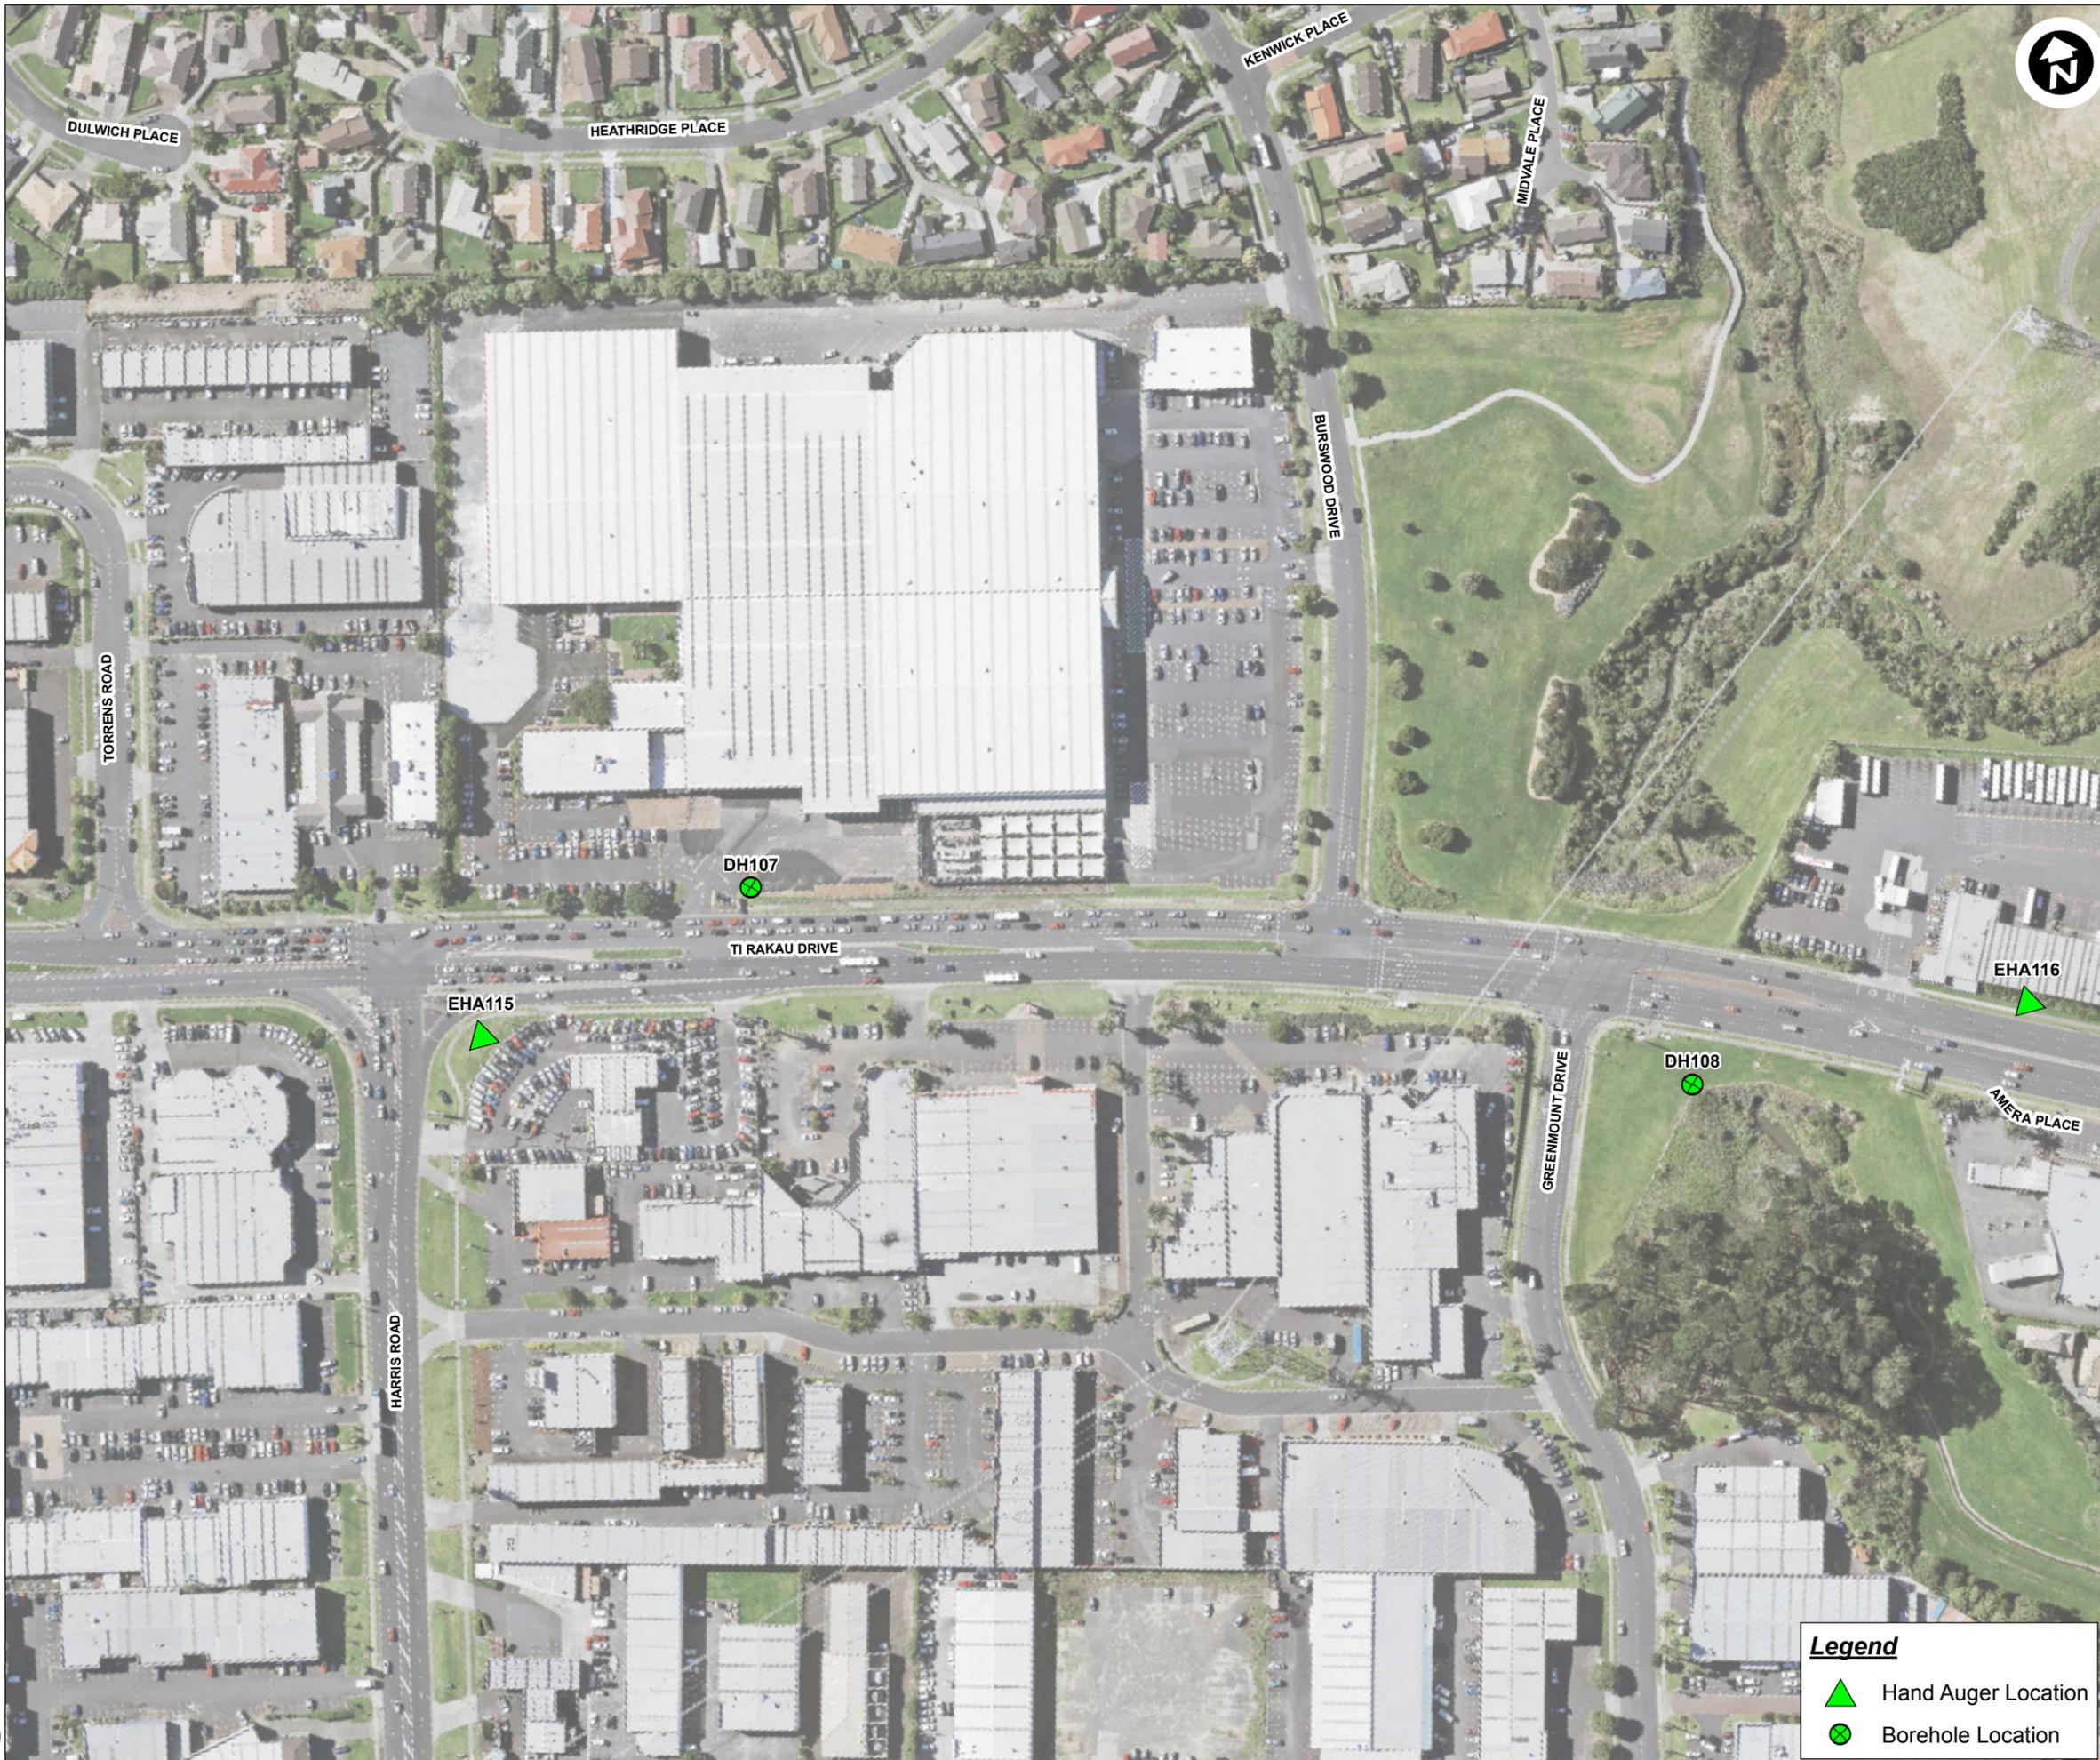
**MAP NUMBER**  
 FIGURE 4H

- Hand Auger Location
- Borehole Location
