1618 Ararimu Road Hunua
Pavement Impact Assessment Report
Ararimu Road, Hunua between
CH15800-CH16800

Document: Pavement Impact Assessment Report

Project: 1618 Ararimu Road Hunua

CP Document No: 2660 - PIA-v1-scp rjp-20241024

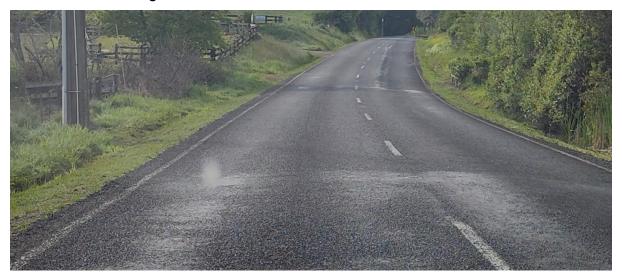
- 1. Minor Surface flushing intermittently for the length, both sides from CH15880 to CH
- 2. Minor rutting at previous patch repairs on edges and in wheel paths CH 15910 to CH 15970.
- 3. Scabbing mostly on east bound lane CH 16060 to CH 16130
- 4. Recent patch repairs, good condition, east bound lane CH 16220 and CH 16240
- 5. Shoving and pothole west bound lane CH 16258
- 6. Shoving and pothole west bound lane CH16535, west bound lane, rutting in wheel path.

General Surface Flushing

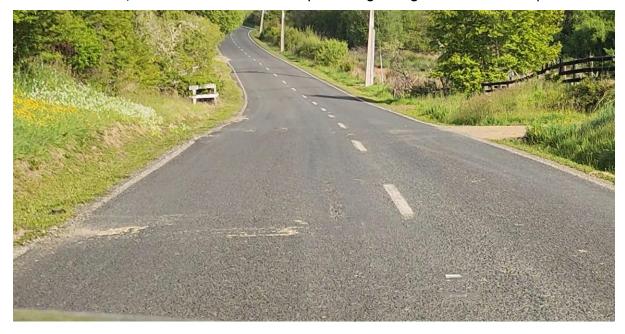
CH 15910 to 16020, West bound lane. Previous repair rutting on edges and inside wheel path.

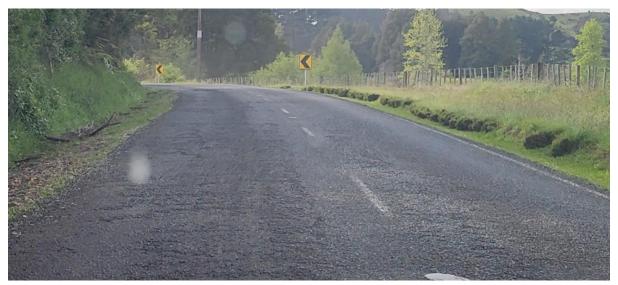
CH16060 to CH 16130, east bound lane. Scabbing.

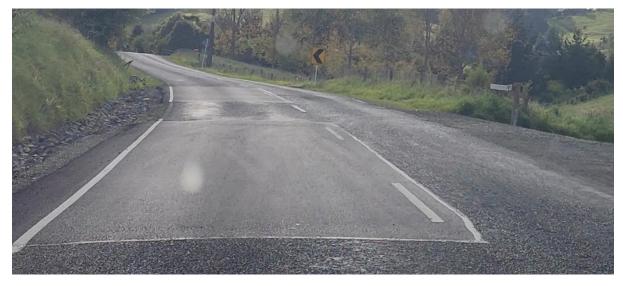
CH 16220 & CH 16240, Patch Repairs to east bound lane

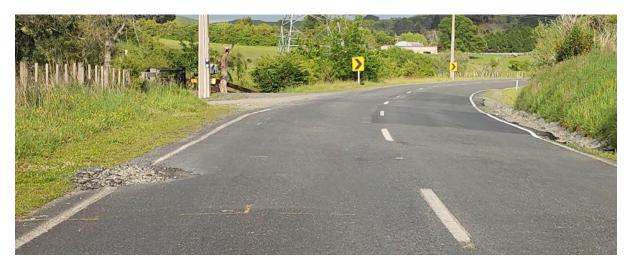
CH16258, west bound lane, Pothole and shoving.

The above pavement rehabilitation will also remediate the pavement failures identified in Section 4 relating to alligator cracking, longitudinal rutting, shoving and surface flushing.

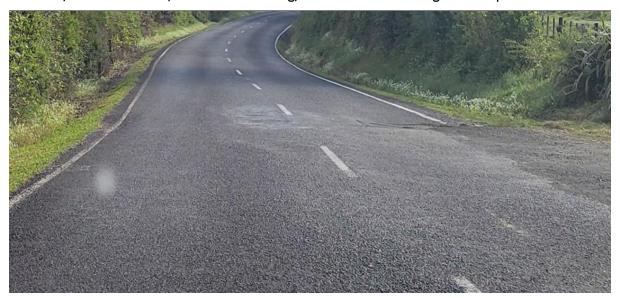
CH16535, west bound lane, Pothole and shoving, east bound lane rutting in wheel path.
