Project No: 2307

1618 Ararimu Road, Papakura: information request regarding ecological effects

Memo

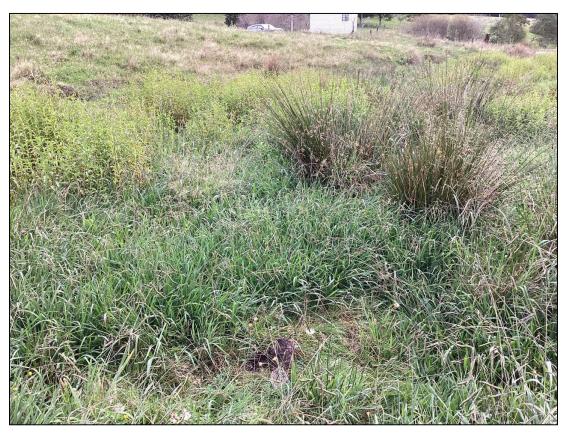
Plate 1: Photo point 6, view south-west. Elevated area dominated by FACU and FAC species, with *Paspalum dilatatum* (FACU) being the most dominant with over 50 % coverage. *Juncus* species are occasional, making up less than 10 % of the plant coverage. *Persicaria hydropiper* lines the bank of Stream P1.

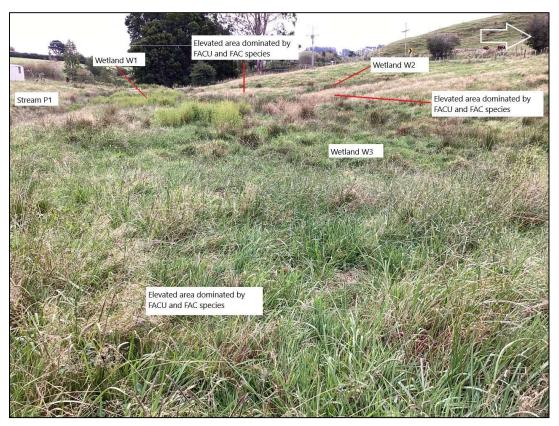
Plate 2: Photo point 7, view west. The slight changes in topography and have resulted in differences in vegetation type. Wetadapted vegetation is growing in the depressions, whereas the elevated areas support dryland species.

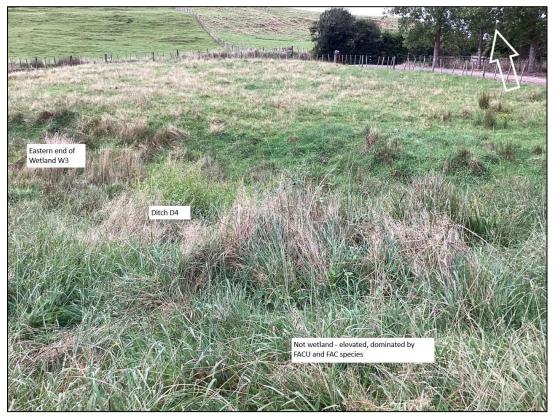
Plate 3: Photo point 7, view north-north-east. The slight changes in topography and have resulted in differences in vegetation type.

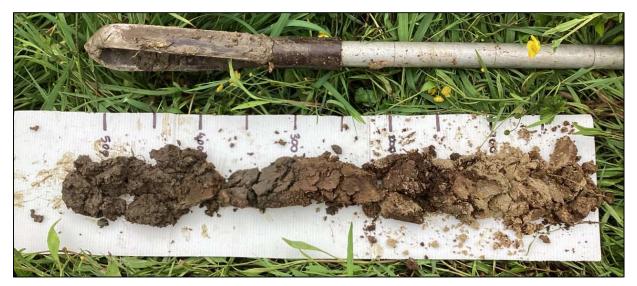
Plate 4: Soil core SC1 from Wetland W1. A disturbed soil profile, ranging from dry in the top 150 mm to wet at 500 mm, with a mix of low and dark chromas. Very minimal mottling at 400-500mm. Hydric properties uncertain.

- Highly disturbed nature of the soil profile soil cores taken from the areas delineated as wetlands show a wide variety of soil profiles across this small area, indicating a high level of disturbance and variety in local hydrology (Plates 4-6).

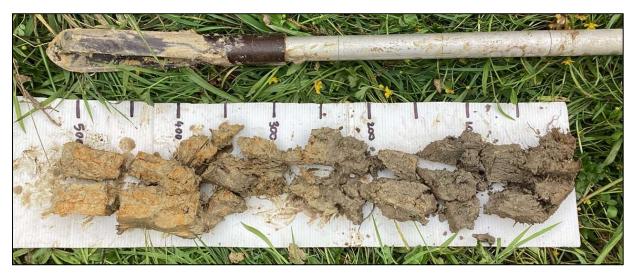
Plate 5: Soil core SC2 from Wetland W2. A wet, low chroma soil profile, with mottling between 300-500 mm. A hydric soil.

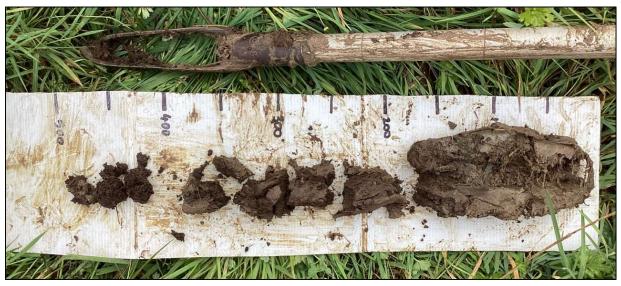
Plate 6: Soil core SC3 from Wetland W3. A saturated soil profile, with an organic element and an eggy smell. A hydric soil.

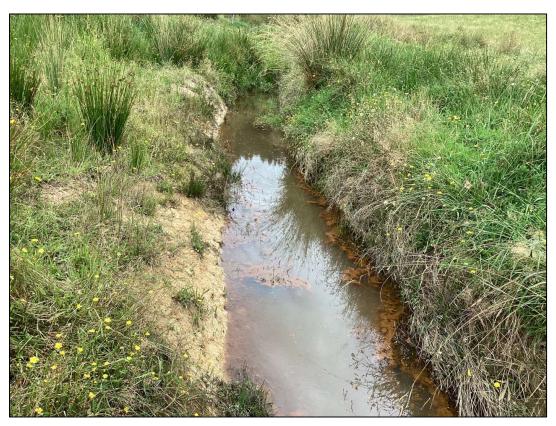
Plate 7: View south along Stream P2. The stream has been recently excavated to a uniform width and depth to increase capacity. The banks are generally steep and support only a narrow band of vegetation before pasture grasses dominate.

Stream P2 at the centre of the site is lined with a narrow band of vegetation that includes a mix of wet-adapted vegetation such as *Persicaria hydropiper* (FACW) and *Juncus* species (FACW), and dryland species including *Paspalum dilatatum* (FACU), *Holcus lanatus* (FAC), *Rubus fructicosus* (FAC), and *Ligustrum sinense* (FACU). The stream has been recently widened and deepened to increase flood capacity, and the excavated material has been deposited along the stream banks. The disturbed nature of the stream banks, the mix of species from FACW to FACU, and the narrow width of this vegetation resulted in the categorisation of this area as riparian margin rather than as wetland (**Plate 7 and Plate 8**).

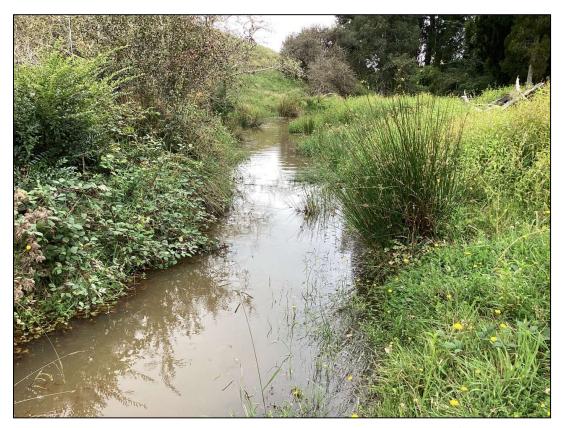
Plate 8: View north along Stream P2. The stream banks support pasture grasses, *Rubus fructicosus* agg., *Persicaria hydropiper*, *Ligustrum sinense* and occasional *Juncus effusus*.

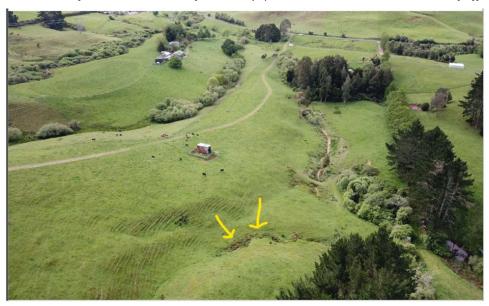
An area with a relatively high density of Juncus species was observed to the west of Wetland 5 (shown in the image below with yellow arrows). Please advise if this area meets the definition of a natural inland wetland and provide the data used for this assessment. If necessary, please also revisit the calculation of offset targets.

The above photograph is not up to date as it pre-dates the construction of the vehicle hard-standing area that has been in existence for at least 18 months.

The photograph shows a line of vegetation along Stream I1.

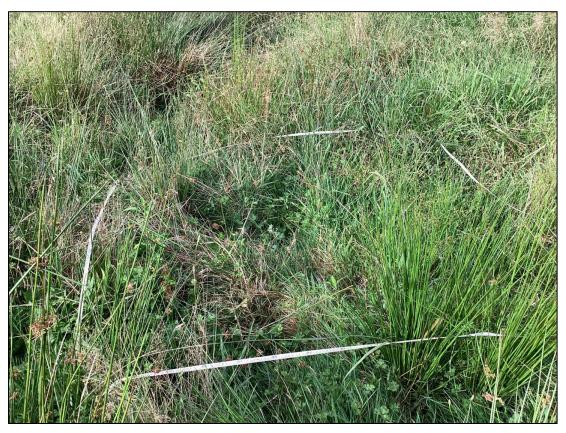
Plate 9: Wetland plot WP4 in which the vegetation passes the Pasture Exclusion Test (over 50 % pasture species), does not pass the Dominance Test (over 50 % of the dominant species are FACU or FAC), and has a Prevalence Score of 3.3.

In addition, the vegetation in this plot does not pass the Dominance Test for vegetation (**Plate 9**), as the dominant species are *Agrostis capillaris* (FACU) 45%, *Paspalum dilatatum* (FACU) 10 %, *Ranunculus repens* (FAC) 10 %, and *Juncus effusus* (FACW) 10 %, and the Prevalence Score is over 3.0 (score = 3.3). The data from this wetland plot is presented in **Figure 2**.

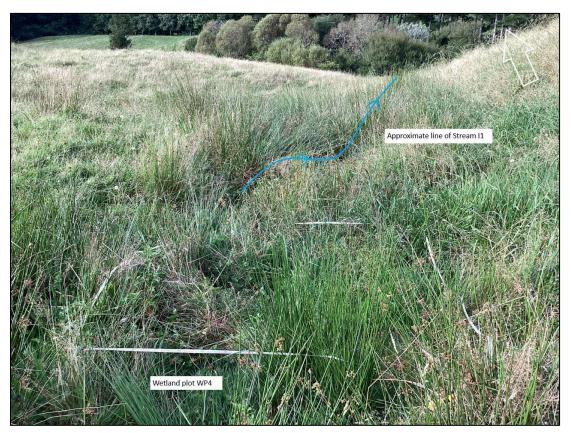
Plate 10: View down Stream I1 from the location of wetland plot WP4 showing a similar suite of plant species as that recorded in the plot.

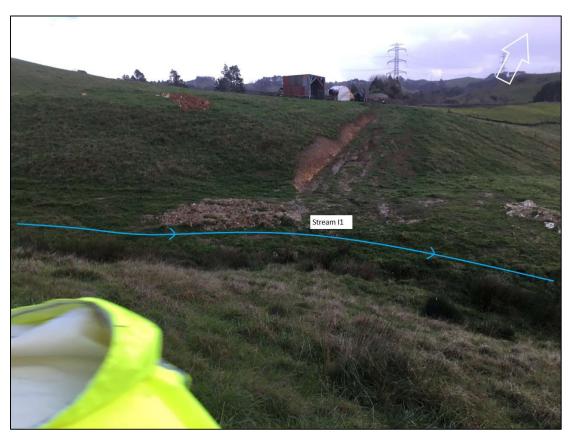
Plate 11: View across Stream I1 from photo point 65, showing the narrow, patchy line of *Juncus* species amongst grasses.

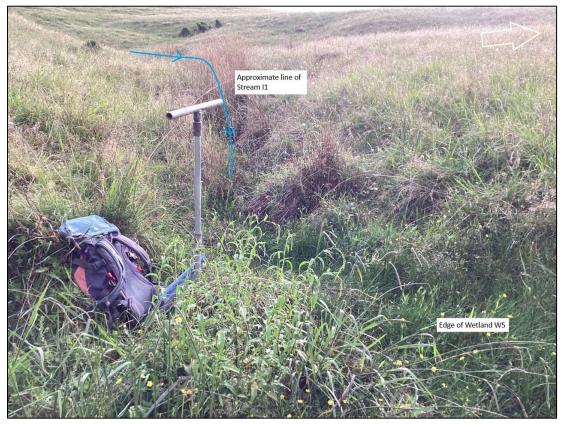
Plate 12: View upstream from the lower end of Stream I1 and at the edge of Wetland W5.

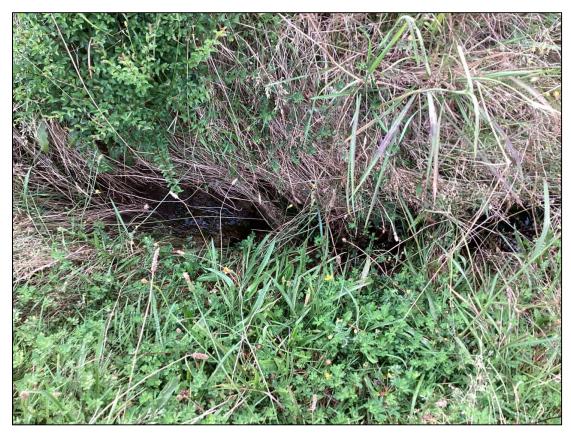
Plate 13: Close up view of the bank vegetation of Stream I1 in its middle reach, which includes *Paspalum dilatatum*, *Ligustrum sinense*, *Lotus pedunculatus*, *Plantago lanceolata*, and *Agrostis capillaris*.

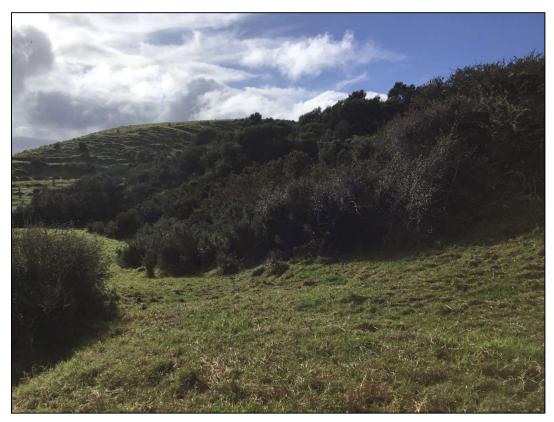
Figure 14: Mixed exotic-native scrub – approximately half of the patch is proposed for clearance (photo point 47).

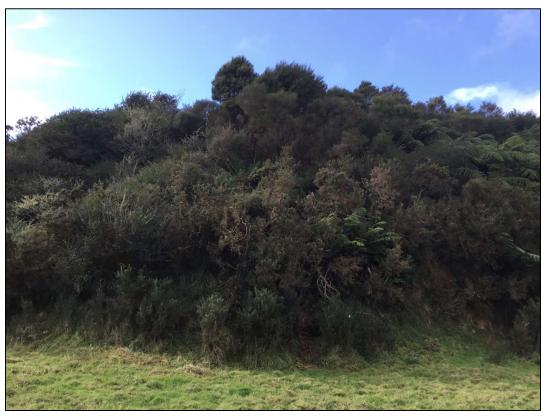
Figure 15: Mixed exotic-native scrub – the area to be cleared comprises mostly *Berberis glaucocarpa* and *Ulex europeaus* (photo point 48).

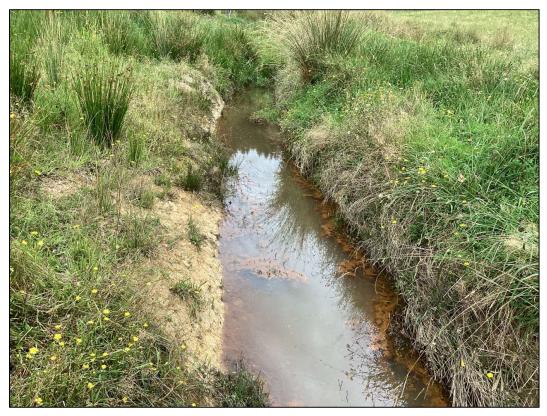
Plate 16: Central section of Stream P2 showing minimal vegetation growing on the bed of the stream.

There is little or no vegetation growing on the beds of Stream P1 or P2. Example photographs are shown in **Plates 16 and 17**. Earthworks required to recreate wetland will not involve changes to the stream beds or removal of vegetation.

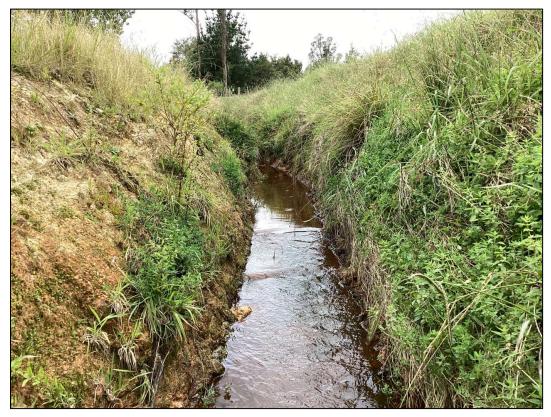
Plate 17: Stream P1 with minimal vegetation growing on the stream bed.
