1618 and 1646c Ararimu Road, Papakura

**Preliminary Site Investigation
(Ground Contamination)**

SB CIVIL LTD

WWLA0745 | Rev. 1

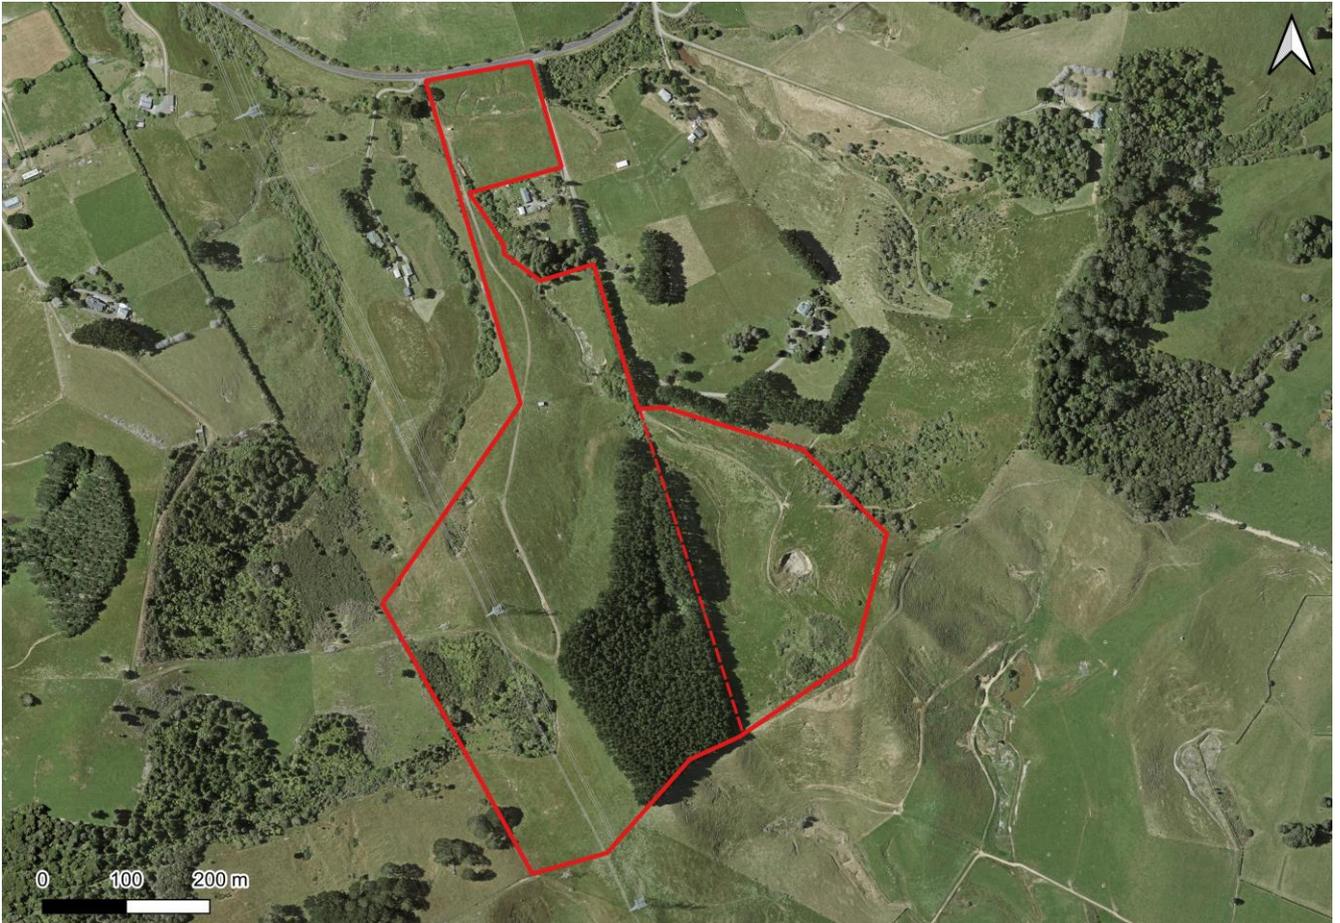
Figure 1. Site Location (outlined red) (Image source: LINZ). Dashed line shows property boundary between 1618 Ararimu Road (left) and 1646c Ararimu Road (right).

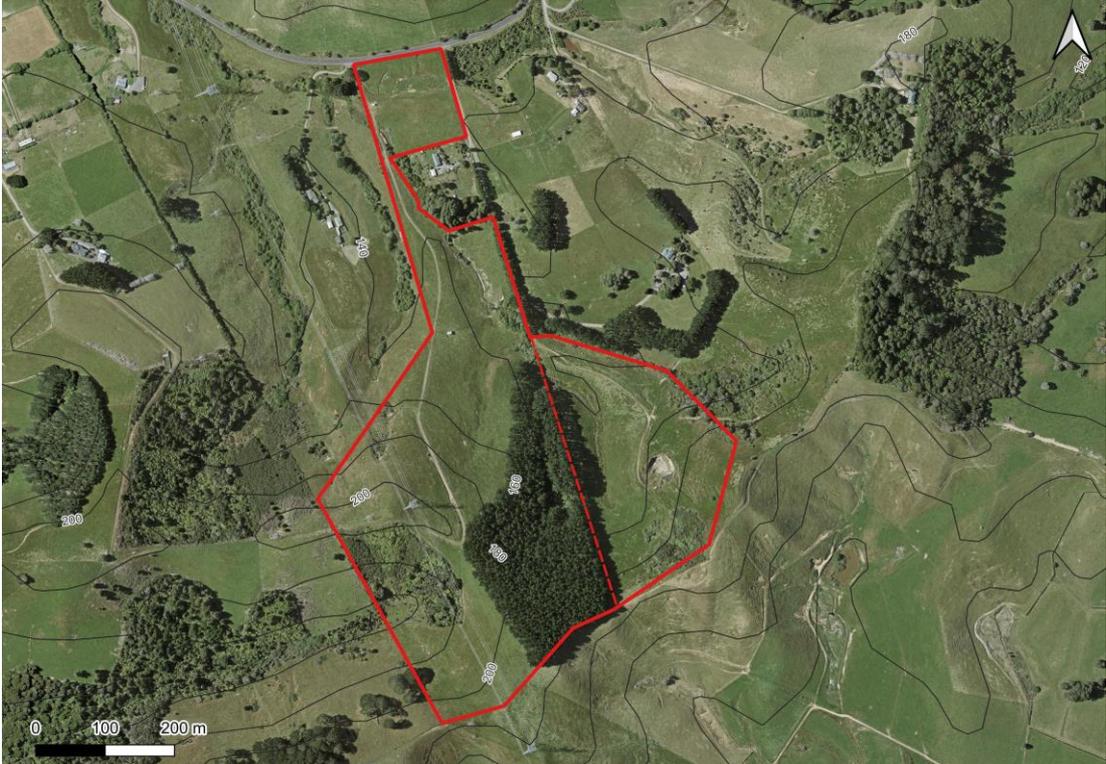
Figure 2. Topography of the site (source: LINZ).

Site surrounds	The site is bordered by open Rural – Rural Production Zone land, primarily used for pasture with isolated dwellings and bush.
Topography	<p><i>The topography of the site impacts where contaminants might migrate to if present.</i></p> <p>The site topography slopes up from north to south from approximately 125m RL to 185m RL. The entrance to the property is relatively flat but it becomes progressively steeper towards the southern boundary. A shallow valley separates the eastern and western sides of the property (Figure 2).</p>

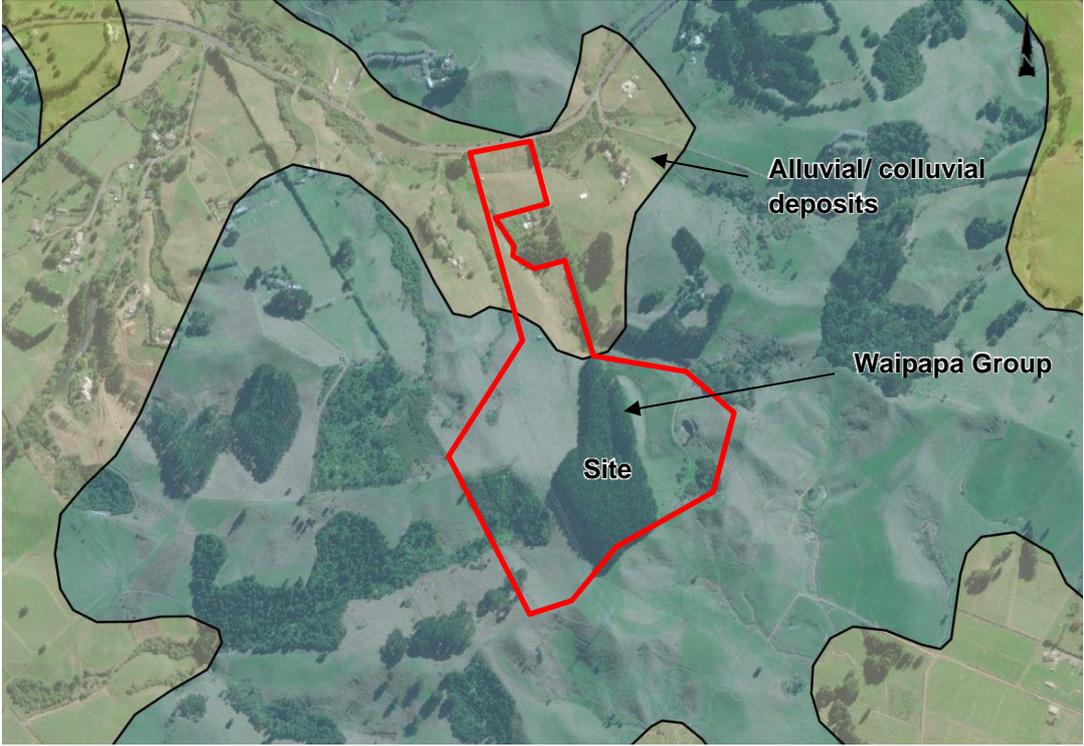
<p>Figure 3. Published geology of the Ararimu area with the site marked red. (Source GNS Webmaps⁴).</p>
<p>Hydrogeology</p>	<p><i>Hydrogeological conditions affect potential risk of contaminants (if present) entering and being transported in groundwater.</i></p> <p>Based on nearby borehole log data available on the NZGD⁵, regional groundwater is expected to occur at approximately 6 m below ground level (BGL) beneath the lower (northern) portion of the site. Regional groundwater is expected to flow to the north into the Hunua River catchment. Perched groundwater is expected to encountered at shallow depth in the lower reaches of the central valley.</p>

<p>Geology</p>	<p><i>Geological conditions are considered in the context of describing the conceptual site model (CSM, Section 4) should a potential for contamination be identified by this desk study. For example, more porous soils can enable contaminants (if present) to move more quickly and potentially further than clay-rich soils that retain/ bind or prevent penetration of contaminants.</i></p> <p>The published geology (Error! Reference source not found.) describes the site being underlain by Waipapa Group composite terrane, composed of massive to thin-bedded, lithic volcanoclastics sandstone, with tectonically enclosed spillite, chert, and red and green argillite. Alluvial deposits are mapped as being present across the lower (northern) portion of the site.</p>

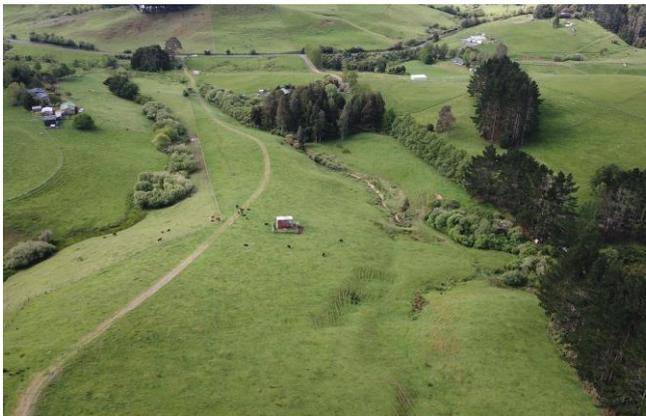
Photograph 1. Western site view looking north towards Ararimu Road.

- The site has an undulating topography (sloping down from south to north) and is surfaced mostly in pasture with areas of native bush and a central pine plantation (**Photograph 1**). All vegetation appeared healthy and unstressed.

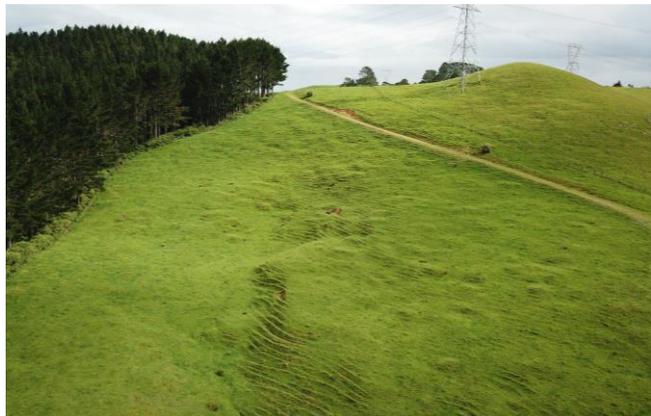
Photograph 2. Looking south across the site at proposed fill site. Telecommunication pylons shown in the background. Unnamed access road to shown on the right.

- Steel power pylons/transmission towers are present on the south-western portion of the site but filling is expected to remain at distance from these (**Photograph 2**).

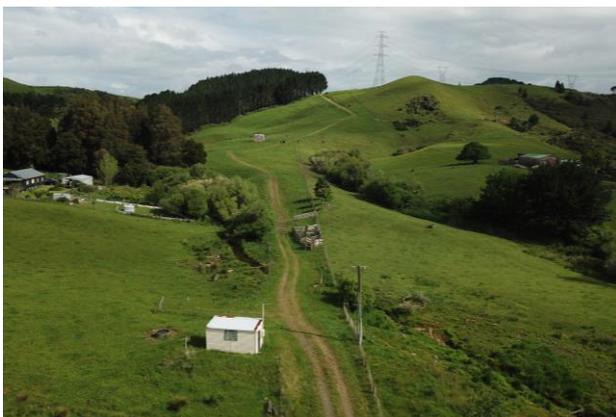
Photograph 3. Looking south across the site. Healthy vegetation and wetland extent shown. Two minor buildings used for agricultural purposes located along the access road.

- Two small sheds associated with agricultural activities are located on western portion of the site. These are constructed of painted corrugated steel. A red coloured shed located centrally on the site (**Photograph 1**) is used as a poultry shelter. A white coloured shed located in the northern portion of the site (**Photograph 3**) was not able to be accessed during our site visit.

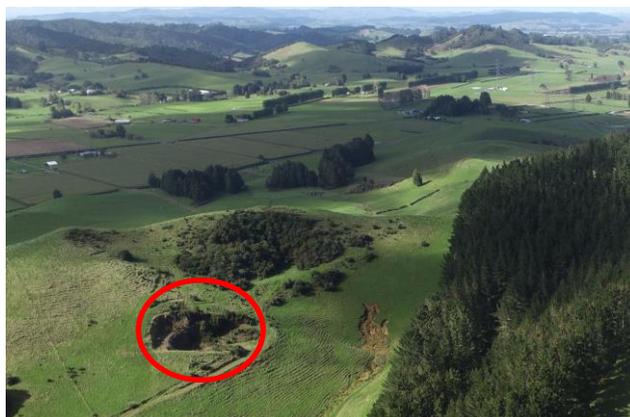
Photograph 4: Former quarry (circled) on eastern portion of site. Small landslide visible to the right of the quarry (image looking south).

- A former quarry is located on the eastern side of the site. It is currently not used but still has an access track leading to it (**Photograph 4**).
- Rural residential properties are located near the western and eastern boundaries (**Photograph 3**).

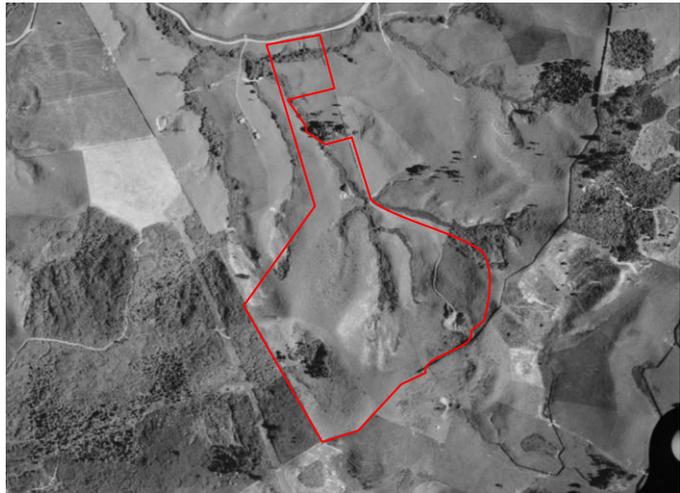
Photograph date (source)	Activities	Aerial image (site in red outline)
1944 Retrolens (SN348 G/9)	Property is predominantly undeveloped pasture, bound by Ararimu Road on the northern side and pastoral land on all other sides. There are no visible structures present on the site. An area of quarrying or earthworks, with associated access track, is evident in the east of the site.

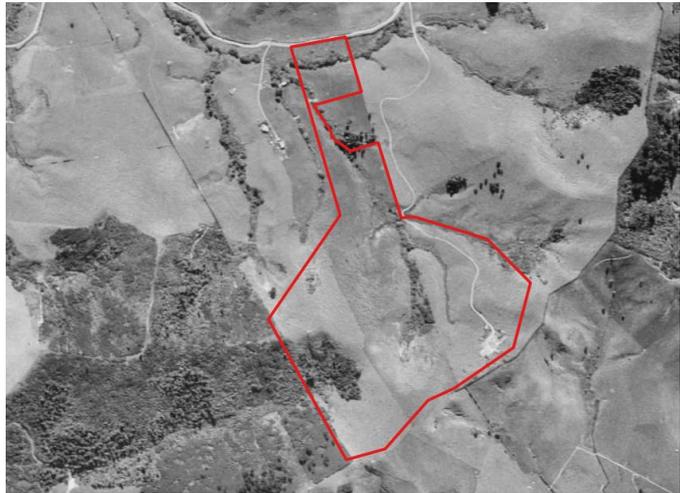
1961-1969 Retrolens (SN1397 3244/46)	Earthworks appear to have been undertaken recently in both the area of quarrying and access track. Otherwise, no material changes evident, relative to previous imagery, on the site or on surrounding properties. A transmission pylon can be seen near the western boundary of the site. (1969 image shown)

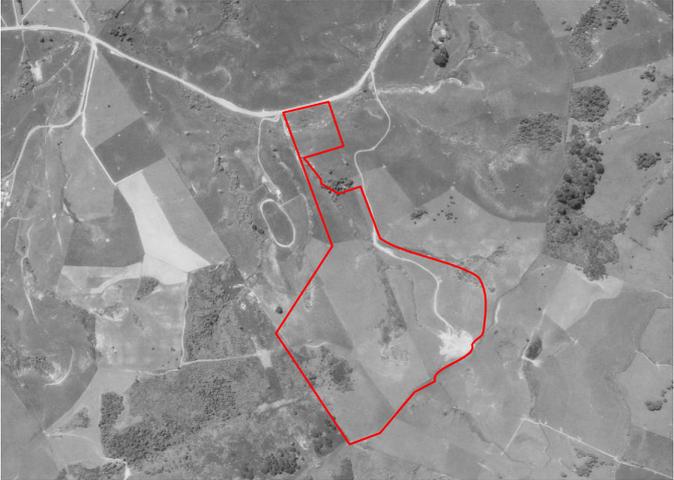
Photograph date (source)	Activities	Aerial image (site in red outline)
<p>1977 Retrolens (SN5164 C4)</p>	<p>There are no significant changes relative to previous imagery. A track (either for horses or vehicle racing) has been developed on the property to east.</p>

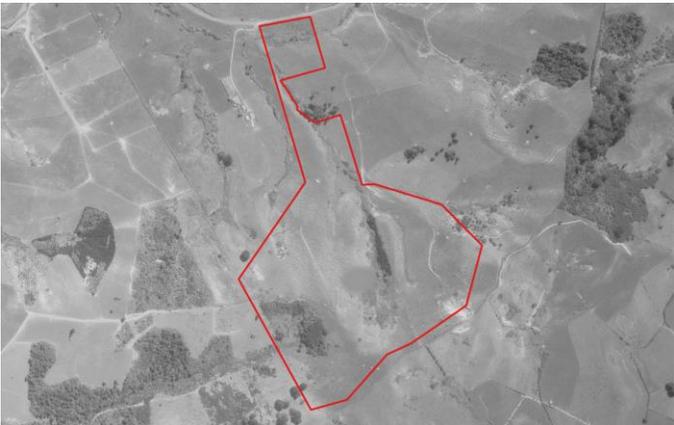
<p>1988 Retrolens (SN8772 W/25)</p>	<p>A stock shed (later confirmed for poultry) is now visible in middle of the site. Quarrying appears to have ceased.</p>

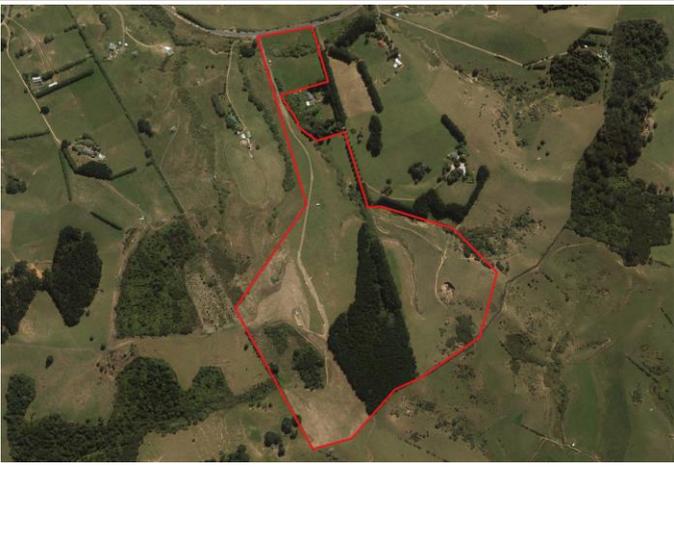
<p>2010-present Google Earth Pro</p>	<p>By 2010 a central access road was established through the property. This appears to have been to support the construction of a second transmission pylon in the west of the site (visible in subsequent images). The central-southern portion of the site is now largely covered in what appears to be plantation forestry, correlating with the remnant pine plantation which remains on the site today. An additional small building has been built near the property entrance on Ararimu Road. This correlates with the location of the current white shed. Quarrying appears to have recommenced in the east of the site.</p> <p>No significant changes are evident in images available through to the present day. (2010 image shown)</p>

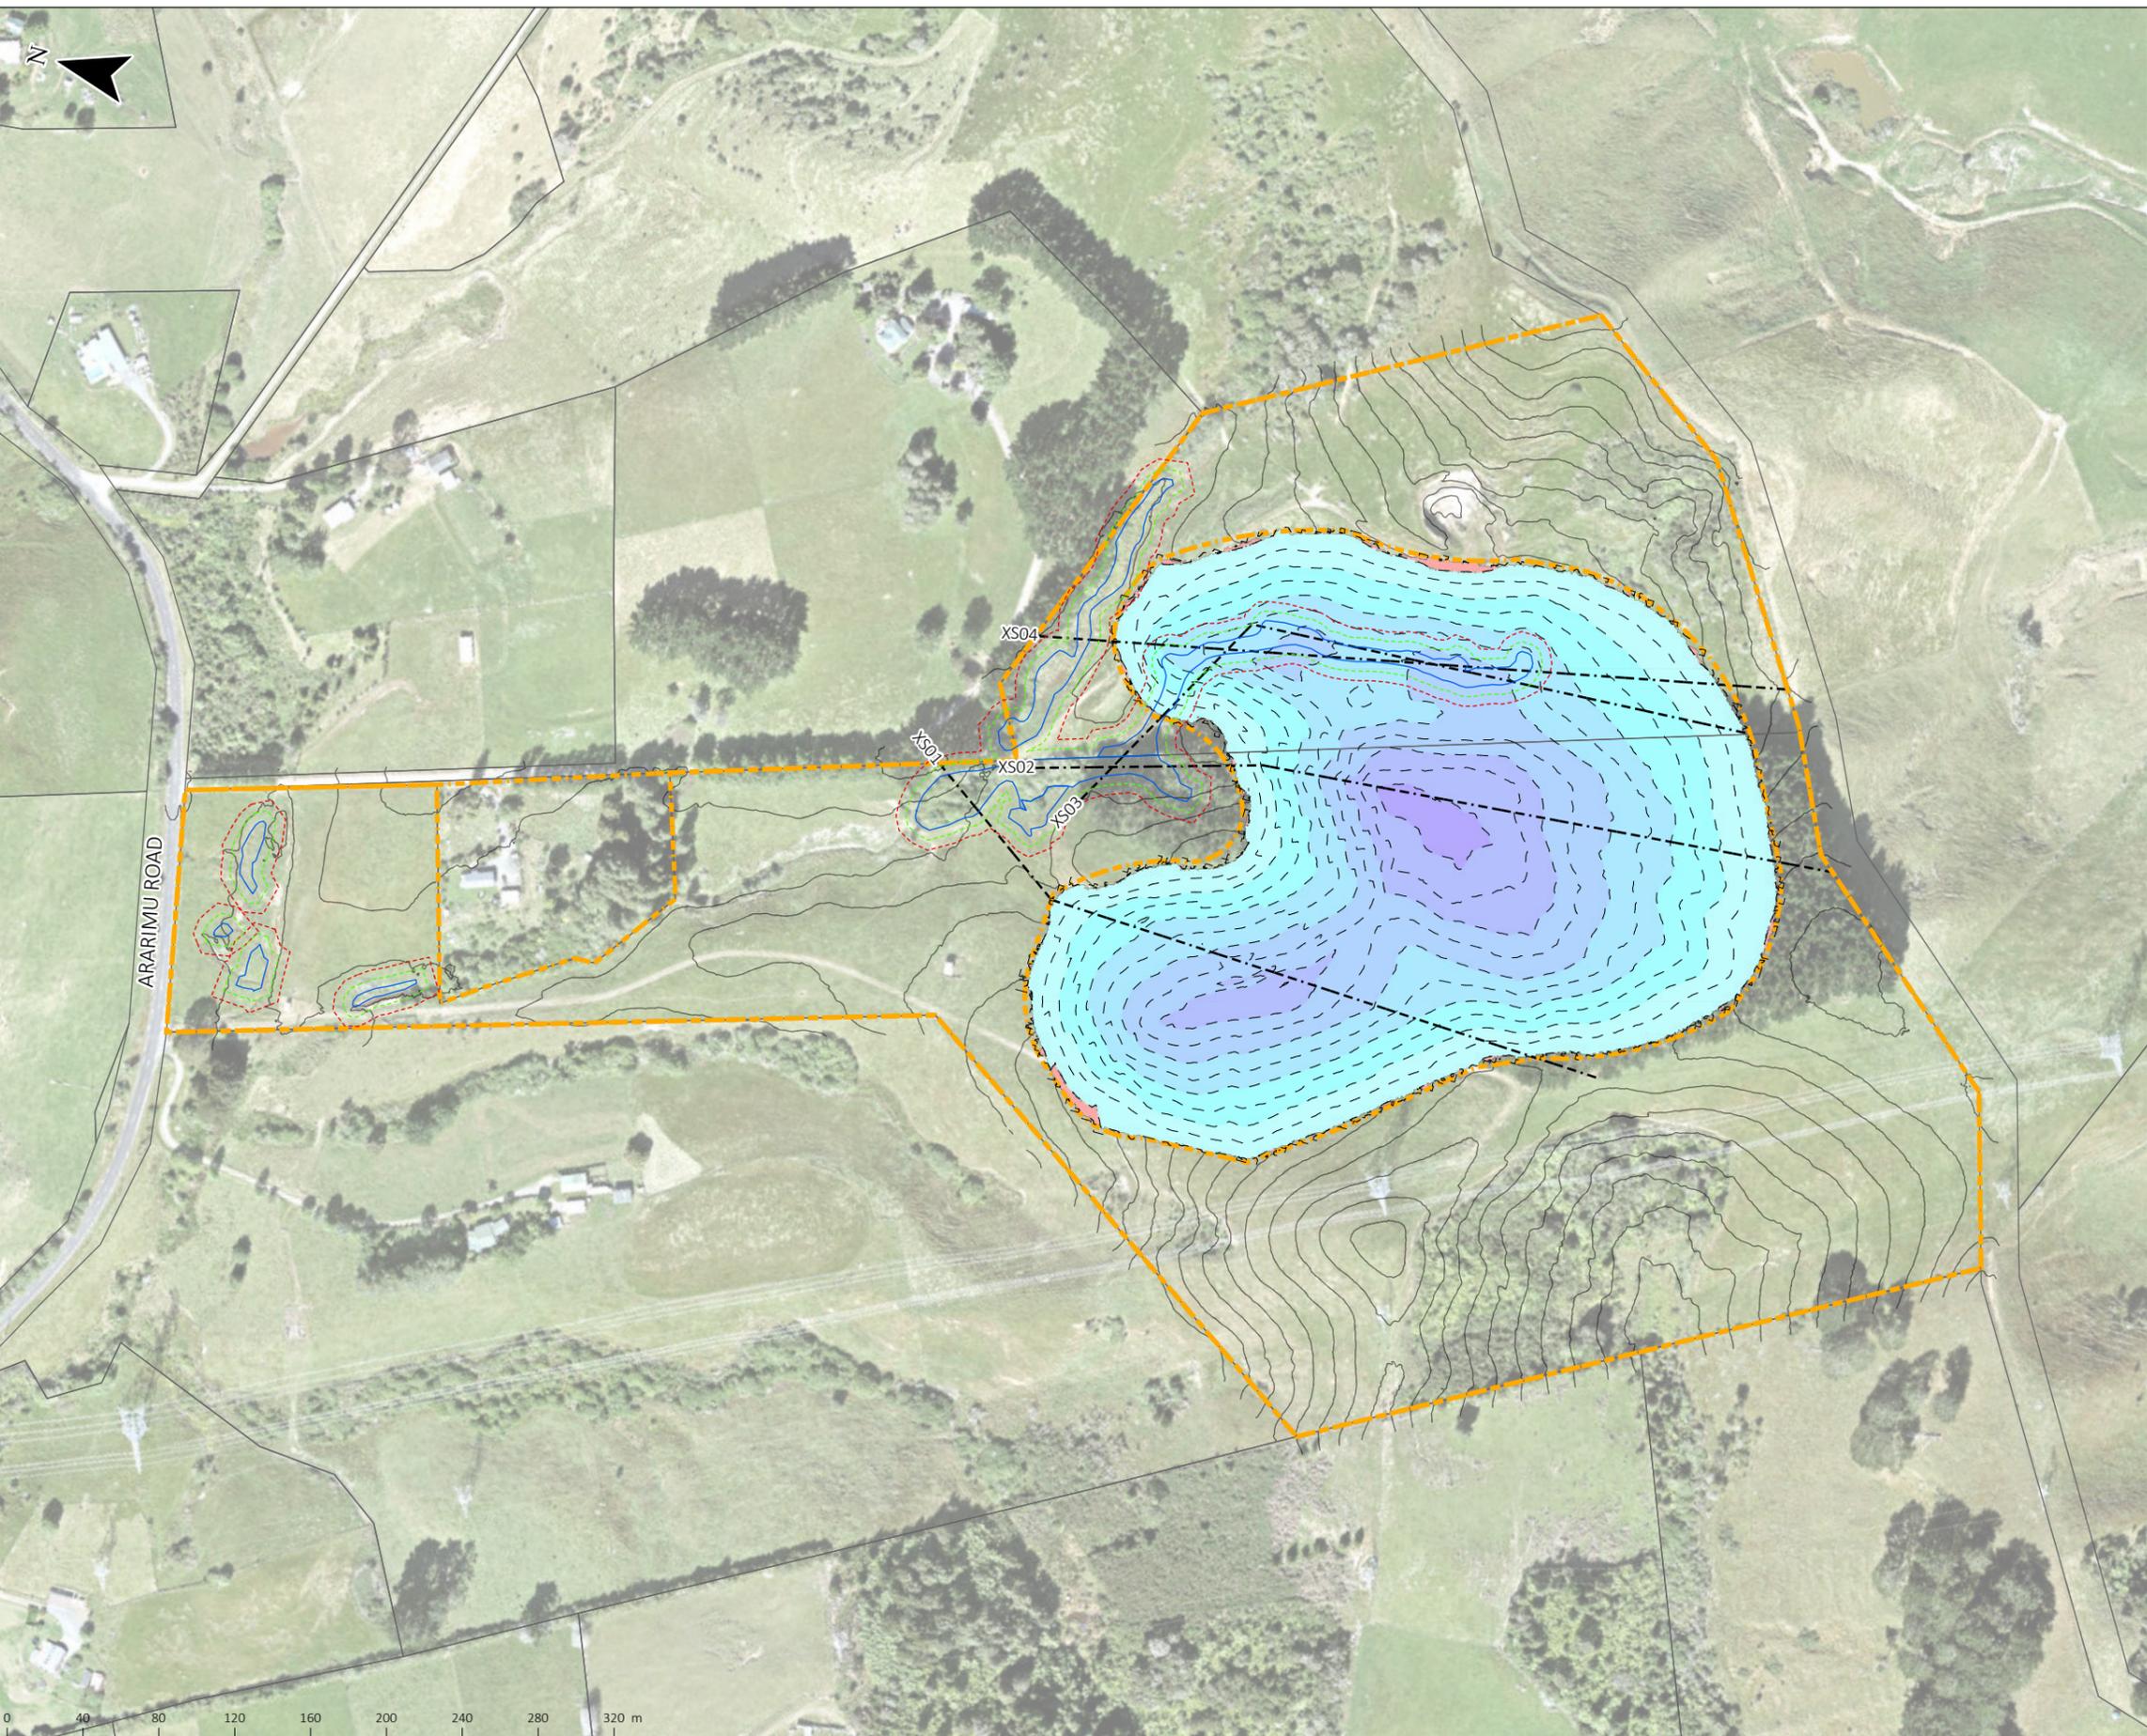
CUT FILL PLAN

EW ID	UNITS	EW001	EW002	TOTAL
AREA	m ²	93,611	272,753	366,364
CUT	m ³	421.3	0.3	421.5
BULK TOT. CUT	m³	421.3	0.3	421.5
MAX. CUT DEPTH	m	3.6	0.2	3.6
FILL	m ³	1,953,838.5	1.5	1,953,840.0
FILL +15% BF.	m ³	2,246,914.3	1.8	2,246,916.0
BULK TOT. FILL	m³	2,246,914.3	1.8	2,246,916.0
BULK CUT OFFSITE	m ³	-	-	0.0
BULK CUT TO FILL	m ³	-	-	421.5
BULK FILL IMPORT	m ³	-	-	2,246,494.5
BULK TOT. VOL.	m³	2,247,335.5	2.0	2,247,337.6
MAX. FILL HEIGHT	m	52.5	0.4	52.5
BULK TRUCKS	Trucks	-	-	374,416
TOPSOIL TOT. VOL.	m³	0.0	0.0	0.0
TOPSOIL TRUCKS	Trucks	-	-	0
EW TOT. VOL.	m³	2,247,335.5	2.0	2,247,337.6
EW TOT. TRUCKS	Trucks	-	-	374,416

A preliminary fill plan is provided in **Appendix A**.
