Geotechnical Assessment Report

Ararimu Road - proposed managed fill

Job Reference: BGL000170 v2.1

Report prepared for: SB Civil Limited

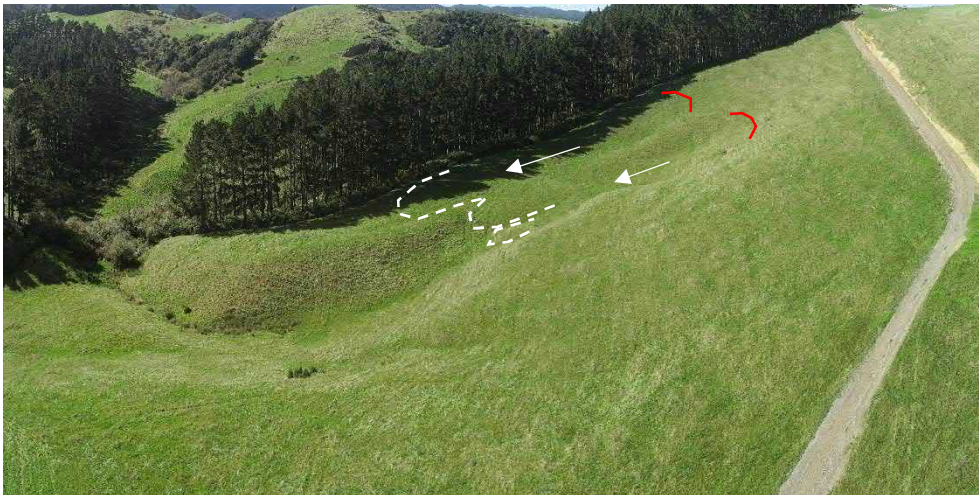
Photograph 2: Oblique aerial view of the Stage 1 western gully. Historic headscarp [red] and debris run out [white].

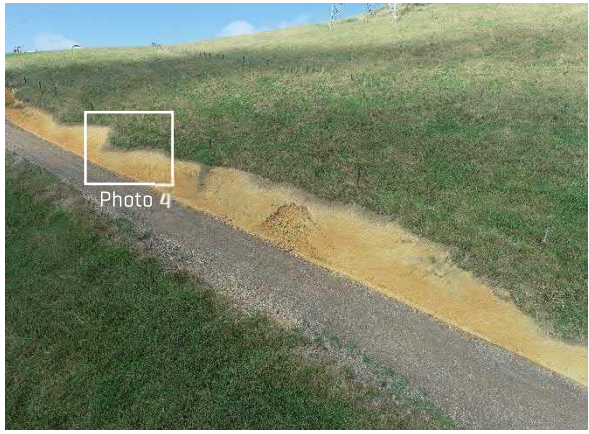
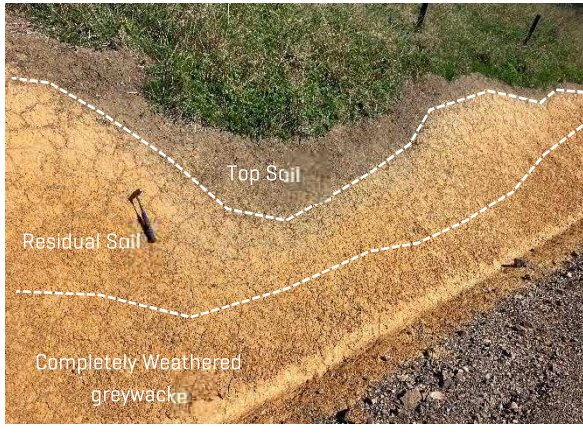
<p>Photograph 3: Exposed soils within access track batter.</p>	<p>Photograph 4: Close up view of photograph 3.</p>

- Topsoil: Approximately 0.4 m thick brown, soft, moist clayey silt with trace sand and rootlets [Photograph 4].
- Residual Soils: Approximately 0.8 m thick light brown, firm, moist clayey silt [Photograph 4].

- Completely Weathered Greywacke: Orange to reddish brown stiff wet silty clay and fine grained sand that extends down into the V-drain [Photograph 5]. Very closely spaced relict defect sets were observed with dark grey to black staining to surfaces. These materials could be remoulded with finger pressure.

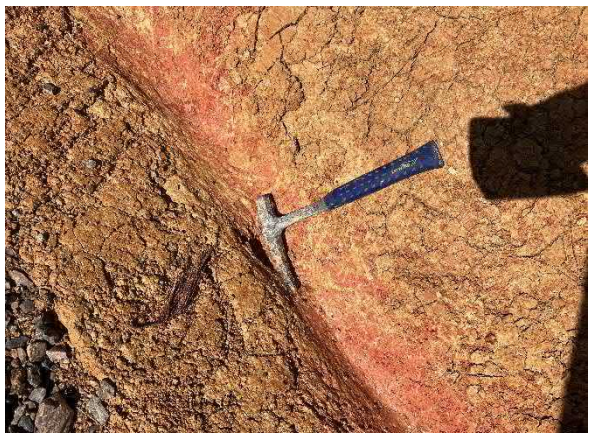
<p>Photograph 5: Exposed completely weathered materials in v-drain.</p>	<p>Photograph 6: Soils exposed upslope of drinking trough.</p>

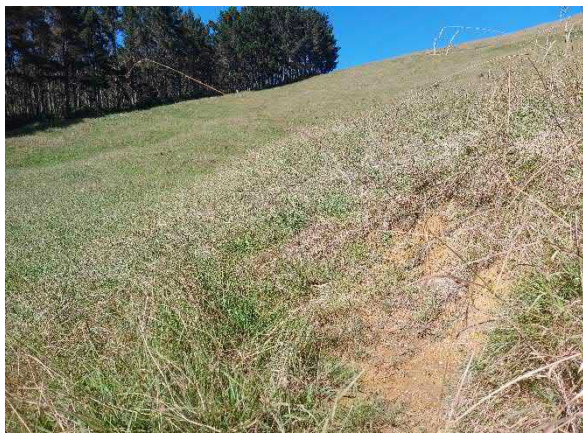
A farm stock trough is located approximately mid slope [Photograph 6] which has also exposed the topsoil and residual soils as per the above descriptions.

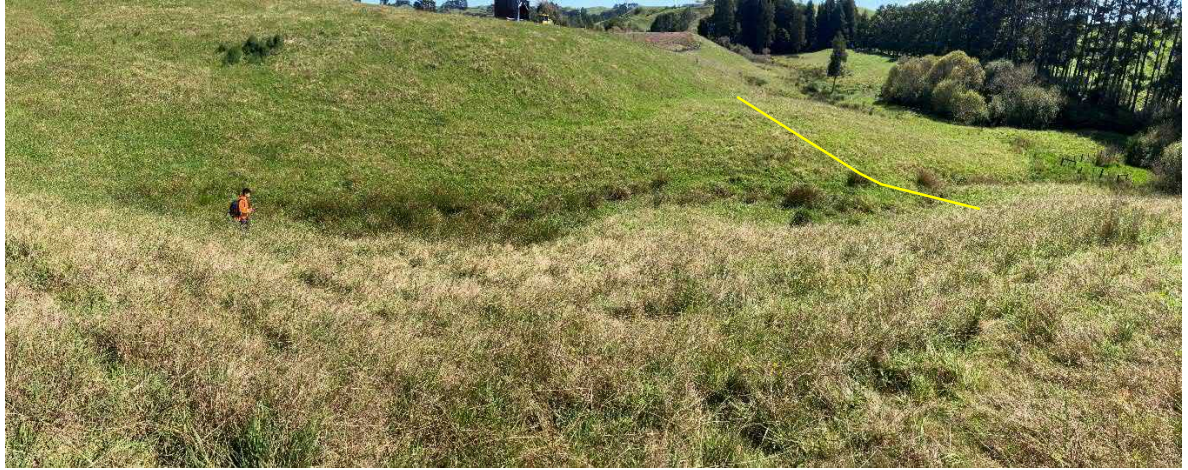
Photograph 7: Northwestern panoramic view of the western gully at approximate location of the proposed managed fill toe [yellow].

At the northern end of the western gully, the gully narrows to approximately 40 m wide with slope shoulders ranging from 8 m to 10 m high [Photograph 7]. A slightly incised surface water channel is located along the gully invert that is approximately 0.8 m deep and has exposed an orange light brown, soft, wet clayey silt.

At the northern extent of the western gully invert, within the vicinity of the proposed managed fill toe, surface water has incised a 1 m wide by 0.8 m deep open channel that is overgrown with grass and small shrubs. Flowing water was observed within the channel over a distance of approximately 40 m before the channel enters a wetland area. The channel water is estimated to have a flow rate of approximately 1 to 2 L/min.

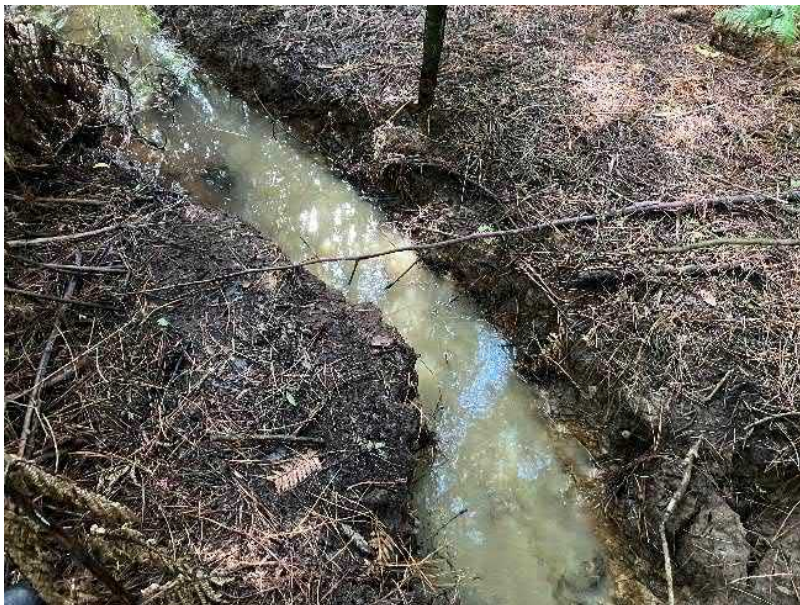
Photograph 8: Soil exposed within the central gully.

Due to the forestry block coverage, limited exposures of materials were observed along the slopes. However, material exposure included topsoil where the slope angle transitioned onto the gully floor. Materials exposed across the central gully floor included saturated clays and silts with decaying vegetation [Photograph 8].

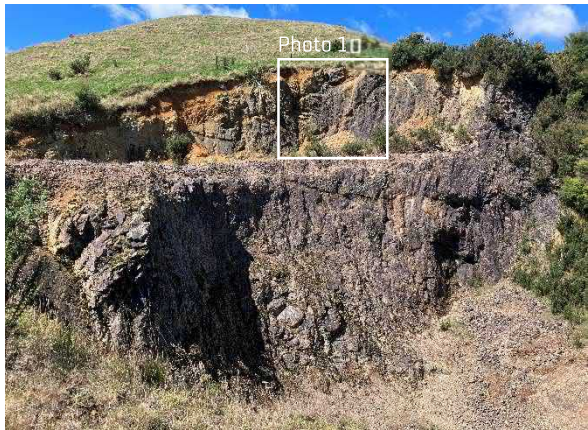
The quarry includes two batters with an overall height measuring 16 m [Photograph 9]. The exposed materials typically include a slightly to moderately weathered, moderately strong sandstone and siltstone. The closely spaced defect sets range from moderately steep to very steeply inclined [Photograph 10]. The three primary defect sets [dip/dip direction format] are summarised as follows:

<p>Photograph 9: Exposed materials upslope of the eastern gully</p>	<p>Photograph 10: Rock and soil exposure from the upper batter.</p>

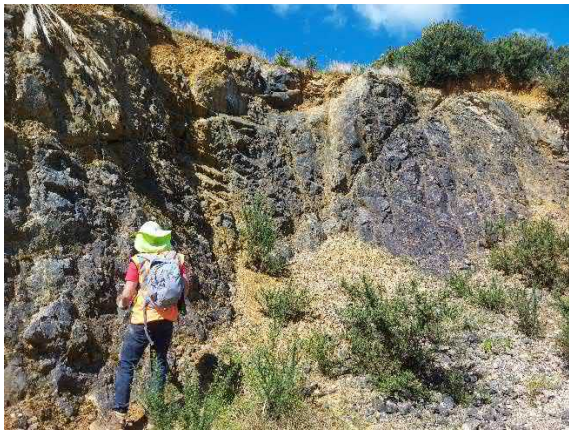
- Set 1: 49°/122 – Lower batter, through going persistent feature.
- Set 2: 72°/082 – Upper batter, through going persistent feature. Moderately wide with dry sand infilling.
- Set 3: 42°/264 – Lower batter, cluster of joint sets daylighting out of the batter.

The depth of residual soil along the crest of the upper bench is 0.6 m.

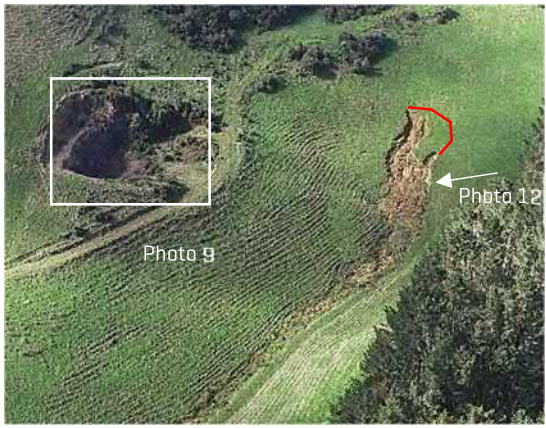
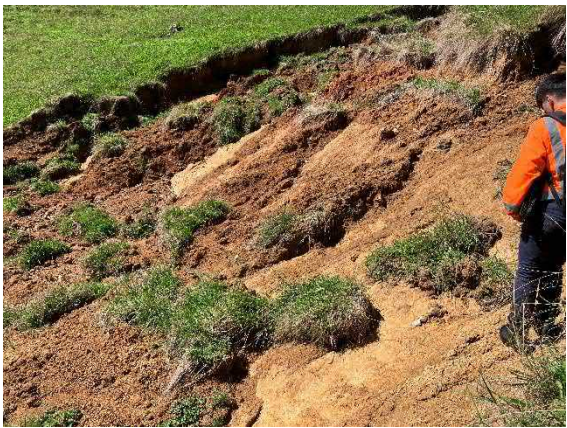
<p>Photograph 11: Recent slope instability on neighbouring property between the quarry and the forestry block. Red line indicates a 50mm tension crack.</p>	<p>Photograph 12: Materials exposed within the recent landslip upslope of the eastern gully.</p>

A tension crack is aligned from the true left lateral scarp and can be traced approximately 50 m to the headscarp [Photograph 11]. The 50 mm wide tension crack has a vertical offset of 100 mm.

Saturated evacuated silt and sand materials have inundated the gully floor for approximately 200 m.

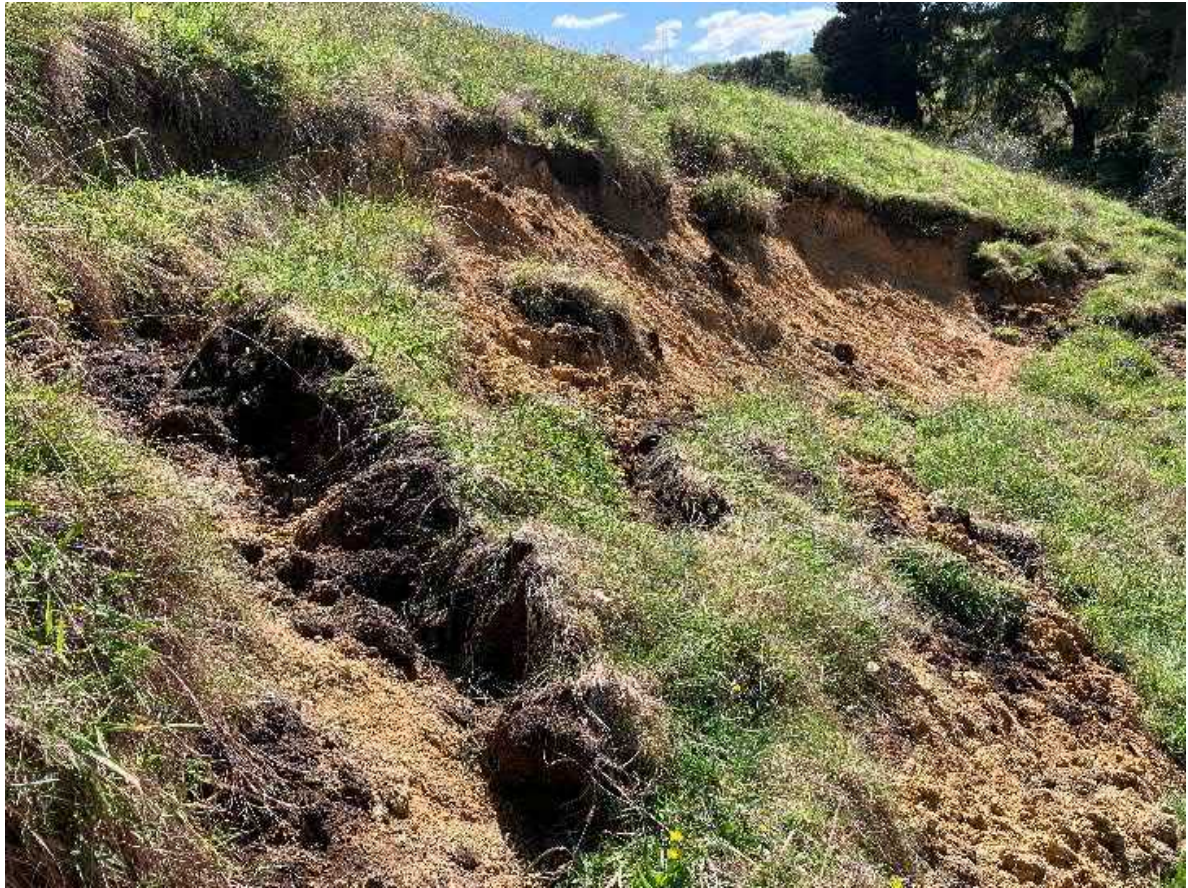
Photograph 13: Landslip north of the proposed office and parking area.

A recent landslip feature was observed within the property boundary north of the proposed office, parking and weigh bridge area [Refer to Appendix B & Photograph 13]. The instability is located mid slope between the access track and the gully invert. The toe of this feature has bulged into the stream channel forcing the stream to flow around it.

The soils exposed in the headscarp include 1.0 m to 1.2 m of residually weathered orange brown clayey firm silt. Beneath the silt, a lightly cemented whiteish light grey pumiceous silty sand is thinly laminated with bedding surfaces dipping towards the northeast at 35°/060.

This landslide is well to the north of the proposed toe of the managed fill area.

Localised shallow soil instability features exist across the side slopes and head of the three gullies. The soft soils in the floor of the three gullies are considered to be locally sourced reworked clay and silt materials that previously inundated the surface water channels, allowing for recent swamp environments to form upslope. A small scale version of this was observed on site, refer to Photograph 13.

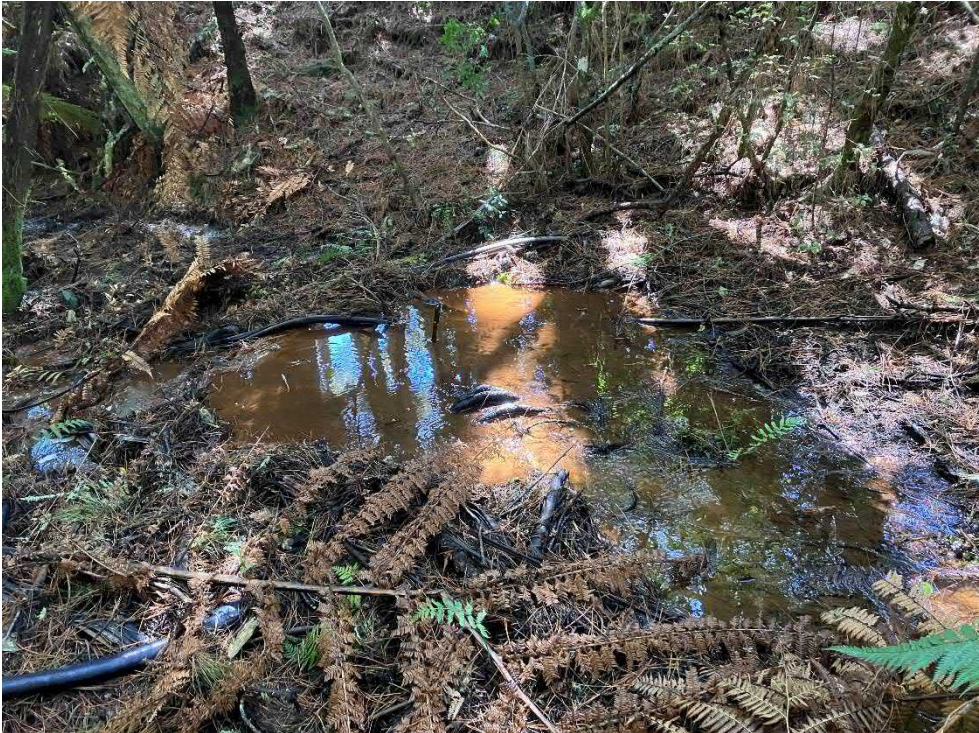
Photograph 14: Water observed in the central gully.

The gully floor is primarily standing pooling water with saturated fine-grained materials forming damming features [Photograph 14]. Seepage is observed at the northern extent to range from approximately 3 to 5 L/min where the gully enters a wet land.

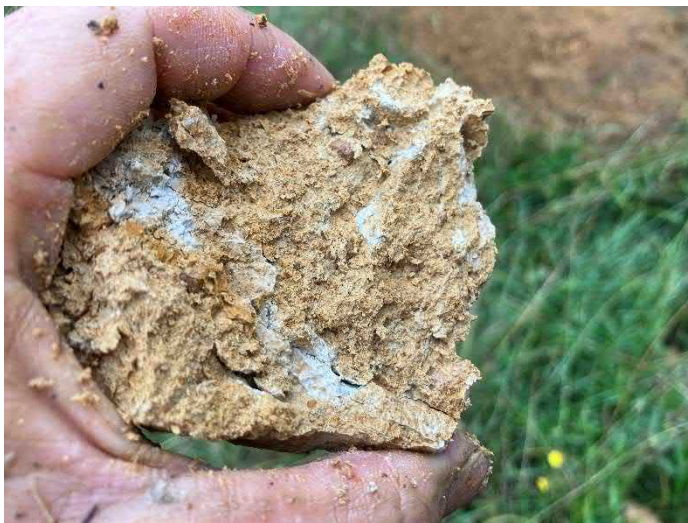
Photograph 17: Orange brown silty clay recovered from TP23-04 at 3 m bgl.

Light brown and grey, moist, firm to stiff silty clay and clayey silt with orange mottling was encountered in TP23-01, TP23-02, TP23-04 [Photograph 17], TP23-09 typically down to 3 m bgl to 4 m bgl. These test pits are located within gully floors. The samples can be remoulded into a ball between thumb and forefinger.

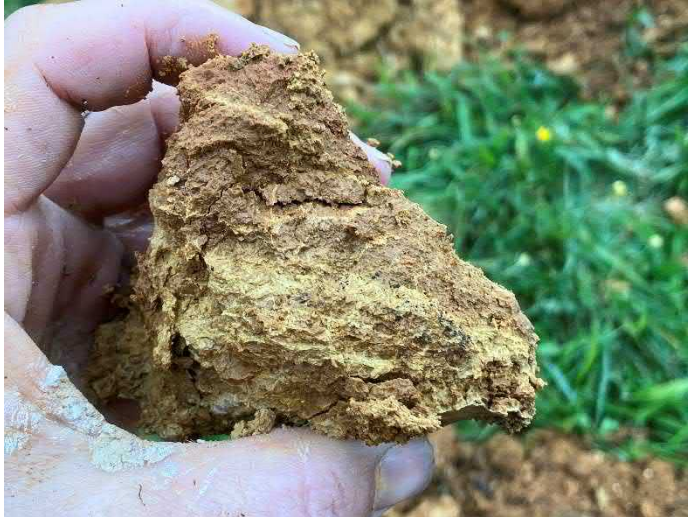
Photograph 18: Orange brown silty clay recovered from TP23-05 at 3 m bgl.

Orange brown moist stiff to very stiff silty clay and clayey silt with limonite staining was encountered in TP23-03 to 3.8 m bgl, TP23-05 to 6.3 m bgl [Photograph 18] and TP23-08 to 1.5m bgl. These test pits are located at similar elevation on the muted ridge lines between gullies.

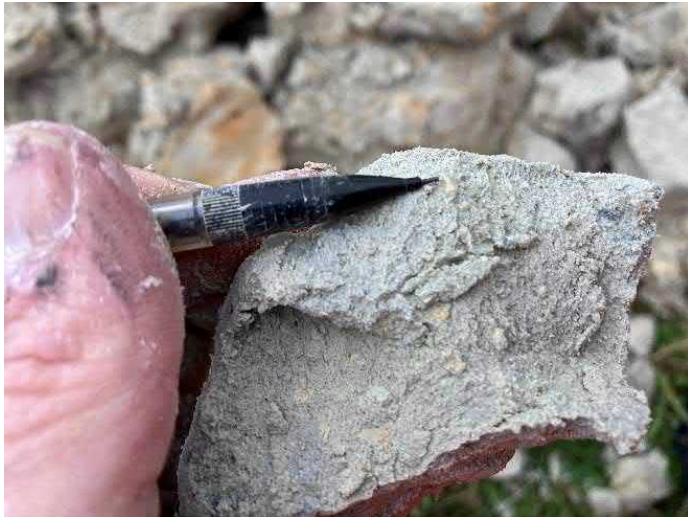
Photograph 19: Floating pumice clasts within a grey moist sand matrix.

Pumiceous deposits included light grey to white fine to coarse sandy silt and silty sand with fine to medium pumice gravels recovered from test pits located within the gully floors [TP23-01, TP23-02, TP23-03, TP23-05, TP23-06 and TP23-09] and in HA23-01. Orange-brown silt laminations were observed in these materials. When moist or dry, the silts were stiff to very stiff as observed in TP23-01 [Photograph 19]. However, when saturated in thin beds with increased silt and clay ratios as observed in TP23-03 and TP23-05 located above the gully invert, the materials transitioned to soft [TP23-05] and very soft [TP23-03] and are easily indented with finger pressure [Photograph 20]. The fine grained sand materials recovered from the hand auger were saturated.

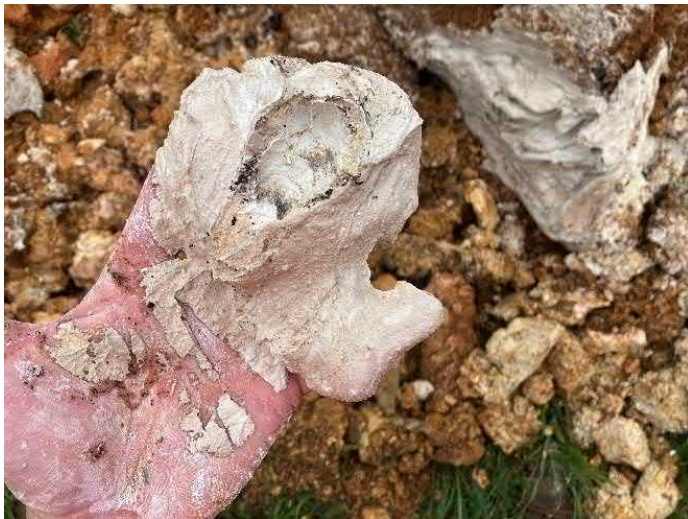
Photograph 20: Saturated clayey silt pumice derived materials TP23-03 at 6.0 m bgl.

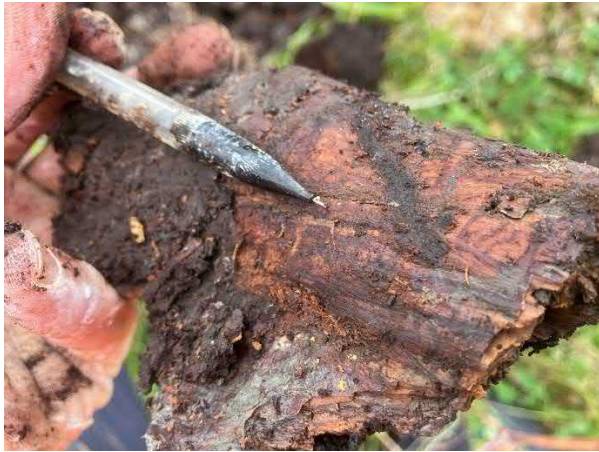
Photograph 21: Fibrous organics from TP23-01.

The fibrous organic matter recovered from these test pits ranged from 20 mm to 50 mm in diameter, had a strong organic odour [Photograph 21] and expelled water when squeezed.

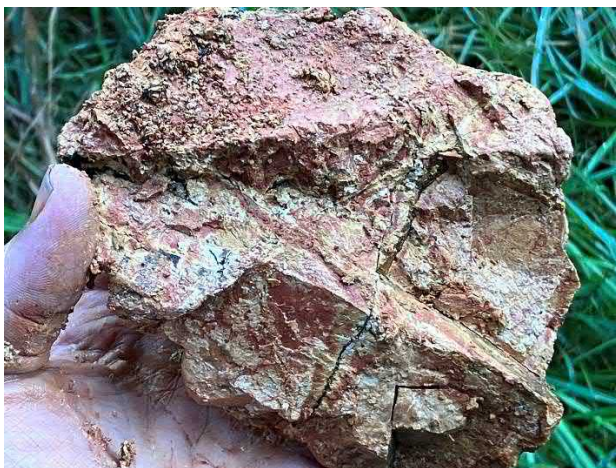
Photograph 22: Completely weathered greywacke material from TP23-07.

Completely weathered to highly weathered siltstone greywacke materials were recovered from TP23-07 below 2.2 m. Relict defect sets were closely spaced with surfaces weathered to clays [Photograph 22]. The reddish orange brown siltstone is extremely weak and can be remoulded to a very stiff clayey silt under hand pressure.
