Geotechnical Investigation

15 - 17 Amaru Road

Onehunga

17137.000.000_01

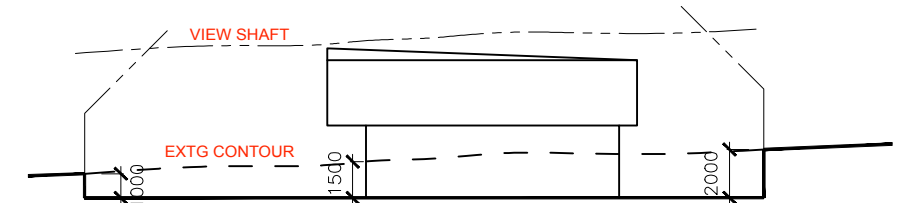
1 1:300 Plan
Initial Design Test

2 1:300 Section
Initial Design Test

ZONING: MHS
SITE AREA: 1,793 SQM (2 SITES)
UNIT NUMBER: 11
CAR PARK: 11

ENGEO has been provided with the TT Architects Limited bulk and location plan dated, 12 February 2020 (reference: 220001) as attached in Appendix 1. The drawing indicates that the proposed development comprises the construction of four residential units within the north-western half of the site fronted to Amaru Road, seven residential units within the south-eastern portion of the site fronted to 13 Amaru Road via an access way / driveway along the western property boundary.

We have also not been provided with any proposed cut fill earthworks plans, however, the initial concept plan indicates that cuts of up to 2.0 m are proposed for the block of seven units located within the south-eastern portion of the site in order to achieve desired design levels. In addition, fills in excess of 1.0 m may be required within the south-eastern portion of the site subject to final finished floor levels.

Initial development plans indicate that cuts of up to 2.0 m will be required to achieve design levels of the proposed development as shown on Cross-Section A presented on the TT Architects Ltd plan (Appendix 1).

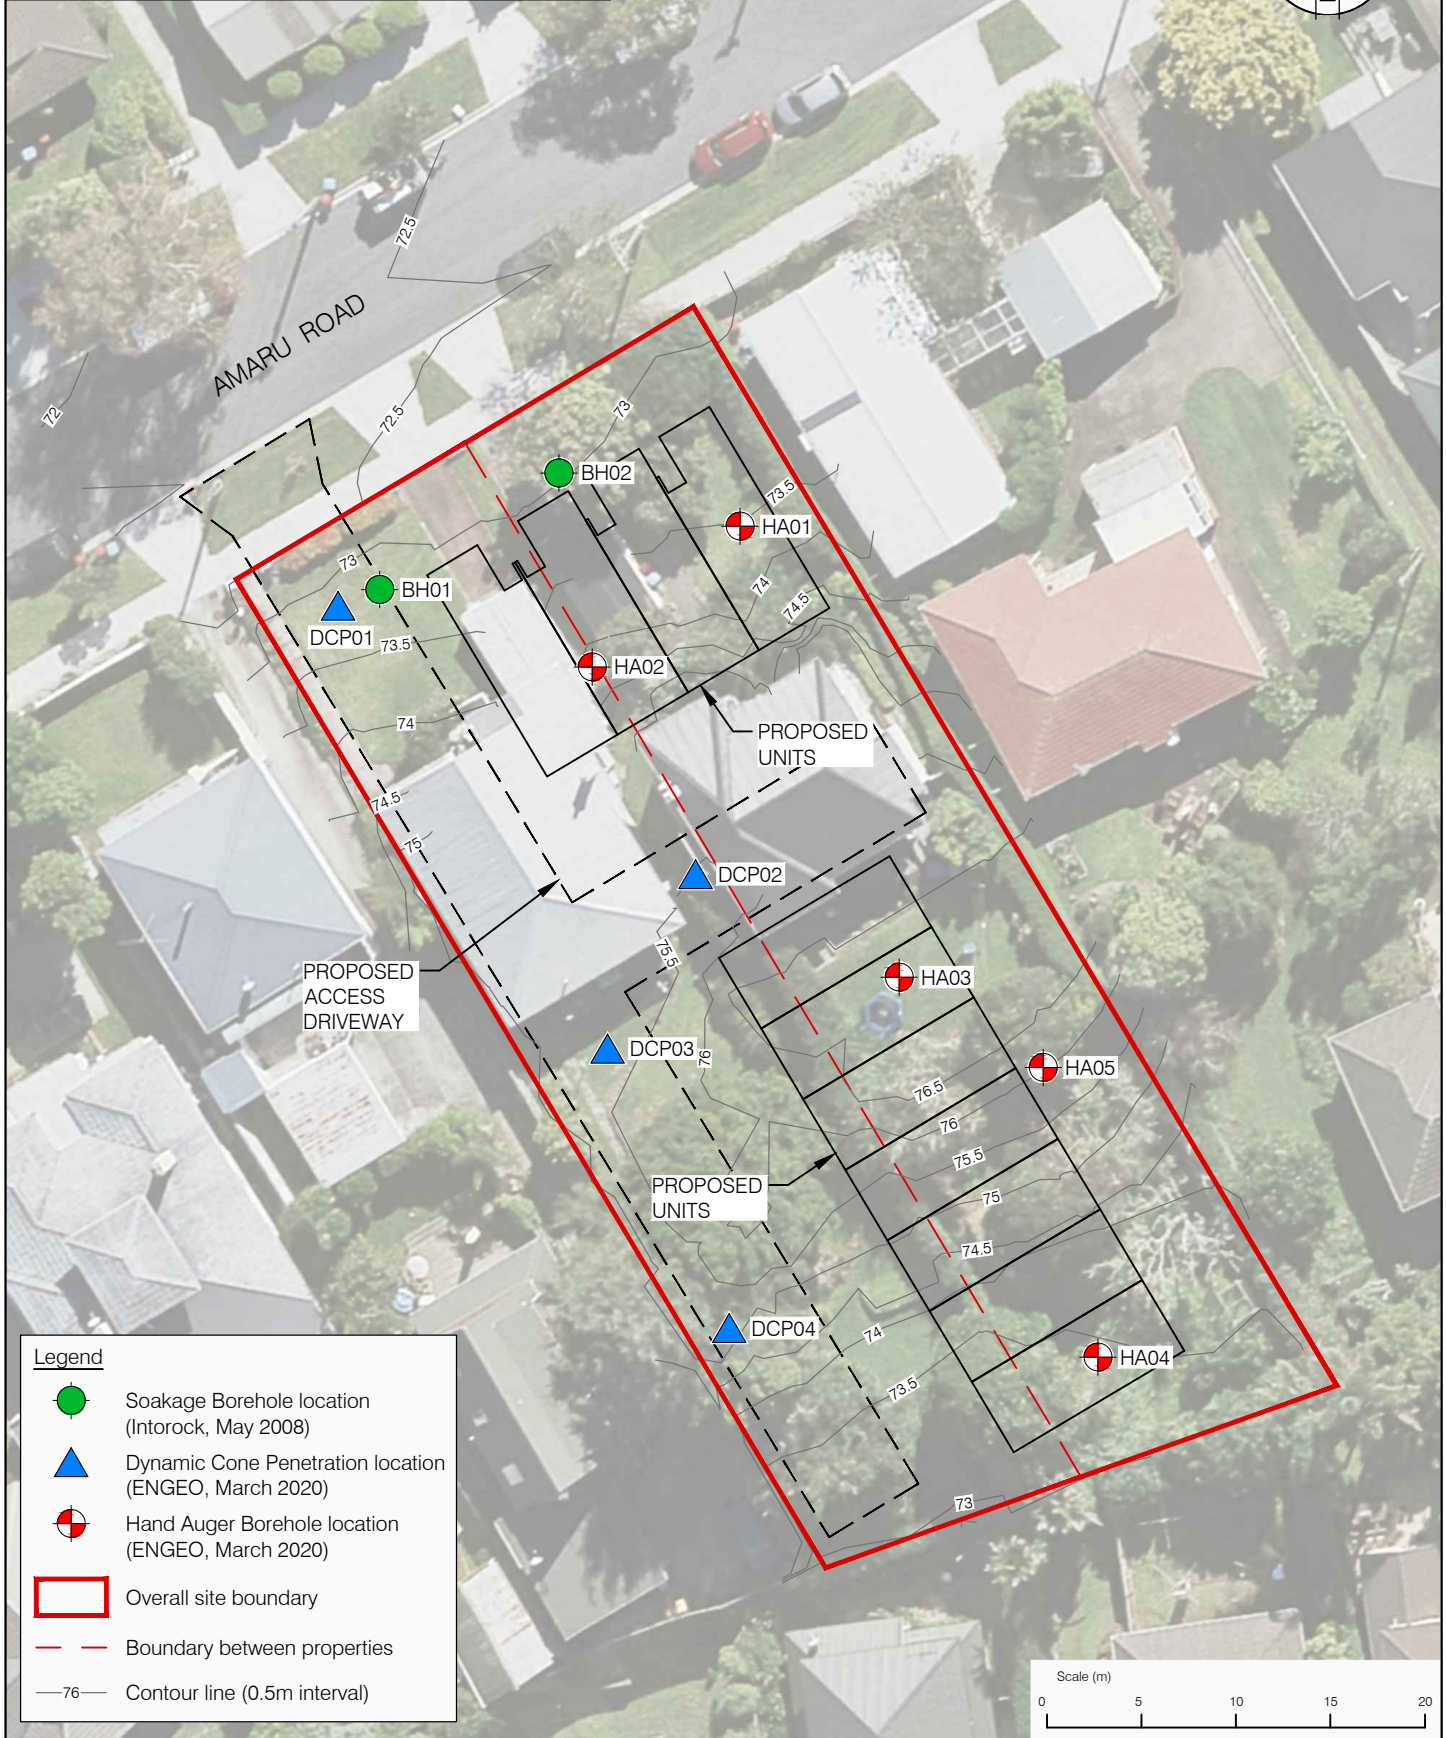
Title: **INVESTIGATION LOCATION PLAN**

ENGEO attended site on 9 March 2020 and completed a site walkover and subsurface ground investigation. The subsurface investigation comprised of five hand auger boreholes drilled to refusal encountered at depths between 0.3 m below ground level (bgl) and 1.9 m bgl and four dynamic cone (Scala) penetrometers test to 0.9 m bgl. These investigations were completed within the general footprint of the proposed development and the location of the testing undertaken has been presented on the Investigation Location Plan (Appendix 2).

Intorock Drilling Ltd have previously completed soakage testing at the site on 5 February 2008 within BH1 and BH2 located within the north-western portion of the site as presented on the Investigation Location Plan (Appendix 2). Intorock Drilling Ltd re-visited site on 9 March 2020 to re-test the soakage rates within BH1 and BH2 to confirm that soakage test results are consistent with those previously obtained in 2008. Soakage tests results from 2008 and 2020 are presented within Table 2 of this report and the full borehole and soakage results from the above testing are presented in Appendix 5.

As discussed within Section 5.1 of this report, Intorock Drilling Limited has previously undertaken soakage testing on 5 February 2008 within BH1 and BH2 (presented on the attached Investigation Location Plan) and re-visited site on 9 March 2020 to re-test the soakage rates within BH1 and BH2. The soakage test results from the testing completed in 2008 and 2020 are presented below within Table 2.
