**Onehunga Wharf: Specialist  
report to support an  
Occupation Permit application**

**Prepared for**  
Eke Panuku Development Auckland (EPDA)  
**Prepared by**  
Tonkin & Taylor Ltd

**Date**  
August 2024  
**Job Number**  
1094624 v2

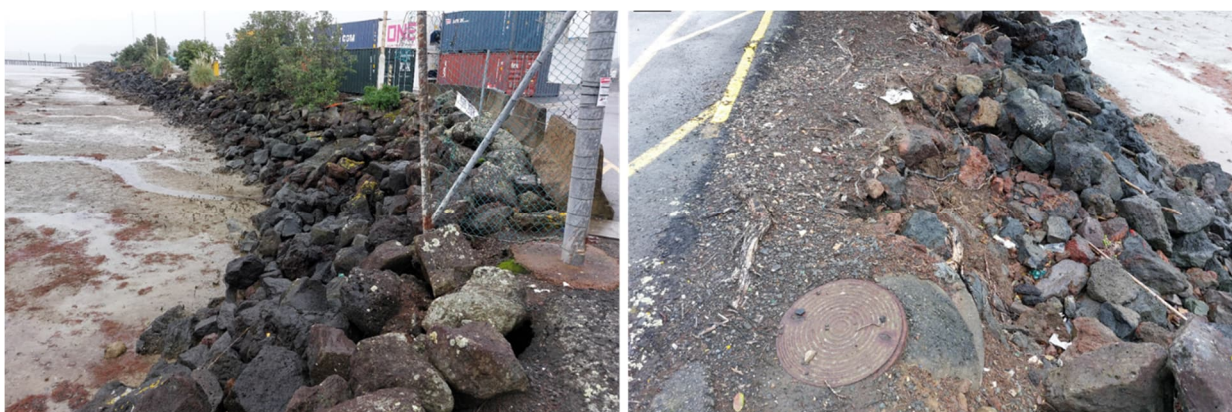
*Photograph 2.2: Rock armoured edge of inner berthing area.*

Onehunga Wharf protrudes from the land along the edge of the channel to Māngere Inlet and has a perimeter of approximately 500 m. The site comprises a large wharf which consists of three separate structures constructed over a period between 1923 and 1962 and a reclamation edged with a combination of grouted rock walls and rock armour revetments. The wharf structures generally comprise reinforced concrete piles and headstocks with beams in two directions and diagonal bracing providing lateral constraints. A timber fender system extends around the perimeter of the wharf face. The wharf structures are in moderate to poor condition. The deck of the wharf is around 3.0 to 3.4 m AVD so is likely to be subject to increased inundation with sea level rise. Inland of the wharf the reclamation is likely formed from at least 4 metres of gravel fill overlying around 3 m of marine sediments that overly stiff volcanic tuff at greater depths. The reclamation and shoreline are protected with a rock armoured edge and grouted rock seawalls. The surrounding area has a mixture of different coastal protections in place ranging from rock armouring to grouted rock wall as well as unmodified sections undergoing erosion.

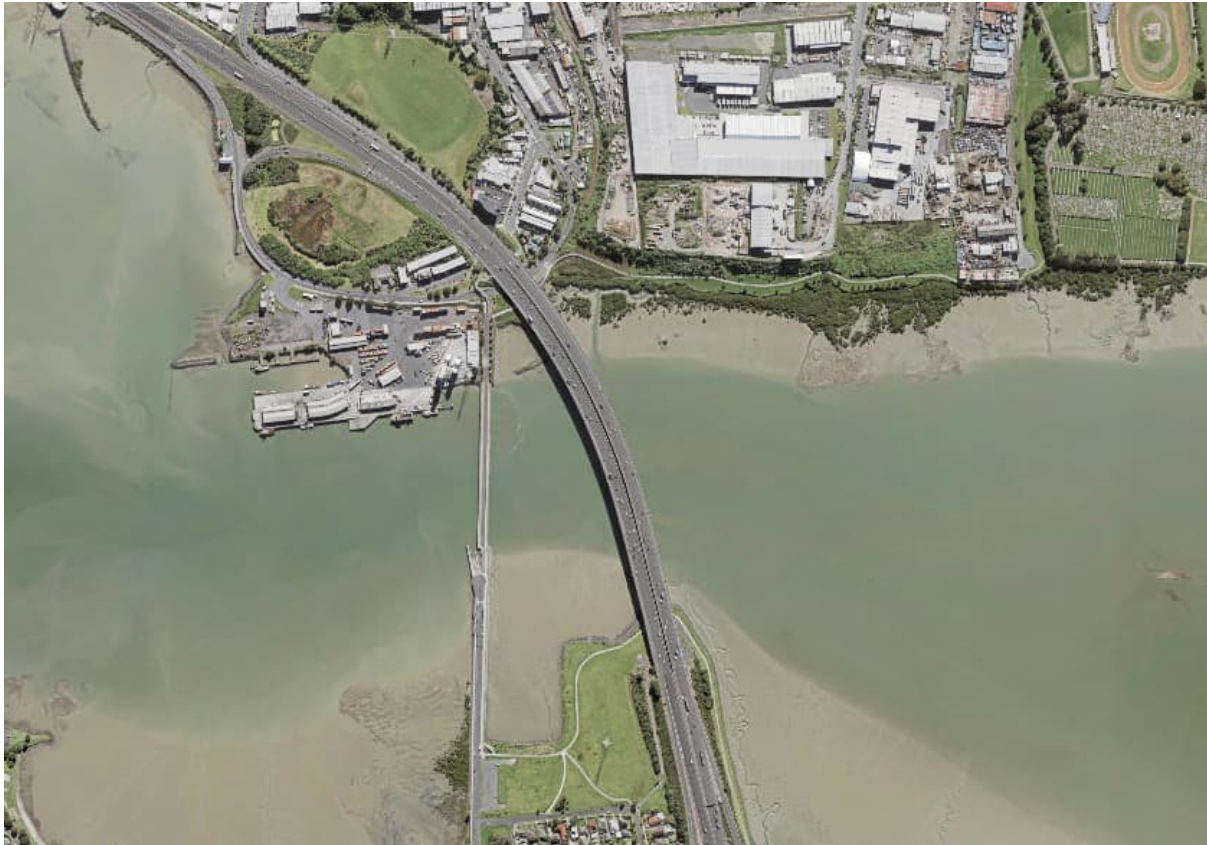
Figure 4.1: Aerial image of Port of Onehunga, SH20 and the mouth of Māngere Inlet (Source, Auckland Council GeoMaps, 2024).

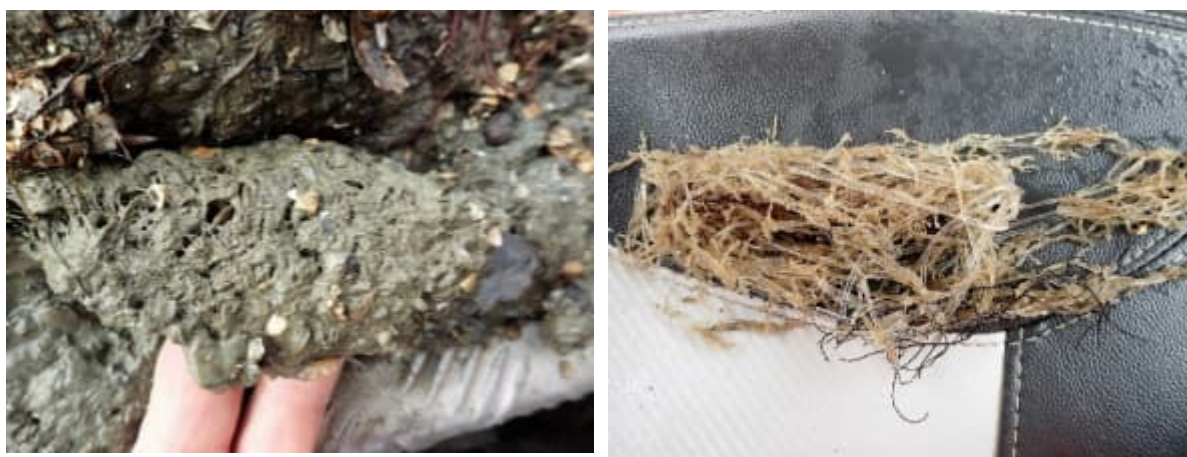
Figure 4.4: Bed mat of Asian date mussel (*Arcuatula senhousia*) and *Amathia verticillata* in the Manukau Harbour (Tupe et al., 2020).

A targeted marine pest survey was carried out in the Manukau harbour in 2019 and identified no primary target species, one secondary target species (Asian date mussel - *Arcuatula senhousia*) and eight non target NIMS at the Port of Onehunga (Appendix E) (Tupe et al., 2020). No further species were identified from the Marine Biosecurity Porthole records. Results for the wider Manukau harbour detected no primary target species, one secondary target species (Asian date mussel) and 14 non target NIMS (Figure 4.4; Tupe et al., 2020).
