BROADCASTING CORPORATION OF NEW ZEALAND TRANSMITTER STATION - ID 00056

2-12 Selwood Road, Henderson

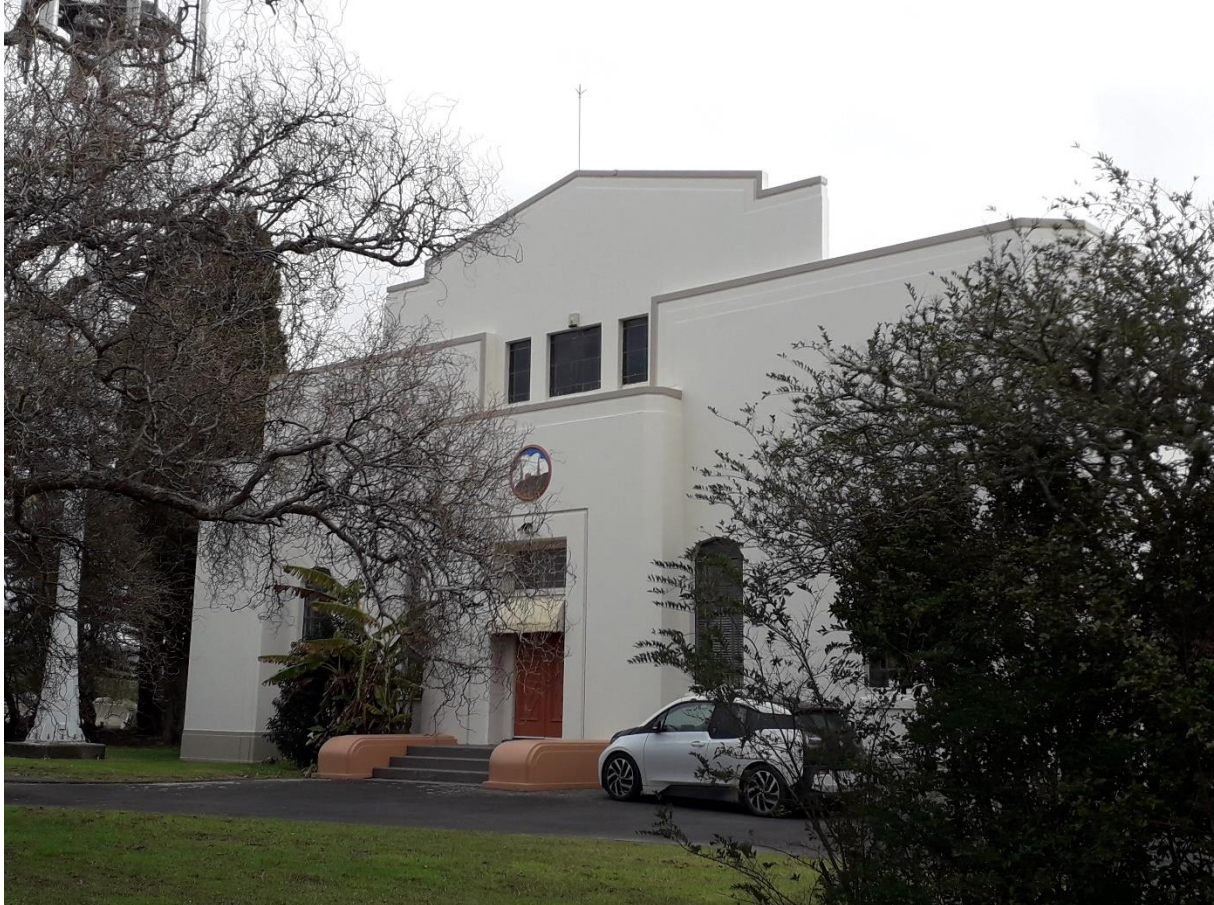
Figure 1: Broadcasting Corporation of New Zealand Transmitter Station (Auckland Council, 6 August 2020)

The transmitter station is essentially a large rectangular gable-roofed structure with an elaborate Art Deco parapet and façade. The front façade is broken into three stepped masses: at the rear is a central, flat pediment-topped parapet wall, punctuated with three steel windows. The parapet was originally lettered with “Broadcasting Service”, but this has since been removed. The middle mass, forward of the flat parapet wall, wraps around either side of the building, stopping short of meeting in the middle to frame the three windows of the rear massing. These massings have chamfered corners and are punctuated by two hexagonal-arched steel windows on each side. The front mass is broken into three: two wrapping around either side of the building with chamfered corners, and one centred in the front façade and containing the entrance.

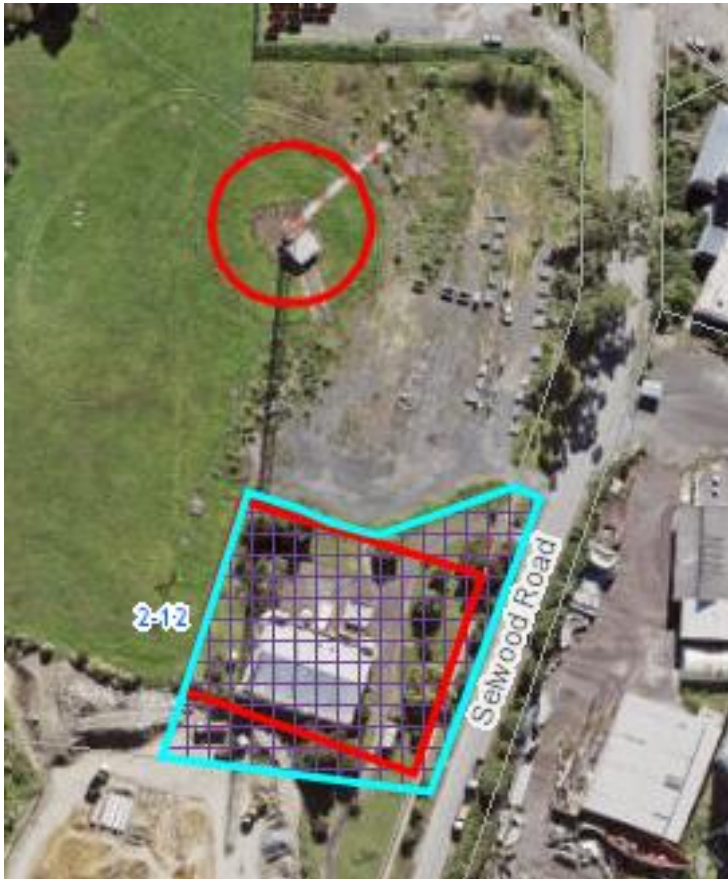
Figure 3: Proposed EOP (red line) for ID 00056 (Auckland Council GeoMaps)

- The current extent of place extends over a semi-circular driveway and into the road reserve. Historic aerial photography from 1940 and 1959 indicate that the driveway is a recent feature and does not need to be managed. The transmitter station originally had a straight driveway leading from the front entrance directly to Selwood Road. The vegetation in the verge is also more recent.
- Although the place has identified aesthetic values, these values are not best appreciated from Selwood Road, and therefore the EOP does not need to extend into the road reserve.

- The EOP proposed below aligns with a historical boundary. The 1940 and 1959 aerials show a distinct “yard” that is clearly defined around the transmitter station. It is proposed the EOP align with the boundaries of this yard.
- In addition, the EOP should be extended to include the transmitter mast, as this is an original and key component to the historical and technological significance of the place. The space between the transmitter station and mast does not need to be managed, and therefore a non-contiguous EOP is proposed.

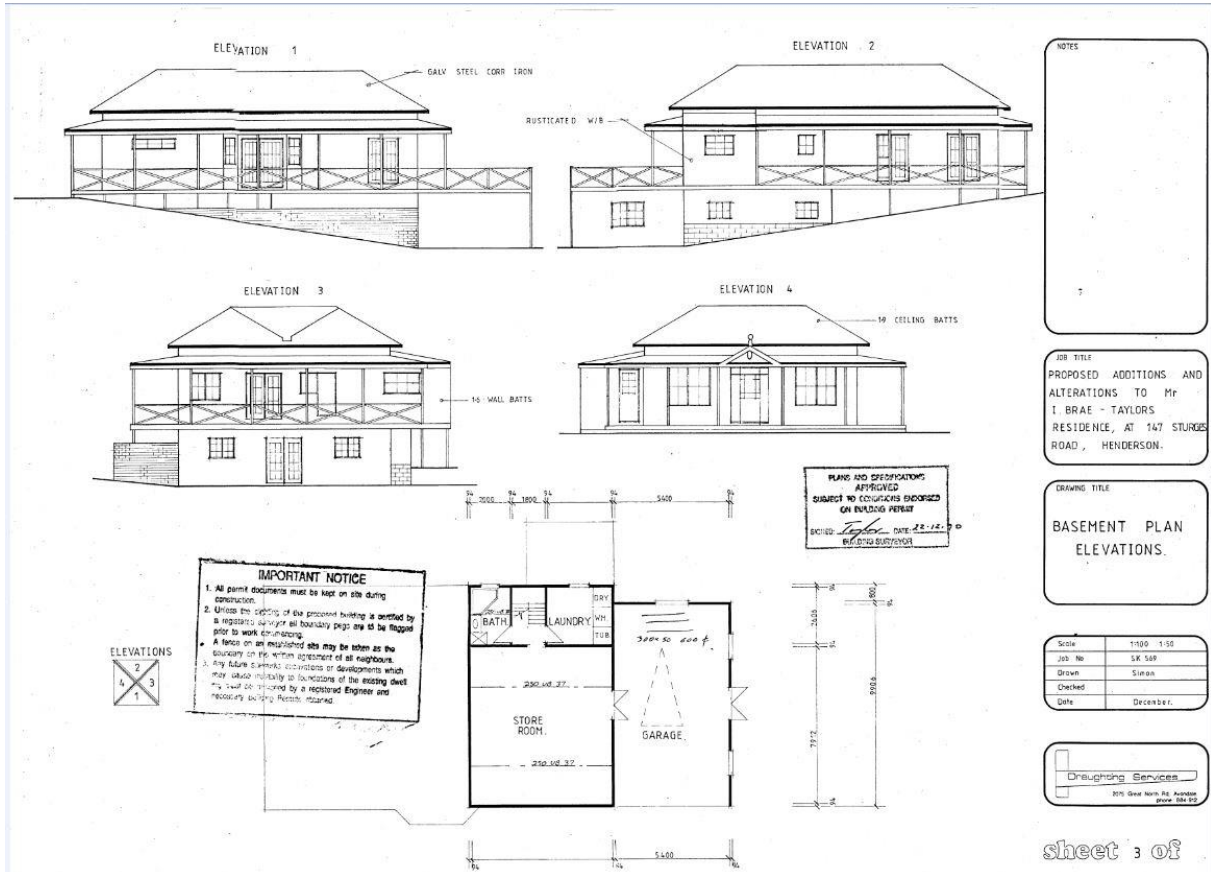
APPENDIX 3: The drawings from 1990 showing the proposed addition and alterations

The alterations are including a basement addition, rear extension, and a new entryway with decorative gabled roof.

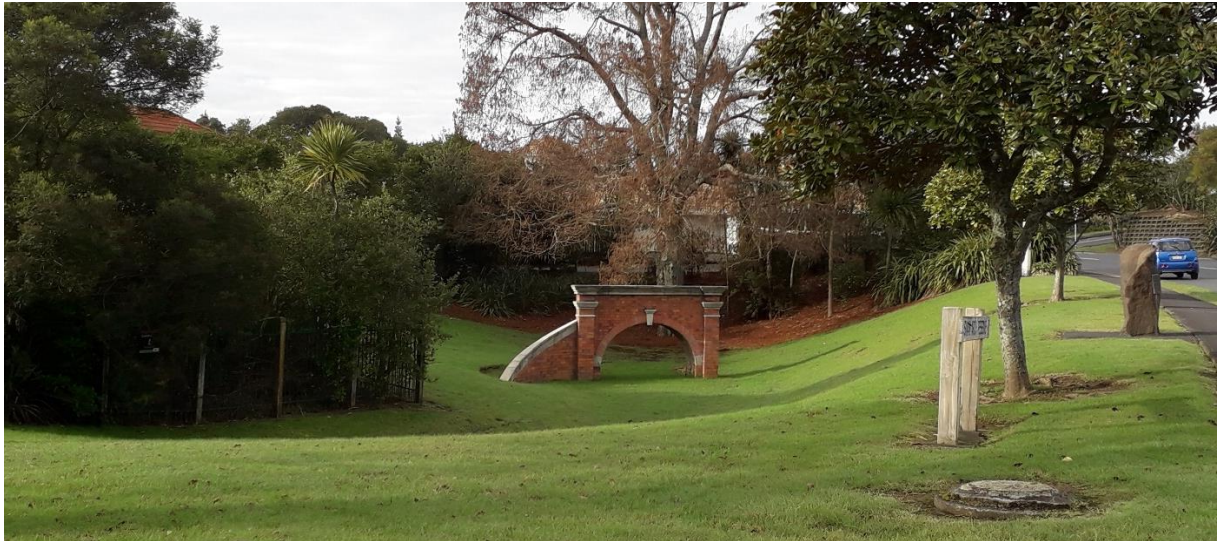
Figure 8: Swan Arch, viewed from the footpath at the northern end of the park (photo by author dated 27 July 2020).

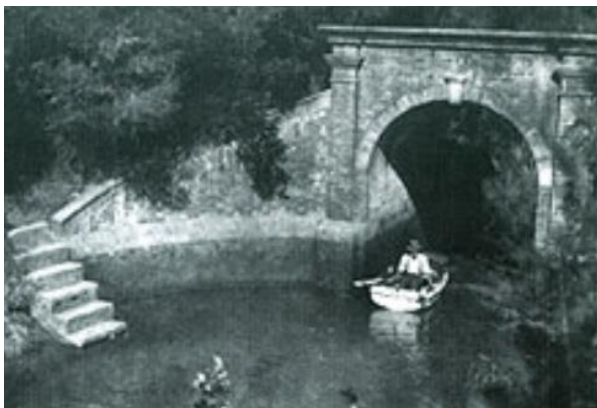
Figure 3: Historic photo of Swan Arch, showing original depth of structure. Steps lead down to the pool area where people can be seen swimming. Photo courtesy of www.geocaching.com

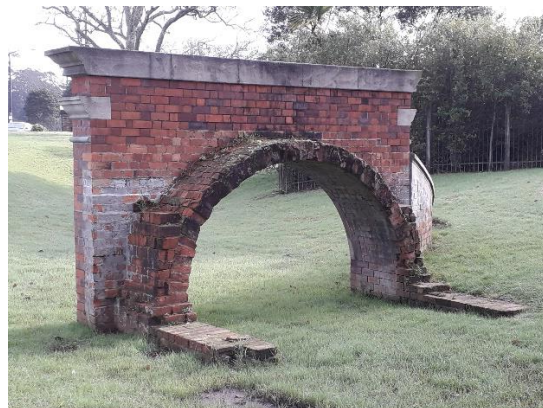
Figure 4: Rear view of Swan Arch showing the truncated vault structure with lower walls still present. In the background is the fenced-off vault.

Also associated with the arch is a large brick vault (to the north-east of the arch) which is currently fenced off due to substantial collapse of the roof. It is believed that this vault was created by Swan to store his collection of books. Around 1921 a fire swept through Swan's property and destroyed his storage hut, and it is thought that the vault was subsequently constructed as fire-proof storage for

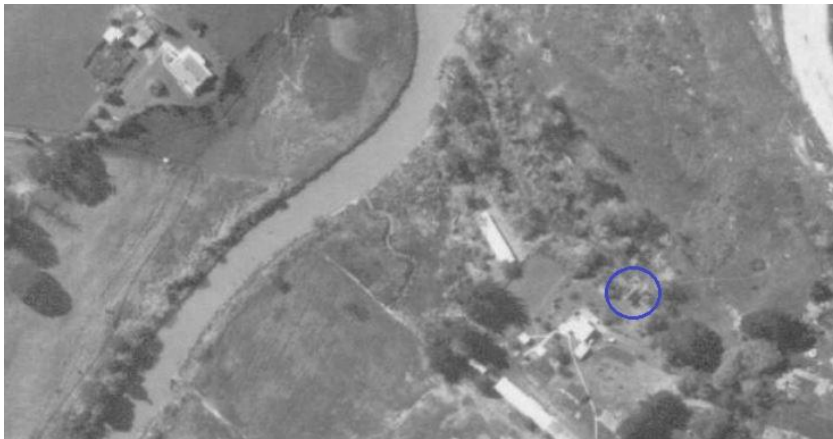
Figure 5: 1959 aerial photograph showing the arch circled in blue (Auckland Council GeoMaps)

The somewhat isolated location of the arch appears to have largely protected it from modification or removal for many decades, until Central Park Drive was created during the 1980s to connect Lincoln and Edmonton Roads. The creation of the road, and subsequent land modification, saw the eastern portion of the stream in-filled and the surrounding landform largely modified to accommodate the raised level of the roadway. Fortunately, local efforts to preserve the arch, including obtaining

inclusion on the HNZPT List have seen the arch preserved (albeit partially buried and some of the arch vault removed) and a park created around it.

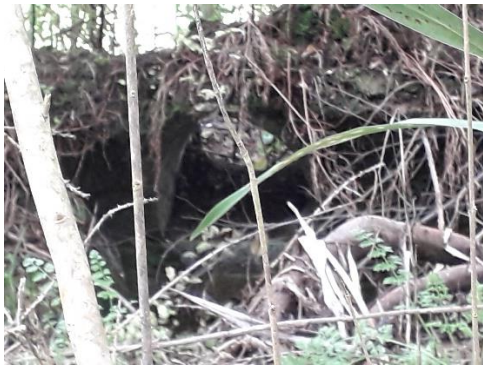
Figure 5: Part of the remaining vault structure with what appears to be a window to the west wall.

The brick vault is a long, relatively narrow structure which was largely subterranean, although the roof appears to have sat above ground level. It is likely that the brick roof was a barrel vault, like the arch structure, but this has long since collapsed. There appears to be a small window to the western

side just above ground level, and a set of steps at the south end. Close scrutiny of the structure is not possible, as the vault is fenced off for safety reasons and now surrounded by trees and shrubs.
