Watercare Services Limited

Whenuapai Redhills Wastewater Package 1 Geotechnical Interpretive Report

March 2021

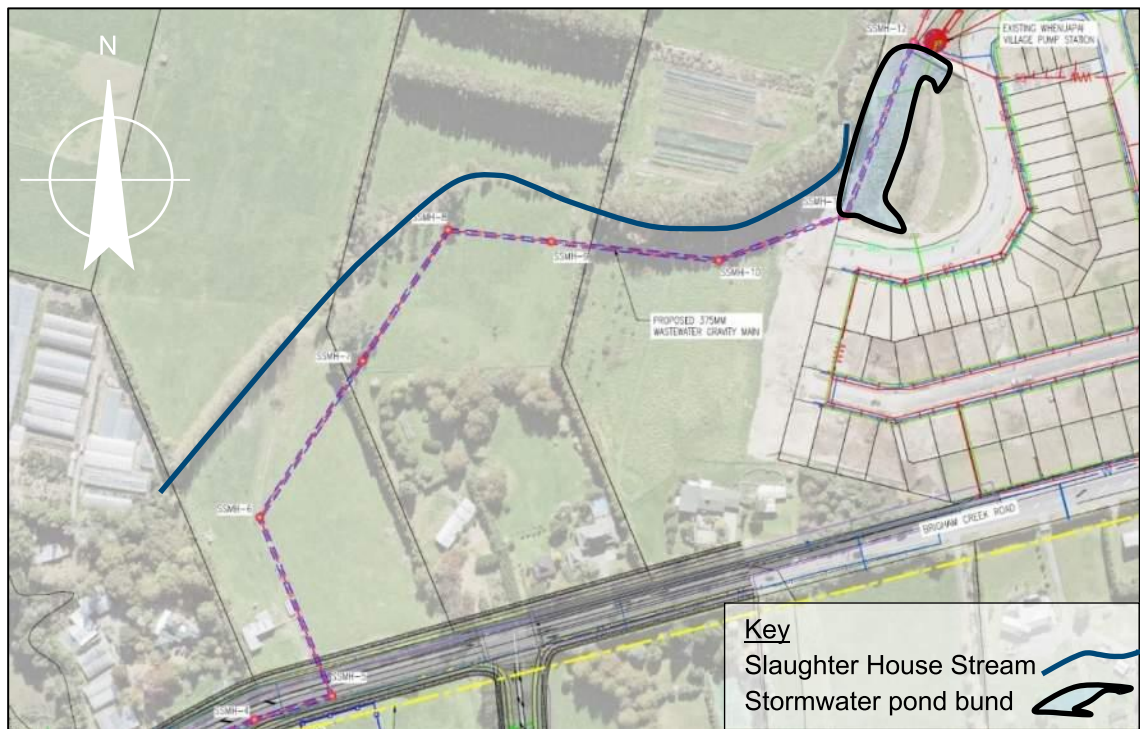
Figure 1 Features of note along between CH 167 and CH 740 along gravity sewer main alignment

- Recent earthworks associated with the construction of a swale for a stormwater pond between SSMH-12 to SSMH-11
- A small stream, known as Slaughter House Stream, approximately 0.5 m wide and 0.2 m deep runs adjacent to SSMH-11 to SHMH-5 offset approximately 3.6 m at its closest point (SSMH-8).

Minimal development is noted on the historical aerial photographs until 2015 when the photograph shows recent development adjacent the northern most end of the alignment and includes the creation of the stormwater pond (see Figure 1). The only significant feature of note is earthworks occurring in the area of the wetland (see Figure 2) in the photograph dated 1996 suggesting this feature is manmade.

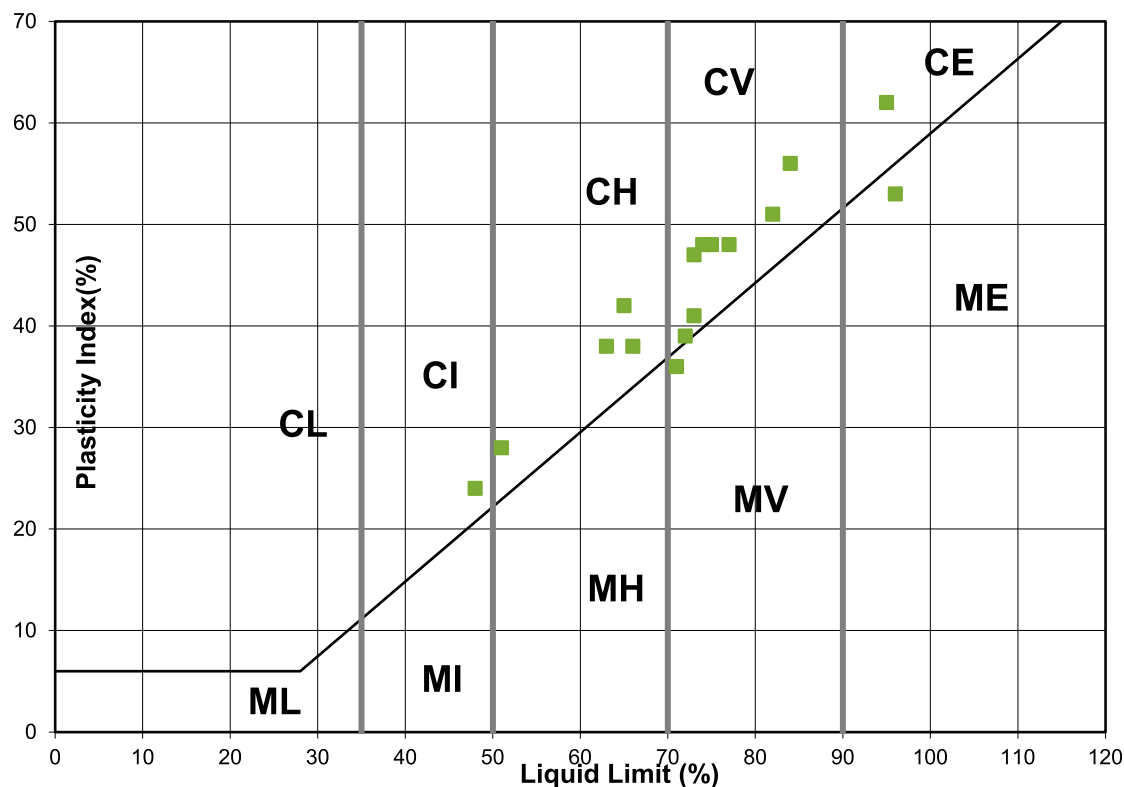
Figure 4: Casagrande (A-line) graph (PI vs LL)

A brief summary of each sub-unit is presented in the following sub-sections. Atterberg test results for all sub-units is plotted on a Casagrande graph presented as Figure 4 below. The majority of the data indicates high plasticity clays are present, with plasticity indices generally in excess of 25.

The laboratory data available in Appendix C and summarised in Section 4.2 for each unit, includes eighteen Atterberg Limit tests completed between 1.5 m bgl and 5.8 m bgl along the alignment. The Plasticity Index (PI) values were greater than 24 in all tests, with a median PI of 48. These results indicate that the clay and silt mixtures encountered are highly plastic. Soils that exhibit PI greater than 12 are generally considered unlikely to liquefy (MBIE 2016). It should be noted that the soil descriptions included on the borehole logs does not always reflect the high plasticity materials reported in the laboratory test results.

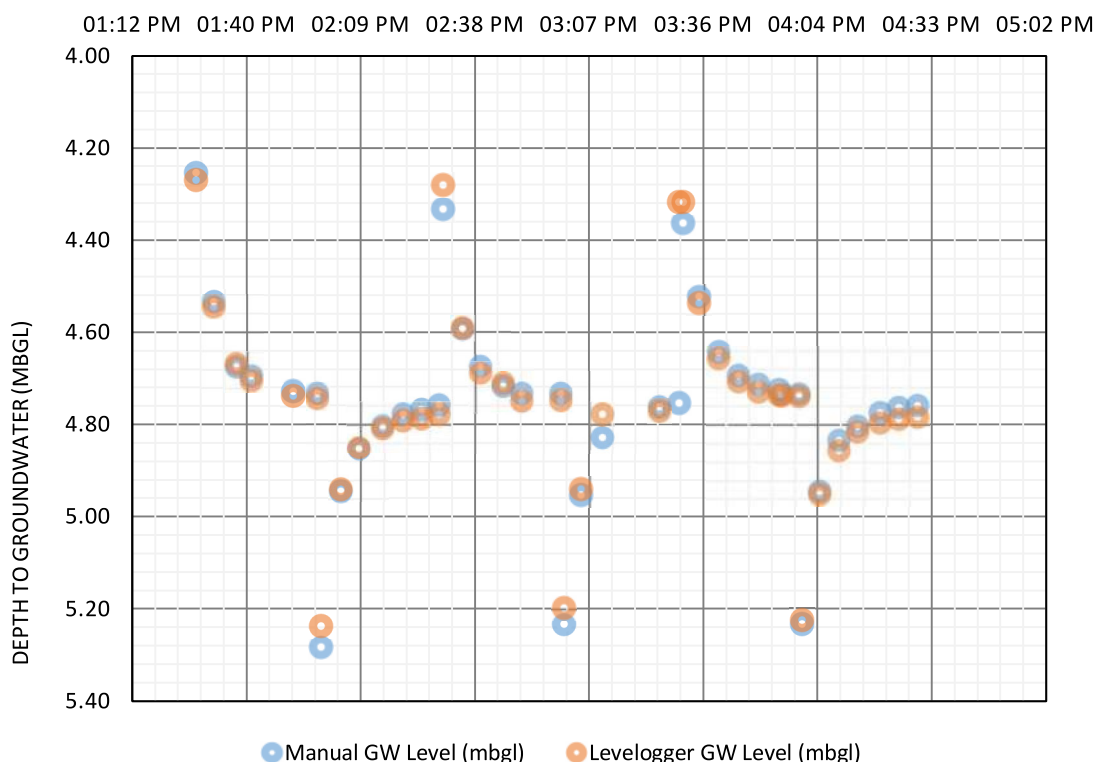
Figure 5-1: Comparison of manual dip data and level logger (transducer) data, for the falling and rising head tests in BH110.

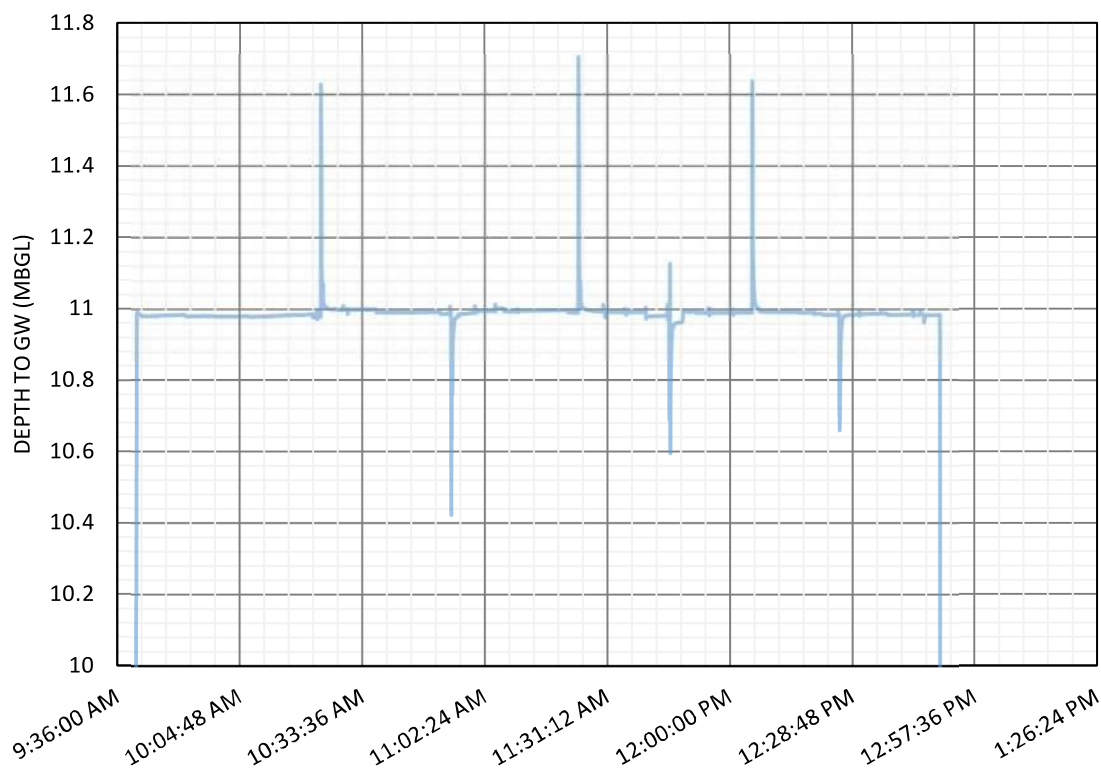
Figure 5-2 shows example groundwater level data recorded by the level logger (transducer) in BH05A. Table 5-2 shows the groundwater levels (m bgl) at start of each test, and the duration of each test.

Figure 5-2: Example groundwater level data recorded by the level logger (transducer) in BH05A

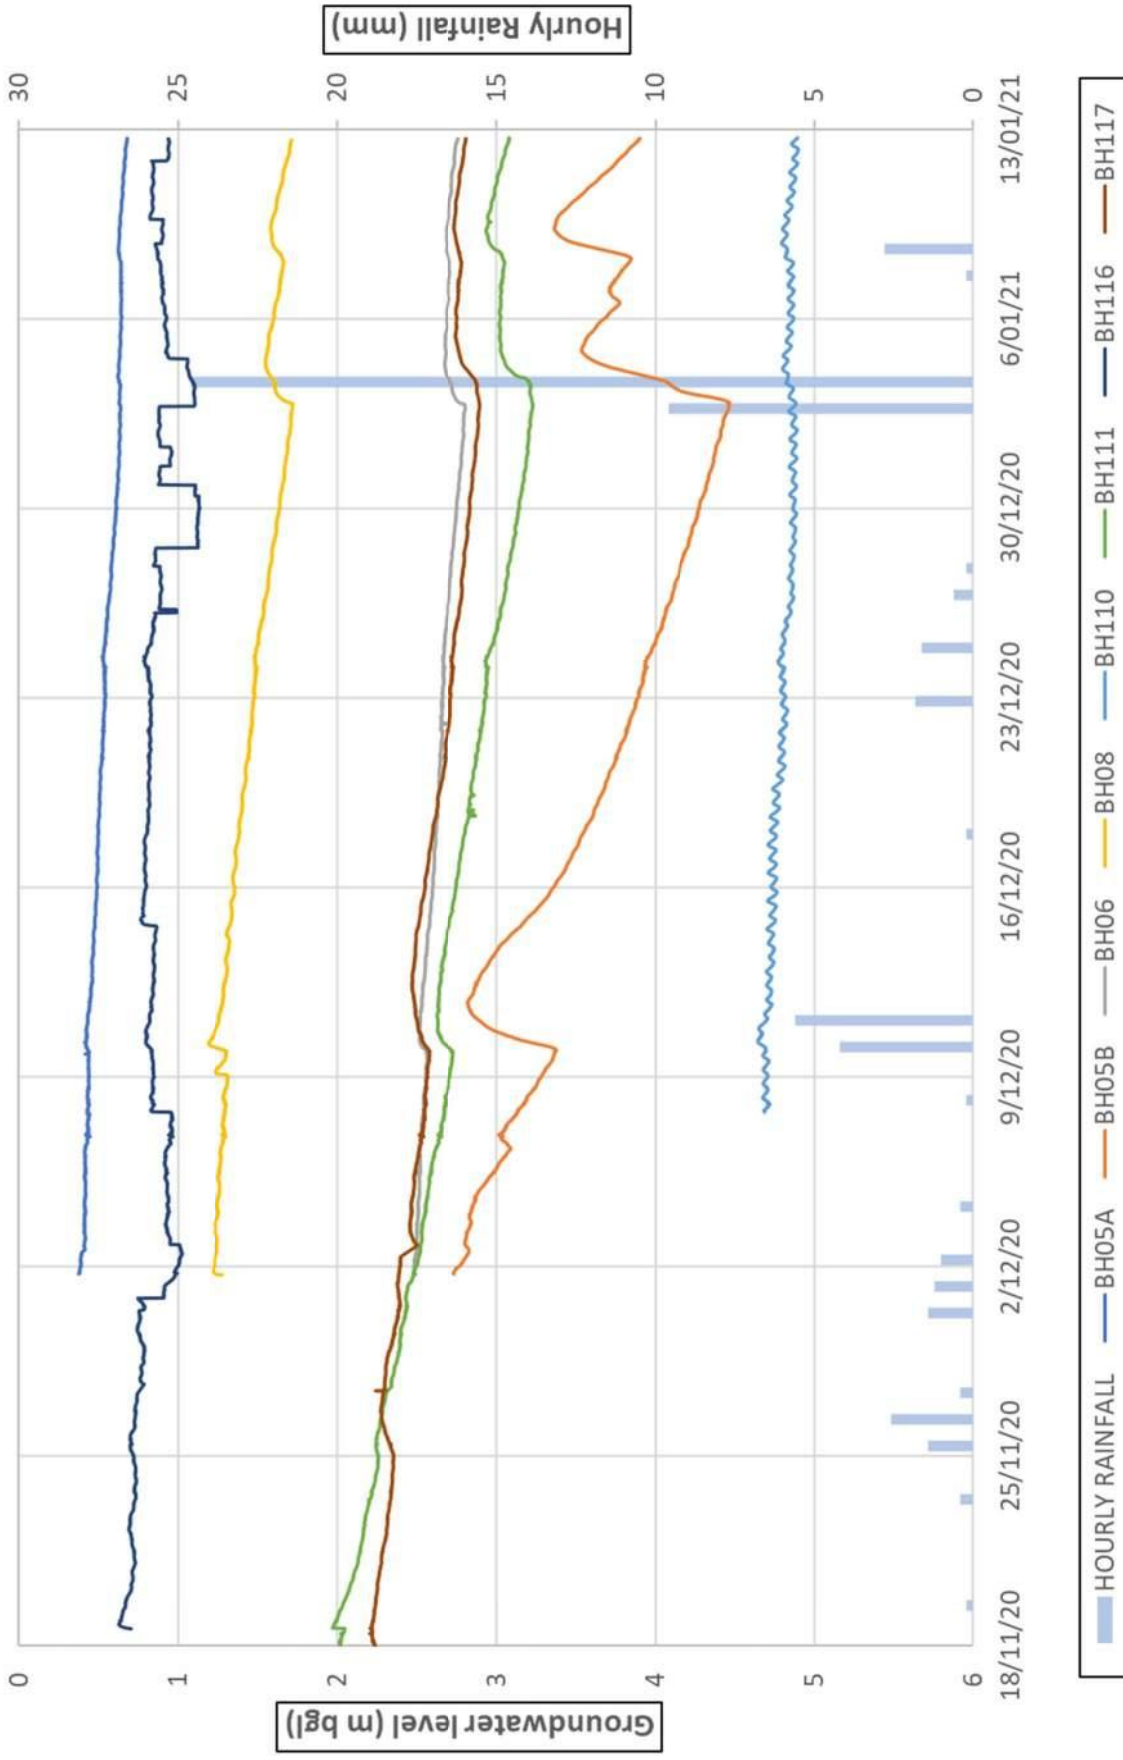
Figure 5-3: Continuous groundwater level monitoring results (m bgl), and rainfall (mm) recorded at the MOTAT gauging site located approx. 15 km southeast of the site.

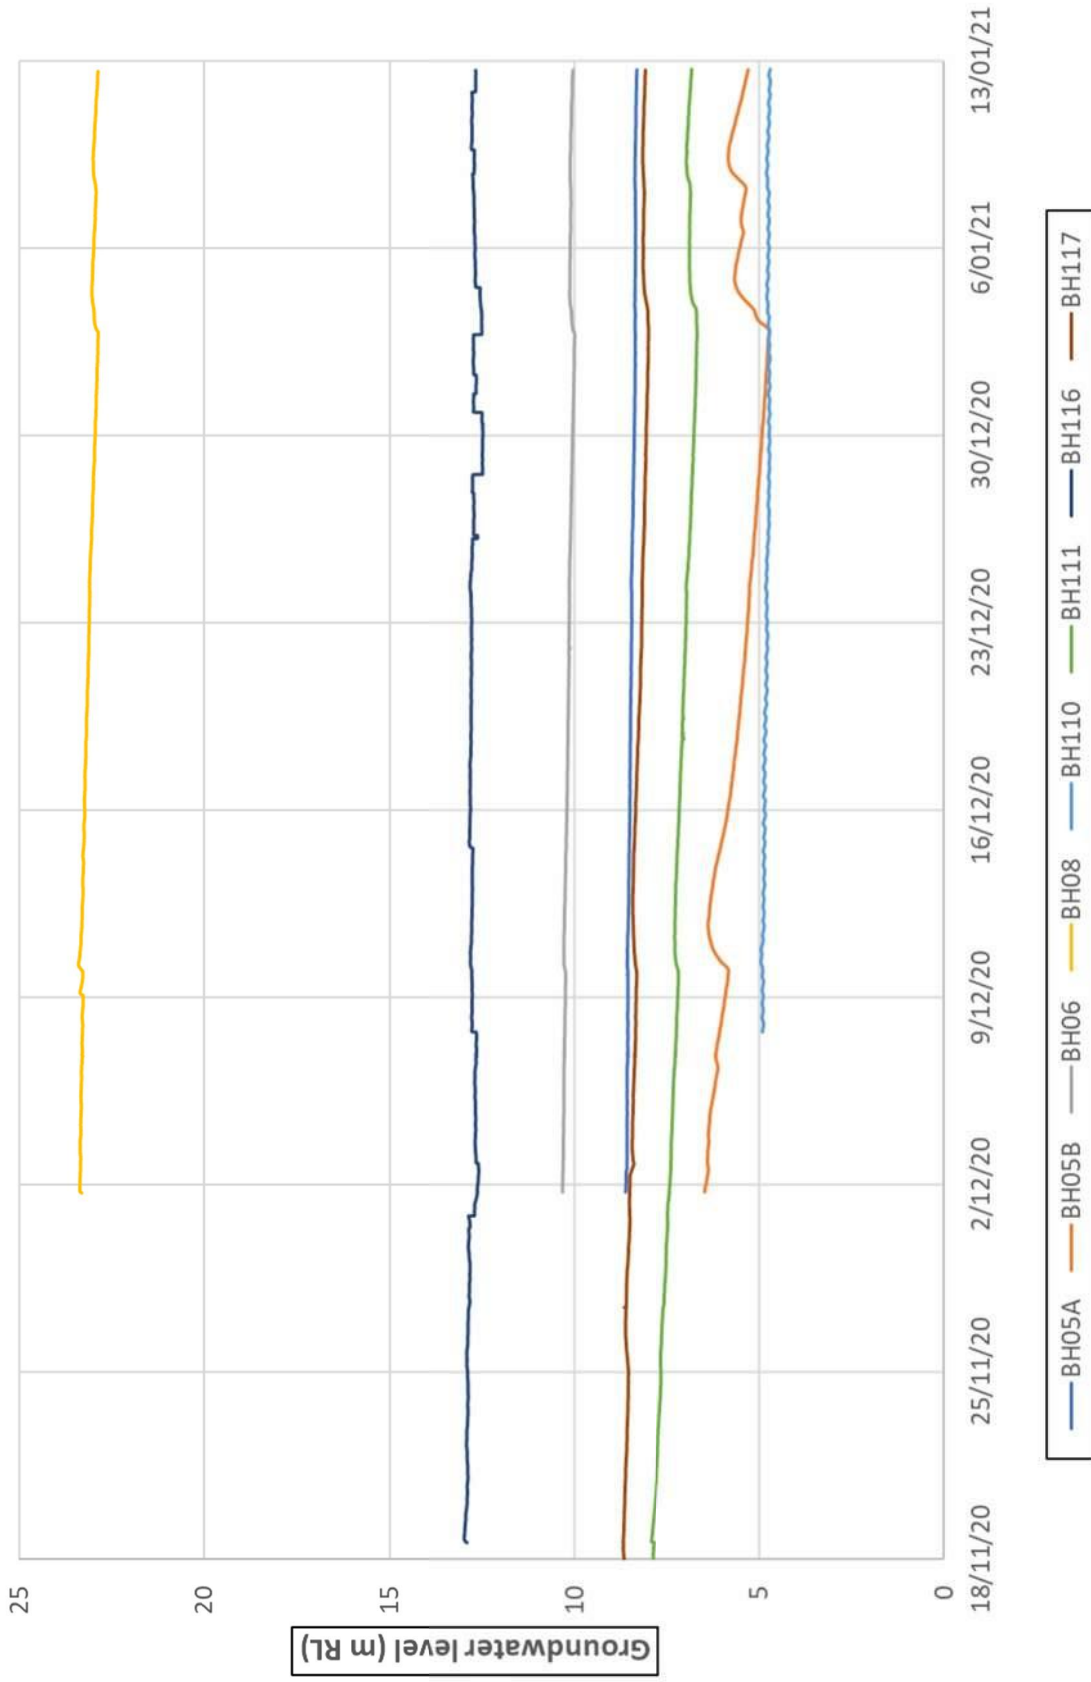
Figure 5-4: Continuous groundwater level monitoring results (m RL)
