Appendix D: CPT Logs

CONE PENETRATION TEST (CPT) LOG

Test Number: CPT-02

G.I. Job Ref: 200824

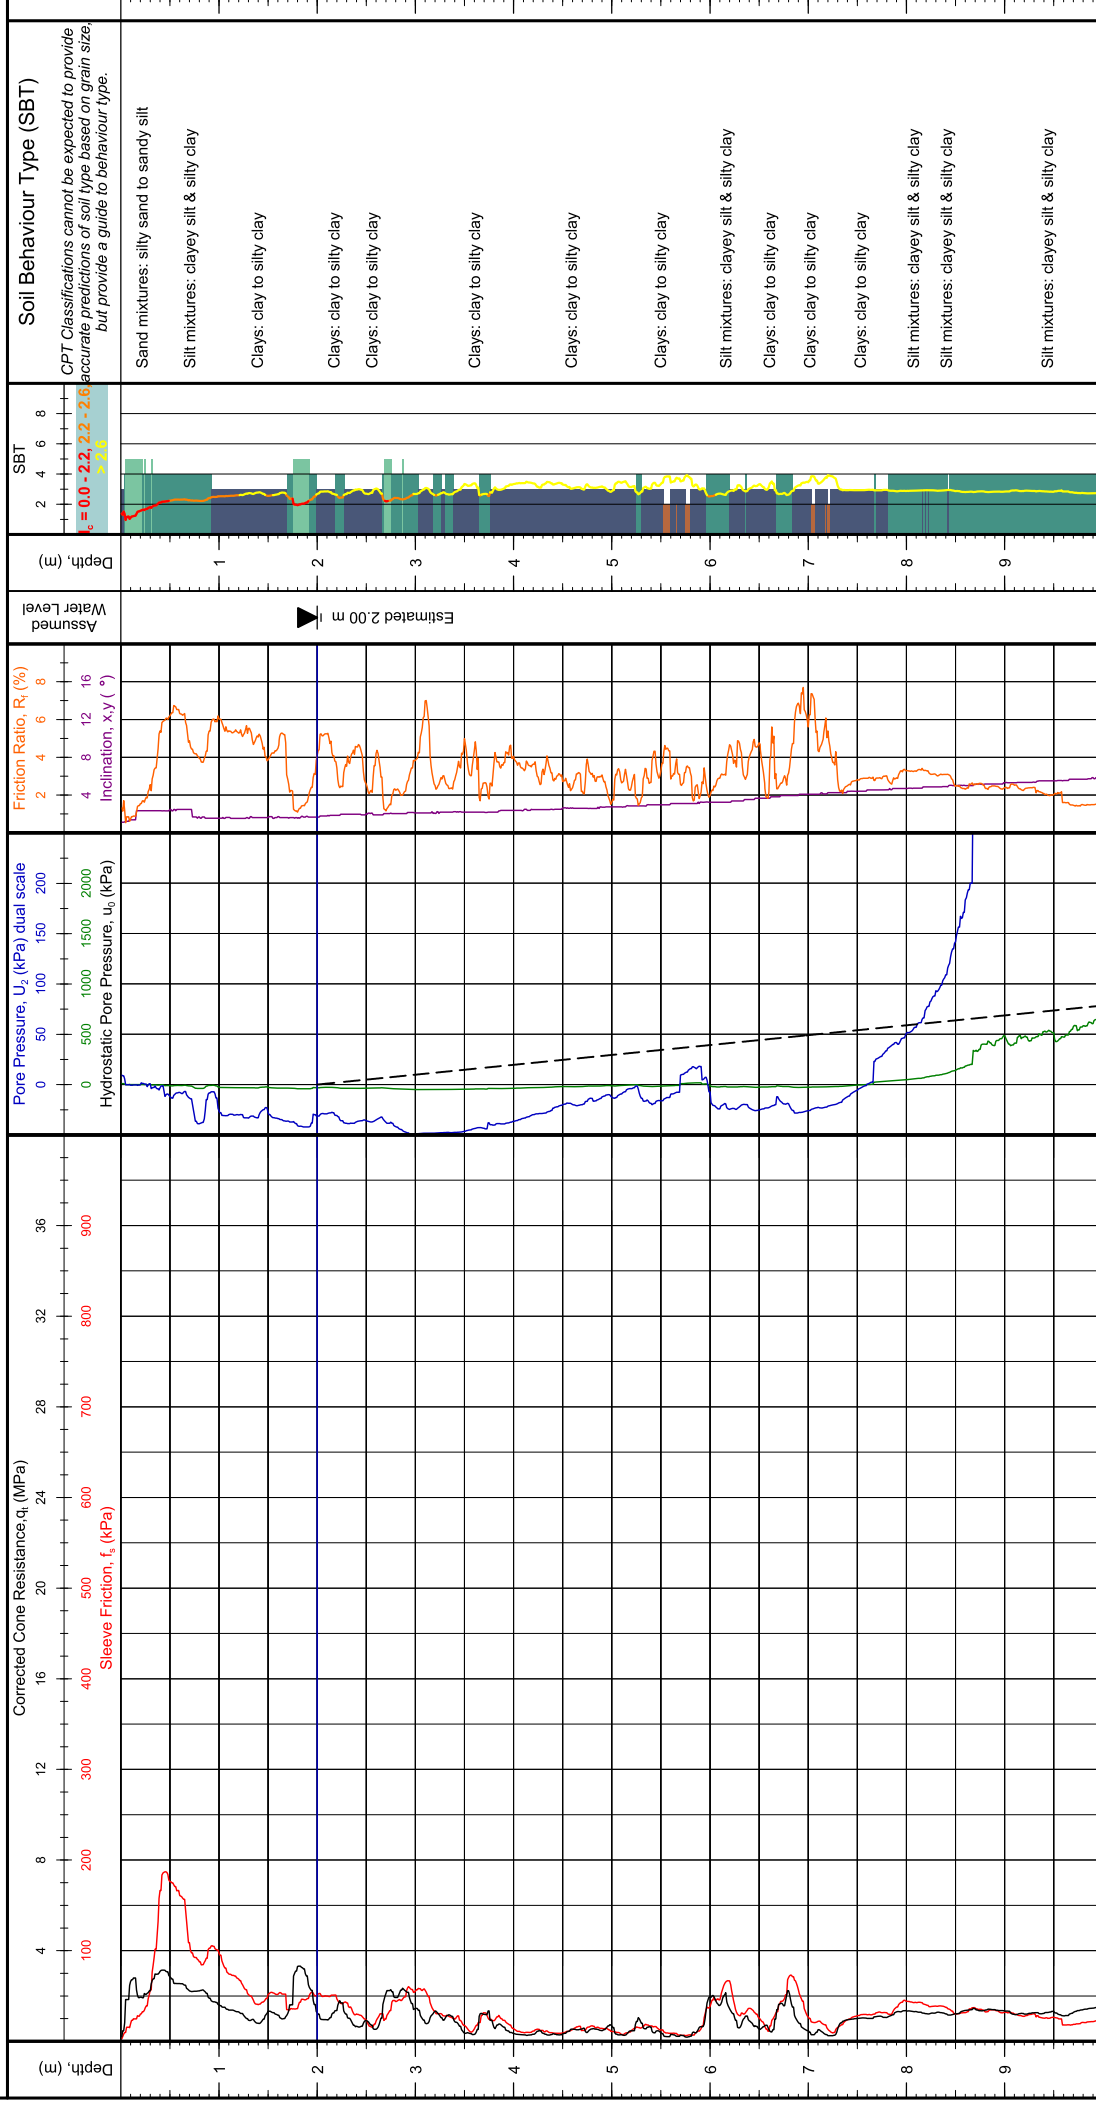
Client: Tonkin + Taylor	Operator: Ben Thom	Elevation (m): Unknown
Project: Whenuapai-Redhills Wastewater Servicing	Cone Ref: MK1325	Date of Test: 2/11/2020
Location: Trig Road to Tamiro Road, Auckland	Cone Type: 10cm ² Compression	Depth (m): 18.00
Engineer: Benjamin Westgate	Area Ratio: 0.80	Pre Drill (m): N/A
Contractor: Ground Investigation Ltd	Filter Type: u_2	Client Reference:
Comments:	Termination Reason: High cone end resistance	Test Number: CPT-117
		G.I. Job Ref: 200824

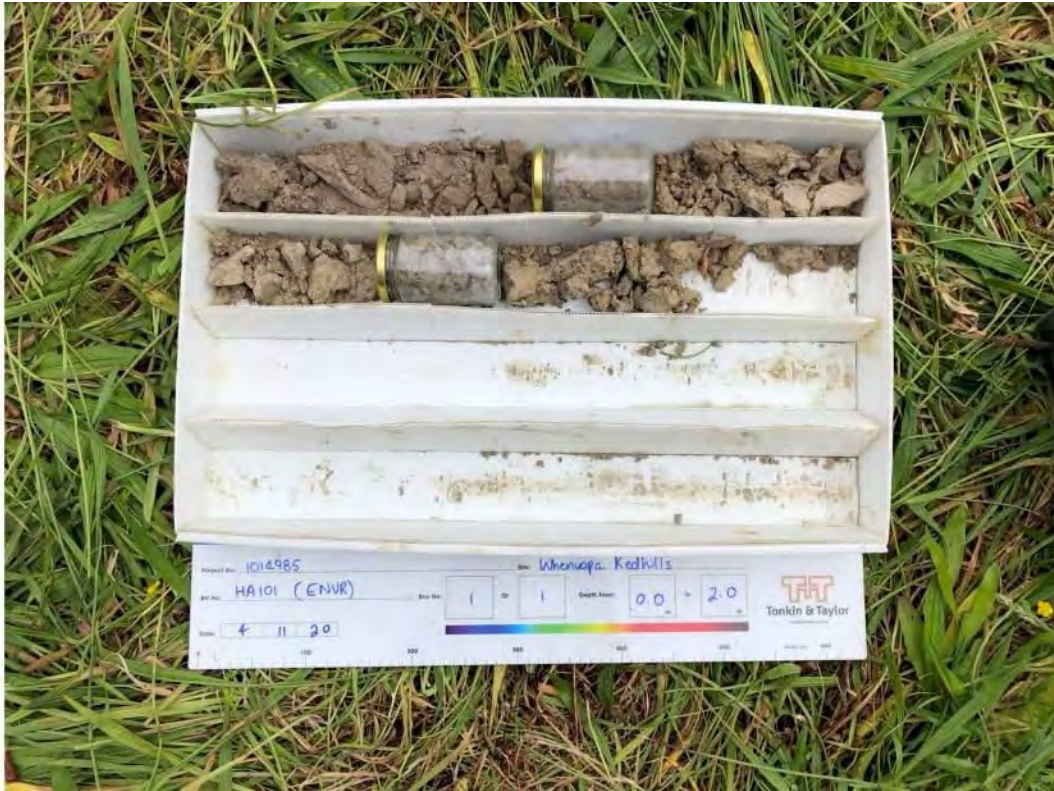
0.00-2.00m

GEOLOGICAL				ENGINEERING DESCRIPTION									
GEOLOGICAL UNIT, GENERIC NAME, ORIGIN, MATERIAL COMPOSITION.	WATER	CORE RECOVERY (%)	METHOD	SCALA PENETROMETER (Blows/100mm)	TESTS	SAMPLES	RL (m)	DEPTH (m)	GRAPHIC LOG	WEATHERING	STRENGTH/DENSITY CLASSIFICATION	SHEAR STRENGTH (kPa)	Description and Additional Observations
Topsoil					asb/gl/split @ 0.00m					M			SILT; brown. Moist, non-plastic.
					● 186/56 kPa asb/gl @ 0.40m PID, 0.0ppm ● 121/48 kPa		19	0.5		VSt			SILT; friable. Very stiff, moist, non-plastic. Silty CLAY; light greyish white mottled orange brown. Very stiff, moist, high plasticity. 0.5m: mottled yellowish brown
Tauranga Group					● 180/77 kPa asb/gl @ 0.90m PID, 0.0ppm ● 114/48 kPa		18	1.0					
					● 104/54 kPa att/psd @ 1.45m		18	1.5					
					● 114/60 kPa asb/gl @ 1.90m		18	2.0					2.1m: light greyish white, low plasticity
					● 162/77 kPa		18	2.5					
					● 122/66 kPa		17	3.0

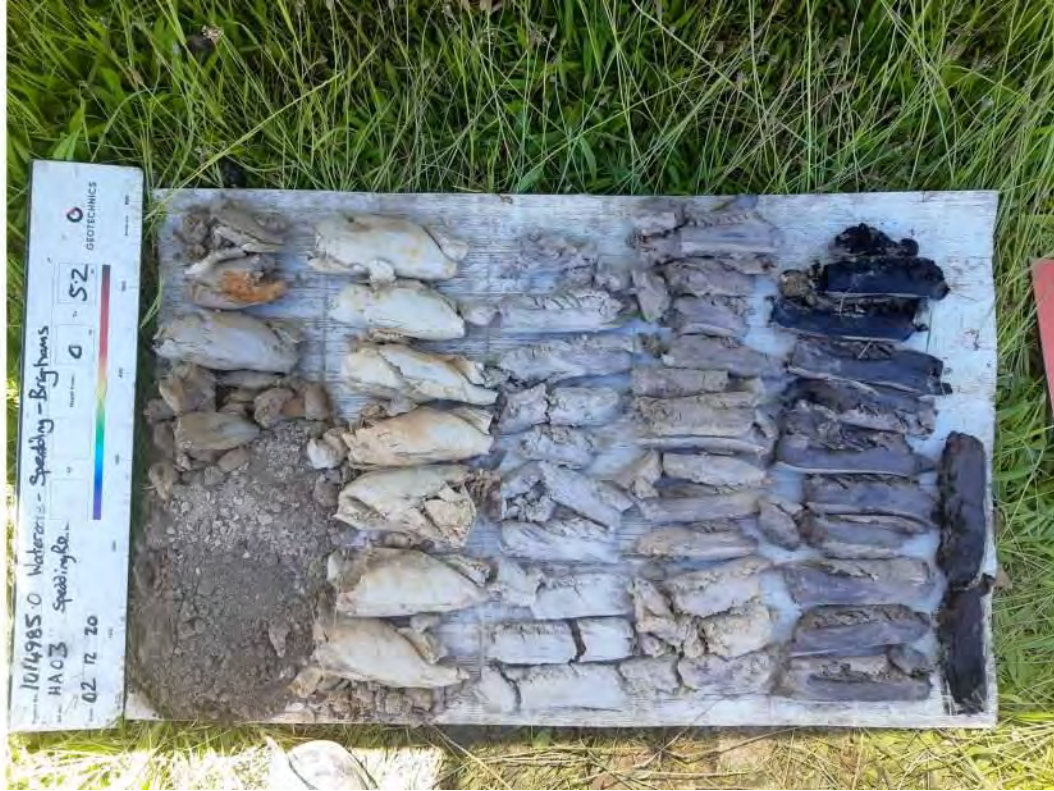
0.00-5.20m

M	Vst	plasticity. Organic clayey SILT; dark brown. Very stiff, moist medium plasticity organics amorphous End of handauger 5.2m. Scala (blows per 100mm): 3,3,4,4,6,13,19,13 13,18,20,21 Organic clayey silt, dark brown, adhering to lowest rod on withdrawal

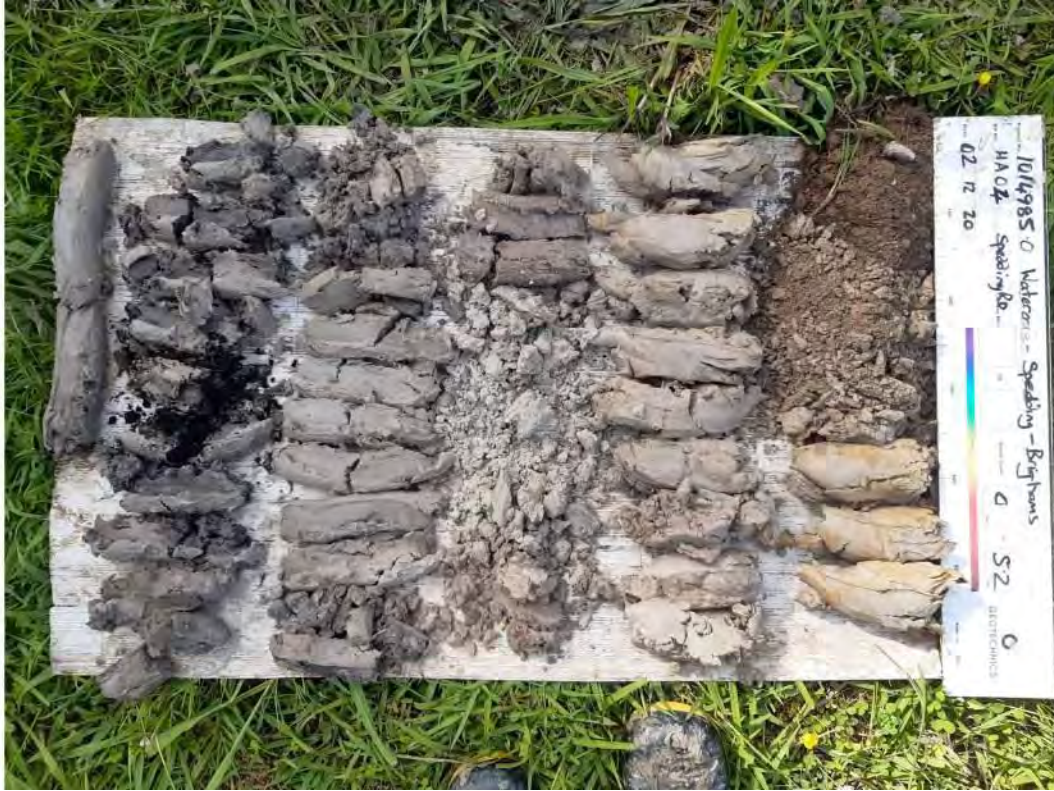
0.00-5.20m

GEOLOGICAL				ENGINEERING DESCRIPTION										
GEOLOGICAL UNIT, GENERIC NAME, ORIGIN, MATERIAL COMPOSITION.	WATER	CORE RECOVERY (%)	METHOD	SCALA PENETROMETER (Blows/100mm)	TESTS	SAMPLES	DEPTH (m)	GRAPHIC LOG	WEATHERING	MOISTURE CONDITION	STRENGTH/DENSITY CLASSIFICATION	SHEAR STRENGTH (kPa)	Description and Additional Observations	
Topsoil					asb/gl/dupB @ 0.00m		21				St		SILT; dark brown. Stiff, moist, non-plastic; inclusion of agricultural plastic sheet.	
					>186 kPa asb/gl @ 0.40m PID, 0.0ppm @ 0.50m ● 179/50 kPa		0.5				Vst		Sandy SILT; light whitish brown. Very stiff, moist, non-plastic.	
Tauranga Group					● 159/61 kPa asb/gl @ 0.90m PID, 0.1ppm @ 1.00m ● 122/54 kPa		20				St-VSt		Silty CLAY; light greyish white mottled yellowish brown. Very stiff to stiff, moist, high plasticity.	
					● 109/44 kPa att/psd @ 1.45m		1.5						1.0m: light grey mottled yellowish brown	
					● 90/35 kPa asb/gl @ 1.90m		2.0						1.8m: some sand, light brownish white

● 127/46 kPa att/psd @ 2.45m		19				Vst		Clayey SILT; light brown. Very stiff, moist, low plasticity.	
					asb/gl @ 2.80m		18				M-W		Silty SAND; white. Moist to wet; sand, fine to medium; well packed.

3.0						2.5m: Scala (blows per 100mm): 13,22,22,20,18 3.0m: light brown	
						● 97/45 kPa asb/gl @ 3.80m		3.5				M		SILT; light brown. Stiff, moist, non-plastic; Scala (blows per 100mm): 5,6,8. Clayey SILT; grey. Stiff, moist, low plasticity.
						● 90/32 kPa ● 101/28 kPa		4.0				W M		Silty SAND; greyish brown. Wet; sand, fine to medium. SILT; brown and grey. Very stiff, moist, non-plastic.
						● 159/32 kPa ● 117/33 kPa asb/gl @		4.5				Vst		4.4m: abundant organics and inclusions of decomposed wood Clayey SILT; light grey. Very stiff, moist, low plasticity.

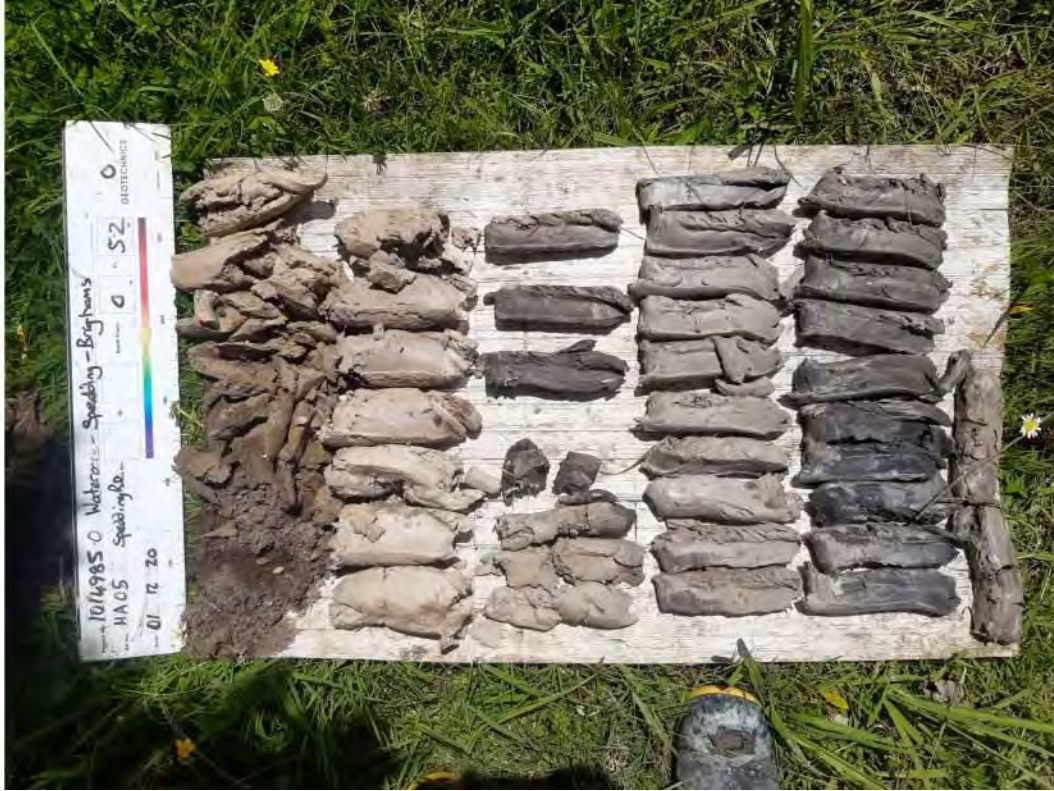
0.00-5.20m

GEOLOGICAL				ENGINEERING DESCRIPTION										
GEOLOGICAL UNIT, GENERIC NAME, ORIGIN, MATERIAL COMPOSITION.	WATER	CORE RECOVERY (%)	METHOD	SCALA PENETROMETER (Blows/100mm)	TESTS	SAMPLES	RL (m)	DEPTH (m)	GRAPHIC LOG	WEATHERING	STRENGTH/DENSITY CLASSIFICATION	SHEAR STRENGTH (kPa)	Description and Additional Observations	
														0
Fill					asb/gl/split @ 0.00m		27			M			SILT; dark brown. Moist, non-plastic; inclusions of gravel, black plastic twine.	
					● 130/32 kPa asb/gl @ 0.40m PID, 0.1ppm @ 0.50m ● 88/29 kPa		0.5			St-VSt			Silty CLAY; light grey. Stiff to very stiff, moist, high plasticity.	
Tauranga Group					● 82/32 kPa asb/gl @ 0.90m PID, 0.1ppm @ 1.00m ● 108/35 kPa		26						1.8m: light greyish brown. Low plasticity	
					● 80/33 kPa att/psd @ 1.45m		1.5							
					● 96/41 kPa asb/gl @ 1.90m		2.0			W	St		Sandy SILT; light greyish brown. Stiff, wet, non-plastic.	
					● 56/19 kPa att/psd2 @ 2.45m		2.5			M	F-St		Clayey SILT, trace sand; light brown. Stiff to firm, moist, low plasticity.

● 37/20 kPa asb/gl @ 2.70m		3.0							
					● 41/21 kPa		3.5				F			Silty CLAY; light grey. Firm, moist, high plasticity.
					● 40/24 kPa		4.0							4.0m: brown
					● 35/16 kPa asb/gl @ 3.70m		4.5							4.2m: blackish brown
				● 35/13 kPa		5.0							4.5m: brown	
				● 35/13 kPa		5.5								
				● 41/21 kPa		6.0								
				● 45/21 kPa asb/gl @		6.5

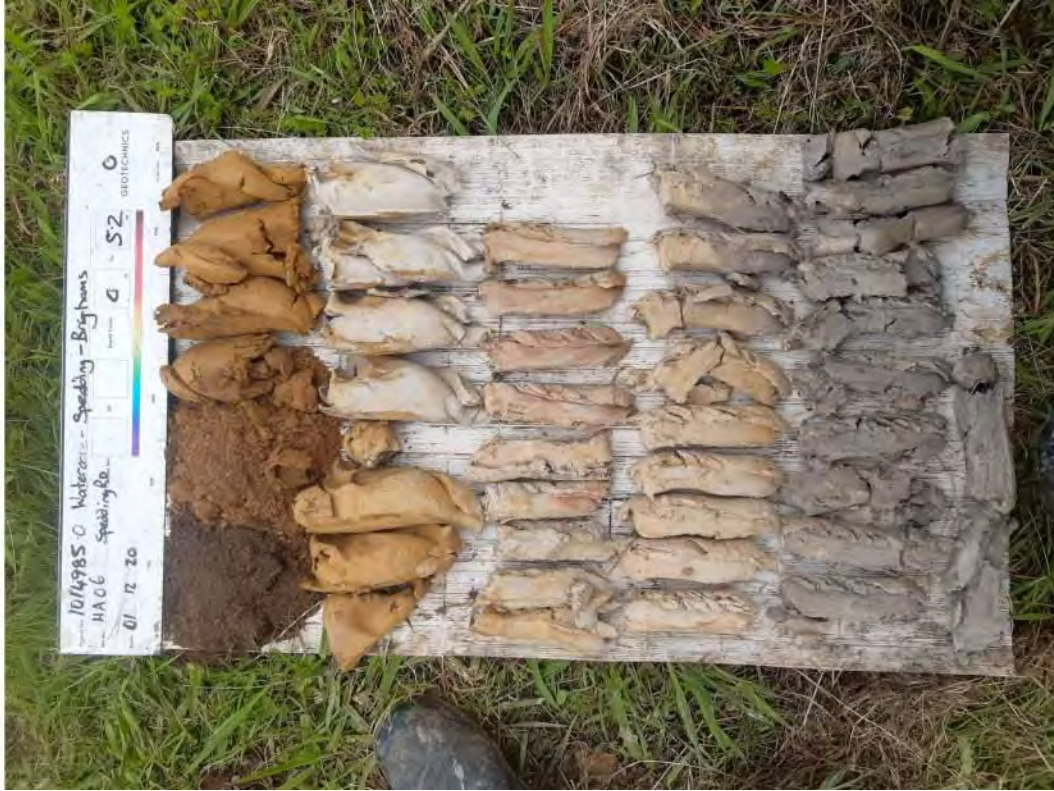
0.00-5.20m

GEOLOGICAL				ENGINEERING DESCRIPTION														
GEOLOGICAL UNIT, GENERIC NAME, ORIGIN, MATERIAL COMPOSITION.	WATER	CORE RECOVERY (%)	METHOD	SCALA PENETROMETER (Blows/100mm)	TESTS	SAMPLES	RL (m)	DEPTH (m)	GRAPHIC LOG	WEATHERING	MOISTURE CONDITION	STRENGTH/DENSITY CLASSIFICATION	SHEAR STRENGTH (kPa)	Description and Additional Observations				
				0 2 4 6 8 10 12 14 16 18														
Tauranga Group	01/12/2020 W/L on completion				asb/gl/dupA @ 0.00m									SILT; dark brown. Moist, non-plastic; friable.				
					● 157/66 kPa										SILT; light yellowish brown. Very stiff, moist, non-plastic.			
					● 122/56 kPa											Clayey SILT; yellowish brown. Stiff to very stiff, moist; low to medium plasticity.		
					asb/gl @ 0.40m													
					PID, 0.2ppm @ 0.50m													
					● 106/48 kPa													
					asb/gl @ 0.90m													
					PID, 0.3ppm @ 1.00m													
					● 98/44 kPa

● 119/42 kPa													
					att/psd @ 1.45m													Silty CLAY; light brownish grey. Very stiff, moist, high plasticity.
					● 108/73 kPa													
					asb/gl @ 1.90m													
					● 141/82 kPa													
					● 129/84 kPa													
	● 86/66 kPa																	
	asb/gl/att/psd @ 2.70m																	
	● 58/37 kPa																	
	● 69/37 kPa																	
	● 61/31 kPa																	
	asb/gl @ 3.70m																	
	● 66/29 kPa																	
	● 74/21 kPa																	
	● 64/42 kPa																	
	● 64/31 kPa																	
	asb/gl @

[CONT] Sandy SILT; grey. Stiff, moist, low plasticity; sand, fine.
						5.5 6.0 6.5 7.0						End of hand auger 5.2m. Scala only (blows per 100mm) 3,4,4,5,6,8,9,9 10,13,11,11,13,14,15,16,16,16, 16,17
						7.5 8.0 8.5 9.0 9.5						7.25m: Target depth

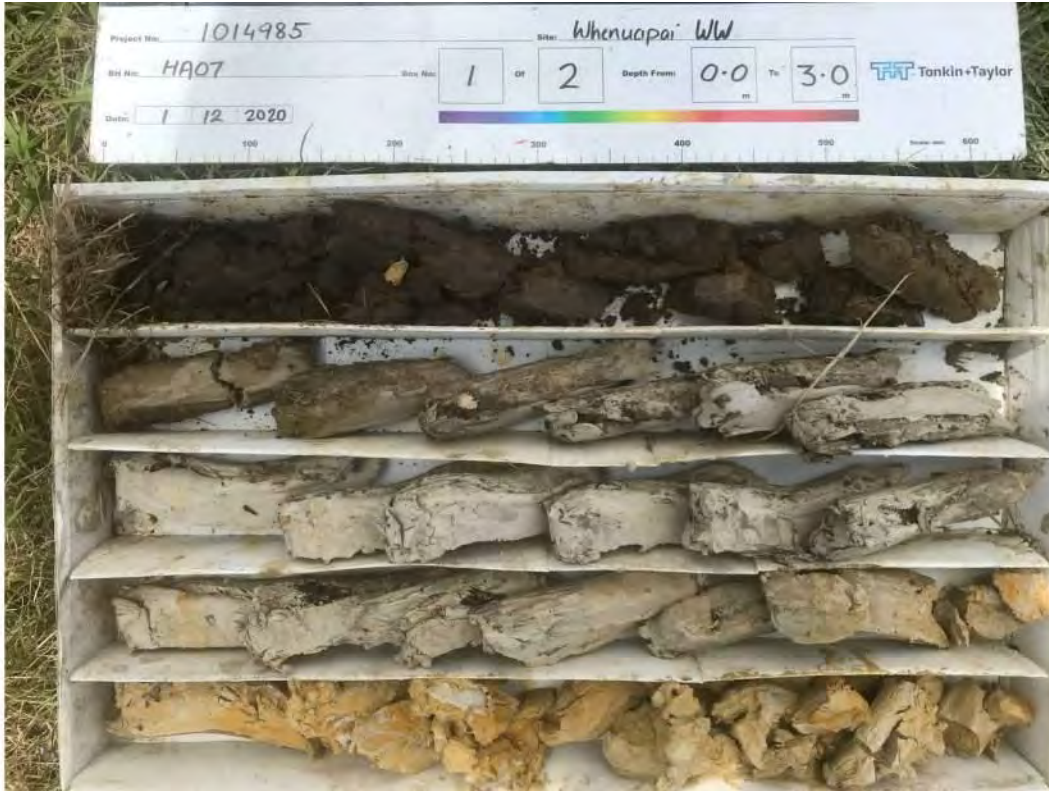
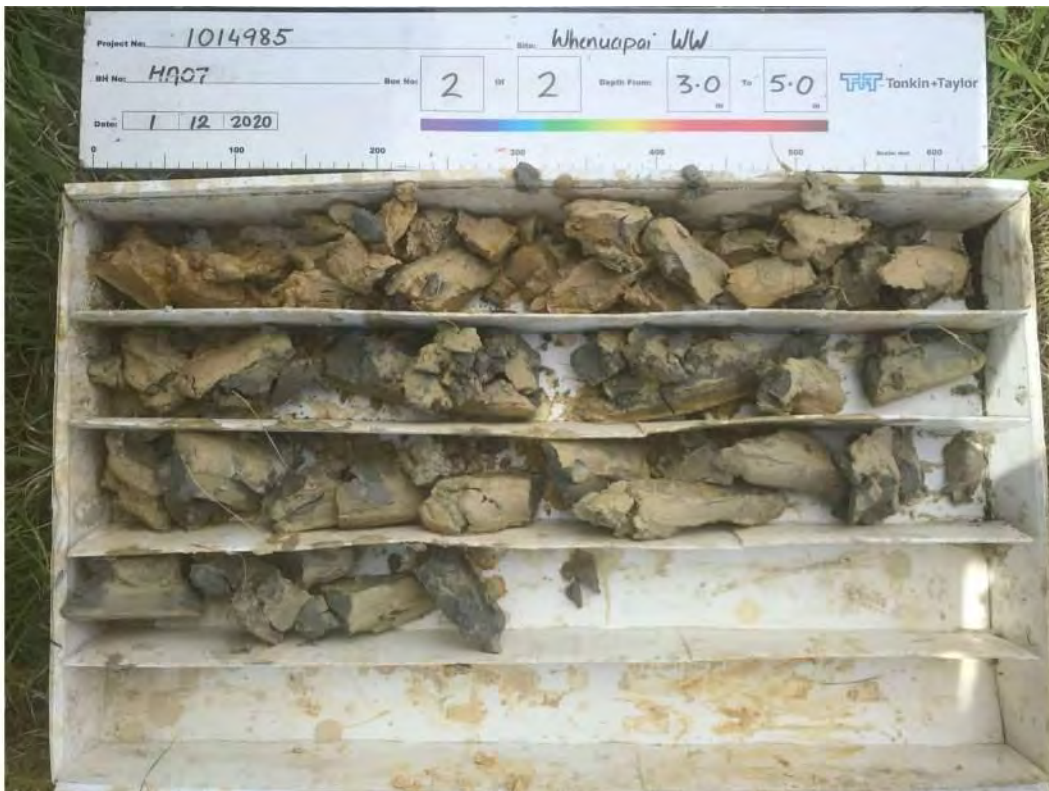
0.00-3.00m

GEOLOGICAL					ENGINEERING DESCRIPTION							
GEOLOGICAL UNIT, GENERIC NAME, ORIGIN, MATERIAL COMPOSITION.	WATER	CORE RECOVERY (%)	METHOD	SCALA PENETROMETER (Blows/50mm)	TESTS	SAMPLES	DEPTH (m)	GRAPHIC LOG	WEATHERING	STRENGTH/DENSITY CLASSIFICATION	STRENGTH (kPa)	Description and Additional Observations
Topsoil				0 2 4 6 8 10 12 14 16 18	asb/gl @ 0.10m				M	F		Sandy SILT; dark brown. Firm, moist, low plasticity; sand, fine.
					<ul style="list-style-type: none"> 85/22 kPa PID, 0.1ppm @ 0.50m asb/gl @ 0.50m 		0.5		St		Sandy SILT, trace organics; brown, mottled orange. Stiff, moist, low plasticity; sand, fine; organics, rootlets. 0.5m: Light brown, mottled orange. PID test, 0.1ppm.	
Tauranga Group	01/12/2020	100	HA		att/psd @ 0.80m		32					Clayey SILT, minor sand, trace organics; light brown. Stiff, moist, medium plasticity; sand, fine; organics, rootlets. 1.0m: PID test, 0.2ppm
					<ul style="list-style-type: none"> 82/47 kPa PID, 0.2ppm @ 1.00m asb/gl & att/psd @ 1.00m 		1.0				SILT, some clay, minor sand; light brown, mottled orange. Stiff, moist, medium plasticity; sand, fine.

69/37 kPa		1.5				SILT, some clay and sand; light brown, mottled orange and brown. Stiff, moist, medium plasticity; sand, fine.	
					corrosivity @ 1.80m		31				Sandy SILT, trace organics and clay; light brown, mottled orange. Stiff, moist, low plasticity; sand, fine; organics, rootlets. 2.5m: Grey and orange.	
					<ul style="list-style-type: none"> 63/33 kPa asb/gl @ 2.00m 		2.0				Sandy SILT, trace organics; light brown, mottled orange. Stiff to very stiff, moist, low plasticity; sand, fine; organics, rootlets. 3.4m: Light brown, mottled orange. 3.5m: Grey.	
					corrosivity @ 2.40m		30				Silty SAND, trace organics; light brown mottled orange. Dense to very dense, moist, poorly graded; sand, fine to medium; organics, rootlets.	
					<ul style="list-style-type: none"> 90/47 kPa 		2.5					
					<ul style="list-style-type: none"> 87/31 kPa asb/gl @ 3.00m 		3.0					
					131/31 kPa		3.5

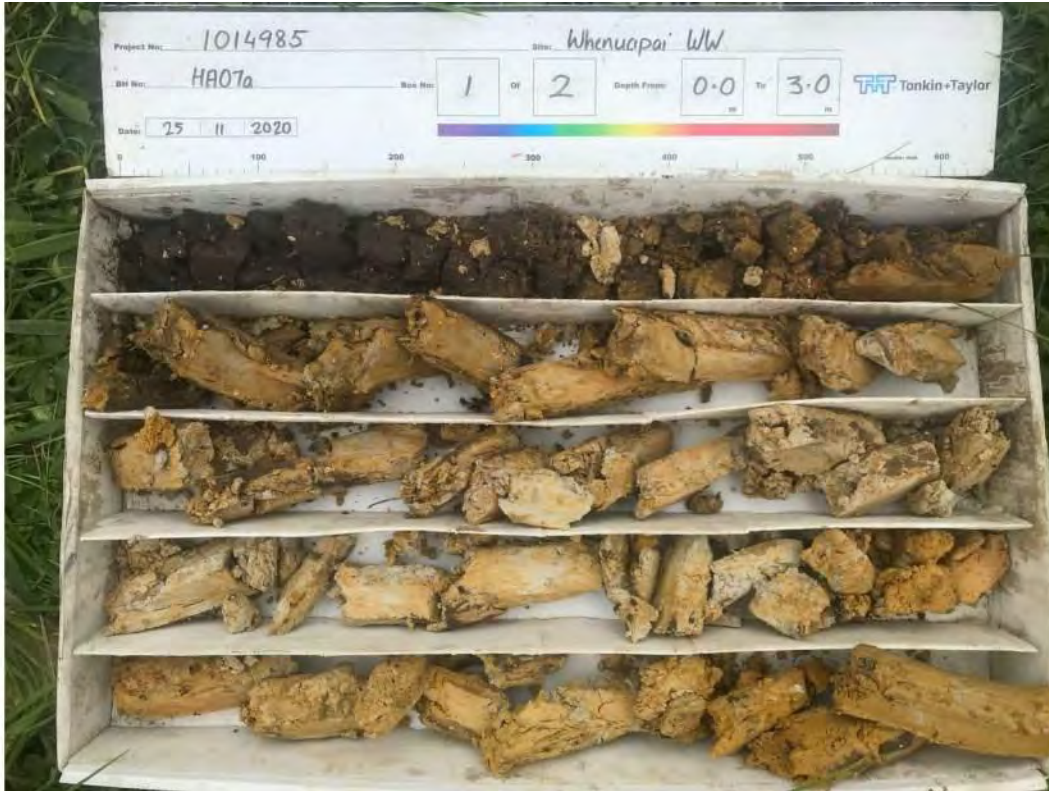
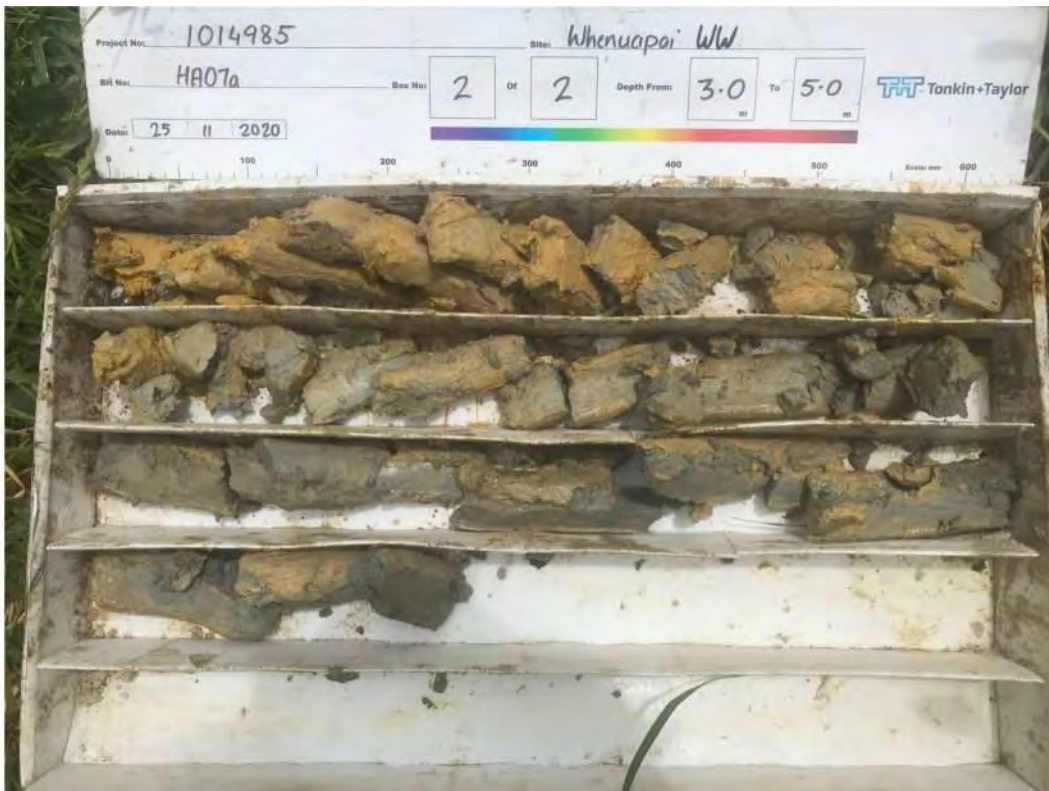
0.00-3.00m

GEOLOGICAL				ENGINEERING DESCRIPTION											
GEOLOGICAL UNIT, GENERIC NAME, ORIGIN, MATERIAL COMPOSITION.	WATER	CORE RECOVERY (%)	METHOD	SCALA PENETROMETER (Blows/50mm)	TESTS	SAMPLES	RL (m)	DEPTH (m)	GRAPHIC LOG	WEATHERING	STRENGTH/DENSITY CLASSIFICATION	SHEAR STRENGTH (kPa)			Description and Additional Observations
												10	20	30	
Topsoil					asb @ 0.10m						M				Sandy SILT, trace organics; dark brown. Firm, moist, low plasticity; sand, fine; organics, rootlets.
Tauranga Group			100		>218 kPa asb @ 0.50m PID, 0.0ppm @ 0.51m		35	0.5			VSt-H				SILT, some sand, minor clay, trace organics; orange, mottled brown-red and brown. Very stiff, moist, low plasticity. Organics, rootlets. Grades to: clayey SILT, minor sand, trace organics; grey and brown mottled orange. Very stiff to hard, moist, medium plasticity. Sand, fine; organics, rootlets.
					174/62 kPa asb @ 1.00m PID, 0.8ppm @ 1.01m corrosivity @ 1.20m			1.0				Vst			Sandy SILT, some clay, trace organics; grey mottled orange and brown. Very stiff, moist, low to medium plasticity. Organics, rootlets.

187/75 kPa			1.5							2.1m: trace clay; grey, mottled orange.
					159/87 kPa asb @ 2.00m			2.0							
					geo @ 2.20m										
					geo @ 2.40m										
					188/73 kPa			2.5							Silty CLAY; grey, mottled orange and pink. Very stiff, moist, high plasticity. Sandy SILT, some clay, trace organics; grey mottled orange and brown. Very stiff, moist, low to medium plasticity. 2.8 - 2.9m: orange, mottled grey.
					199/84 kPa asb @ 3.00m			3.0							
					>218 kPa			3.5				VSt-H			Sandy SILT; grey, speckled white. Very stiff to hard, moist, low plasticity; sand, fine to coarse.

3.2				VD			Grades to: Silty, fine to coarse SAND; grey, speckled white. Very dense, moist, well graded.
							4.0				VSt-H			Sandy SILT; grey, speckled white. Very stiff to hard, moist, low plasticity; sand, fine to coarse.

5	5	6	7	8	15	17	8	11	10	11	10	11	10	11	11	asb @ 5.00m		30	5.5		M				Silty CLAY; grey. Hard, moist, high plasticity. 5.0 m: END OF HAND AUGER. Scala only to 5.85 m (blows per 50 mm): 5,5,6,7,8,5,7,8,11,10,11,10,11,10,11,10,11,11
5																														
5																														
6																														
7																														
8																														
15																														
17																														
8																														
11																														
10																														
11																														
10																														
11																														
10																														
11																														
11																														
								29						5.85m: END OF INVESTIGATION																
								28																						
								27																						
								26

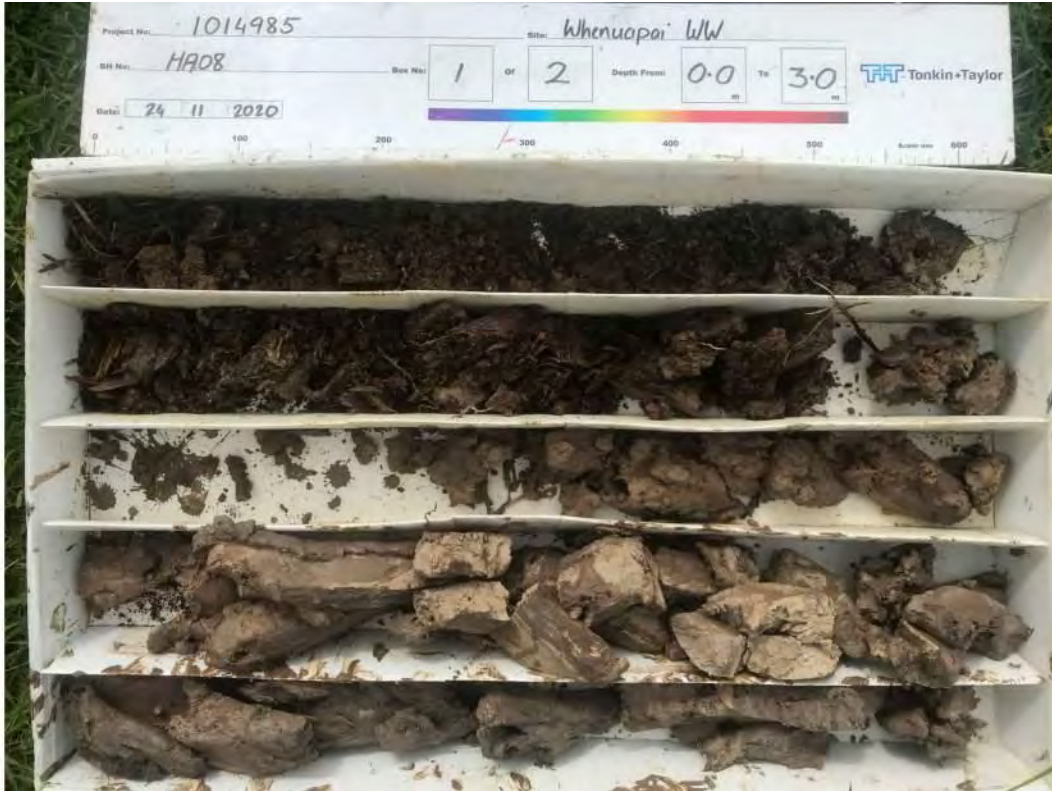
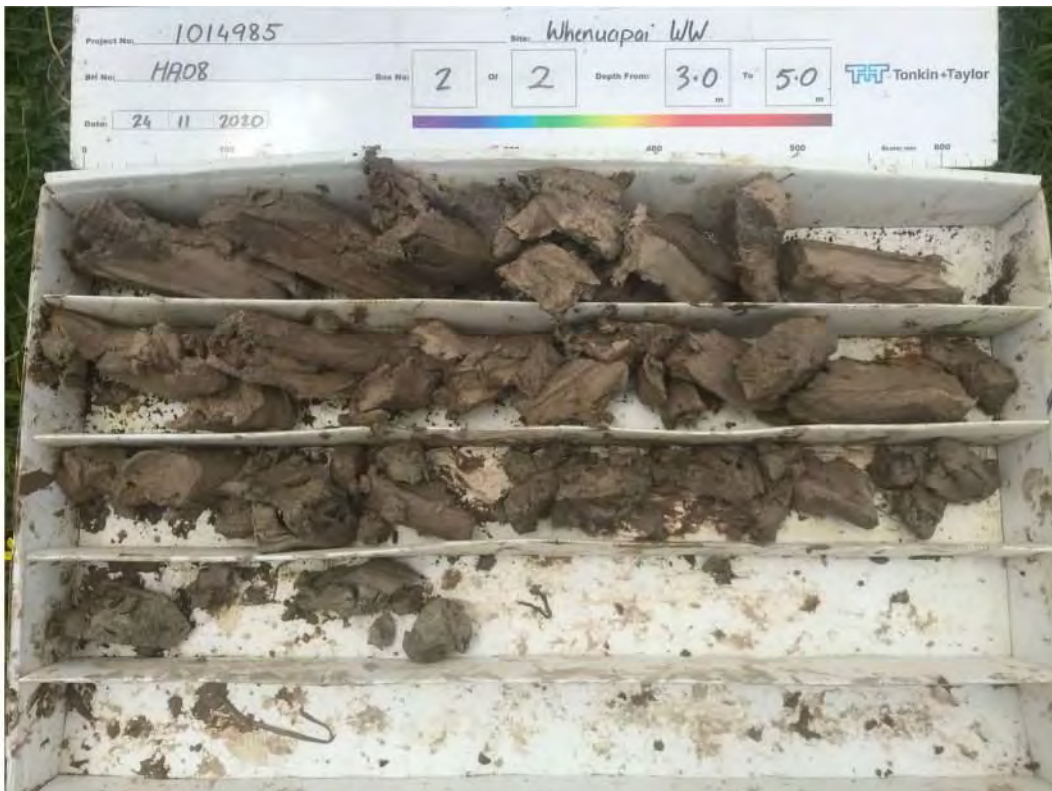
0.00-3.00m

GEOLOGICAL				ENGINEERING DESCRIPTION									
GEOLOGICAL UNIT, GENERIC NAME, ORIGIN, MATERIAL COMPOSITION.	WATER	CORE RECOVERY (%)	METHOD	SCALA PENETROMETER (Blows/50mm)	TESTS	SAMPLES	RL (m)	DEPTH (m)	GRAPHIC LOG	WEATHERING	STRENGTH/DENSITY CLASSIFICATION	SHEAR STRENGTH (kPa)	Description and Additional Observations
Topsoil					Env @ 0.10m		49		TS	M	F		Sandy SILT, trace organics; brown. Firm, moist, low plasticity; sand, fine. Organics, rootlets
Tauranga Group	24/11/2020	94	HA+DCP		● 48/16 kPa Env @ 0.50m PID, 1.8ppm @ 0.50m		0.5		TS				Sandy SILT, minor organics; grey-brown, mottled orange. Firm, moist, low plasticity; sand, fine; organics, rootlets.
					● 57/11 kPa Env @ 1.00m PID, 2.5ppm @ 1.00m		1.0					1.2-1.5m: CORE LOSS	
					● 82/6 kPa		1.5			St		SILT, some sand, mior clay, trace organics; grey-brown, speckled black. Stiff, moist, high plasticity; sand, fine; organics, rootlets.	
					● >200 kPa Env @ 2.00m		2.0			VSt-H		Grades to: Silty CLAY, minor sand, trace organics; brown, mottled orange, speckled brown. Very stiff to hard, moist, high plasticity; sand, fine; organics, rootlets.

● >200 kPa		2.5					2.4m: dark brown.	
					● >200 kPa Env @ 3.00m		3.0			VSt		Sandy SILT, minor clay, trace organics; brown, spotted brown. Very stiff to hard, moist, low plasticity; sand, fine ; organics, rootlets.	
					● 135/73 kPa		3.5			VSt-H		Sandy, silty CLAY, trace organics; brown, spotted dark brown. Very stiff, moist, medium plasticity; sand, fine; organics, rootlets.	
					● 149/72 kPa Env @ 4.00m		4.0			VSt		Grades to: Sandy SILT; brown, mottled orange, spotted black and dark brown. Very stiff, moist, low plasticity; sand, fine; organics, rootlets.	
					● 129/56 kPa		4.5					4.2m: light grey-brown, spotted black.	
					● >200 kPa		4.9			H		4.9m: hard.

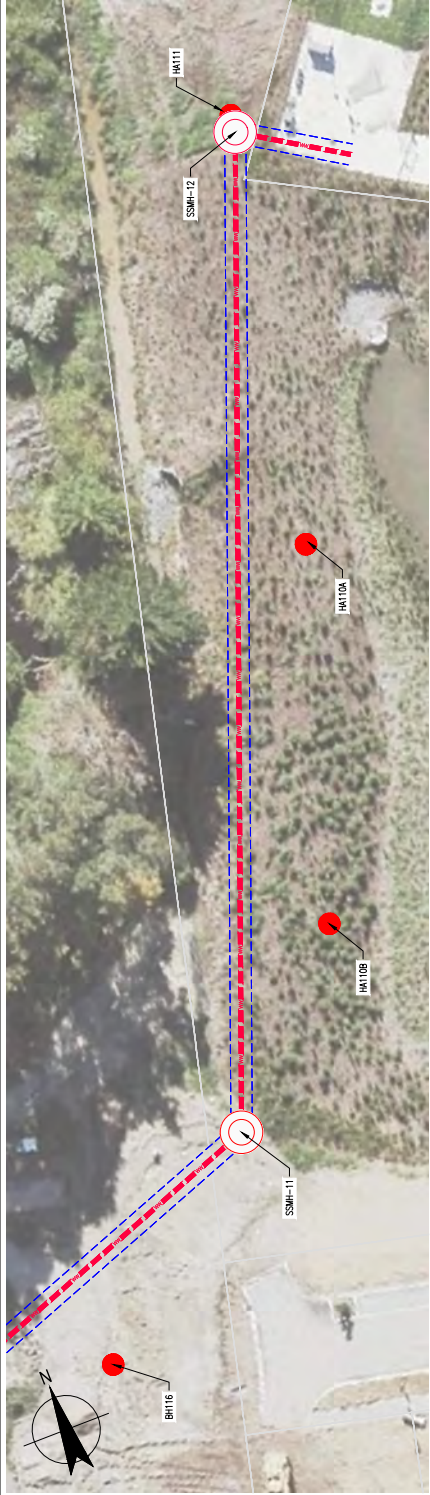
Drawing Title: **GEOTECHNICAL LONG SECTION SHEET 5 OF 6**
Drawing No: **12508391-1C105**
Status: **Subst**
Scale: **G206**
Rev: **RW**

PLAN
SCALE 1:250

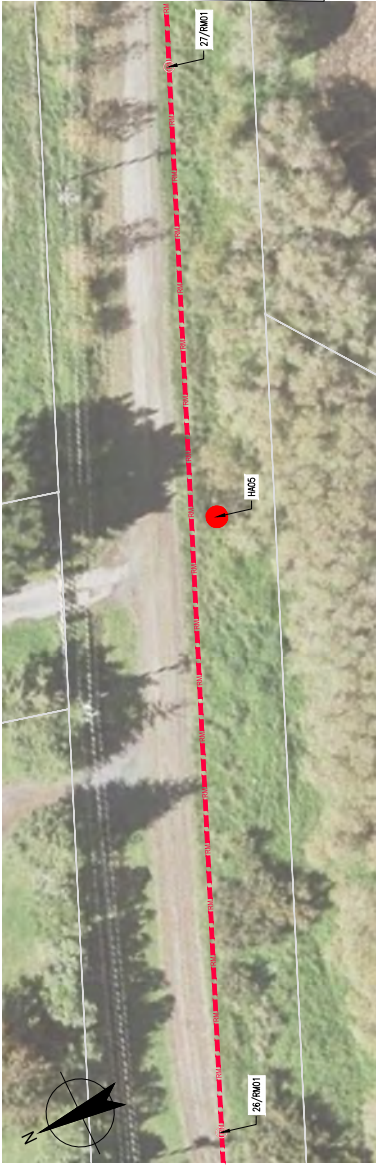
Project No: **12508391**
Drawing Title: **GEOTECHNICAL LONG SECTION SHEET 6 OF 14**

PLAN
SCALE 1:250
