# DETAILED SITE INVESTIGATION (DSI)

8 WHANGAPOURI ROAD, KARAKA, AUCKLAND

**Reference Number:** REP-1625/DSI/JUL21

**PREPARED FOR:** ERGO CONSULTING LTD

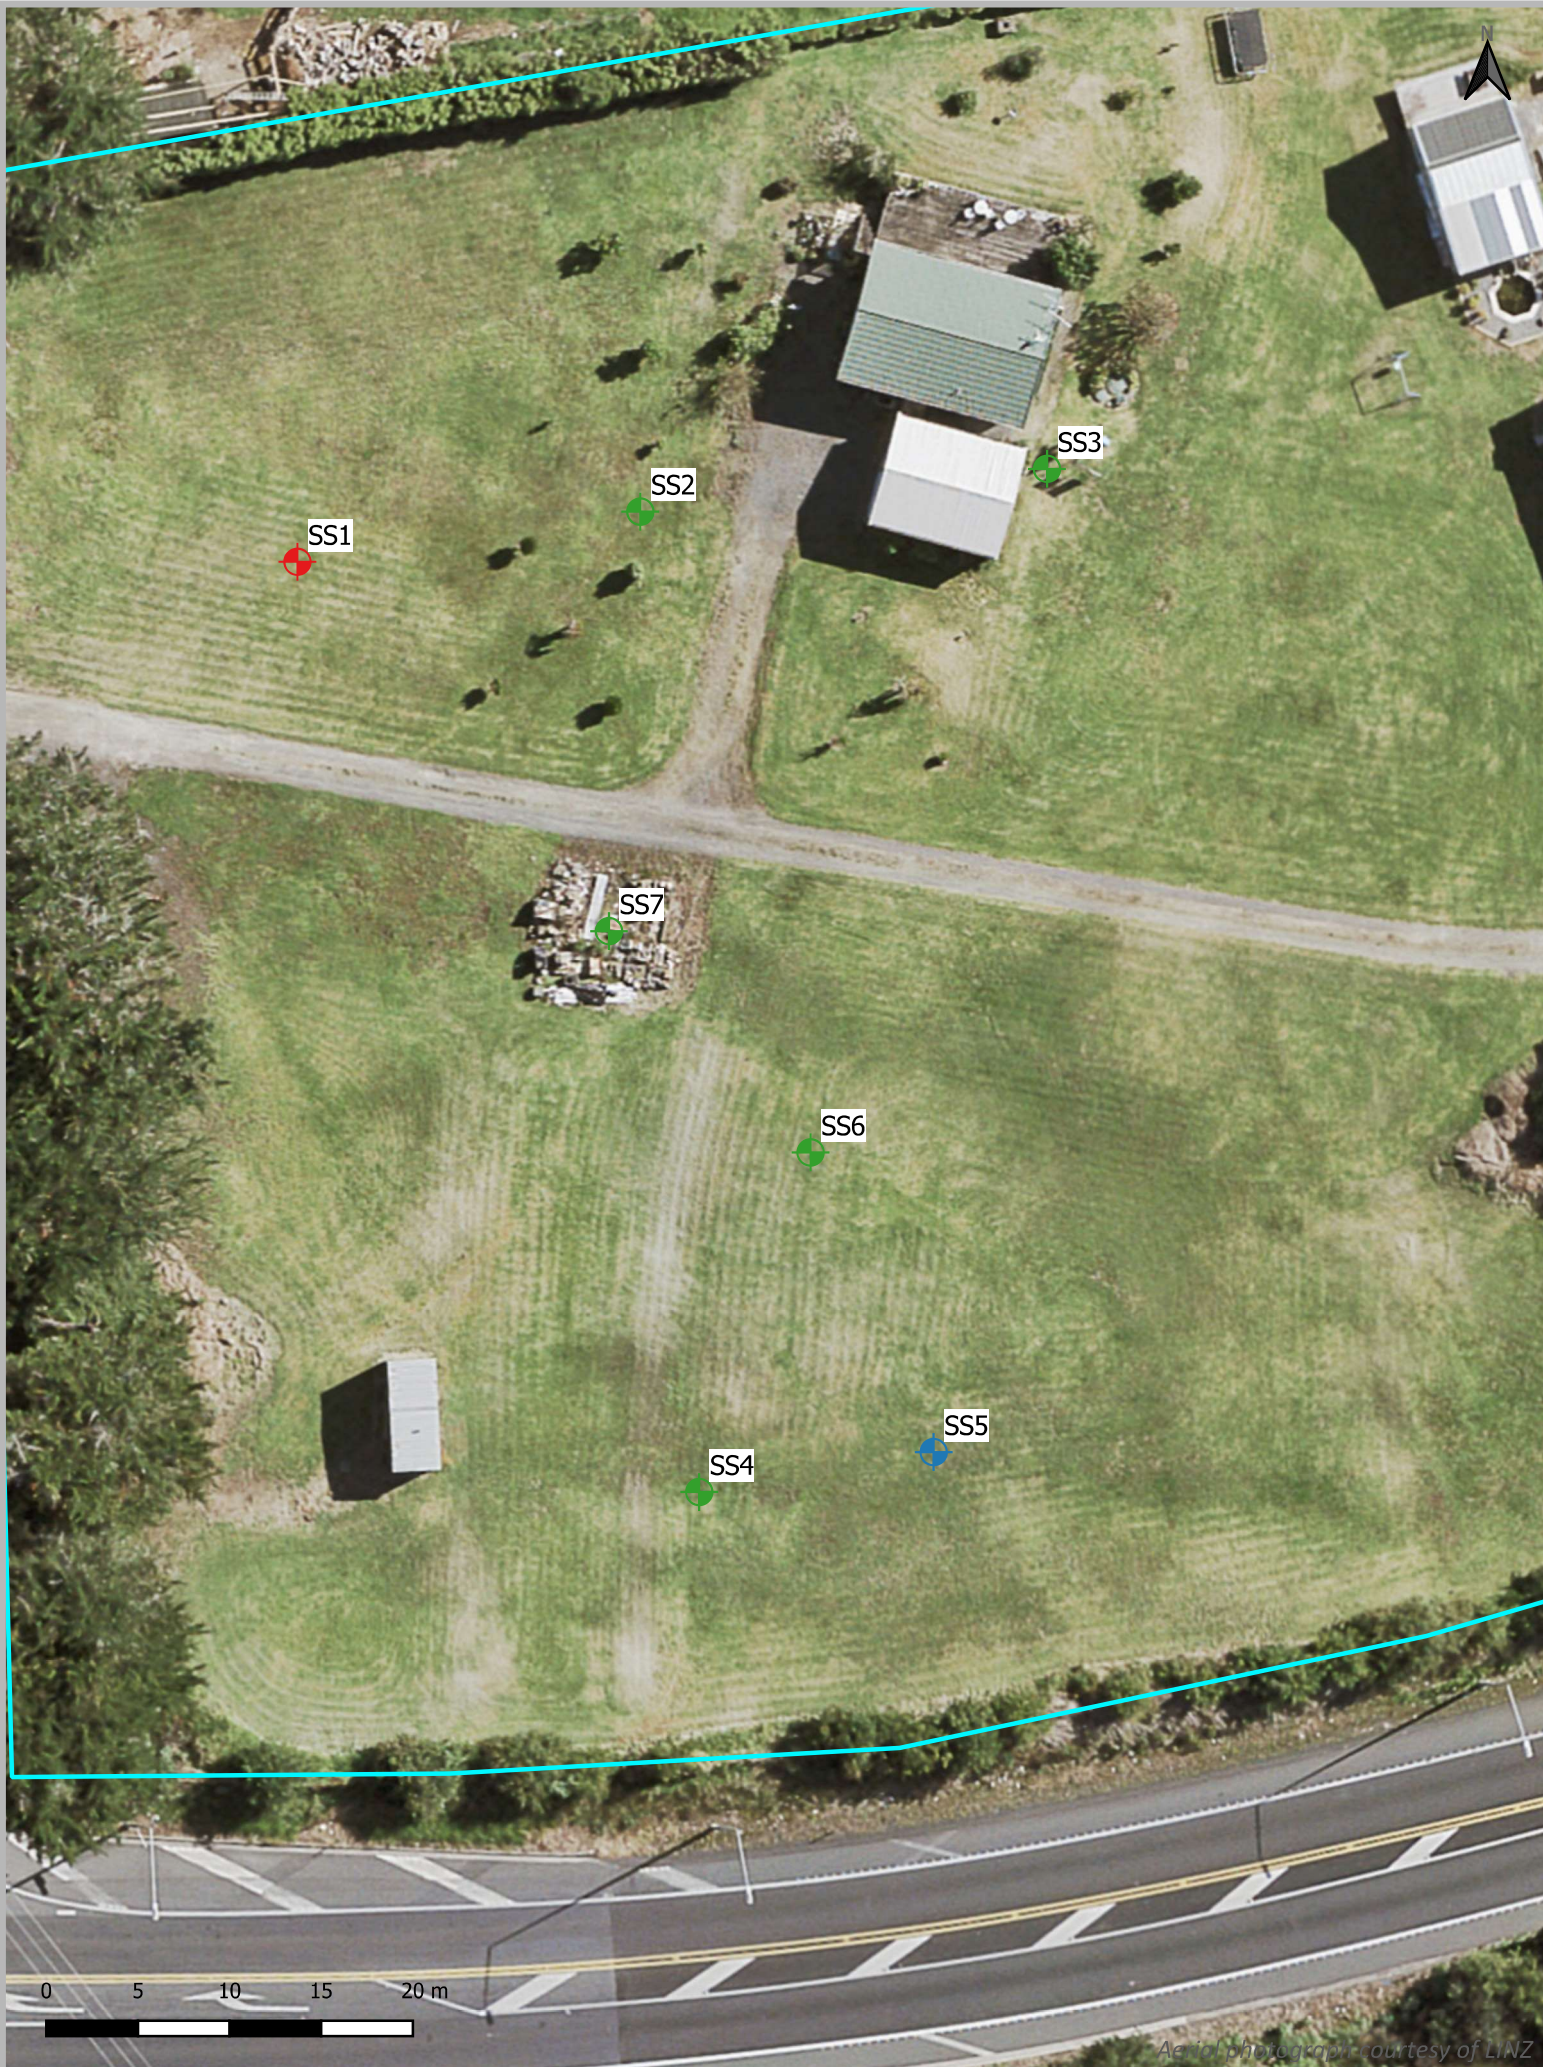
**Figure 2 - Soil Sample Locations**  
**8 Whangapouri Road, Karaka**

Excavations for intrusive soil sampling revealed a layer of topsoil overlying subgrade clays consistent with the natural geology except for soil sample location SS5 where a thin layer of buried topsoil was encountered at 300mm below relative ground level.

Consequently, GSL employed a judgemental soil sampling methodology across the western portion of the site through the collection of soil samples from seven locations within the locations of proposed future earthworks. Soil sample locations are shown in Figure 2.

Seven soil samples were collected from the surface 0-75mm alongside three samples collected at 300mm and one sample collected at 500mm using a hand auger and were transferred directly from the auger head to laboratory provided glass jars and plastic sampling containers with the date, location, sample identification number, sample depth, and initials of the sampler noted on the bag.

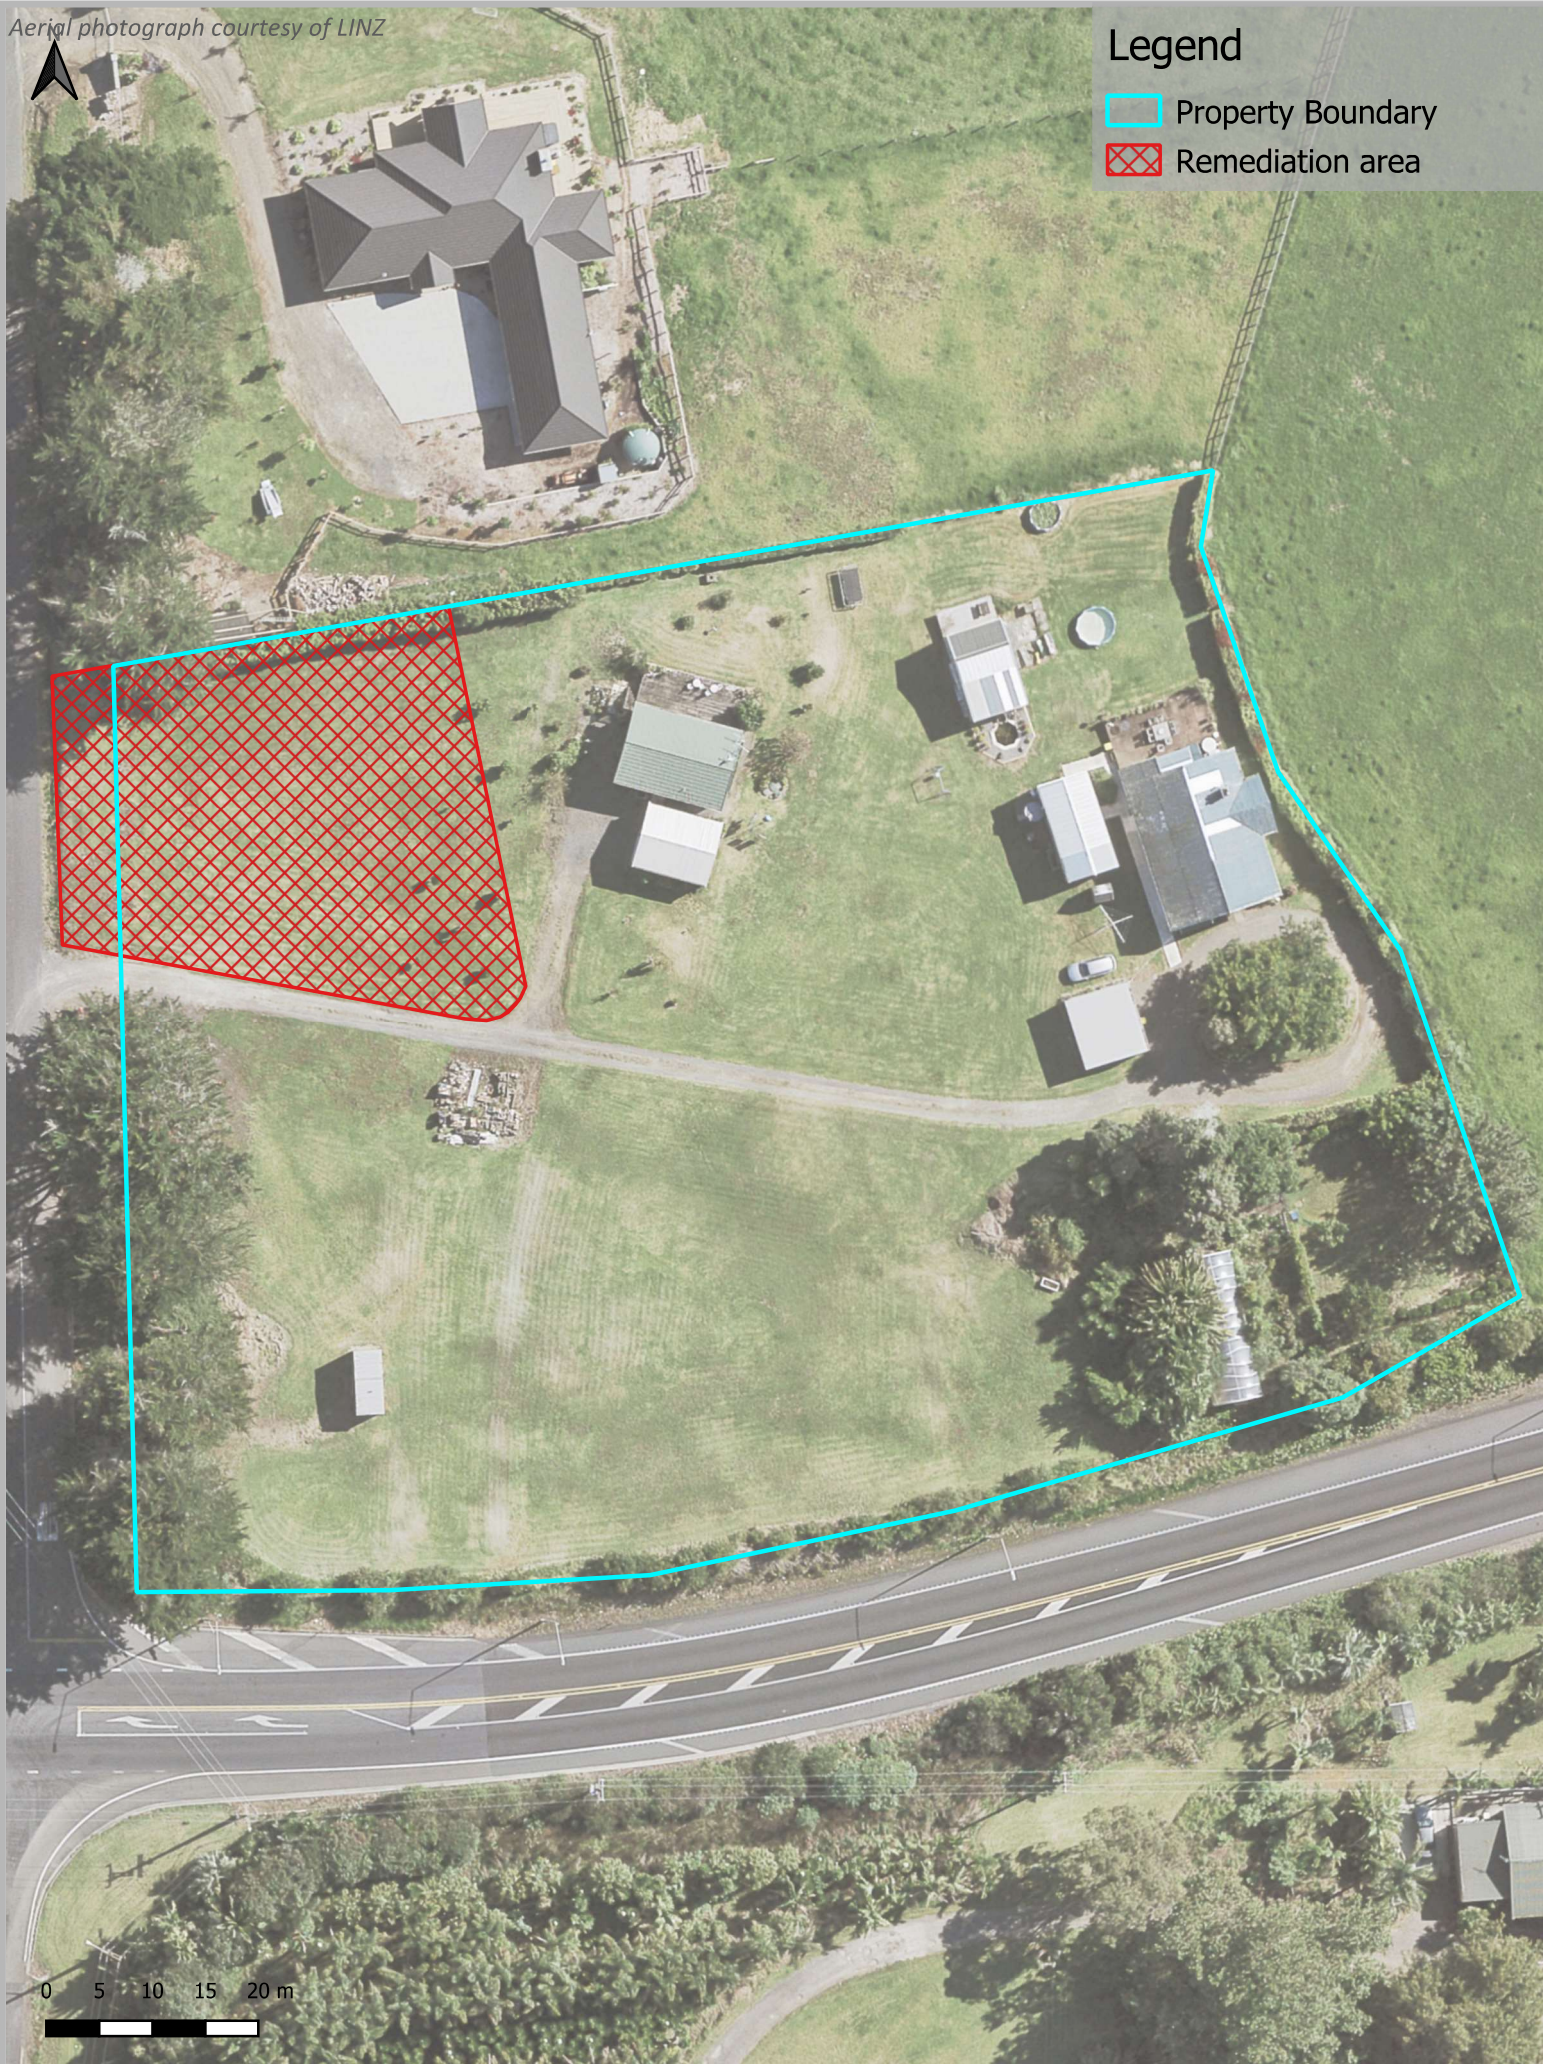
Remediation area

- As a result of the above identified NES SCS and AUP(OP) exceedance remediation of an area of approximately 1,380m<sup>2</sup> will be necessary (Figure 3). Further delineation soil sampling is recommended to accurately determine the lateral and vertical extents of impacted soil;

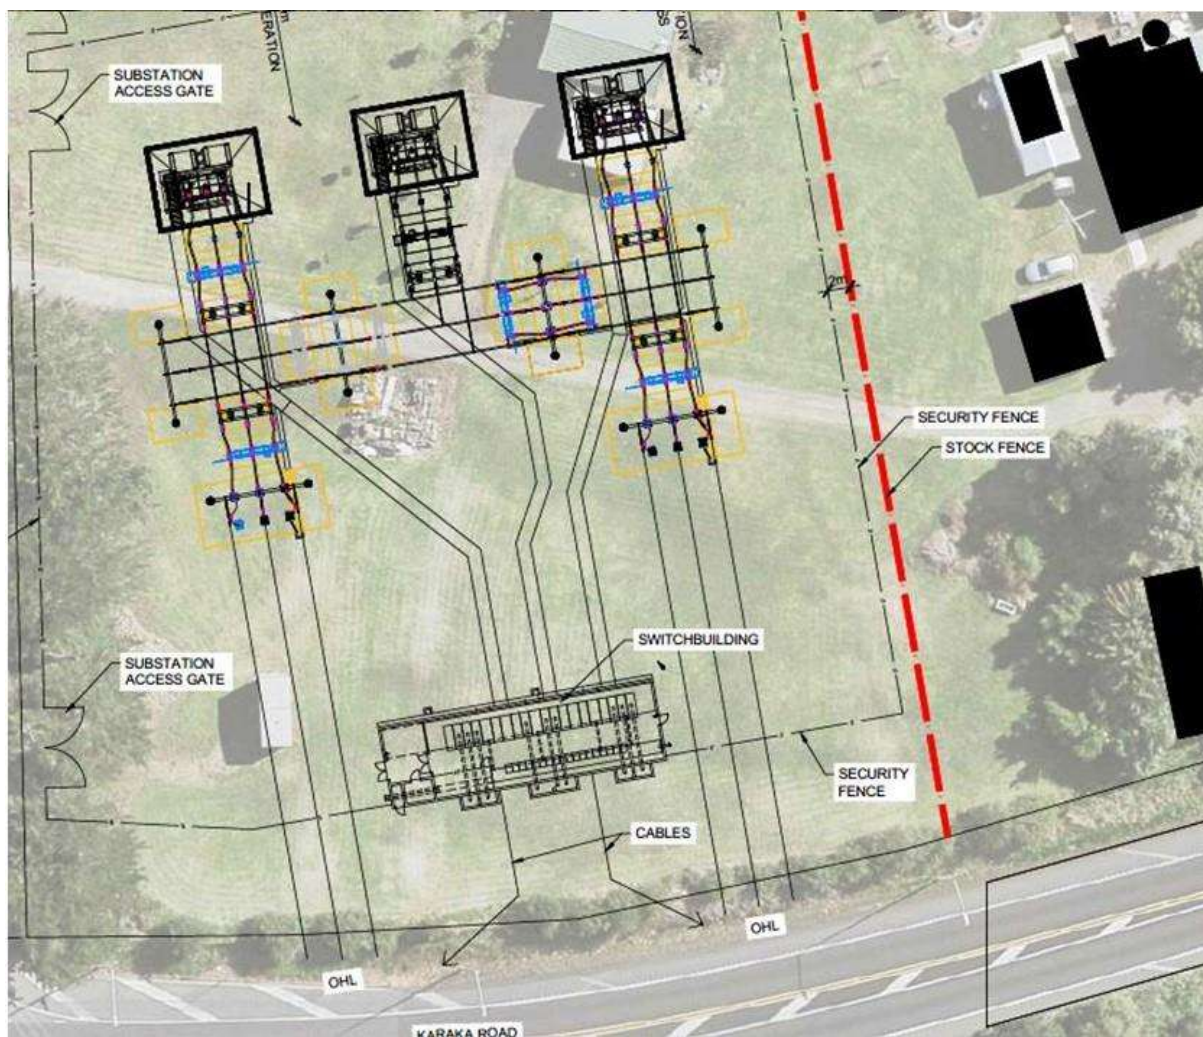
## APPENDIX A      PRELIMINARY SCHEME PLAN

Counties Power propose to subdivide the property, creating an eastern residential lot retaining its' existing residential configuration and a new western lot (the site) where a substation, comprising of a switch room with a 2m deep basement, outdoor transfer on a pad foundation, outdoor electrical equipment on steel stands and concrete pad foundations, power pole structures, and associated accessways will be constructed. A proposed scheme plan is attached in Appendix A.

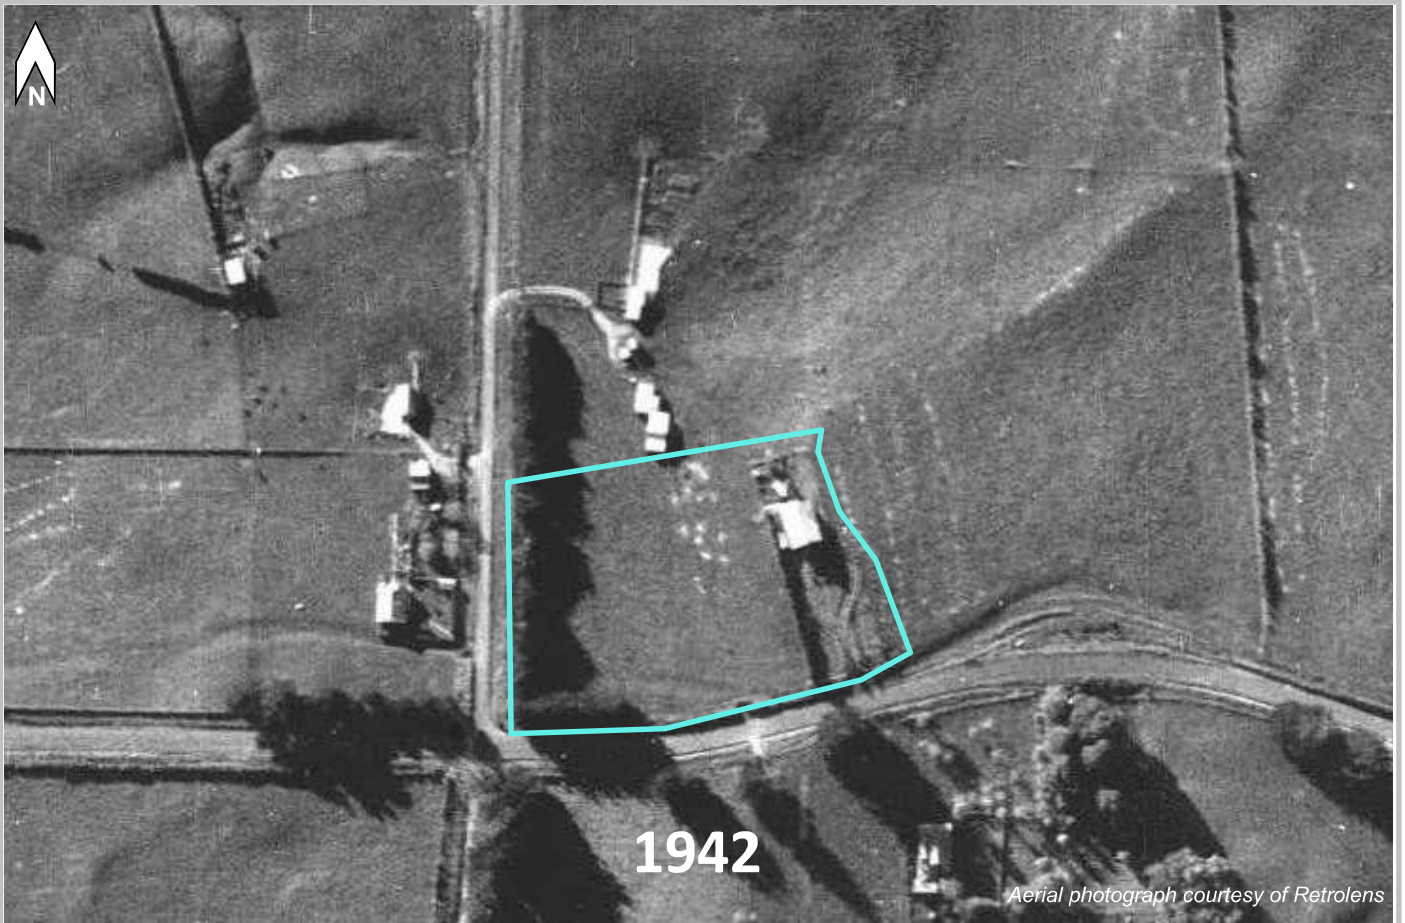
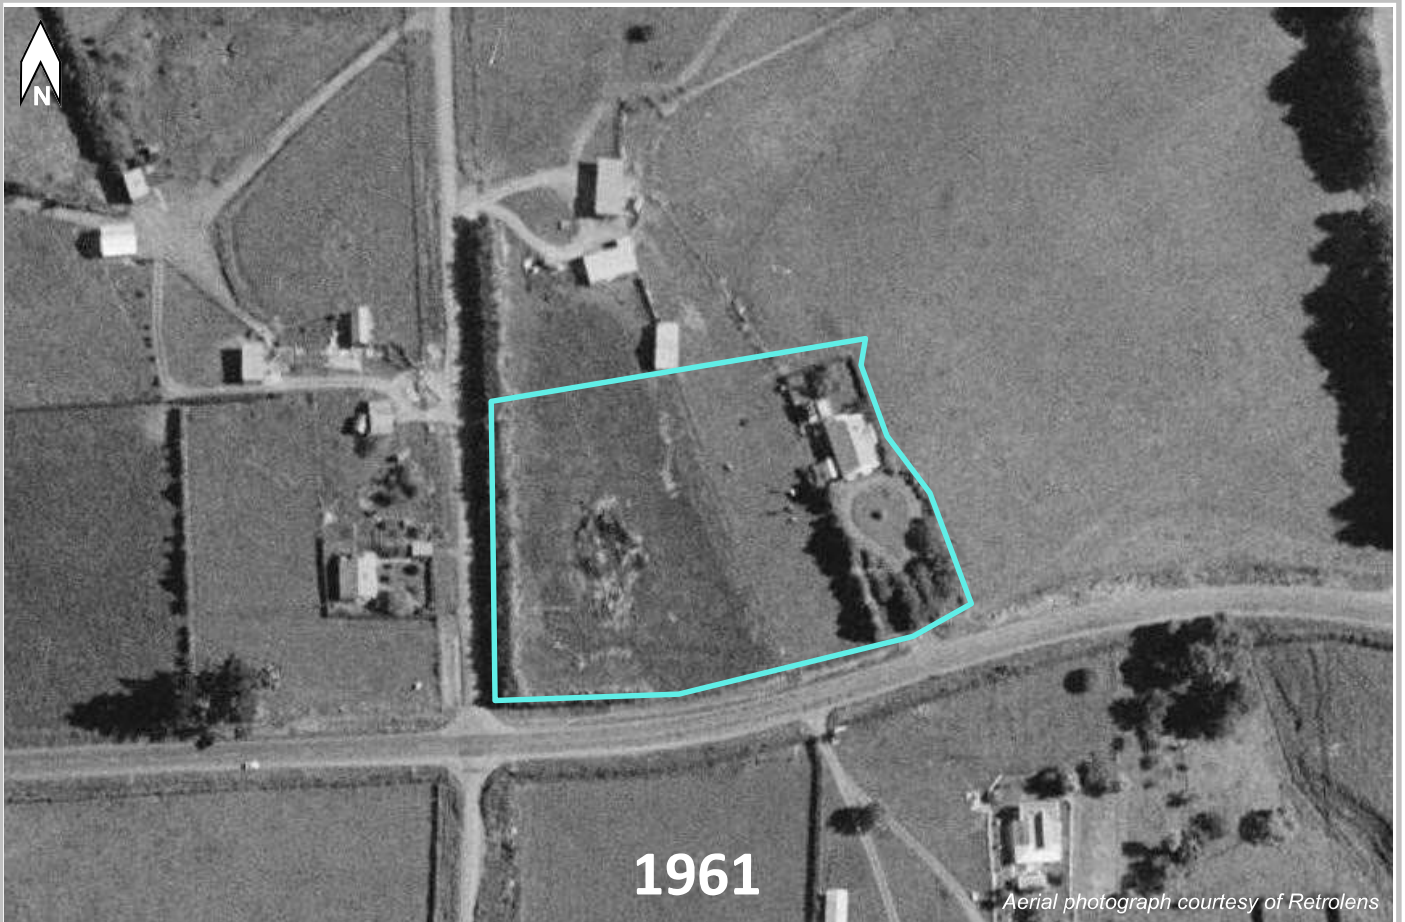
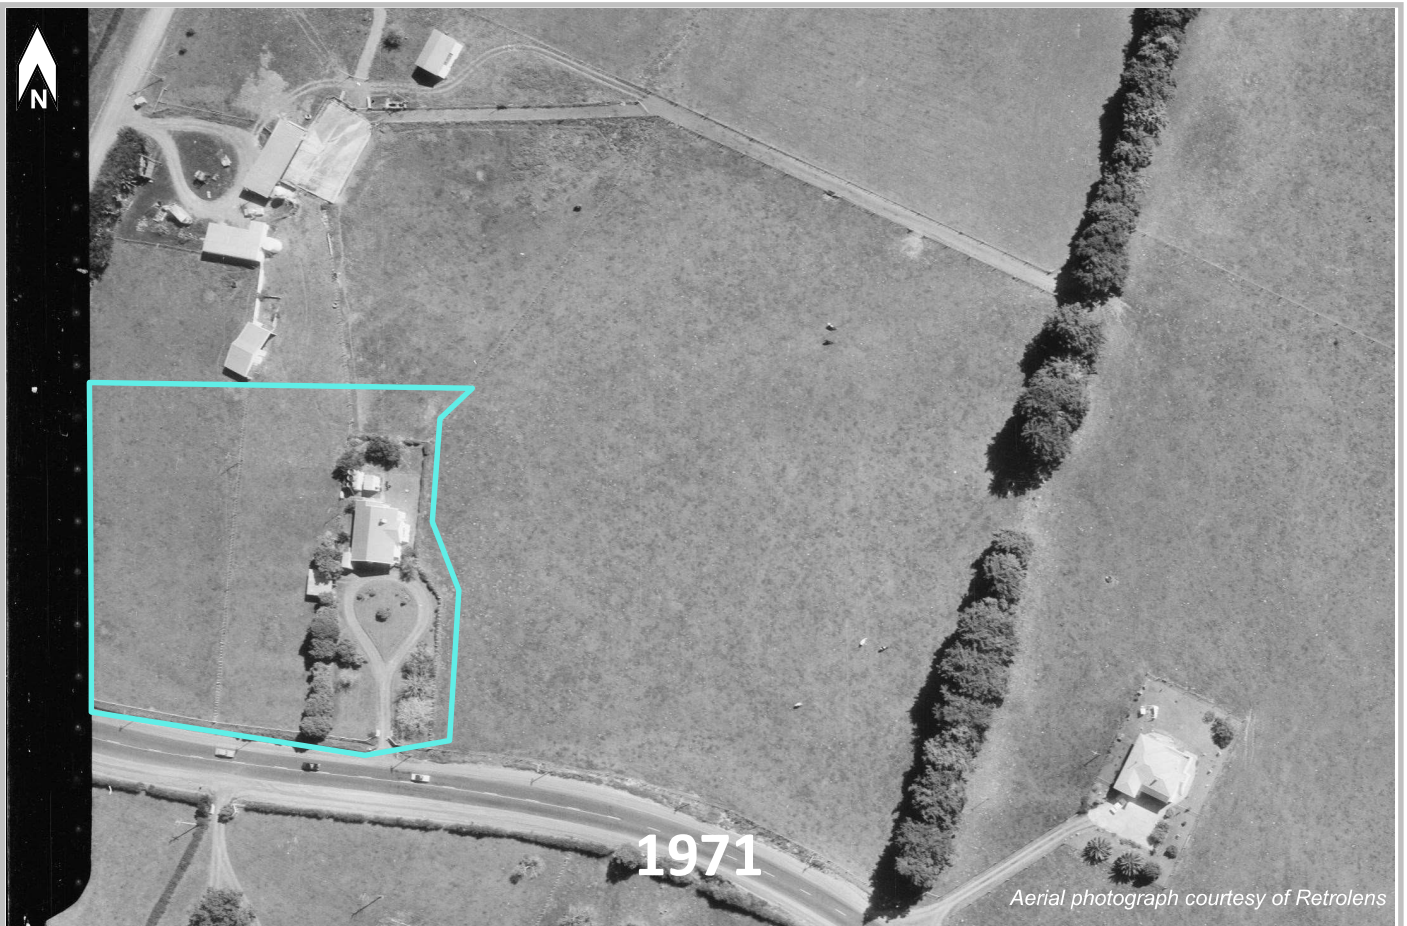
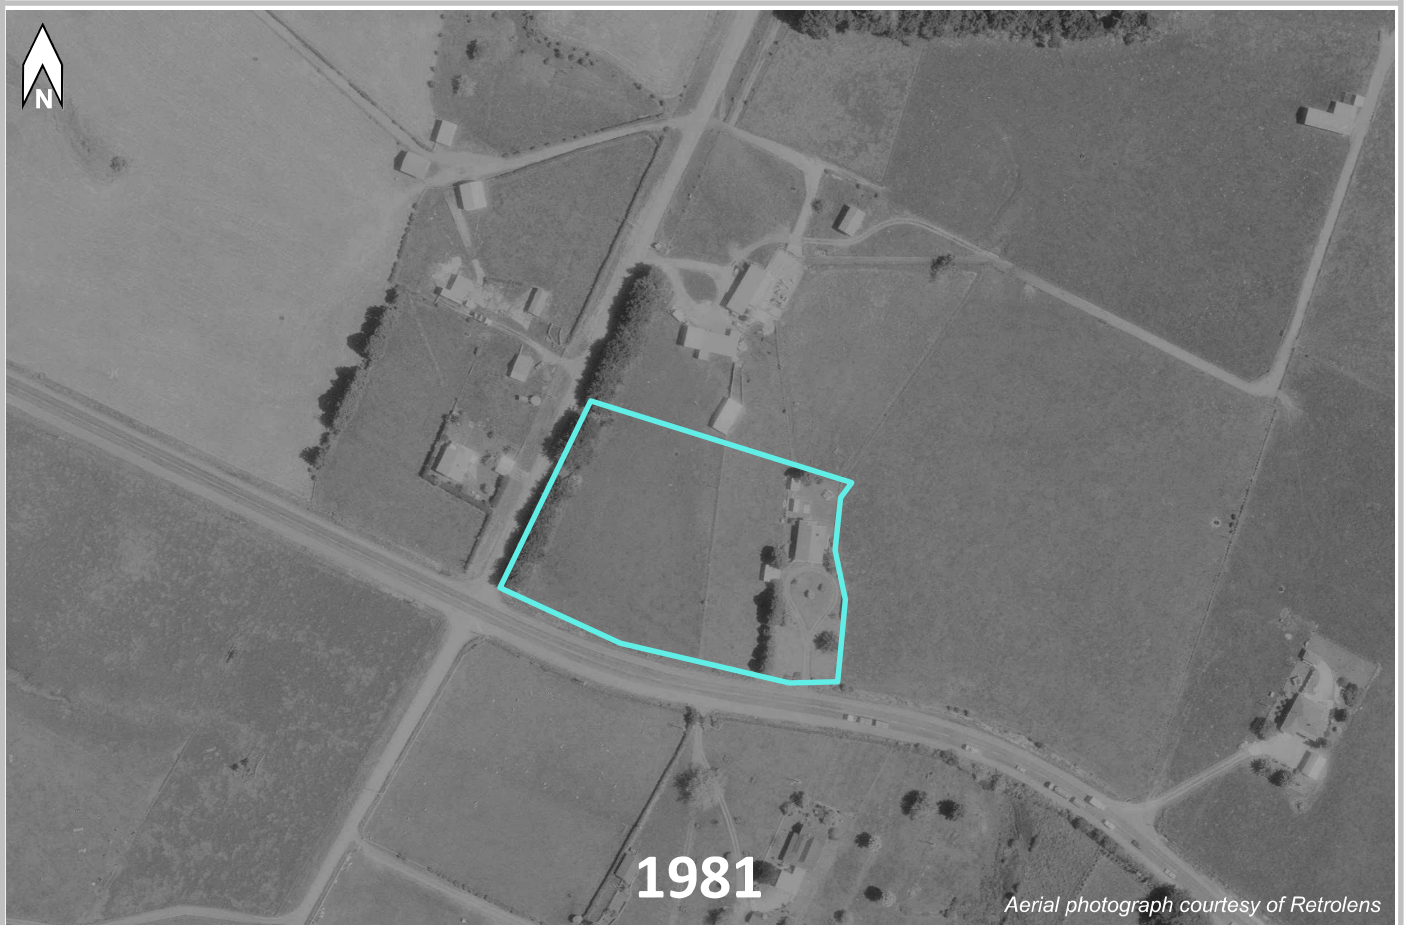
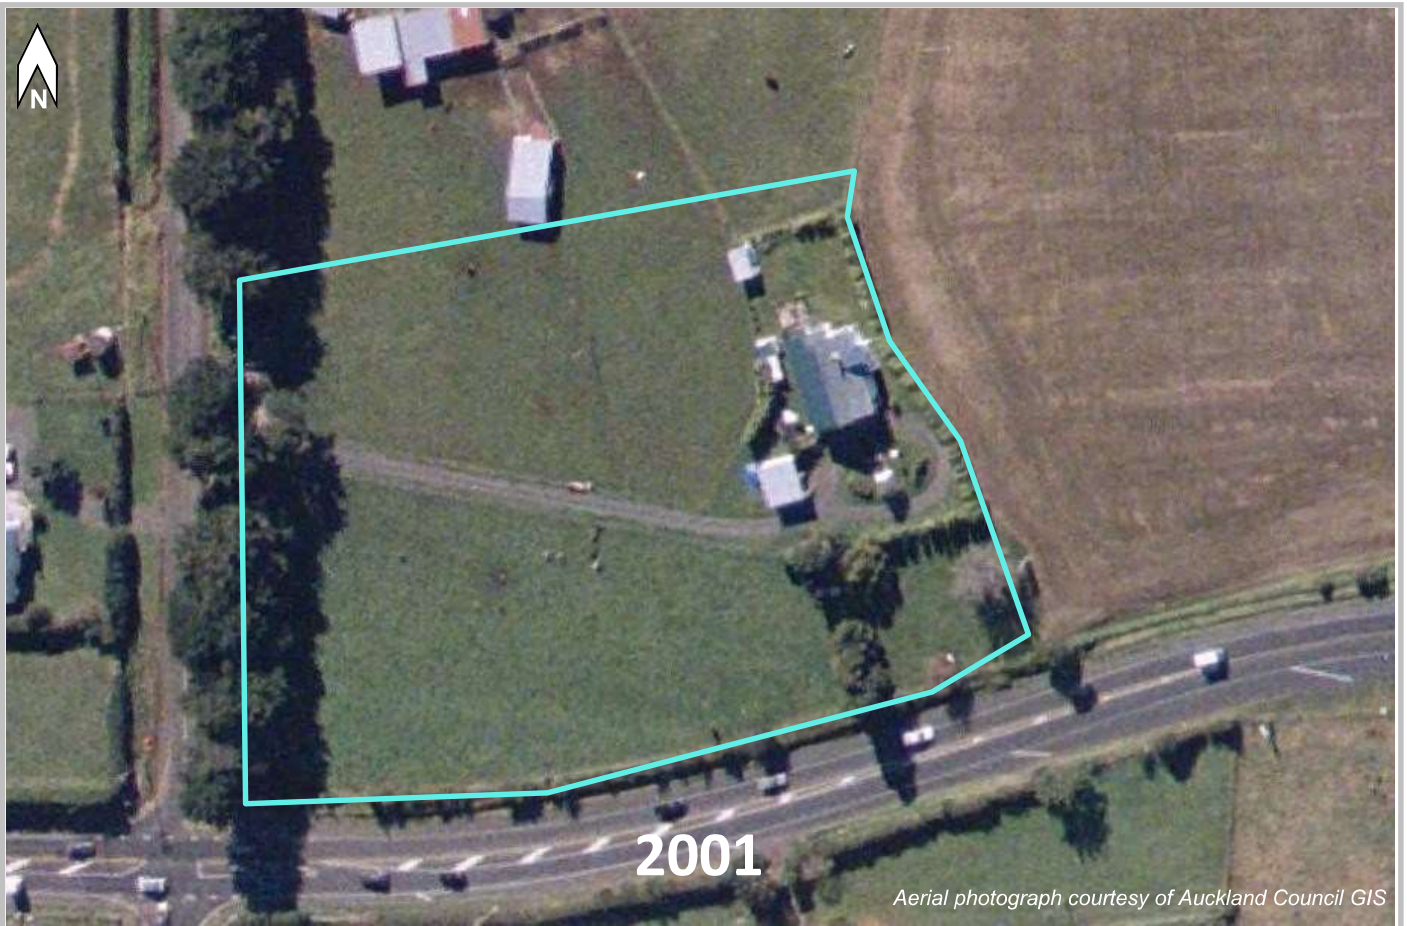
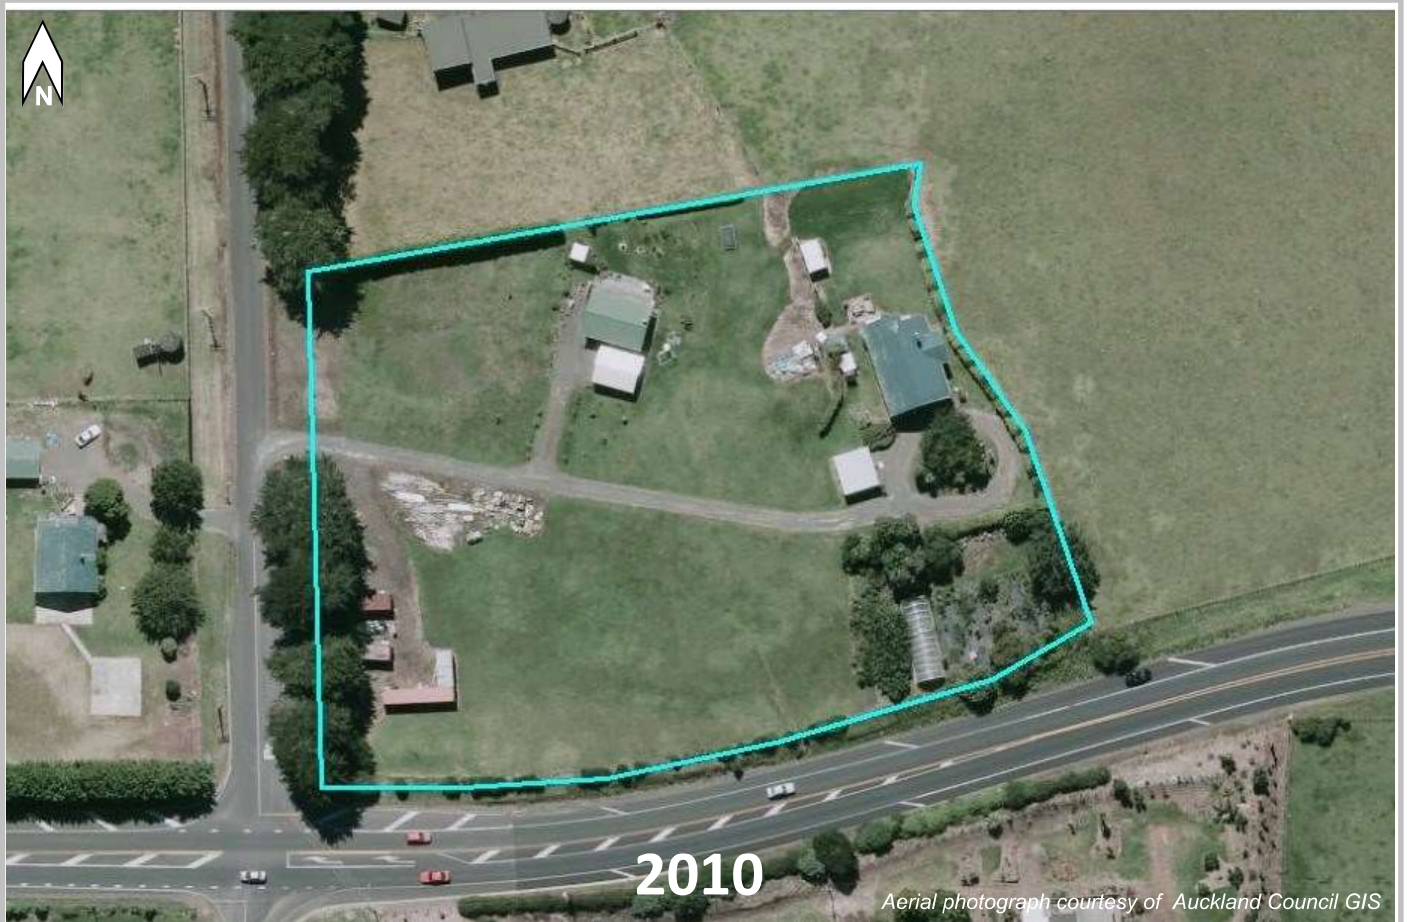
## **APPENDIX C                      HISTORICAL AERIAL PHOTOGRAPHS**

**1942-1961** This is the earliest photograph available for the site and despite the poor quality of the image, it is clear that a residential dwelling has already been established in the north-eastern portion of the site with what appears to be a garage and a garden shed in proximity. A circular driveway can be seen connecting the dwelling with Karaka Road while the western area of the site is vacant pasture with no distinctive structures noted.

The plate also shows that Karaka Road and Whangapouri Road had been established at the time the 1942 photograph was taken and the wide area shows minor residential activity, being mainly vacant pastureland.

The site shows no significant changes through the images up to 1961 apart from the increased vegetation in the back and front yard of the dwelling.

**1971-1981** The 1971 image is of better quality allowing the features of the site to be observed in more detail. The same general configuration is maintained from previous plates and except for three water tanks are now observable next to garage towards the rear of the dwelling (north) as well as a new double carport/garage to the southwest of the dwelling and a fence dividing the site in two areas.

The imagery from 1981 shows no significant changes in the site except from the tanks and storage garages mentioned above which have then been removed and what appears to be two new storage garages and a small garden shed have been erected.

**2001** The 2001 plate is the first coloured image available for the site and shows the site in the same residential configuration with some changes in the layout. These changes include the relocation of the driveway which now provides access to the dwelling from Whangapouri Road; the removal of some structures in the rear of the dwelling; and the addition of what appears to be a garden shed to the west of the dwelling.

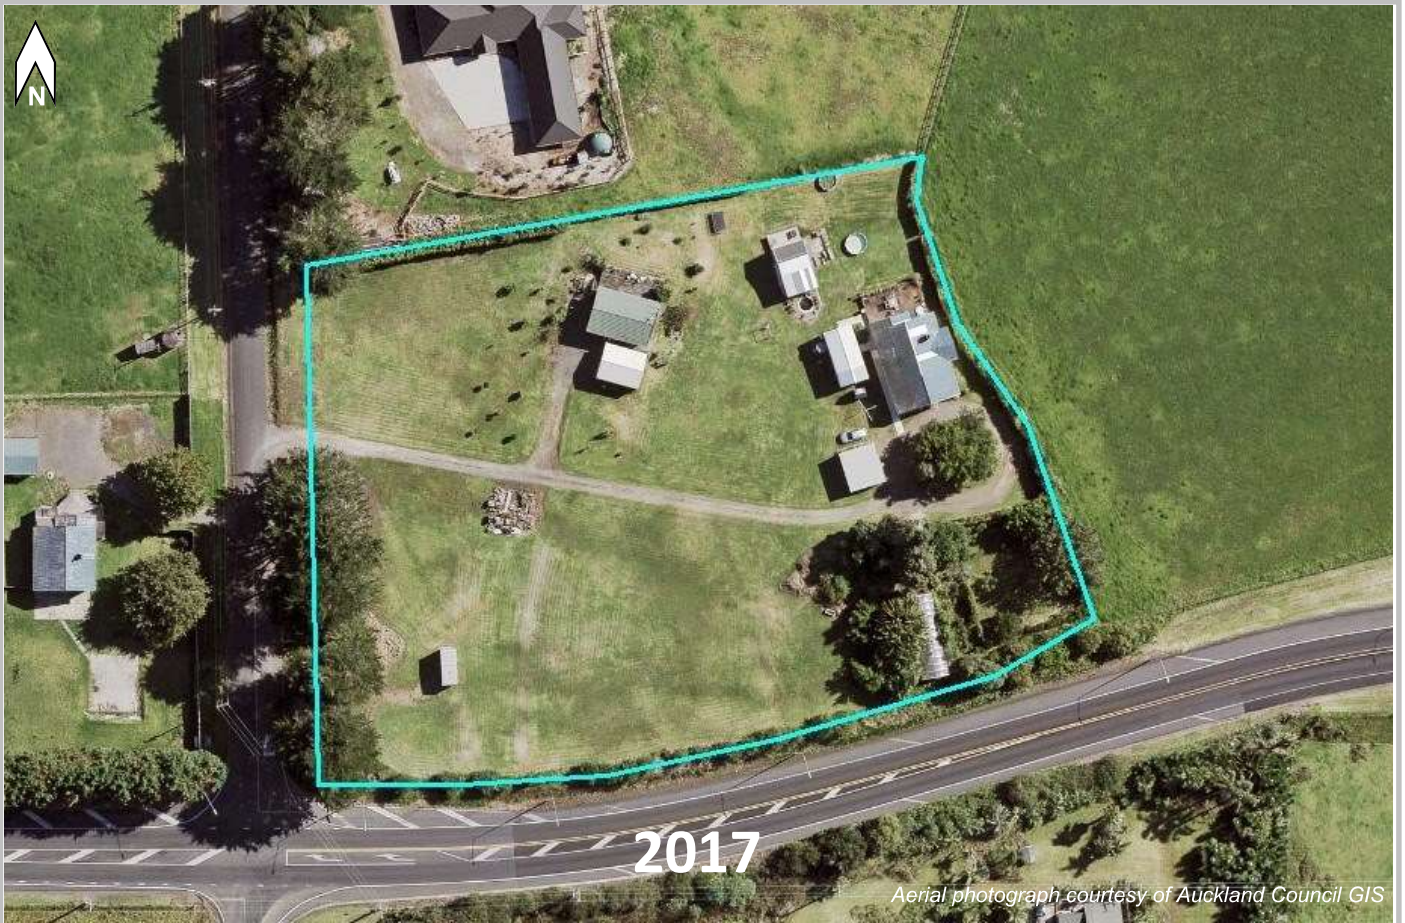
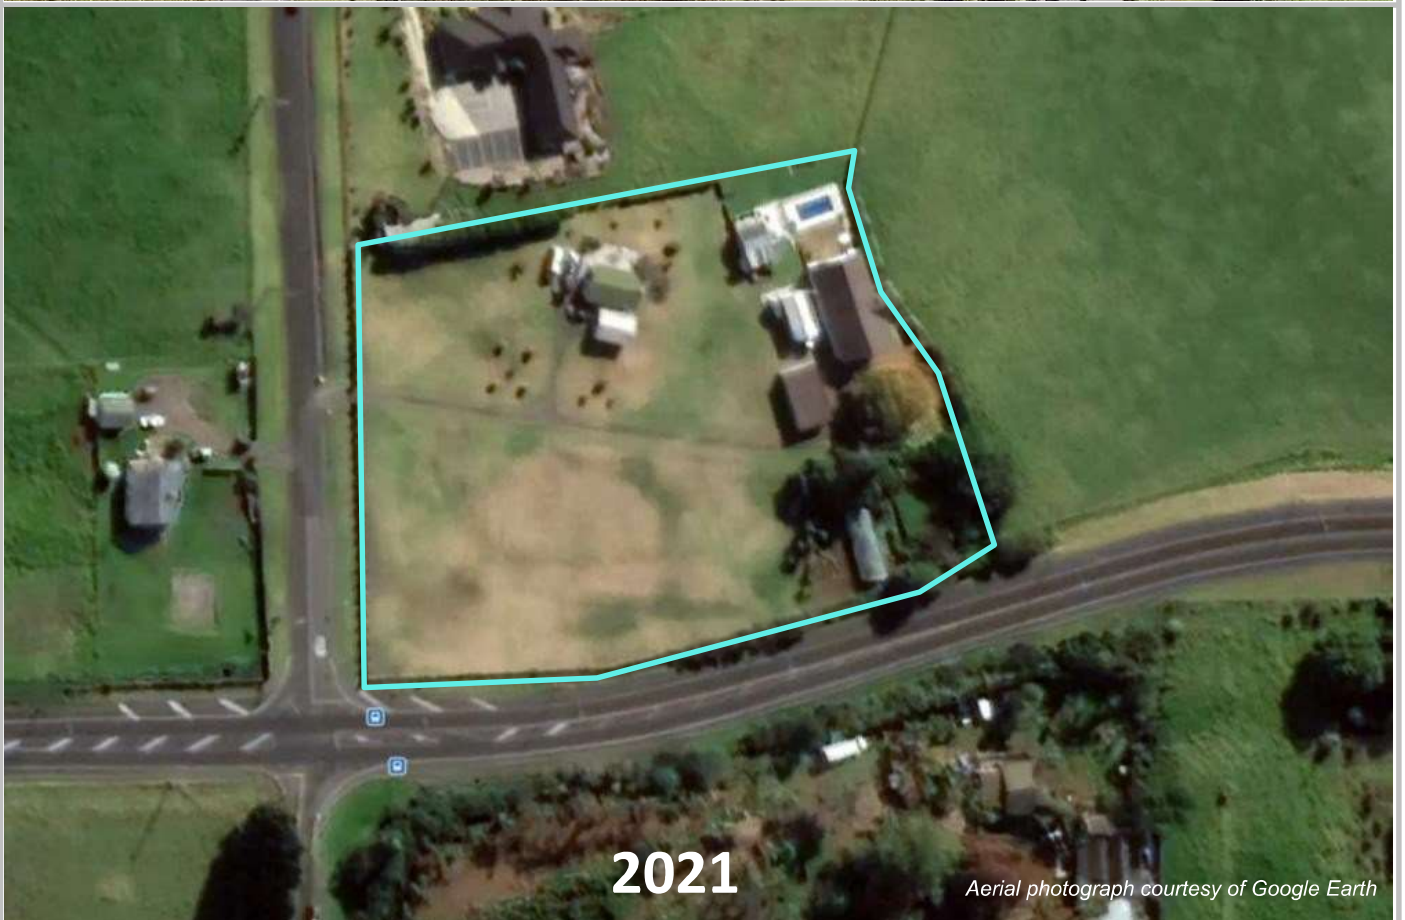
**2010** This plate shows few new features have been developed in the site. A new residential dwelling with a garage and a garden shed has been erected in the middle-north portion of the site by the northern boundary. The appearance of the surface in the northeast and southwest portions of the site suggests that minor earthworks are taking place in the site. Additionally, a vegetable garden area with a small glasshouse can be seen in the south-eastern corner of the site as well as four shipping containers in the south-western corner of the site with a stockpile of unknown materials.

**2017-2021** The 2017 plate shows the site in the same general configuration. The garden shed by the northern boundary of the site has been removed and additional features include what appears to be a detached addition to the pre-existing residential dwelling in the north-eastern portion of the site alongside new ornamental landscaping features in the same area.

There are no significant changes in the 2021 plate apart from the development of a swimming pool in the north-eastern corner of the site and the extension of the garage in the eastern portion of the site to the front of the residential dwelling.

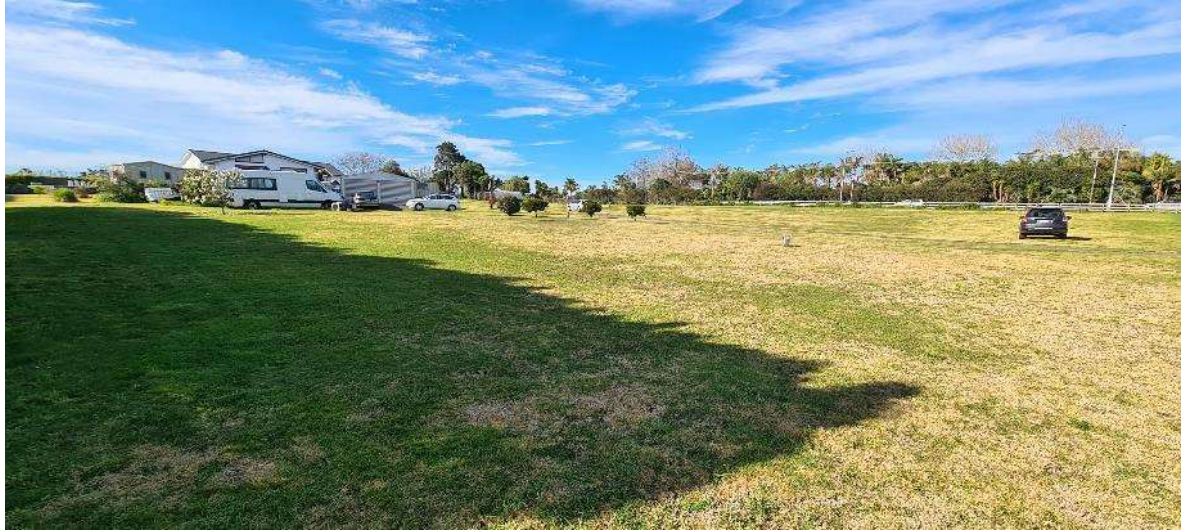
**PLATE 1: VIEW OF WESTERN PORTION OF THE SITE FROM NORTHWEST.**

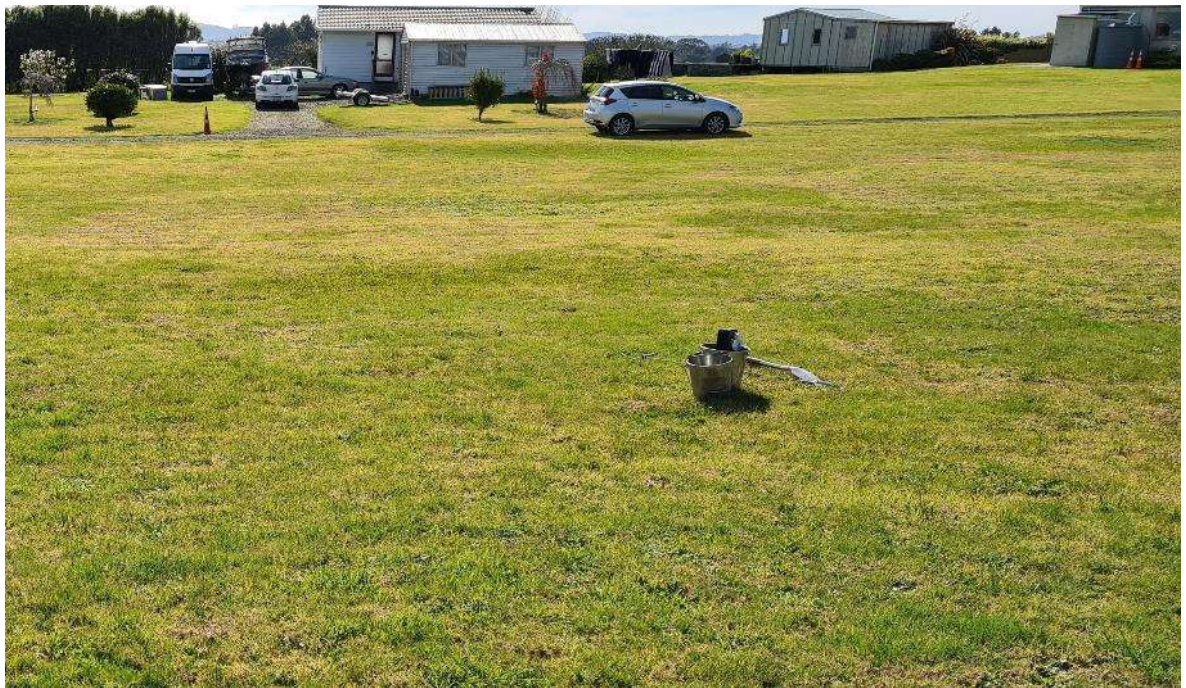
**PLATE 2: SOUTHERN PORTION OF THE SITE AND EXISTING BUILDINGS**

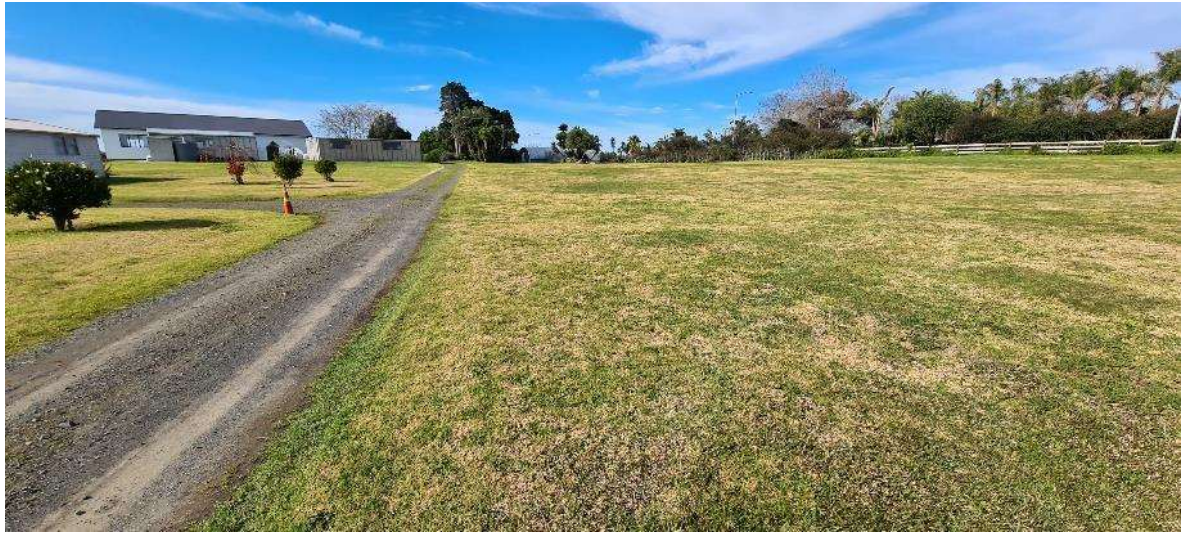
**PLATE 3: SIDE VIEW OF THE SOUTHERN PORTION OF THE SITE**

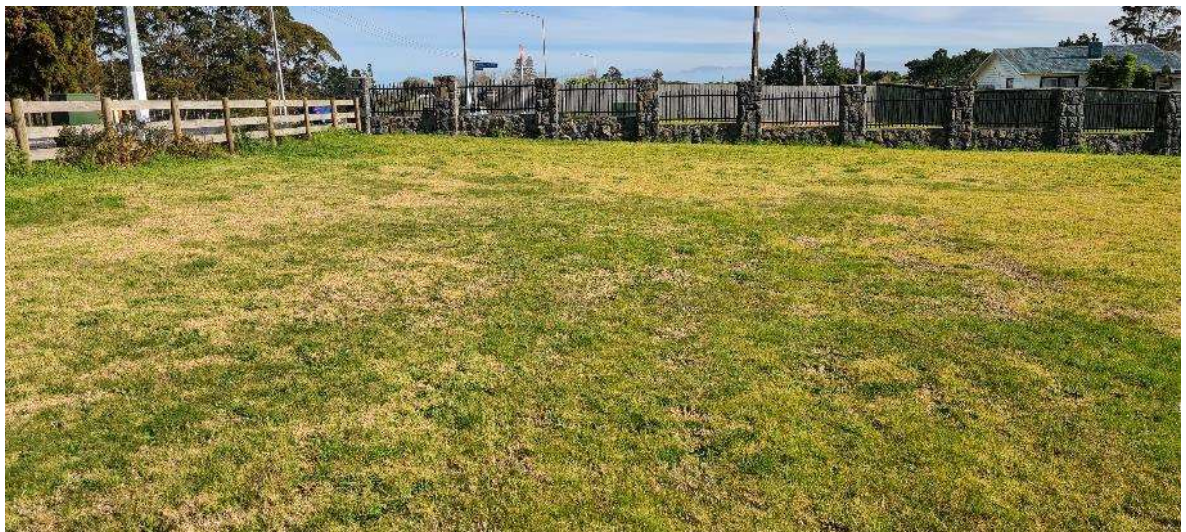
**PLATE 4: SOUTH-WESTERN CORNER OF THE SITE**
