TE TUPU NGĀTAHI
SUPPORTING GROWTH

Warkworth Assessment of Archaeological and Heritage Effects

May 2023

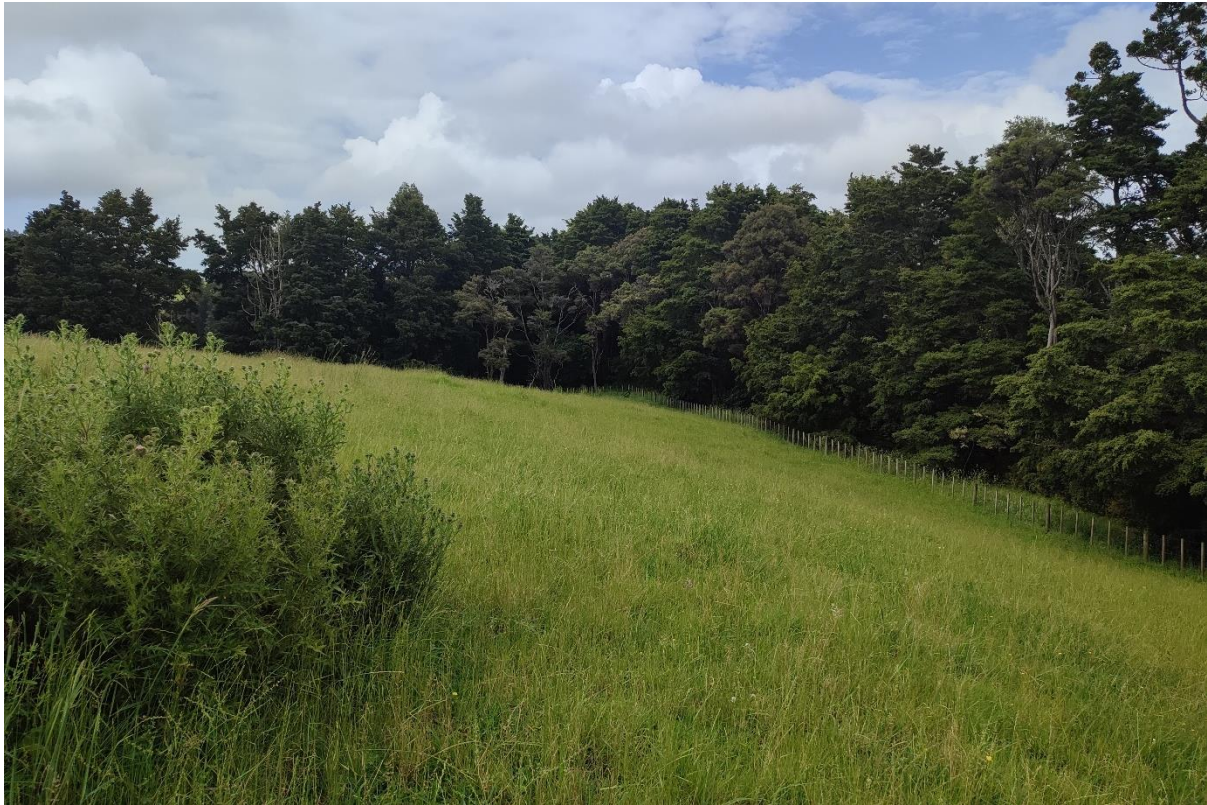
property, he primarily resided in Auckland. Brassey's site visit found no surface evidence of the hut, but he noted that subsurface material was likely present.

This site was walked over during a field assessment for this project. It appears largely unchanged since it was recorded; the paddock remains in pasture and has not been subject to any recent building or earthworks. It is likely that subsurface remains are still present, with the landowner mentioning that they had seen all sorts of glass and ceramic fragments in the ground around their property, though they are unlikely to be within the proposed designation.

Figure 8. View towards Cherry's Hut (R09/2243), no surface remains visible.

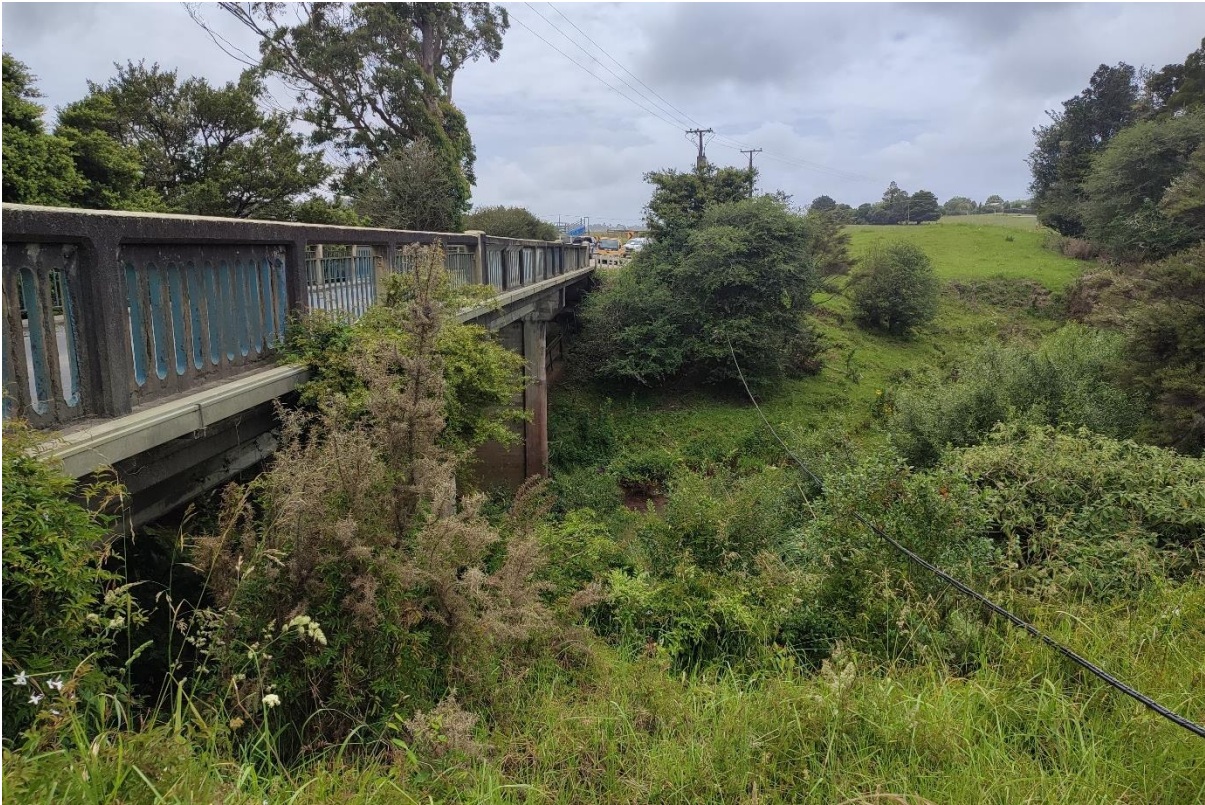
An attempt was made to view this site during the field assessment for this project, but the dense vegetation on the eastern river bank meant there was little to no visibility from that point. The current bridge was not safely accessible on foot, being a one-lane bridge with heavy industrial traffic. The landowner briefly mentioned that he may have seen some evidence of where the original bridge was (immediately south of the current bridge) but he did not provide any further detail or state when this was (the family has owned the property for around 80 years).

There is some potential that piles or other structures from a pre-1900 bridge are still present, obscured by the tide or vegetation, and could be affected by works.

Figure 9. View towards the location of Cherry’s Bridge (209/2244), no surface remains visible with the vegetation.

The proposed works have potential to damage two archaeological sites recorded in the NZAA SRS (R09/2244 and R09/2247) and one site scheduled in the Auckland Council CHI (17004). An archaeological authority will need to be obtained from HNZPT to modify any pre-1900 sites (R09/2244 and R09/2247) and works near these sites will need to be monitored to record any archaeological material that may be impacted by works.

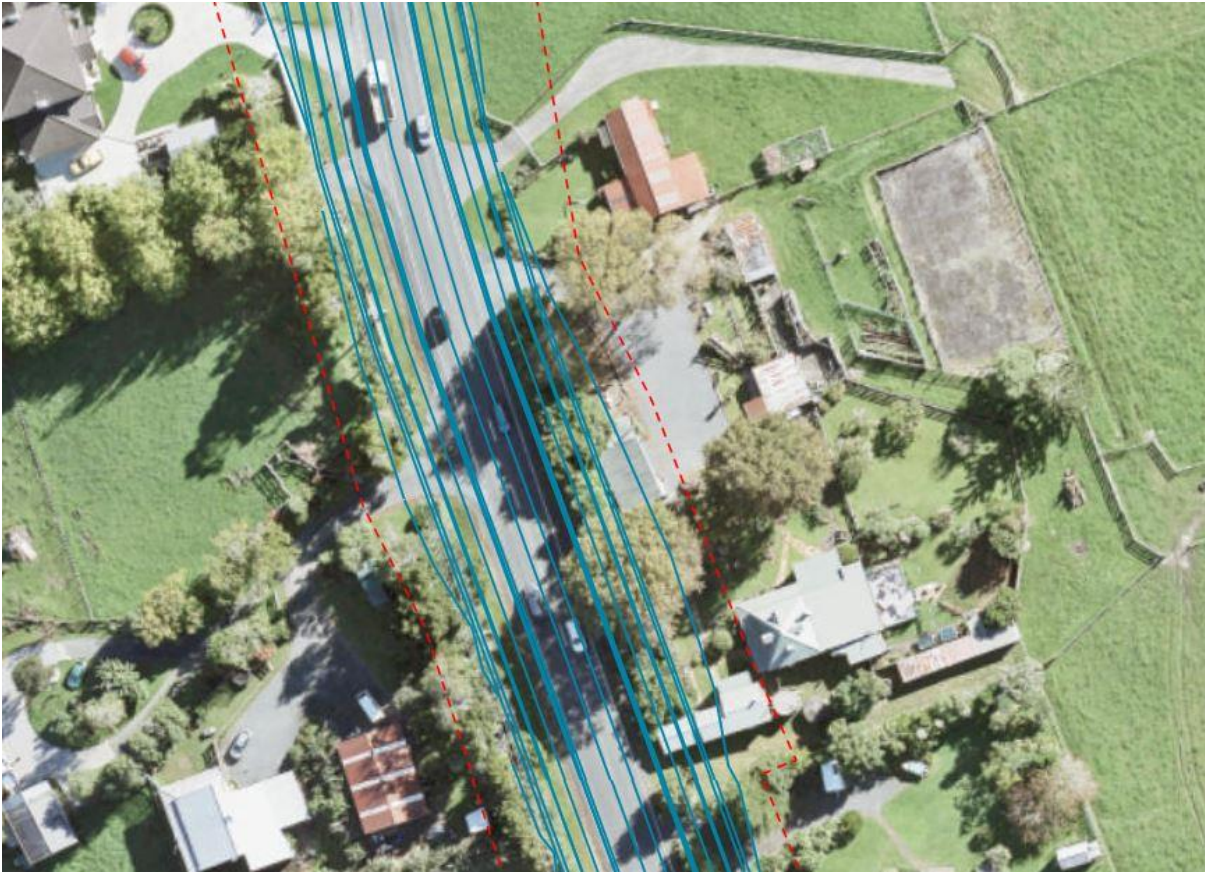
This property was viewed from the roadside and the carpark entrance during the field assessment for this project. Despite fossicking and significant modification to the grounds (i.e., driveway and landscaping), some historic material may still be present beneath the surface within the scope of the proposed works. The proposed designation does extend into the property and includes a later 20th century garage and ancillary buildings constructed adjacent to the house. The 19th century cottage itself lies immediately outside the proposed designation boundary.

Figure 10. Extent of proposed designation and R09/2253.

The proposed works have potential to damage an archaeological site recorded in the NZAA SRS R09/2253). An archaeological authority will need to be obtained from HNZPT to modify any pre-1900 sites (R09/2253) and works near this site will need to be monitored to record any archaeological material that may be impacted by works.

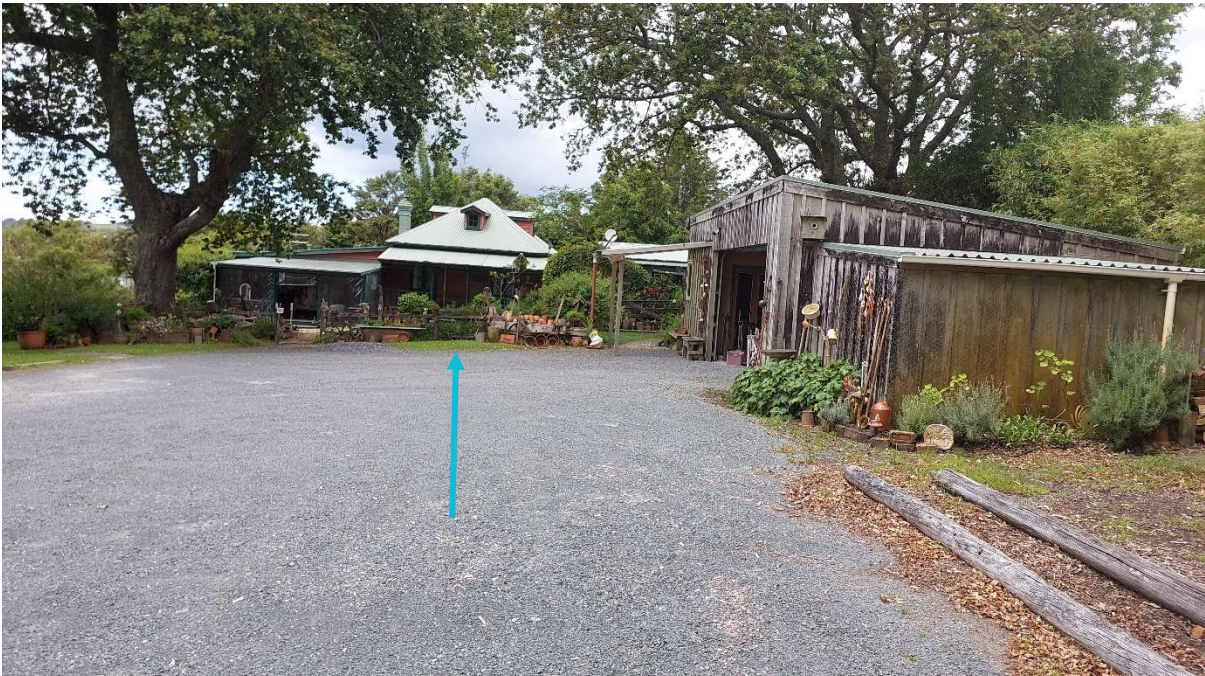
Figure 11. View of 19th century cottage from entrance to carpark.

There is some potential for subsurface archaeological or historic material from R09/2253 (domestic) to be affected by works. Additionally, construction of the road berm would require removal of the modern (non-archaeological) ancillary buildings and garage (Figure 10 **Error! Reference source not found.**). This does not impact on archaeological or other historical values associated with the cottage itself, though there is potential for the removal of the garage and ancillary buildings to result in accidental damage to the cottage. This risk could be actively managed through the HHMP.

Condition	The property has been fossicked but it is likely that some subsurface material remains. The cottage itself is extant with only minor modifications visible.
Rarity	The cottage is an early surviving example of vernacular Mid-Late Victorian architecture, which is not common in the region.
Context	This site has moderate contextual value being part of the early European settlement / colonisation of Warkworth.
Information	This site could provide some information on the use of homesteads and farms at Warkworth in the colonial period and on construction techniques and materials used throughout this time.
Amenity	The site is on private property. There is little opportunity for amenity values to be enhanced in terms of public access, but the cottage is partially visible from the public realm.
Cultural	This is a colonial period site.

Effect	Assessment	Recommendation
Construction		
R09/2253	Damage to site and effects on cottage setting	Archaeological authority and monitoring. HHMP to control construction activity in vicinity of cottage, and replacement planting scheme when works completed.

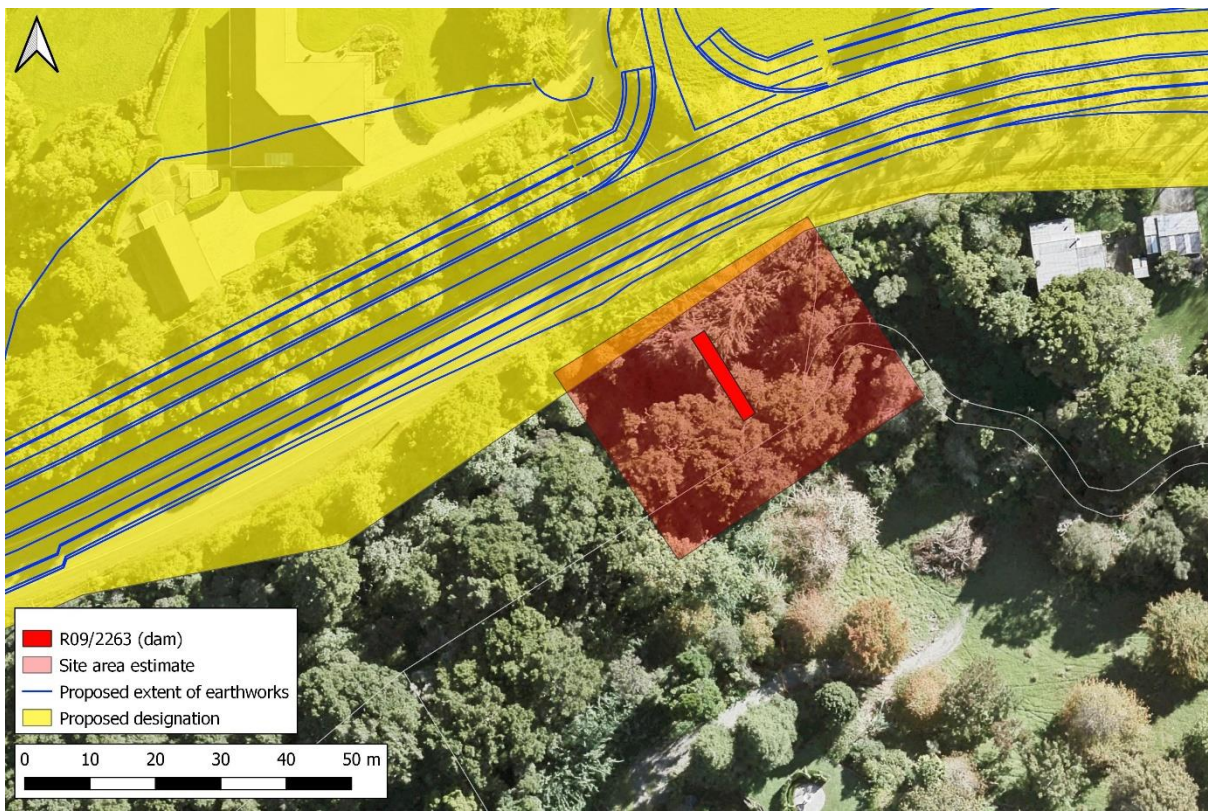
Figure 12. Map of proposed designation and works in relation to extent of R09/2263 as identified by Brassey (2020).

As works around R09/2263 are confined to the upper bank at the edge of the current Sandspit Road, there are not likely to be any construction effects on this site. However, during the site walkover, several very sparse scatters of highly fragmented redeposited shell were visible beside the current road. These scatters of shell were near the western end of the road. One scatter was immediately east of the Matakana Road junction, with another at the first crossing of a Mahurangi River tributary heading east. This shell was likely redeposited from a midden at some stage during construction of the road or bridge, indicating an increased likelihood that an unrecorded in situ midden could be present within the proposed designation. The approximate location of these scatters are shown in Figure 15 below.

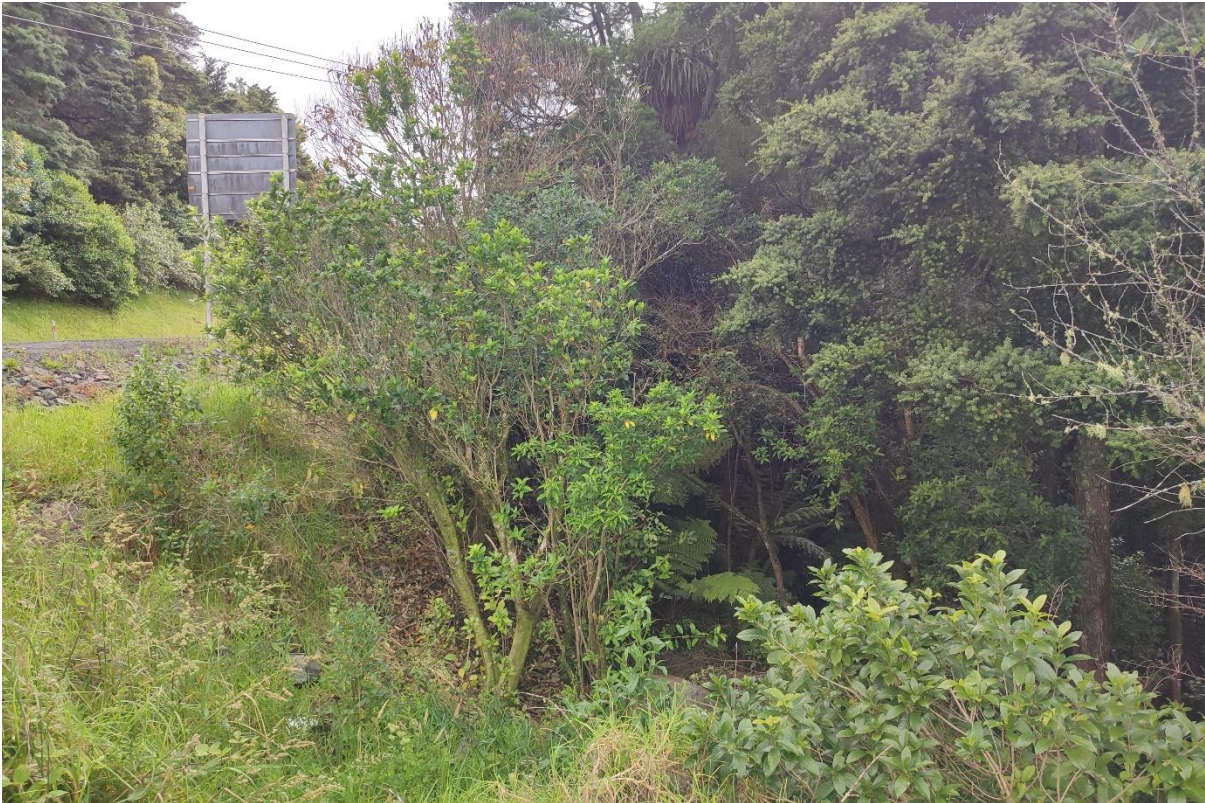
Figure 13. Bank from roadside drops very steeply to the right in this image, dam (R09/2263) is located below in the bush.

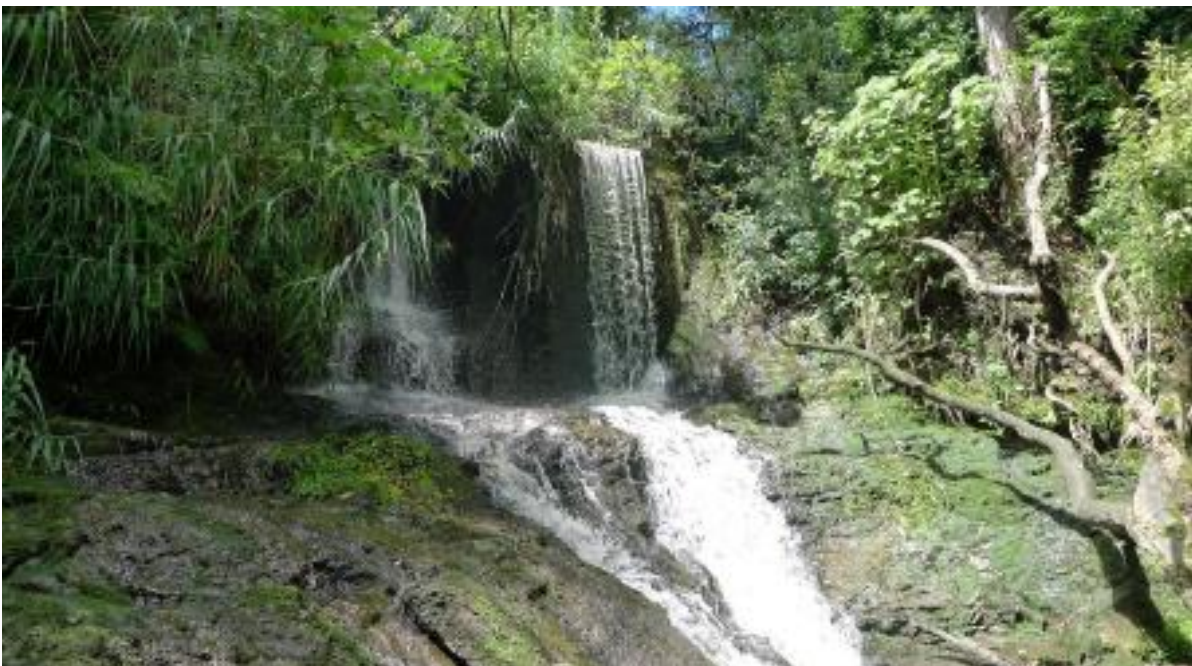
This site was recorded in 2018 by Robert Brassey. It is the likely site of a dam from the later 1870s or early 1880s used for water supply for steamers in Warkworth and is also recorded in the CHI as 21947. The extant dam is a 1913 concrete gravity arch dam. The 1913 dam was reported to be in good condition, viewed from a distance in 2018, but no evidence of the pre-1900 dam was visible. Brassey notes however that poor access and dense vegetation means visibility was poor.

Figure 14. Image from Auckland Council Plan Change 81 Historic Heritage Evaluation report: Wilson Portland Cement Company Dam Appendix 2 (Auckland Council 2020) showing downstream face of dam.

Effect	Assessment	Recommendation
Construction		
Potential unrecorded midden.	Potential damage to site.	Archaeological authority and monitoring.
Operational		
R09/2263 – Dam	Potential increased weathering/ water scour on structure over time because of changing water flow	Manage through HHMP, taking structural condition and flow rates into account.

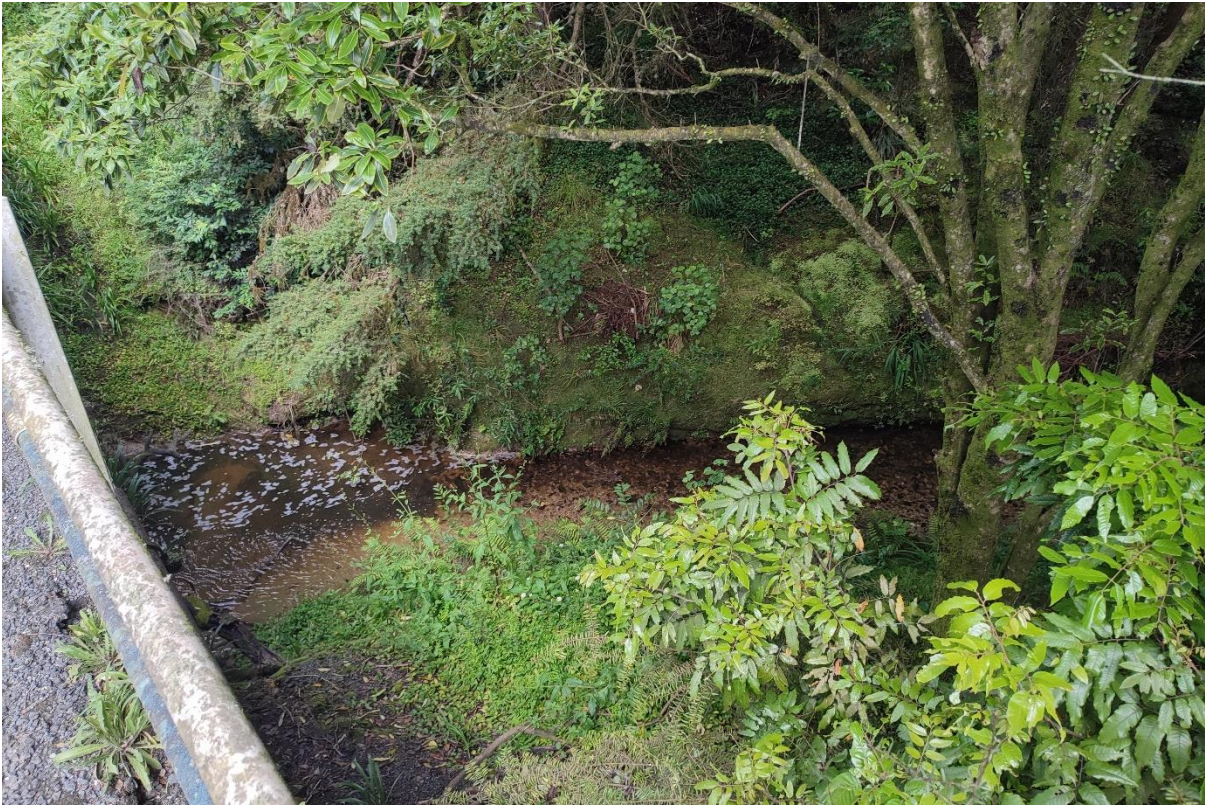
Figure 16. Tributary crossed by Sandspit Road beside which small scatters of shell were visible.

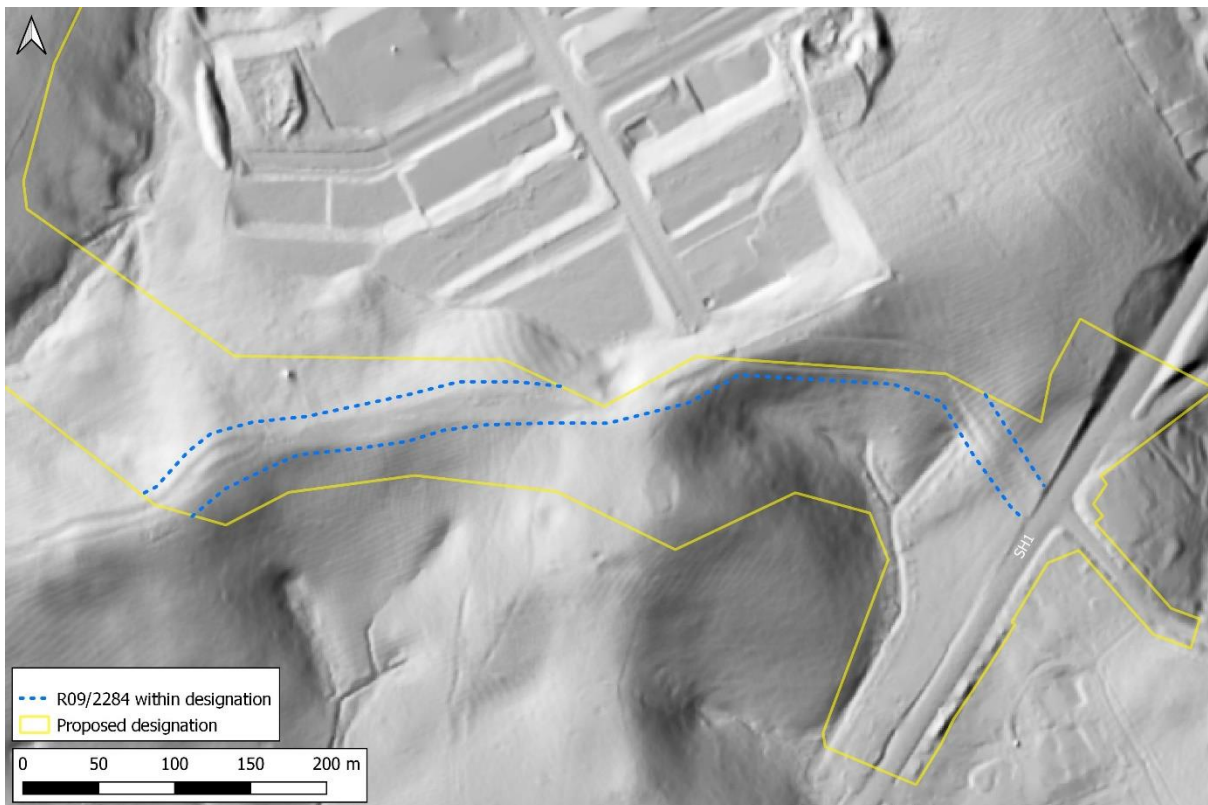
Based on LiDAR imagery, parts of R09/2284 (road) are evident within the proposed designation (Figure 17) and will be affected and partially destroyed by works. However, recently consented earthworks associated with the subdivision to the north were undertaken in 2019 and 2020 prior to identification of the site. These have impacted on the remains of the roadway within the property boundary of 25 Gumfield Drive. The site condition was assessed by Plan Heritage Ltd in January 2023 as part of an unrelated subdivision application (Plan Heritage 2023). This included visual assessment, test pitting and probing. The area was found to be modified within the extent of the subdivision earthworks, with surviving elements discernible in the neighbouring property to the east, and further west. Much of the road bench within the proposed designation has been destroyed by these works (Figure 18). The following assessment of values and significance relates only to archaeological values. Other interested parties, in particular mana whenua, may hold different values regarding the sites.

Figure 17. Hillshade derived from LiDAR (2013) showing route of R09/2284 within designation.

The proposed works have potential to damage an archaeological site recorded in the NZAA SRS R09/2284). An archaeological authority will need to be obtained from HNZPT to modify any pre-1900 sites (R09/2284) and works near this site will need to be monitored to record any archaeological material that may be impacted by works.

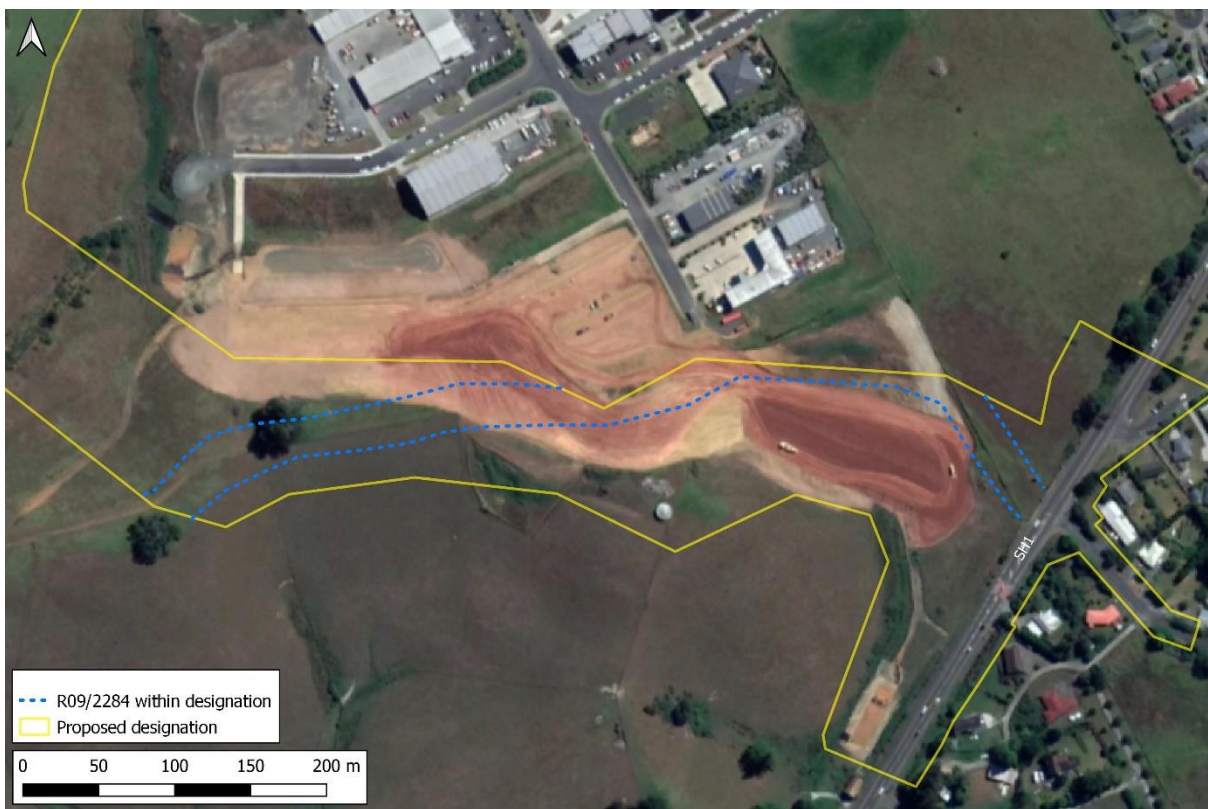
Figure 18. Aerial photography (Google Earth, 2019) showing extent of earthworks and R09/2284.

Condition	While parts of this site have been destroyed by development and roading, segments still remain in reportedly good condition, many now used as farm tracks.
Rarity	Surviving pre-1900 road benches are not commonly seen.
Context	This site has some contextual value being part of the early European settlement / colonisation of Warkworth.
Information	This site could provide some information on the growth and development around Warkworth in the mid to late 1800s.
Amenity	The site is on private property.
Cultural	This is a colonial period site.
