41-43 Brigham Creek Road, Auckland

Ecological Effects Assessment for resource consent

Job 2112

August 2021

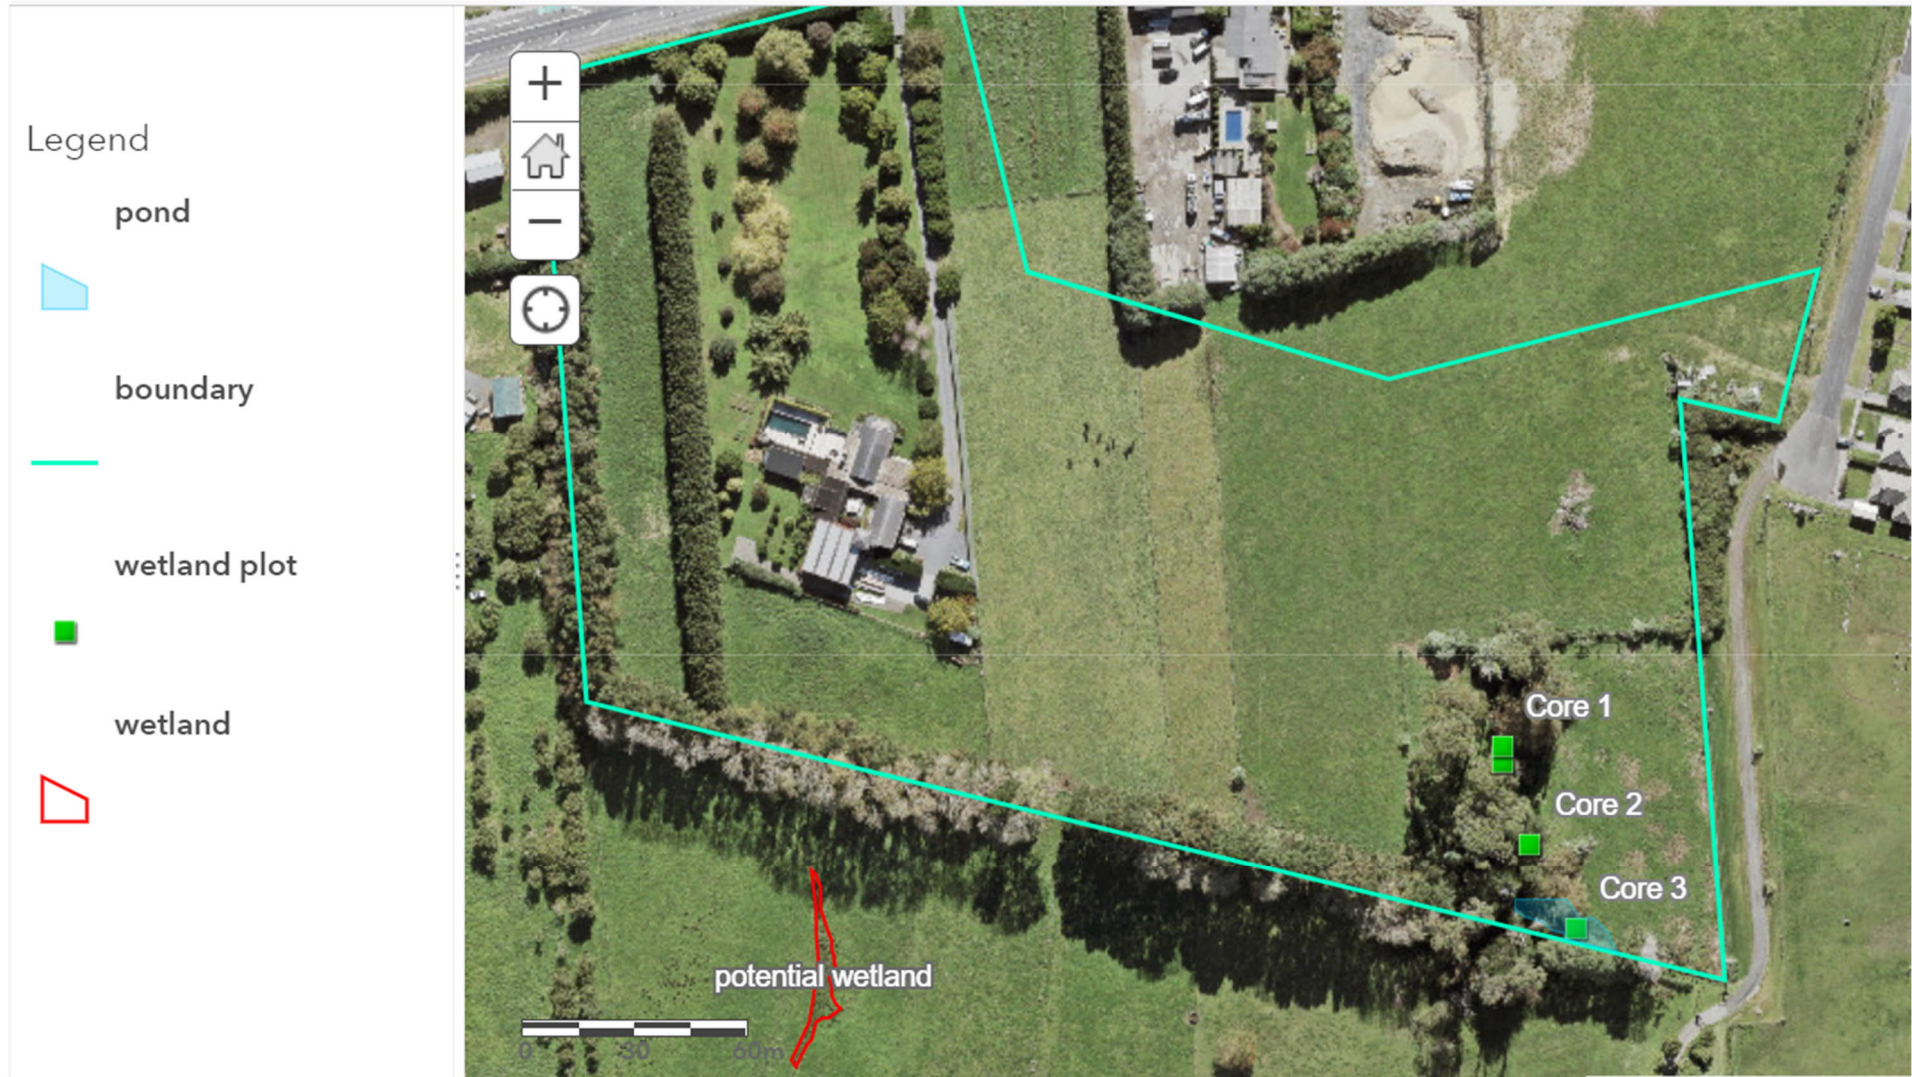
Figure 1. The investigations area (turquoise boundary), with location of wetland investigation soil cores and vegetation plot, and potential wetland (off-site).

Two potential wetland areas were identified, both of which were associated with headwater gullies. Further assessment of these was undertaken by applying the full Wetland Delineation Protocols in the NPS-FW (a derivation of the Clarkson et al. 2013 method). The locations are shown on Figure 1.

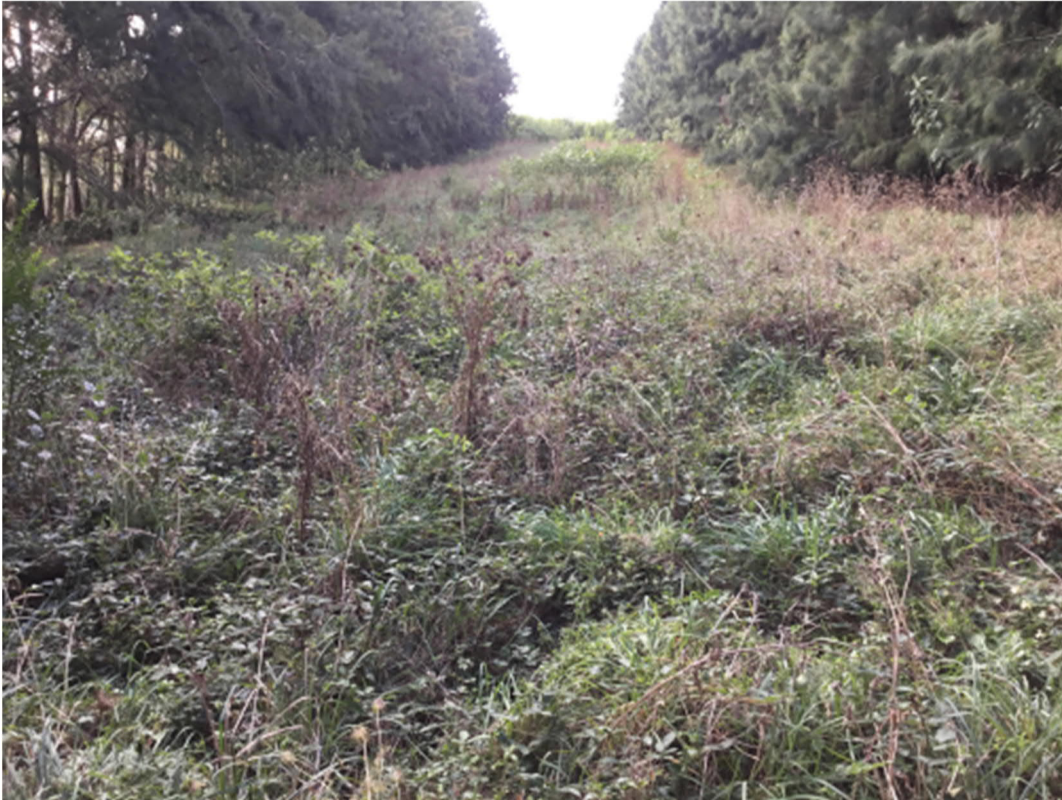
Plate 1. Western part of the site looking to the north (slightly upslope). The vegetation comprises exotic blackberry, inkweed, cocksfoot, ryegrass and kikuyu grass – all dryland terrestrial species.

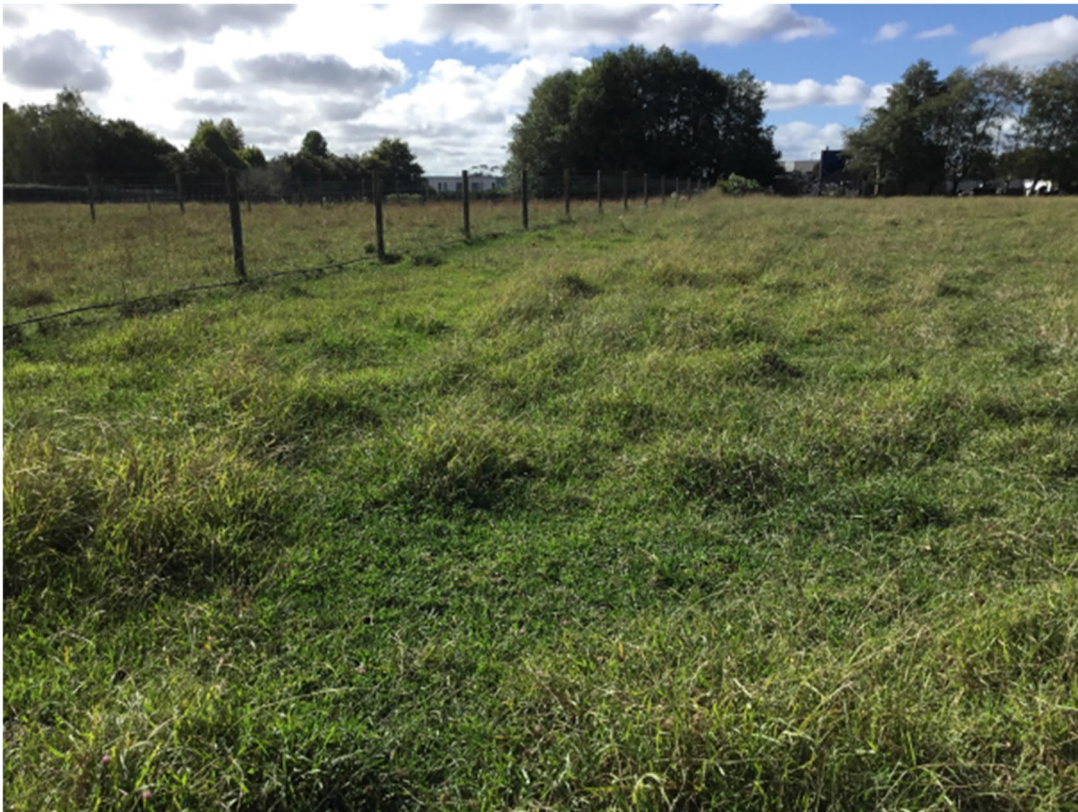
Plate 2. Central part of the site looking to the north (upslope).

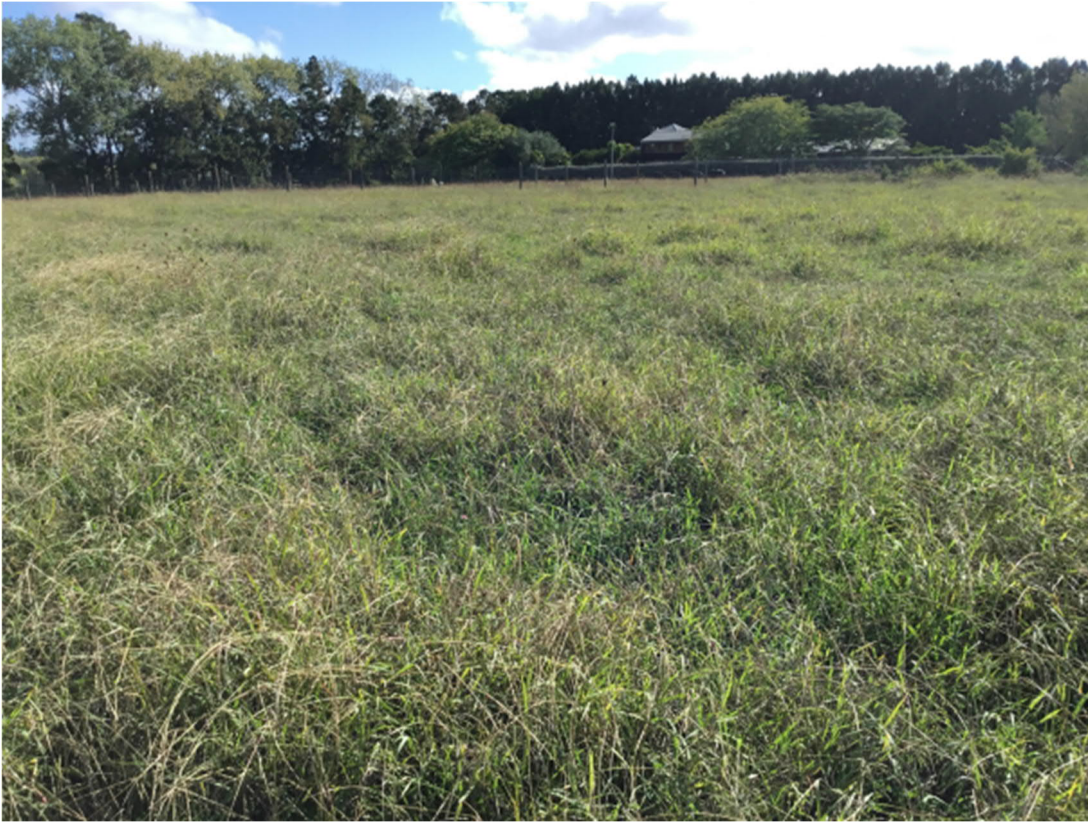
Plate 3. Central part of the site, looking south (downslope). Pasture is mainly Paspalum, cocksfoot and kikuyu.

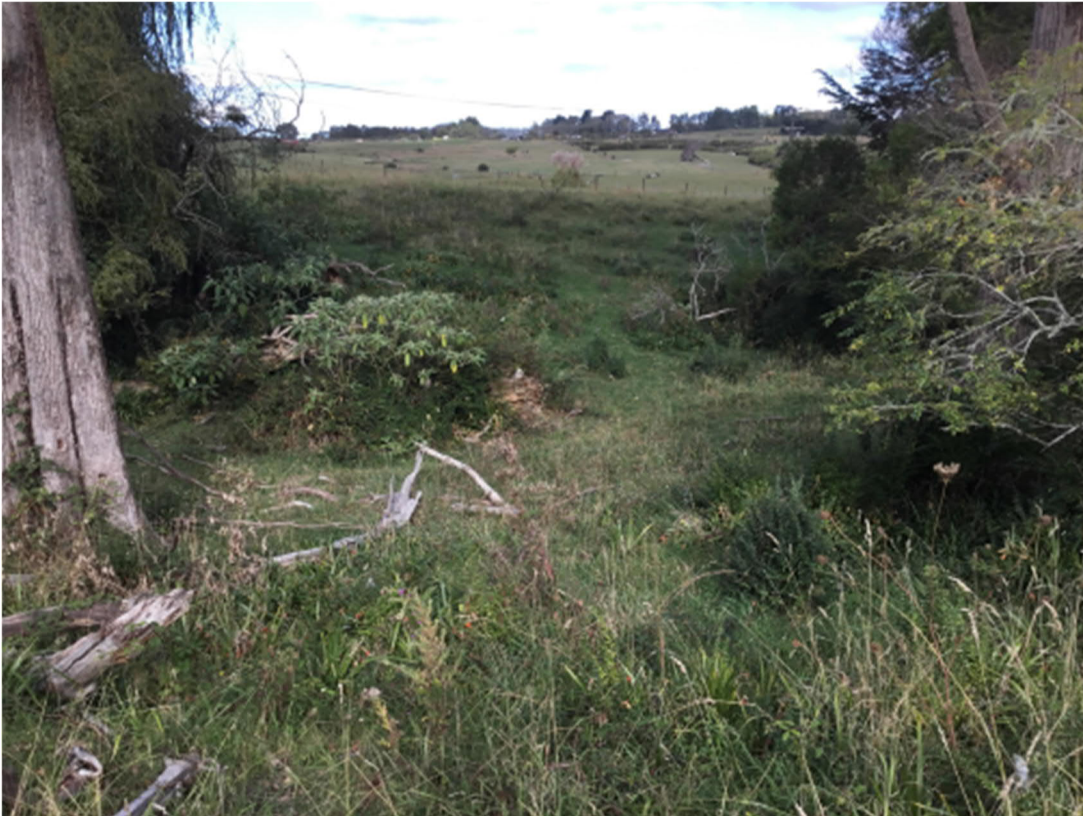
Plate 4. Gully head of the eastern gully showing broad shallow bowl and weedy pasture grassland with privet, gorse, pampas, woolly nightshade and macrocarpa pine over kikuyu, cocksfoot, sweet vernal and ryegrass.

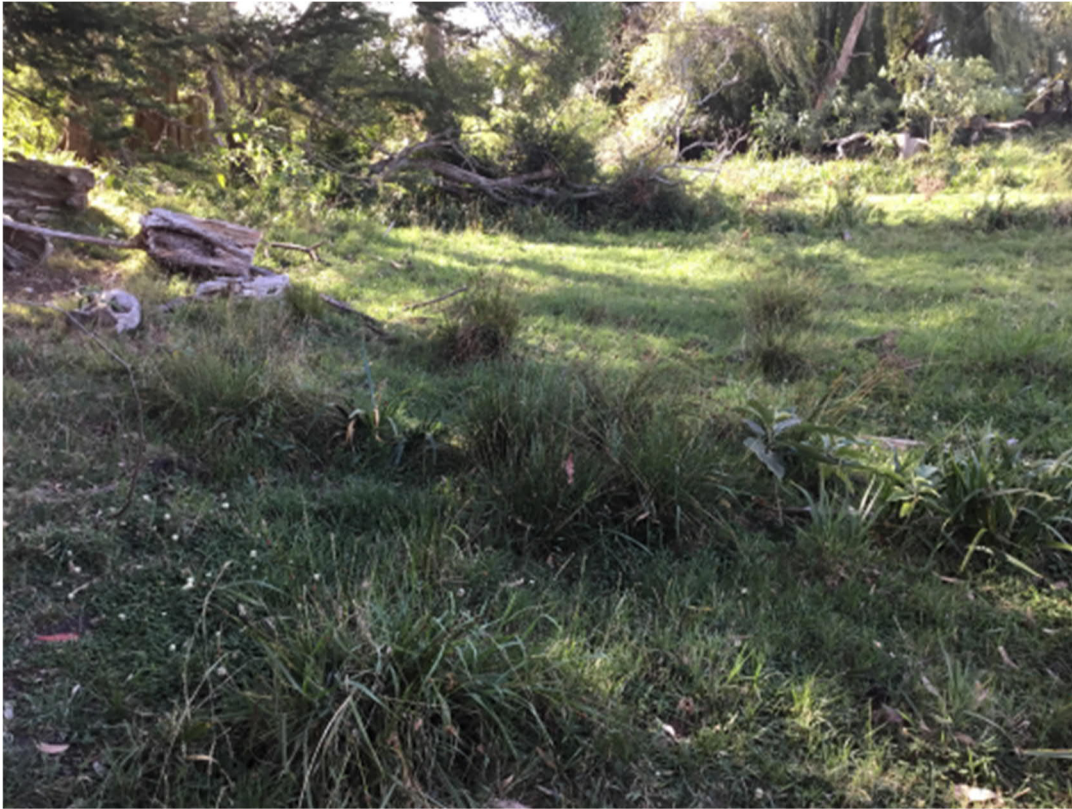
Plate 5. Mid-section of eastern gully.

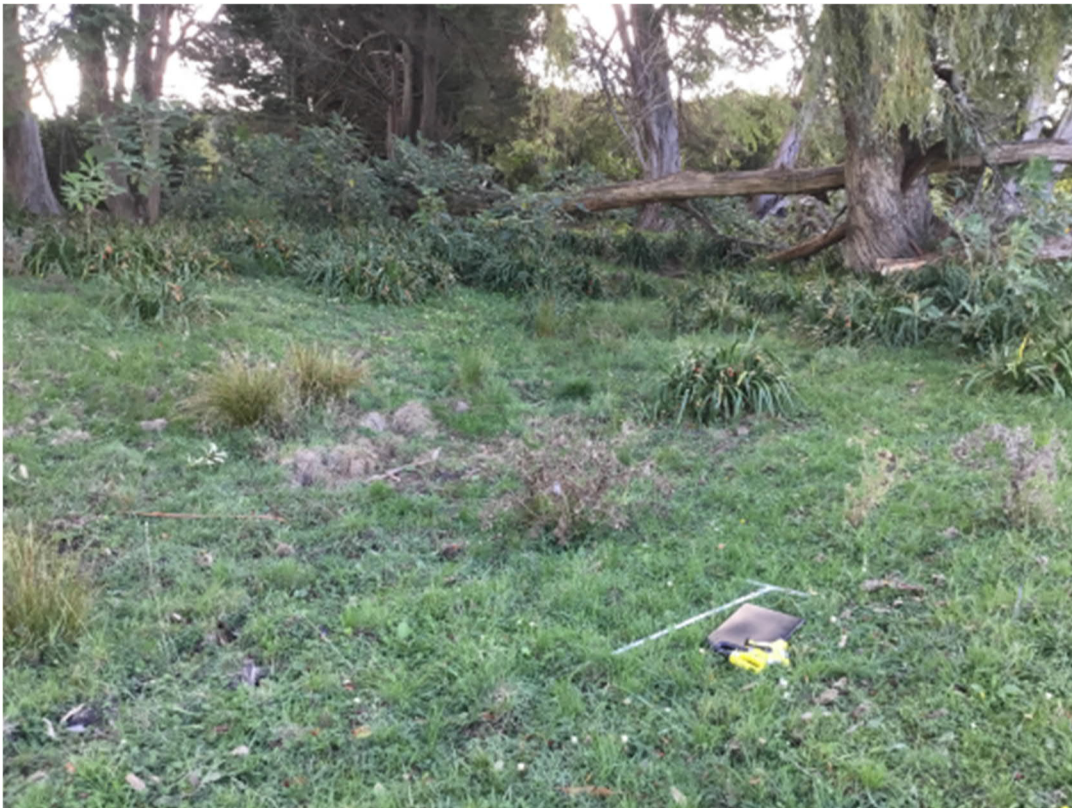
Plate 6. Lower part of eastern gully just above the ponded section formed by the boundary bund.

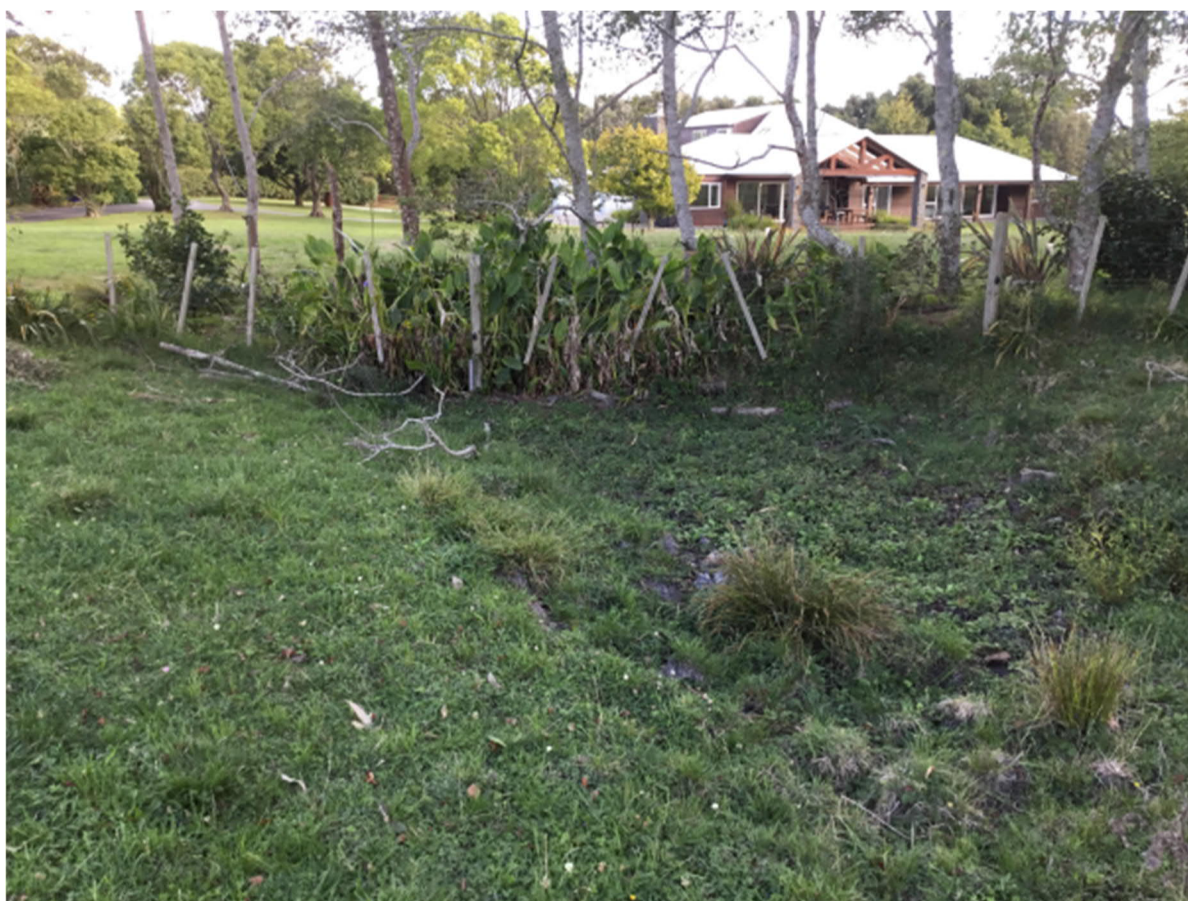
Plate 7. Discharge point for the eastern gully, showing constructed pond and vegetation forming a bund which impounds water along the southern boundary.

The first potential wetland is at the base of the eastern gully. Water pools there and the soils are pugged from stock damage. The 'pond' or seasonally wet area has been formed by a bund of arum lily that has been planted or has otherwise established along the boundary of the adjoining property, which has impounded surface flows down the gully (Plate 7).

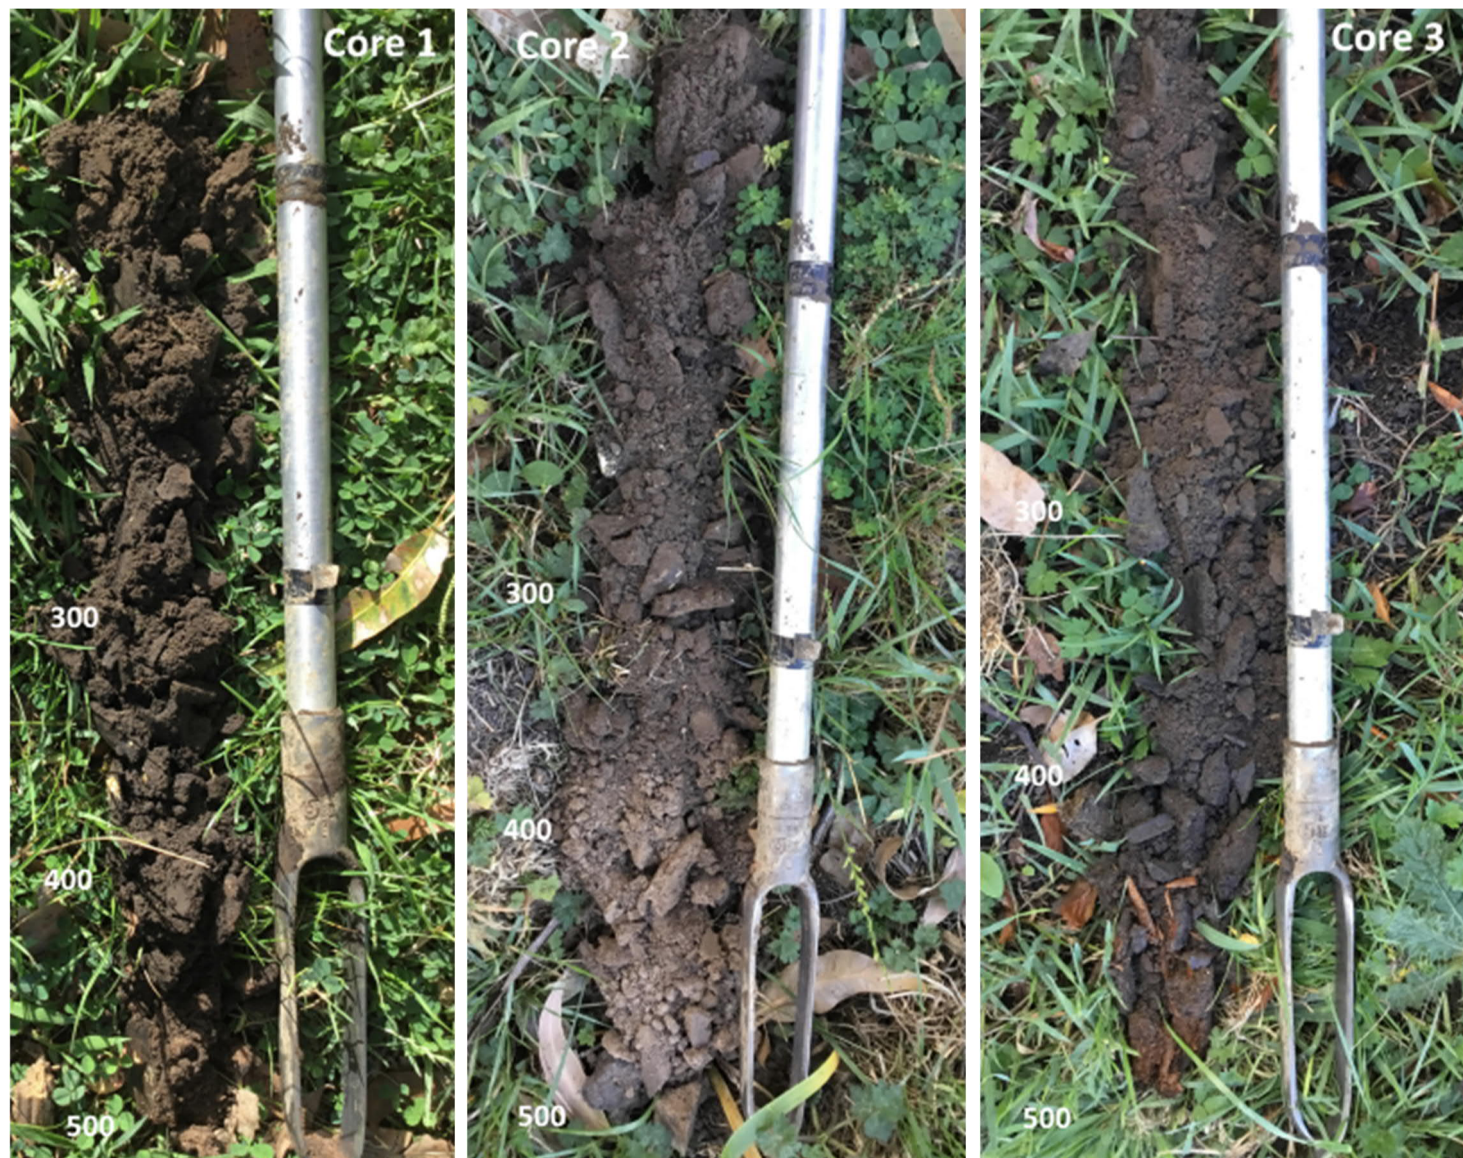
Plate 8. Soil cores within the eastern gully. See Figure 1 for locations. All soil cores show deep topsoils with no mottling or light or dark low chroma colours in the soils that might indicate wetland.

Soil samples taken within the ponded area – as well as further up the gully (Plate 8) show no evidence of hydric soil characteristics, meaning that this ponded area, and the gully upslope is not wetland.

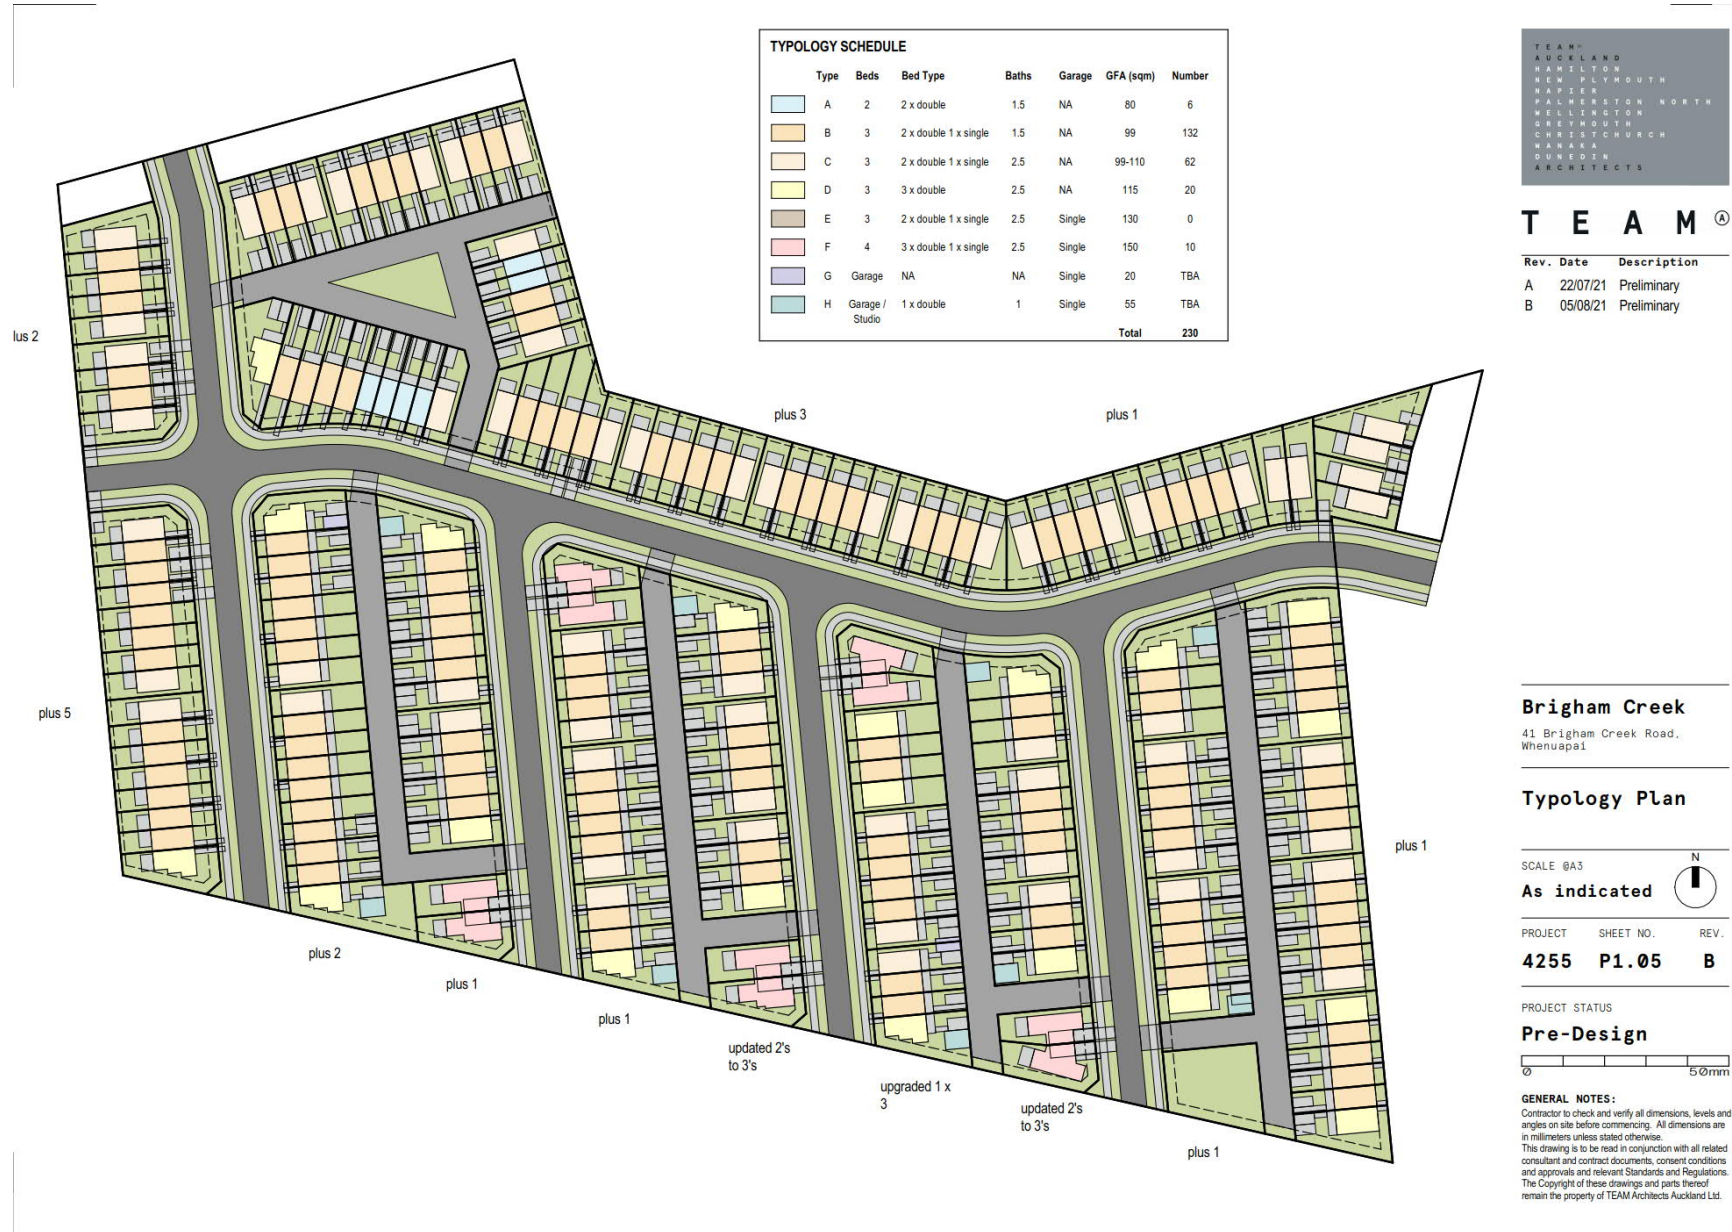
Figure 2. Scheme plan for the development of the site.

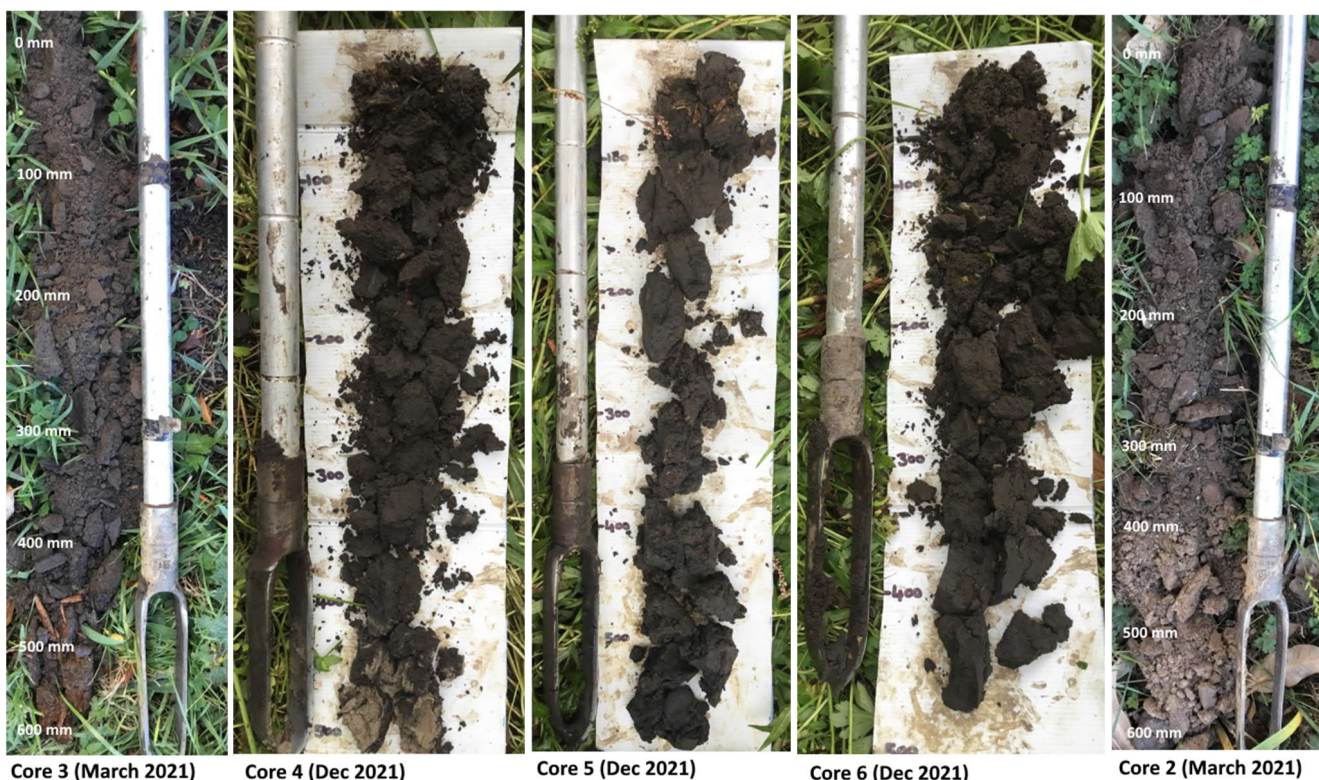
(above). Soil cores taken within the wet basin on the site, and a core taken outside of the basin on the nearby slope/ spur (Core 2). Core 3 is taken after summer and shows dry soils. Cores 4 – 6 are taken just after the wet season and show moist profiles. None of the cores show redox mottling in the upper 300 mm or dark or light low chroma colours within the top 400 mm that are at variance with the reference core. The cores indicate that the basin comprises accumulated fine sediments over underlying basement clays.

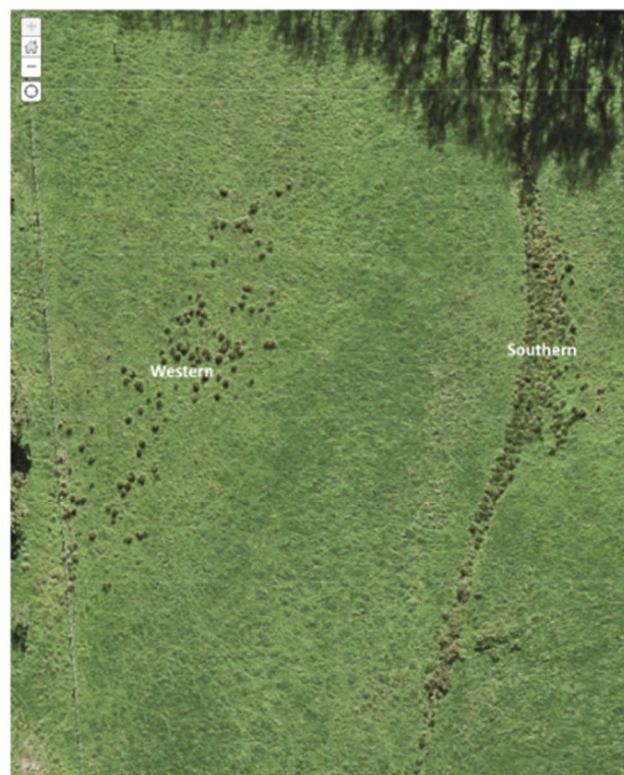
We refer to these sites as the southern wet area and the western wet area (see below).

Southern wet area:

- Vegetation dominated by Yorkshire fog (40 %), lotus (10 %) and sweet vernal (5 %), also with creeping buttercup (35 %), soft rush (10 %) and sorrel (2 %).
- Most of the stippling on the aerial photo (indicative of soft rush areas) above has either been removed by pasture maintenance since this aerial photo was taken, or is along the margins of the adjoining overland flow path; the potential wetland area is at the head of the gully and in this aerial is beneath the shading caused by the adjacent shelterbelt line.

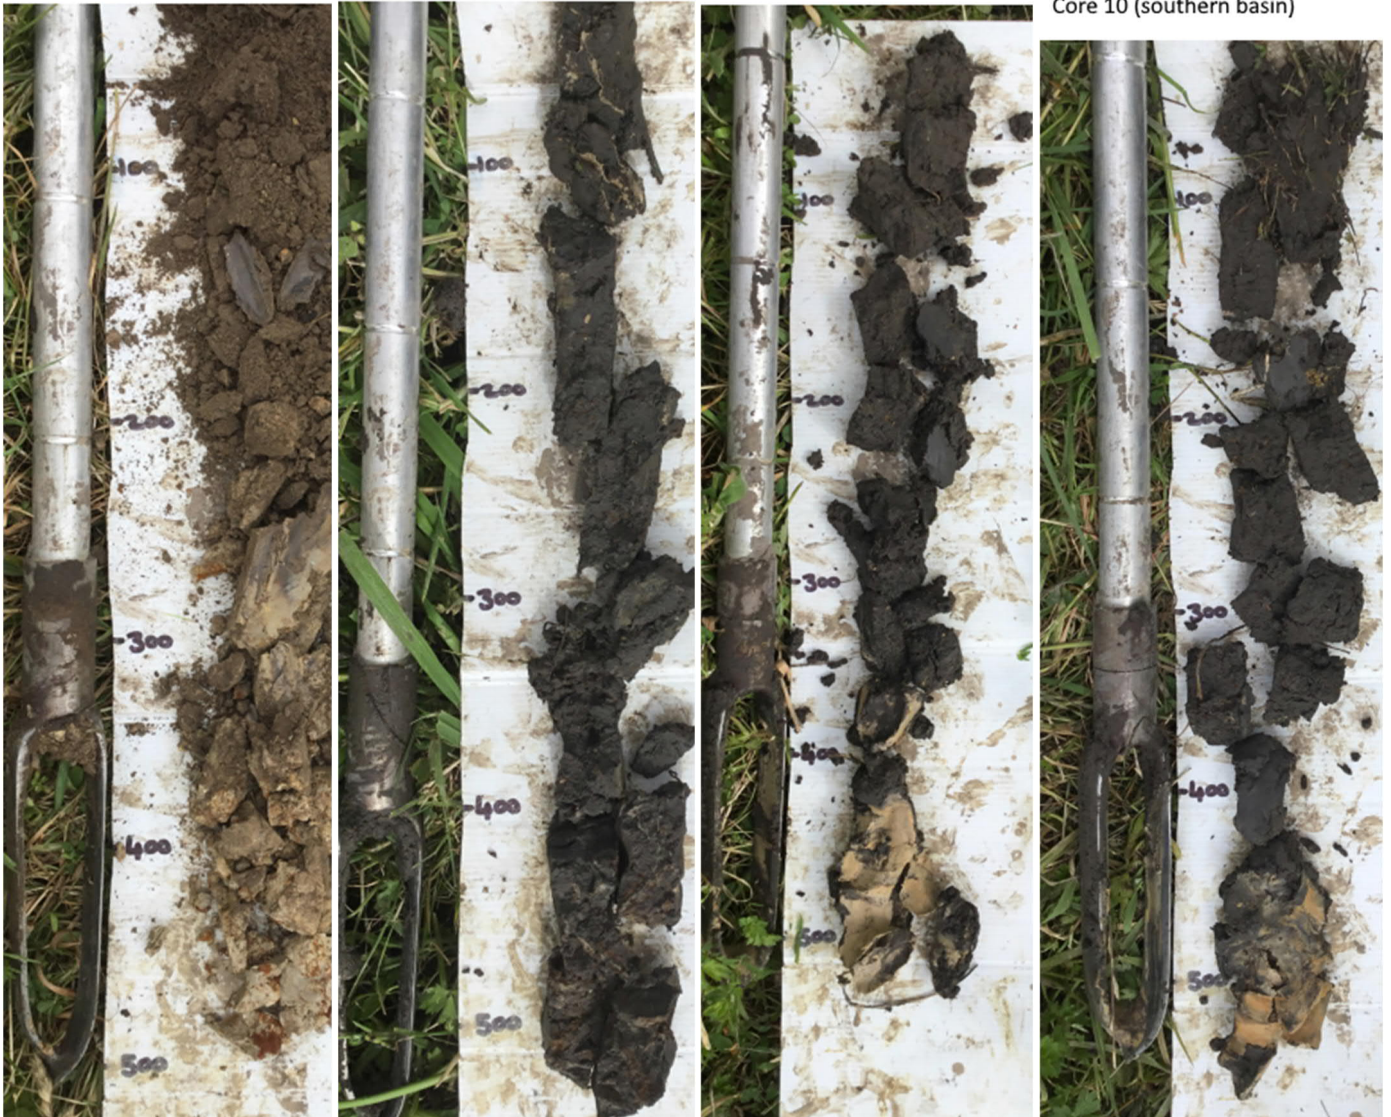
Core 9 (southern basin)

Core 10 (southern basin)

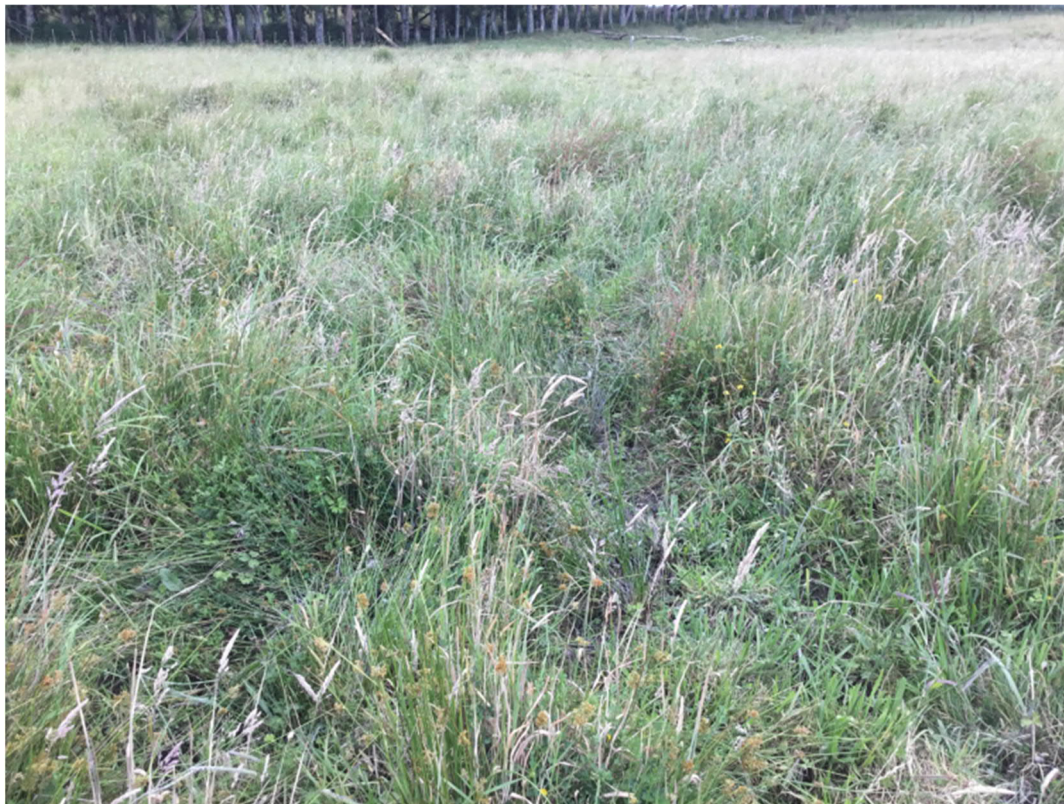
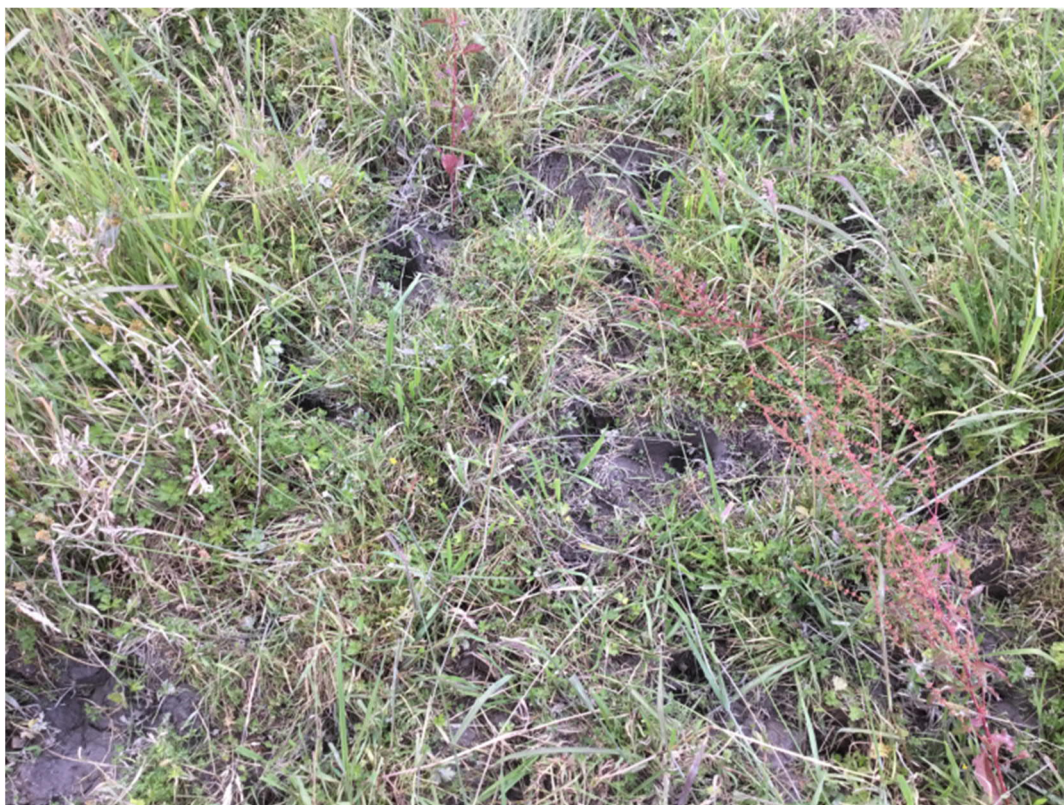
Core 11 (western wet area)

See below for photo of the western wet area, picture of a representative 2 m x 2 m portion and a soil core taken within the wettest part of this western area.

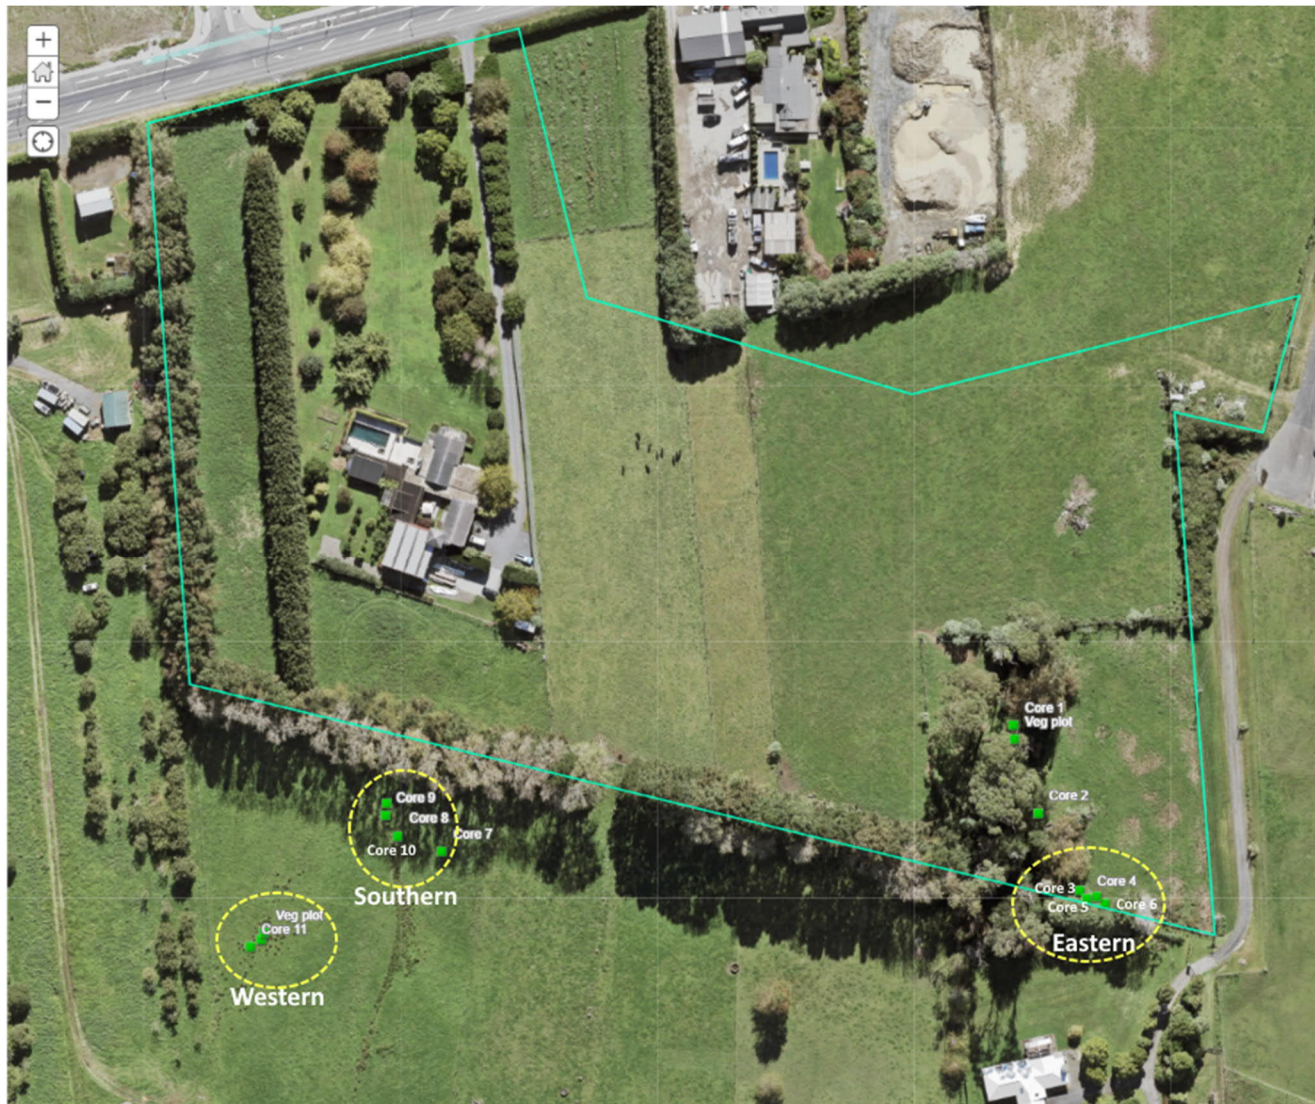
Figure 1. The investigations area (turquoise boundary), with location of wetland investigation soil cores and vegetation plots. Potential wetland areas in the eastern ('pond') part of the site and in the southern and western parts of adjoining land (not on the site) were investigated for the presence of wetlands (yellow circles).
