# GEOTECHNICAL SERVICES PROPOSAL

**Project:** 751 & 787 Kaipara Coast Highway, Kaukapakapa

Document Ref: AKL2021-0052AB Rev. 0

**RE: PRELIMINARY GEOTECHNICAL APPRAISAL  
751 & 787 KAIPARA COAST HIGHWAY, KAUKAPAKAPA**

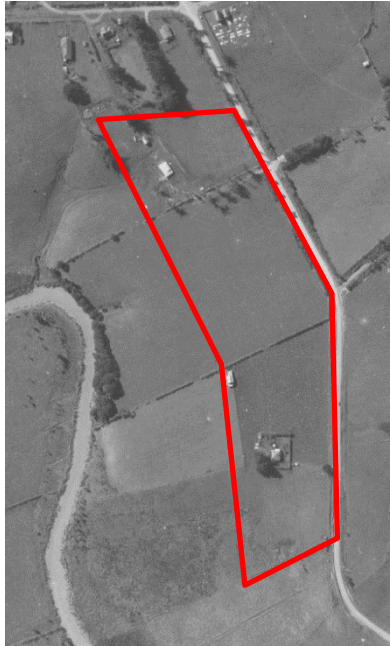
Figure 1: 1940 aerial photo with approximate subject site boundaries outlined in red. Source: Retrolens

The site topography appears consistent with the current landform. The western shed appears to be located at the head of a wide gully feature with indications of soil creep or pugging.

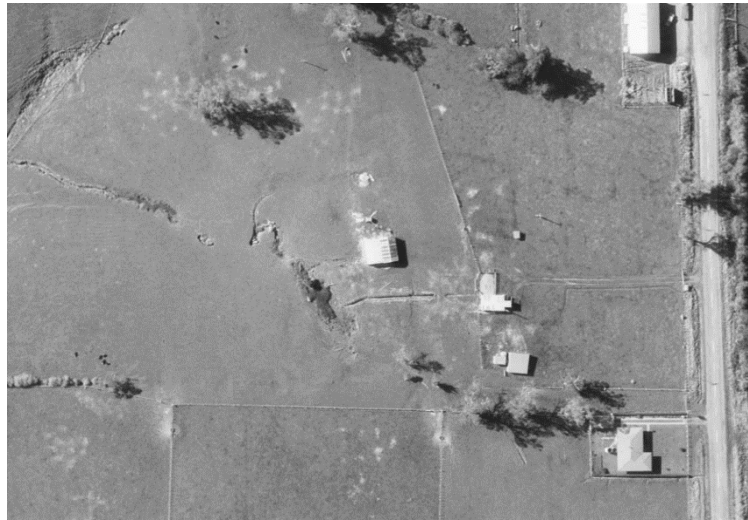
**Figure 2: 1966 aerial photo showing erosional features next to shed. Source: Retrolens**

and the western shed on 787 Kaipara Coast Highway is located next to a steeply incised erosional feature with possible tomos.

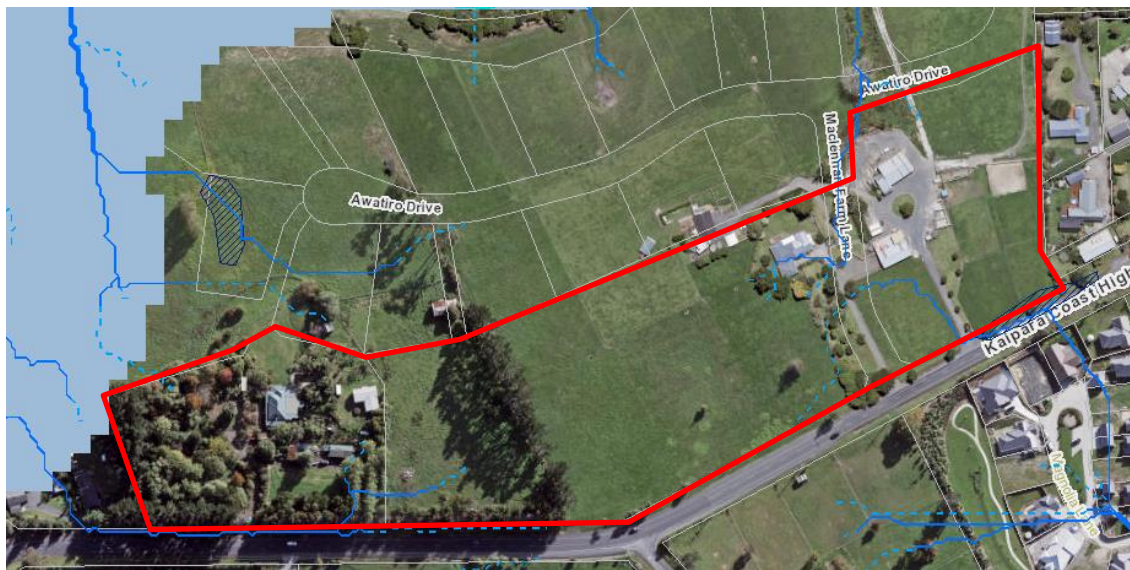
Figure 3: Map showing Overland Flow Plaths (Dark Blue lines and Dotted Light Blue lines) and Flood Plains (Light Blue area and hatched area) with subject site outlined in red. Source: Auckland GIS

A review of the Auckland Council GIS shows a series of overland flow paths and a flood plains across the site.
