WARKWORTH SOUTH PLAN CHANGE: ARCHAEOLOGICAL ASSESSMENT

Prepared for KA Waimanawa Partnership Ltd and Stepping Towards Far Limited

December 2022 (Updated from April 2022)

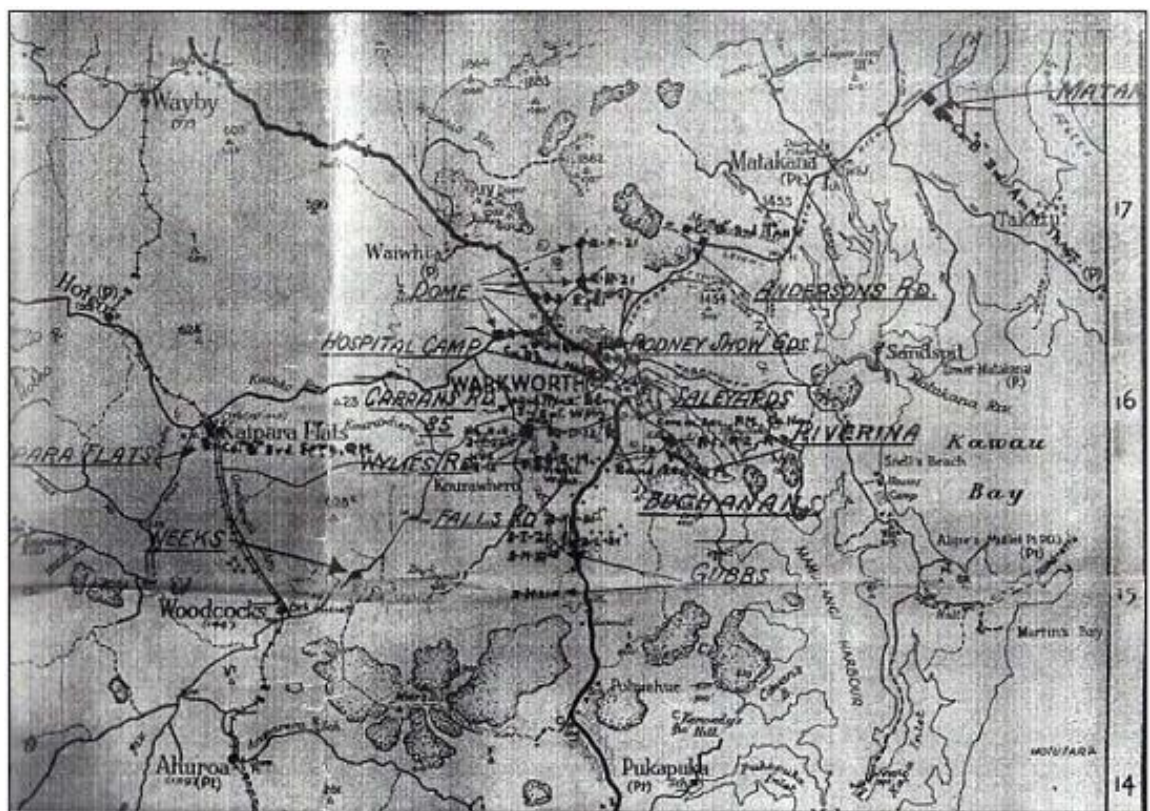
Figure 5. Plan, unnamed and undated, showing the locations of the US military camps in the Warkworth District. Source: Warkworth and District Museum and Archives

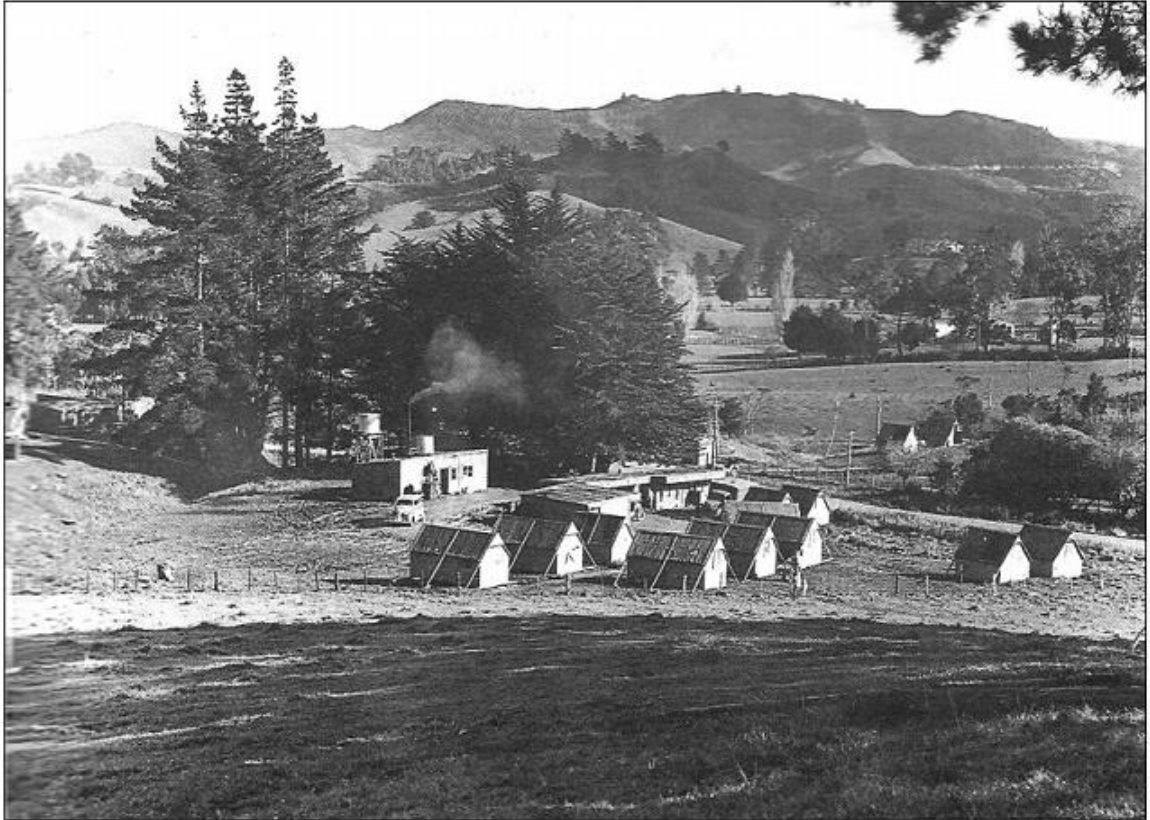
Figure 6. Photograph, dated 1940s, by Tudor Collins, showing a typical US military camp with two- and four-men huts. SH1 heading north to Wellsford is visible in the photo. Source: Bioletti 1989:27

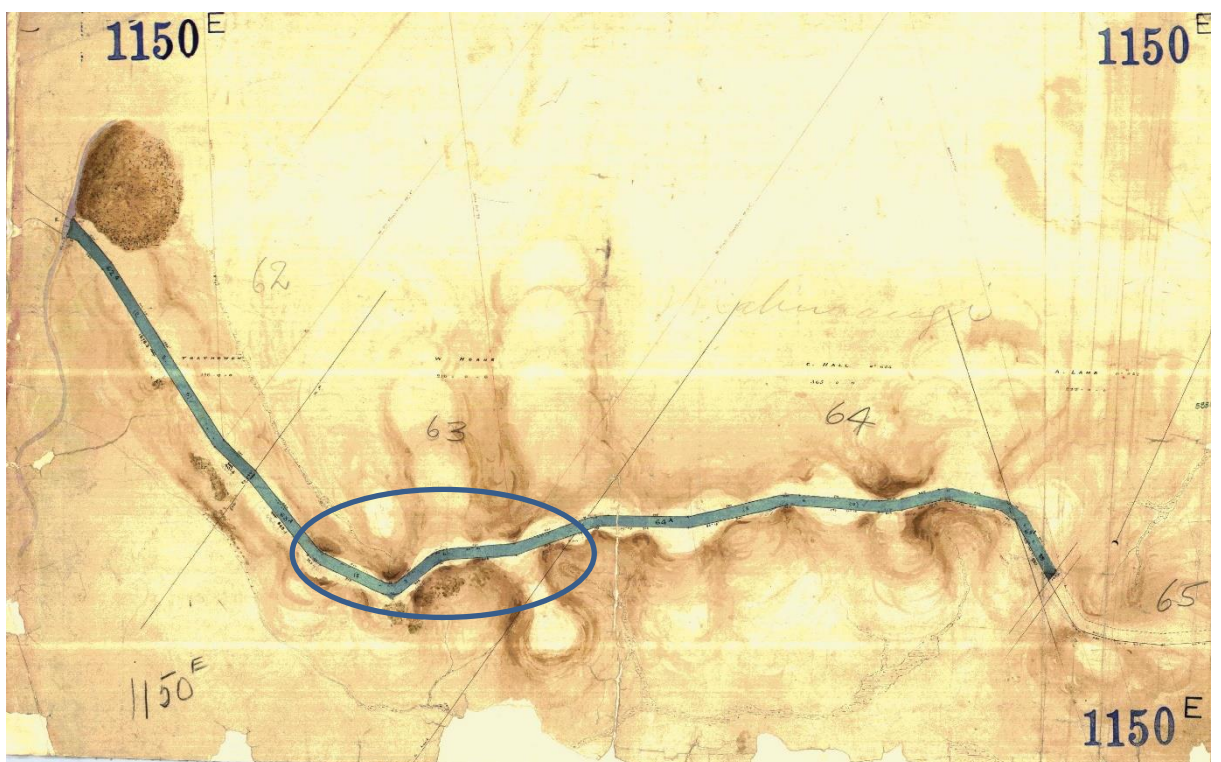
Figure 10. Enlargement of SO1150E dated 1855 showing the private road constructed over Lots 62 to 64 (in blue). Road on Lot 65 is McKinney Road (source: Quickmap). Section that crosses through the proposed Plan Change Area circled in blue

The road noted in the 1874 advertisement was a road initially constructed over Robert Meikle's land (Lot 64, see below) that was continued over Lot 63 and Lot 62 as far as the river (Figure 10). Survey Ordinance plan SO1150E indicates the path of the road drawn in blue. It is likely that Lot 62, being under cultivation, was the location of Trethowen's orchard, which a year earlier was the subject of a report describing two apples being the size of a moderate sized pumpkin with 'the flavour to be excellent, combining a pleasant tartness with a delicious sweetness; crisp between the teeth, but mellow on mastication, sending out a delicious aroma' (*New Zealand Herald*, 12 March 1873:2). Much earlier Trethowen won the best pig award at the Mahurangi and Matakana Agricultural Society show (*New Zealand Herald*, 26 November 1867:4), suggesting the land was utilised for both agricultural and horticultural pursuits.

Hall sold Lot 64 to Robert Meikle of Mahurangi, settler, on 21 January 1859 for the sum of £182 10/0 (DR B1/555, Archives NZ). Survey Ordinance plan SO 1150E shows a private road across Lots 62 to 64 with the path of the road drawn in blue (Figure 10, Figure 42). Some years after the private road was constructed the following appeared in the newspaper regarding Meikle and the private road:

One site was recorded as a result of the historic research (above) and field survey (see below). This was recorded as R09/2284, a historic road identified from an 1855 plan, part of which runs through the Plan Change Area as shown in Figure 10 and Figure 39 (see site record form in Appendix A).

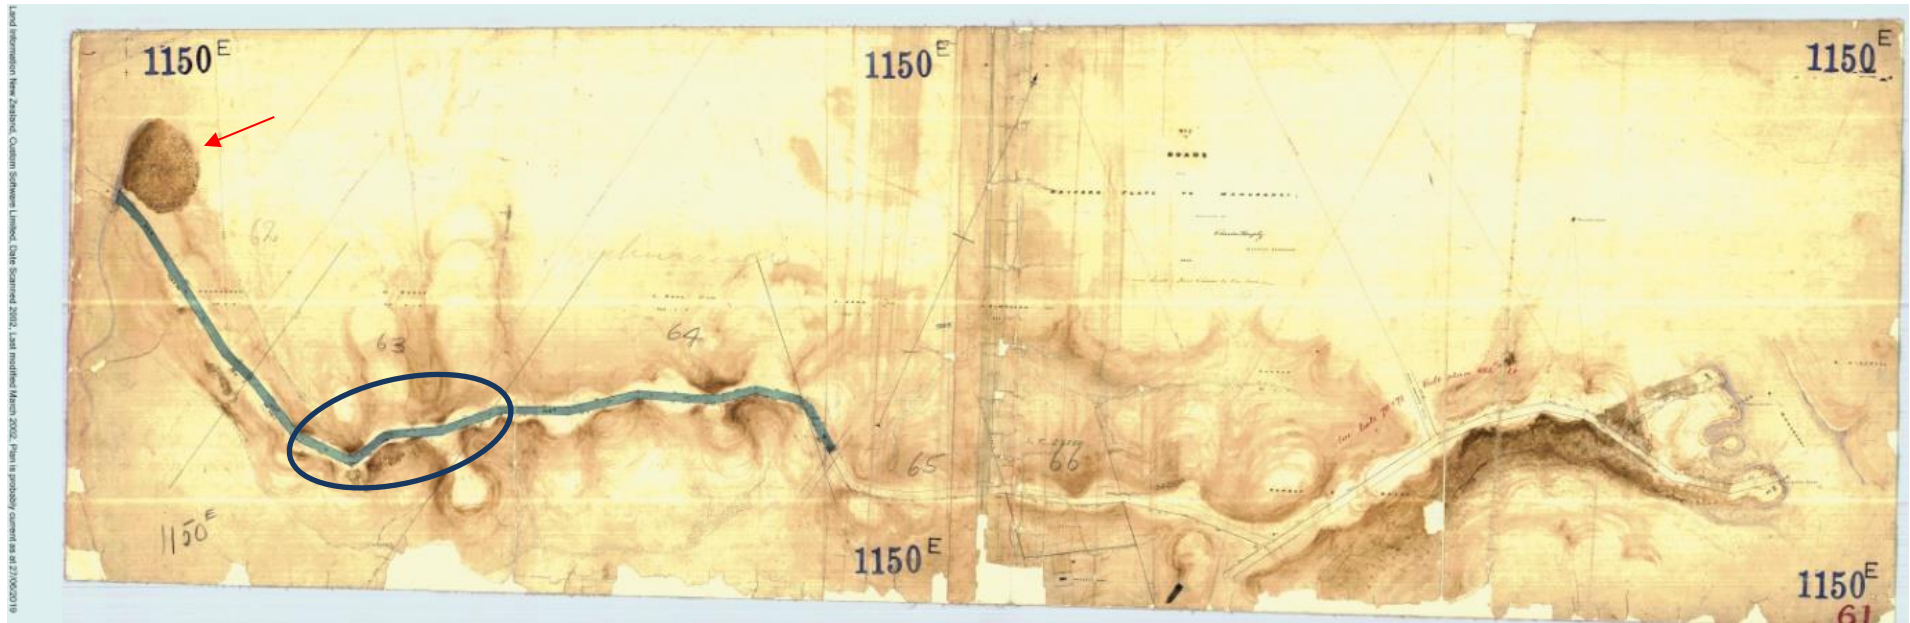
Figure 42. SO 1150E dated 1855 shows private road in blue and road to the west (now McKinney Road) along with Daldy's wharf and kiln, and the Southgate Lime Works at extreme right. Bush area on Lot 62 arrowed. Section that crosses through the project area circled in blue Source: LINZ

SO 1150E dated 1855 (Figure 42), a portion of which was shown in Figure 10, shows the path of the private road constructed through Lots 62-64 by landowners on the left, and an official road (McKinney Road) leading to the west, the intersection of the two roads being the Great North Road. No structures are depicted in the Plan Change Area, but to the east on the banks of the Mahurangi River, Daldy's wharf and kiln and the Southgate Lime Works structures are shown. The northwest portion of Lot 62 is shown covered in bush.

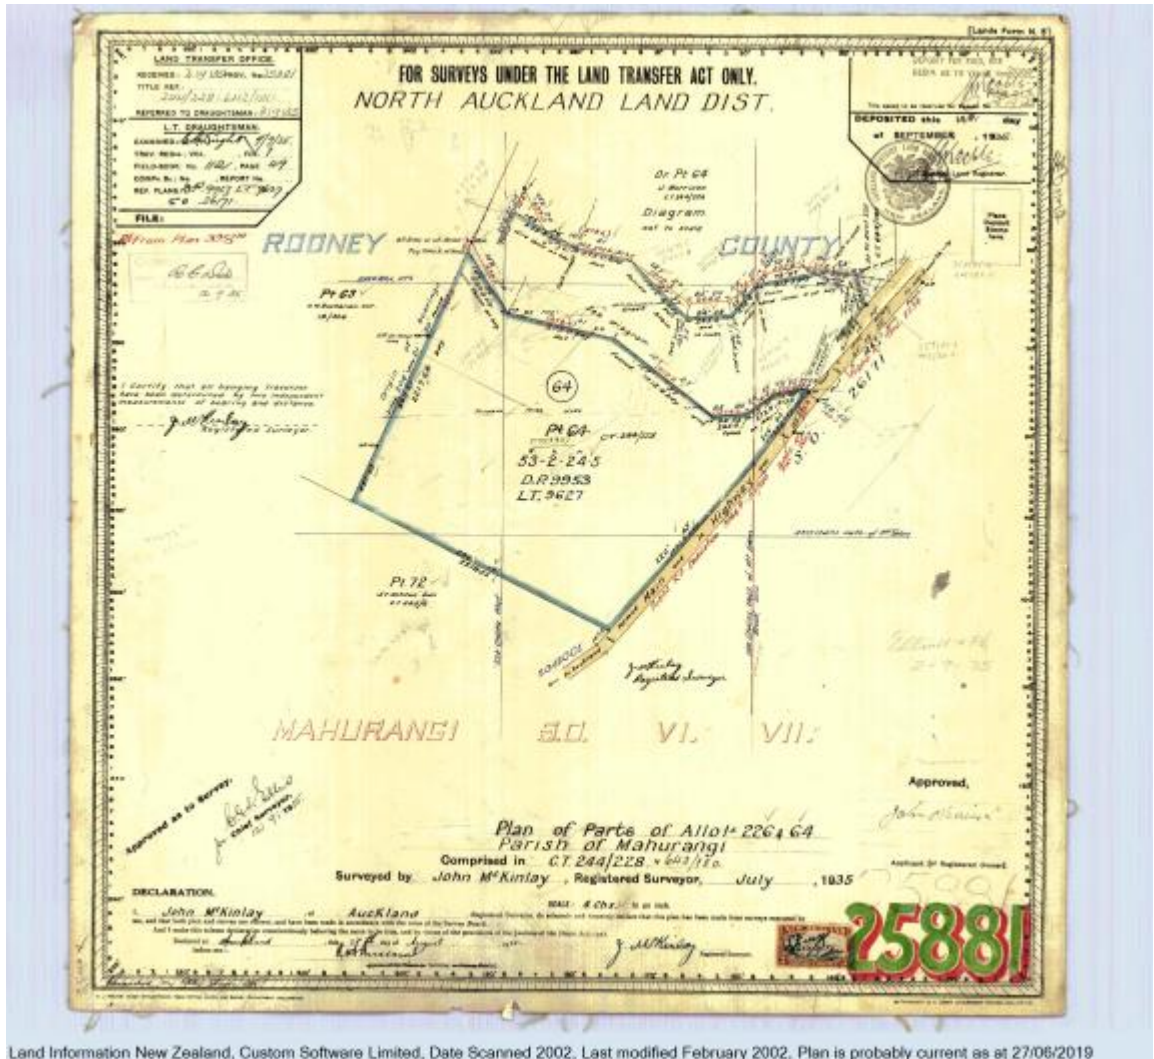
Figure 44. DP25881 dated 1935 showing land transferred to Athol Morrison. Source: LINZ

DP 587I dated 1887 shows the subdivision of Nathan's Lot 129 along with a portion of Lots 72 and 73, but no structures are within the Plan Change Area. DP25881 dated 1935 (Figure 44) shows the subdivision of Lot 64 and the area transferred to Athol Morrison.

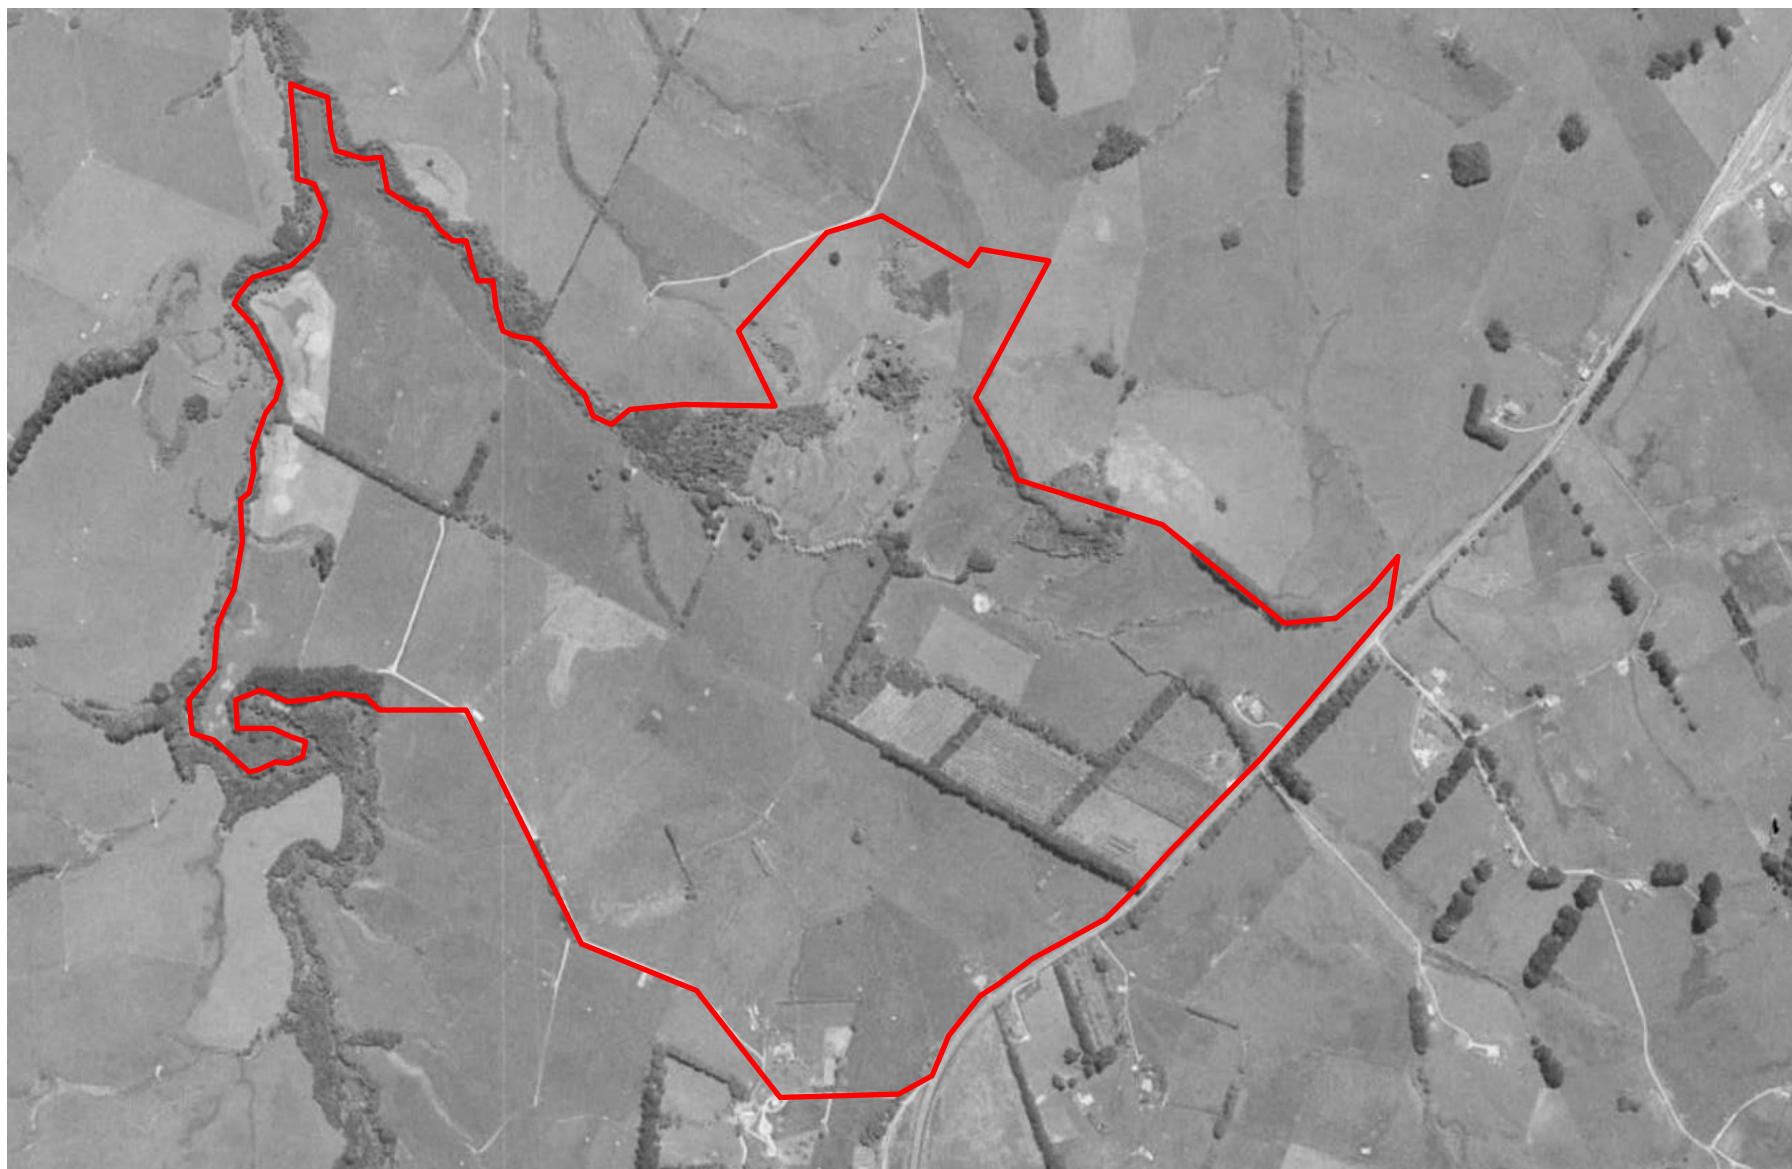
Figure 48. Enlargement of portion of 1966 aerial showing the whole Plan Change Area (source: Retrolens, 1966, Neg 5039/13)

No aerial photographs of the Plan Change Area pre-dating 1963 could be located. The 1963 aerial photographs capture only the eastern half of the Plan Change Area (Figure 46 to Figure 47). A 1966 aerial was located which shows the Plan Change Area in its entirety, largely in pasture (Figure 48 and Figure 49). The most notable feature is the Morrison's Orchard and residence on part Lot 64 with trees planted within three main shelterbelted areas. No structures are visible on Lots 62 and 63. Lot 72 shows a single residence on Valerie Close near State Highway 1 and an outbuilding towards the west. There is scarring on the landscape suggesting recent earthworks at the southwest boundary of Lot 62 and northwest boundary of Lot 72, and on Lot 72 near the boundary with Lot 63 (now 46 Valerie Close).

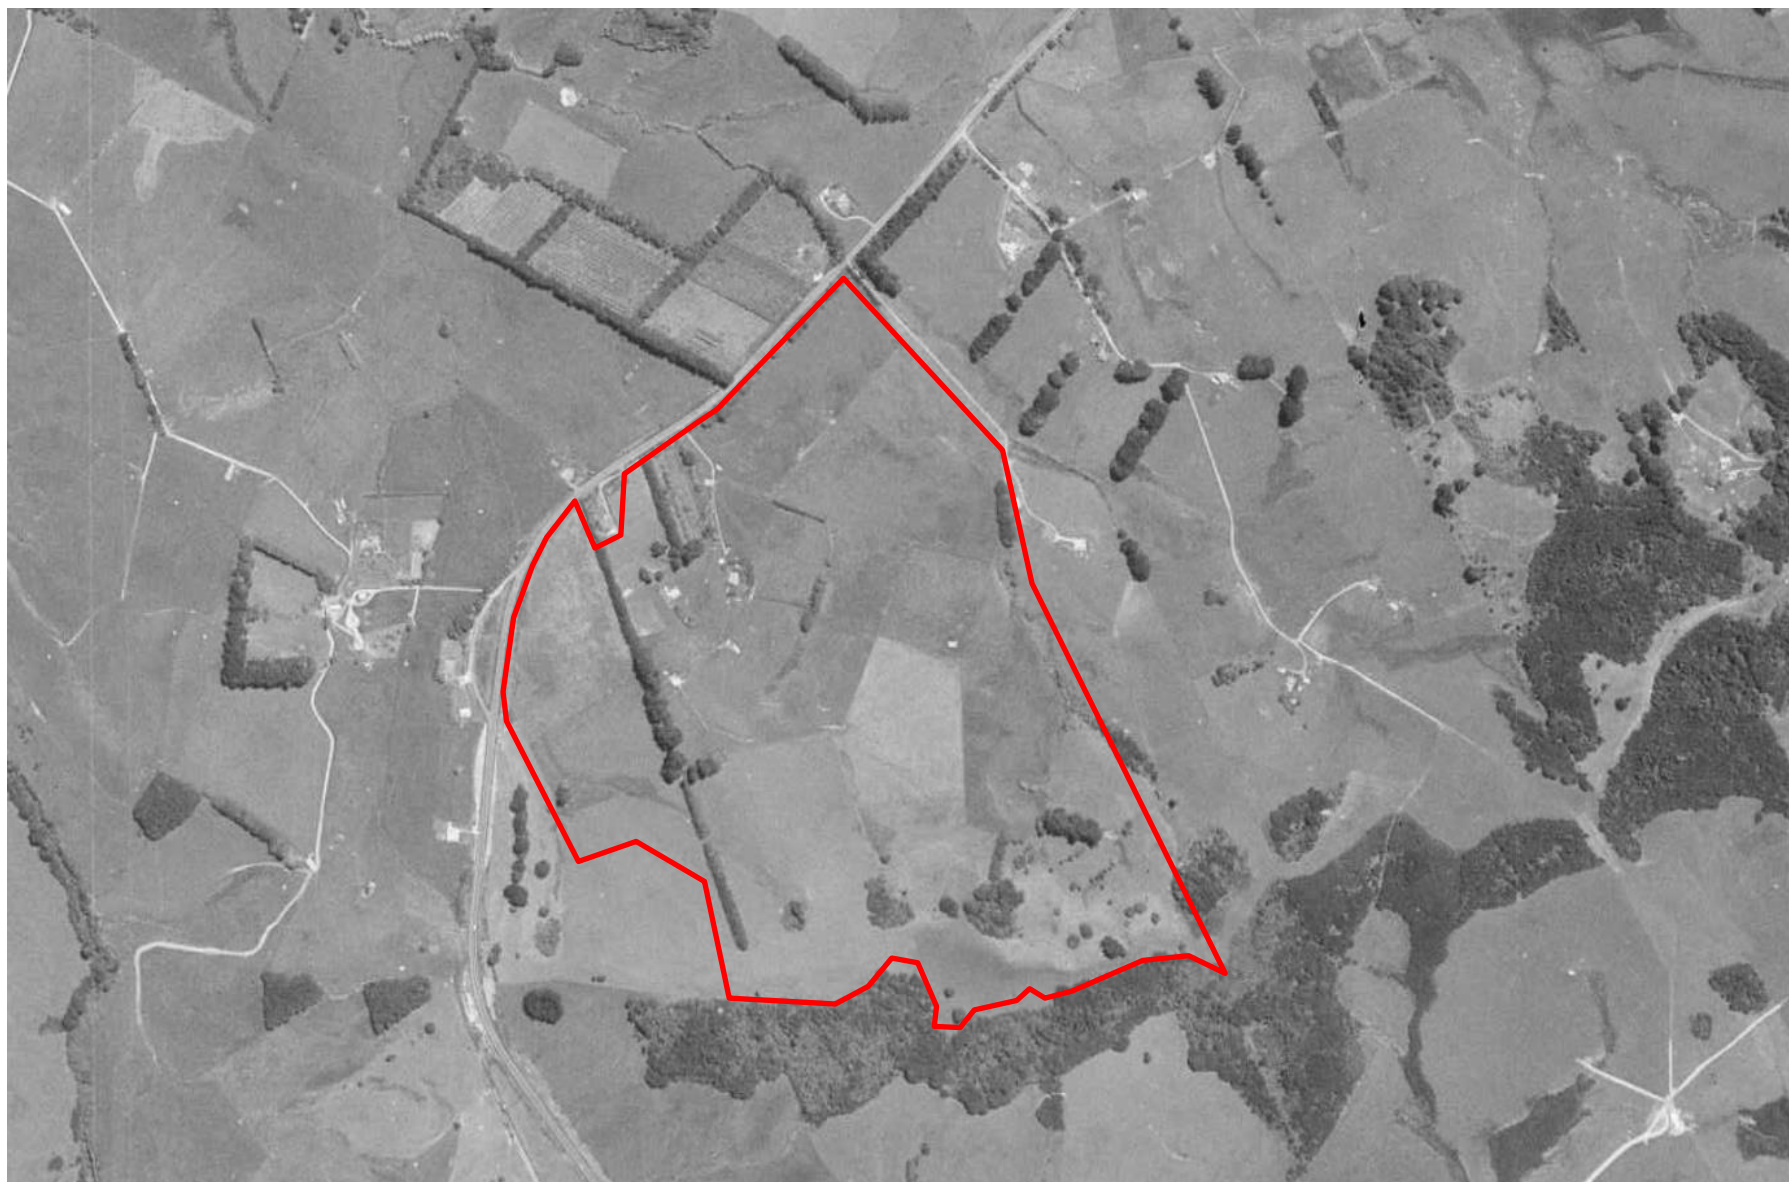
Figure 49. Enlargement of portion of 1966 aerial showing the Plan Change Area (source: Retrolens, 1966, SN1875 Neg 5039/13)
December 2022

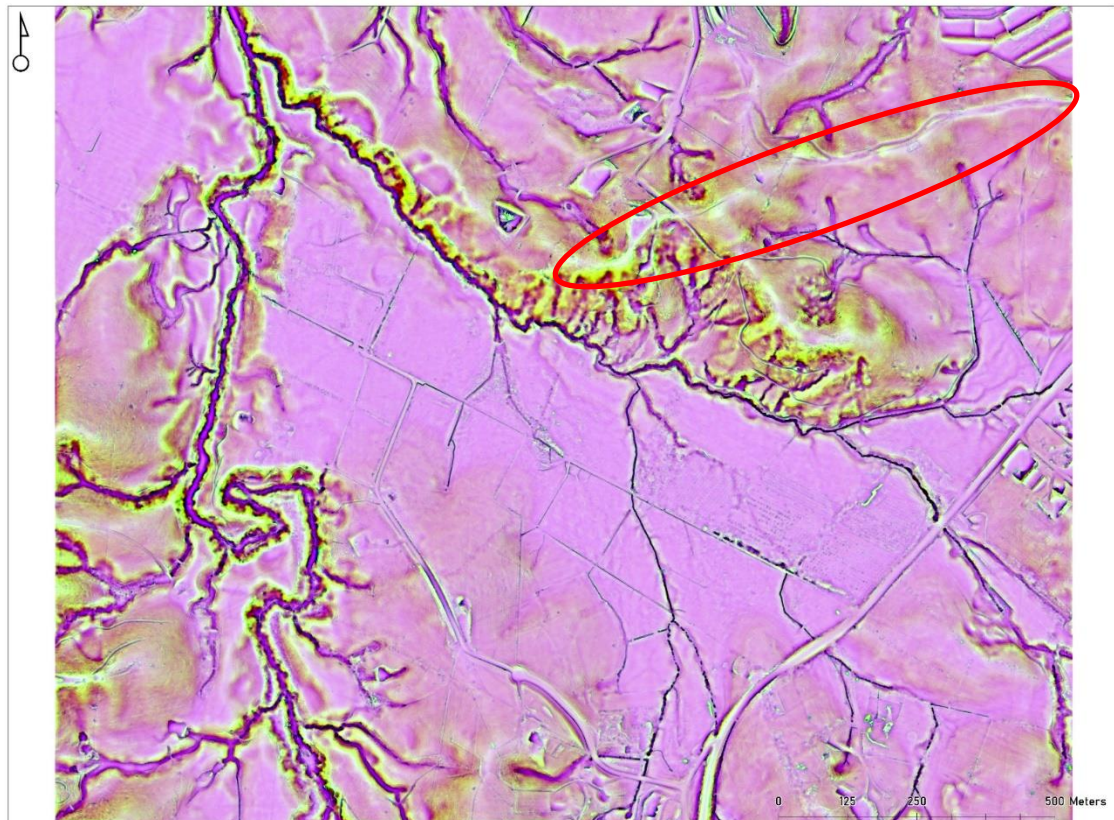
Figure 53. Composite of slope, local relief and openness raster derived from LiDAR. Old road route highlighted in red

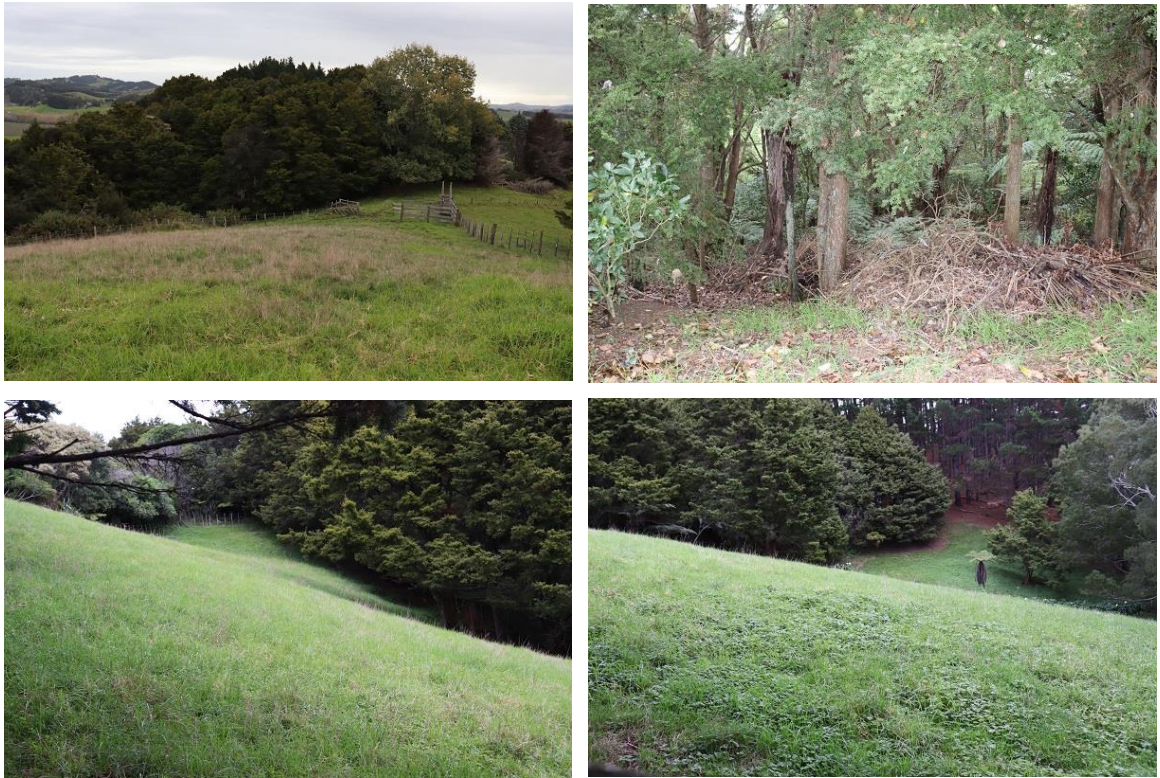
Figure 54. Top left: Standing on hill in P2 looking towards forested area P1-F, facing southwest. Top right: Looking into forested area P1-F, facing southwest. Bottom left: Standing in P1 looking towards P1-G with small forested valley just outside of P1-G to the right, facing south. Bottom right: Standing in P1 looking down towards small forested valley just outside of P1-G, facing southwest

P1 is accessed from the north of the Plan Change Area via Mason Heights. The majority of P1 is forested woodland with dense bush covering its southern (Figure 54, bottom left and Figure 55, bottom left) and eastern portions (Figure 54, top left and right); these areas are labelled as P1-G and P1-F in Figure 3. A modern domestic dwelling and external garage are located in the central northern portion of the property (Figure 55, top left), which also contains a long driveway and is surrounded by well-maintained lawns (Figure 55, top right). The southern lawn is used to care for various animals including rabbits (Figure 55, bottom left). A smaller modern domestic dwelling is located in the forested area just south of the main domestic dwelling, at the south/south-eastern side of the property down a long driveway (Figure 55, bottom right). The northwest side of the property contains a small, steep field separated with post and wire fencing that leads to a small forested valley within the property that is just outside of P1-G (see Figure 54, bottom left and right). In terms of vegetation, the forested area contains a variety of trees, shrubs and ferns. The modern landscaped portion of the property contains a variety of planted trees, shrubs and flowers. Due to the dense vegetation, the forested area could not be properly surveyed.

P2 is accessed from the north of the Plan Change Area via Mason Heights. The northern/western portion of P2 shares its border with the forested woodland of P1 (Figure 54, top left). The property comprises generally steep terrain (Figure 56, top left) and several areas/fields fenced off with post and wire fencing. Several streams/overland flow paths exist across the southern portion of P2 (the main one is labelled P2-S in Figure 3), which could not be accessed due to post and wire fencing, steep terrain and dense vegetation that is present across the central northern portion of the property (Figure 56, bottom left). The north-eastern portion of the property is dominated by a hill with steep sides (Figure 56, top right). A track/path has been cut along the northern side of the hill, running directly adjacent to P2's shared boundary with P18 in a northeast/southwest orientation and loosely connects to the track seen on the north/northeast side of P18 (Figure 56, bottom right). There is a significant amount of stock trampling, particularly around the northern side adjacent to P18. However, there were no cattle on the property at the time of survey.

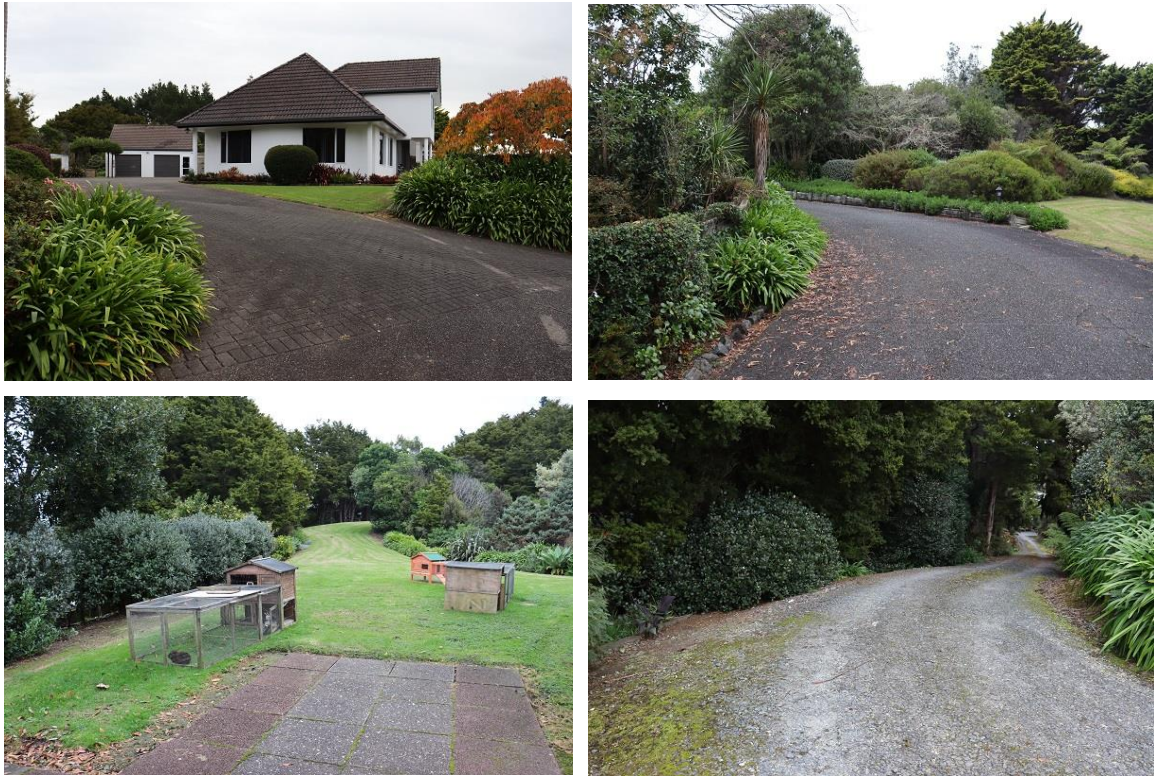
Figure 55. Top left: Modern dwelling with garage in background in P1, facing southwest. Top right: Long driveway with landscaped lawn and planted vegetation in P1, facing south/southeast. Bottom left: Southern lawn with animal enclosures and P1-G in background, facing southwest. Bottom right: Long driveway at southern end of property leading to second modern dwelling, P1-F to the left, facing south

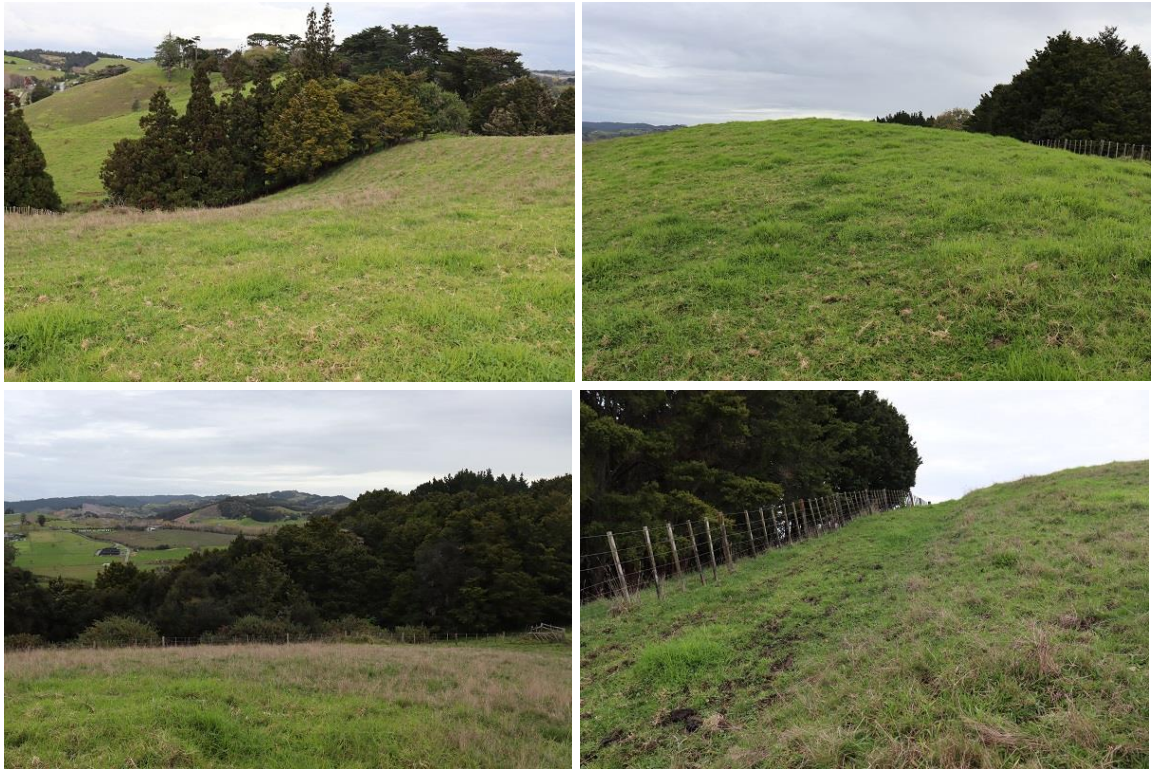
Figure 56. Top left: Looking towards northeast border of P2 showing dense vegetation and steep terrain, facing southeast. Top right: Hill located on northern side of P2, facing southwest. Bottom left: Central northern portion of P2 showing steep terrain, dense vegetation and fencing, facing south. Bottom right: Looking up towards the upper portion of the hill on the north side of P2, adjacent to P18 to the left. Note the track running along the northern side of the hill adjacent to wire and post fence. Facing northeast

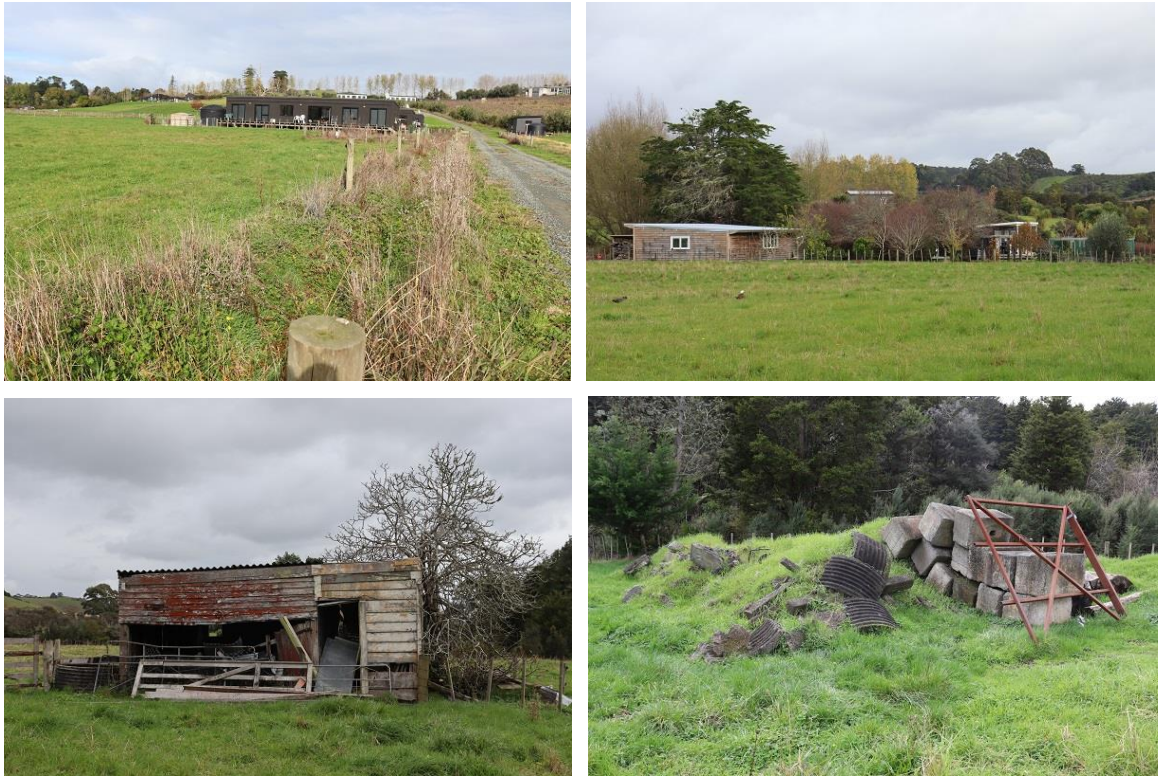
Figure 57. Top left: Modern dwellings (units) located on the southern side of P4, facing south. Top right: modern dwelling at the centre of property P4 with adjacent barn/shed, facing west. Bottom left: Old dilapidated barn on the central northern side of property P4, facing west. Bottom right: Large pile of concrete rubble, blocks and steel framing on central northern side of P4, facing north

P4 is accessed via a long gravel driveway off Valerie Close to the south of the Plan Change Area. P4 is one of the largest properties surveyed, and mainly comprises wide, open terrain with three modern domestic dwellings (units) at the southern end (Figure 57, top left) and one (house) at the centre with an adjacent barn/shed (Figure 57, top right). An old dilapidated barn/shed of unknown age is located near the central northern border (Figure 57, bottom left). A large pile of large concrete blocks (presumably foundation blocks), timber, steel framing and other miscellaneous concrete/rubble is present just to the east of this barn/shed (Figure 57, bottom right). Another structure is therefore likely to have

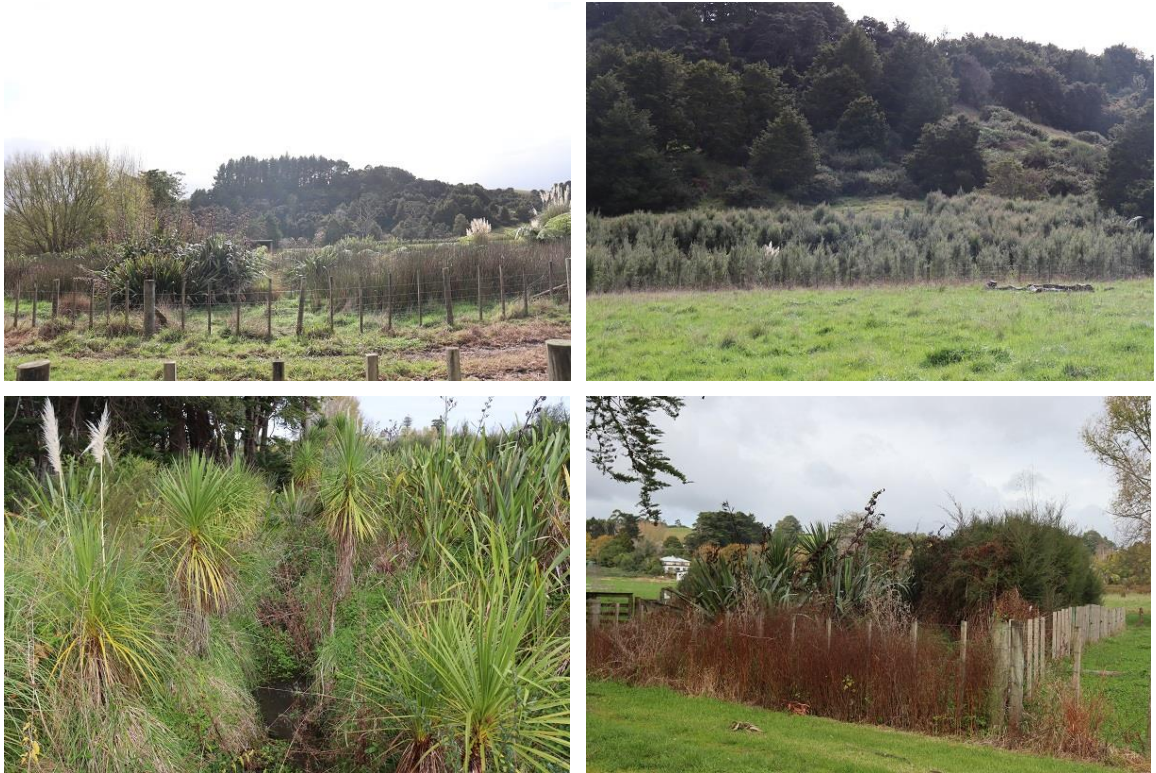
Figure 58. Top left: Central stream running through property P4, facing northwest. Top right: Stream P4-T on northeast side of property P4, facing north. Bottom left: Stream P4-U on east side of property P4, facing south. Bottom right: Stream P4-V on southeast side of property P4, facing southeast

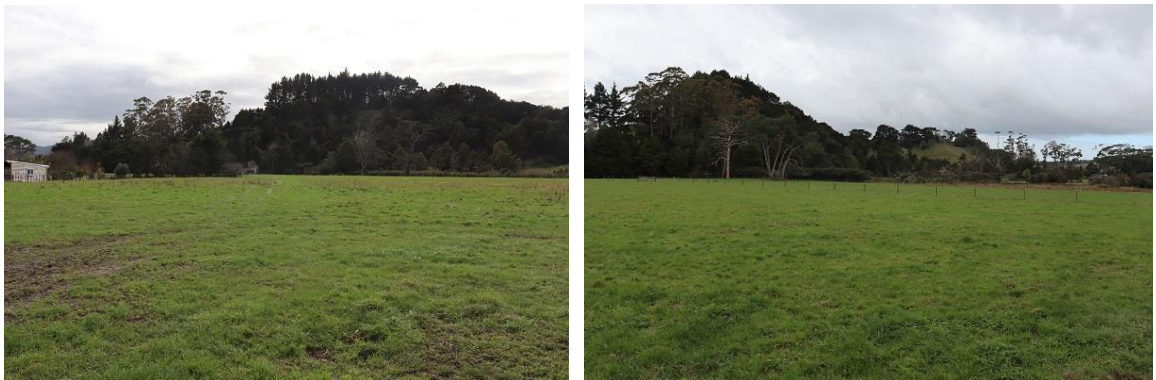
Figure 59. Left: Northeast field of P4 showing flat terrain, facing north. Right: Northwest field of P4 showing flat terrain, facing northeast

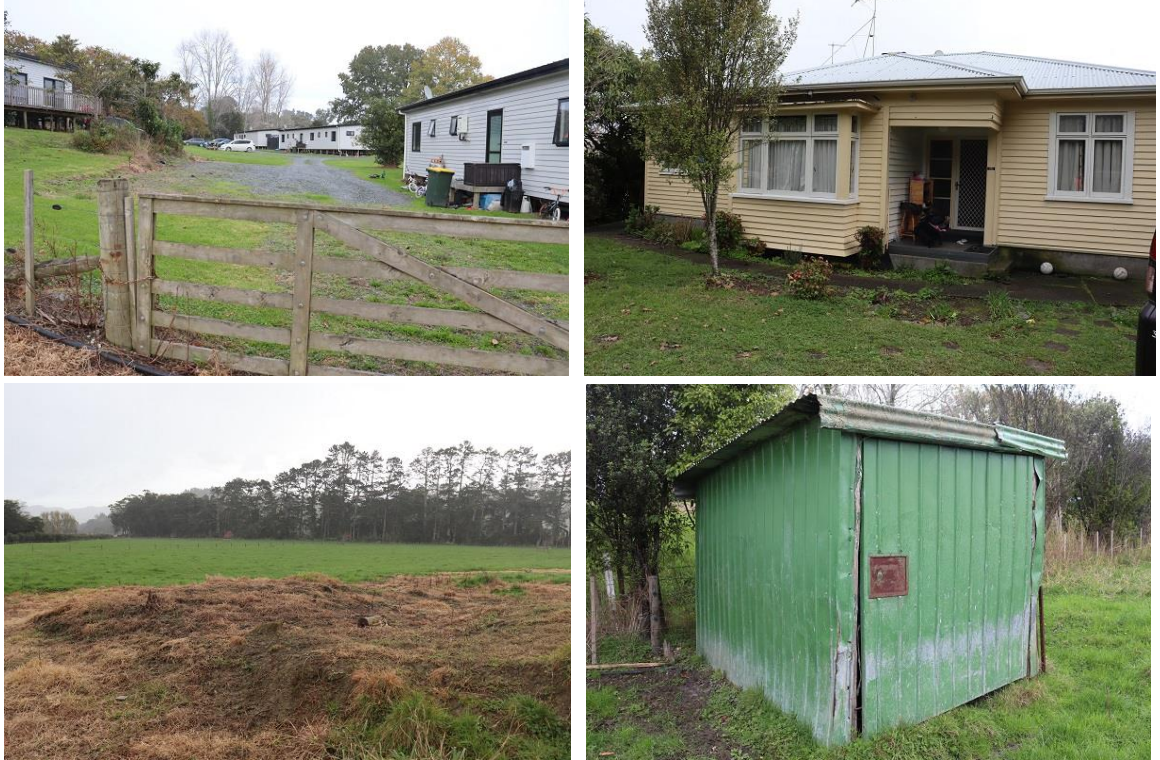
Figure 60. Top left: Modern dwellings (units) on south side of property P5, facing south. Note, the ones on the left and right are contained within P5 while the ones in the background are contained within P6. Top right: older (c. mid-20th century) house on the south side of property P5, facing west. Bottom left, fields on the north side of P5 showing flat terrain, facing northwest. Bottom right: Old corrugated iron shed on the east side of P5, facing south

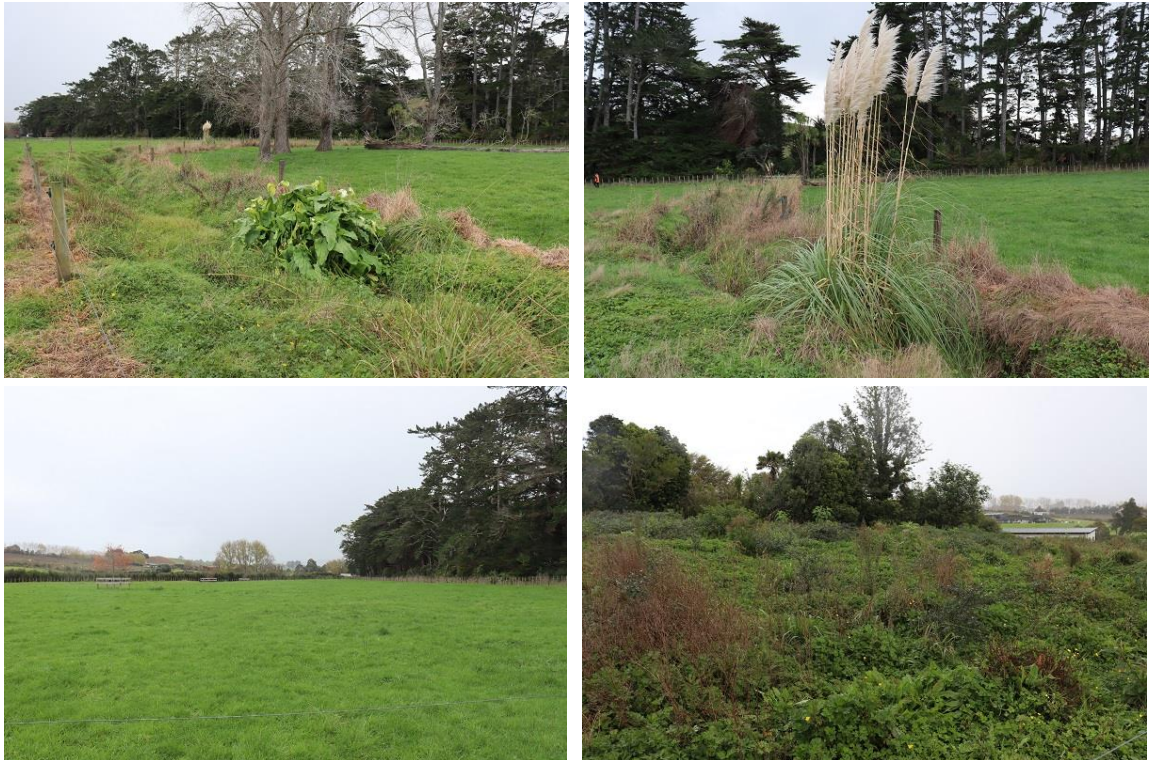
Figure 61. Top left: Stream running through northeast side of P5, facing northwest. Top right: Toetoe grass growing alongside stream, facing north. Bottom left: Small tree enclosures running along northwest side of P5, facing west. Bottom right: Southeast area of field with enclosed area full of overgrown grasses, weeds and bushes, facing southwest

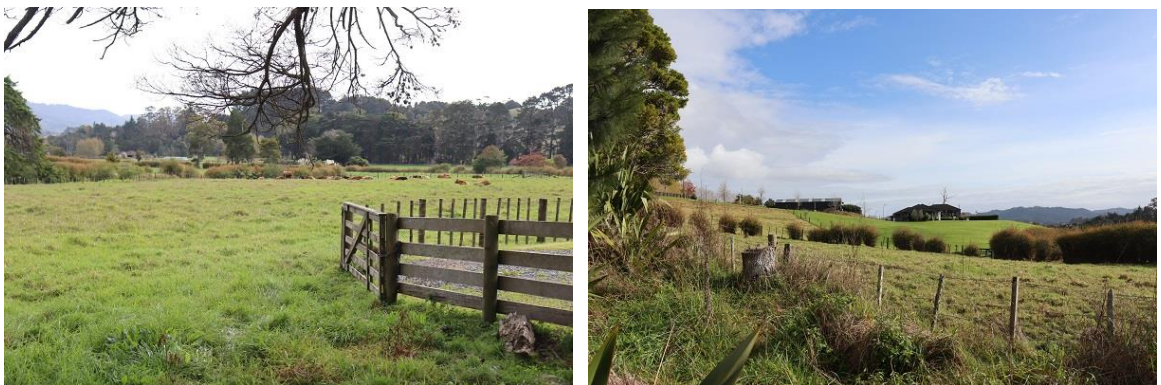
Figure 62. Left: Standing on southeast side of P6 facing northwest, note the central stream in background. Right: Southwest side of P6 with P10 in background, facing northwest

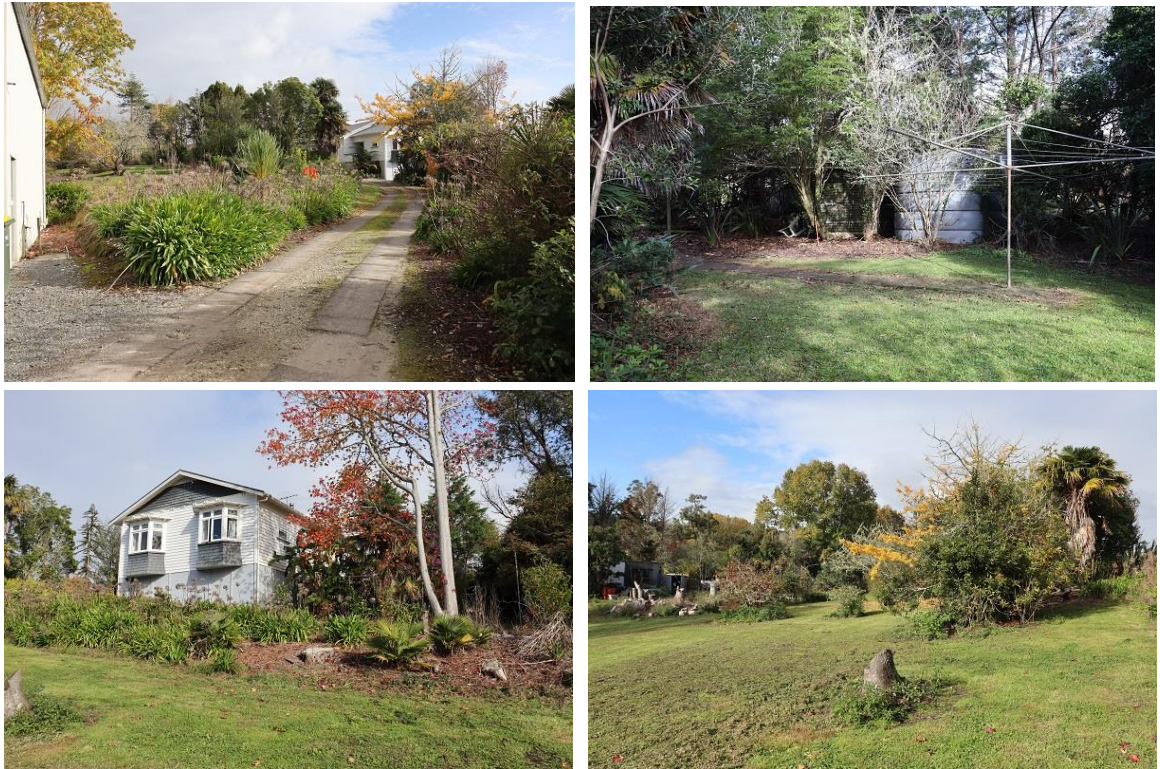
Figure 63. Top left: Long driveway with an older house, possibly dating to the 1920s/1930s, in the background in P7, facing northwest. Top right: Small garden area at the rear of house (north side of property), facing west. Bottom left: Large landscaped garden area on central north side of property in foreground with house in background, facing west/southwest. Bottom right: Large garden area on central north side of property, facing south

The building in P7 is on the northwest side of the property (Figure 63, top and bottom left), which is located on the south side of the project area accessed via Valerie Close. The building was noted in Brassey and Walker as being a bungalow era dwelling (2018, p.81). The structure is positioned at the top of a relatively gentle slope and has a gable roof with white-painted timber weatherboard cladding typical of earlier 20th century houses. The chimney is brick-lined with a concrete cap (Figure 93). The eastern side of the building contains oriel style windows that protrude from the building where the lower portions utilise overlapping tiles as cladding (Figure 94, left). The window frames are hexagonal (half hexagon) in shape and contain eight separate glass panels. The upper glass panels of these oriel windows are smaller than the lower panels and have a banded design utilising pieces of blue and textured glass. A similar design is seen on a few other small windows on the building (Figure 94, right). A modern deck has been added to the northwest side of the building (see Figure 93, bottom left). The structure appears to have timber foundations and has a lower floor that appears to only be for storage and to access utilities. A ceramic pipe was found protruding out of the ground on the northwest side of the building amongst the vegetation and is presumably an old septic tank associated with the house.

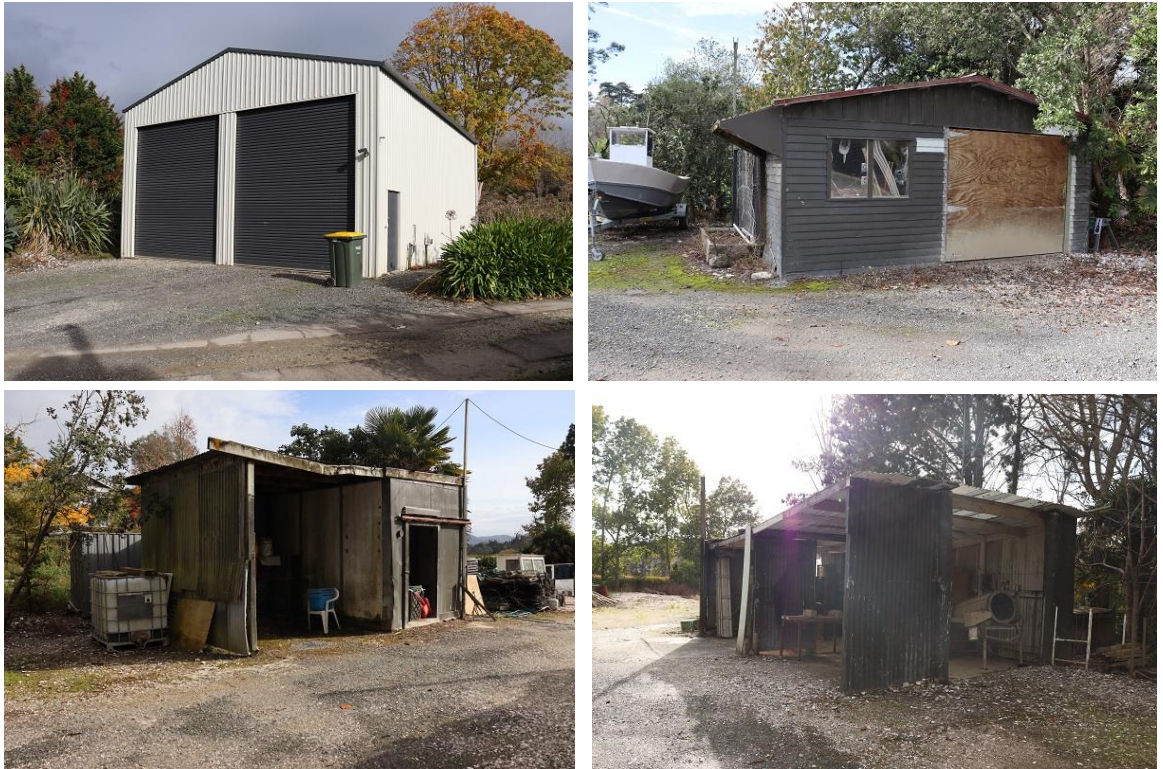
Figure 64. Top left: Large double garage on central south side of property, facing southwest. Top right: Shed on southeast side of property, facing east. Bottom left: shed on central east side of property, facing northwest. Bottom right: Shed on central east side of property, facing northeast
