WARKWORTH SOUTH PLAN CHANGE: ARCHAEOLOGICAL ASSESSMENT

Prepared for KA Waimanawa Partnership Ltd and Stepping Towards Far Limited

December 2022 (Updated from April 2022)

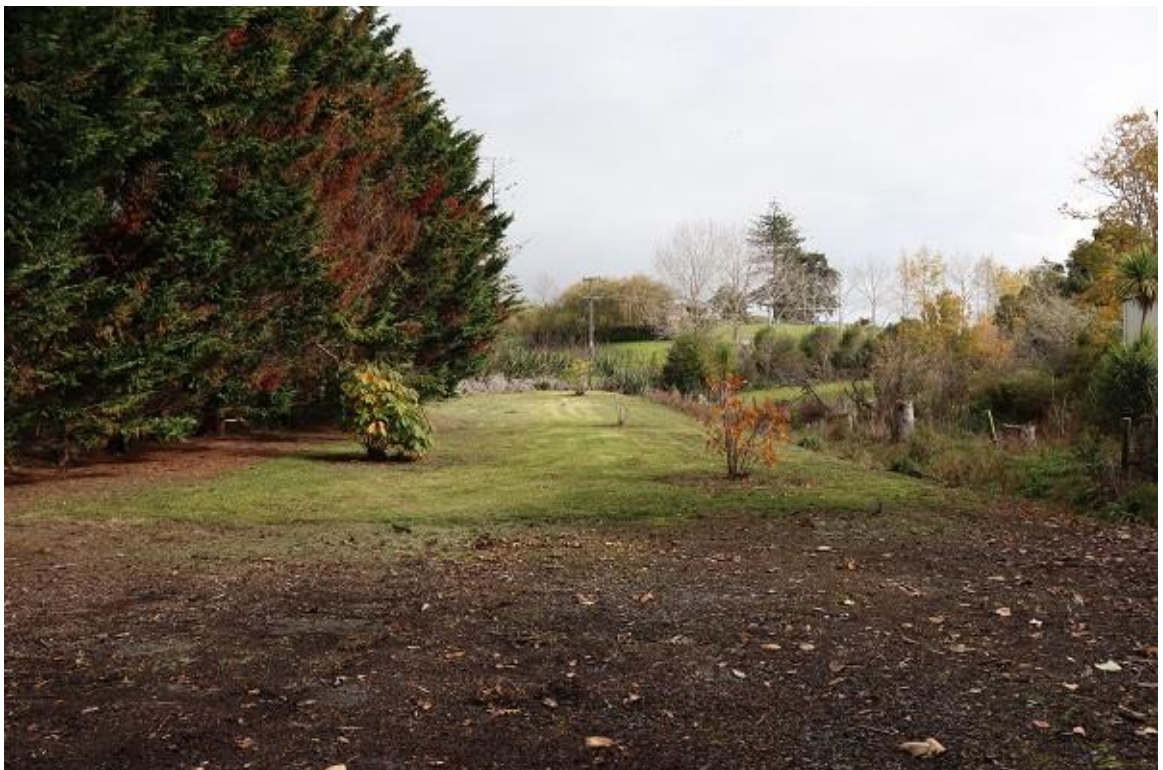
Figure 65. P8 showing stream on north side of property (right) and vegetation along southern boundary (left), facing west

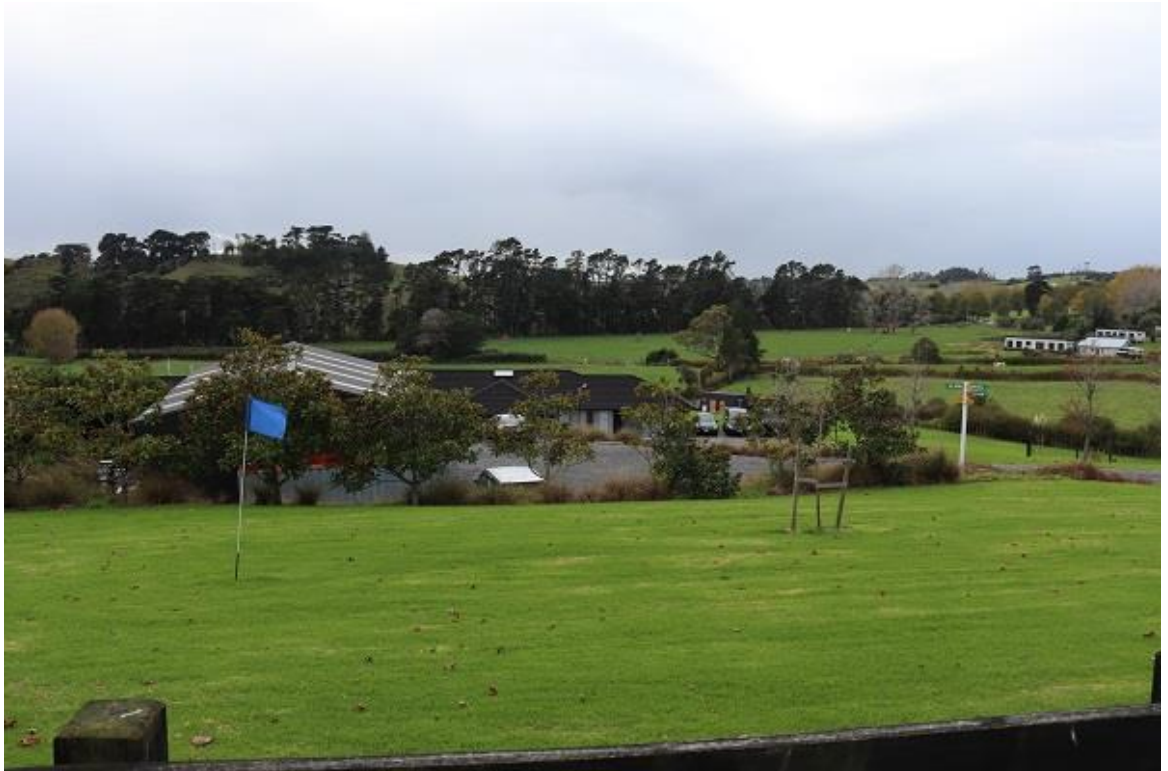
Figure 66. Front/road facing portion of P10, facing north/northeast

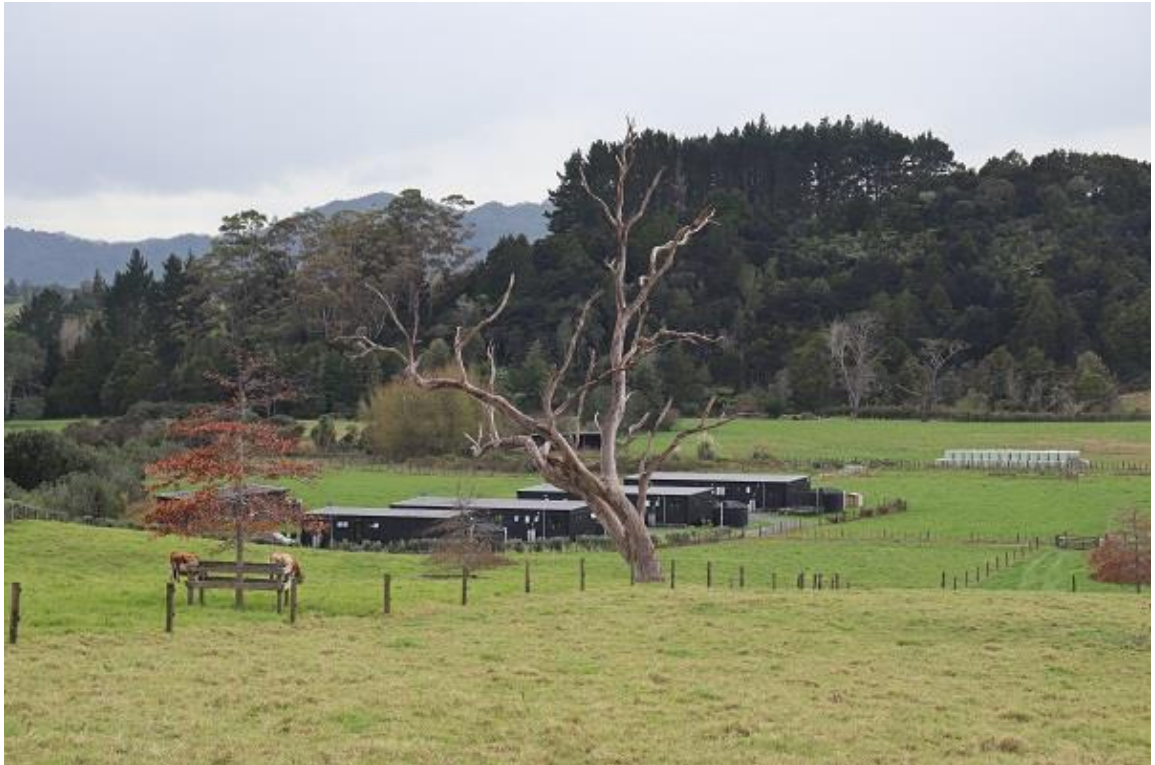
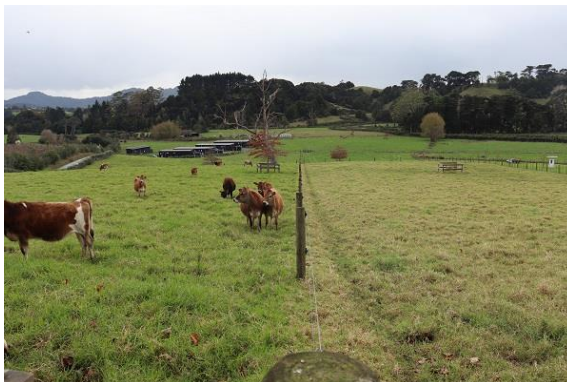
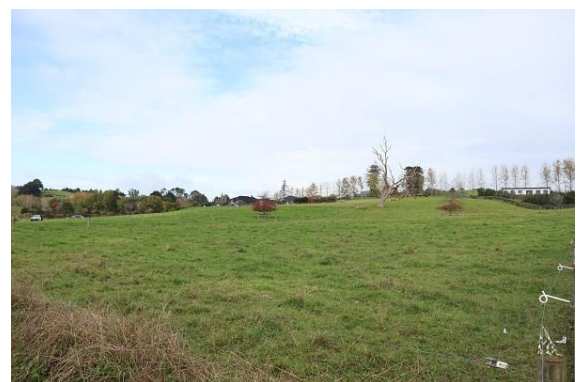
Figure 67. Top: Dying tree on north side of southwest field of P11, facing north/northwest. Note modern dwellings (units) in background. Bottom left: South side of P11 showing fields and cattle, facing north. Bottom right: North side of P11 showing fields, facing north/northeast

tree on the north side of the southwest field (see Figure 67, top). All fields show minor stock trampling.

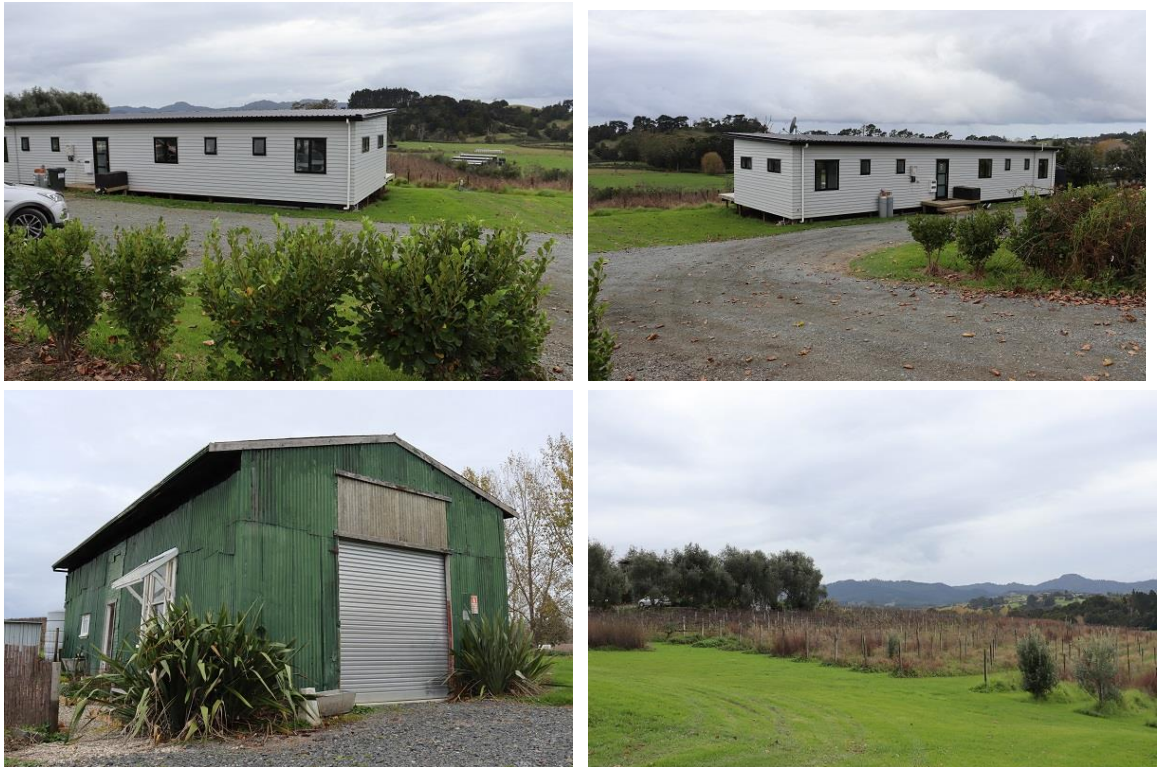
Figure 68. Top left and right: Modern dwellings (units) on south side of P12, facing northwest (top left) and northeast (top right). Bottom left: Old barn converted into dwelling located on central west side of property P12, facing southeast. Bottom right: South/southeast portion of property P12 showing vineyard. Note modern dwelling (house) in background to the left. Facing northwest

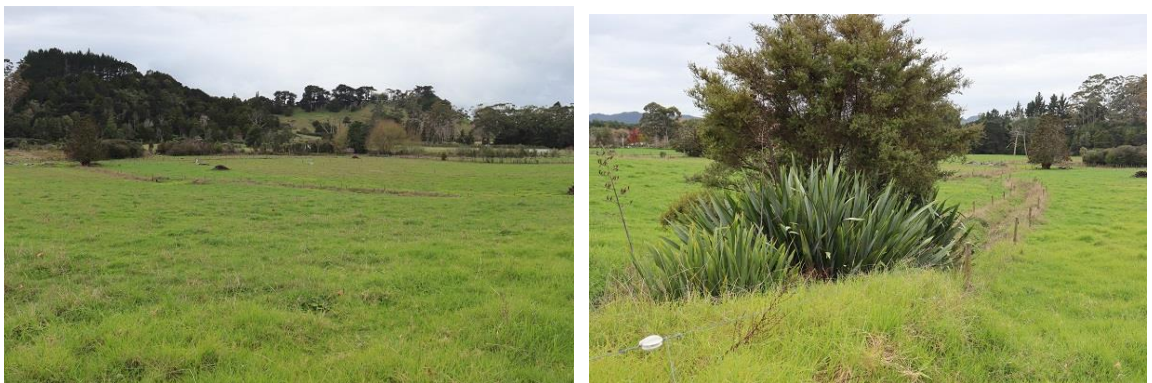
Figure 69. Left: Fields on the northern side of P12, facing northeast. Right: Stream running through central north side of P12 in between the two central fields, facing north

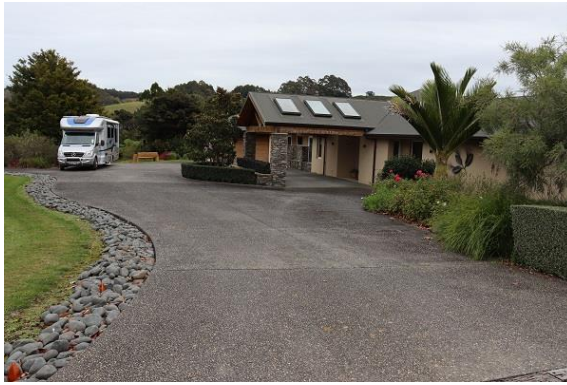
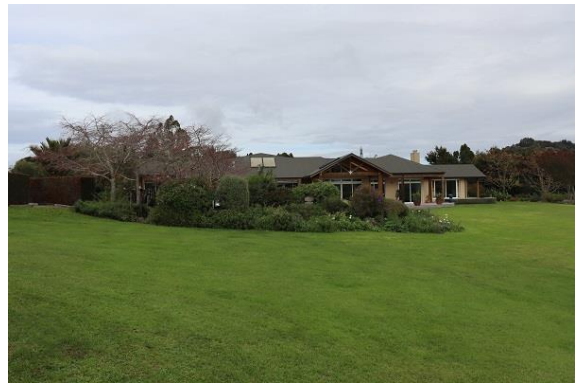
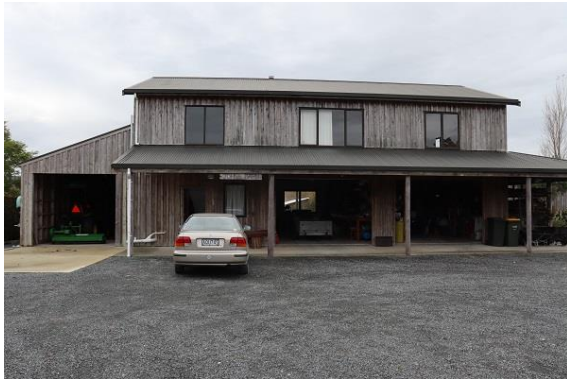
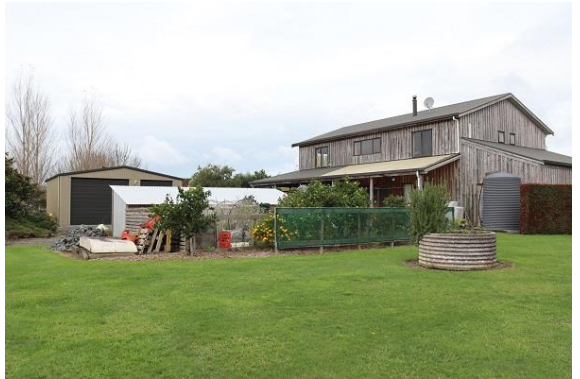
Figure 70. Top left: Modern dwelling (house) located on the central portion of P13, facing southwest. Top right: Modern dwelling (house) located on the central portion of P13, facing east. Bottom left: Large garage/shed with upper floor used as dwelling located on the central portion of P13, facing west. Bottom right: Large garage/shed with upper floor used as dwelling to the right and smaller garage/shed at the rear to the left, facing east/southeast

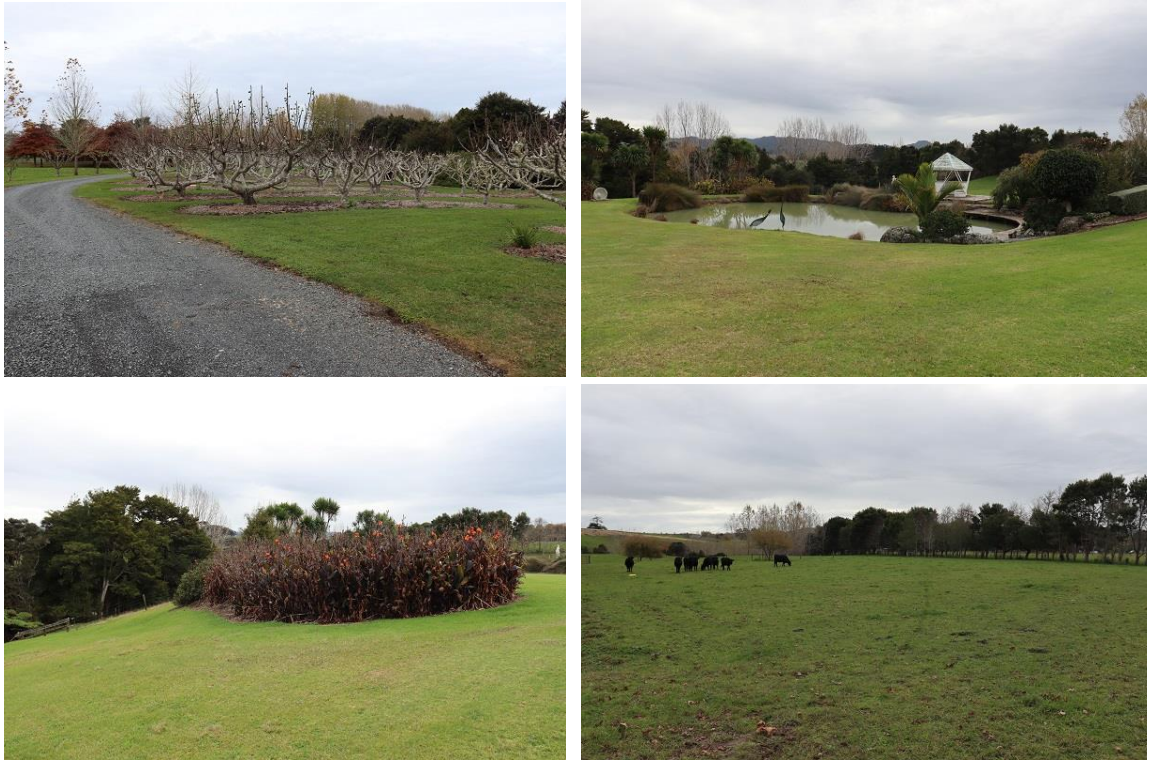
Figure 71. Top left: Landscaped garden east of the dwelling in P13 showing fruit trees on south side, facing southeast. Top right: Landscaped garden west of the dwelling in P13 showing pond and gazebo, facing northwest. Bottom left: Planted vegetation in the landscaped garden west of the dwelling in P13, facing northwest. Bottom right: Central northern field of P13 with cattle grazing, facing northwest

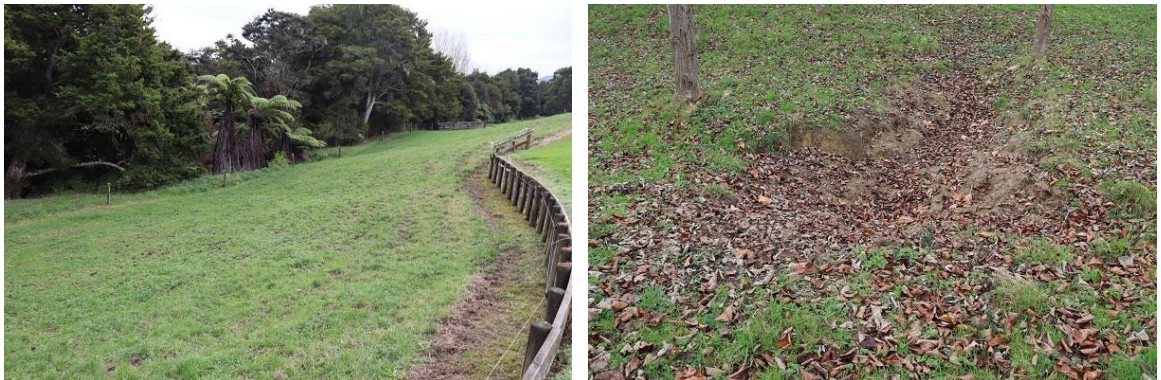
Figure 72. Left: Central west side of P13 with stream and dense vegetation running along western border of property, facing northwest. Right: Central northern portion/field of property P13 showing minor collapse in the ground due to stream running through here underground. Note, the collapsed area has been partially filled in with grass trimmings/mulch

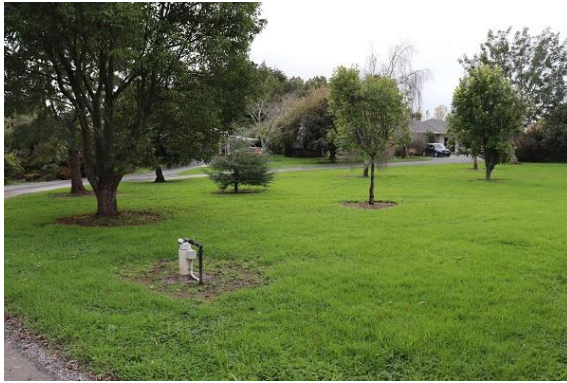
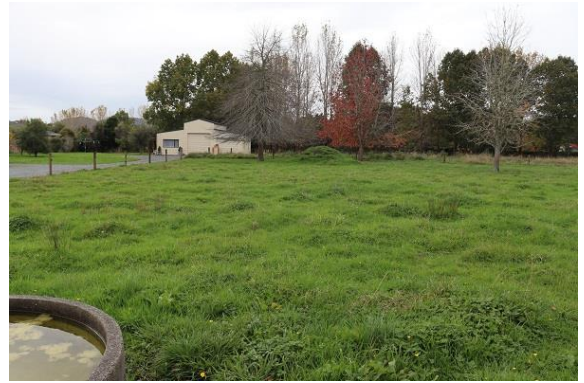
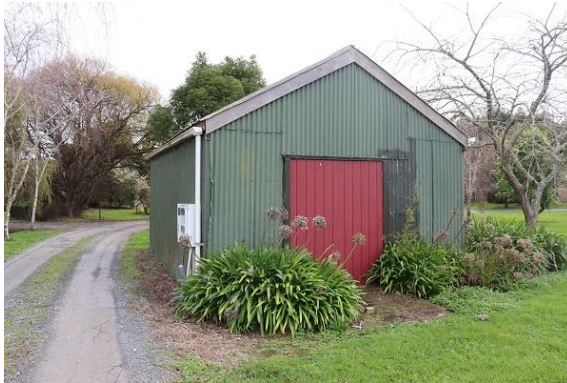
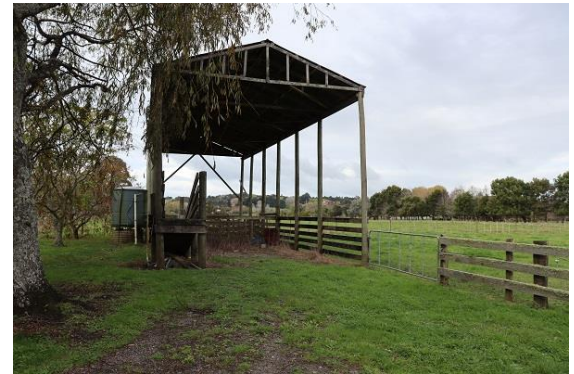
Figure 73. Top left: Modern dwelling (house) on the northwest side of P14, facing northwest. Top right: west side of northwest field with dwelling in the background located adjacent to central northern border of property P14. Bottom left: Old green corrugated iron shed adjacent to driveway and dwellings, facing west. Bottom right: Large open cattle barn adjacent to southern fields and driveway, facing east/southeast

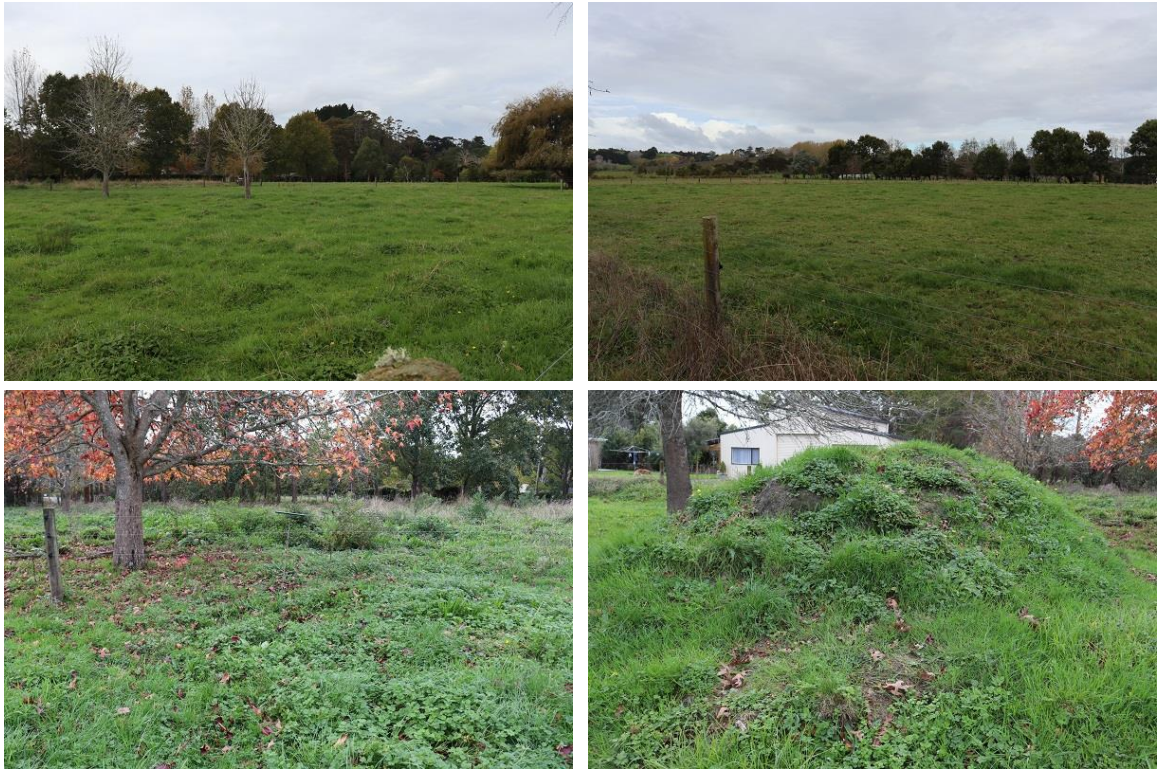
Figure 74. Top left: Northern field of property P14, facing northeast. Top right: Southern fields of property P14, facing southeast. Bottom left: Area of buried rubble marked by probe, facing north. Bottom right: Old spoil heap located at northwest side of northwest field of property P14, facing north

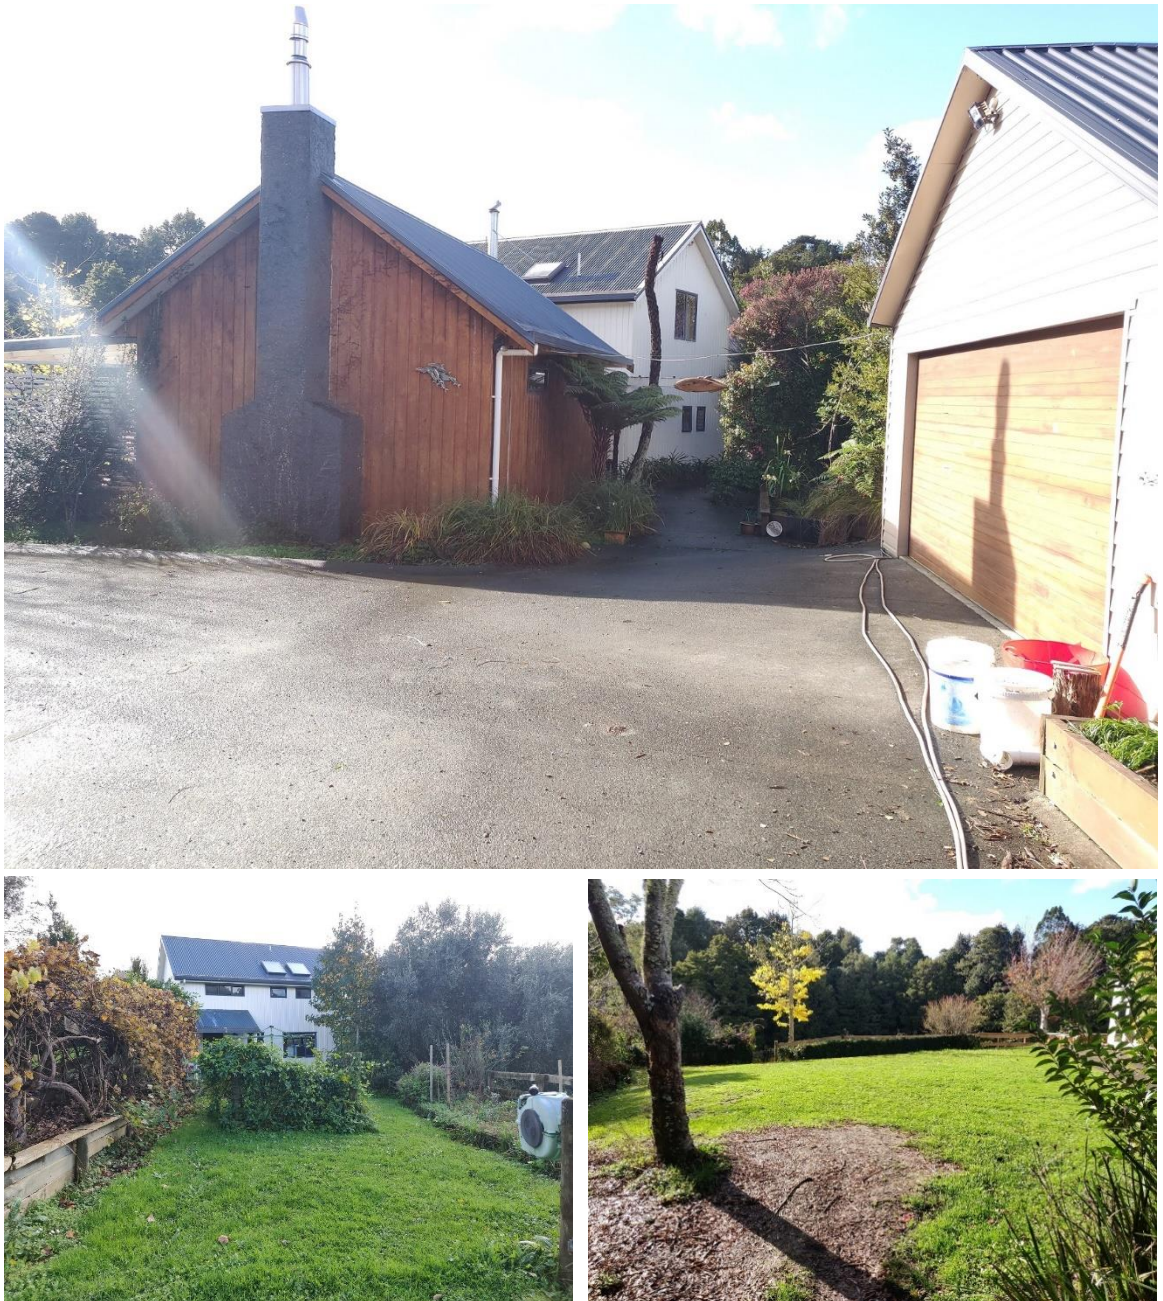
Figure 75. Top: Modern house and large garage on northwest side of P15, facing north. Bottom left: Small landscaped garden on the east side of house, facing west. Bottom right: Relatively large landscaped garden on the west side of house, facing north

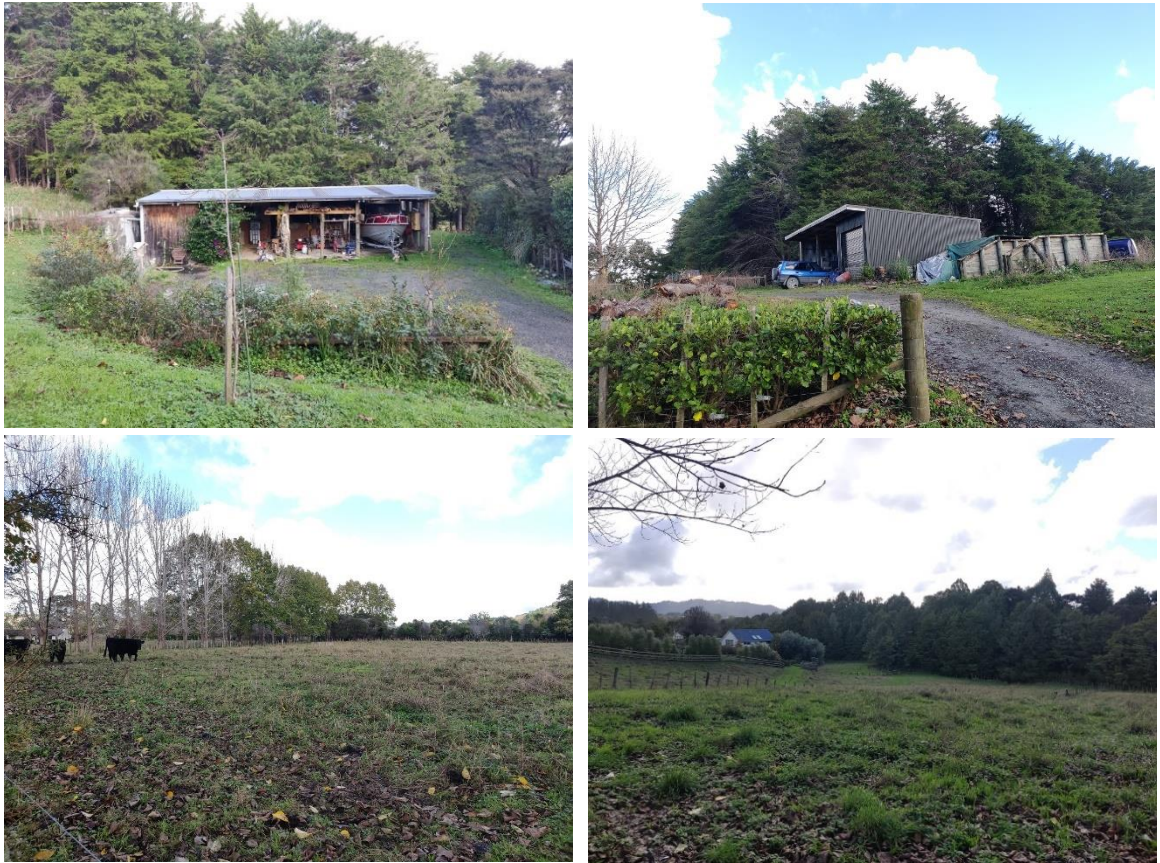
Figure 76. Top left: Shed/work area on central west portion of property P15, facing south. Top right: Shed/work area on central west portion of property P15, facing south. Bottom left: Field on southern side of property P15, facing southeast. Bottom right: Field on north side of property P15 with house in background, facing northwest

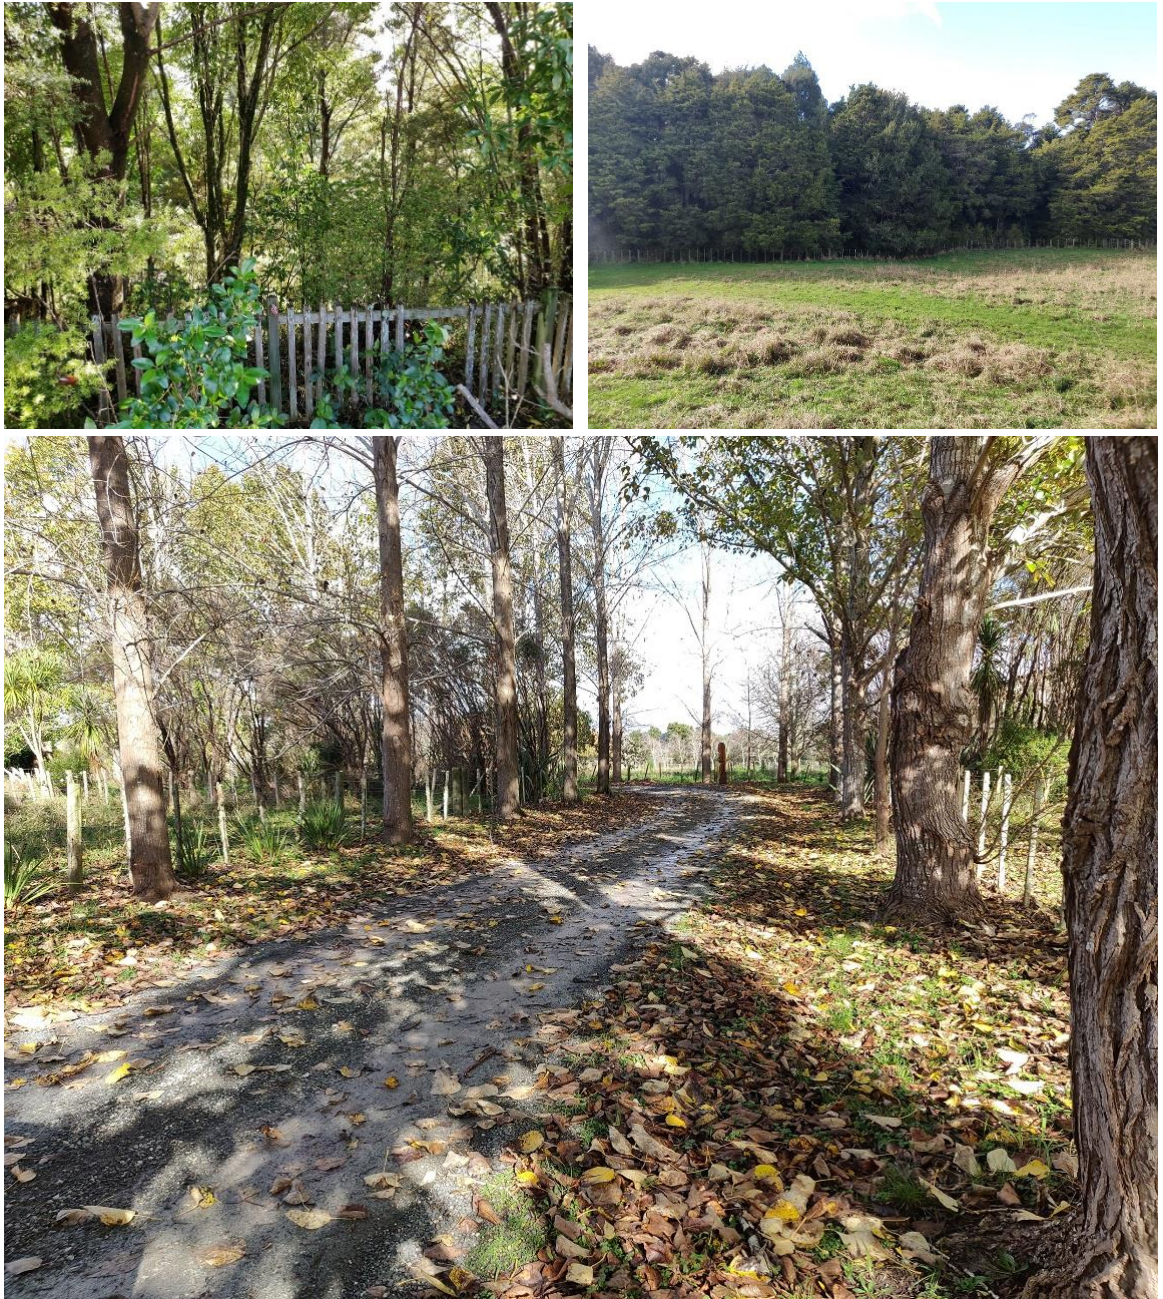
Figure 77. Top left: Looking at vegetation surrounding stream P15-G on west side of property P15, facing west. Top right: Looking towards stream P15-F on north side of property P15, facing north. Bottom: Long driveway leading to property P15 on southeast side with trees along either side, facing south

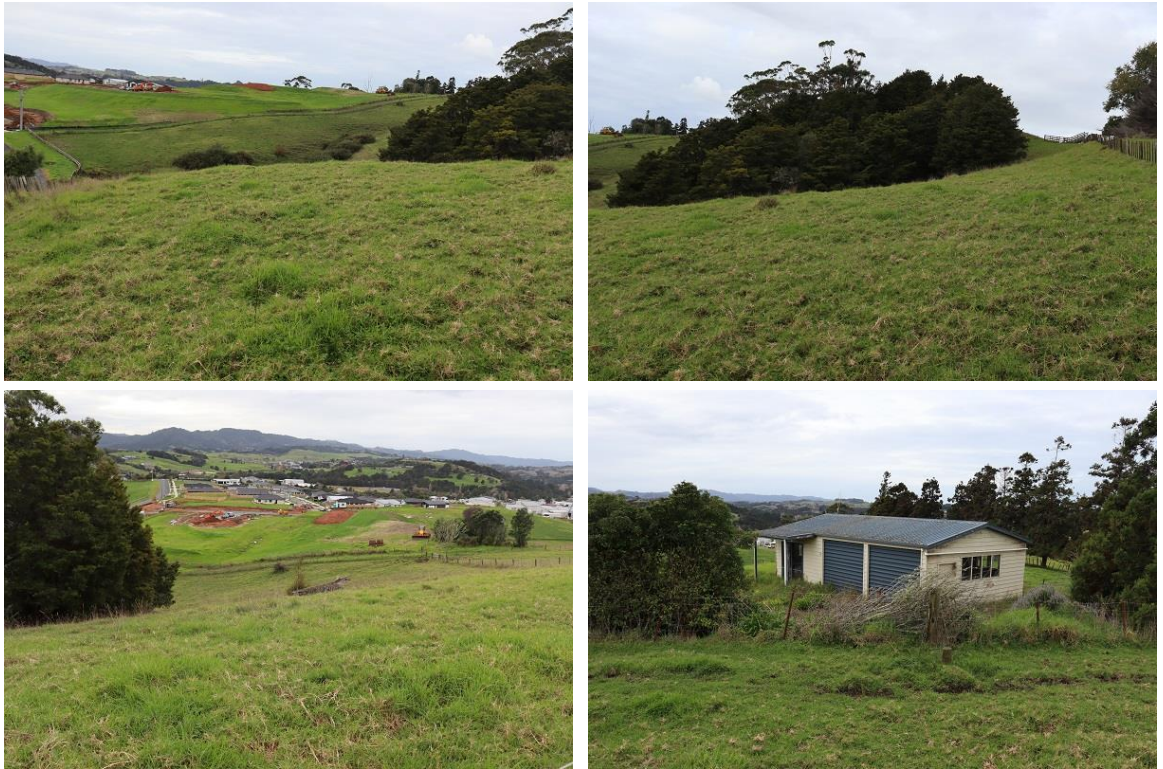
Figure 78. Top left: northwest side of P18 showing steep terrain and dense vegetation to the right, facing north. Top right: Central portion of P18 showing steep terrain and dense vegetation at centre, facing east. Bottom left: central northern side of P18 showing steep terrain and dense vegetation to the left, facing north. Bottom right: Shed/workshop located on the hill at the central east side of property P18, facing north

The only other vegetation seen across the property that is not associated with the streams consists of rows of planted trees seen throughout the property that typically run along field and property borders (see Figure 82–Figure 90). There is also a patch of planted pine trees adjacent to the central west border and stream, one of which has recently fallen (Figure 92). The terrain on the northern extent of the property is relatively flat with gently sloping hills, whereas the terrain on the southern extent is relatively mountainous with steep slopes that lead to a large and long hill running along the entire length of the southern border (see contours in Figure 87). The far west side of the property was inaccessible due to steep terrain and dense vegetation along this stream/valley but was photographed from a distance.

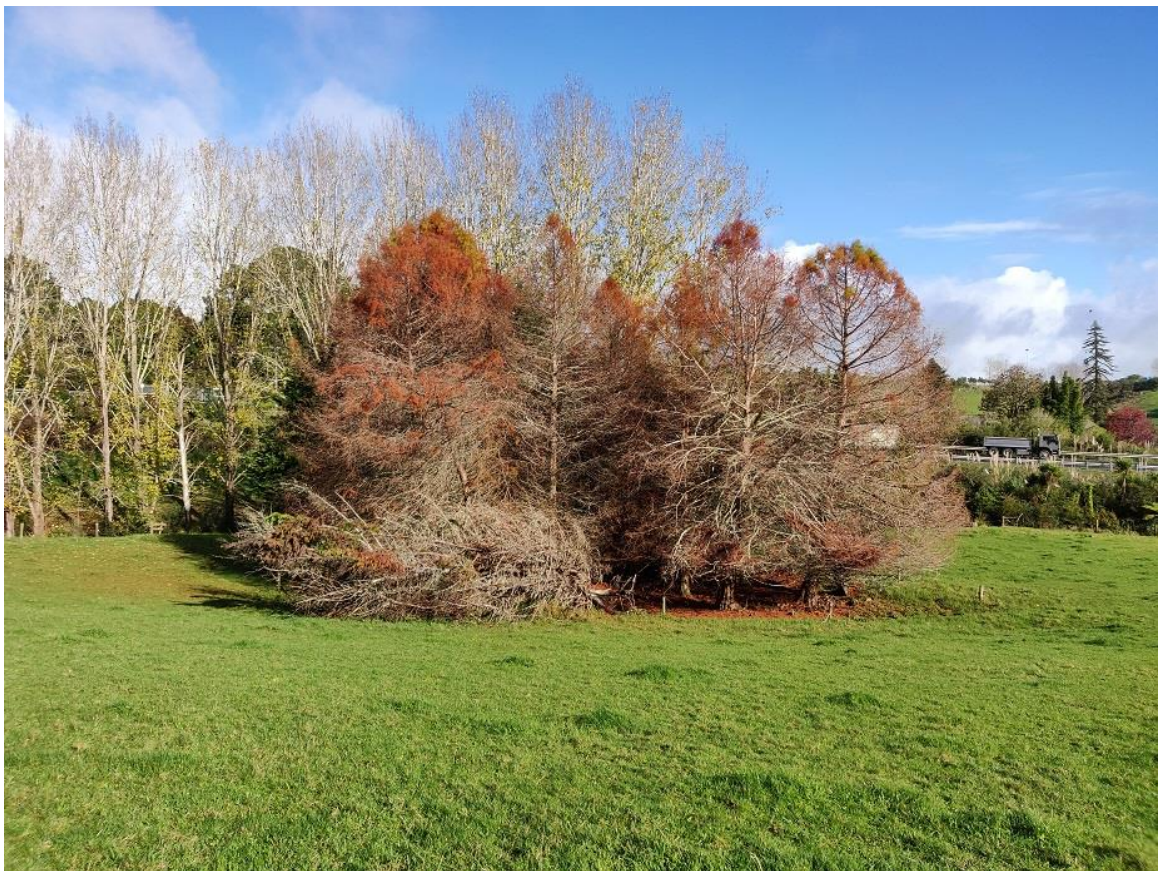
Figure 92. Patch of planted pine trees adjacent to the central west border and stream (note one has fallen), facing northwest

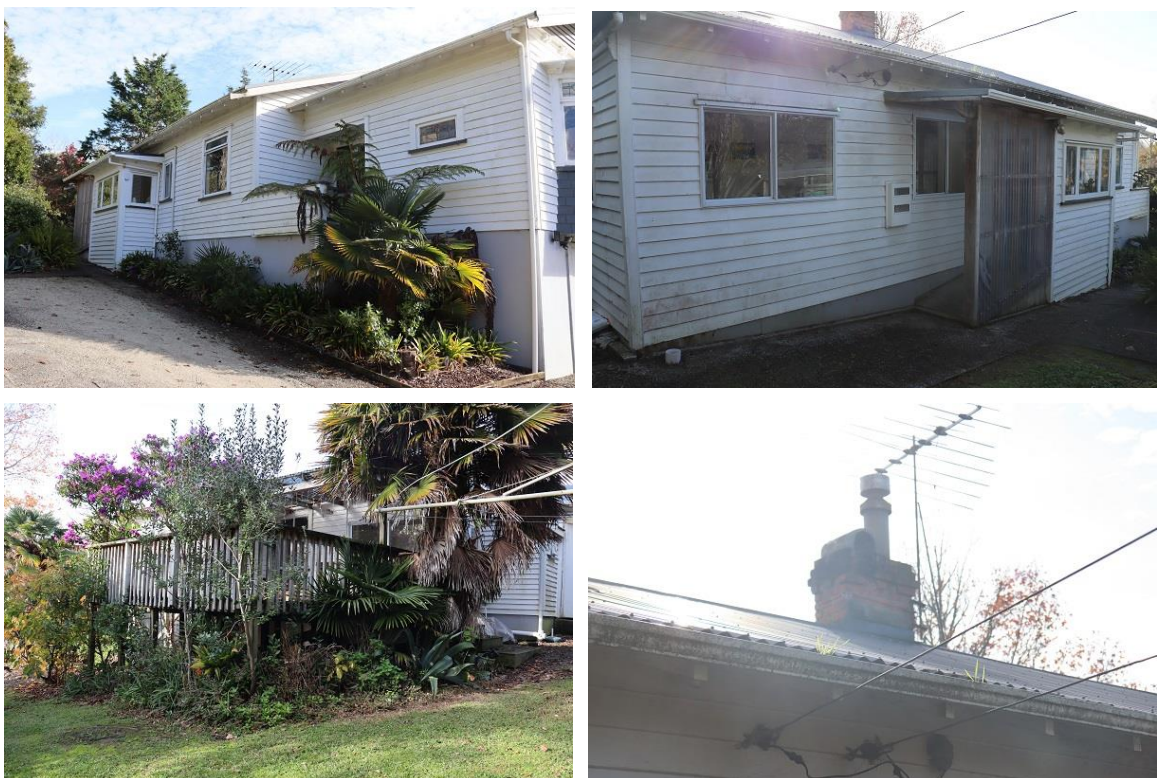
Figure 93. Top left: The c.1920s/1930s house located on the northwest side of P7, facing northwest. Top right: The same house, facing northeast. Bottom left: The same house, facing south. Bottom right: Chimney of the c.1920s/1930s house, facing north/northeast

The building in P7 is on the northwest side of the property (Figure 63, top and bottom left), which is located on the south side of the project area accessed via Valerie Close. The building was noted in Brassey and Walker as being a bungalow era dwelling (2018, p.81). The structure is positioned at the top of a relatively gentle slope and has a gable roof with white-painted timber weatherboard cladding typical of earlier 20th century houses. The chimney is brick-lined with a concrete cap (Figure 93). The eastern side of the building contains oriel style windows that protrude from the building where the lower portions utilise overlapping tiles as cladding (Figure 94, left). The window frames are hexagonal (half hexagon) in shape and contain eight separate glass panels. The upper glass panels of these oriel windows are smaller than the lower panels and have a banded design utilising pieces of blue and textured glass. A similar design is seen on a few other small windows on the building (Figure 94, right). A modern deck has been added to the northwest side of the building (see Figure 93, bottom left). The structure appears to have timber foundations and has a lower floor that appears to only be for storage and to access utilities. A ceramic pipe was found protruding out of the ground on the northwest side of the building amongst the vegetation and is presumably an old septic tank associated with the house.

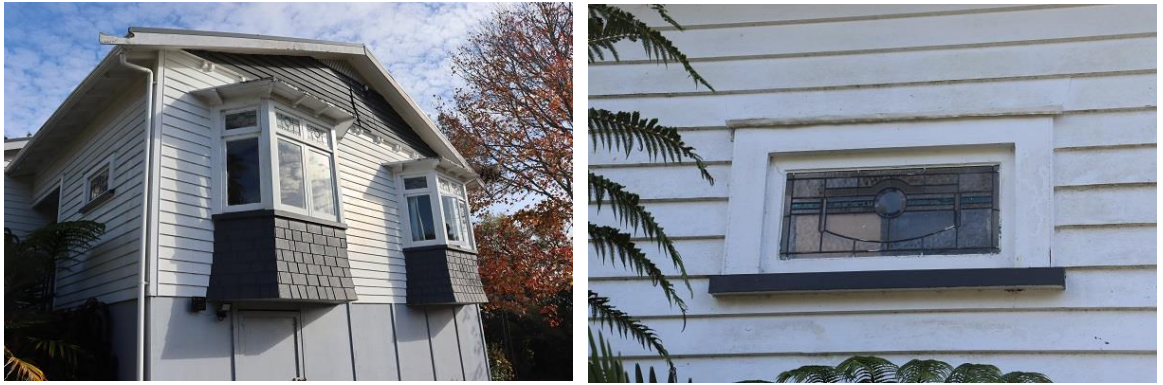
Figure 94. Left: Oriel style windows of c.1920s/1930s house located on the northwest side of P7, facing northwest. Right: Close-up view of one of the small decorative windows, facing north. This example is located on the south wall of the building, east side

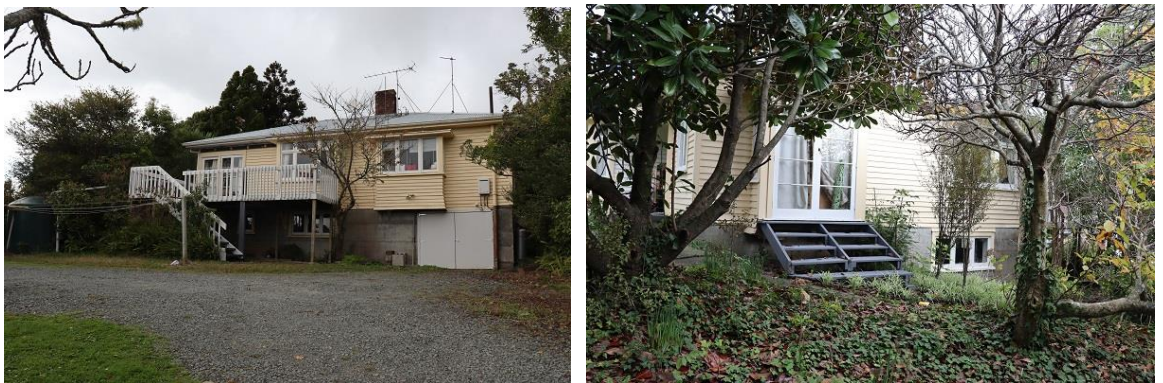
Figure 95. Left: West side of mid-20th century house located on the southeast side of P5, facing south. Right: North side of the same house, facing west.

The second building, thought to be of c.mid-20th century date, is on the south side of P5 (Figure 60, top right and Figure 95), which located on the eastern side of the Plan Change Area accessed via a gravel driveway off Valerie Close. The building was noted in Brassey and Walker to be probably a transitional villa (2018, p.90). The house is positioned at the top of a relatively gentle slope and has a hip roof with timber weatherboard cladding painted beige. The east and west sides of the property have protruding window bays. The window frames are boxed shaped and contain 10 glass panels, the upper panels smaller than the lower panels, and the ones on the east side have a banded design utilising pieces of textured glass, similar to the decorative glass panels seen on the building in P7. The chimney is brick-lined with no apparent cap. A presumably modern deck has been added to the west side of the building. The property has two floors and sits on box-poured concrete foundations. The lower floor appears to only be used for storage and to access utilities.

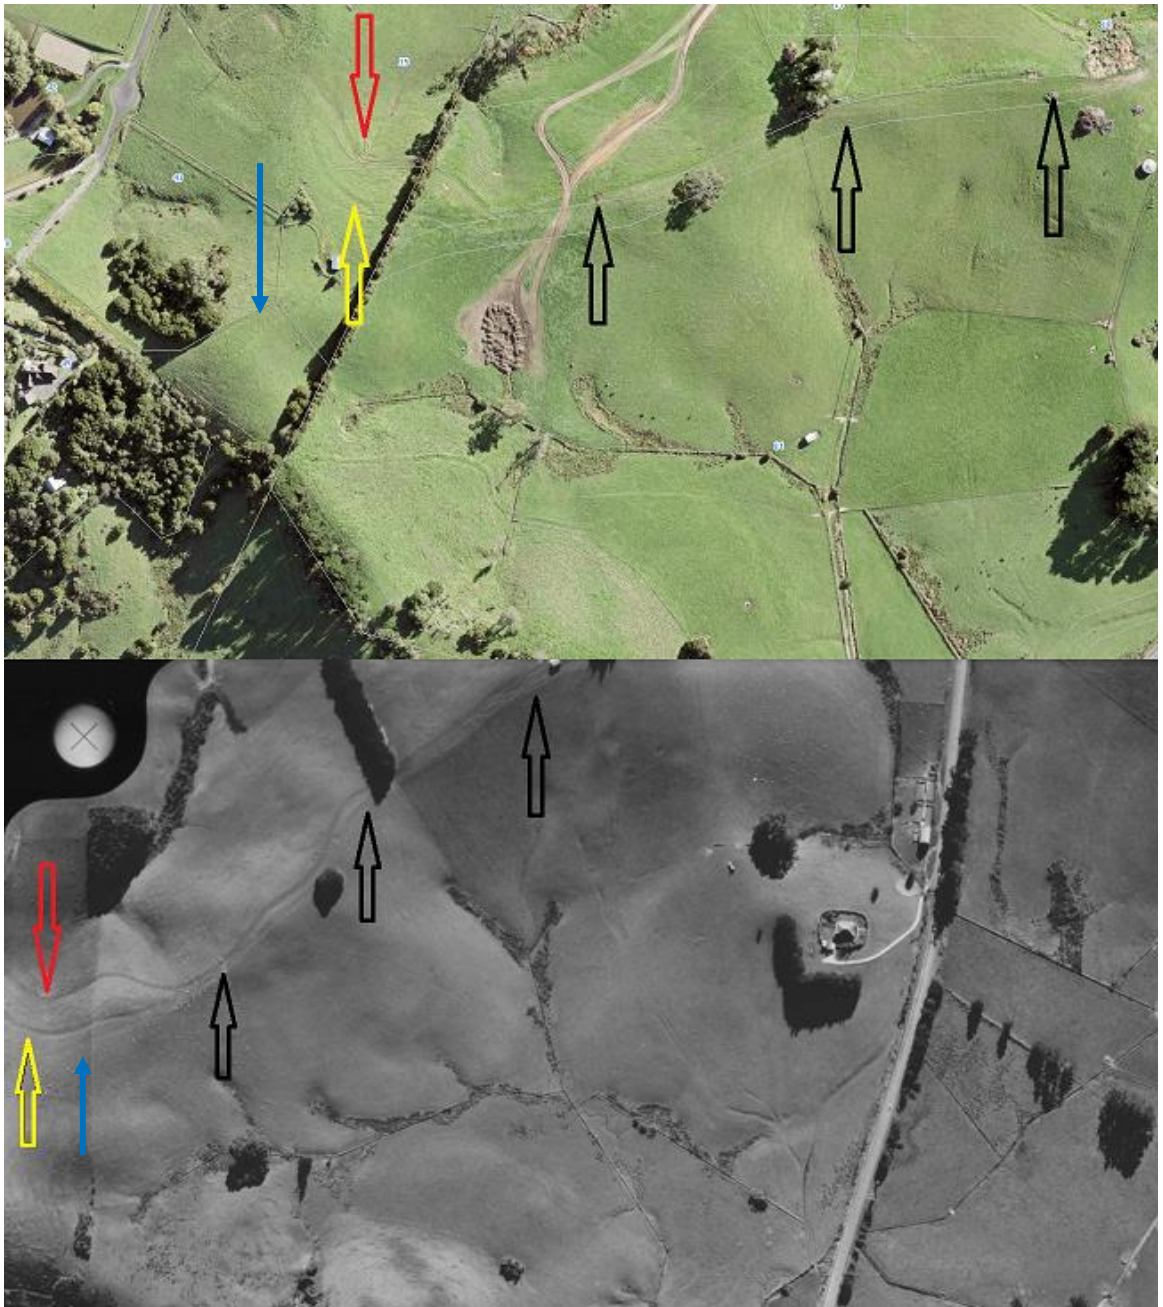
Figure 96. Top: Modern aerial showing old track on the northeast side of project area (source: Auckland Council Geomaps). Bottom: April 1963 aerial showing the same old track (source: Retrolens). The black arrows indicate the track running through the neighbouring property SH 1, Warkworth. 0981, Lot 13 DP 541462 (outside of the project area), the yellow arrows indicate the extant/visible portion of farm track located on the northeast side of P18 and the red arrows indicate the damaged/no longer visible portion of the track on the south-eastern boundary of the adjacent property 35 Mason Heights. The old road alignment curves towards the south as indicated by the blue arrows

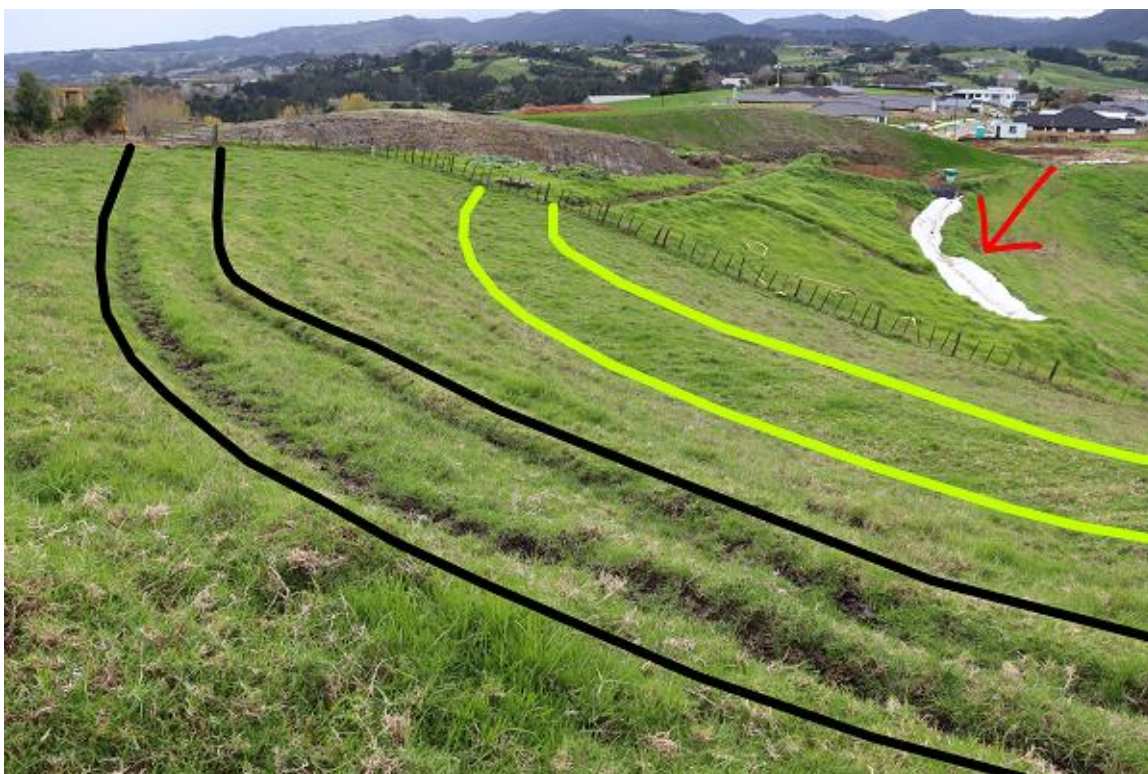
Figure 97. Northeast side of property P18 showing modern farm track indicated by black lines, old farm track indicated by yellow lines, and the damaged/no longer visible portion of old track on the south-eastern boundary of the adjacent property 35 Mason Heights indicated by red arrow

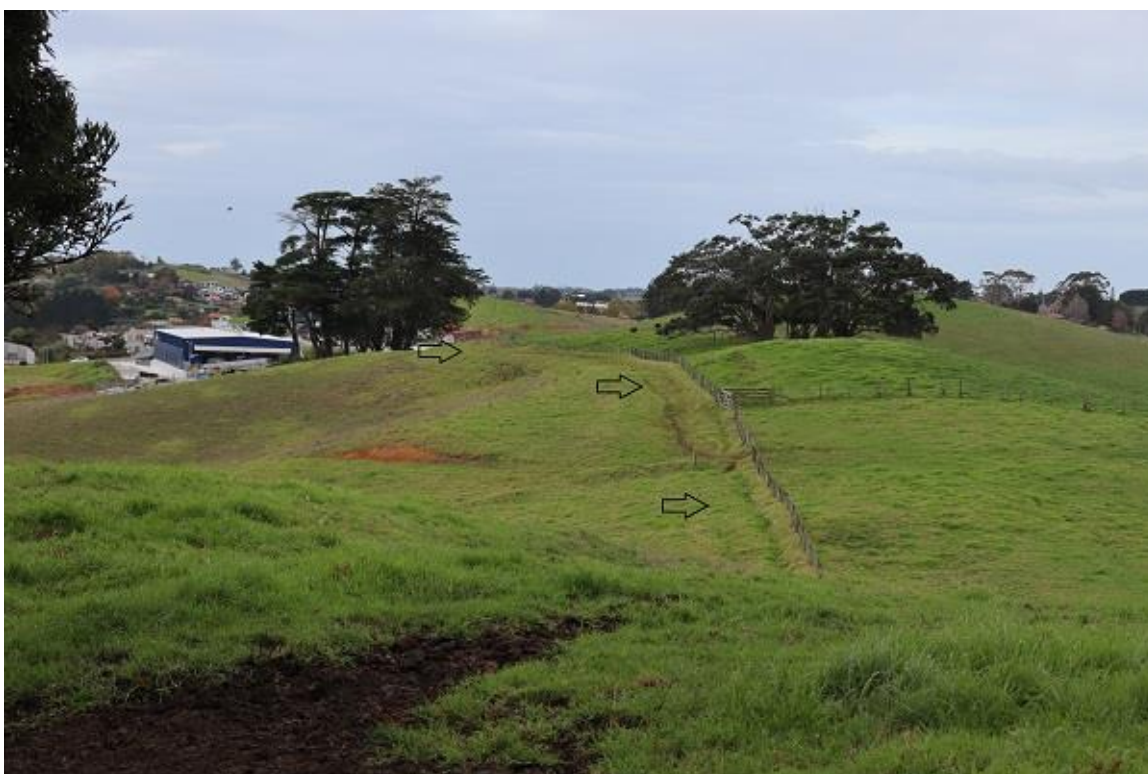
Figure 98. Standing on northeast side of property P18 facing east towards old track visible in adjacent property SH 1, Warkworth. 0981, Lot 13 DP 541462, indicated by black arrows

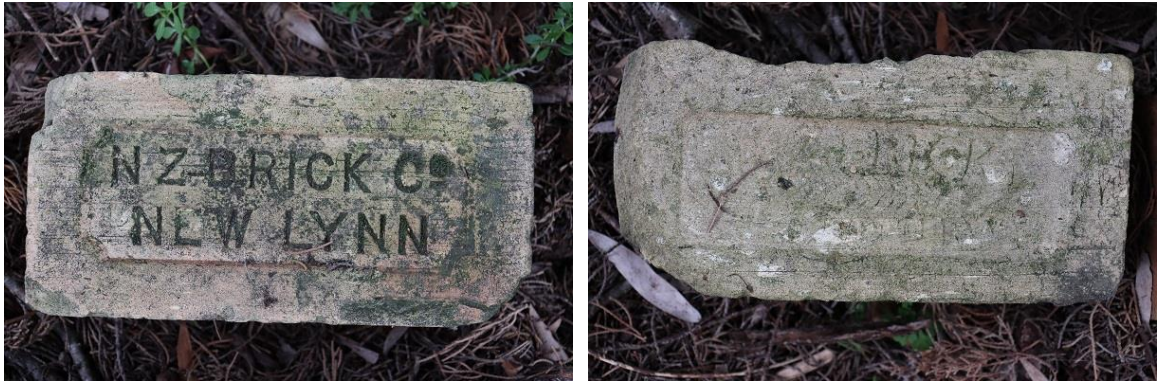
Figure 99. Left: Brick found adjacent to gate leading to the southwest field in property P1, reading 'NZ Brick Co. New Lynn'. Right: One of several of this type of brick found adjacent to gate leading to the southwest field in property P1 with illegible letters/markings

Several old bricks were found adjacent to the gate leading to the southwest field in property P1 (Figure 99). One reads 'NZ Brick Co. New Lynn'. Also known as the NZ Brick, Tile and Pottery Co. Ltd., this company began producing their products in 1905 and amalgamated with several other companies in 1929 (Truttman 2015:4-5). There are several unmarked bricks and several marked bricks of another maker, but the words/markings are illegible.
