WARKWORTH SOUTH PLAN CHANGE: ARCHAEOLOGICAL ASSESSMENT

Prepared for KA Waimanawa Partnership Ltd and Stepping Towards Far Limited

December 2022 (Updated from April 2022)

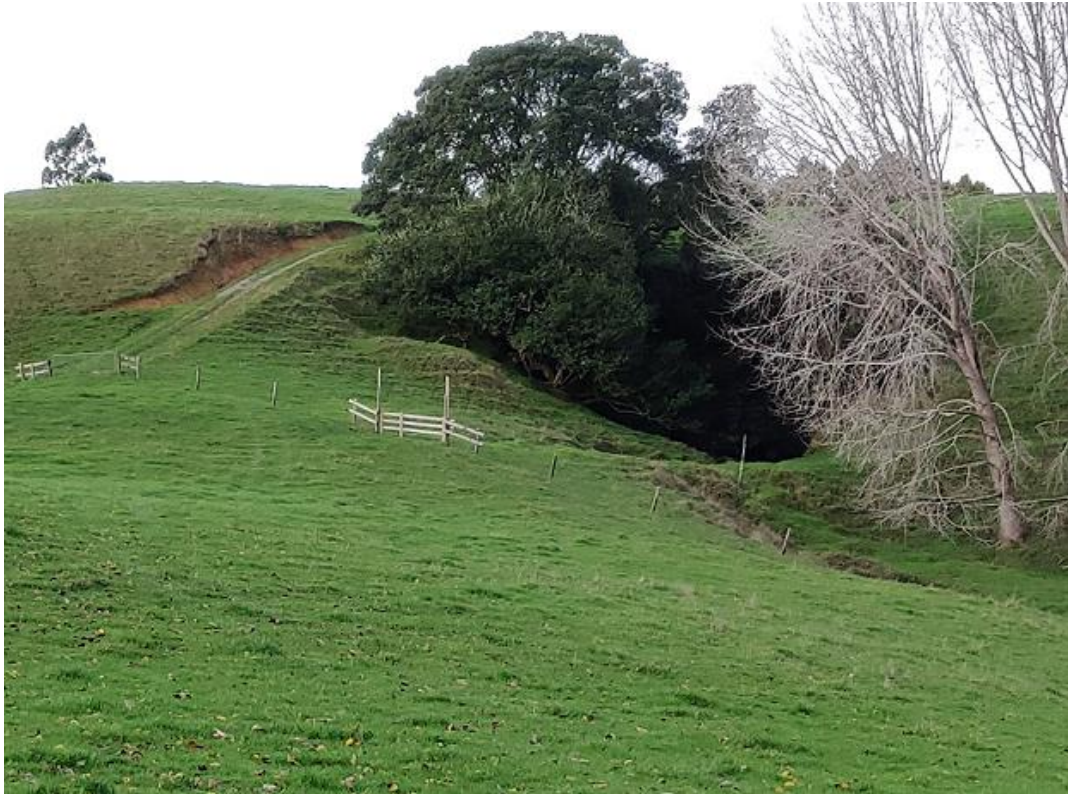
Figure 101. Track cut into hill on the left, bedrock enclosure and stream on the right, facing south

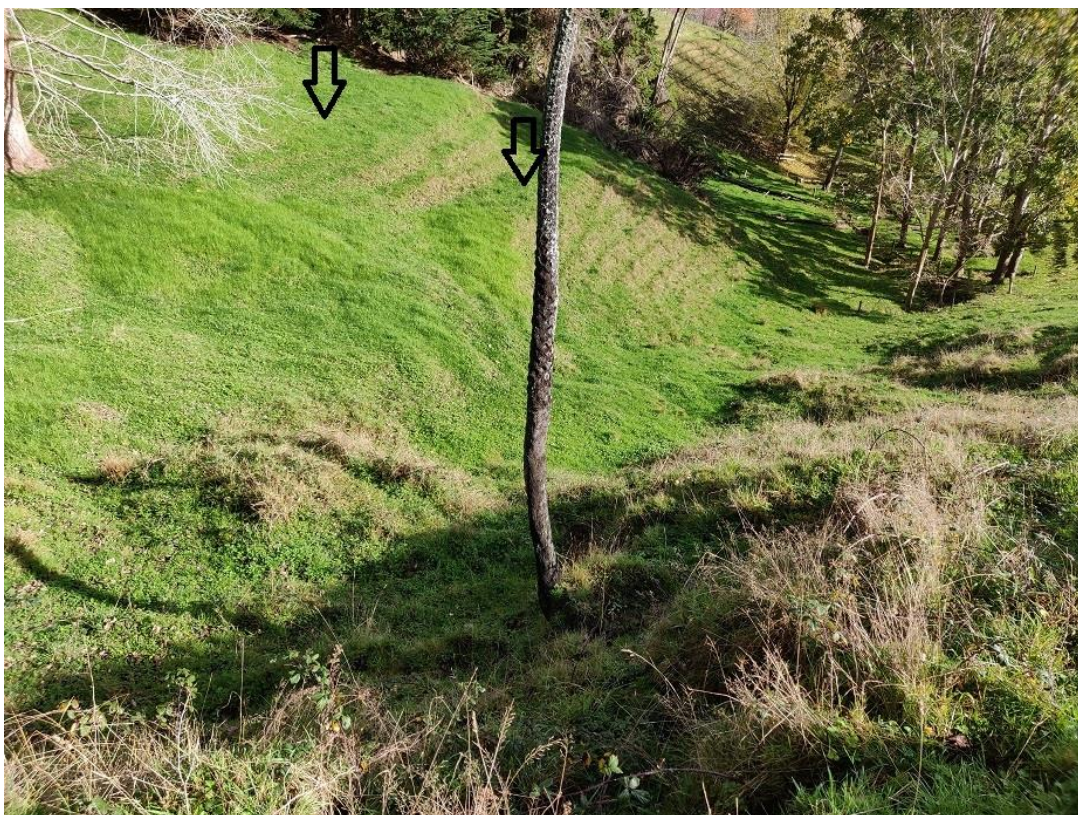
Figure 102. Lower two platforms of the natural terrace complex indicated by black arrows, photo taken standing outside the bedrock enclosure and facing northwest

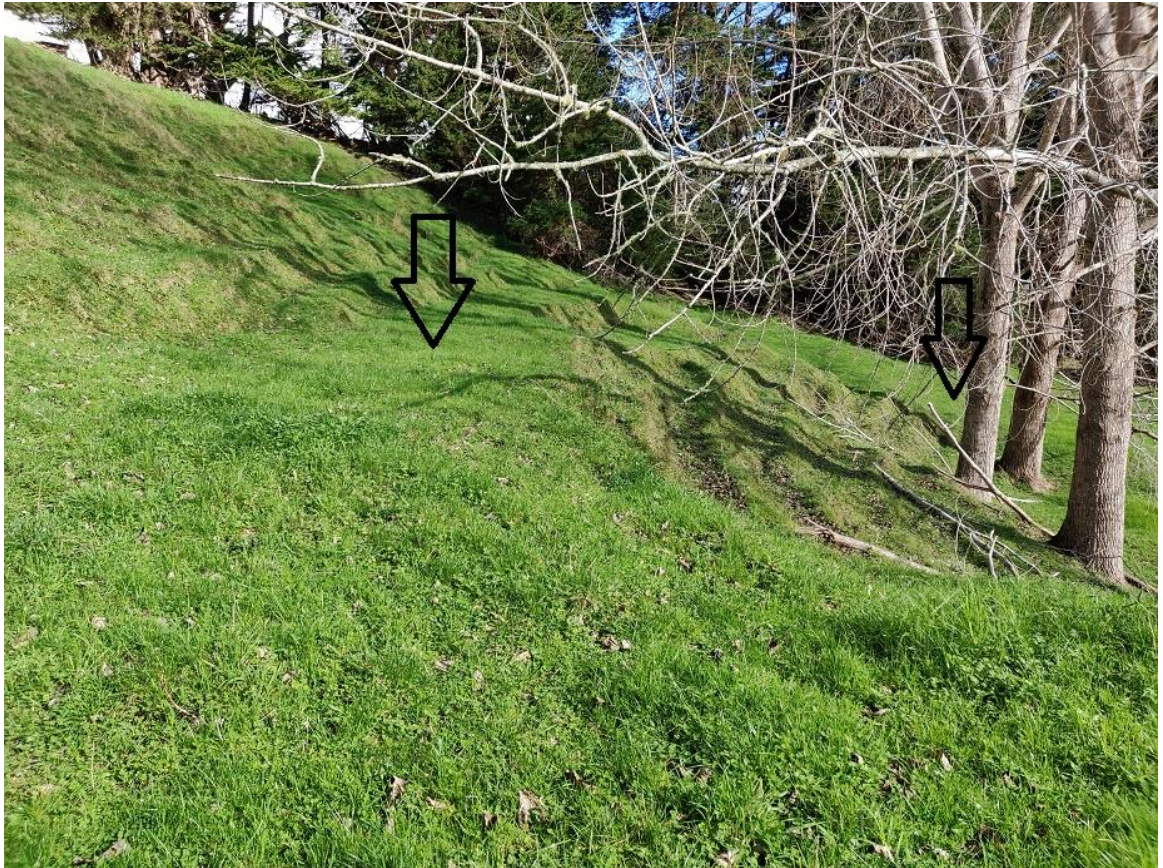
Figure 103. Platform at the level of bedrock enclosure marked by arrow on the left, lower platform marked by arrow on the right, photo taken standing outside the bedrock enclosure and facing west

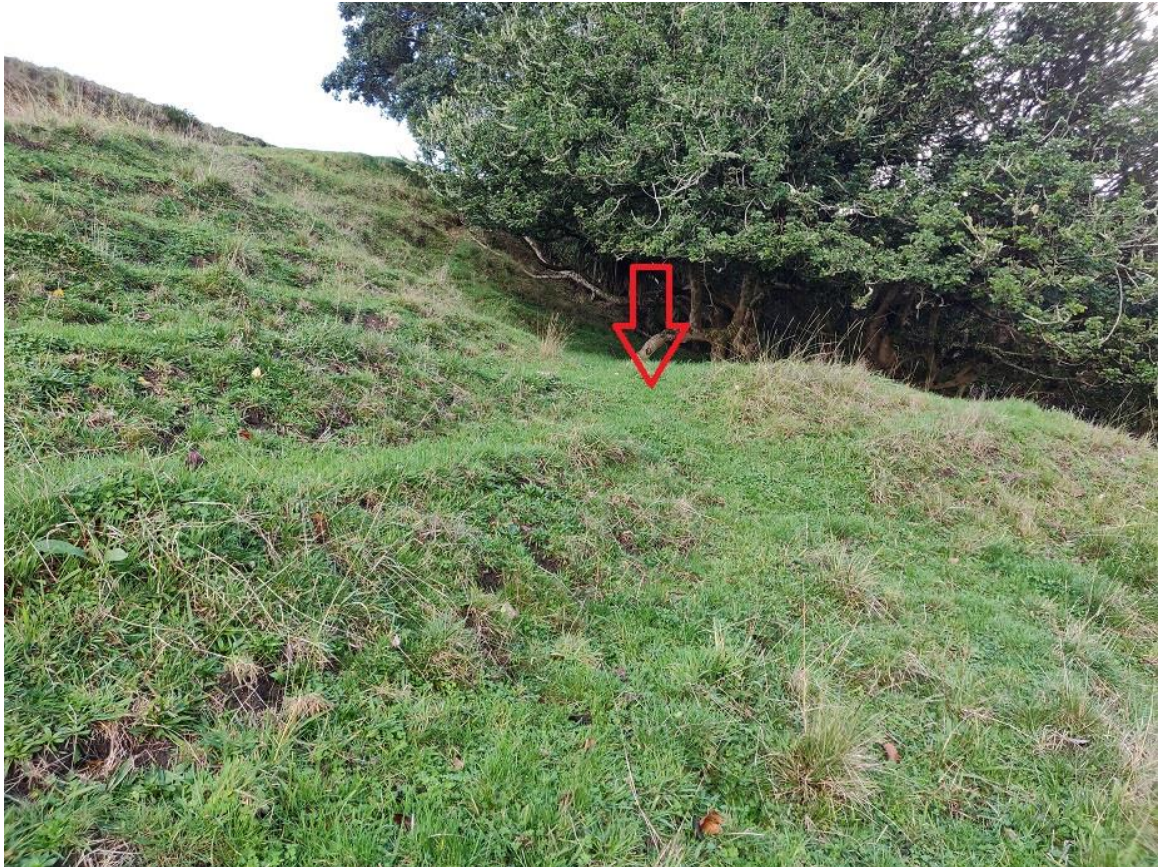
Figure 104. Platform above the bedrock enclosure on its northeast side marked by arrow, facing south

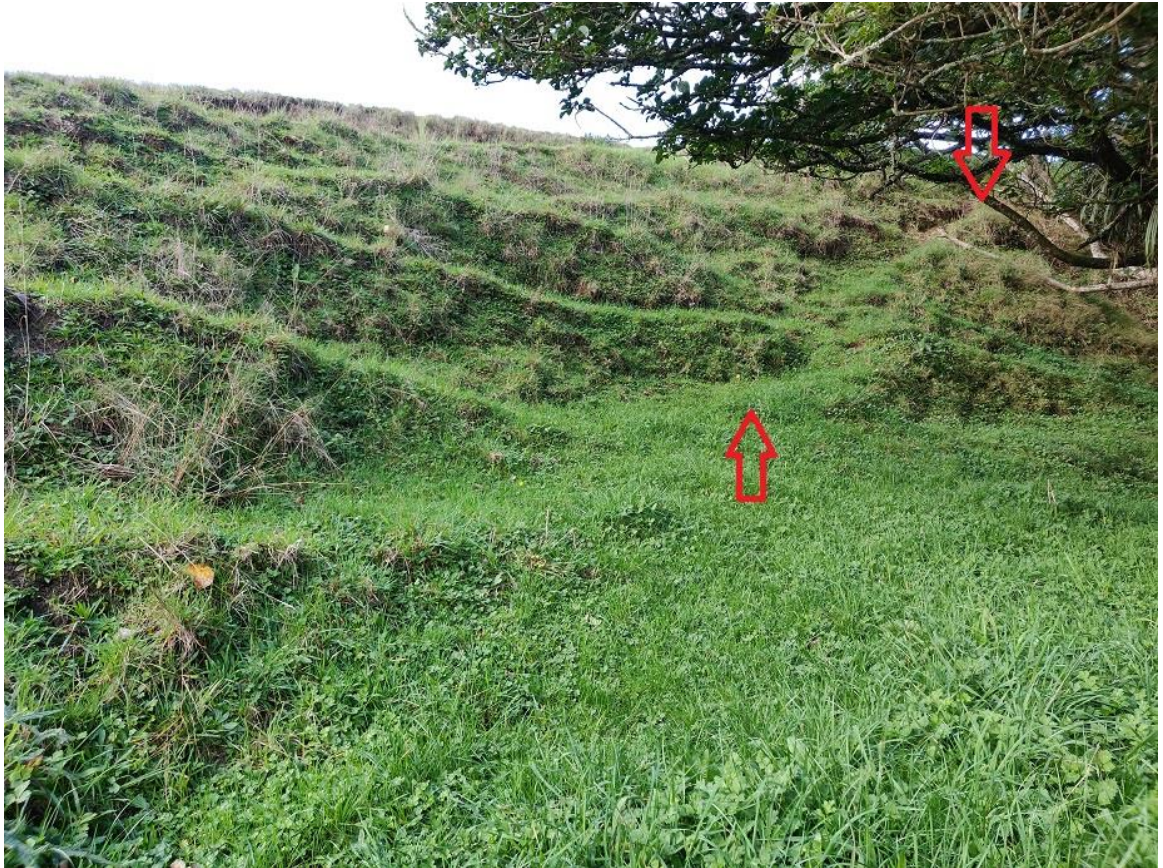
Figure 105. Path cutting through natural terrace-like features marked by arrows, standing on upper platform of terrace complex on the northeast side of bedrock enclosure, facing southeast

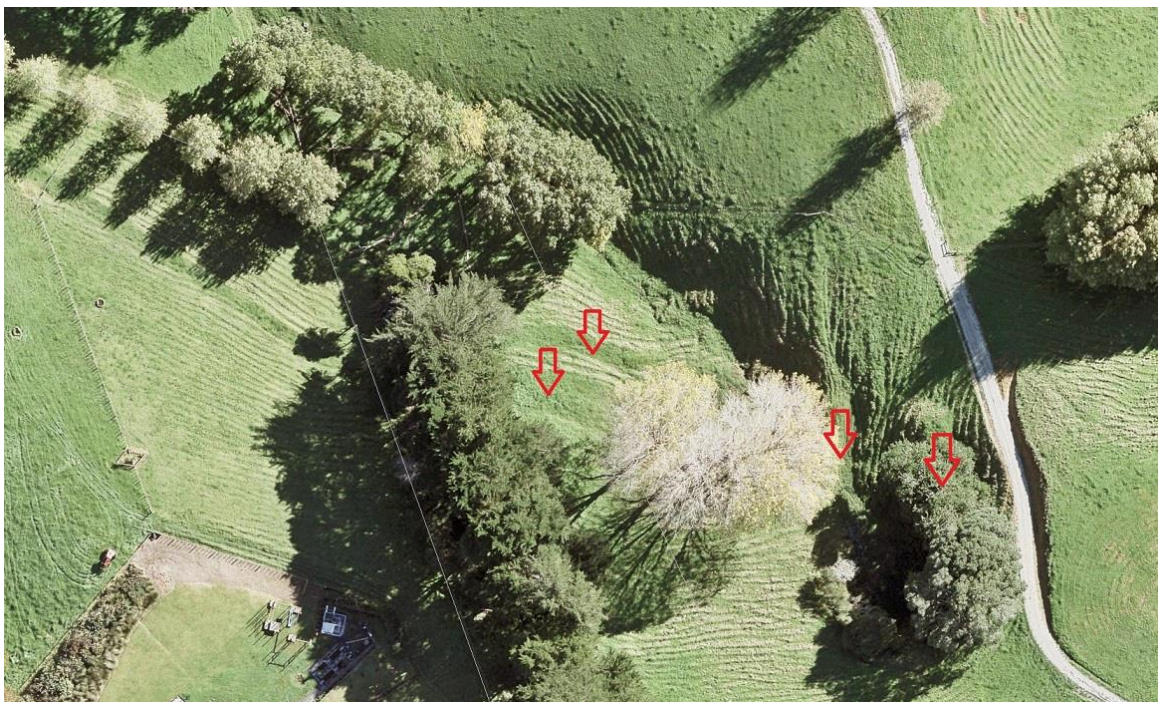
Figure 106. Looking out west towards adjacent property 1648A State Highway 1, where well-defined terrace-like features could be seen from a distance

The complex appears to continue into the neighbouring property at 1648A State Highway 1, where well-defined terrace-like features could be seen from a distance (Figure 106). A modern aerial shows these platforms around the bedrock enclosure and the apparent continuation to the west in the neighbouring property (Figure 107). These features are thought to be the result of a combination of natural slumping of the hillside around the creek, the use of this by cattle and farm machinery.

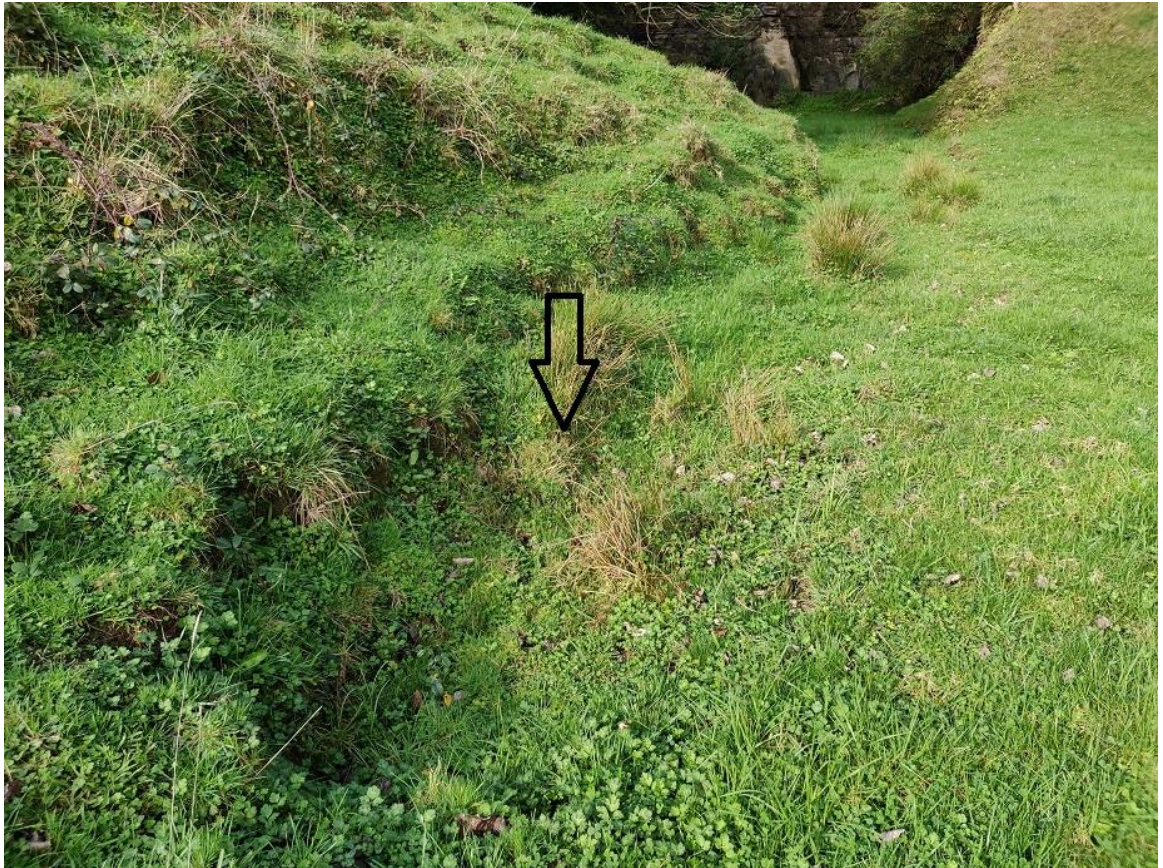
Figure 108. Small channel on the east side of the entrance to the enclosure, facing south

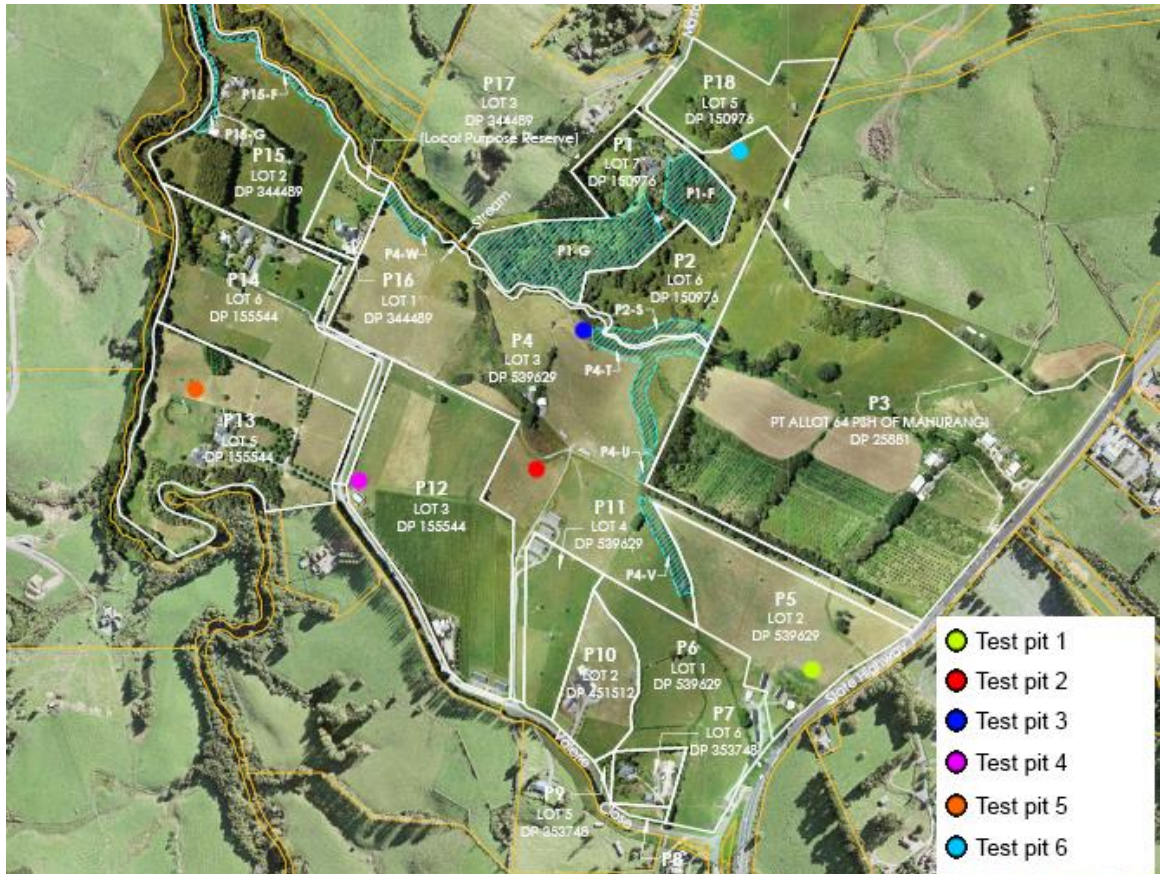
Figure 109. Modern aerial showing the western half of Plan Change Area showing properties and locations of six test pits (source: Modified from client files)

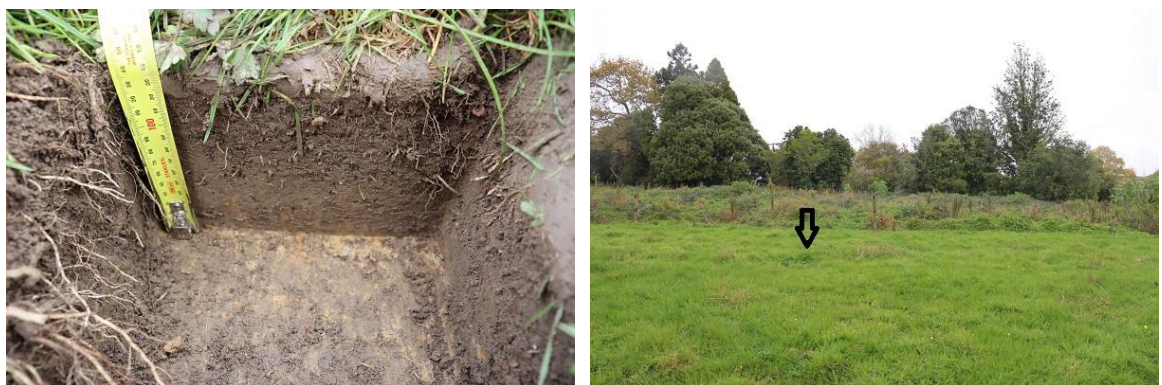
Figure 110. Left: Test pit 1 placed on southeast side of P5. Right: Location of test pit 1 placed on southeast side of P5 indicated by arrow, facing south

The first test pit was placed on the southeast side of P5 (Figure 110) near the peak of the shallow slope that exists here (NZTM coordinates 1747714 5968067 \pm 3m). Probing around this area indicated a soft and relatively shallow topsoil over a relatively soft clay. This test pit was 20cm wide, 20cm long and 15cm deep. The stratigraphy was as follows:

- Layer 1: 7-9cm of a medium-dark brown silty soil, moderately loose with minor root disturbance.
- Layer 2: 5-7cm of a light-medium brown silty soil with high clay content and moderately loose (but more compact than Layer 1). Some clay (layer 3) inclusions in the lower portion of this layer.
- Layer 3: 1cm-base of pit of a light brown-orange clay, moderately compact.

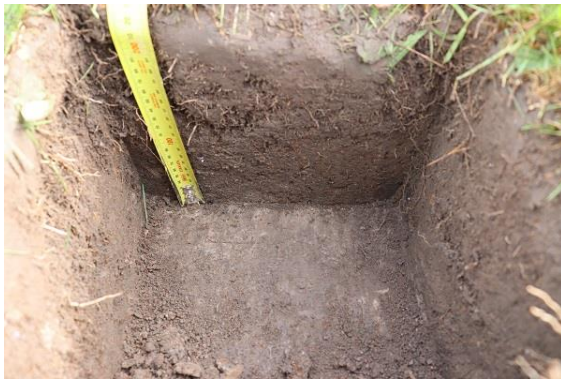
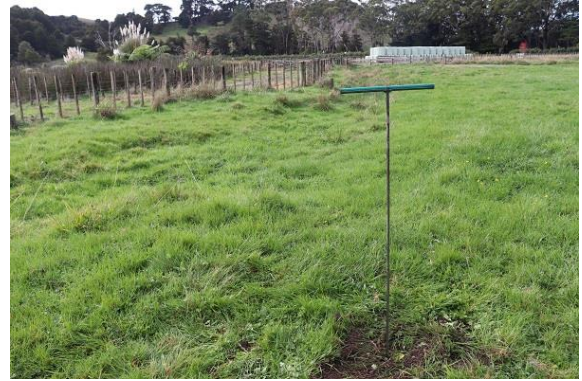
Figure 111. Test pit 2 placed on southwest side of P4. Right: Location of test pit 2 indicated by probe, facing northeast

The second test pit was placed on the southwest side of P4 (Figure 111) adjacent to a small overland flow path/stream that appears to have had some minor modifications for irrigation (NZTM coordinates 1747322 5968371 \pm 3m). Probing around this area indicated a soft topsoil over a relatively soft clay. This test pit was 20cm wide, 20cm long and 23cm deep

- Layer 1: 22cm of a dark brown silty soil, loose with minor root disturbance. The water content in the ground here has had a significant impact on the compaction of this layer making it softer.
- Layer 2: 1cm-base of pit of a light grey clay, moderately compact.

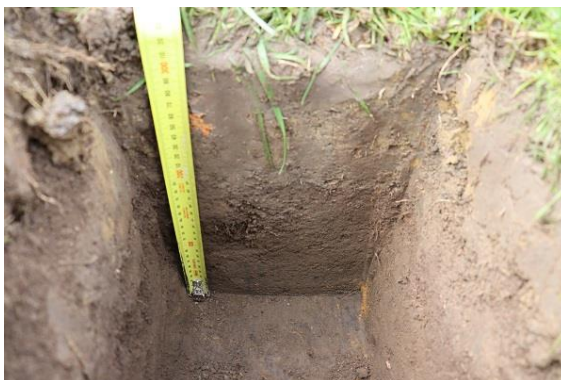
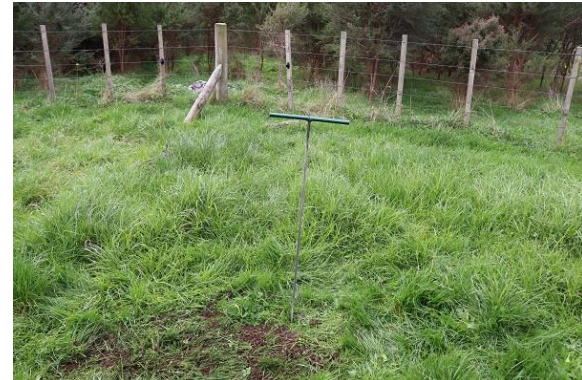
Figure 112. Left: Test pit 3 placed on the north side of P4. Right: Location of test pit 3 indicated by probe, facing north

The third test pit was placed on the north side of P4 (Figure 112) adjacent to the stream along the northern border and P4-T (NZTM coordinates 1747403 5968574 \pm 3m). The test pit was placed several metres away from a large pile of concrete blocks, rubble and metal framing. The test pit showed a significant amount of disturbance that may be related to a structure that once existed here or within the immediate area. This test pit was 20cm wide, 20cm long and 33cm deep and was dug to examine the stratigraphy adjacent to the stream here. Probing around this area indicated a relatively soft topsoil and could not seem to locate the depth of a natural clay layer. The stratigraphy was as follows:

- Layer 1: 33cm+ of a disturbed medium brown silty soil with high clay content. Moderately loose with numerous clay inclusions/deposits and specks of charcoal-stained soil indicative of vegetation clearance. Natural clay layer was not reached.

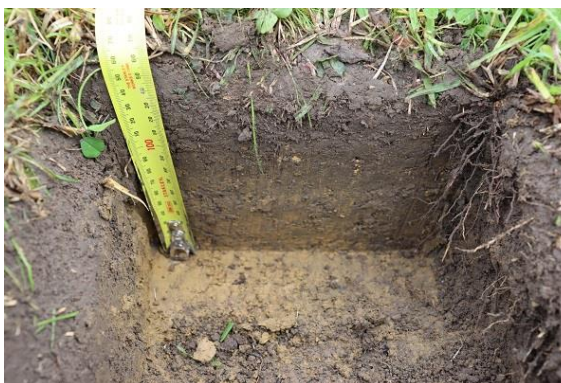
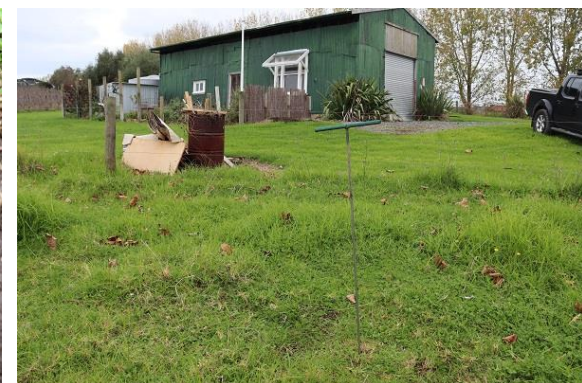
Figure 113. Left: Test pit 4 placed on the central west side of P12. Right: Location of test pit 4 indicated by probe, facing south/southeast

The fourth test pit was placed on the central western side of P12 (Figure 113) adjacent to the western border (NZTM 1747045 5968352 \pm 3m). Probing around this area indicated a soft and relatively shallow topsoil over a relatively soft clay. This test pit was 20cm wide, 20cm long and 16cm deep and was dug to examine the stratigraphy of the general area. The stratigraphy here was very similar to the stratigraphy seen in the first test pit in P5, and was as follows:

- Layer 1: 6cm of a medium-dark brown silty soil, moderately loose with minor root disturbance.
- Layer 2: 9cm of a light-medium brown silty soil with high clay content and moderately loose (but more compact than Layer 1). Significant clay (layer 3) inclusions in the lower portion of this layer that progressively increases in amount as it approaches the clay (layer 3).
- Layer 3: 1cm-base of pit of a light brown-orange clay, moderately compact.

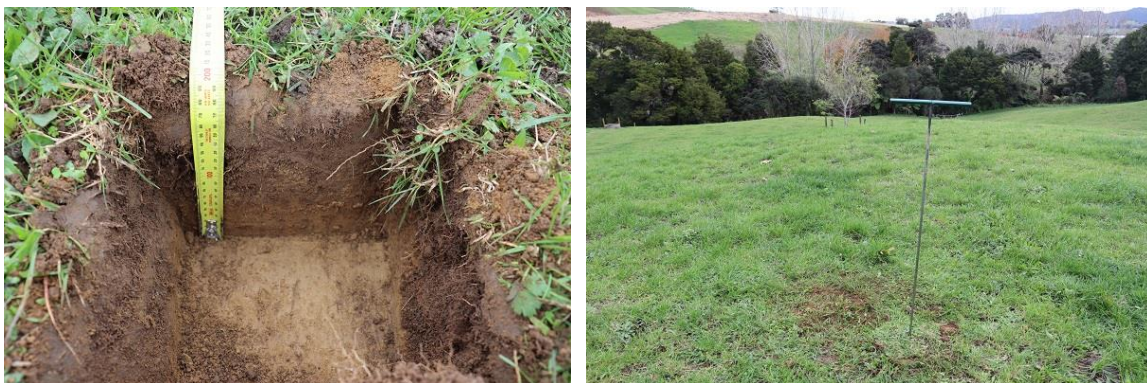
Figure 114. Left: Test pit 5 placed on the northwest side of property P13. Right: Location of test pit 5 indicated by probe, facing northwest

The fifth test pit was placed the top of a small hill on the northwest side of property P13 (Figure 114) in the northwest field (NZTM coordinates 1746820 5968496 \pm 3m). Probing around this area indicated a relatively shallow topsoil over a relatively compact clay. This test pit was 20cm wide, 20cm long and 19cm deep and was dug to examine the stratigraphy in the general area. The stratigraphy was as follows:

- Layer 1: 11cm of a medium brown-grey silty soil, moderately loose with minor root disturbance.
- Layer 2: 7cm of a light brown/orange silty soil with high clay content, moderately loose. Similar in colour to clay (layer 3) but significantly different texture.
- Layer 3: 1cm-base of pit of a light brown/orange clay, moderately compact.

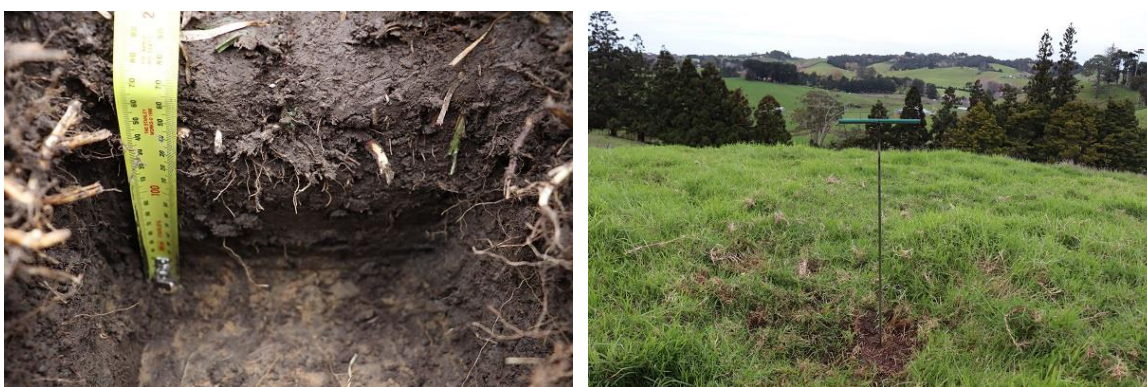
Figure 115. Left: Test pit 6 placed on the northeast side of P2. Right: Location of test pit 6 indicated by probe, facing southeast

- Layer 1: 19cm of a dark brown loam, moderately loose but compacted in the upper portion of this layer with significant root disturbance.
- Layer 2: 1cm-base of pit of a light brown/orange compact clay.

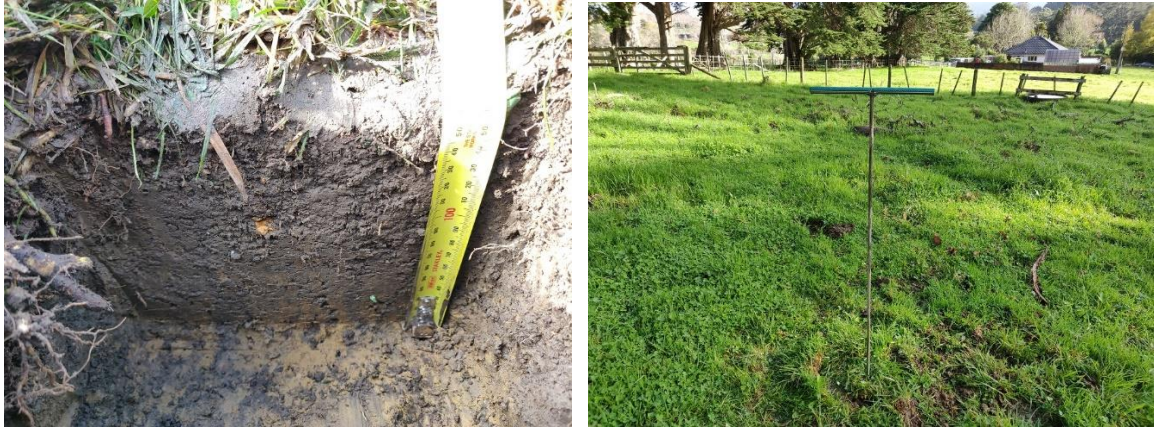
Figure 116. Left: Test Pit 1 on northwest side of the property, just to the northwest of where the recently removed barn/shed was located. Top right: Location of test pit marked by probe, facing northwest

The second survey focussed on the property on the eastern side of State Highway 1. The first test pit was placed on the northwest side of the property (Figure 116), just to the northwest of where the recently removed barn/shed was located (NZTM coordinates 1747787 5967846 \pm 3m). Probing around this area indicated a relatively soft and shallow topsoil over a moderately compact clay. The test pit was 20cm long, 20cm wide and 17cm deep. The stratigraphy was as follows:

- Layer 1: 8cm of a medium brown/grey loam, loose with significant root disturbance.
- Layer 2: 8cm of a medium brown loam with high clay content, moderately loose.
- Layer 3: 1cm-base of pit of a light brown/orange clay, moderately compact.

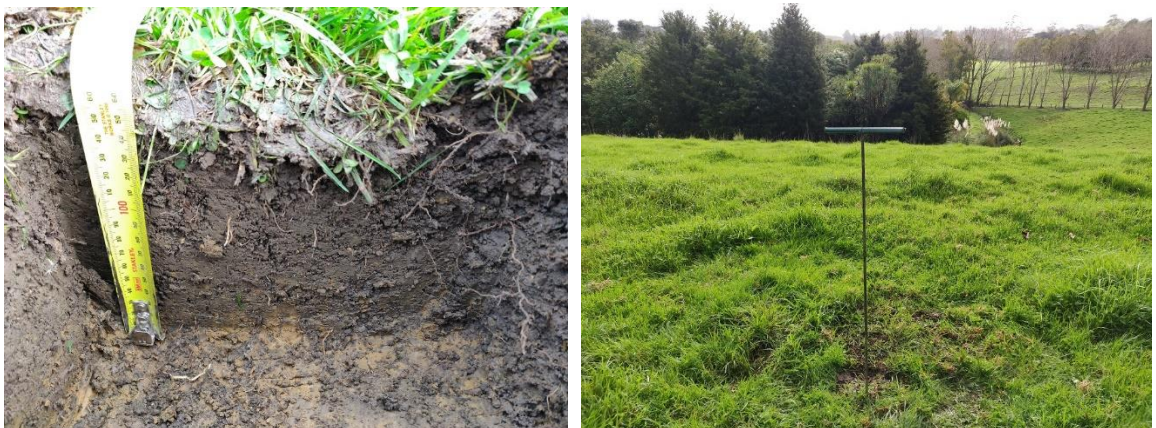
Figure 117. Left: Test Pit 2 on the ridge/hill to the southwest of the dwelling, adjacent to a branch of the central stream that runs along the southern border of the dwelling. Right: Location of test pit marked by probe, facing northeast

- Layer 1: 9cm of a medium brown/grey loam, loose with minor root disturbance.
- Layer 2: 7cm of a medium brown loam with high clay content, moderately loose.
- Layer 3: 1cm-base of pit of a light brown/orange clay, moderately compact.

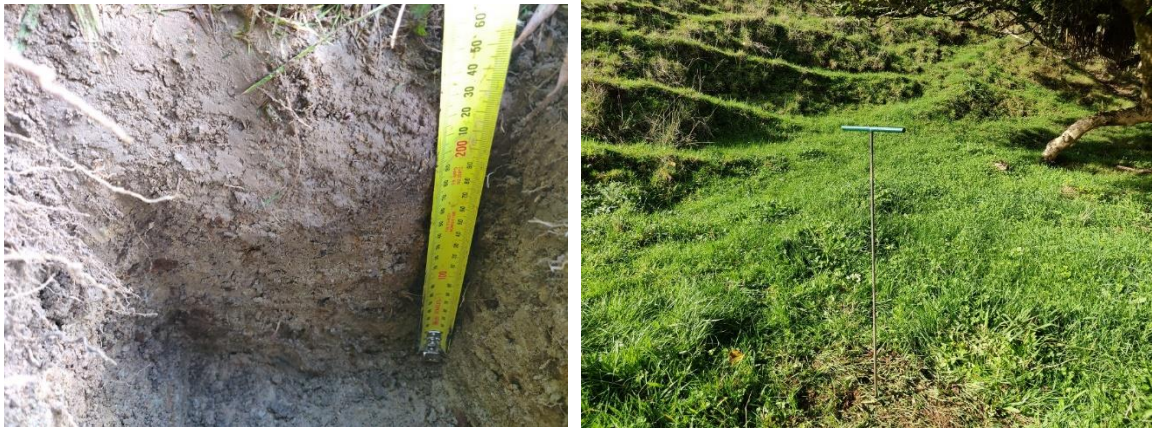
Figure 118. Left: Test Pit 3 on the southwest side of the property adjacent to the bedrock enclosure, on the fourth platform of a potential terrace complex. Right: Location of test pit marked by probe, facing southeast

- Layer 1: 26cm+ of a light brown sandy/silty soil, loose with minor root disturbance up to approximately 20cm below the surface. Iron pan or compacted sediment inclusions began to occur at a depth of approximately 15cm below the surface to the base of pit. Inclusions/small deposits of a darker grey silty soil began to occur in small amounts at a depth of approximately 7cm below the surface, and then more significantly at a depth of 20cm below the surface to the base of pit. No natural clay layer was reached and probing in the test pit could not discern whether a natural clay layer existed at a deeper depth.

The strata seen in all test pits, except for Test Pit 3, showed that Layer 1, being a loose medium brown/grey loam, appears to be consistent throughout much of the property. Layer 2 also seems to be consistent, this being a medium brown loam with high clay content, although this was not seen in Test Pits 3 and 5. The different strata seen in Test Pit 3 may indicate past modification in the immediate area.

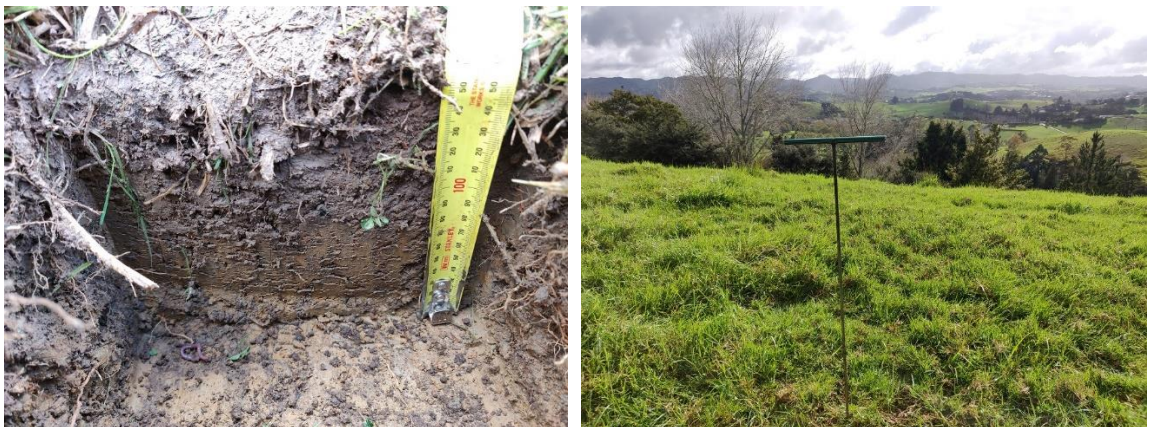
Figure 119. Left: Test pit 4 on the southeast side of the property, on the top of the long hill that covers the southern border of the property. Right: Location of test pit marked by probe, facing north/northwest

An area of potential terracing was noted on the southwest side of the property at 1738 SH1, This was situated surrounding the southwest stream. The potential terrace complex is located on the north side of the large, long hill that covers the southern border of the property (see location of Test Pit 3 and adjacent stream/valley in Figure 100). A modern track (c.1990s) has been cut into the northern side of the hill providing access to the top of the hill (Figure 101). The complex is on the west side of the track and consists of well-defined natural terrace-like features which appear to have been modified in certain areas, creating wide level platforms that surround the bedrock enclosure, stream and valley; particularly on the west side of the enclosure. The complex appears to have four main platforms; one at the level of the bedrock enclosure on its north and west sides, two below the level of the enclosure on its west side and a smaller fourth platform above the enclosure on its northeast side (Figure 102–Figure 105). A distinct path can also be seen leading from this fourth platform up the slope of the hill cutting through natural well-defined terrace-like features (see Figure 105). This path is an old cattle path, which is very defined in aerial photographs from the 1960s and appears to have been the main east-west track across the farm. A test pit placed on the fourth platform suggests modification as the stratigraphy here is significantly different to the strata seen elsewhere on the property and appears to be disturbed. Looking at the stratigraphy seen in the test pit (Figure 120) and the stratigraphy seen in a hill cut several metres to the east (Figure 121) we can see that the topsoil layer

appears to be missing on this upper platform. The Layer 1 described for this test pit (Test pit 4) appears to be similar to Layers 3 and 4 described for the track cut strata seen on the hill.

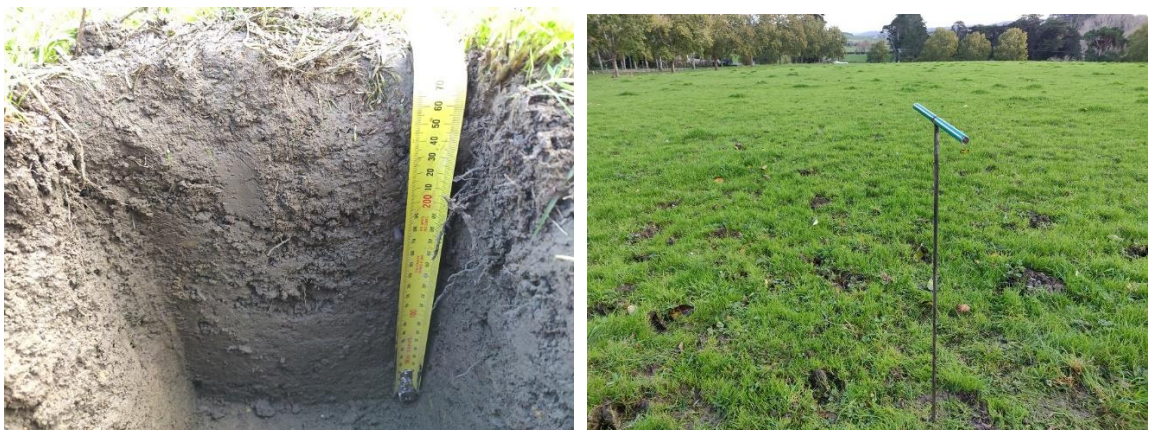
Figure 120. Left: Test pit 5 on the north/northeast side of the property on the southern end of one of the road-facing fields. Right: Location of test pit marked by probe, facing northwest

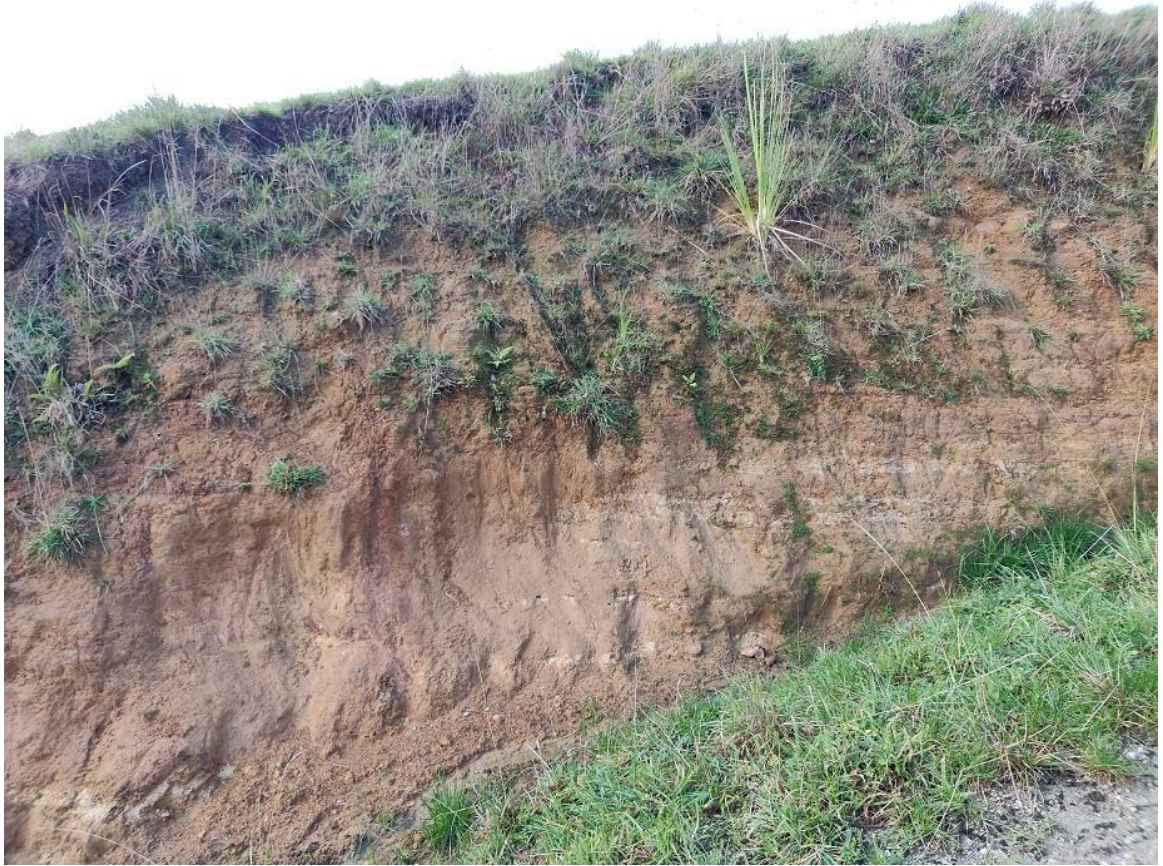
Figure 121. Profile of hill from track cut into hill. Note the stratigraphy here. Facing east
