**TE TUPU NGĀTAHI**  
SUPPORTING GROWTH

# North West Redhills Riverhead Assessment of Effects on Heritage / Archaeology

December 2022

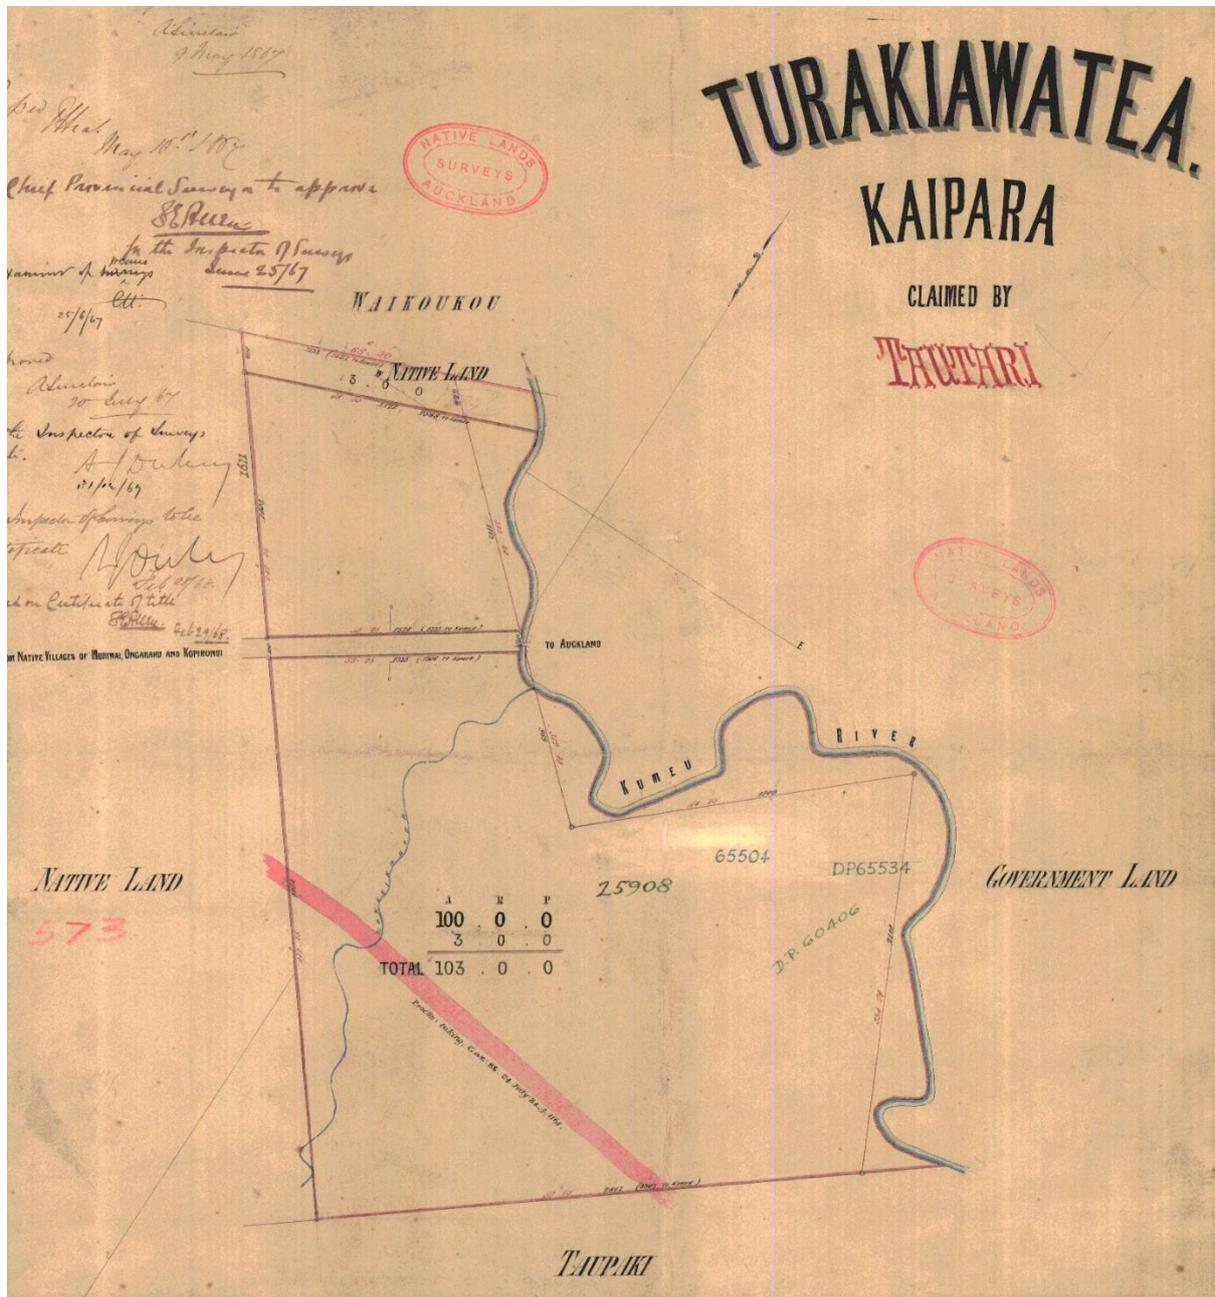
Figure 4-3: Detail of ML533, 1867, shows an area of a Maori claim along the stream called Turakiawatea. The red line indicates the area taken for the railway. This includes the area of Kumeū. It seems possible that one of the pre-Contact settlements was located within the area.

One of the first visits by a European to the area was by Samuel Marsden in 1820 who reported that plenty of food was around the Kaipara. Ngāti Whātua settlements near Kumeū are reported for this period (Dunsford 2002; Stone 2001). A land claim map from 1867 might indicate one of the areas of settlement (see figure below).

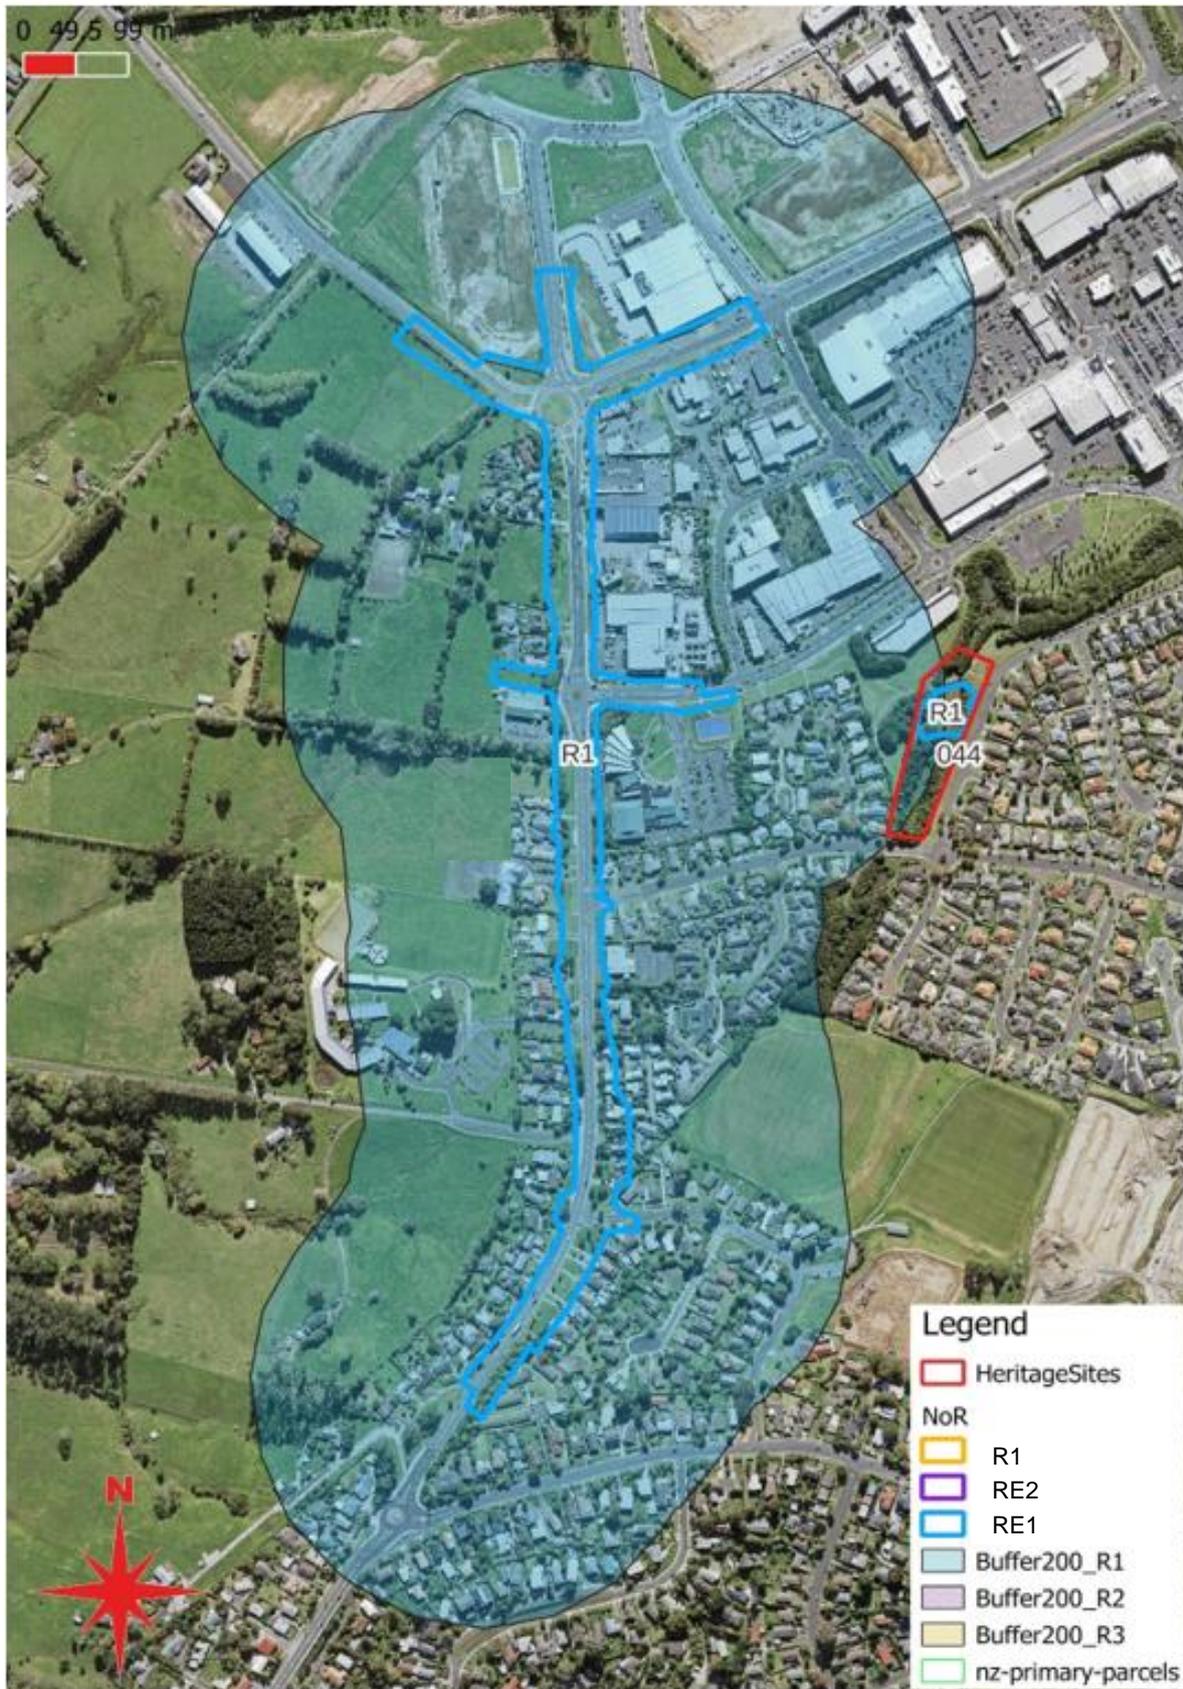
Figure 6-2: NoR RE1. The risk area around the stream is shown as 044. The picture also shows the 200 m buffer zone around the NoR of the road.

Within NoR RE1 and the 200 m buffer zone no archaeological sites are recorded. No notable trees are recorded in this part of the study area, nor are any historic overlays, structures or buildings recorded in the AUP:OP or the CHI.

The only heritage item within the study area of NoR RE1 is a possible risk zone whereas yet unrecorded archaeological features may be encountered around a small stream / wetland identified above. However, the site visit and the comparison of the modern aerial to the 1940 aerial shows that major modifications of the stream and surrounding the stream have taken place. It is therefore less likely that any intact archaeology would have survived those modifications.

It is recommended that all areas of earthworks or topsoil stripping undertaken during construction are included in the Accidental Discovery Protocol.

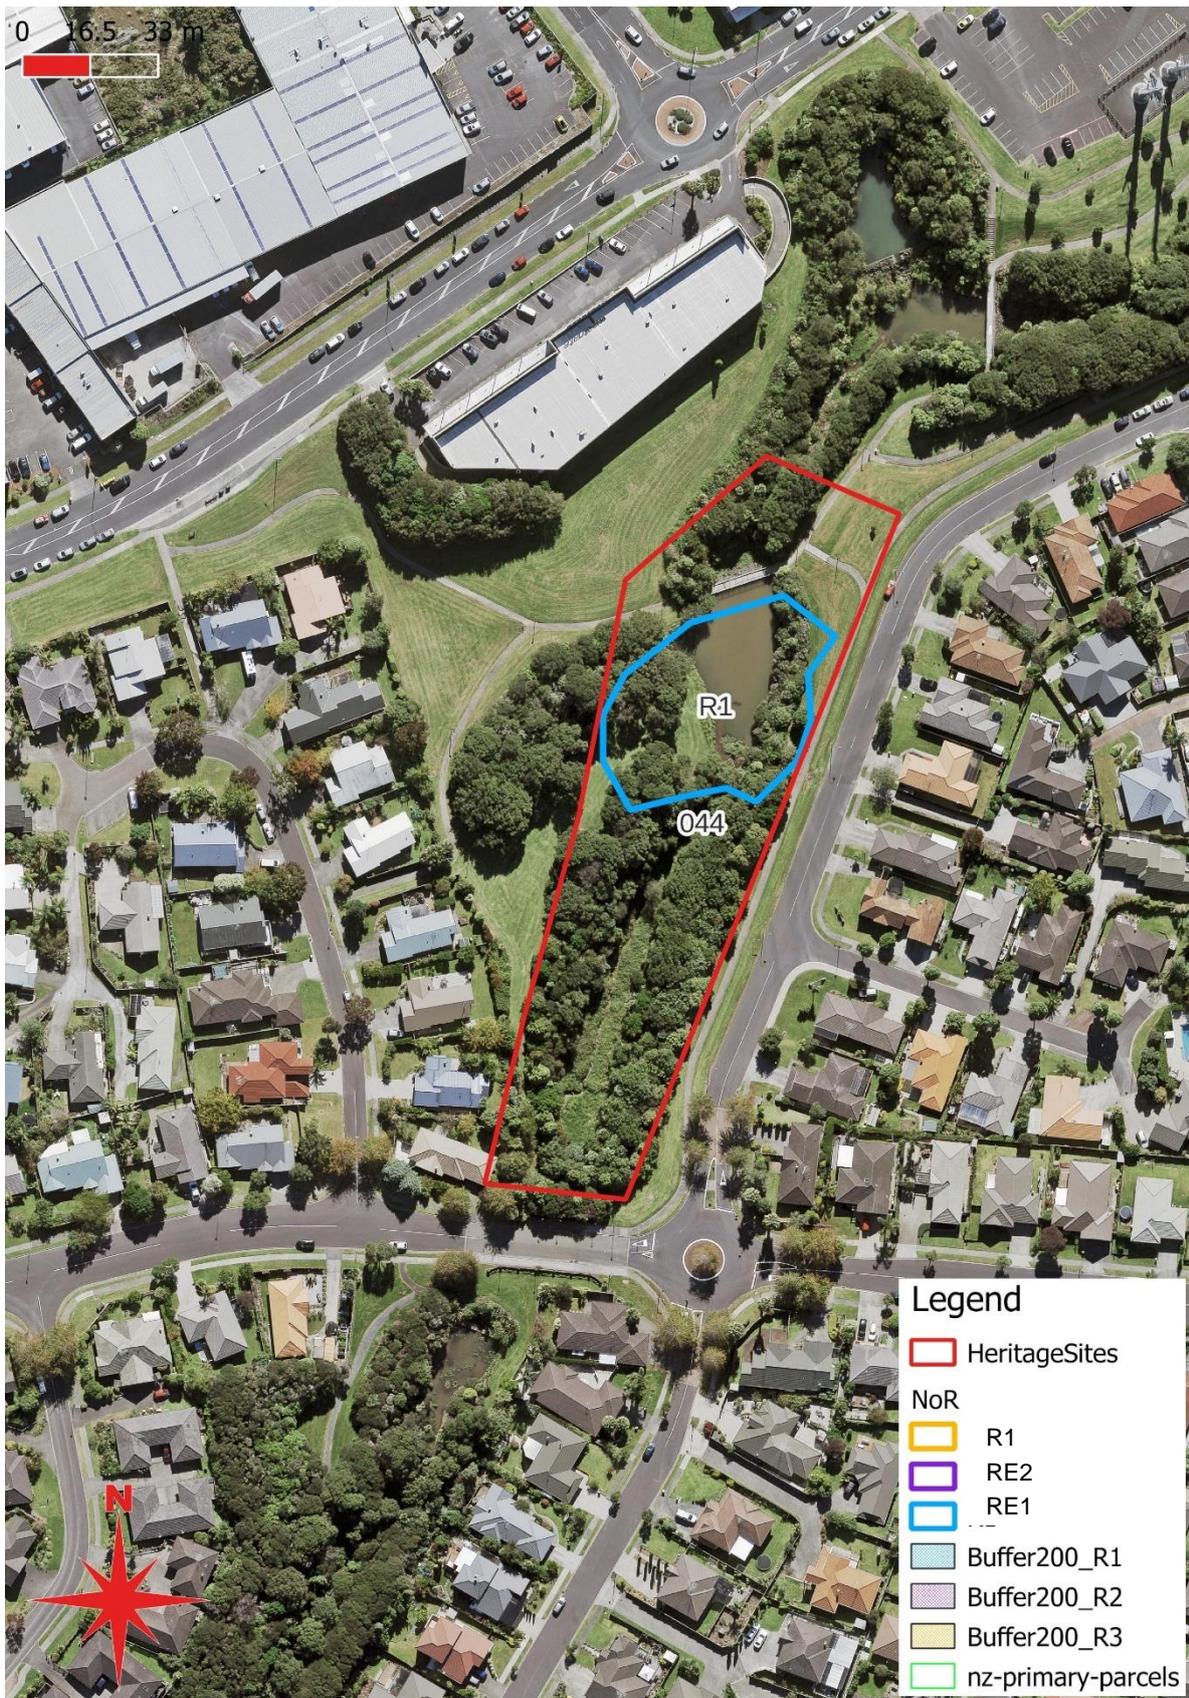
Figure 6-3: Risk area 044 overlaid onto a modern aerial.

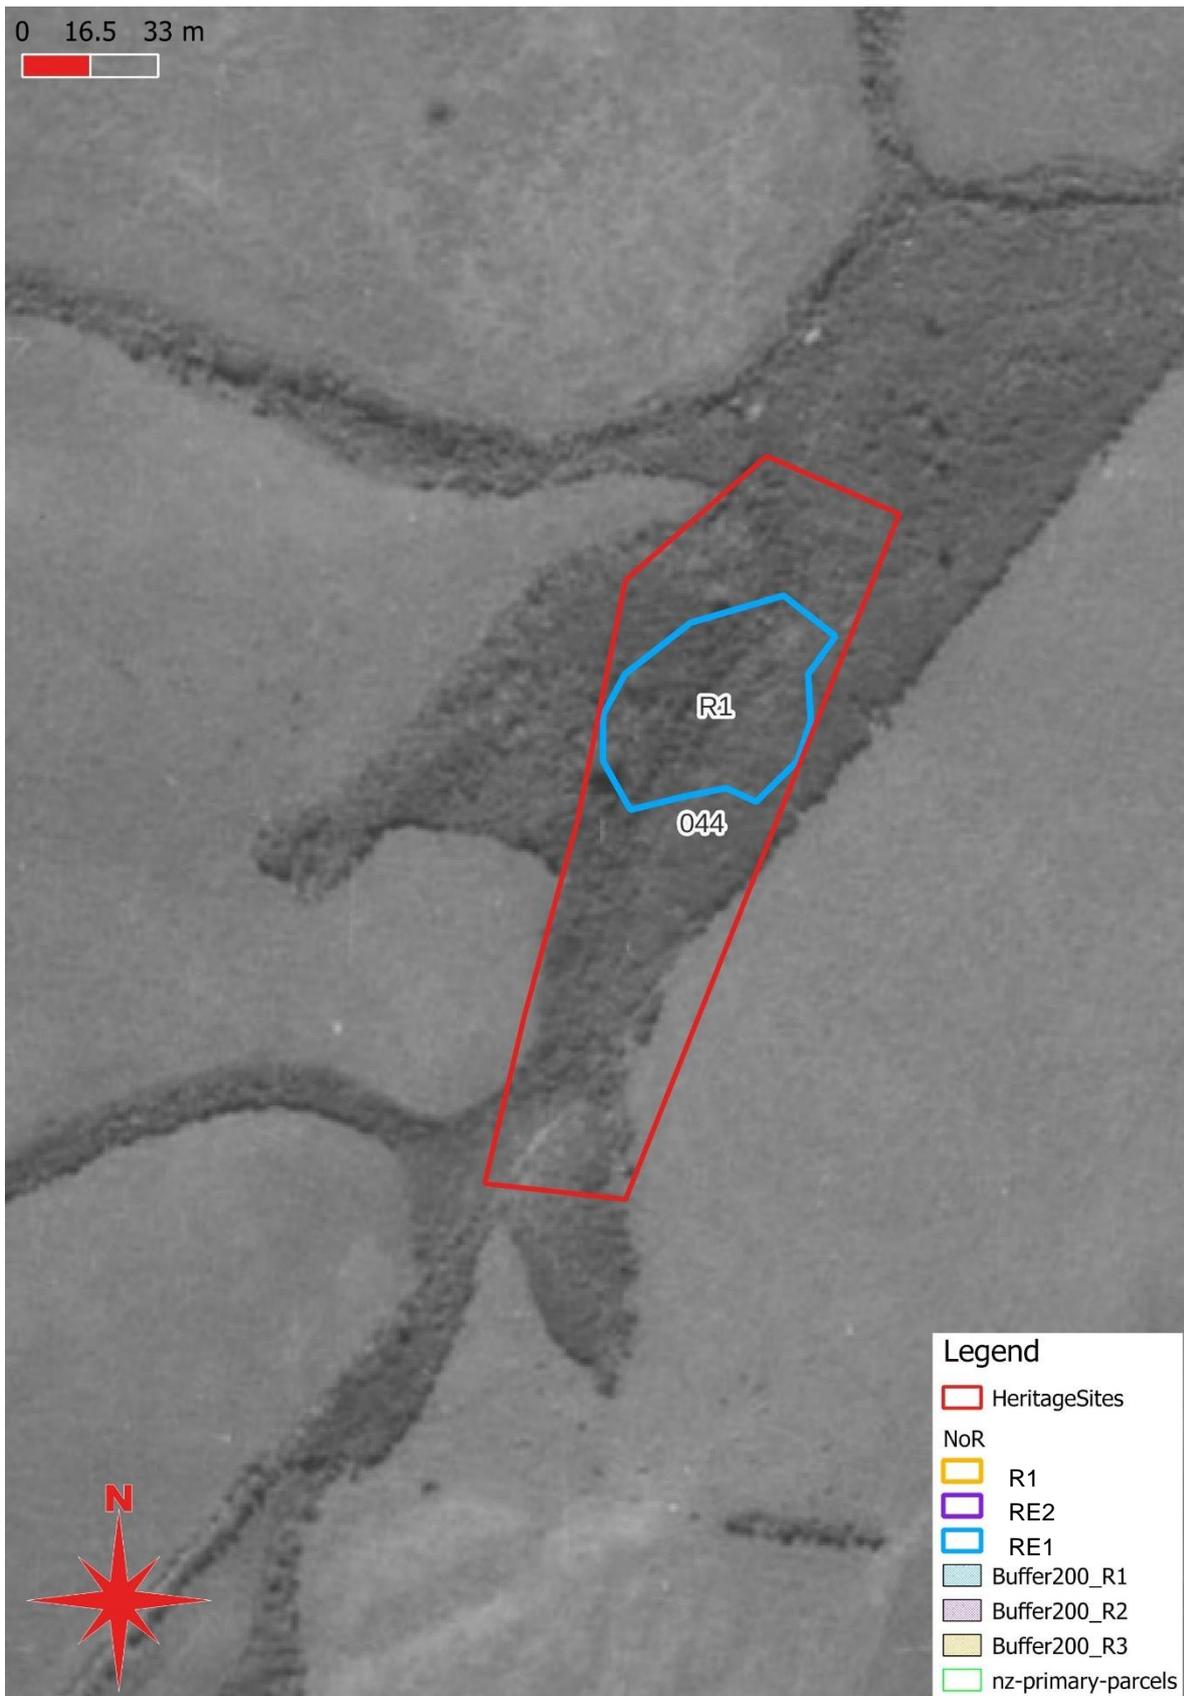
Figure 6-4: Risk area 044 overlaid onto the 1940 aerial. It shows a largely unmodified wetland and small stream surrounded by grazing fields.

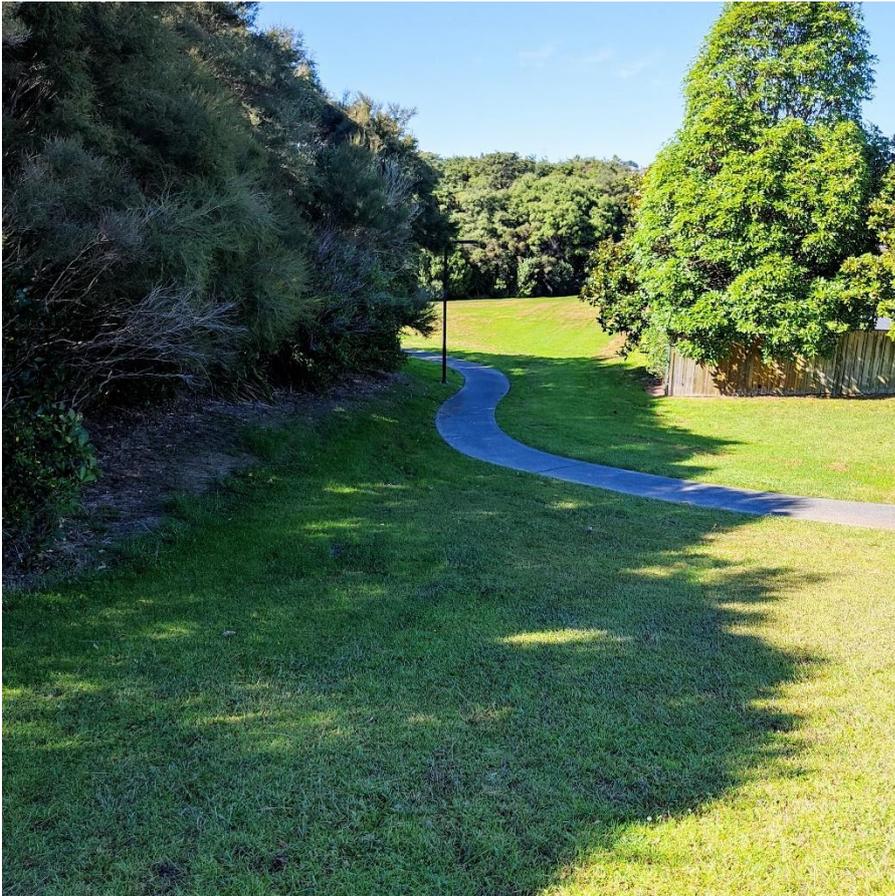
Figure 6-5: View onto largely modified park area looking towards risk area 044. It shows the highly modified nature of the modern environment.

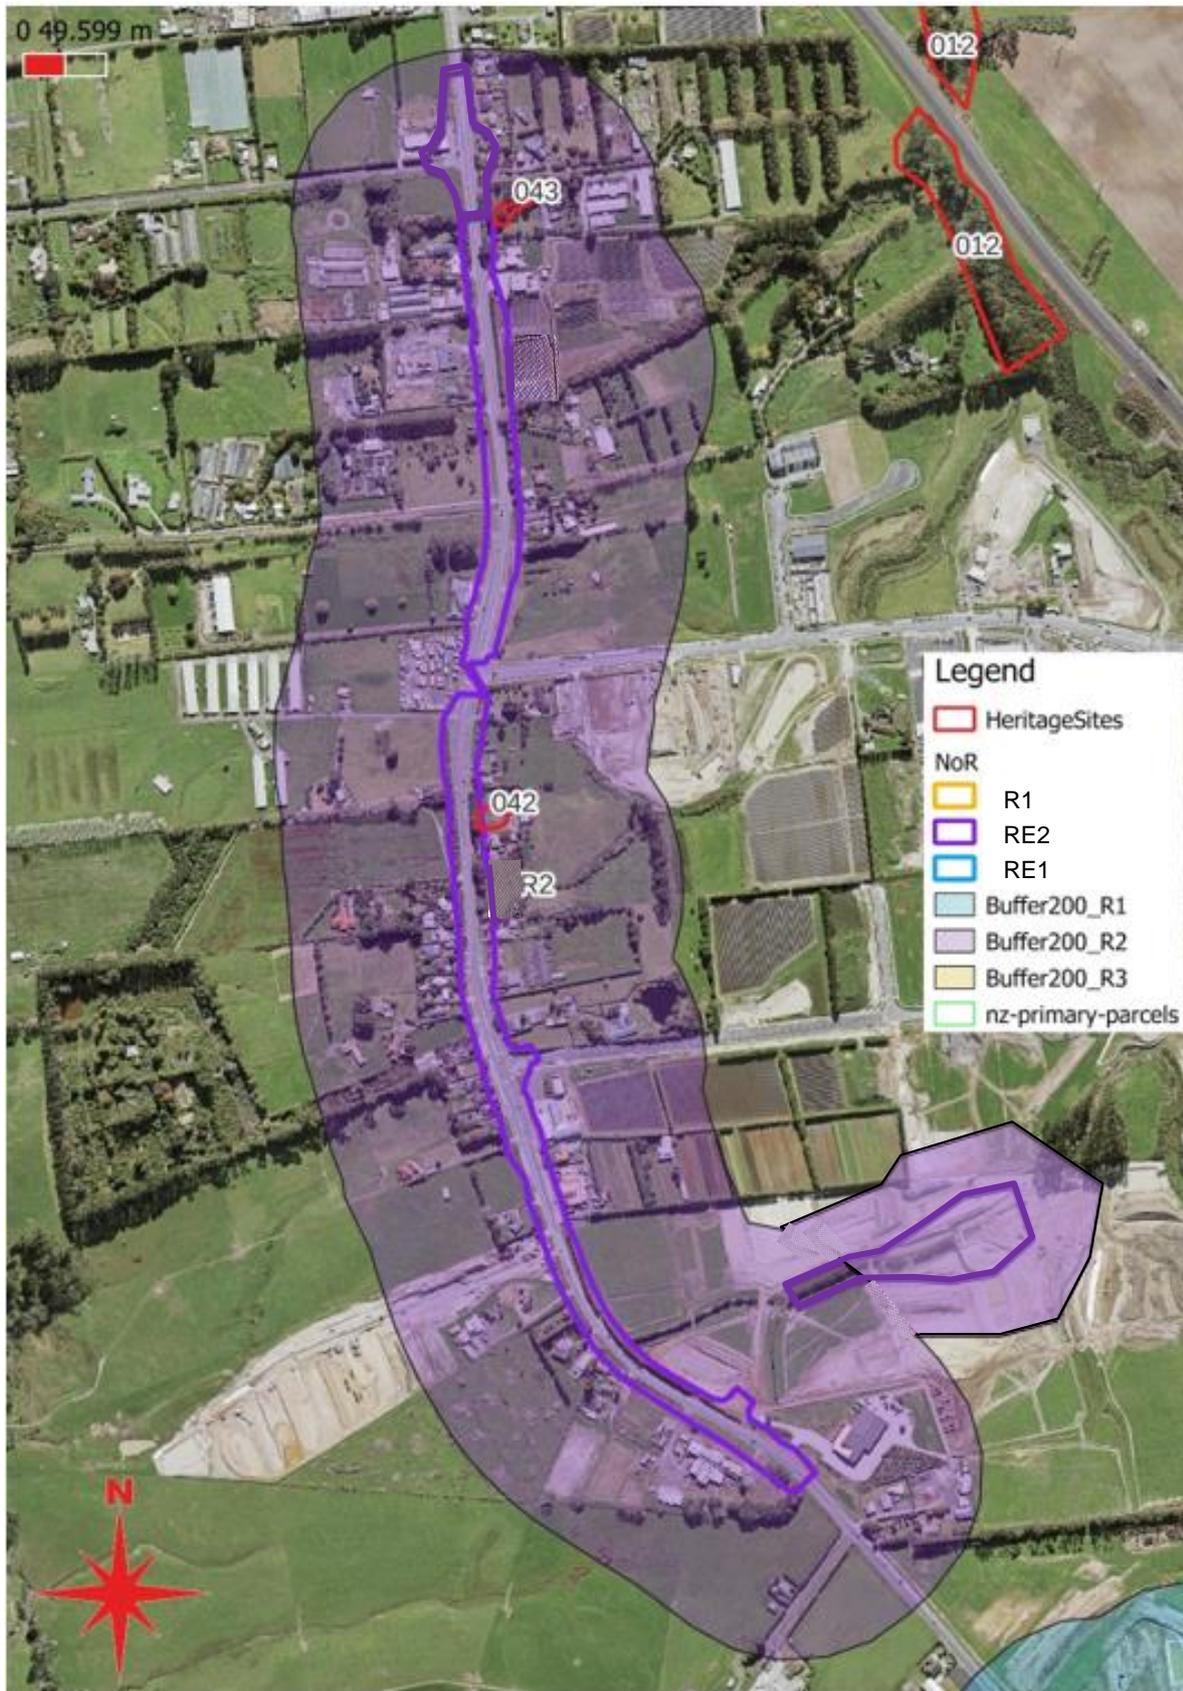
Figure 7-2: NoR RE2 and 200 m buffer zone. The figure also shows two trees (043) recorded in the CHI and one archaeological site (042).

Within NoR RE2 and the 200 m buffer zone one archaeological site (042) is recorded (R11/3097; CHI#20445). No notable trees are recorded in this part of the study area, nor are there any historic overlays, structure or buildings recorded in the AUP:OP. Two trees (043) are recorded in the CHI (#2164 and 2165).

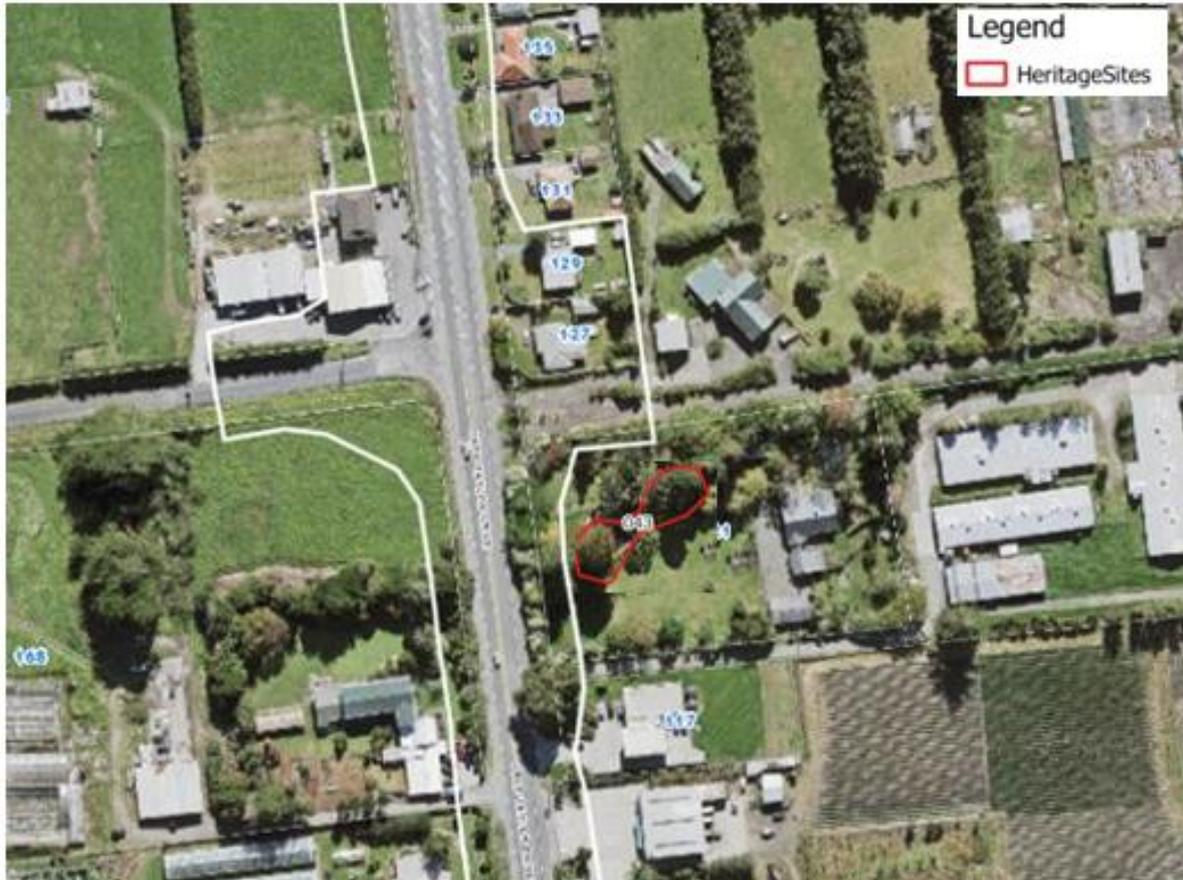
Figure 7-3: Two trees recorded as CHI 2164 and 2165. They are not on the notable tree list of the AUP:OP.

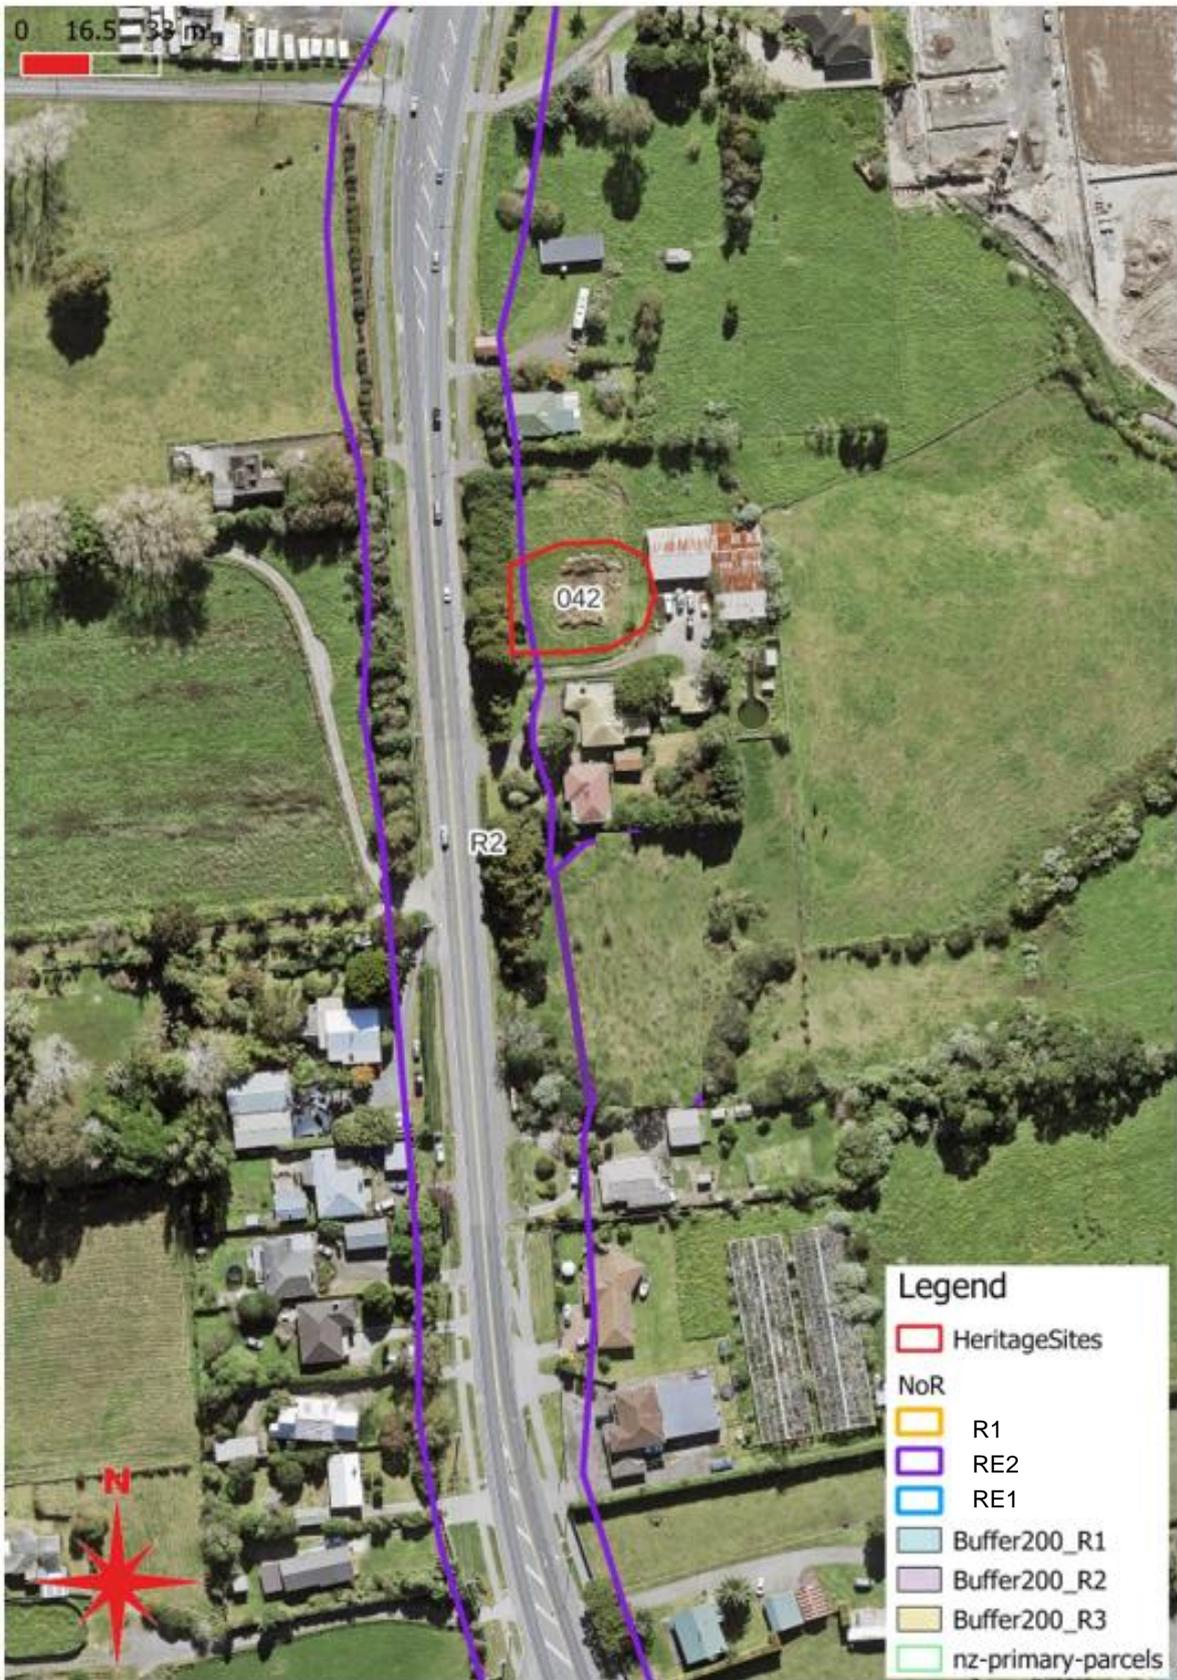
Fragmented human remains of the 11 crew and passengers could be possibly found along the entire debris field.

Overall there is little risk to encounter any cultural heritage or archaeology within or close to the NoR RE2, apart from the risk to encounter a small part of the debris field of the B17 crash site which could include fragmented human remains. Despite the clean-up efforts at the time, due to the nature of the crash it is possible not all human remains were found and collected.

Figure 7-4: Recorded crash site of a B17 bomber (042).

The footprint of the recorded archaeological site R11/3097 could possibly extend into NoR RE2. To mitigate this potential adverse effect, it is recommended that a precautionary archaeological authority is obtained to record any element of the crash site including potentially fragmented human remains that might be discovered in NoR RE2.

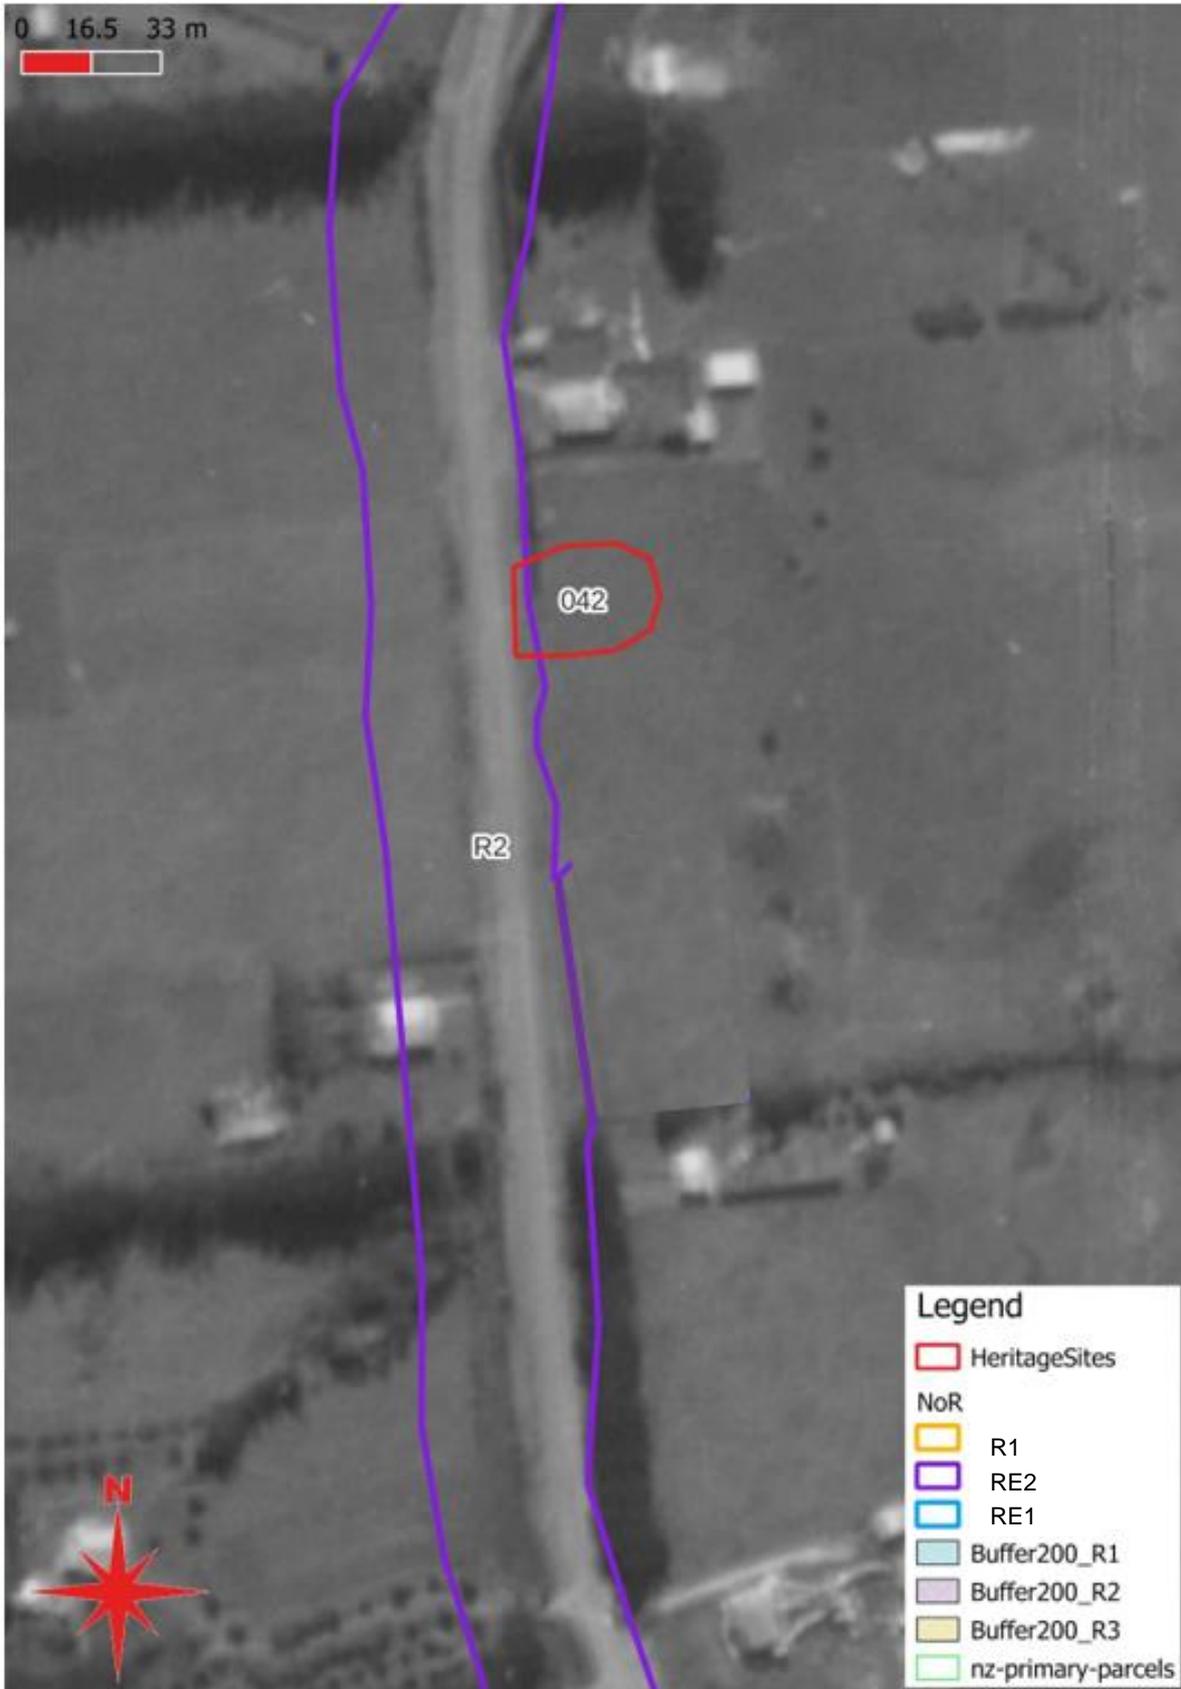
Figure 7-5: Crash site overlaid onto 1940 aerial, two years before the crash occurred.

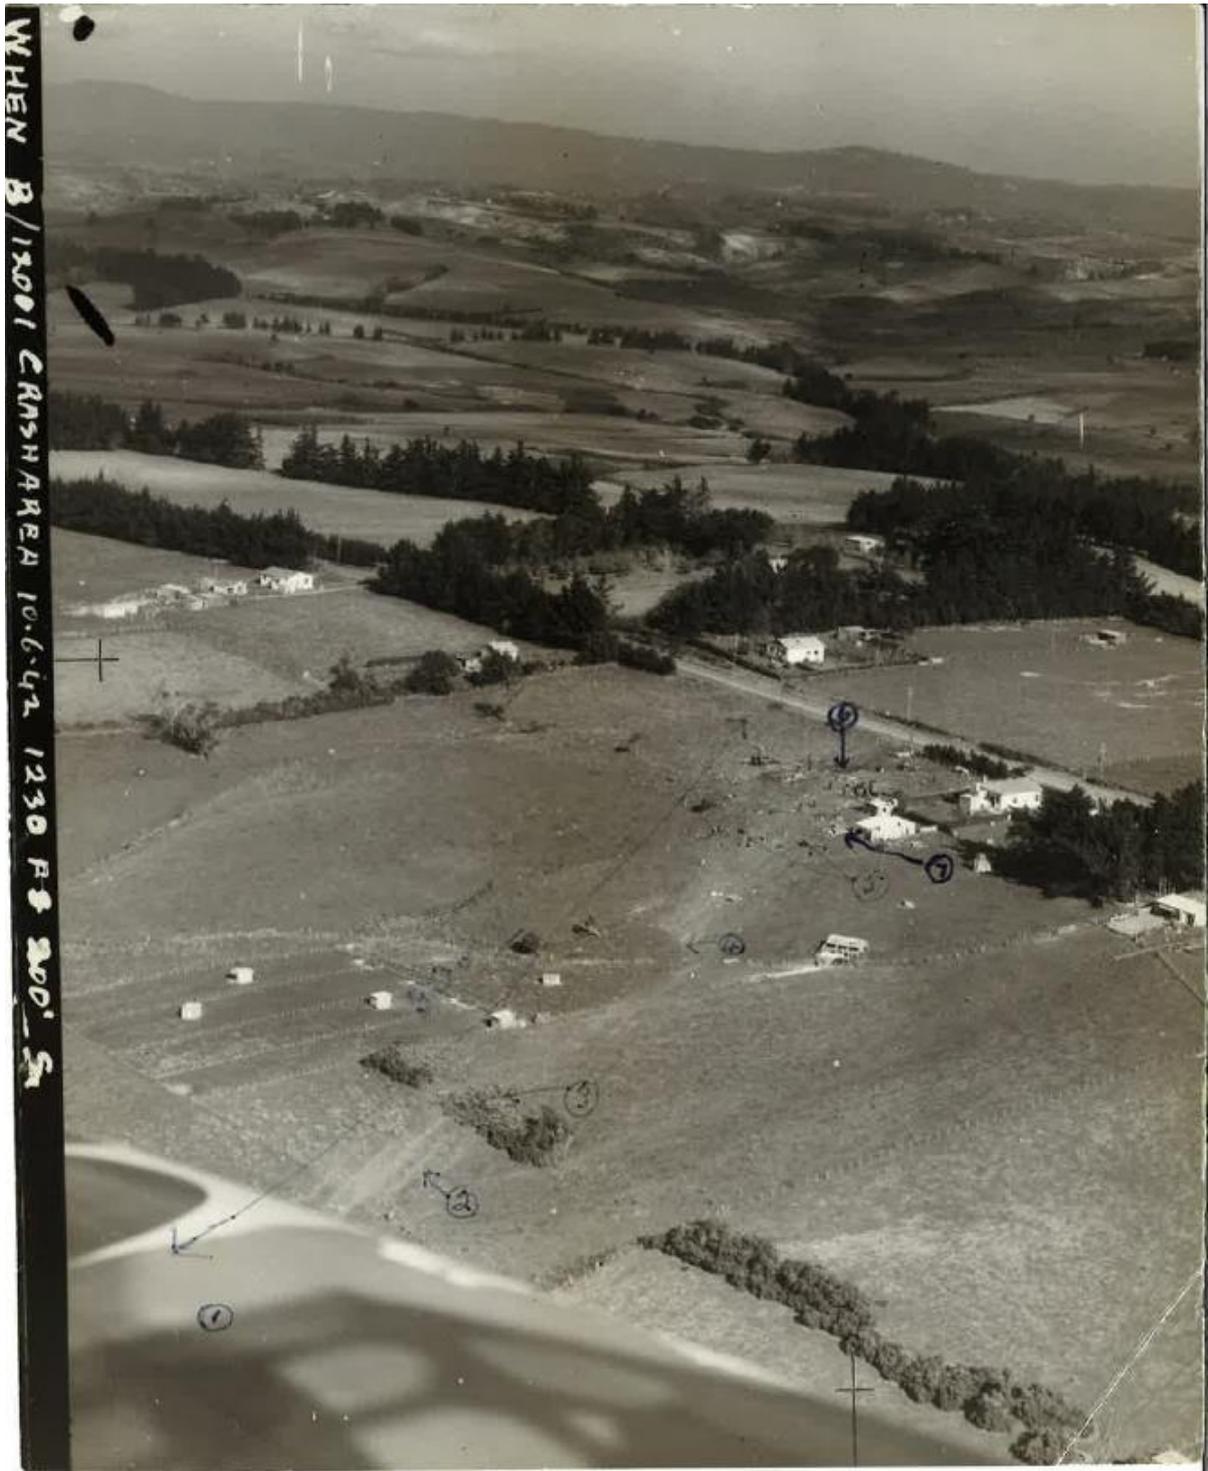
Figure 7-6: Photo from the inquiry into the crash showing the extent of the debris field (CHI archives).

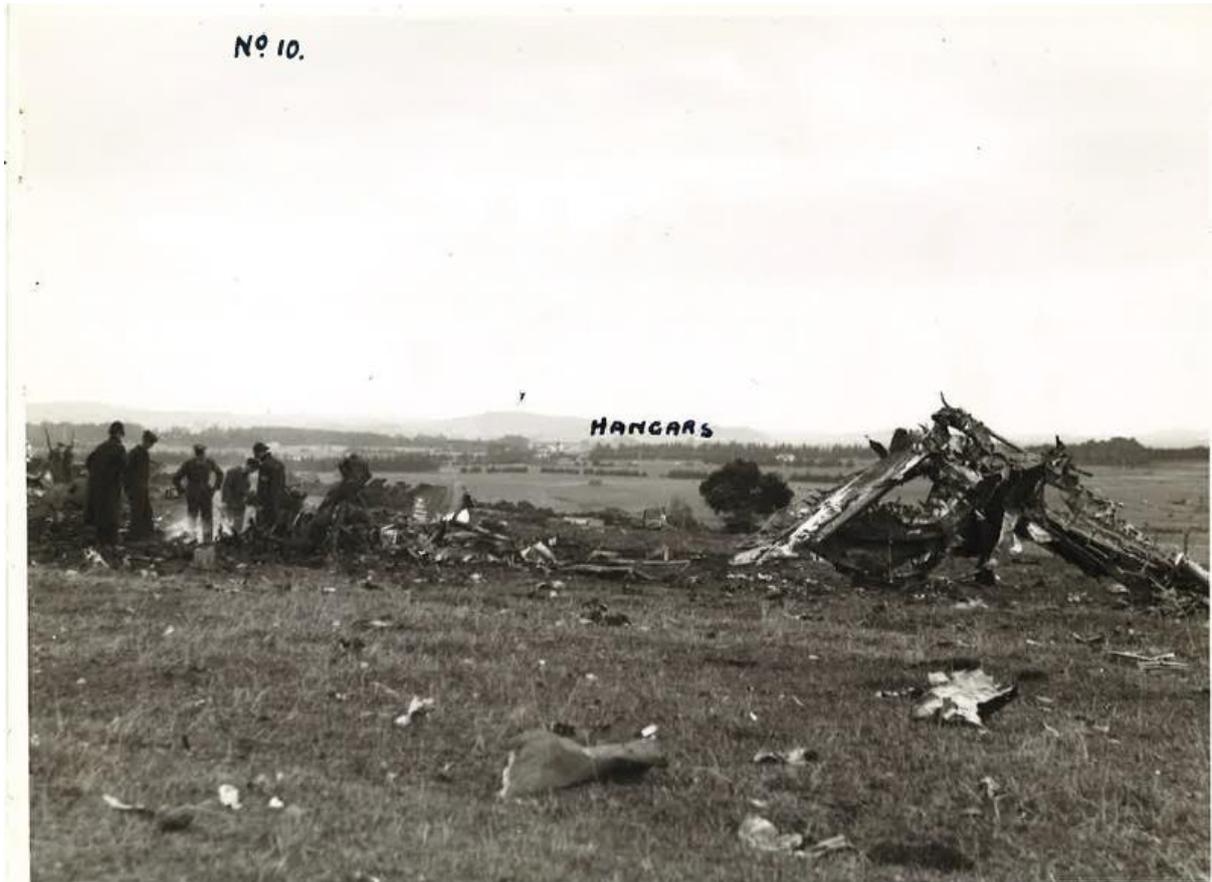
Figure 7-7: View onto the crash site from the ground (CHI archives).

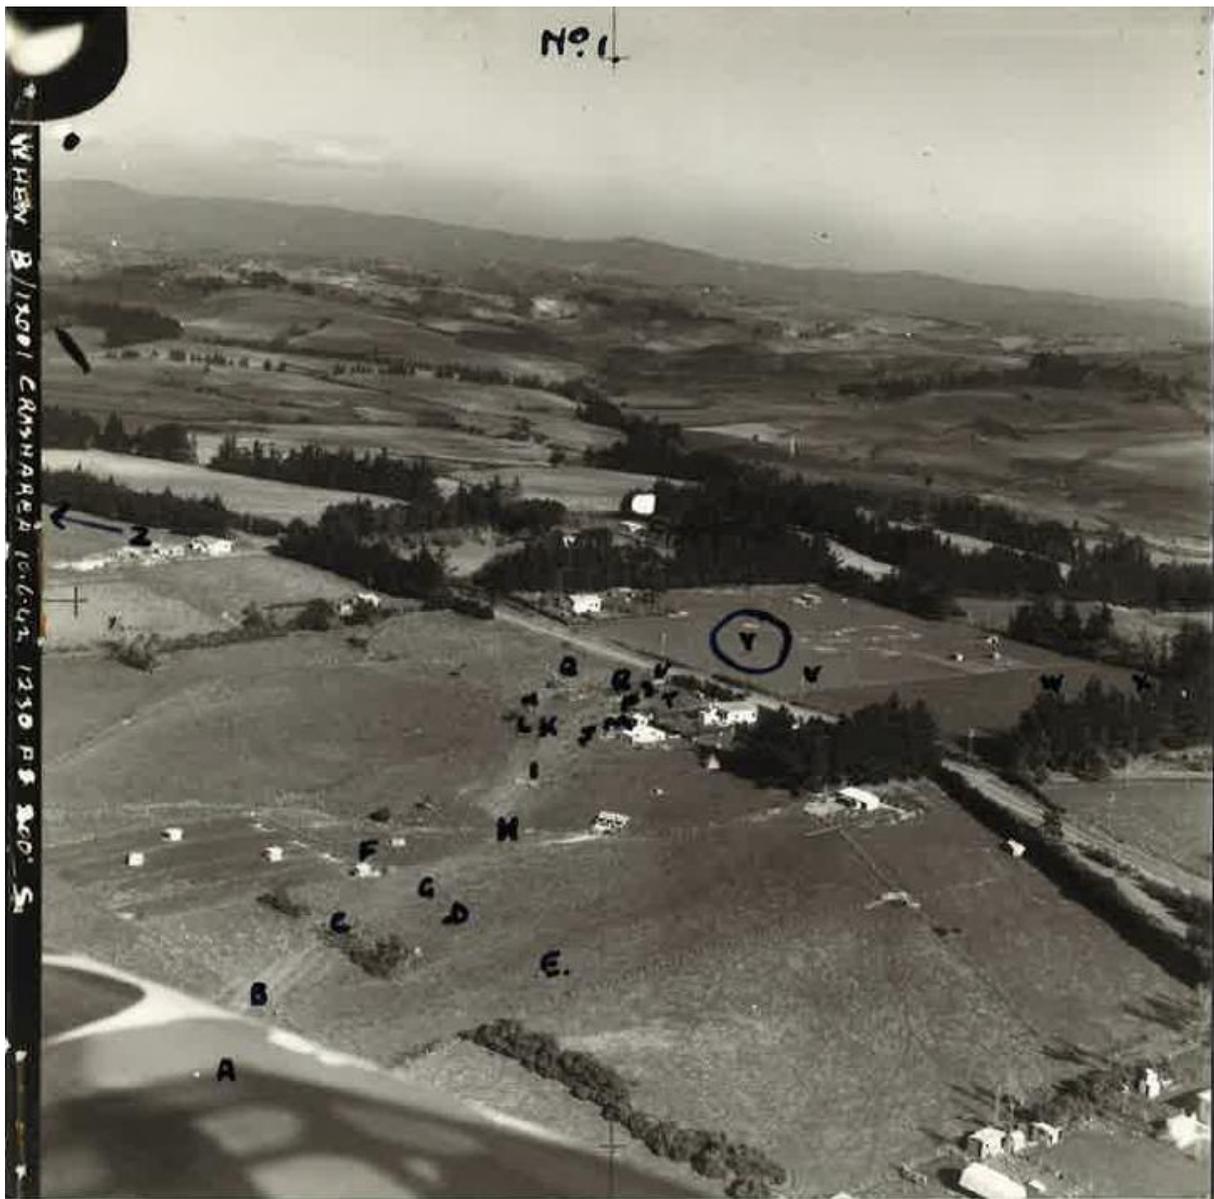
Figure 7-8: Marked up view over the debris field used for the official inquiry into the crash (CHI archives). It clearly shows that the debris field extends across Fred Taylor Drive.

It is recommended that all areas of earthworks or topsoil stripping during construction are included in the Accidental Discovery Protocol.

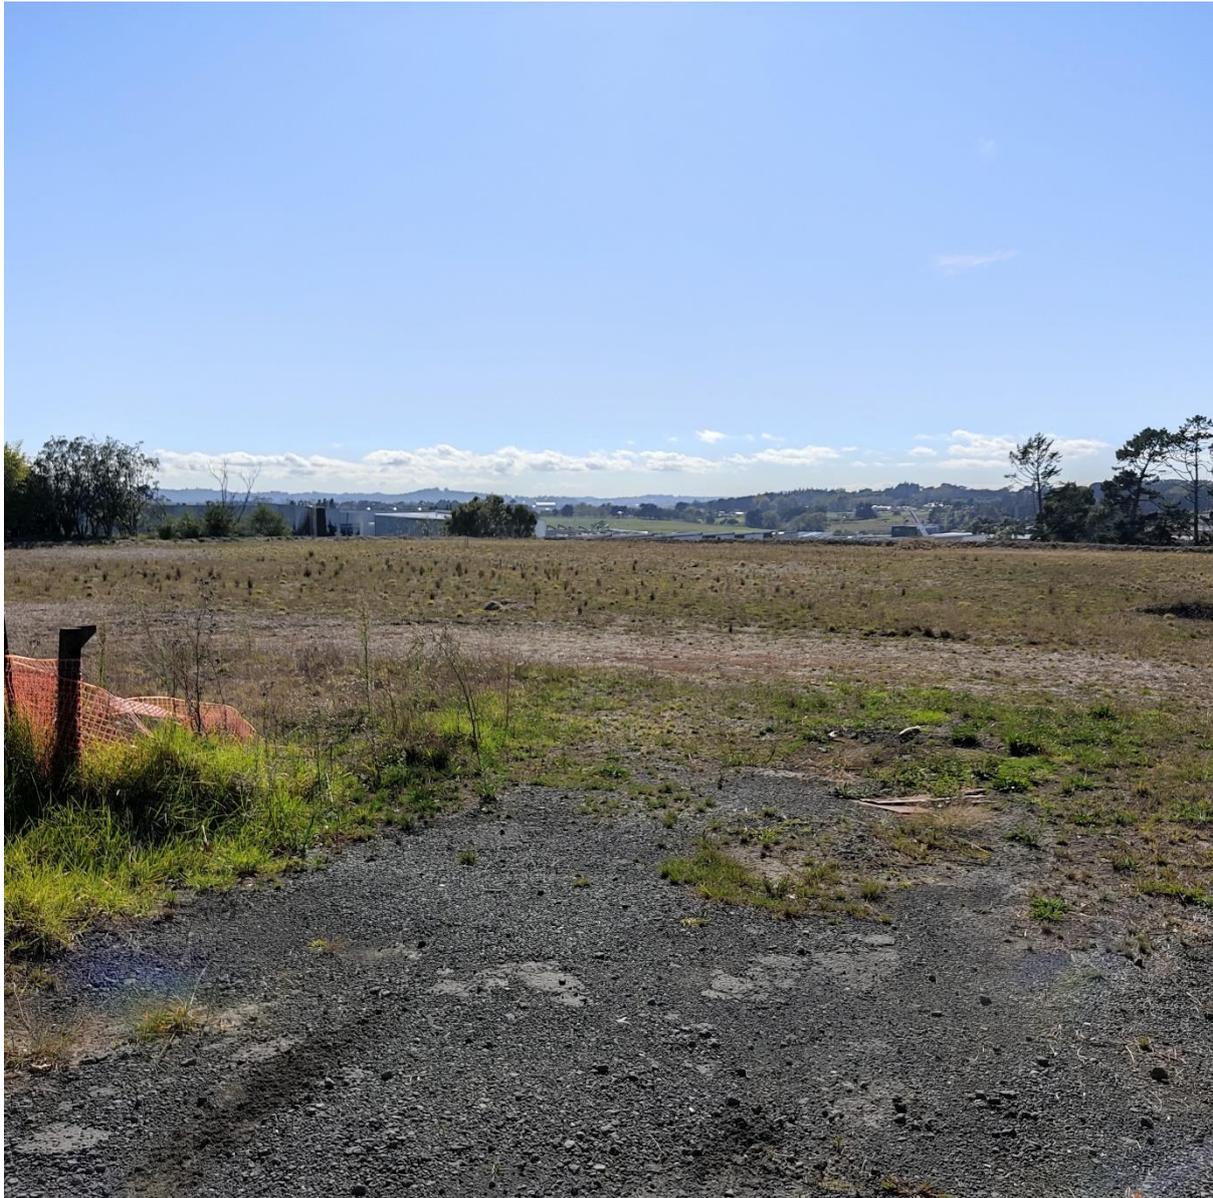
Figure 7-9: Large scale earthworks over the archaeological site to the east of Fred Taylor Drive. There is nothing left of the archaeological site on the eastern side of the road.
