**TE TUPU NGĀTAHI**  
SUPPORTING GROWTH

# North West Redhills Riverhead Assessment of Effects on Heritage / Archaeology

December 2022

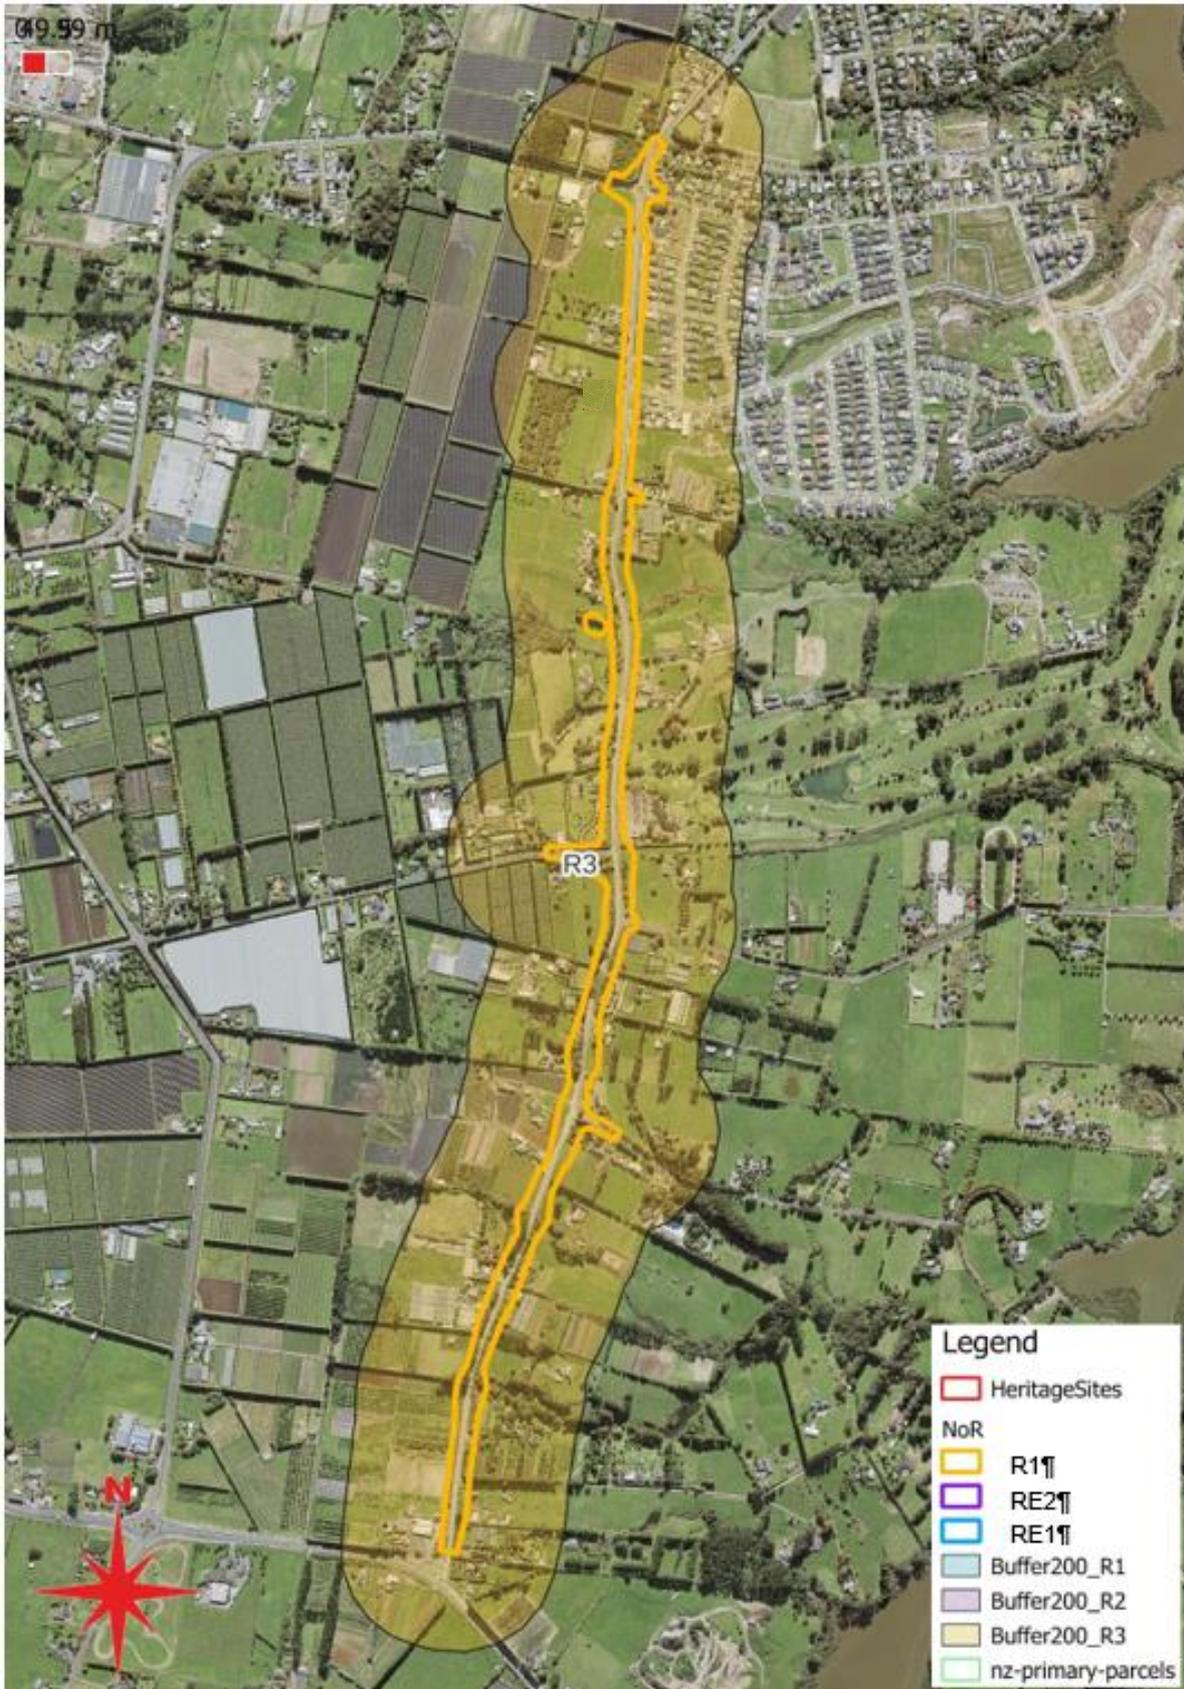
Figure 8-2: Extent of NoR R1 and 200 m buffer zone. No heritage sites and no high risk areas are within the NoR or the buffer zone or in the vicinity.

There are no recorded archaeological sites or historic overlays recorded in the AUP:OP. No CHI sites are shown either.

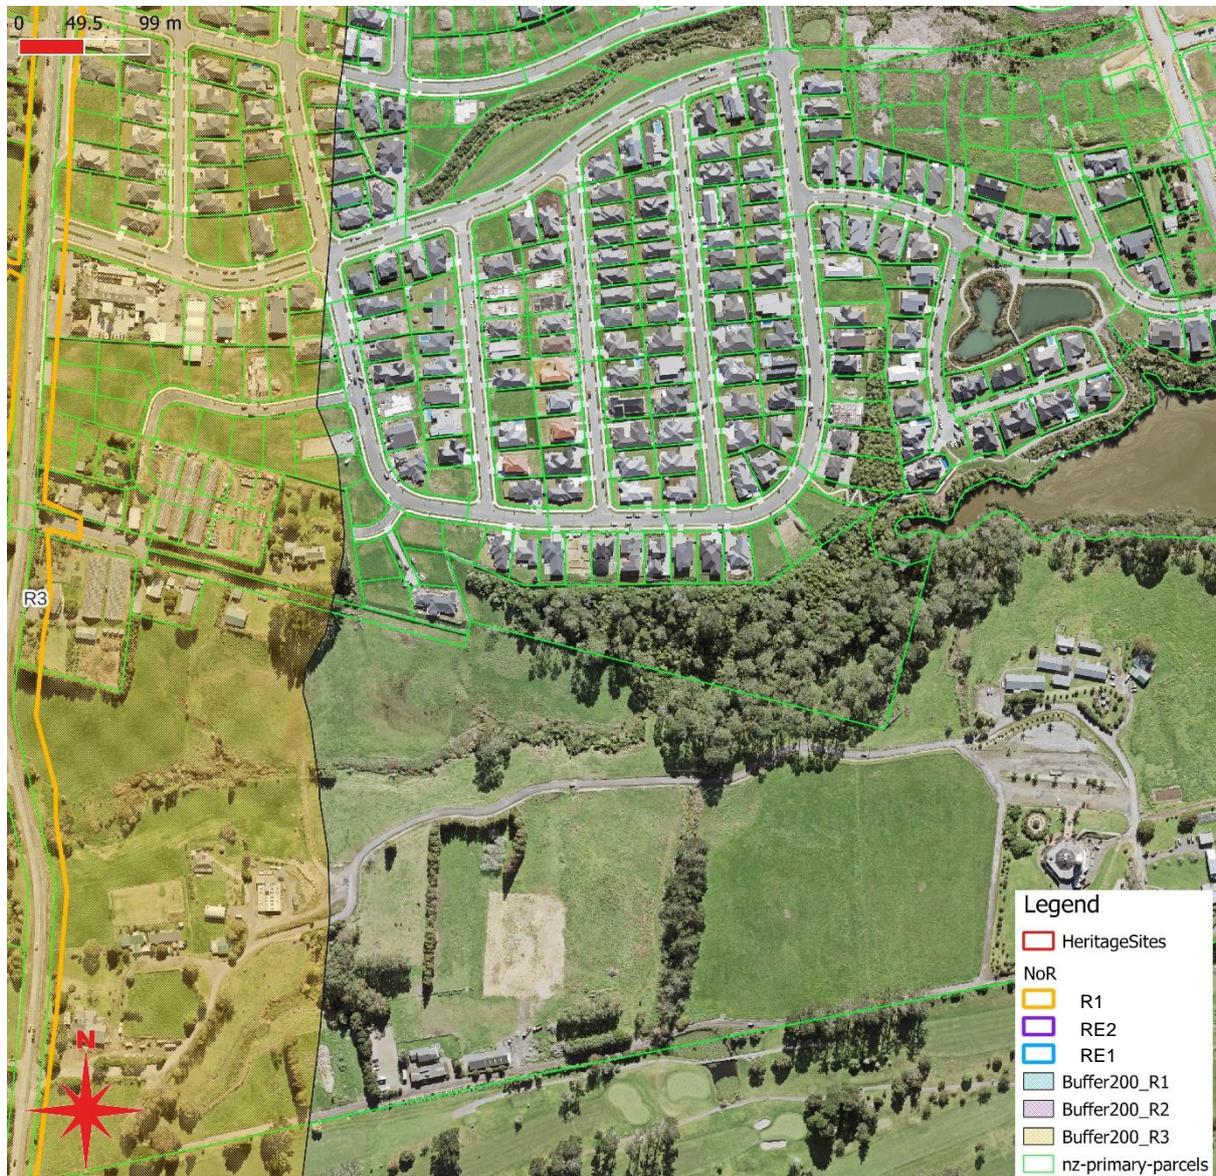
An early map of the harbour survey (Figure 4-2) shows a canoe landing area, presumably the start of an “ara” (pathway) from the upper harbour to the Kumeū River (Figure 8-3). This potential pathway would cross NoR R1. Nonetheless pathways are rarely recognised in the archaeological record.

Figure 8-3: On the right-hand side of the picture a small creek of the upper harbour is shown. This is the location of a canoe landing. Any potential pathway would lead west towards the Kumeū River.
