Milldale Argent Lane Extension Ecological Assessment of Effects

Report prepared for: Mott MacDonald/Fulton Hogan

Report prepared by: Paul Battersby, Principal Ecologist Epoch Ecology

5 October 2020 Epoch Ref: 1-MM001

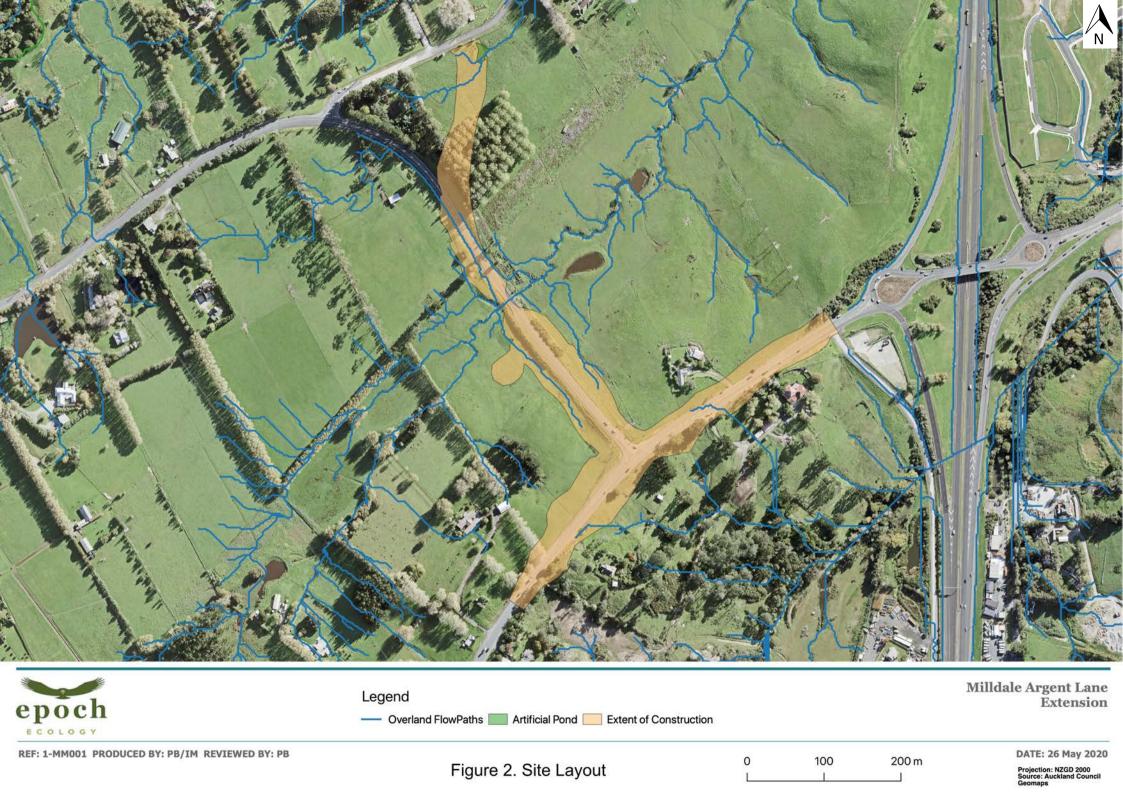
Various overland flow paths are present within the pasture area that flow in an approximate south-west to north-east direction, adjacent to and across the footprint of the proposed road (Figure 2).

An approximately 270 m² artificial pond is located within the alignment of the proposed new road (Figure 2). The pond will be filled and flow will run through a 1500 mm wide by 750 mm high 43 m long box culvert underneath the road to join the downstream channel. The invert level of the culvert will be 250 mm below the stream bed, meaning the stream bed will form over the culvert floor over time, and allow fish passage. An approximately 40 m new channel, with the purpose of mimicking the natural stream channel, will be created adjacent to the proposed road to connect the culvert outlet with the existing downstream stream channel (Appendix 1).

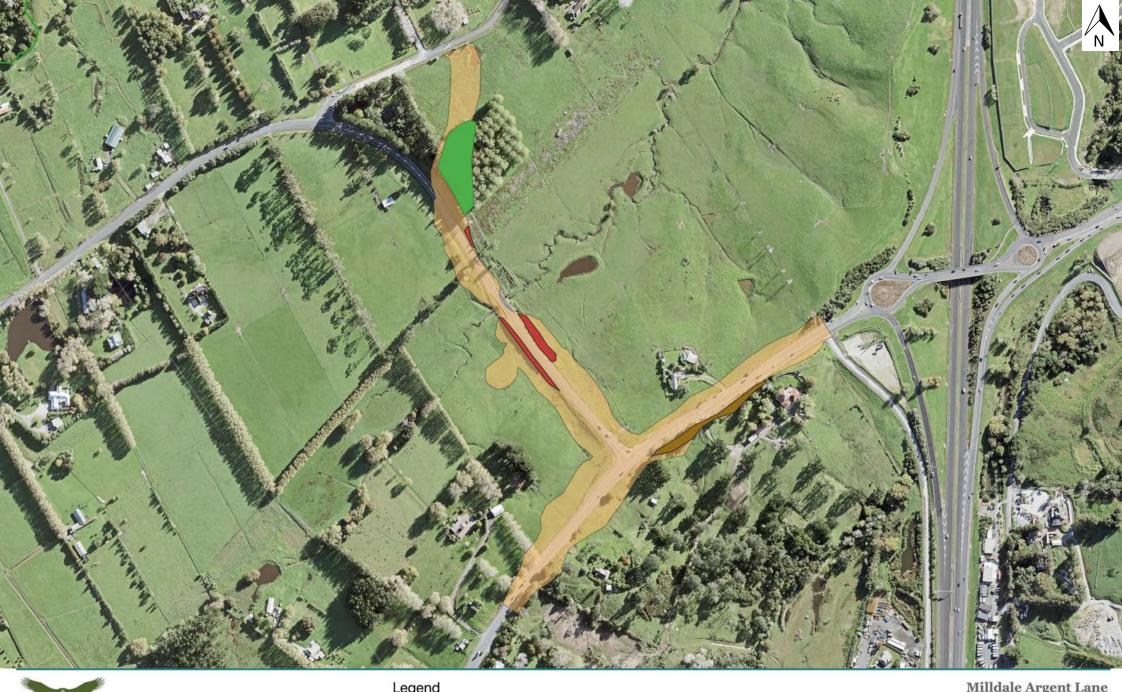
Native plantings are located within the road corridor of Pine Valley road, near the existing culvert of the permanent stream. Tree species consist of approximately 2-3 m kahikatea (*Dacrycarpus dacrydioides*), tanekaha (*Phyloclladus trichomanioides*), and rimu (*Dacrydium cupressenum*). A row of flax (*Phormium tenax*) and ti kouka (*Cordyline australis*) is located either side of the road (Figure 3). Scattered wiwi (*Juncus edgariae*) is also present.

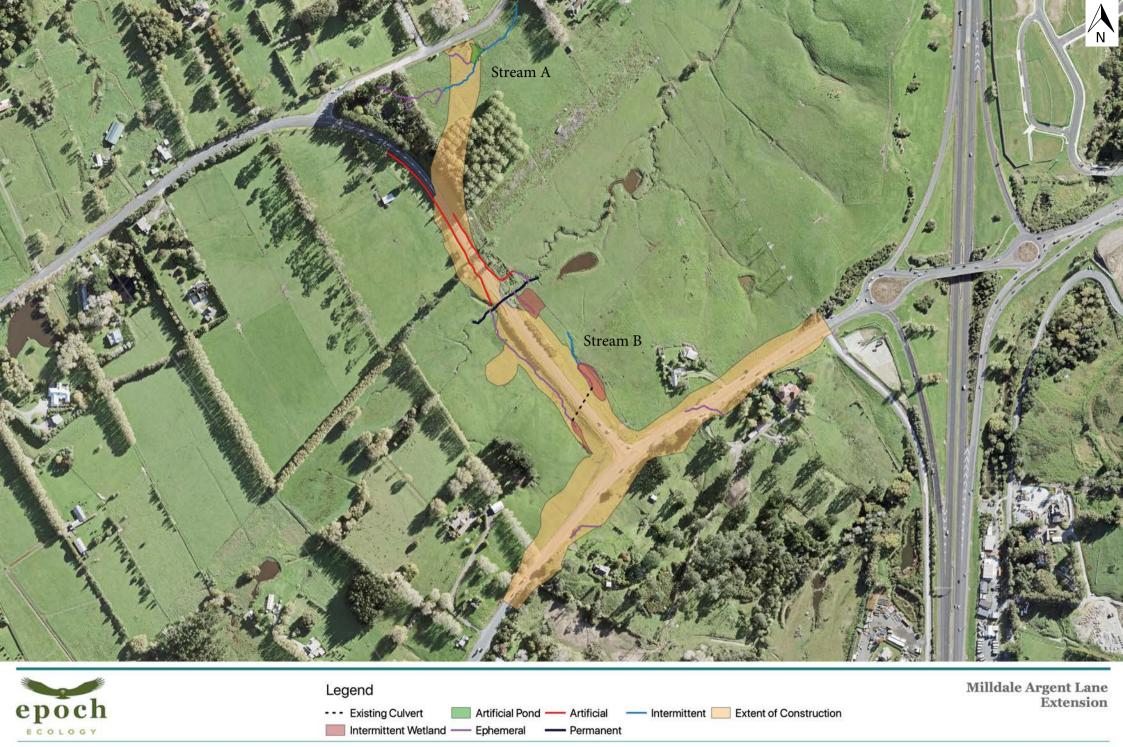
Figure 4. Waterway classification within the road alignment

A total length of 93 m of stream reaches were classified as intermittent within the Project area (Figure 4). The longest reach is 49 m upstream from the artificial pond near Old Pine Valley Road at the northern edge of the proposed road (stream A). A smaller reach of approximately

Projection: NZGD 2000 Source: Auckland Council Geomaps 43 m is located on the eastern side of the alignment draining a wetland on the slope adjacent to Pine Valley Road (stream B).

Reaches classified as ephemeral failed to meet three out of the five criteria for intermittent streams and were therefore classed as ephemeral. The modelled catchment size of the ephemeral reaches were all under 1.2 ha, indicating that the catchment is too small to support intermittent stream criteria.

Intermittent Stream A

All intermittent reaches met three out of the five criteria-

- a) It has natural pools;
- b) It has a well-defined channel, such that the bed and banks can be distinguished;
- c) Rooted terrestrial vegetation is not established across the entire cross-sectional width of the channel

The upstream point where Intermittent stream A crosses the alignment has a modelled catchment size of approximately 1.49 ha, and 2.22 ha at the downstream point. This indicates the reach within the alignment is intermittent. The site visit showed the reach below the boundary shown in Figure 4 had natural pools and held more water than any point upstream. Livestock pugging in pasture areas often makes it difficult to establish where the bed or banks are located. There was a definite change in the stream bed downstream from the point in Figure 4 so that banks were able to be distinguished. In addition, there was a definite change to aquatic vegetation within the channel.

Intermittent Stream B

Intermittent stream B is more difficult to classify as it has a modelled catchment area of less than 1 ha, however there is a well-defined channel, with minimal terrestrial vegetation and there is a substantial amount of water present compared to upstream. It appears that the flowpath on the western side of Pine Valley Road is contributing to the flow via the small culvert underneath the road, shown in Figure 4, and therefore the modelled catchment size could be underestimating the actual catchment size.

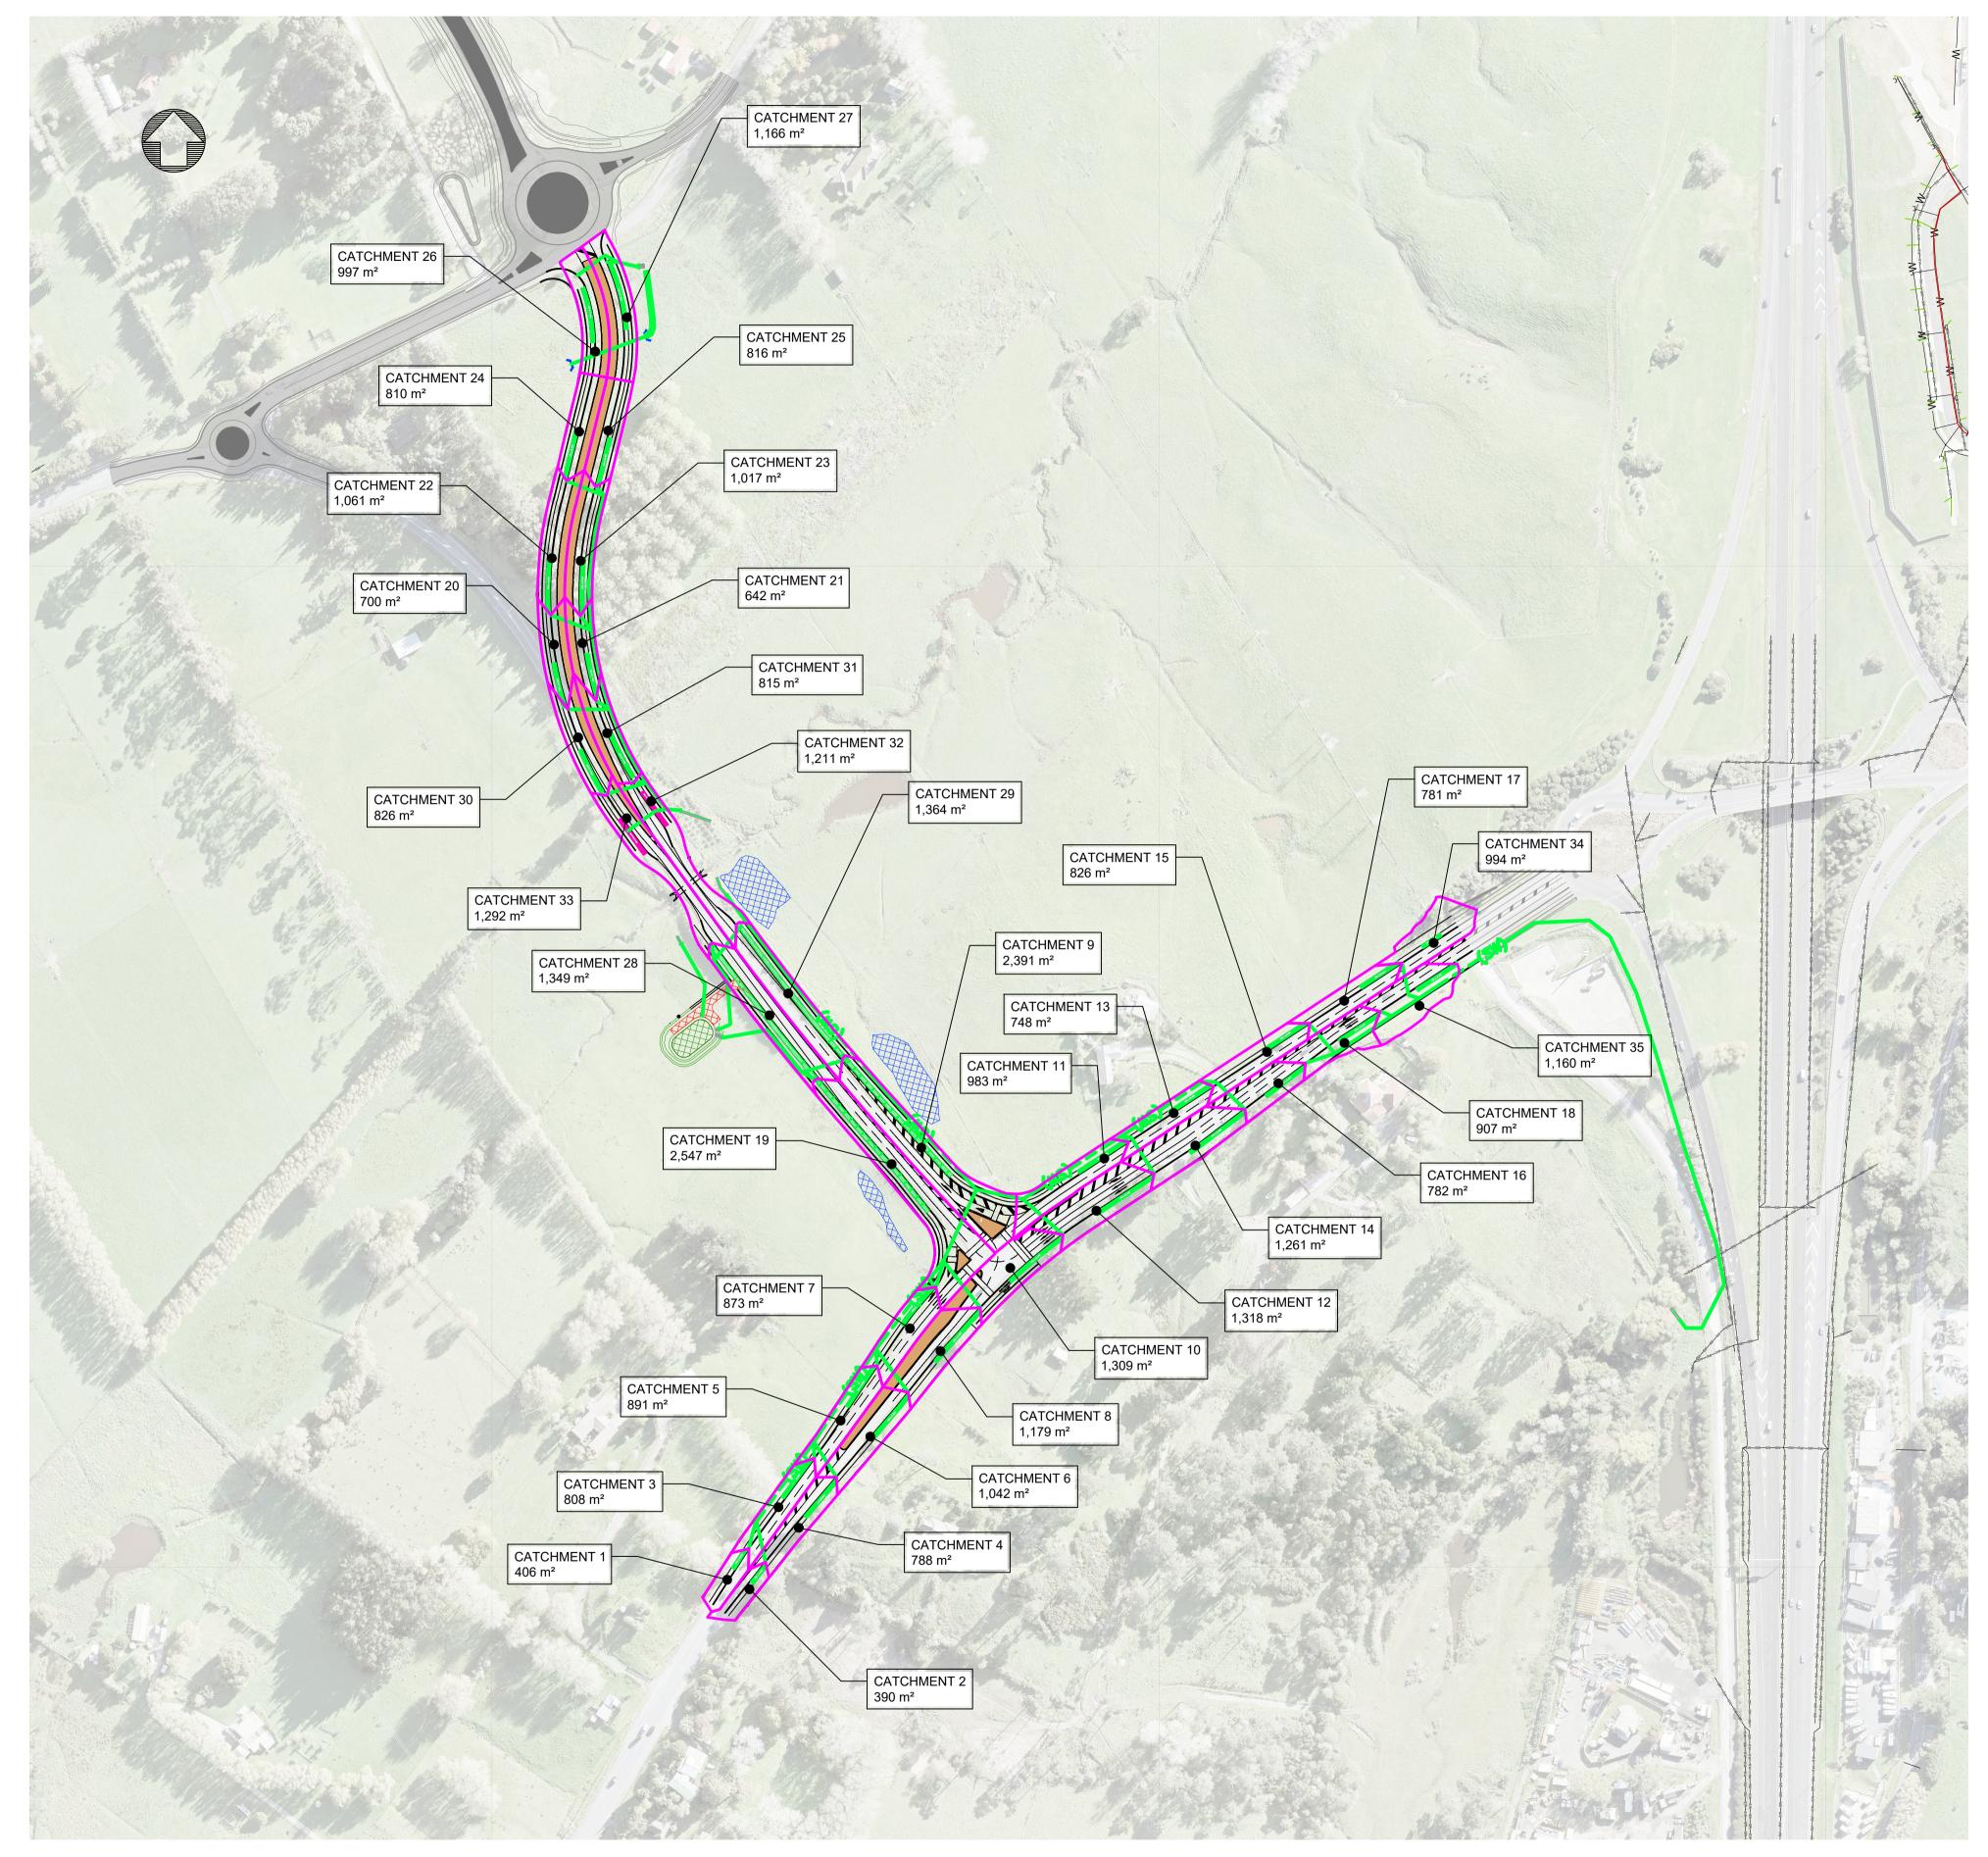
DRAFT - FOR RESOURCE CONSENT			
DRAWING			
Milldale Development, Argent Lane - Dairy Flat Highway Stormwater Pipe Network Catchment Plan			
DRAWING NO.		REVISION	
402828-MM-DWG-02-CV-DD-0850		В	
FOR RESOURCE CONSENT	SCALE (A1)	1:2000	
	DRAWING Milldale Development, Arger Stormwater Pipe Network Ca DRAWING NO. 402828-MM-DWG-02-C	DRAWING Milldale Development, Argent Lane - Dairy Fla Stormwater Pipe Network Catchment Plan DRAWING NO. 402828-MM-DWG-02-CV-DD-0850

All stormwater from the new road and the upgraded existing roads will be treated through a series of raingardens, with a super raingarden constructed in a pasture area adjacent to Pine Valley Road. A new outlet will be constructed adjacent to the northern end of the constructed channel, south of Old Pine Valley Road. Another outlet will be constructed to discharge stormwater into an ephemeral stream that flows into the true left bank of the permanent stream near the existing bridge of Pine Valley Road. Two new outlets will be constructed to discharge stormwater into the true right bank of the permanent stream, and one outlet will be constructed to discharge stormwater flow from the southern side of Dairy Flat Road into the John Creek catchment to the south of the Project Area (Appendix 1).

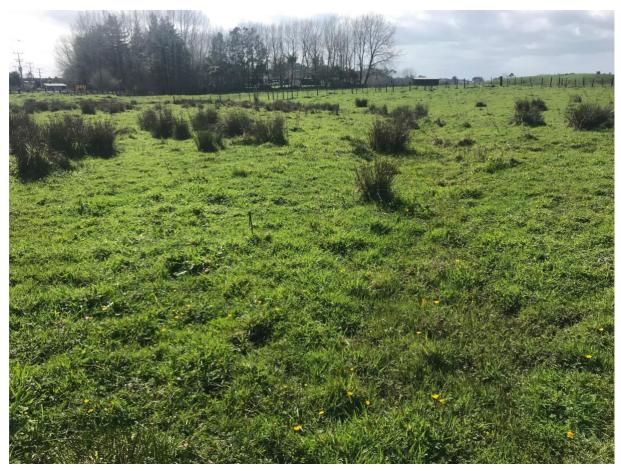
Plate 1. View downstream at approximate location of ephemeral/intermittent boundary for Stream A.

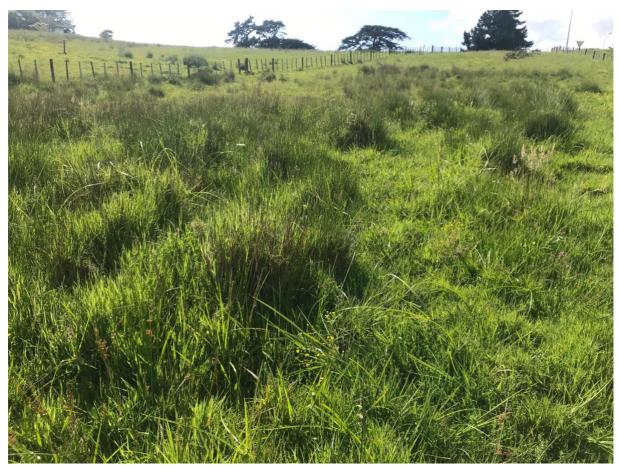
Plate 2. View upstream at approximate boundary of Stream B and the intermittent wetland adjacent to Pine Valley Road.
