Contamination Assessment - 167-173 Pilkington Road, Point England, Auckland (Our Reference: 21255.000.001_02)

1 Introduction

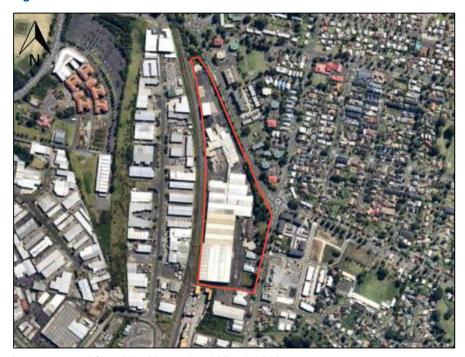
Figure 1: Site Location

Image sourced from NearMaps; dated March 2022

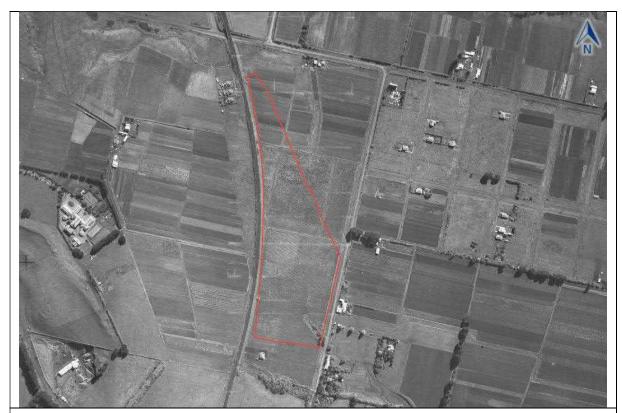
1940 (Retrolens)

- Potential horticultural activity can be observed on-site between the 1940s and 1970s.
- The North Island Main Trunk rail line is observed adjacent to the western site boundary in the earliest aerial image (1940).

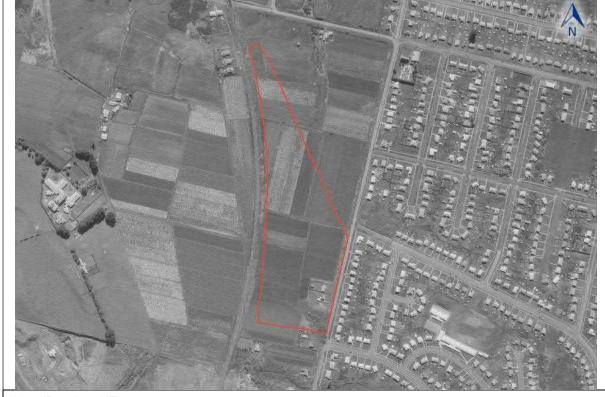
1955 (Retrolens NZ)

- Low density residential housing is observed in the southeast portion of the site from 1955. By the early 1970s, a small development (likely residential based on the size) is observed approximately at the centre of the site.

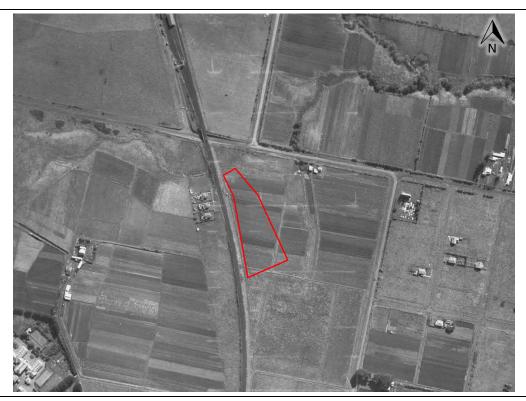
1940 (Retrolens NZ)

Date	Description
1940	Horticultural activity is observed on the site and in the surrounding area. The railway line is observed to the west of the site, and low density residential housing and agricultural land in the wider area.
1955	The site and immediate surrounding area is largely unchanged. A significant increase in residential development to the east and northeast of the site is observed. A large area of land to the northwest of the site appears to be used for storage of timber.
1959	No significant changes to the site are observed. Construction of Apirana Avenue and the residential development to the east is occurring.
1961	Horticultural activity is not observed on the site or the balance of the property to the south. Industrial development are observed to the north of the site.
1974	The site appears to have been earthworked. This is likely associated with construction on the balance of the property to the south of the site.

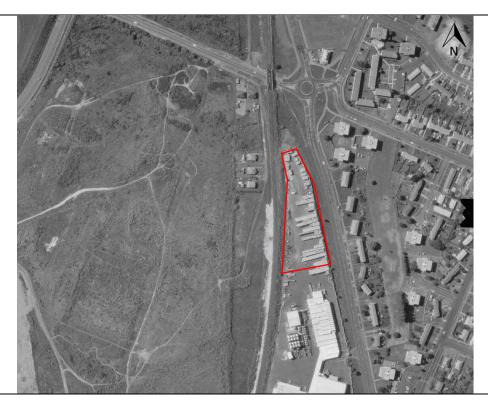
1981 (Retrolens NZ)

1981	Large rectangular items are being stored along the eastern extent of the site. Smaller items are present along the western extent. It is not clear whether the site surface is sealed. Significant construction has occurred on the balance of the property.
1996	Poor image quality does not allow for detailed observations of the site, however storage of miscellaneous items are still observed. Expansion of the facilities on the balance of the property is observed. Development of the industrial estate to the west of the railway line has occurred.
2001	The tank farm has been constructed in the southwest corner of the site. The balance of the site continues to be utilised as a storage area.
2003 / 2004	Poor image quality does not allow for detailed observations of the site, however the site appears to be more or less in its current configuration. The 'tanker unload' area is observed to the north of the tank farm, and the truck turnaround area at the northern end of the site. No significant changes to the surrounding area are observed.

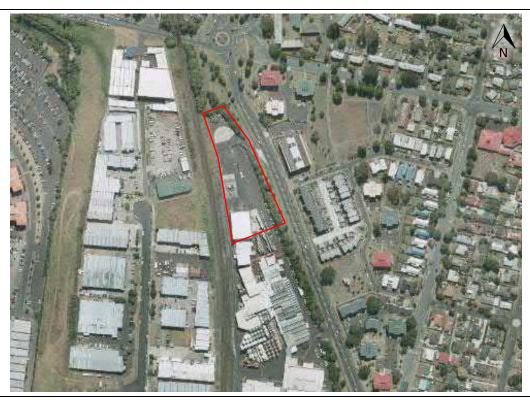
2010 / 2011 (Auckland Council Geomaps)

2010 / 2011	No significant changes to the site are observed. Densification of residential land to the east of Apirana Avenue is observed.
2017	Large shipping containers are observed along the centre of the site, and planting in the northern portion of the site.

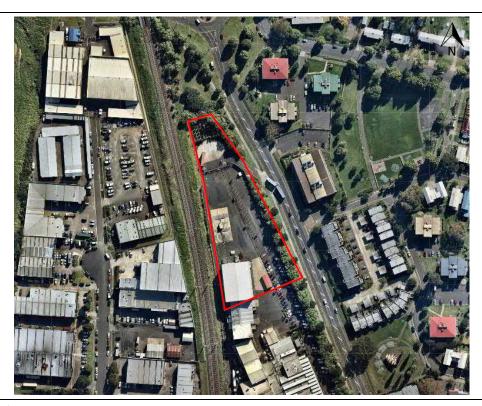
2018 (Nearmaps)

Date	Description
2018	Only one shipping container is observed on the southern boundary, and the tankers in the 'tanker unload' area appear to have been removed.
2021	What appears to be large tanks (positioned on their side) are being stored along the centre of the site. This may be associated with decommissioning of the tank farm.

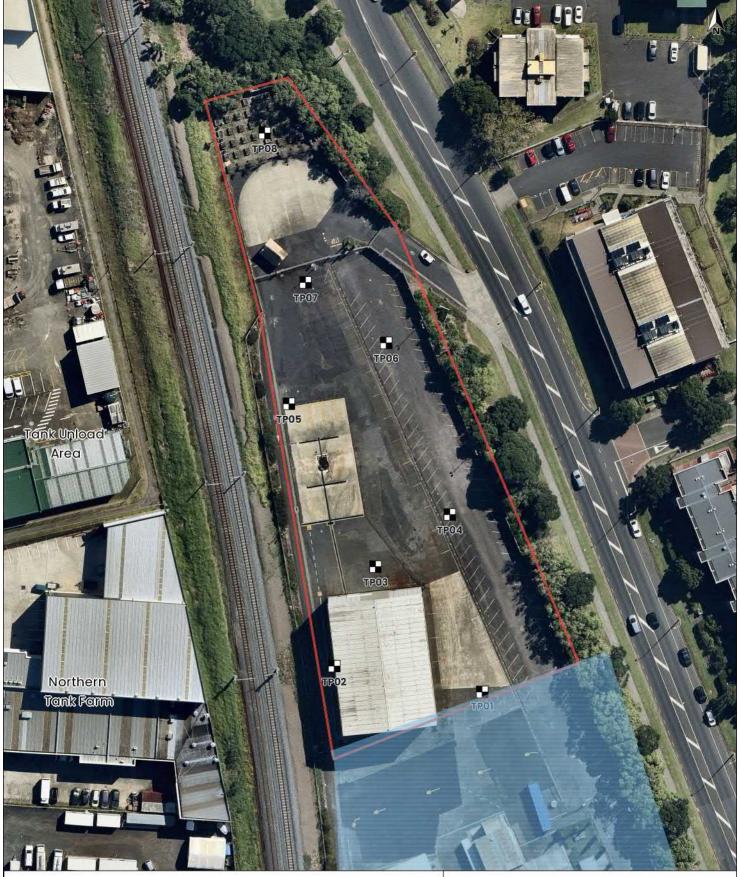
To quantify the potential impacts identified above, ENGEO collected soil samples from testpits on 31 March 2022. Sample locations were selected to provide general coverage across the site (refer Figure 1).
