41-43 Brigham Creek Road JV

41-43 Brigham Creek Road: Plan Change: information request regarding ecological effects

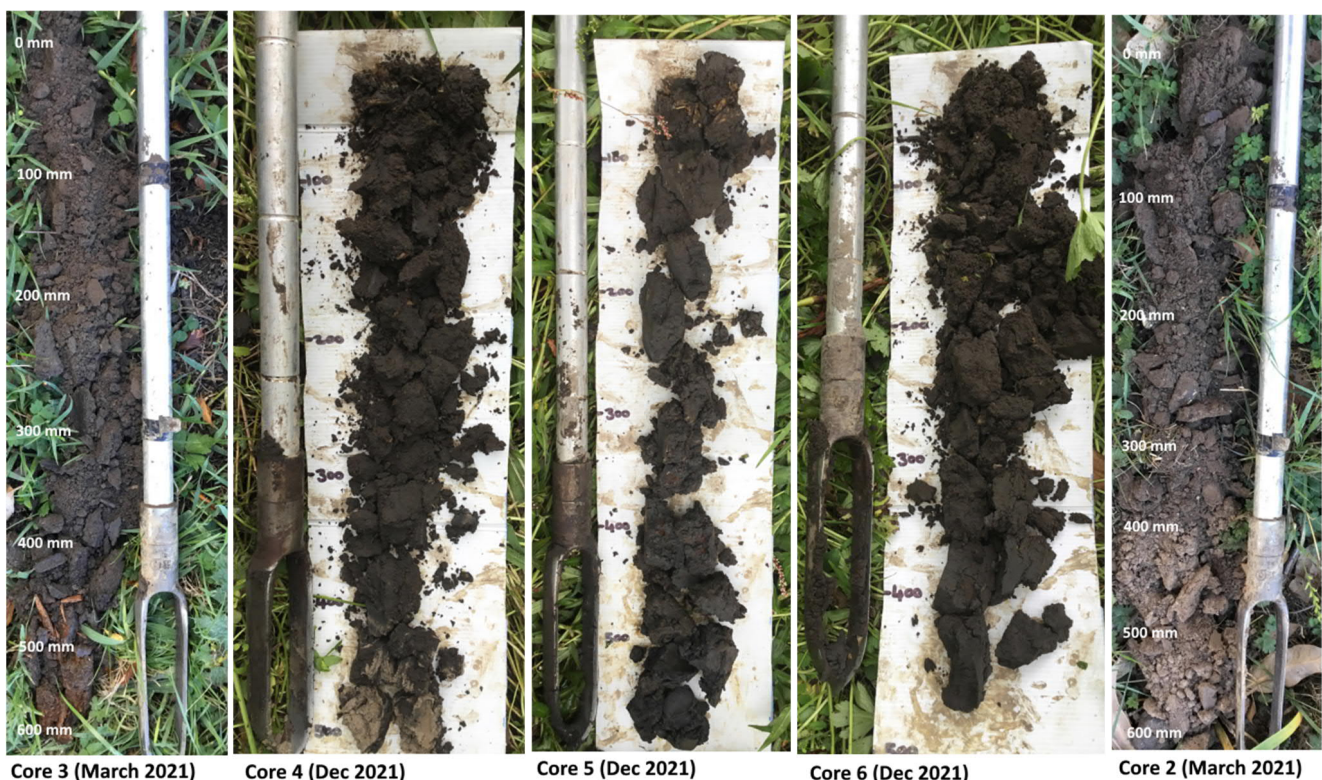
We took three more soil cores within this wet area – within the lowest point and on the edges. All soil cores were within areas dominated by wet-adapted plants (buttercup/ water pepper/ Yorkshire fog grass). These are shown below, together with the soil core taken in March 2021 within the same area, and a reference sample taken on the slope/ dry soils nearby. None contain indicators of hydric soils as defined in Fraser et al. (soil guide referred to in the NPS-FM wetland classification and delineation guidance). Soils must qualify as hydric soils for a potential wetland area to be classed as wetland – if it does not pass the soils test, it is not a wetland (see flow chart in the NPS-FM wetland delineation and classification guidance). Updates to this guidance chart in subsequent clarification documents from MfE have no legal standing (they cannot replace the NPS-FM official guidance) and in any case they also require that soils AND hydrology tests be both met together for a site to be classified as a wetland.

(above). Soil cores taken within the wet basin on the site, and a core taken outside of the basin on the nearby slope/ spur (Core 2). Core 3 is taken after summer and shows dry soils. Cores 4 – 6 are taken just after the wet season and show moist profiles. None of the cores show redox mottling in the upper 300 mm or dark or light low chroma colours within the top 400 mm that are at variance with the reference core. The cores indicate that the basin comprises accumulated fine sediments over underlying basement clays.

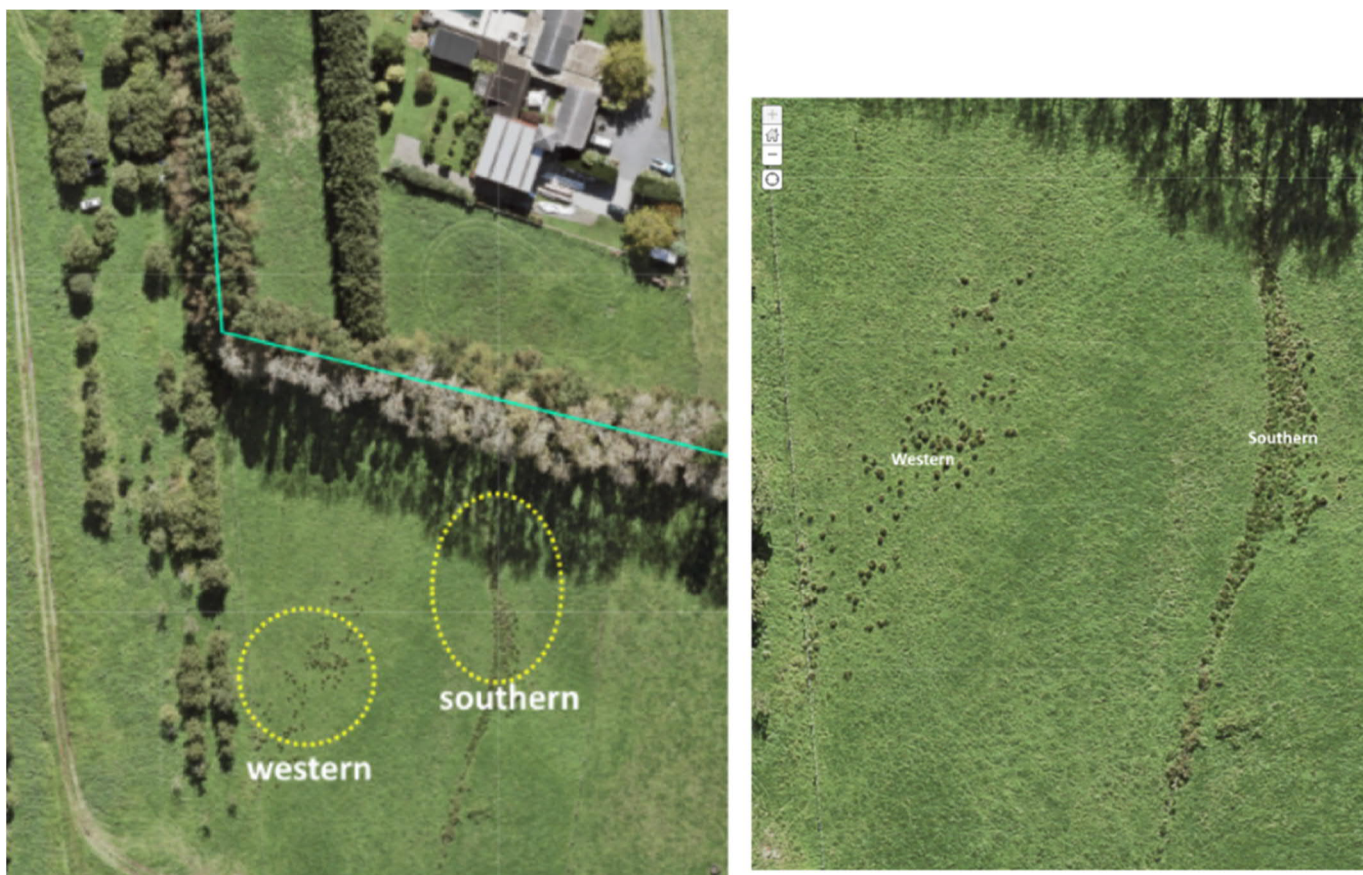
We refer to these sites as the southern wet area and the western wet area (see below).

- Vegetation dominated by Yorkshire fog (40 %), lotus (10 %) and sweet vernal (5 %), also with creeping buttercup (35 %), soft rush (10 %) and sorrel (2 %).
- Most of the stippling on the aerial photo (indicative of soft rush areas) above has either been removed by pasture maintenance since this aerial photo was taken, or is along the margins of the adjoining overland flow path; the potential wetland area is at the head of the gully and in this aerial is beneath the shading caused by the adjacent shelterbelt line.

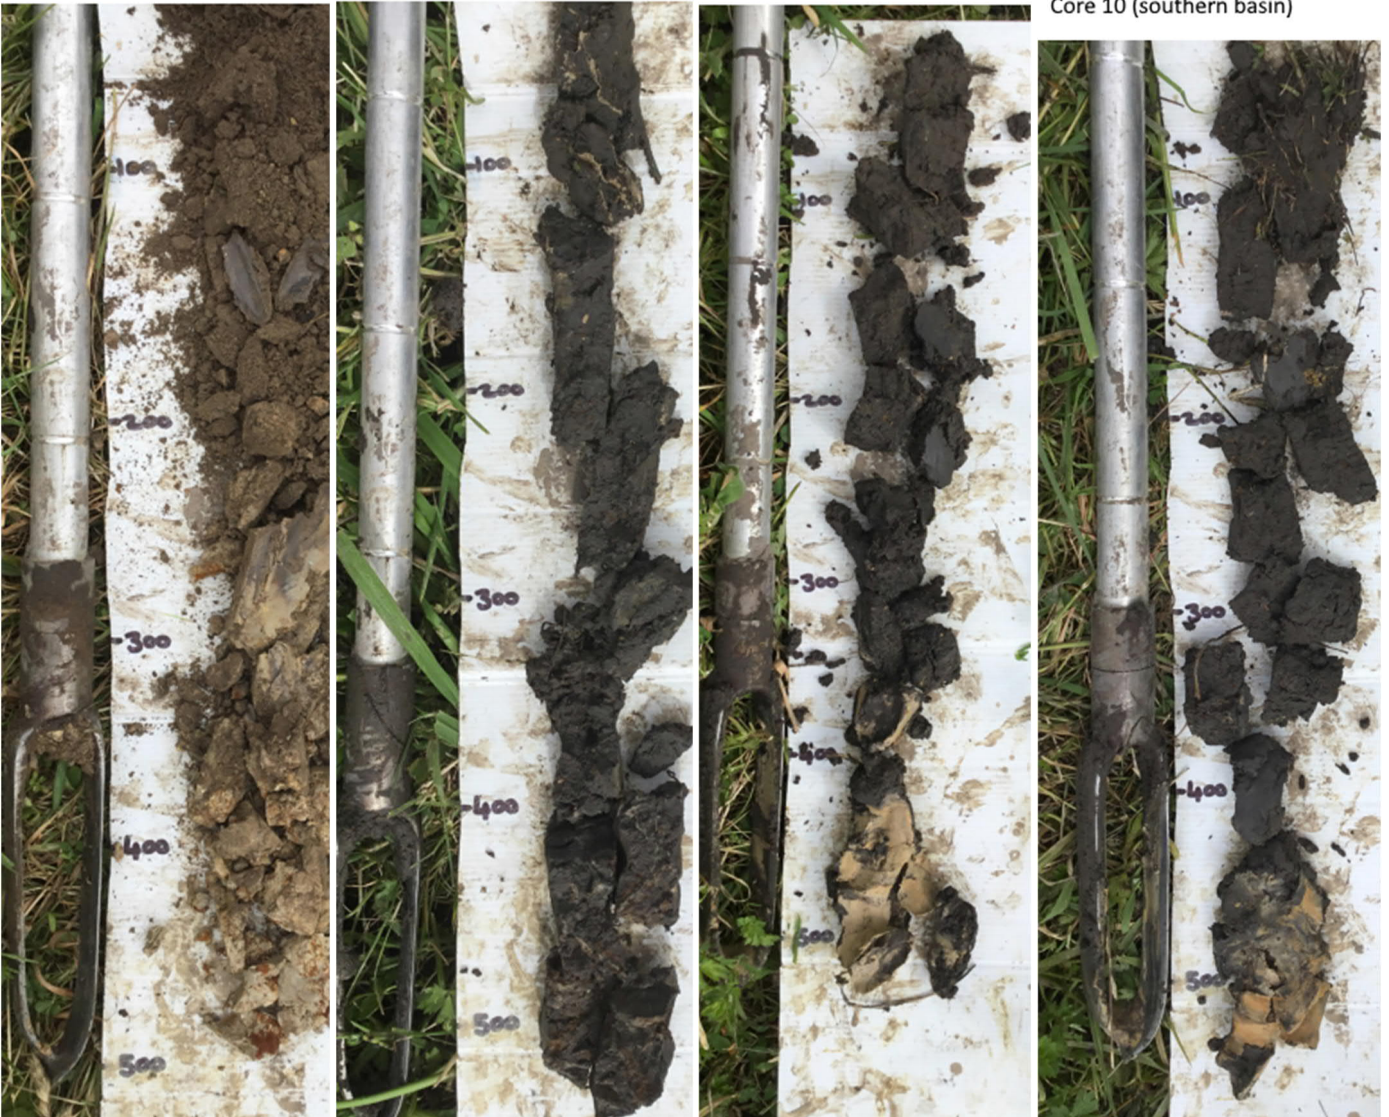
- Soils are fine silts with no mottling and no dark or light low chroma colours in the top 400 mm (see below).
- Overall, while the area is wetter than the surrounding basin sides and spurs, the soils are not hydric, and the vegetation is dominated by pasture grass species (Yorkshire fog, lotus and sweet vernal; which are part of paddock maintenance (pasture improvement) including weed control, fertiliser application and re-seeding) – meaning that the site does not qualify as a natural inland wetland under the NPS-FM nor as a wetland under the RMA.

Core 7 (slope reference)

Core 8 (southern basin)

Core 9 (southern basin)

Core 10 (southern basin)

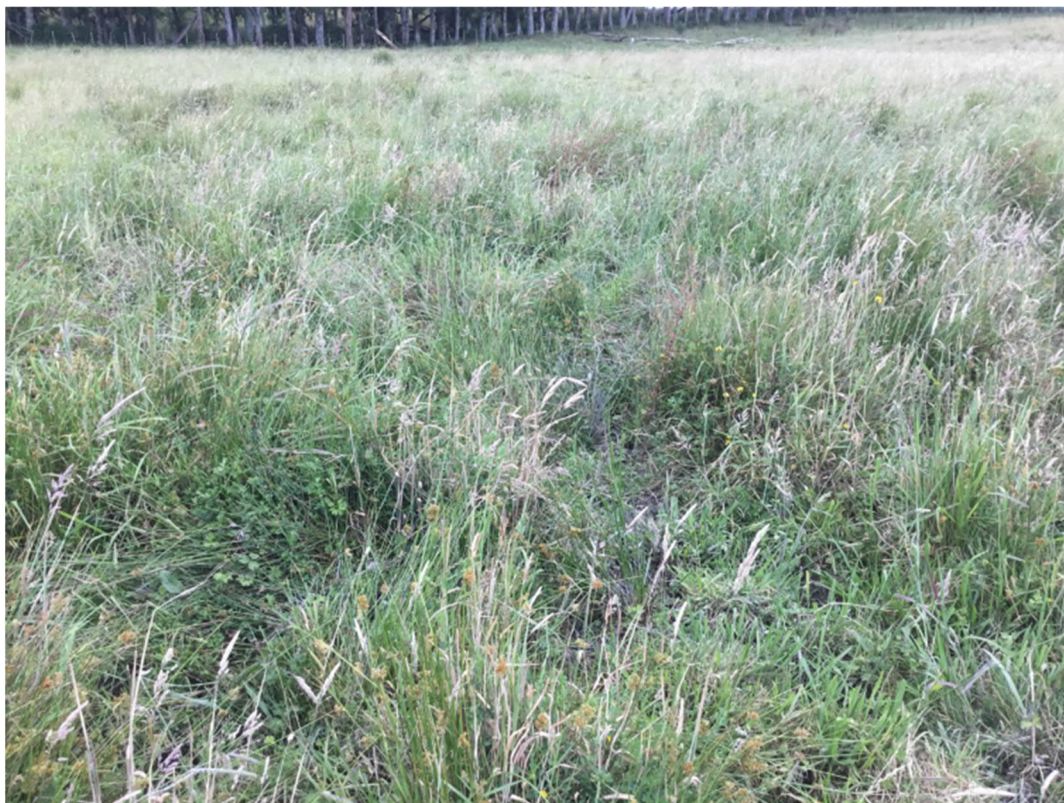
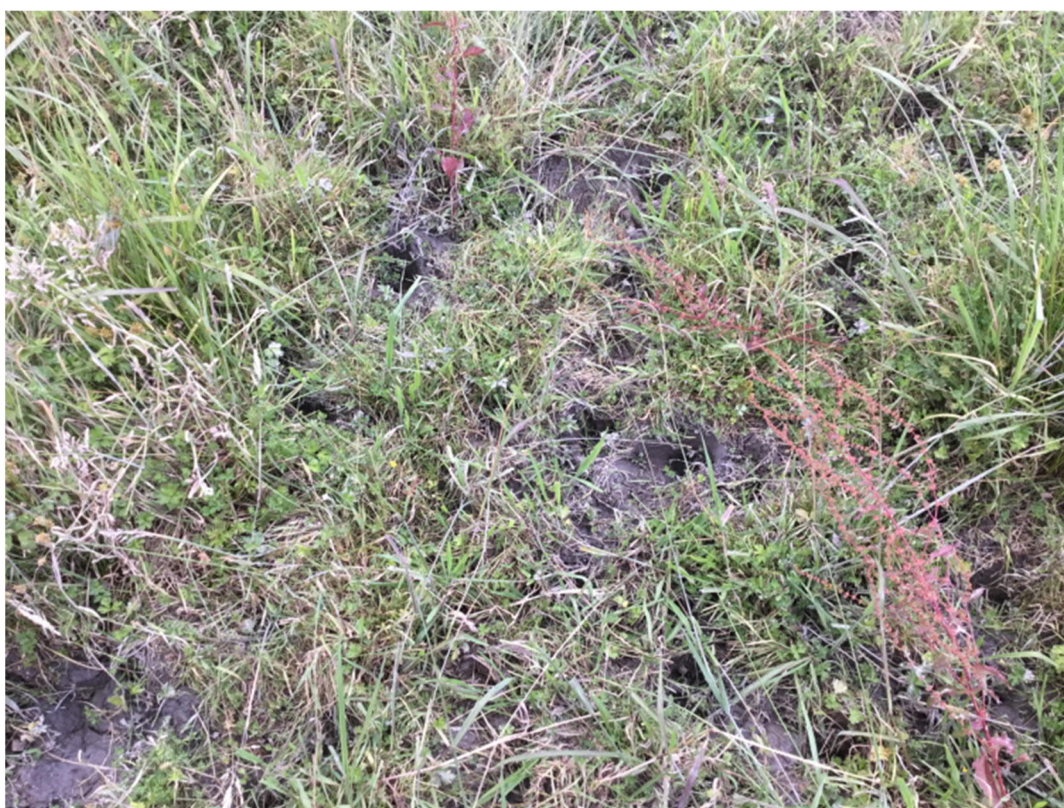
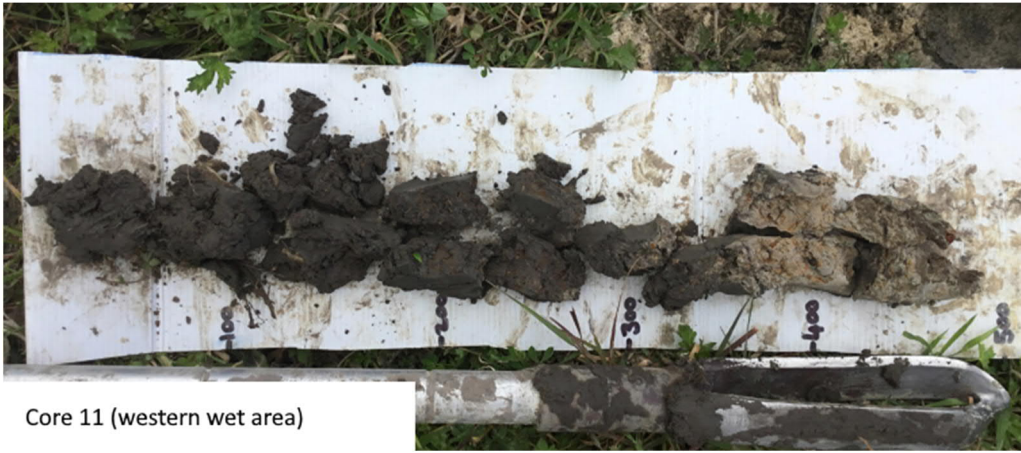
Core 11 (western wet area)

- Vegetation dominated by Yorkshire fog (55 %), lotus (5 %) and sweet vernal (5 %), with also creeping buttercup (10 %), soft rush (5 %), paspalum (10 %), sorrel (3 %) and bare ground (7 %).
- Soils are fine, moist, silts with light red mottling in the top 300 mm and a light low chroma colour change at 350 mm (see below). This qualifies this soil as a hydric (wetland) soil.
- Overall, while the area is wetter than the surrounding basin sides and spurs and the soils are hydric, the vegetation is dominated by pasture grass species (Yorkshire fog, lotus and sweet vernal; which are part of paddock maintenance (pasture improvement) including weed control, fertiliser application and re-seeding) – meaning that the site does not qualify as a natural inland wetland under the NPS-FM.
- The site does qualify as a wetland under the RMA.

See below for photo of the western wet area, picture of a representative 2 m x 2 m portion and a soil core taken within the wettest part of this western area.
