Preliminary and Detailed Site Investigation – Remuera Precinct – 79 Ladies Mile, Remuera, Auckland

Fletcher Residential Limited

✦ December 2023

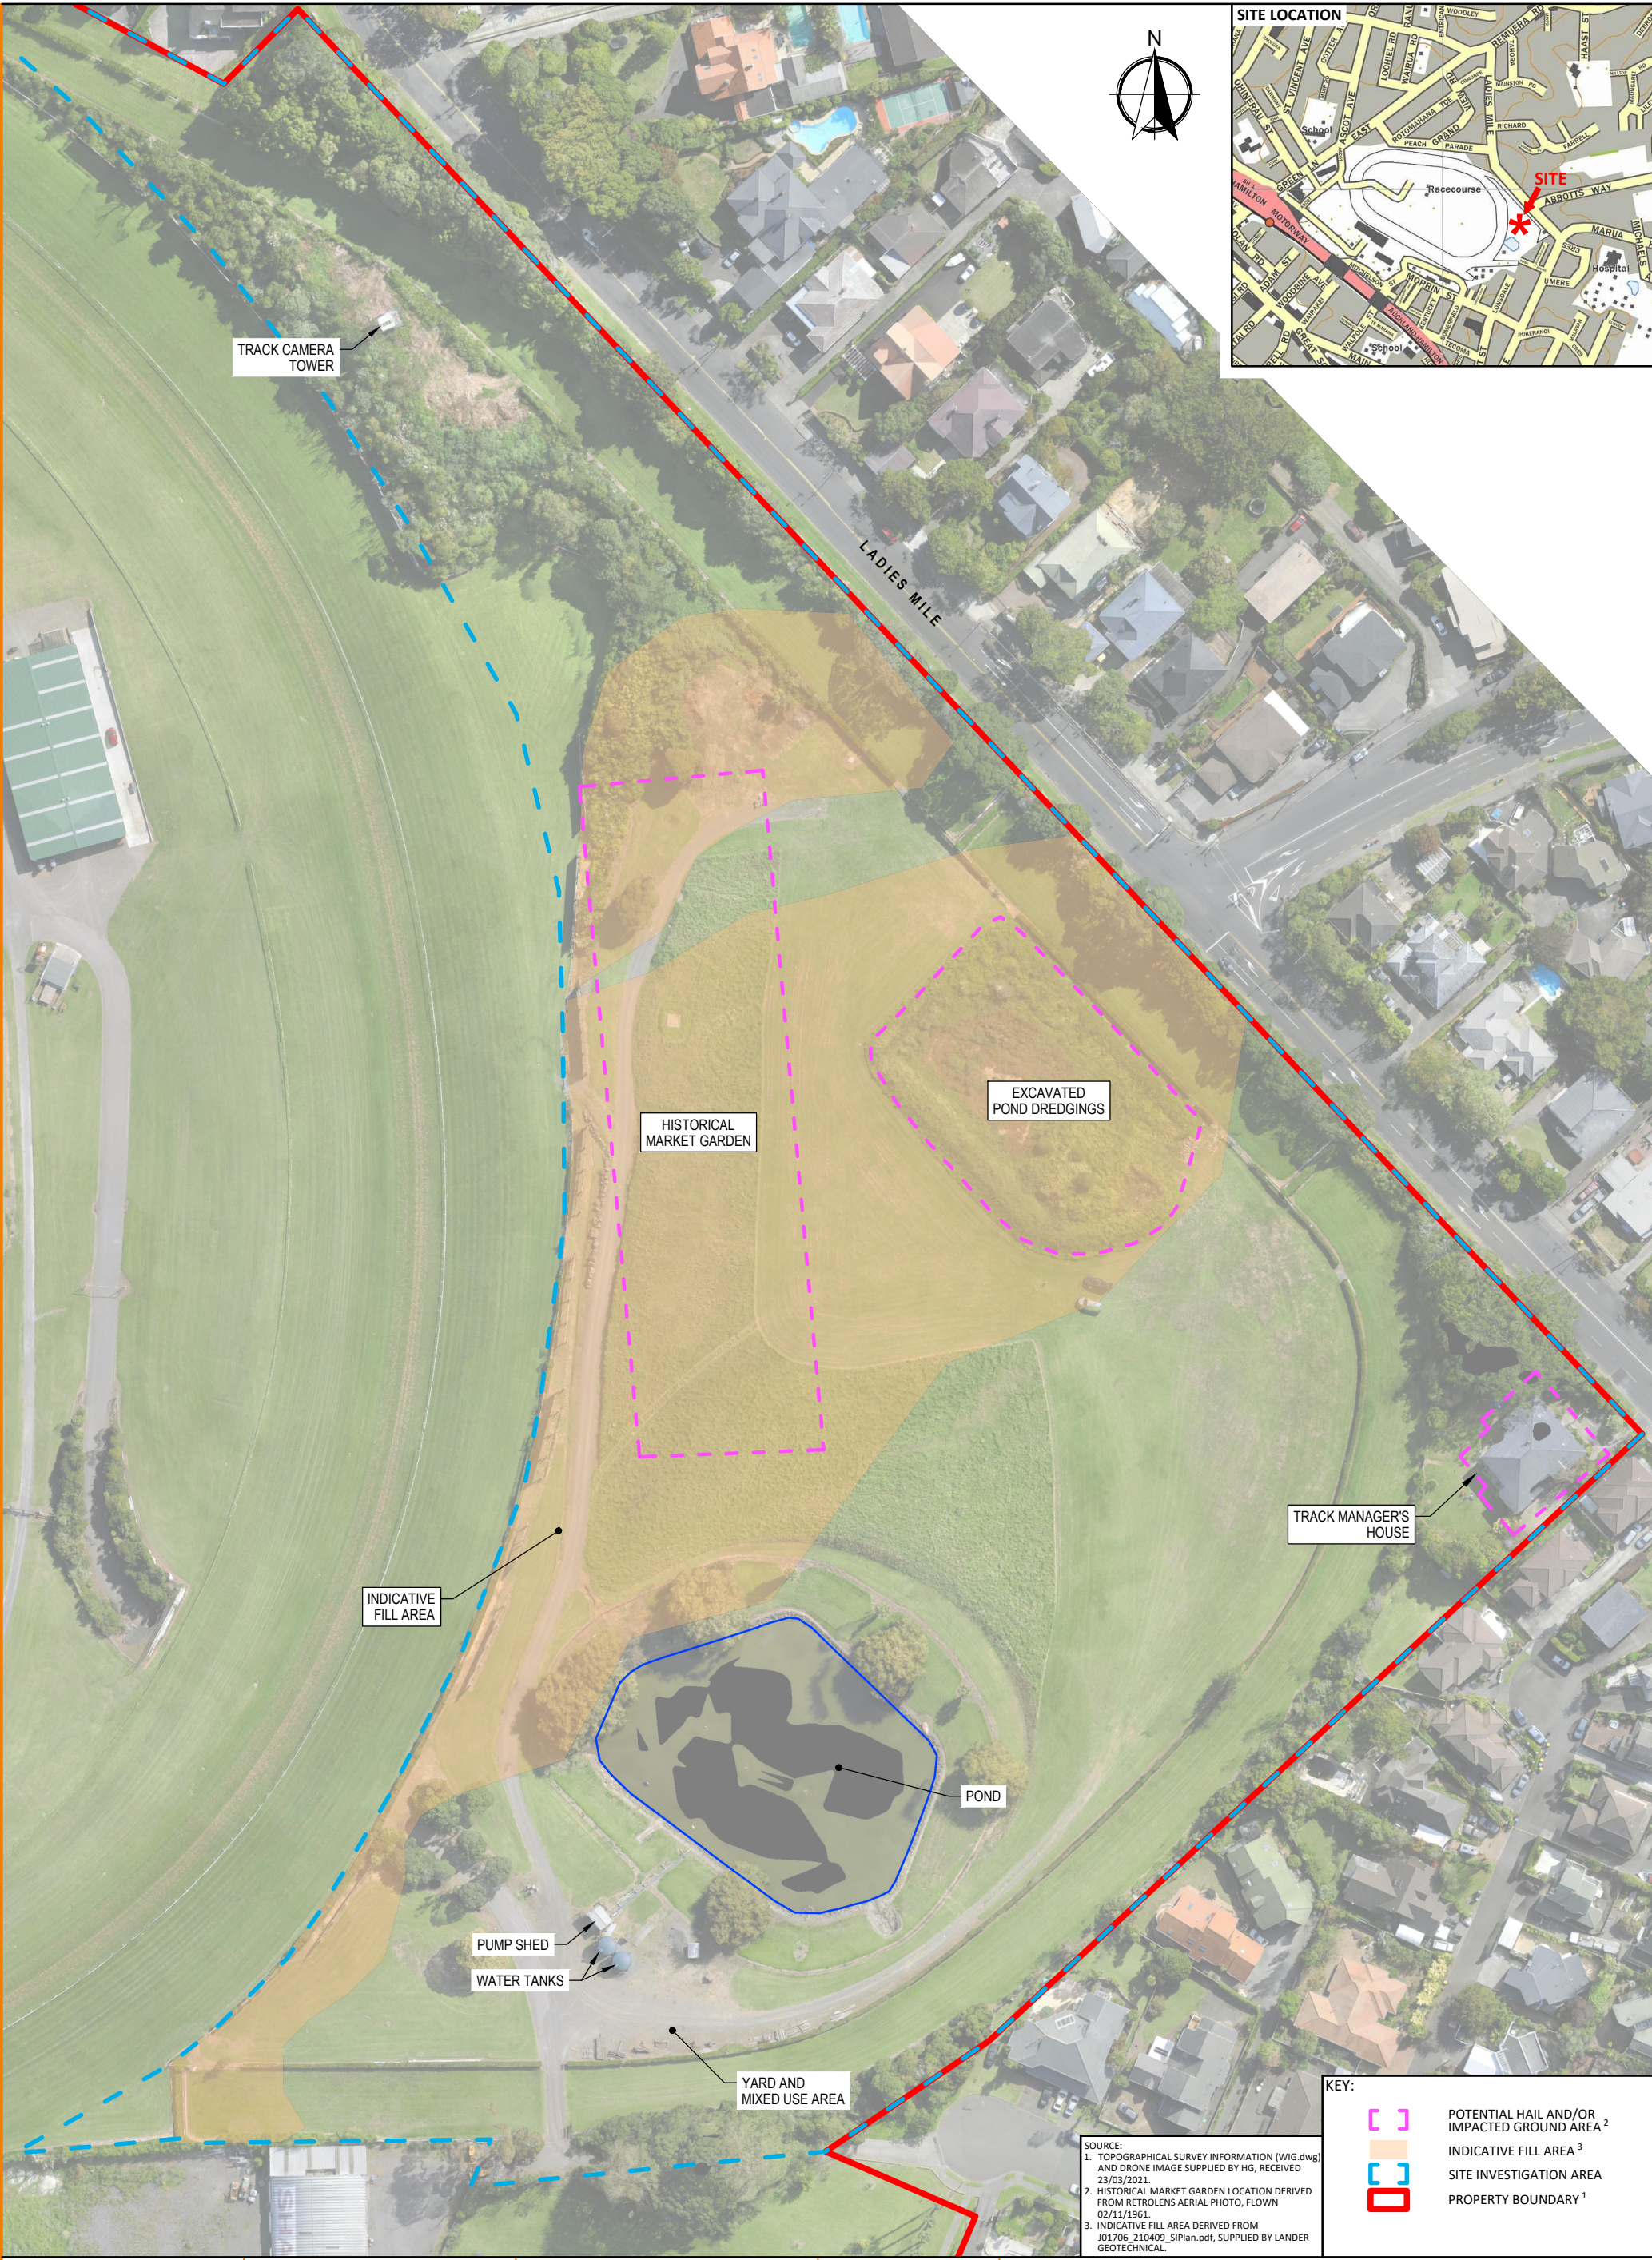
FIGURE
FIGURE 1: POTENTIAL HAIL AND/OR IMPACTED GROUND AREAS
PROJECT
PRELIMINARY AND DETAILED SITE INVESTIGATION - REMUERA PRECINCT, ELLERSLIE RACECOURSE - 100 ASCOT AVENUE, ELLERSLIE, AUCKLAND

The information gathered during this PSI and site walkover regarding the current and historical land uses of the site that have the potential to have caused ground contamination can be summarised as follows. It is considered that HAIL activities are more likely than not to have occurred at the site, with areas of potential and/or actual HAIL shown on Figure 1.

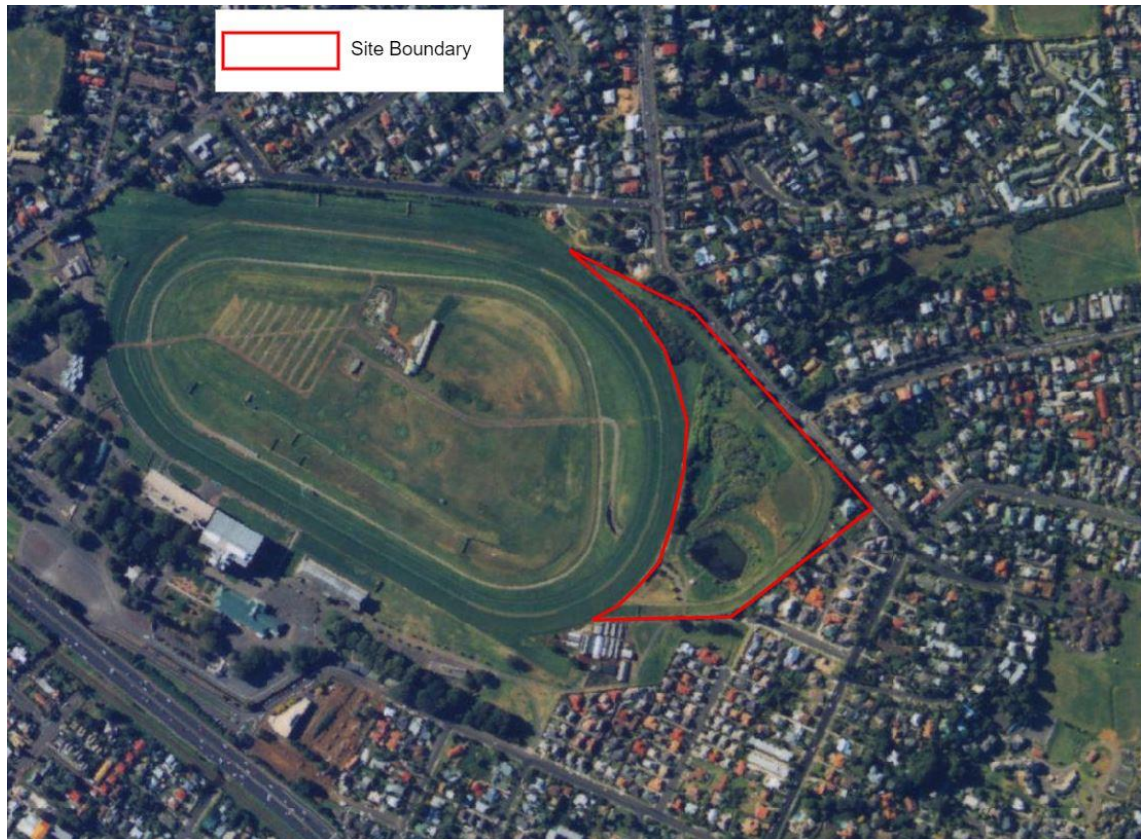
The historical aerial image review confirmed that the stormwater retention pond was established sometime between 1988 and 1996. The pond has been dredged in the past, and the excavated dredgings have been placed in the northeast site area (refer below and Figure 1). The retention pond is assumed to be the terminal point for any stormwater from the site, and receives run-off from the nearby roading network. As such, the water and associated sediment remaining within the pond are assumed to be a receiving environment for any contaminants which may be found in these areas – i.e. copper, lead, zinc and petroleum hydrocarbons.

Photograph 5: Remuera Precinct development area 1996.

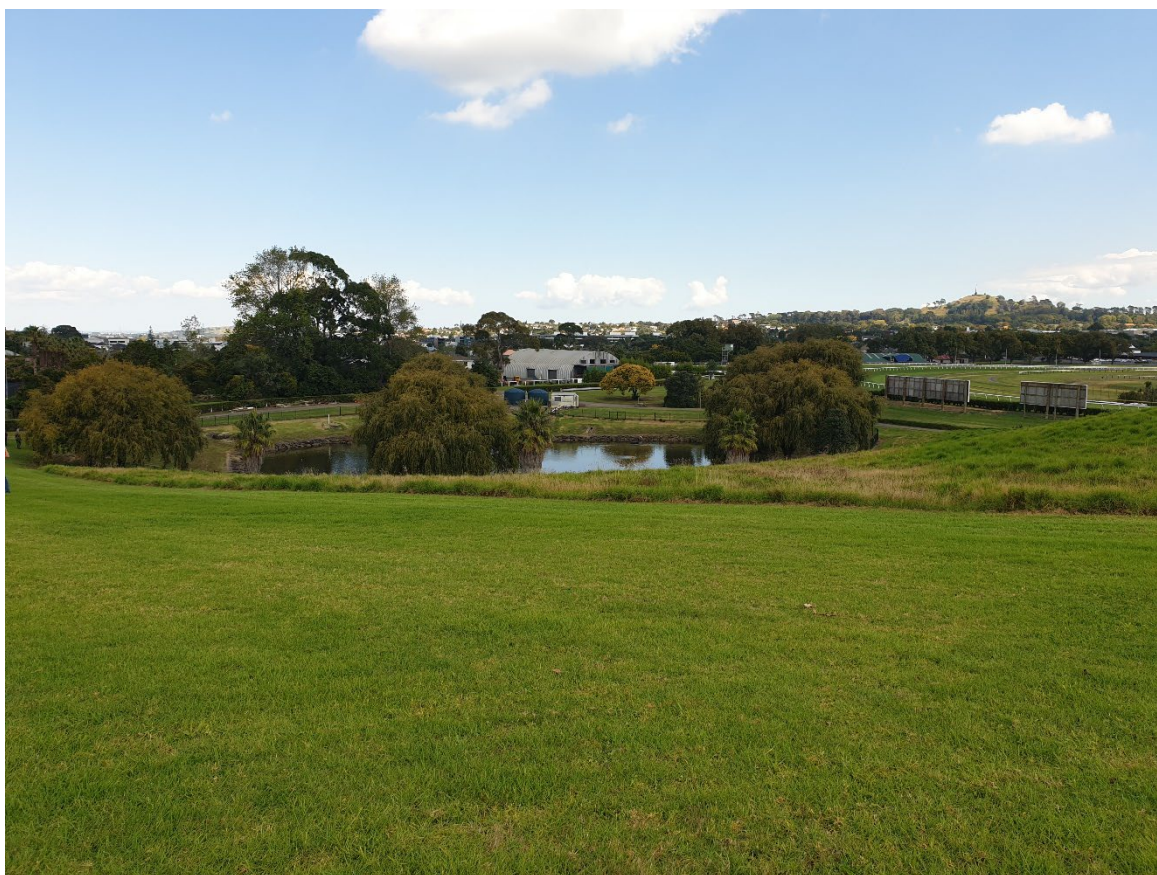
Potential imported fill material was observed across the Remuera Precinct site, running north from the stormwater pond, and west above the pond. During the site visit, these areas were observed to be covered with long grass. No visible signs of contamination were observed e.g., no refuse, or impacted vegetation.

Photograph 1: Looking southwest across the area of uncertified fill towards the stormwater detention pond.

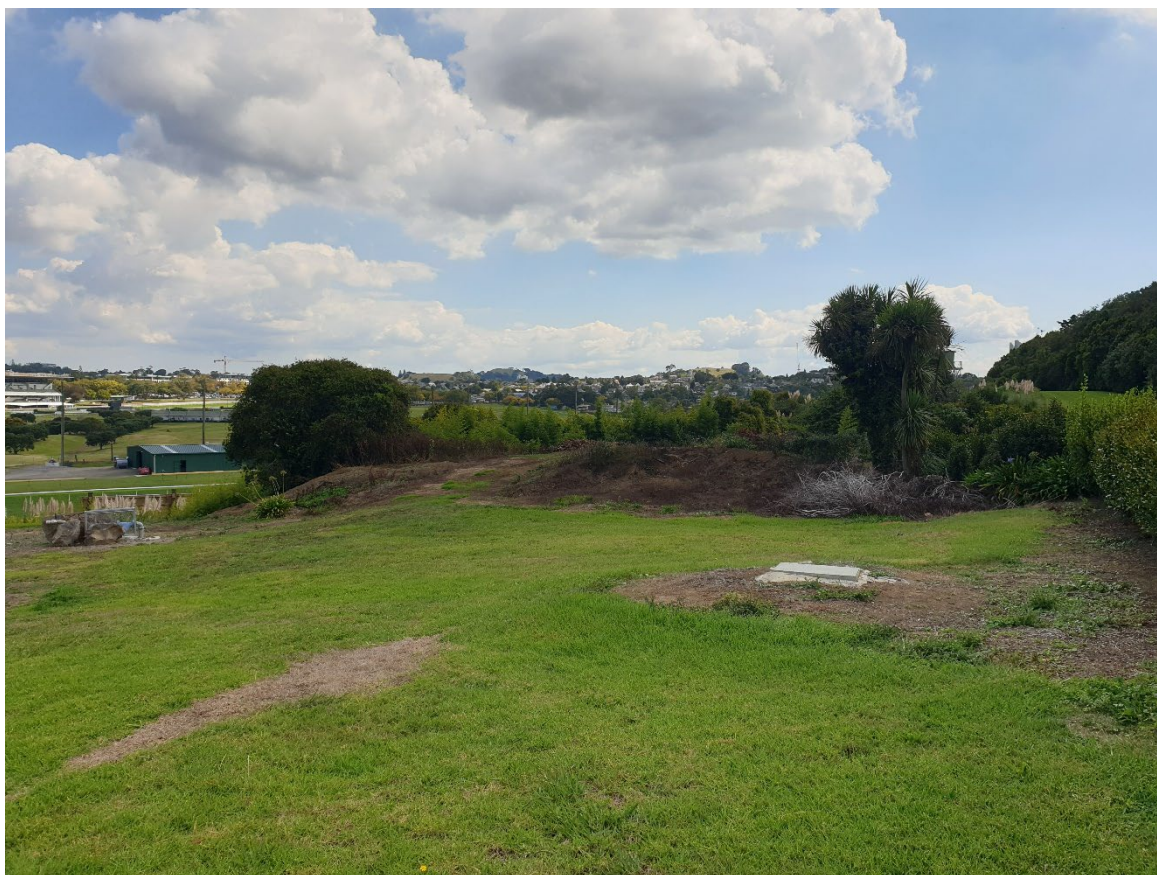
Another area of fill adjacent to the Ladies Mile site boundary was identified. During the site visit, this area was observed to have an uneven ground surface comprised of clay and some rocks (volcanic in appearance). On/within the soil timber, concrete, lengths of drainage pipe and greenwaste (i.e. branches, leaves, etc) were observed. No visible signs of contamination, such as soil staining, were observed beyond the inert materials described. An area of dead grass was present at the end of the access track.

Photograph 2: Looking east at the area of fill adjacent to Ladies Mile site boundary.

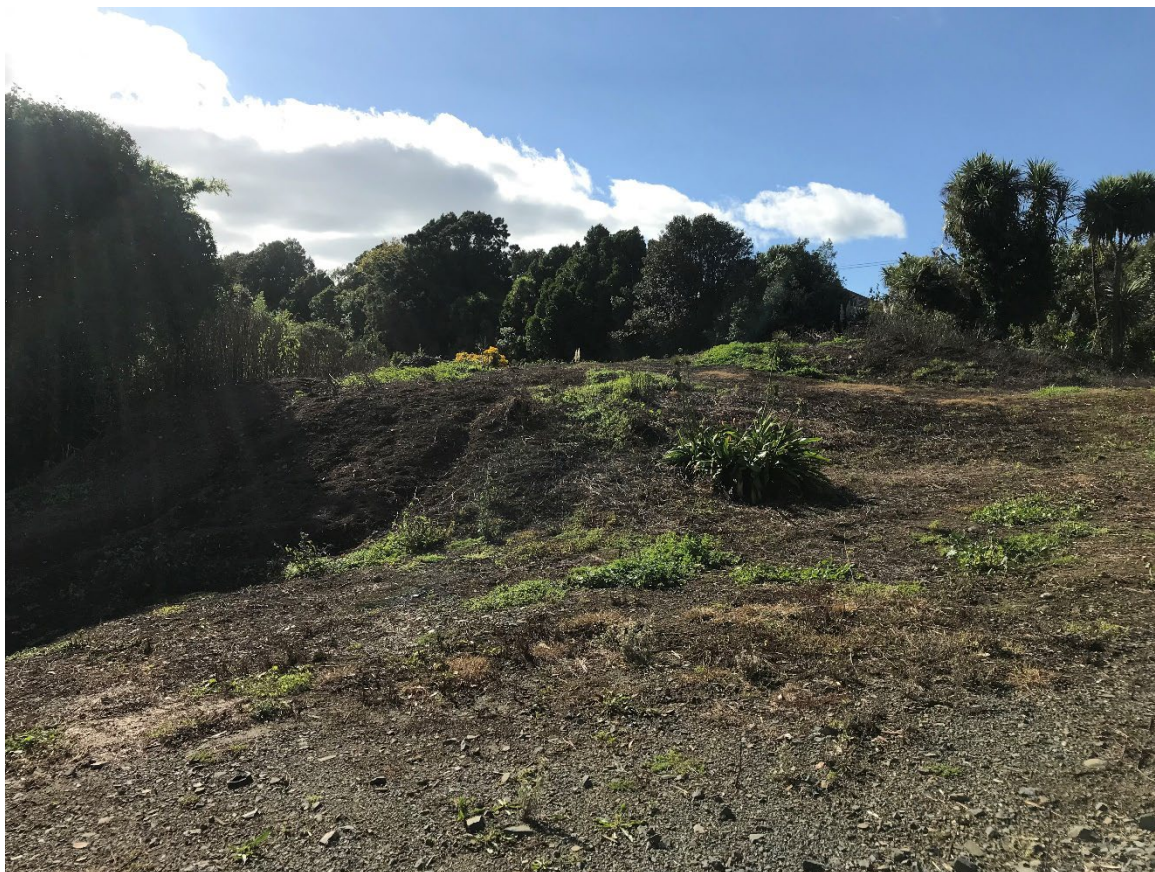
Photograph 3: Looking north at the area of fill adjacent to Ladies Mile site boundary.

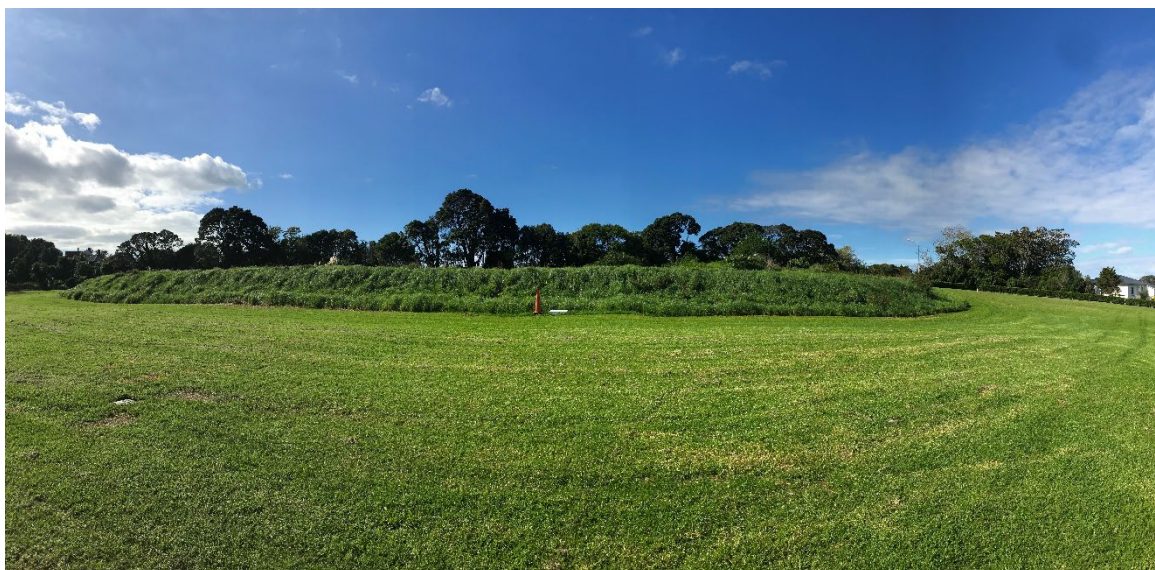
Sediments dredged from the onsite stormwater pond have been placed on the north-eastern boundary of the site (pers. comms. Mr Fulford, ARC Track Manager). The profile of this area is raised approx. 1 m above the surrounding ground level. A small pile of broken concrete was present at the south eastern end of the excavated pond dredgings area.

Photograph 4: Looking north across the area of uncertified fill towards the excavated pond dredgings.

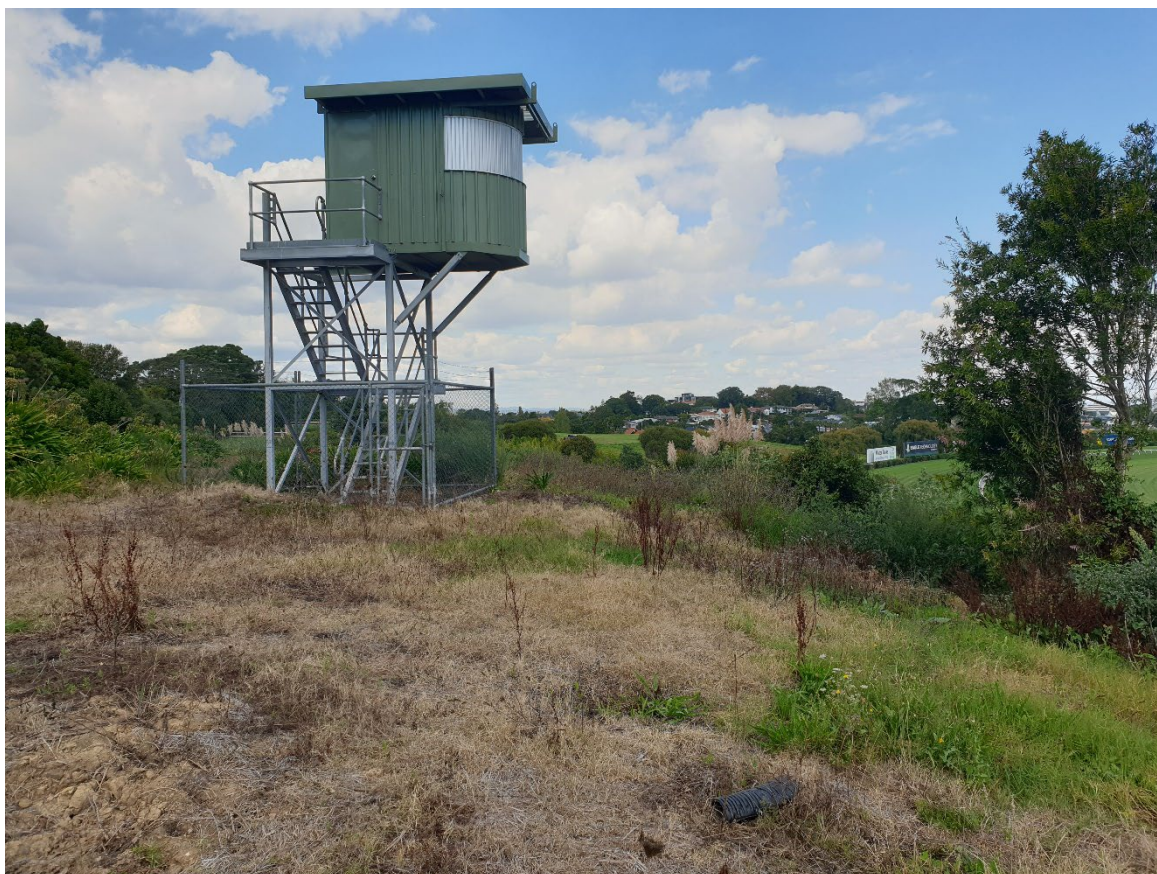
The building located within the north western wedge of the site is a tower, housing track cameras. The tower appeared to be constructed of colour steel and the tower struts of galvanised metal. To the south west of the pond is a shed. The shed appeared to be constructed of metal cladding. No suspected ACM was observed on the exterior. Two HDPE water tanks are present next to the shed.

Photograph 5: Looking north east at the track camera tower.

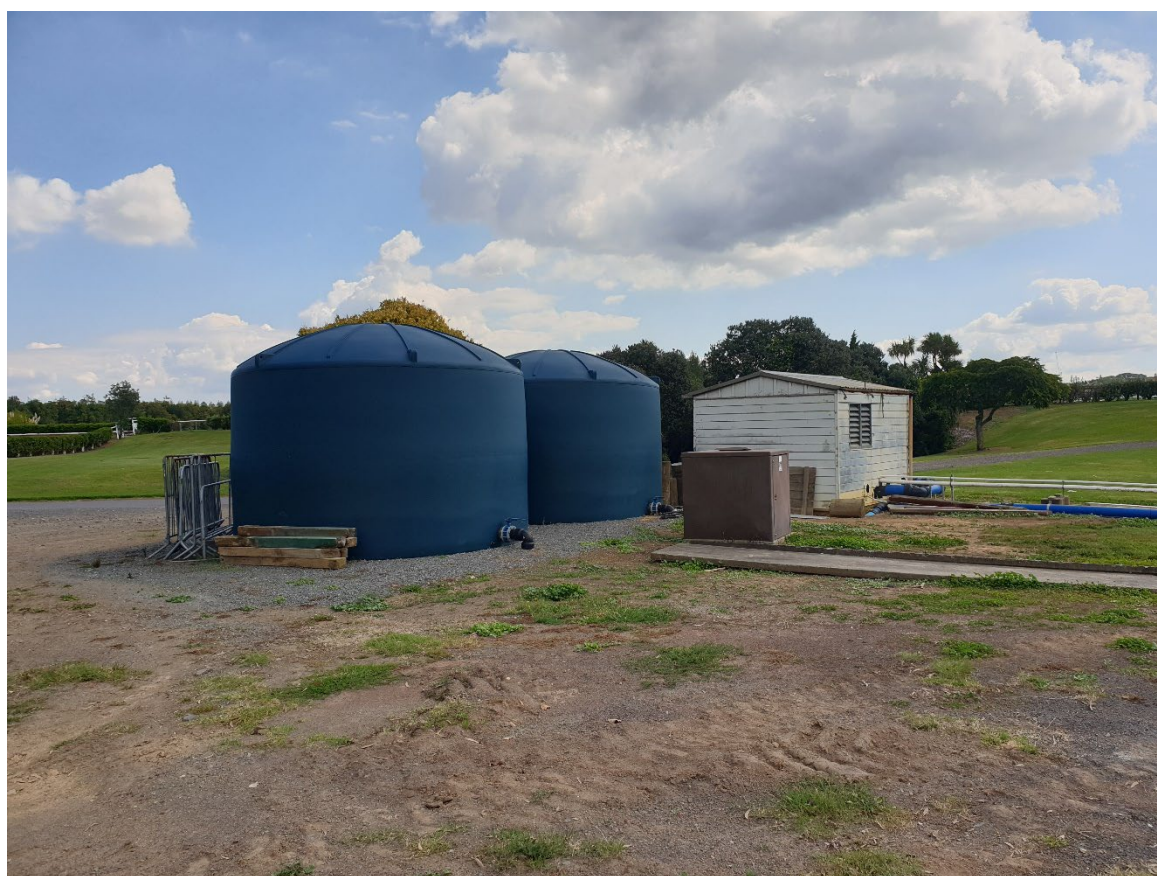
Photograph 6: Looking west at the pump shed and the water tanks.

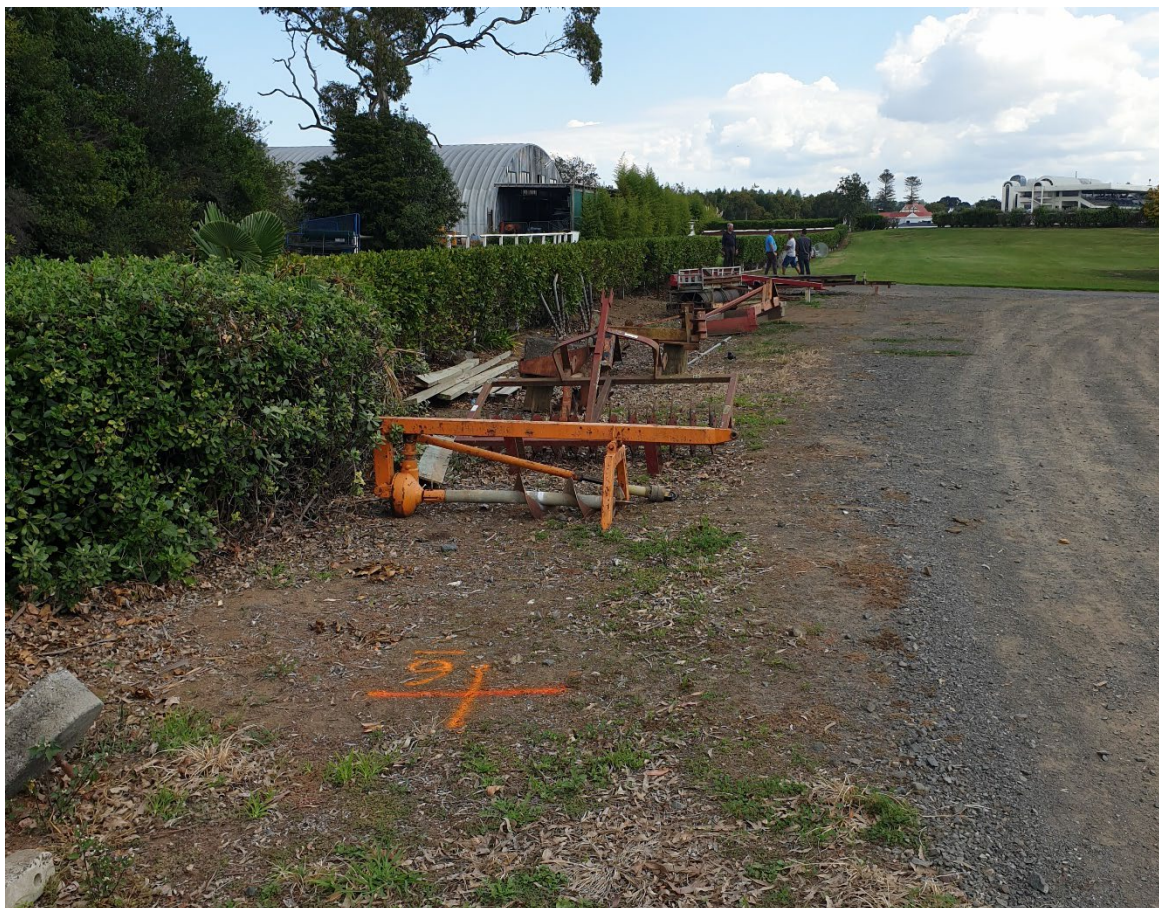
Photograph 7: Looking south west at the mixed yard/storage area.

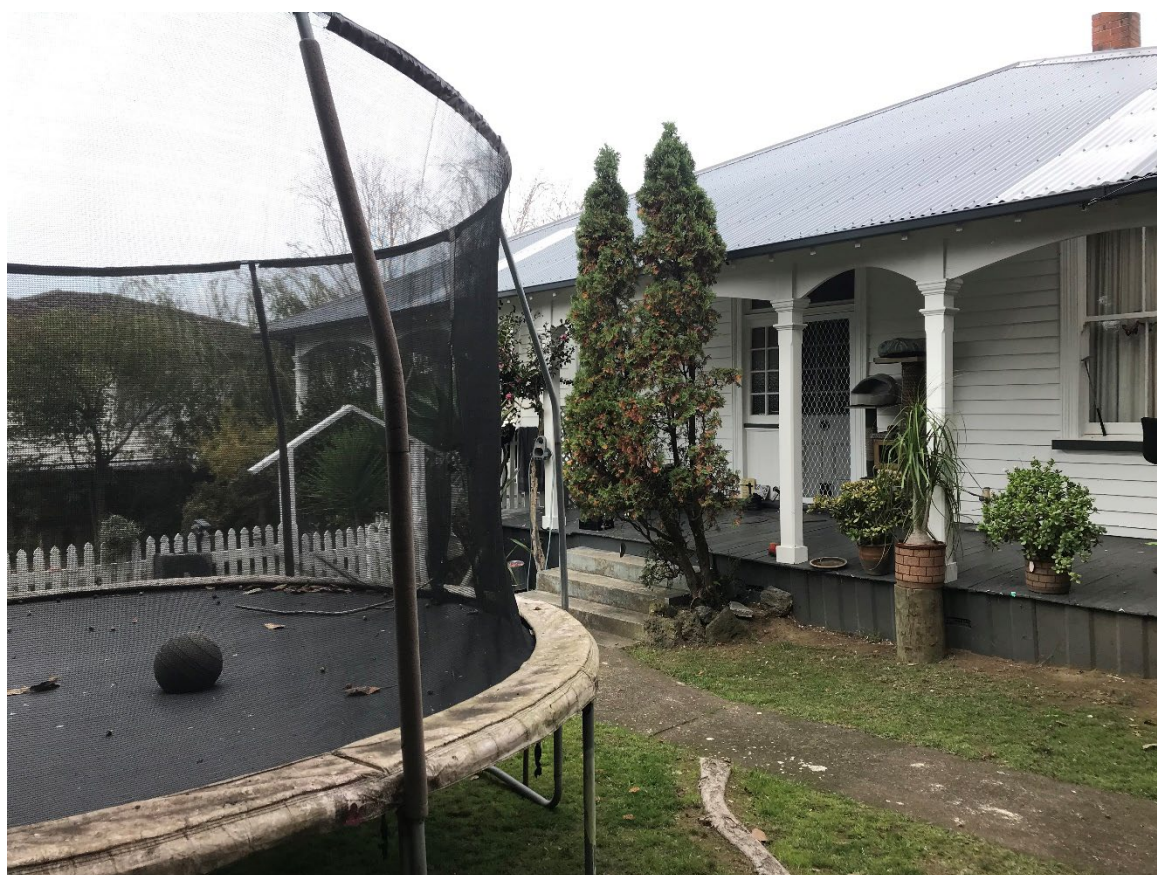
The Track Manager's House is situated in the eastern corner of the site and may be accessed both internally through via the racecourse and via Ladies Mile. It is clad with painted timber weatherboard, and panel baseboard (potentially constructed from asbestos containing material (ACM)). The baseboard was noted to be in good condition. The section was noted to be tidy, and well-kept. No staining or other indication of contamination was observed.

Soil material was observed to comprise of topsoil, reworked natural ground and/or natural ground during the site investigation works, with no identification of stained or odorous soils. ACMs were observed in one of the test pits and in building fabric comprising the baseboard on the Track Manager's house.

Photograph 8: Front of track manager's house.

Soil remediation is recommended to be undertaken as a permitted activity under the NES-CS for the halo (i.e. soils immediately surrounding) of the Track Manager's house. Specifications regarding the extent of removal of soils from this area, and the handling requirements for these soils will be detailed in a Remedial Action Plan (RAP) directed by a SQEP, to demonstrate compliance with the permitted activity requirements of the NES-CS framework (this RAP and associated CSMP will

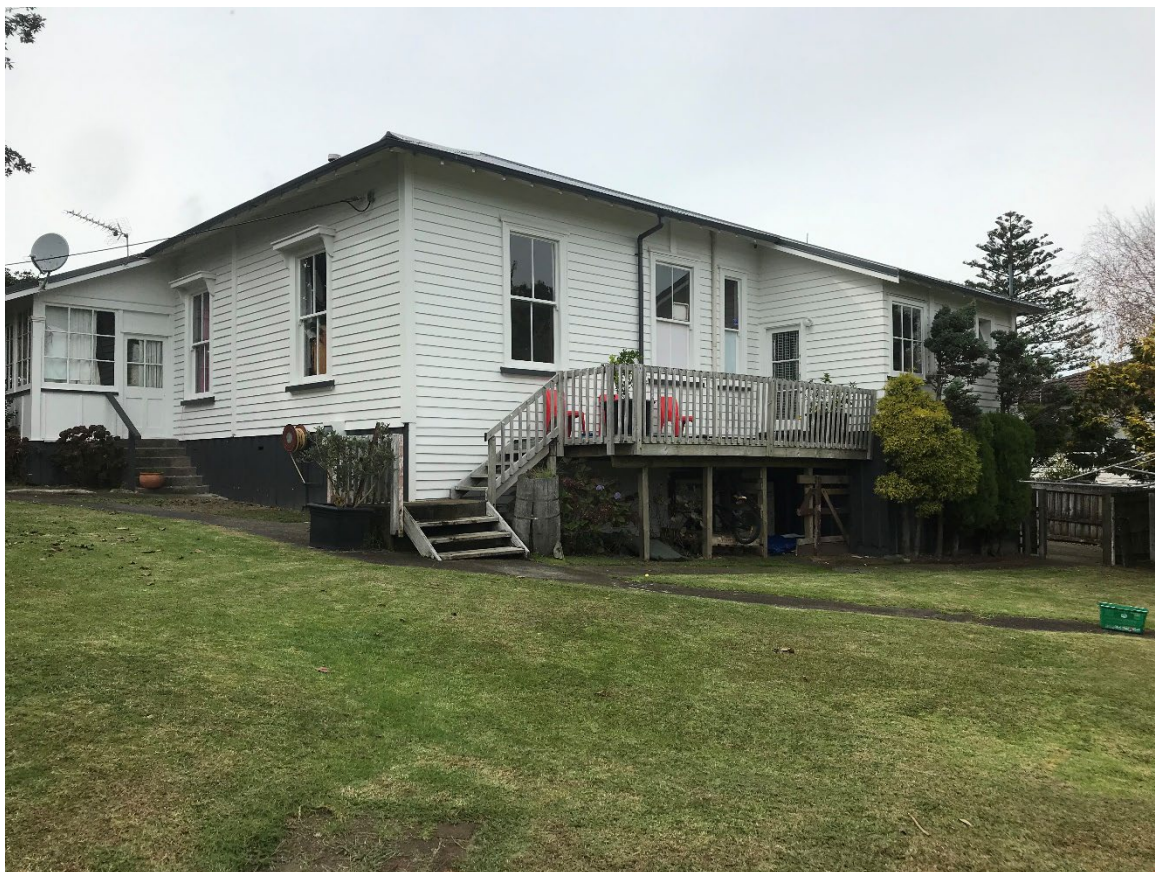
Photograph 9: Back of track manager's house.
