**Environmental Site Assessment:  
Preliminary and Detailed Site Investigation to Support Structure Plan and Plan Change at  
Coatesville - Riverhead Highway, Riverhead**

26 September 2023

Job No. 21710

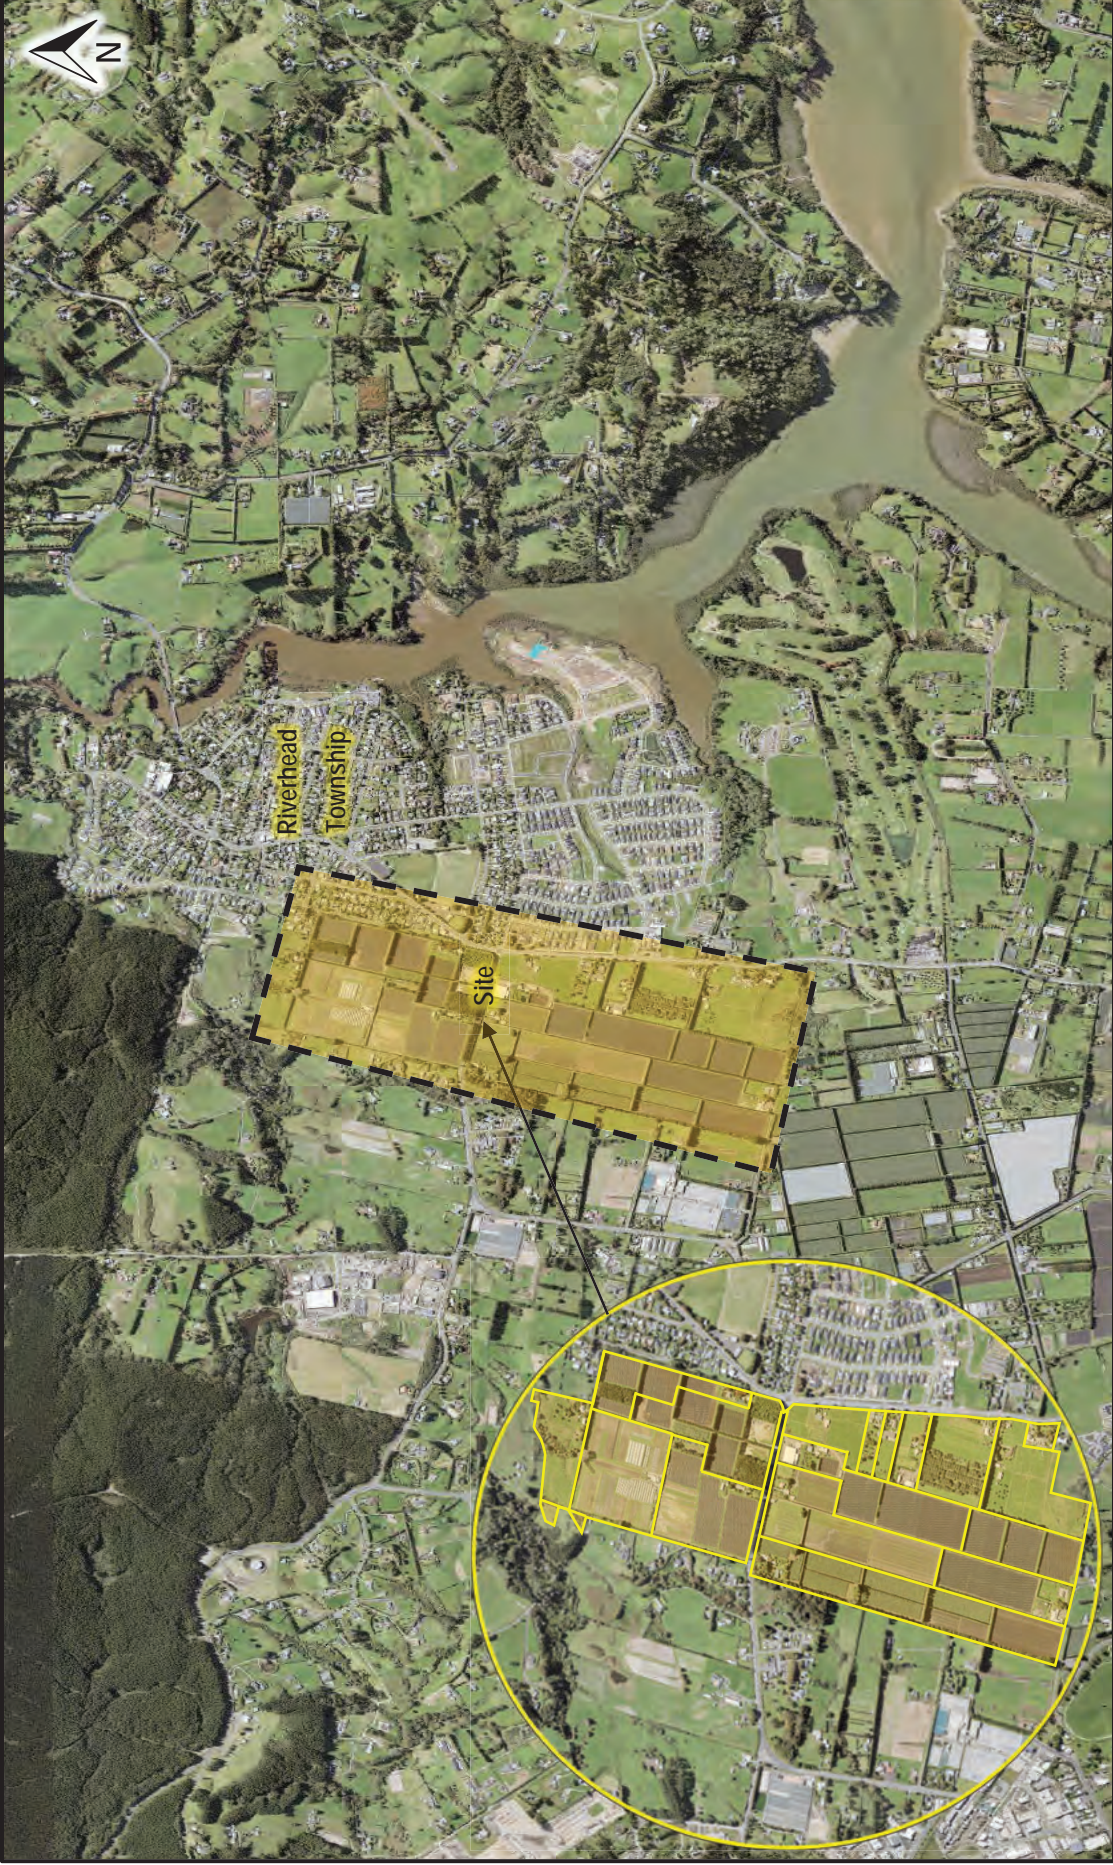
## Site Plan

Soil & Rock Consultants (S&RC) were engaged by Fletcher Residential Limited (FRL) on behalf of Riverhead Landowner Group <sup>1</sup> to undertake an Environmental Site Assessment (ESA) to support a proposed Structure Plan and Plan Change Application at Coatesville - Riverhead Highway, Riverhead, Auckland, the 'site' shown in Figure 1 below and in S&RC Drawing 21710 / 1 provided in **Appendix A**.

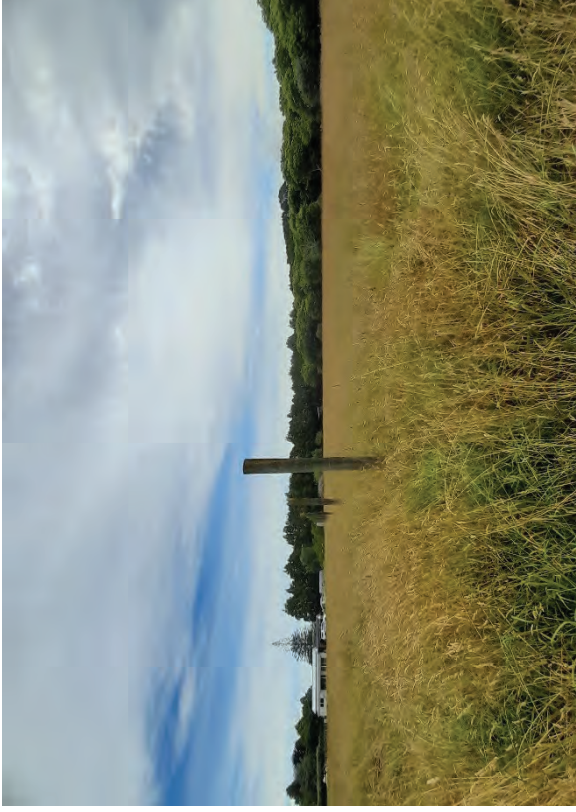
**Photo 1:** View from the north-west corner of 1186 Coatesville – Riverhead Highway looking towards the south-east corner of the site where the dwelling and associated structures are located. The site appears to be completely grassland with wooden poles likely a remnant of past horticultural activities.

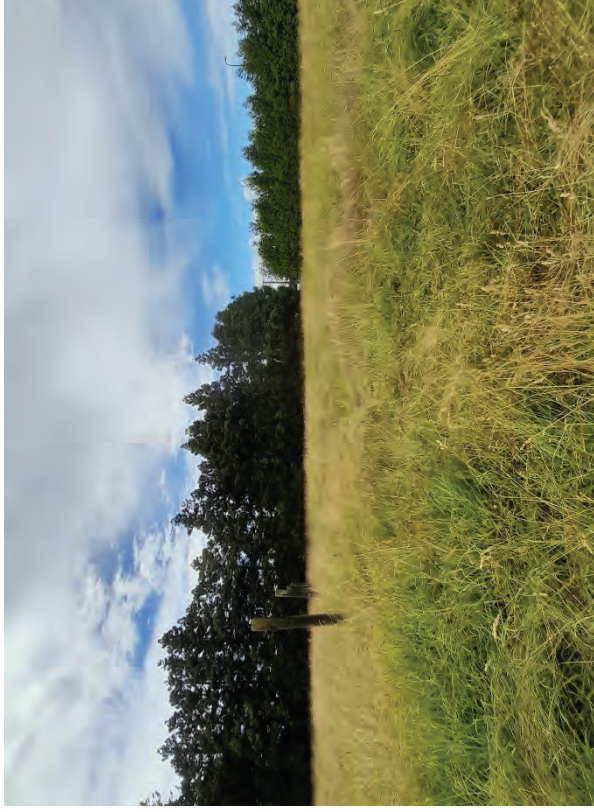
**Photo 2:** View from the south-west corner of 1186 Coatesville – Riverhead Highway looking towards the north-east to where Coatesville – Riverhead Highway is located behind the shorter of the shelterbelt trees.

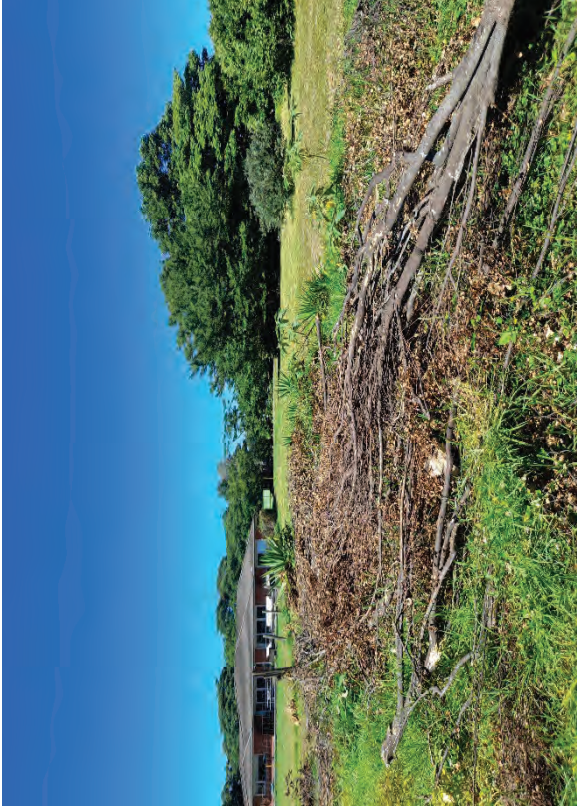
**Photo 3:** View from the dwelling property northern boundary of 51 Lathrope Road looking south towards the dwelling on the site.

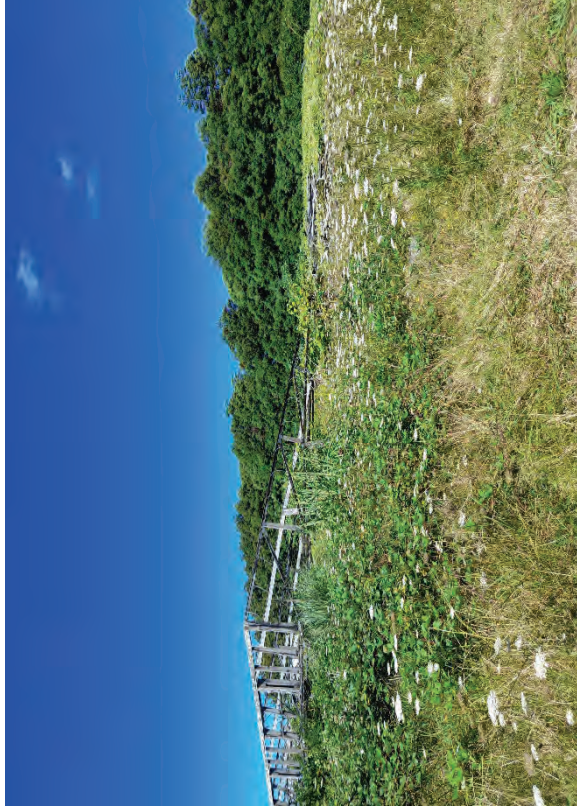
**Photo 4:** View from the dwelling property northern boundary at 51 Lathrope Road looking south-west towards a former structure, it is unknown the use for the structure.

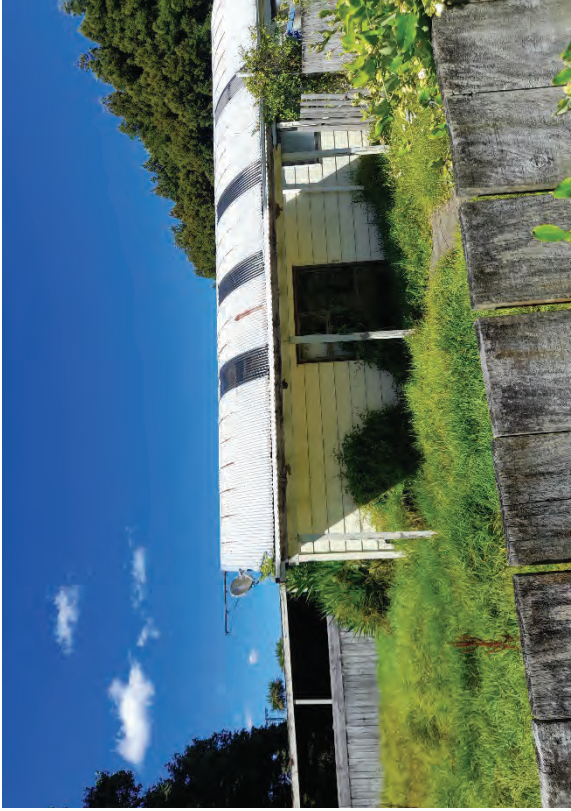
**Photo 5:** View from the associated structure in the south-west corner of 51 Lathrope Road, the structure contains what appears to have been a site office / admin facility and implement sheds for equipment and other sheds for use unknown.

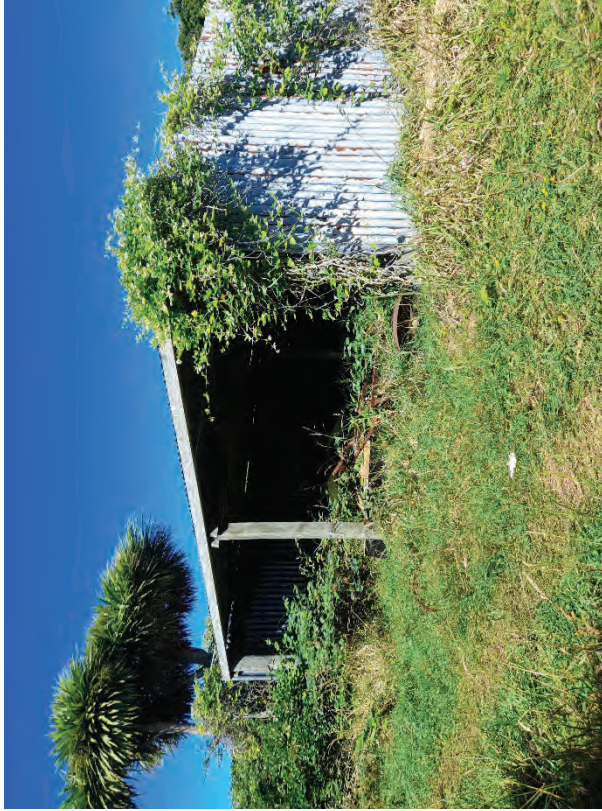
**Photo 6:** View from the south-west corner of the 51 Lathrope Road site towards a shed likely used as an implement shed for storing machinery and equipment.

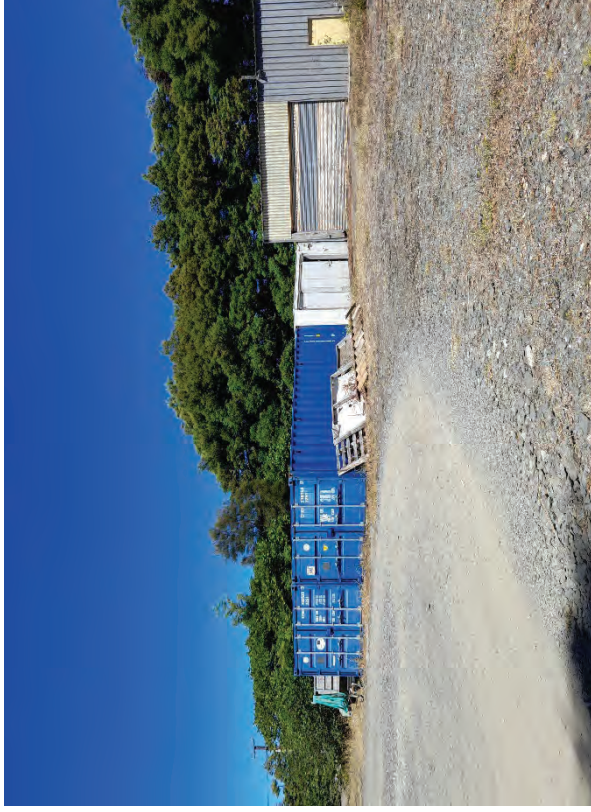
**Photo 7:** View from the associated structure in the south-west corner of the site looking towards the site access / exit (middle left of photograph), shipping containers (in good condition) are visible next to sheds. Ground cover in the area is compacted gravel / fill material.

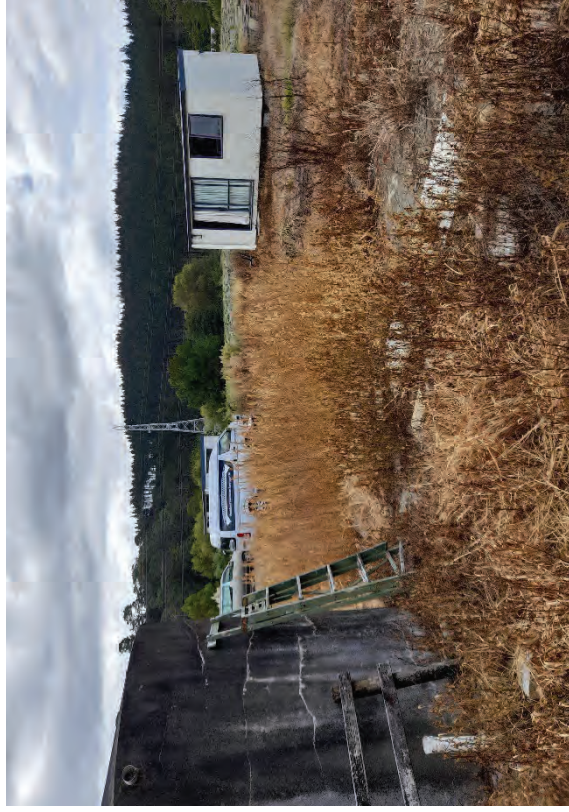
**Photo 8:** View from 30 Cambridge Road looking north-west, site contains random structures across the site and vehicles parked up. High voltage powerlines are on the sites northern boundary, beyond that is the 22 Duke Street site and the Riverhead Forest.

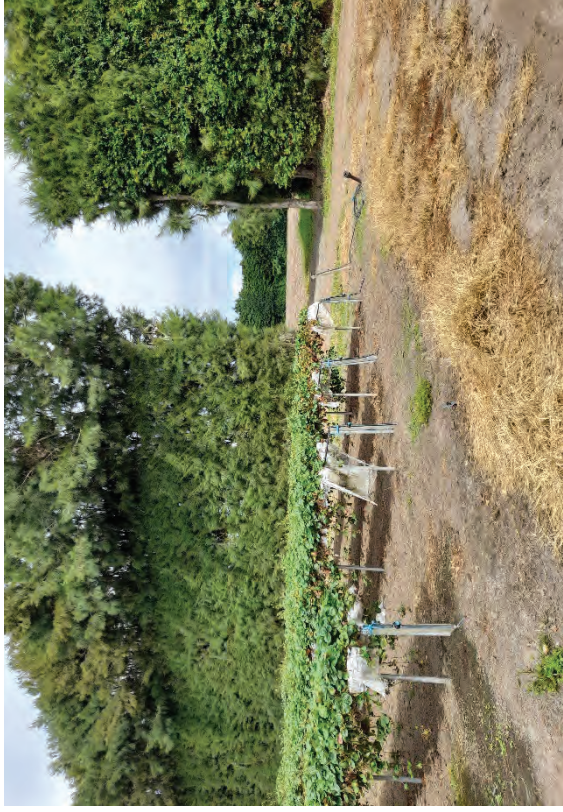
**Photo 9:** View from 340 Riverhead Road looking towards the southwest at the point where the site narrows and changes between the location with structures and driveways to the southern part of the site which is completely utilised for horticultural use.

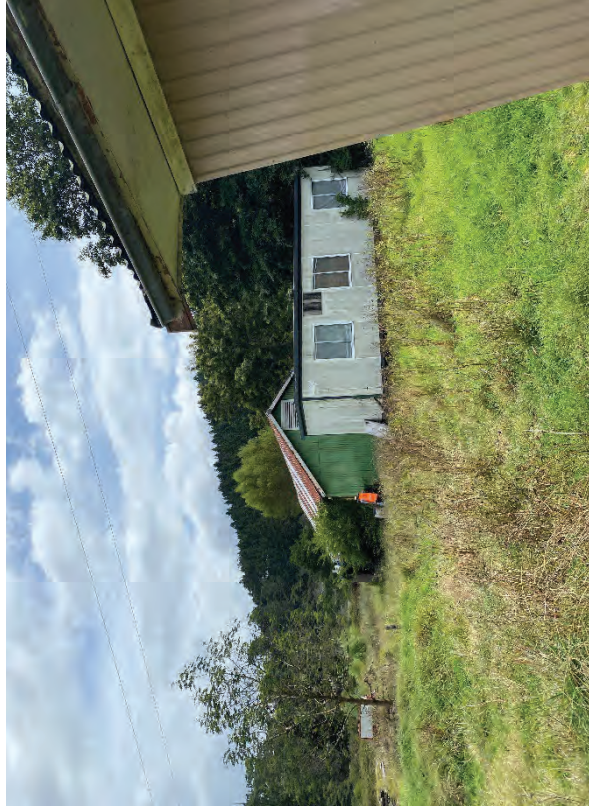
**Photo 10:** View from the structures on the northern boundary at 22 Duke Street looking towards the west with Riverhead Forest in the background. The structures on this site are old and in a state of disrepair.

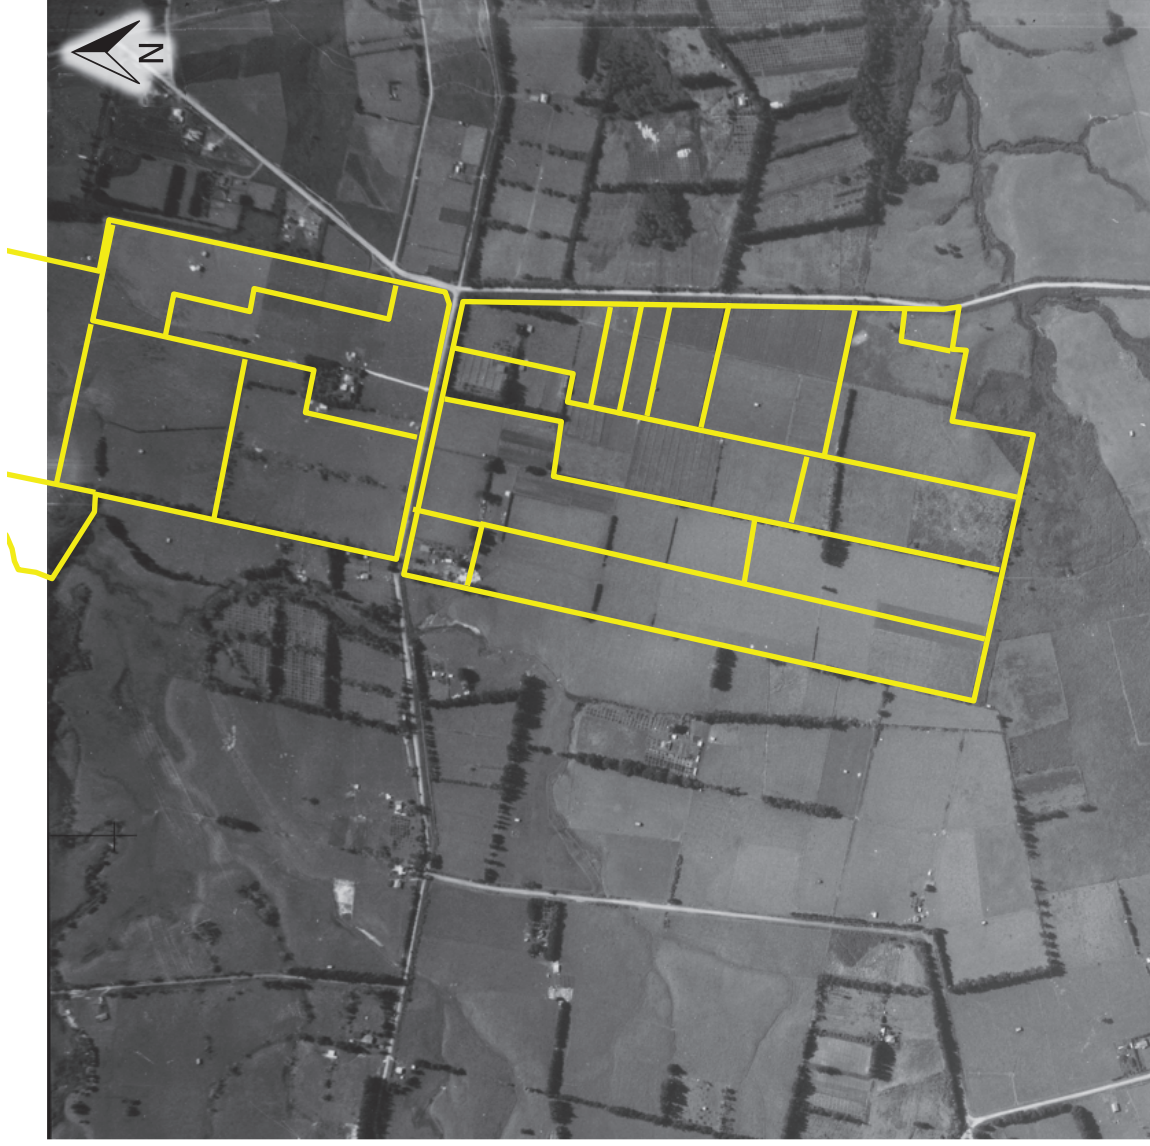
1963

Historical Aerial Photography  
Auckland Council GeoMaps

The most recent aerial photograph was sourced from Auckland Council and is dated 2017. Site conditions observed in the 2017 image are similar to those observed during the January to April 2022 site walkovers.

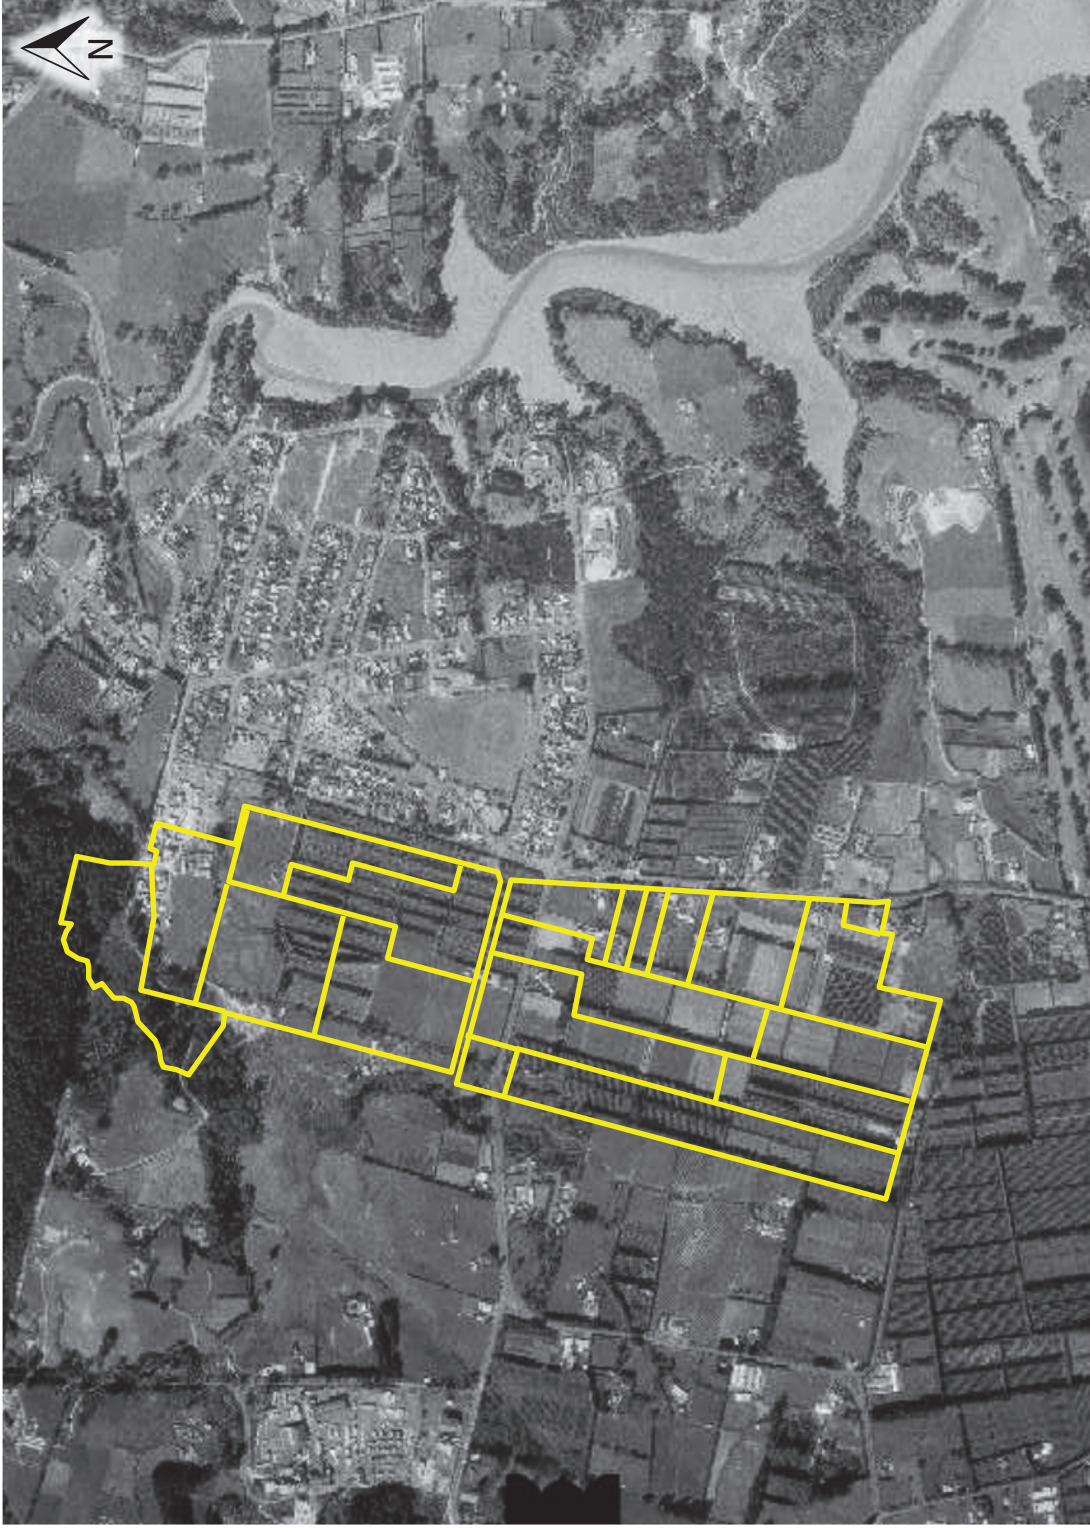
1988

Historical Aerial Photography  
Sourced from <http://retrolens.nz> and licensed by LINZ CC-BY 3.0

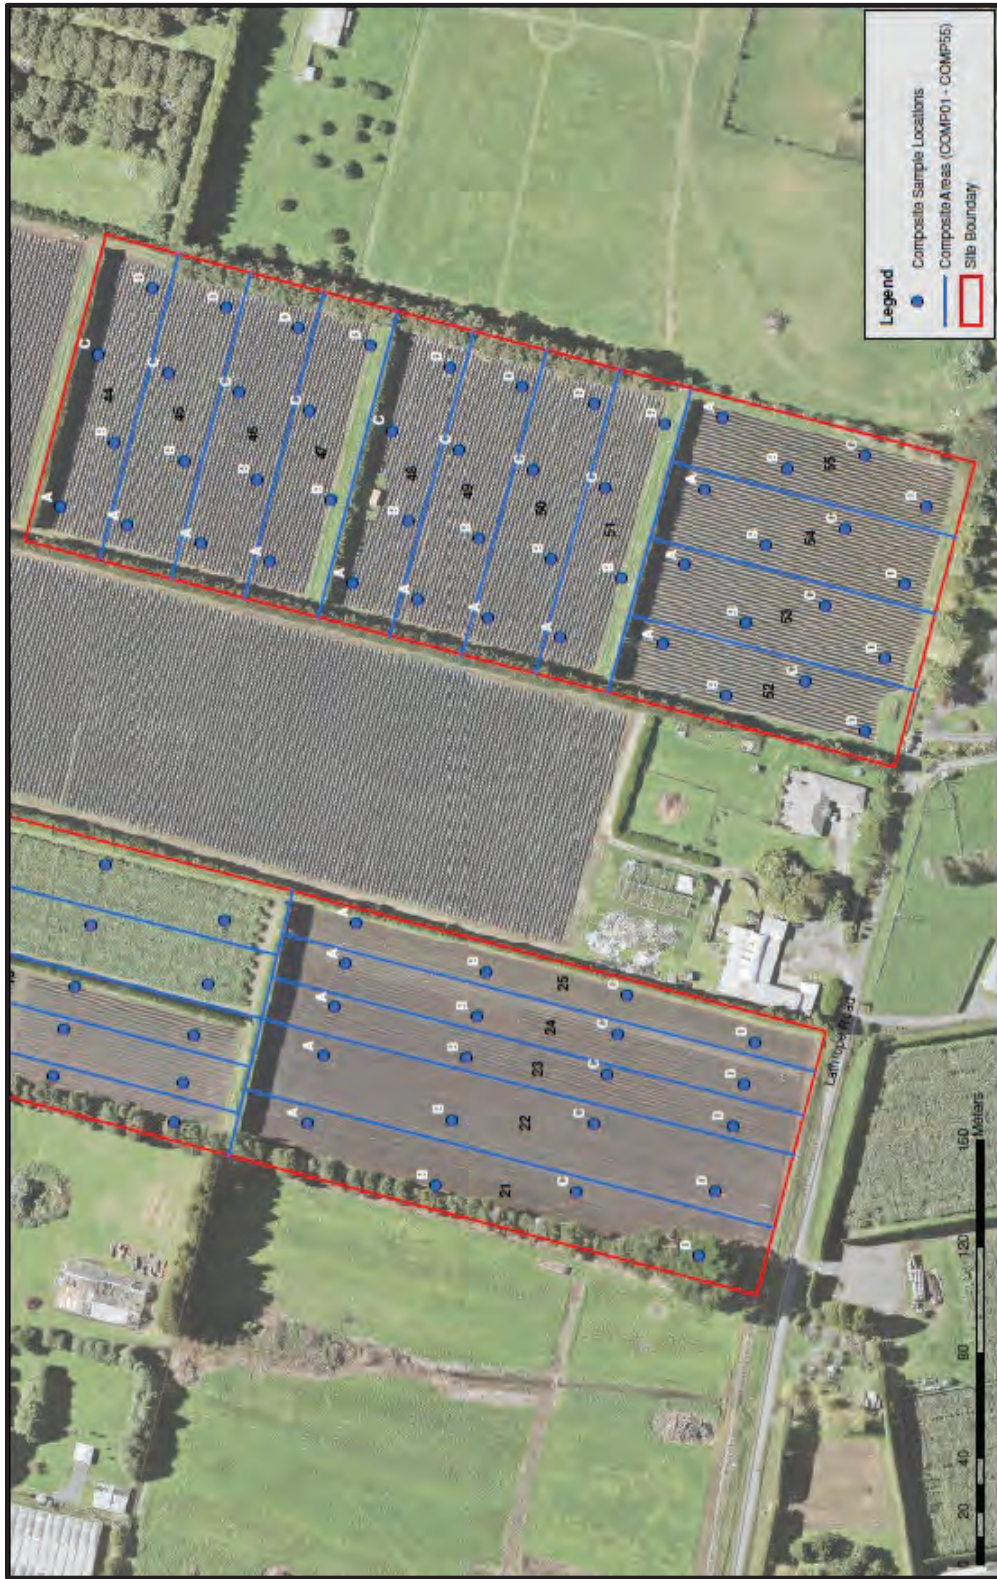
Drawing Number: 1139.001.09  
 Drawn By: SD  
 Checked By: DOR  
 Date: 11/07/2017

**Legend**  
 • Composite Sample Locations  
 — Composite Areas (COMPO1 - COMPS5)  
 □ Site Boundary

Soil samples were collected using a hand auger. Soil sampling equipment was decontaminated between sampling locations and disposable nitrile gloves were used and replaced between sampling locations in order to prevent cross contamination. All samples were collected in accordance with strict environmental sampling protocols to ensure reliable and representative results.
