Supporting Growth

Trig Road
Corridor
Upgrade

Preliminary
Site
Investigation

Version 1.0
August 2020

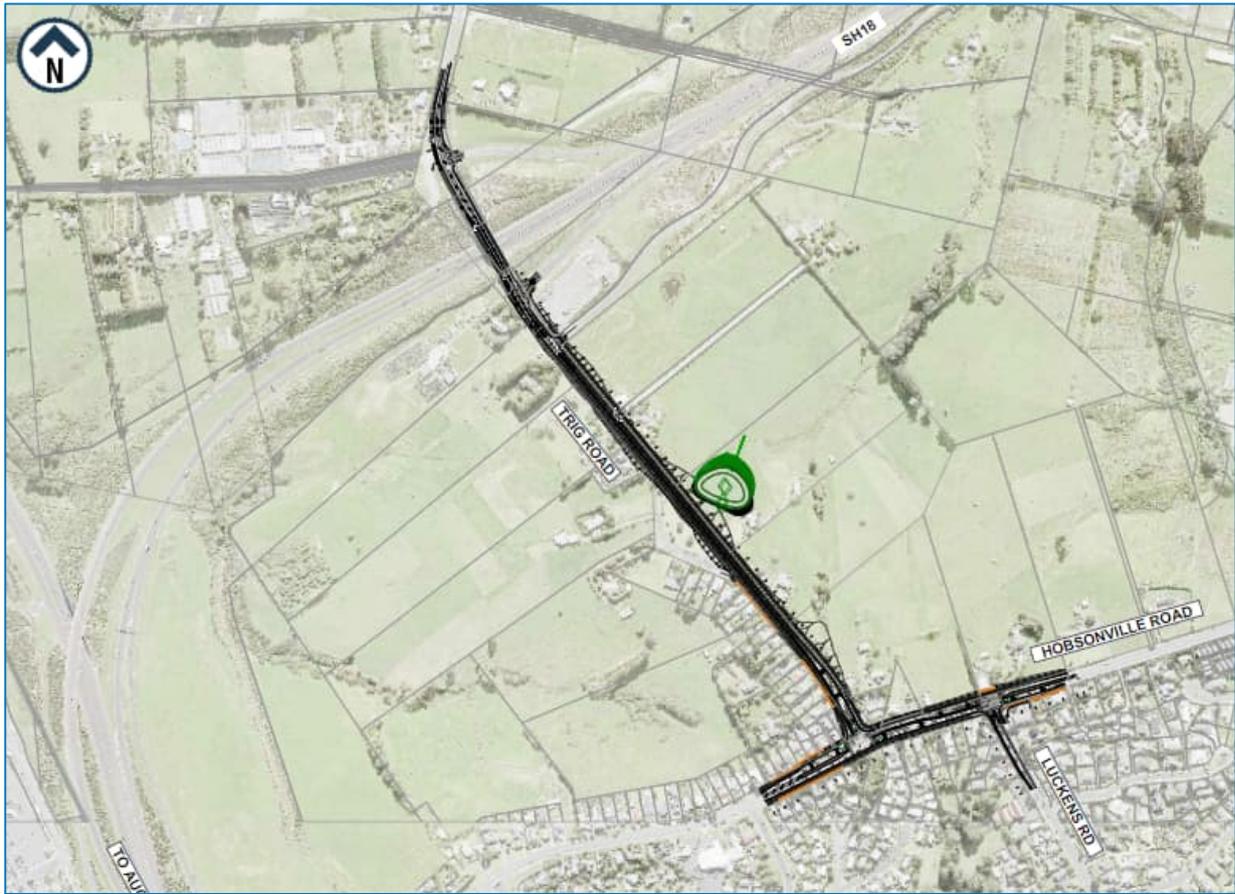
Figure 1: Project Area Plan

The Project consists of the widening and upgrade of Trig Road between the State Highway 18 (**SH18**) off-ramps and Hobsonville Road. The Project area extends along the southern extent of Trig Road starting adjacent to the property located at 82 Trig Road down to the intersection with Hobsonville Road to the south. The Project area also extends along a section of Hobsonville Road between adjacent properties 60 and 78 Hobsonville Road and the northern extent of Luckens Road down to the adjacent property at 5 Luckens Road. Refer to Figure 1 for plan illustrating the extent of the Project area.

The Project is currently in preliminary phases and the final extent of land disturbance activities is yet to be defined. For the purposes of this Preliminary Site Investigation (**PSI**) we have assumed land disturbance to the extent as illustrated in black on Figure 1.

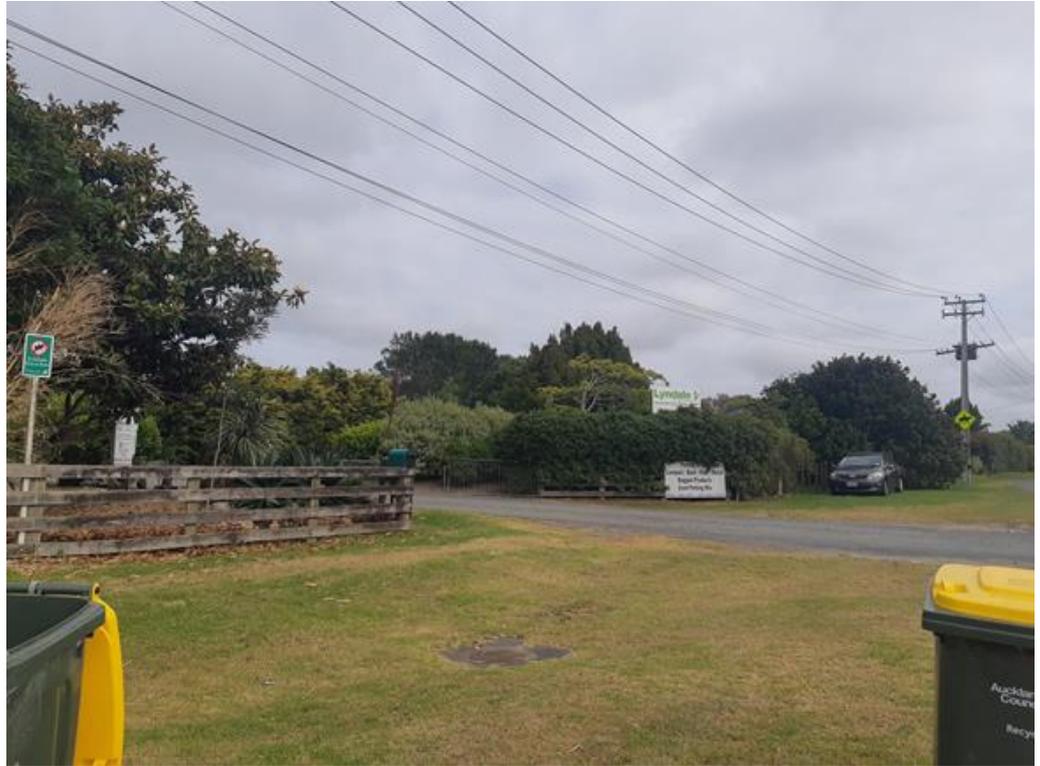
Address:
82 Trig Road,
Whenuapai, Auckland
0618

Description:
Lyndale Nursery, facing
north-west.

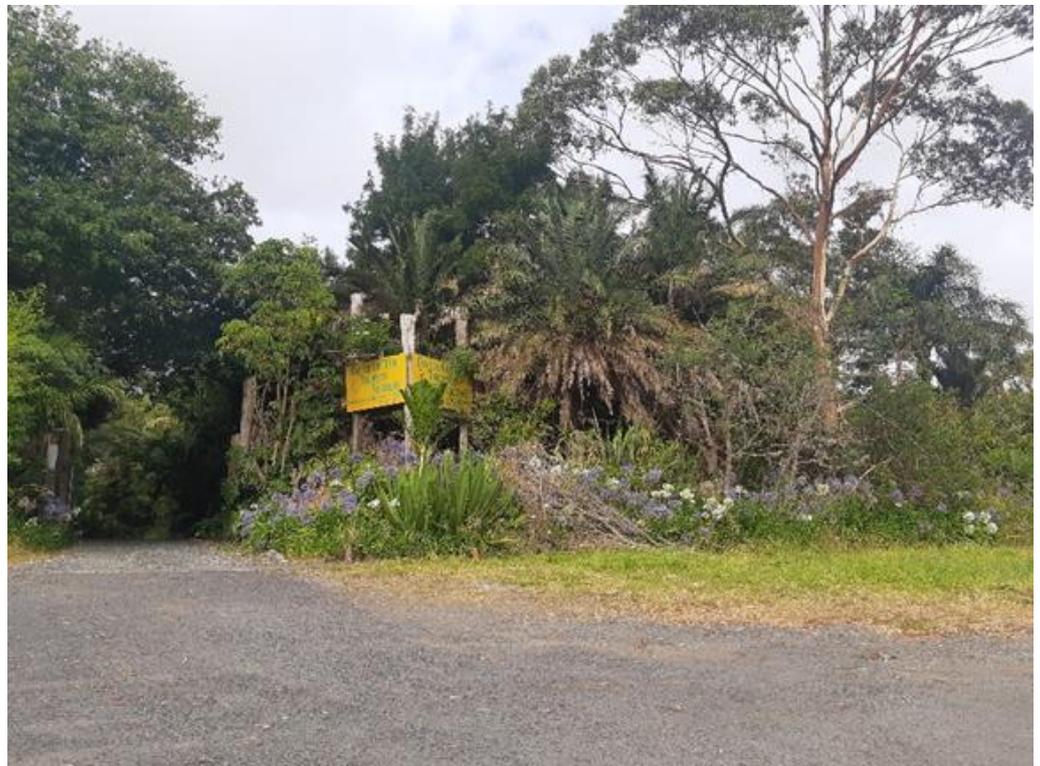
Photo No.
2

Address:
62 Trig Road,
Whenuapai, Auckland
0618

Description:
Touch of the Tropics
Nursery, facing south-
west.

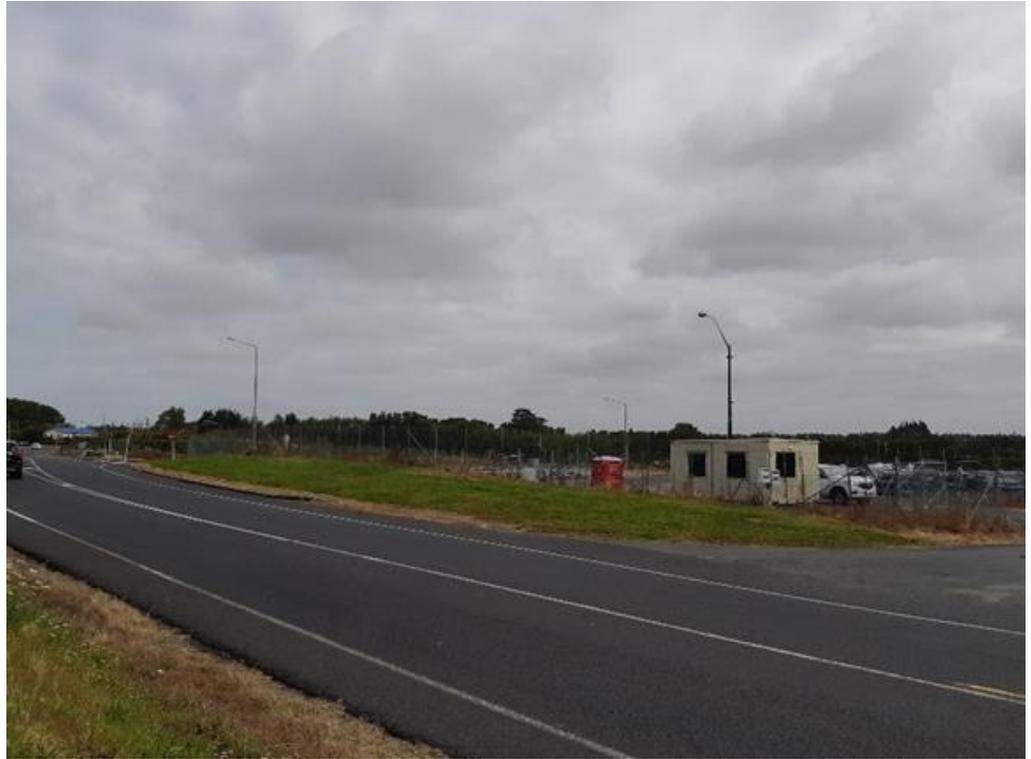
Address:
23-25 Trig Road,
Whenuapai, Auckland
0618

Description:
Highway equipment
laydown area adjacent to
the southern side of
SH18, facing north-east.

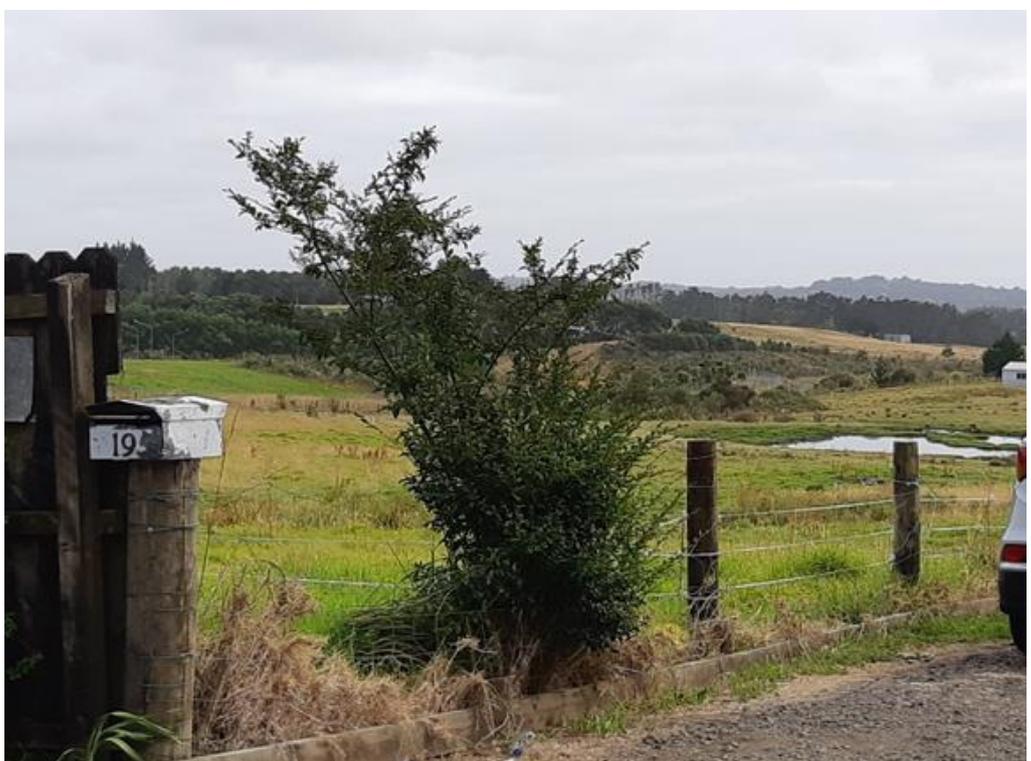
Photo No.
4

Address:
19-21 Trig Road,
Whenuapai, Auckland
0618

Description:
Pond (potentially
associated with former
nursery), facing north-
east.

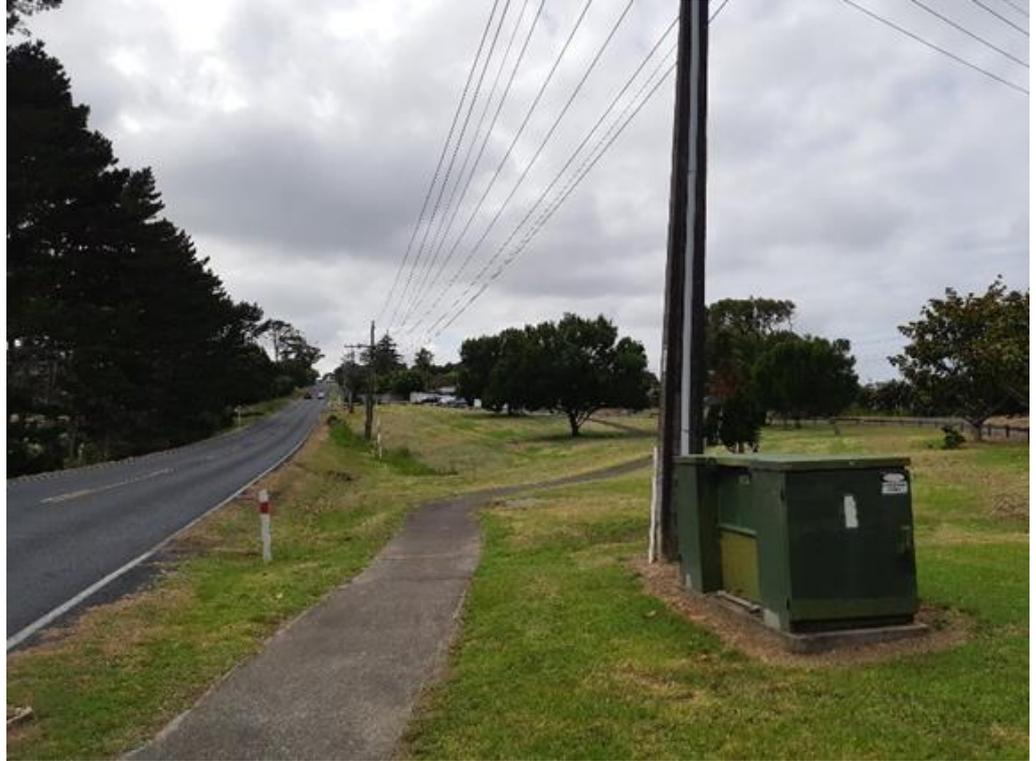
Transformer, facing
south-east.

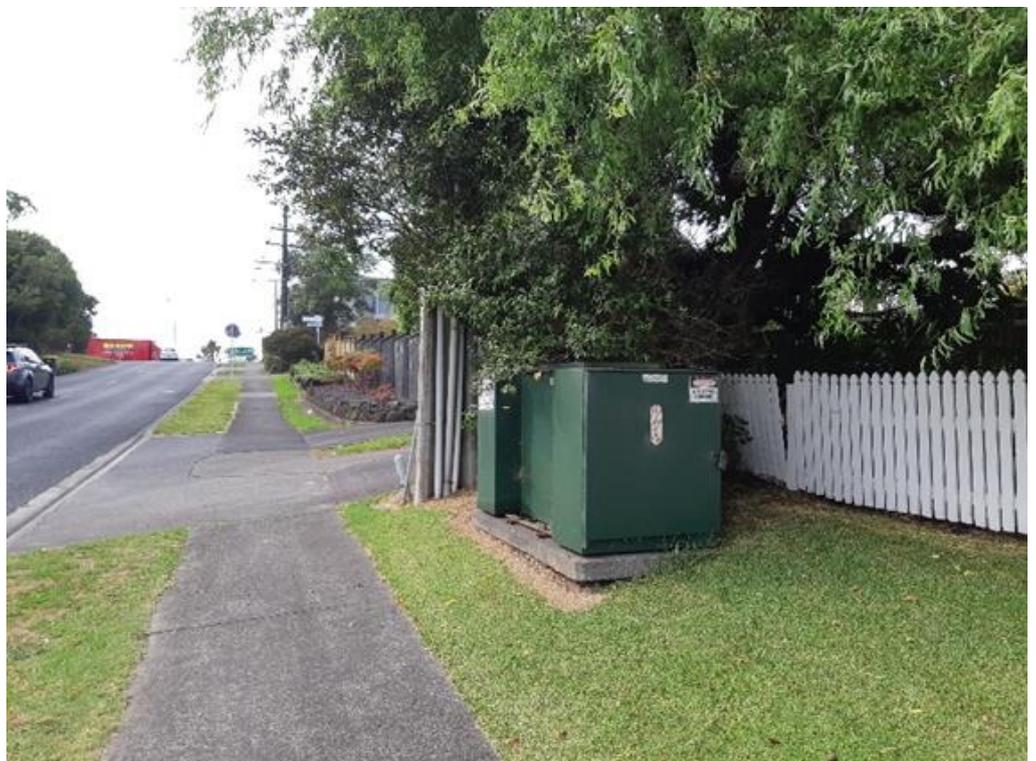
Photo No.
6

Transformer, facing
south-east.

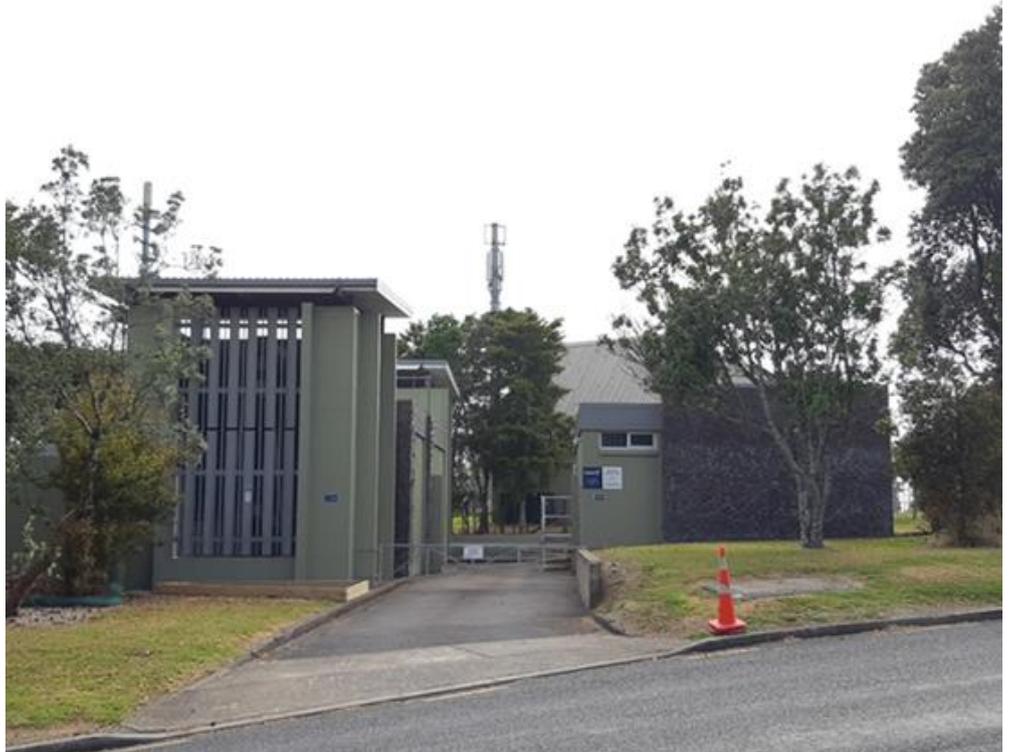
Photo No.
8

Address:
1 Trig Road, Whenuapai,
Auckland 0618

Description:
Hobsonville Substation,
facing east.

The review of current landuse activity within the Project area has identified that activities classified on the MfE Hazardous Activities and Industries List (**HAIL**) are being undertaken i.e., horticultural nurseries, electrical substation, and electrical transformers. Refer to Appendix C for a copy of the HAIL.

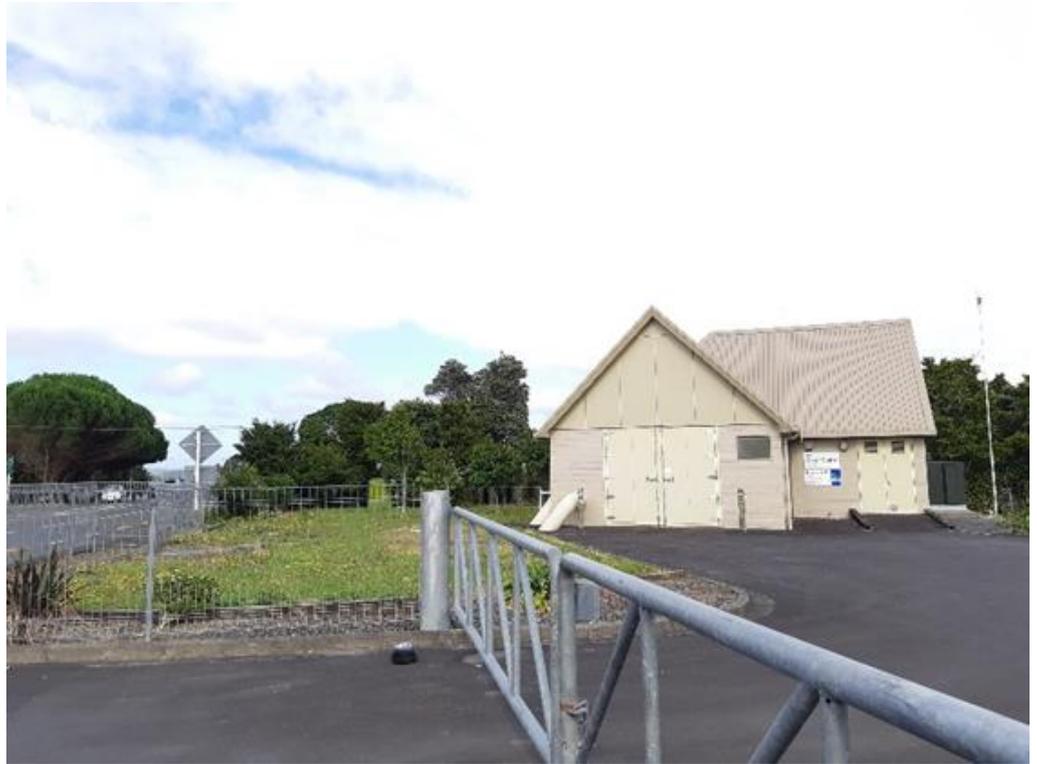
Address:
74 Hobsonville Road,
West Harbour, Auckland
0618

Description:
Watercare pump station
(potable water).
