14 September 2016

## **PRELIMINARY SOIL SAMPLING INVESTIGATION AT KAHAWAI POINT, GLENBROOK BEACH, AUCKLAND**

**FIGURE 1 : SAMPLE LOCATION PLAN**

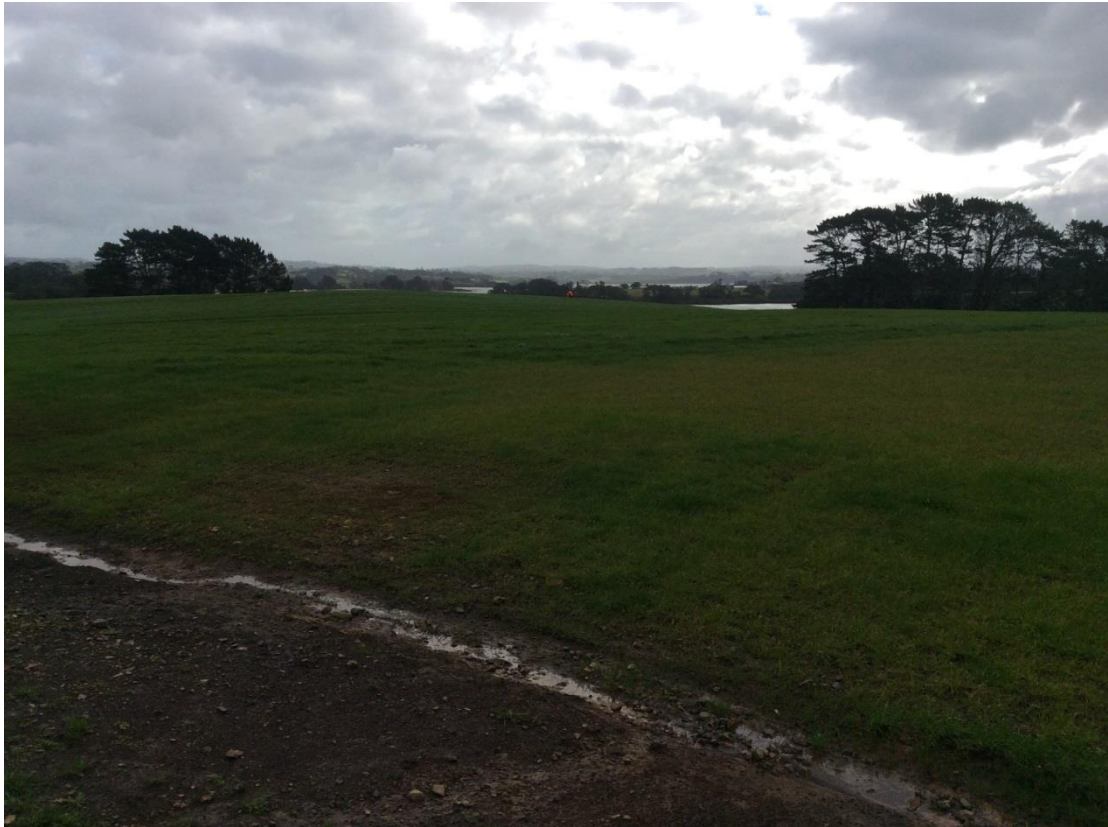
- ✧ If the historical application of pesticides and herbicides (including paraquat and diquat) has resulted in contaminant residues remaining within the shallow soils of the site paddocks (refer Photograph 1); and,
- ✧ If asbestos or asbestos-containing materials (ACM) are present in the building materials of the barn on site (refer Photograph 2 and 3);
- ✧ If petroleum hydrocarbon residues are present in soils beneath the two AST's on site (refer Photographs 4 and 5);
- ✧ Whether the stripped soil material:
  - Is suitable to be reused on site;
  - Is suitable to be on-sold; or,
  - Requires disposal to a licensed disposal facility.

**Photograph 1: Typical onsite paddock where pesticides and herbicides were applied.**

- ✧ Analysis of soil samples within the area where paraquat and diquat was applied report very low concentrations of diquat remaining in the shallow soils. While detectable, the diquat concentrations do not exceed the adopted US EPA guideline values. No concentrations of paraquat were detected above the laboratory limits of reporting.

- ✧ Analysis of some composite samples for organochlorine pesticides reported non-detectable concentrations in all samples with the exception of trace DDE in two samples. The level of organochlorine residues is well below environmental and human health criteria, but the detection of residues precludes the material from being treated as cleanfill.

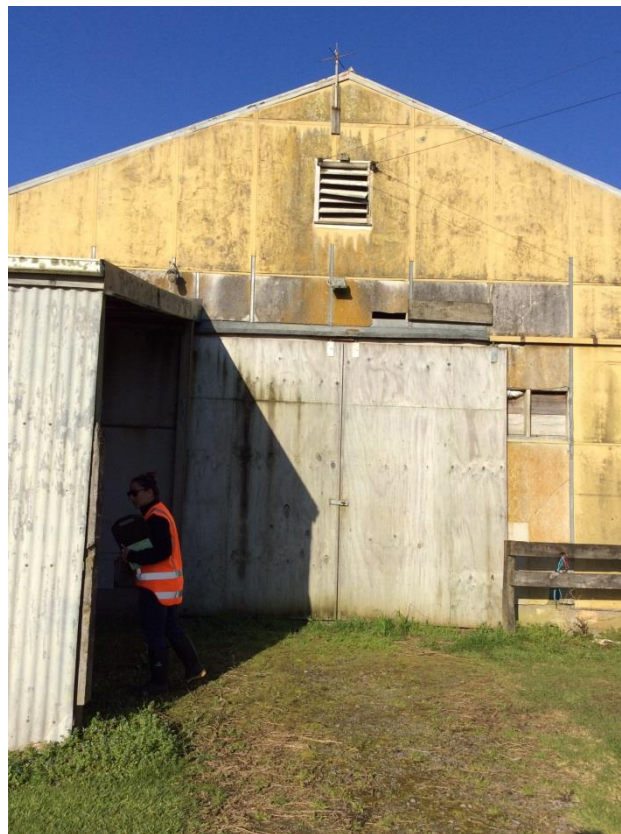
Visual evidence of ACM was identified on the ground surface around the barn, and the barn cladding located on Lot 1 DP 351480.

**Photograph 2: Barn located on site showing ACM in deteriorated condition.**

- ✧ ACM is present in cladding attached to the barn. Removal of this material is recommended to be undertaken by a licensed removalist (as the total area of ACM is greater than 10 m<sup>2</sup>), after a demolition survey has been completed for the structure, and under the management of an Asbestos Removal Control Plan (ARCP) – as required by the Health and Safety at Work (Asbestos) Regulations (HSW, 2016).

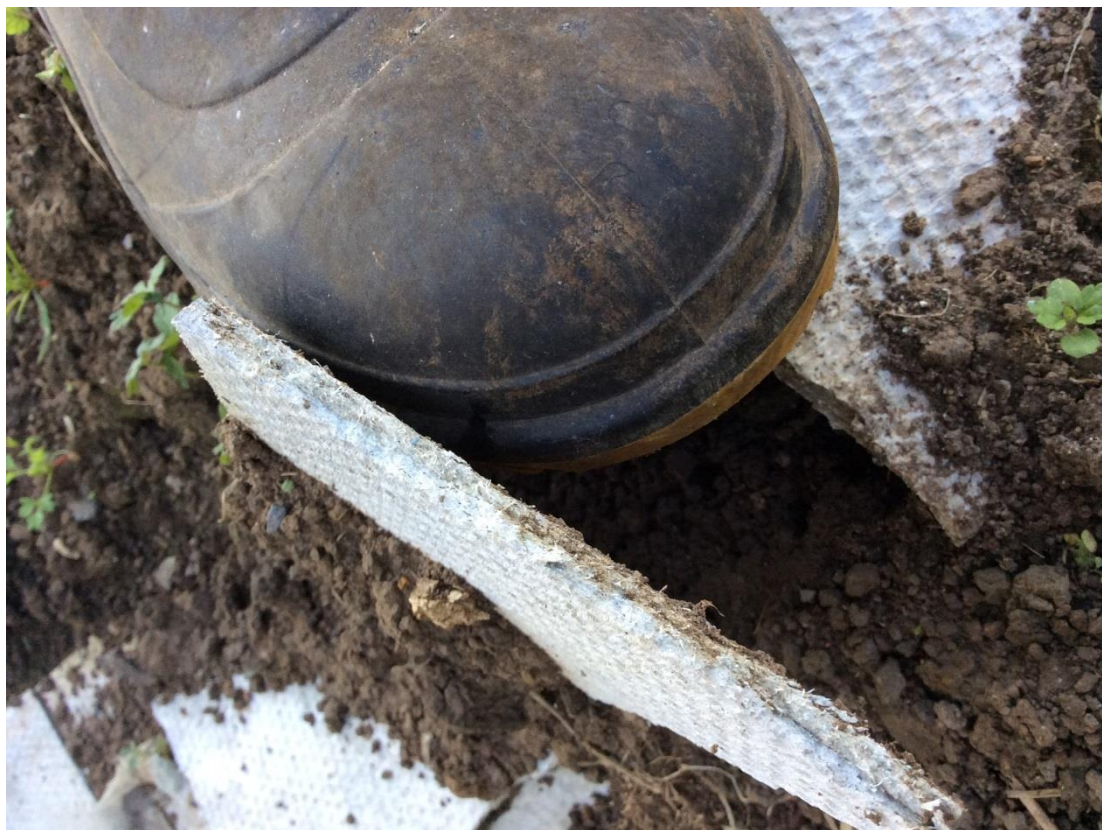
Both samples collected from the building materials from the barn (ACM1 and ACM2) were positively identified as asbestos-containing (laboratory results are appended). As samples were analysed for the presence/absence of asbestos only, the results were not compared to any risk-based guideline criteria.

**Photograph 3: Fibre cement board cladding in deteriorated condition from the barn, identified as ACM.**

As of April 2016, regulations for the management of asbestos in New Zealand were updated. The Health and Safety at Work (Asbestos) Regulations 2016 (HSW, 2016) outline a number of duties and responsibilities relevant to the Person Conducting a Business or Undertaking (PCBU). These include, but are not limited to appropriate removal and disposal of ACM to be undertaken by a licensed removalist (when the total area of ACM is greater than 10 m<sup>2</sup>), after a demolition survey has been completed for the structure, and under the management of an Asbestos Removal Control Plan (ARCP). It is expected that given the area of ACM cladding on the barn represented by samples ACM1 and 2, that the HSW (2016) Regulations apply to any barn demolition works. At the close of any removal works, a clearance inspection and a clearance certificate would be required to confirm the acceptable removal of the ACM.

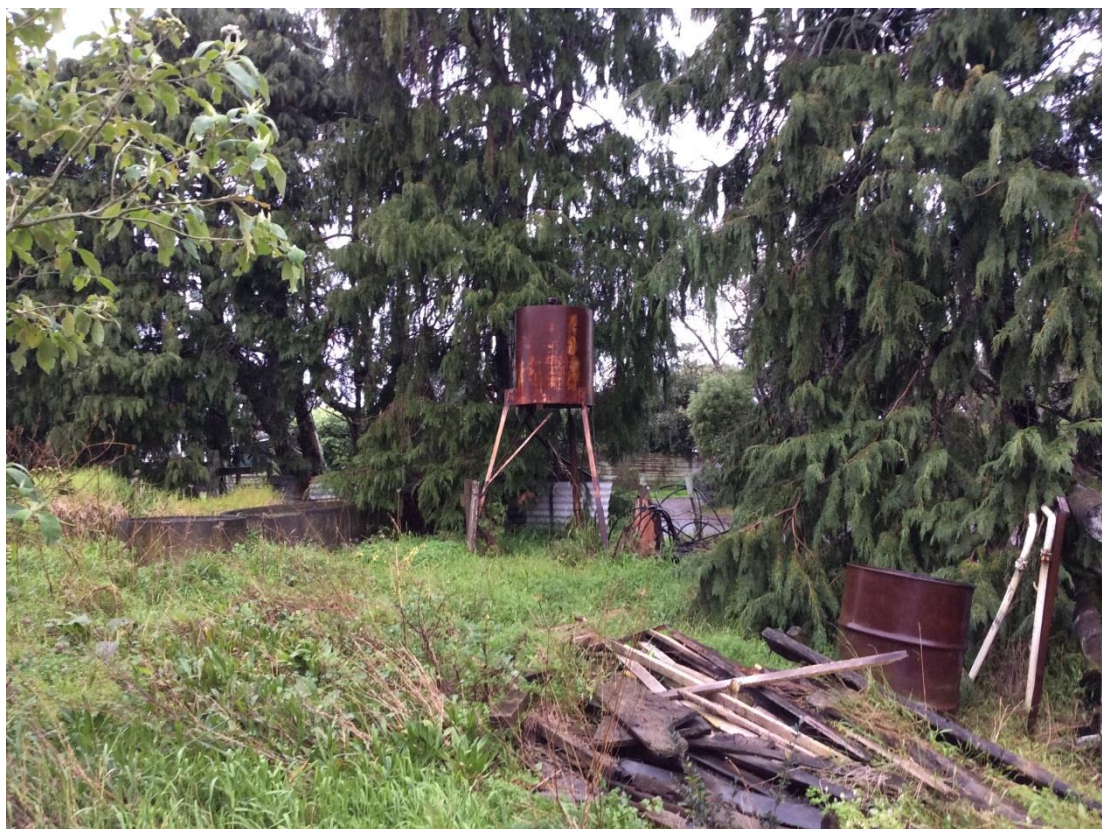
No visual or olfactory evidence of petroleum hydrocarbon contamination surrounding the AST's was noted.

- Sample AST 1/1 had an arsenic concentration (126 mg/kg) value which exceeded the guideline discharge criteria (100 mg/kg).
- All other samples were below the guideline values provided in the PAUP and ACRP:ALW.

**Photograph 4: Above-ground storage tank 1 (AST 1).**

- ∴ Surface soil material represented by sample AST1/1 (and the ACM building materials from the barn) will require removal and disposal to a facility licensed to accept materials with concentrations of contaminants reported (e.g. elevated arsenic, and asbestos), such as a special wastes landfill. (The source of arsenic in AST1/1 is not known (although possibly related to the tank and its former contents). Despite this, results from the wider site area indicate that it is likely to be localised around the tank area. The extent of arsenic residues in this area will require delineation prior to removal).

- ✧ Sample AST 1/1 exceeds the adopted discharge criteria for arsenic and human health NES SCS for residential land-use 10%. It is recommended that impacted soil in this area is delineated and removed during the development works. As the elevated concentration of arsenic is expected to be localised, it is expected that the arsenic residues will be removed along with the soils during these recommended works.

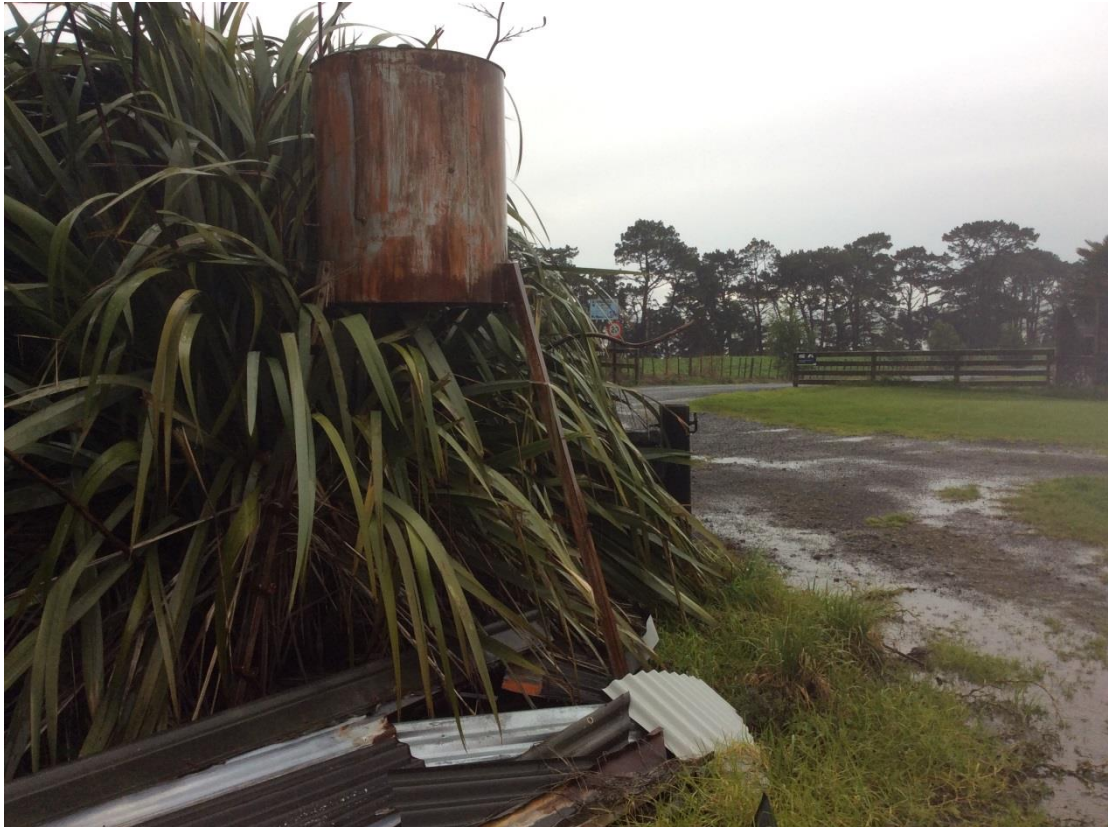
- ✧ Total Petroleum Hydrocarbon residues were present in the shallow soils beneath the ASTs. The level of TPH detected does not exceed the MfE (2011d) Tier 1 Soil Acceptance Criteria for All Pathways (residential), and in turn does not exceed the Route Specific criteria for Maintenance and Excavation workers.

**Photograph 5: Above-ground storage tank 2 (AST 2).**
