Preliminary Geotechnical Investigation to Support Structure Plan and Plan Change Coatesville Riverhead Highway, Riverhead

Rev C

19 September 2023

Job No. 21640

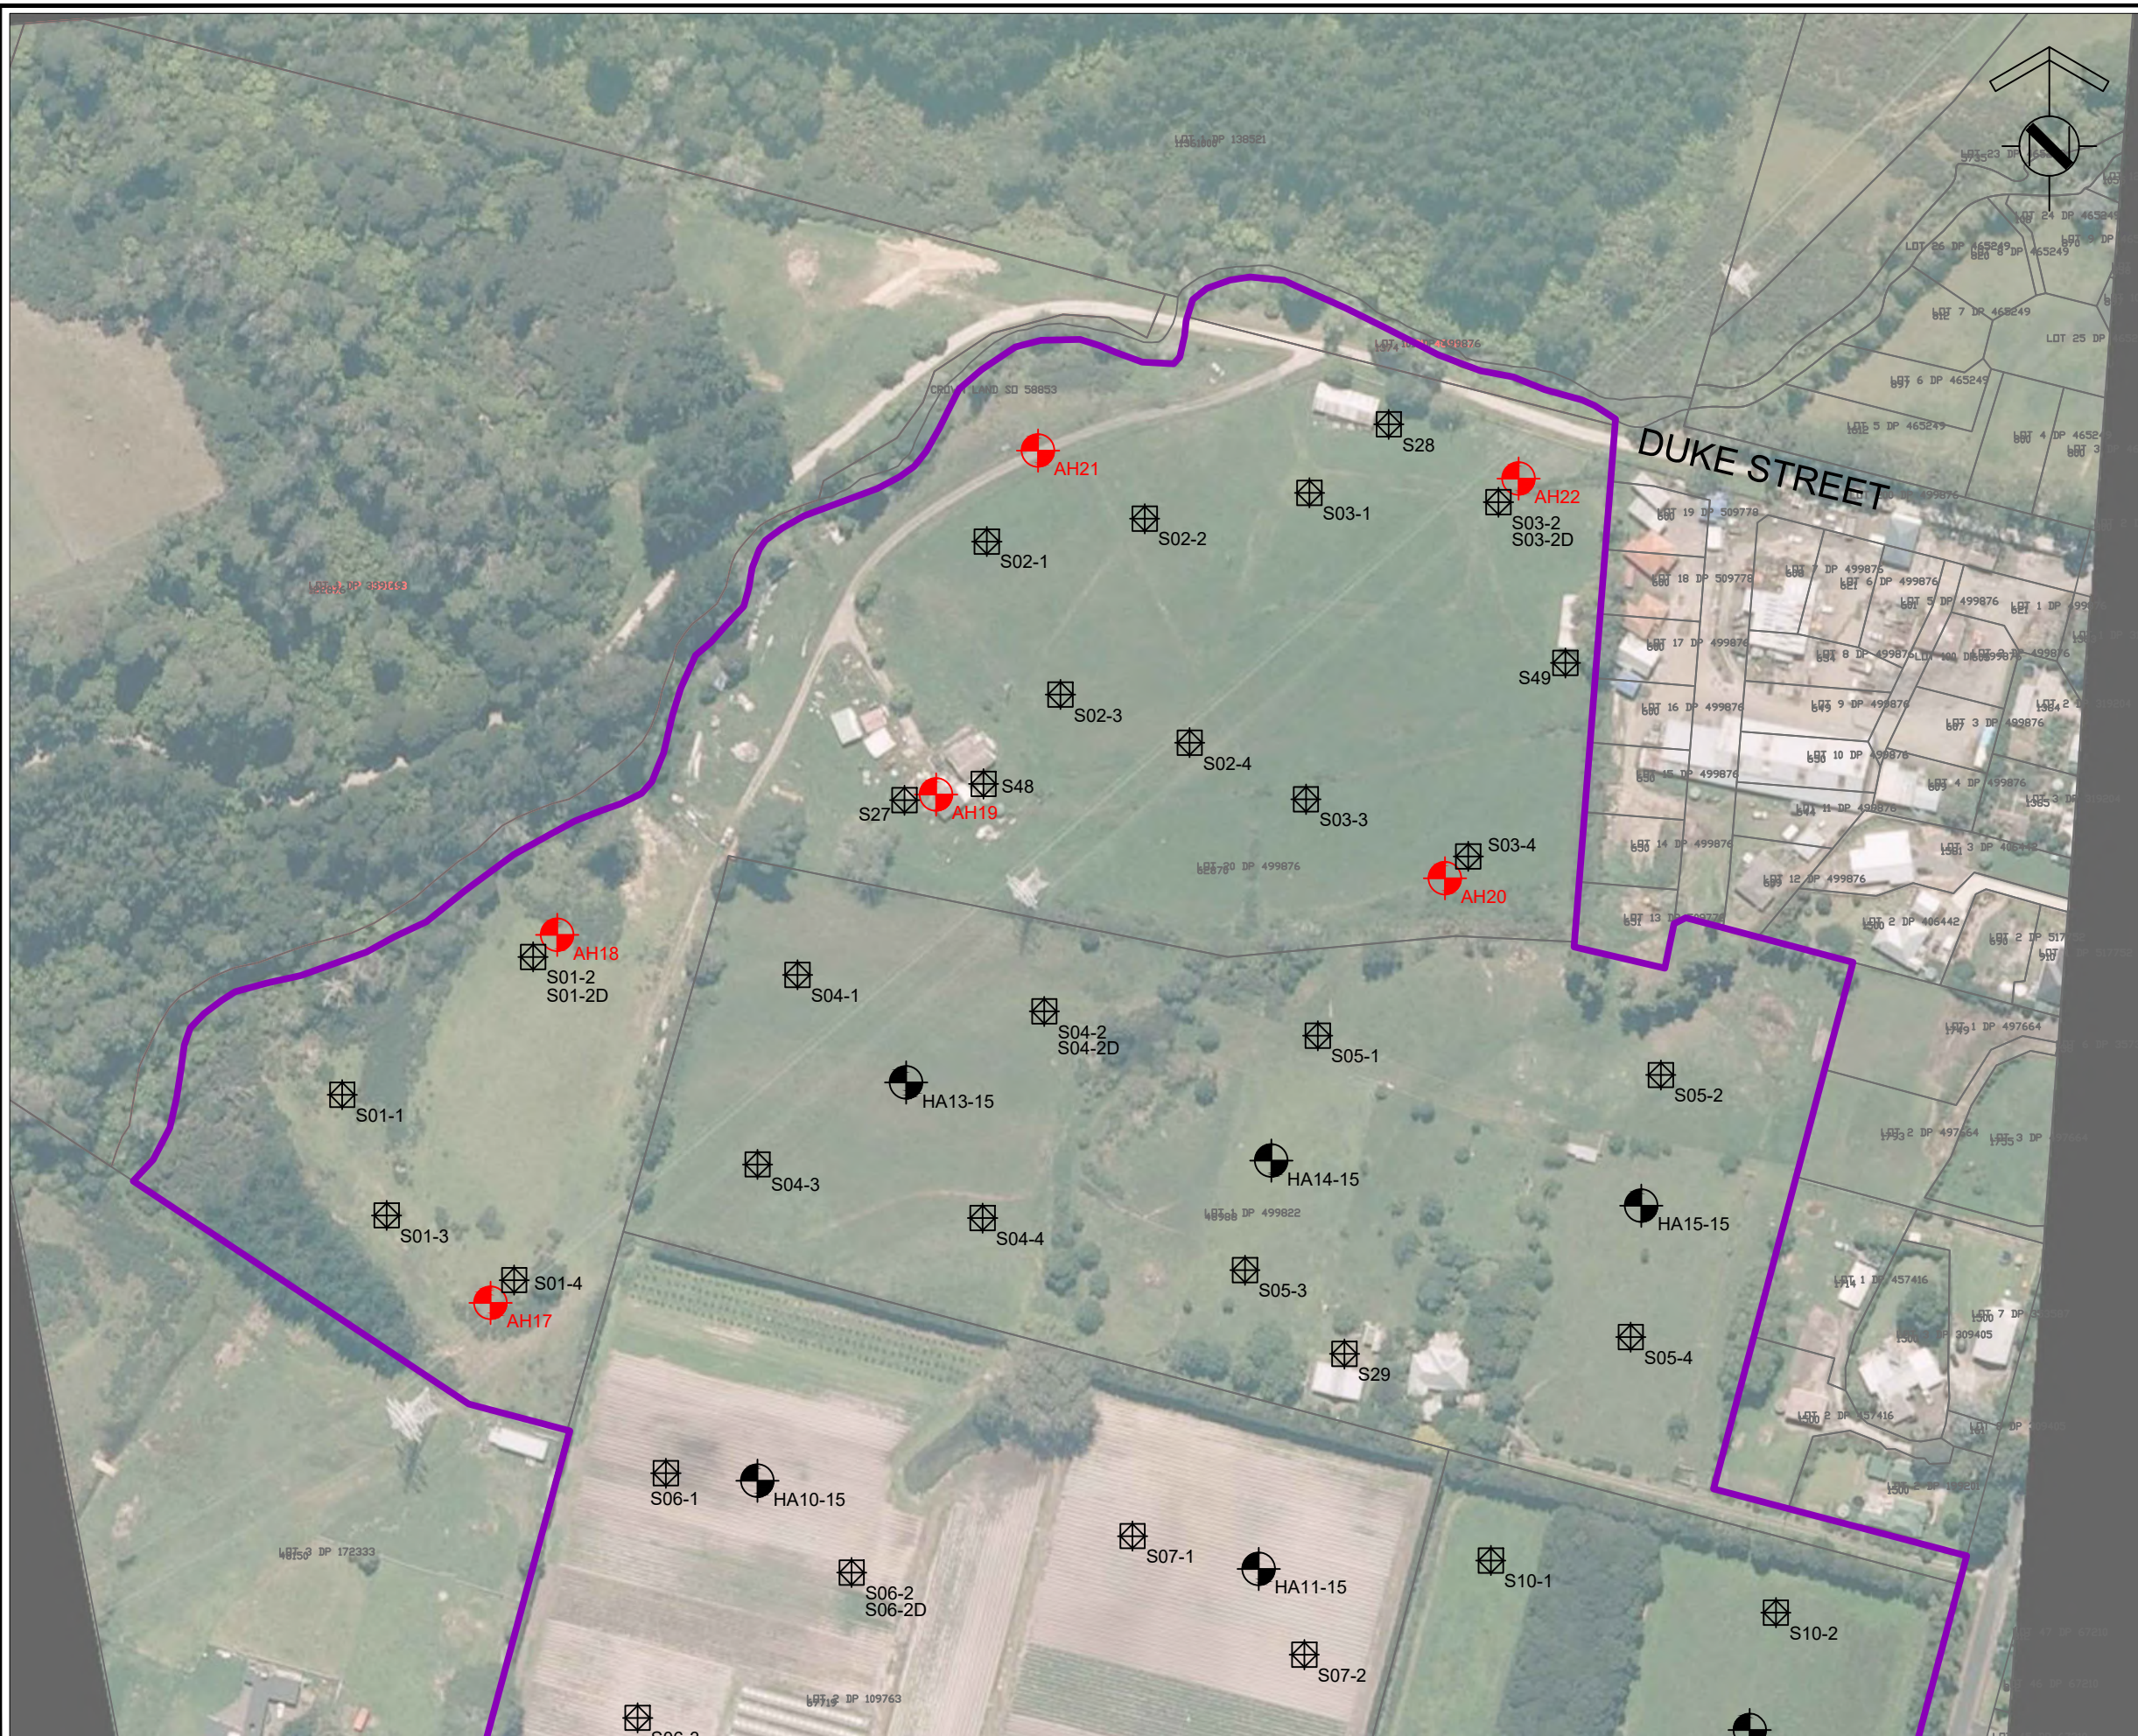
21640 / 1	DRAWN: M.Chan	DATE: 6-May-22
SCALES: 1: 2000 AT A3	CHECKED:	REV.
	DESIGNED:	
Filename: 21640 - master plan gir rev a.dwg

SITE PLAN (1/4)

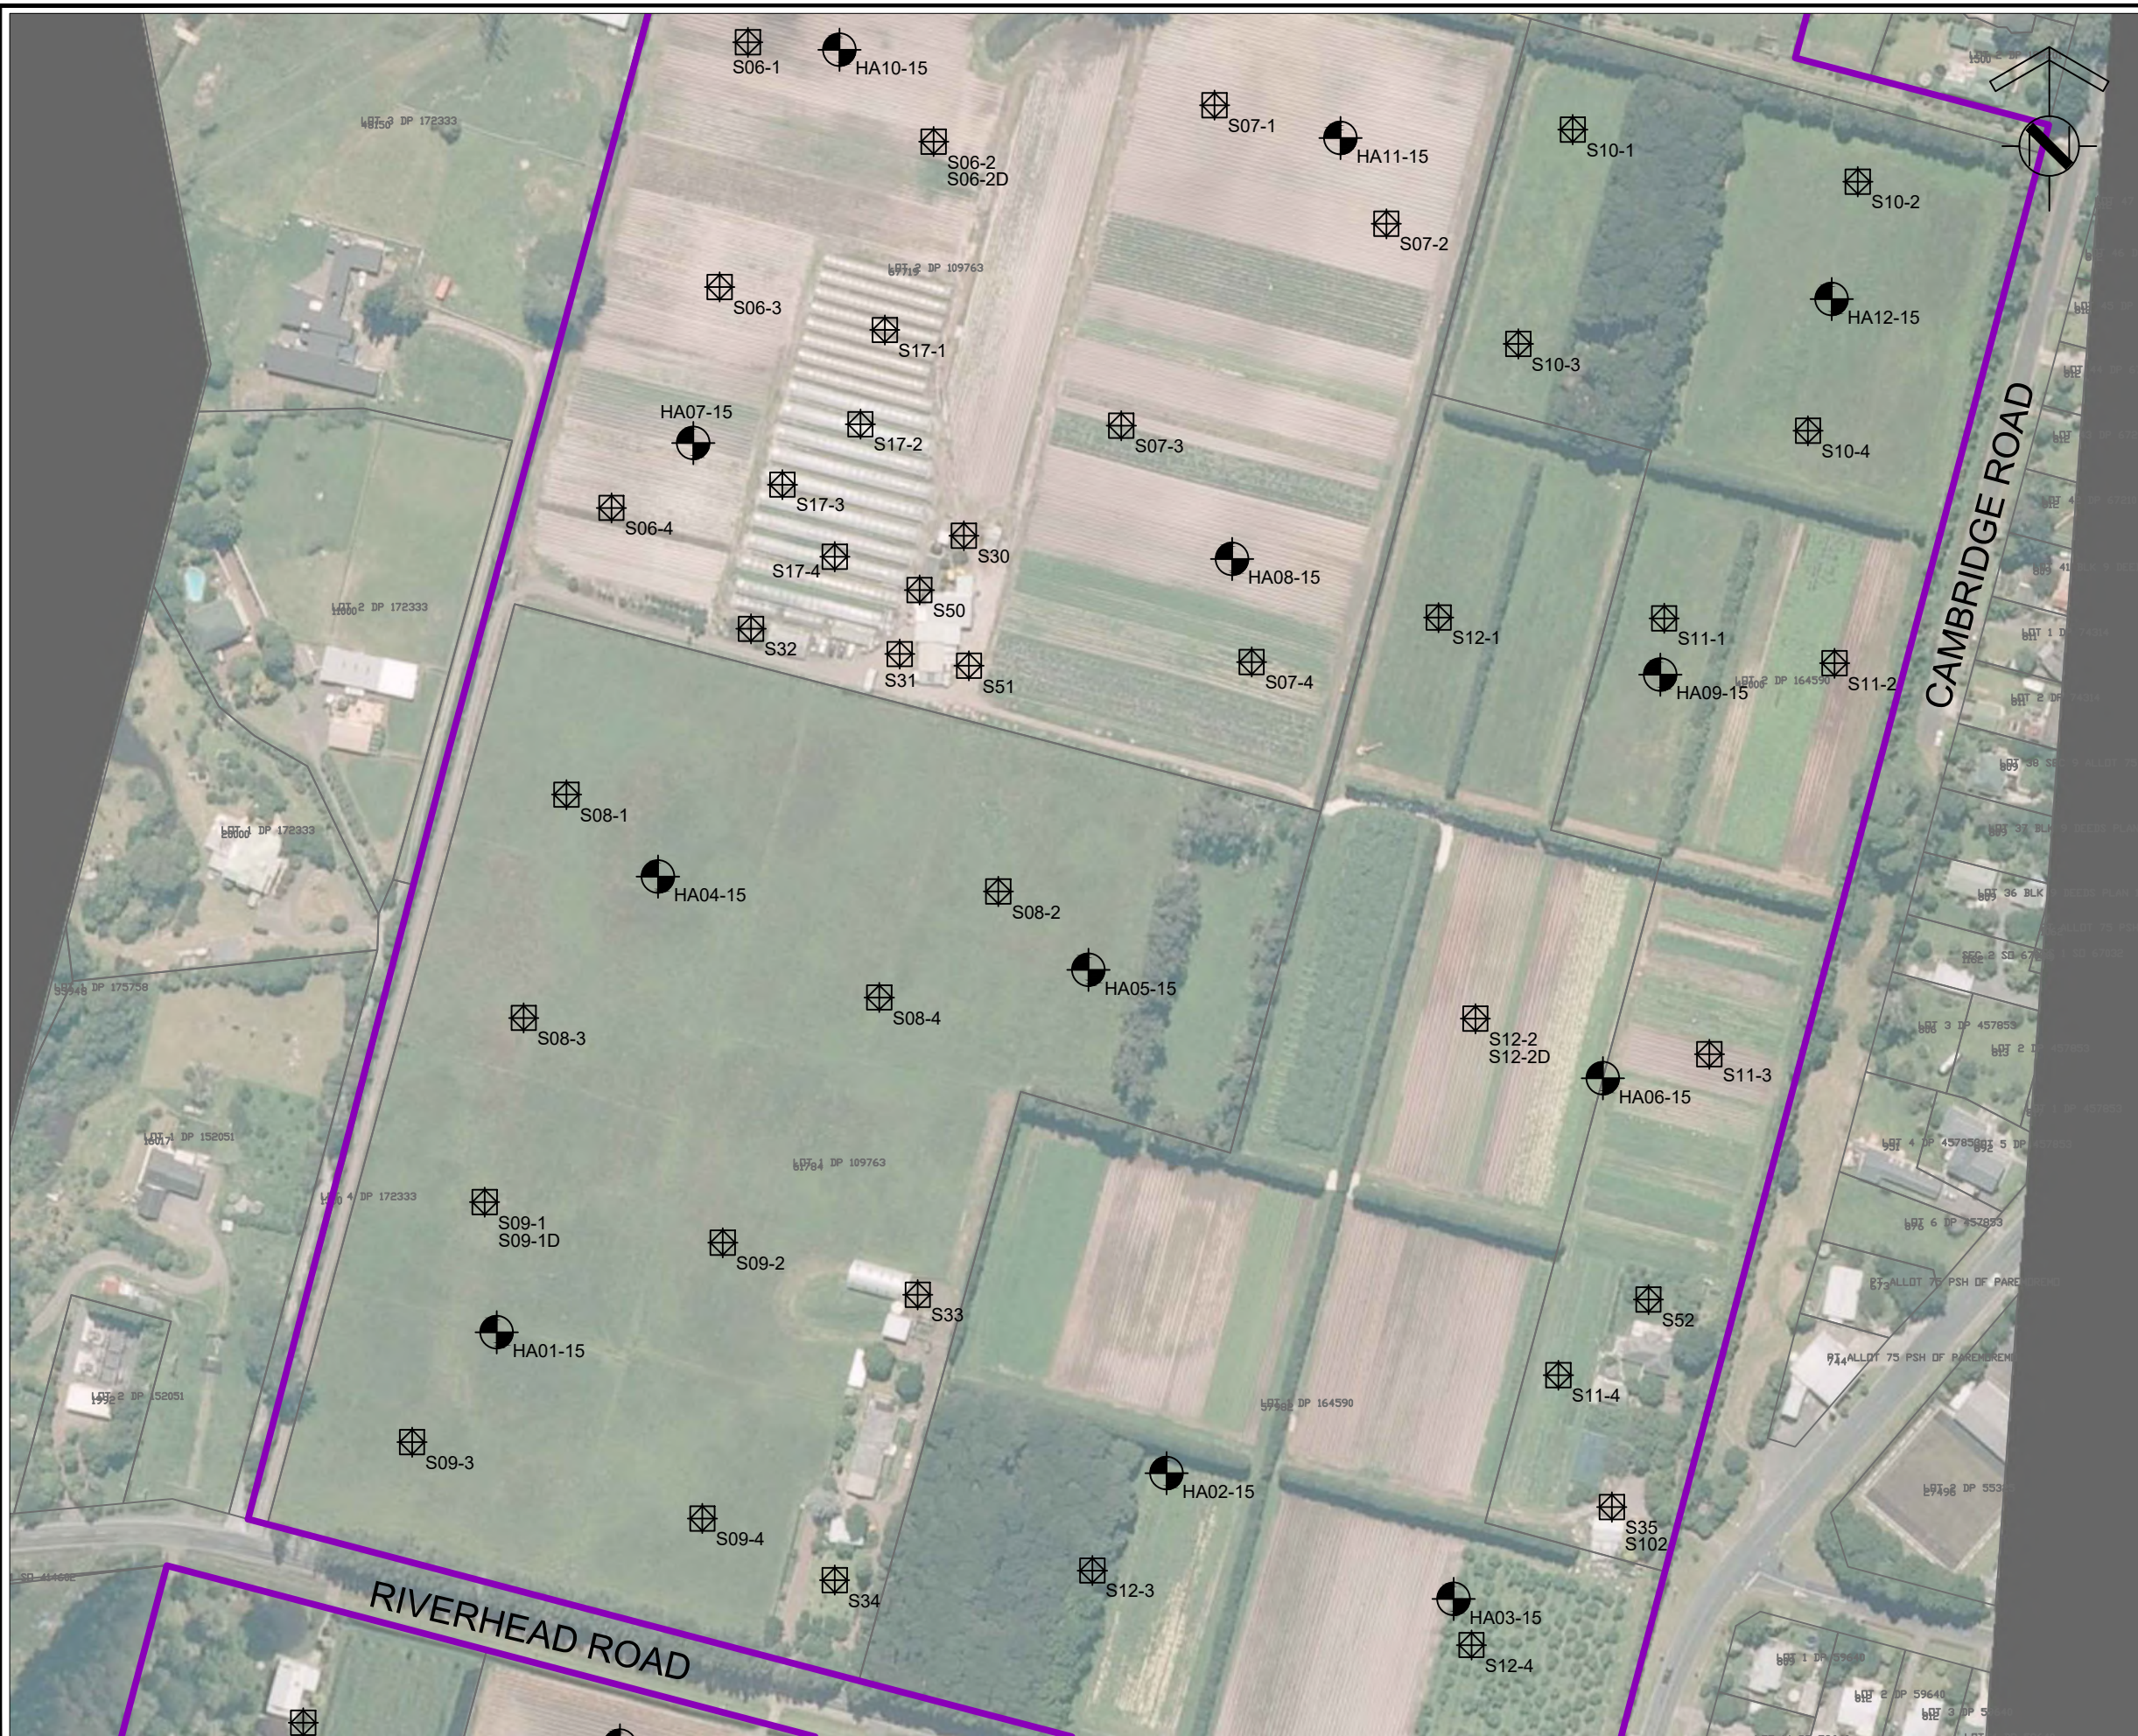
21640 / 2	DRAWN: M.Chan	DATE: 6-May-22
SCALES: 1: 2000 AT A3	CHECKED:	REV.
	DESIGNED:	
Filename: 21640 - master plan gir rev a.dwg

SITE PLAN (2/4)

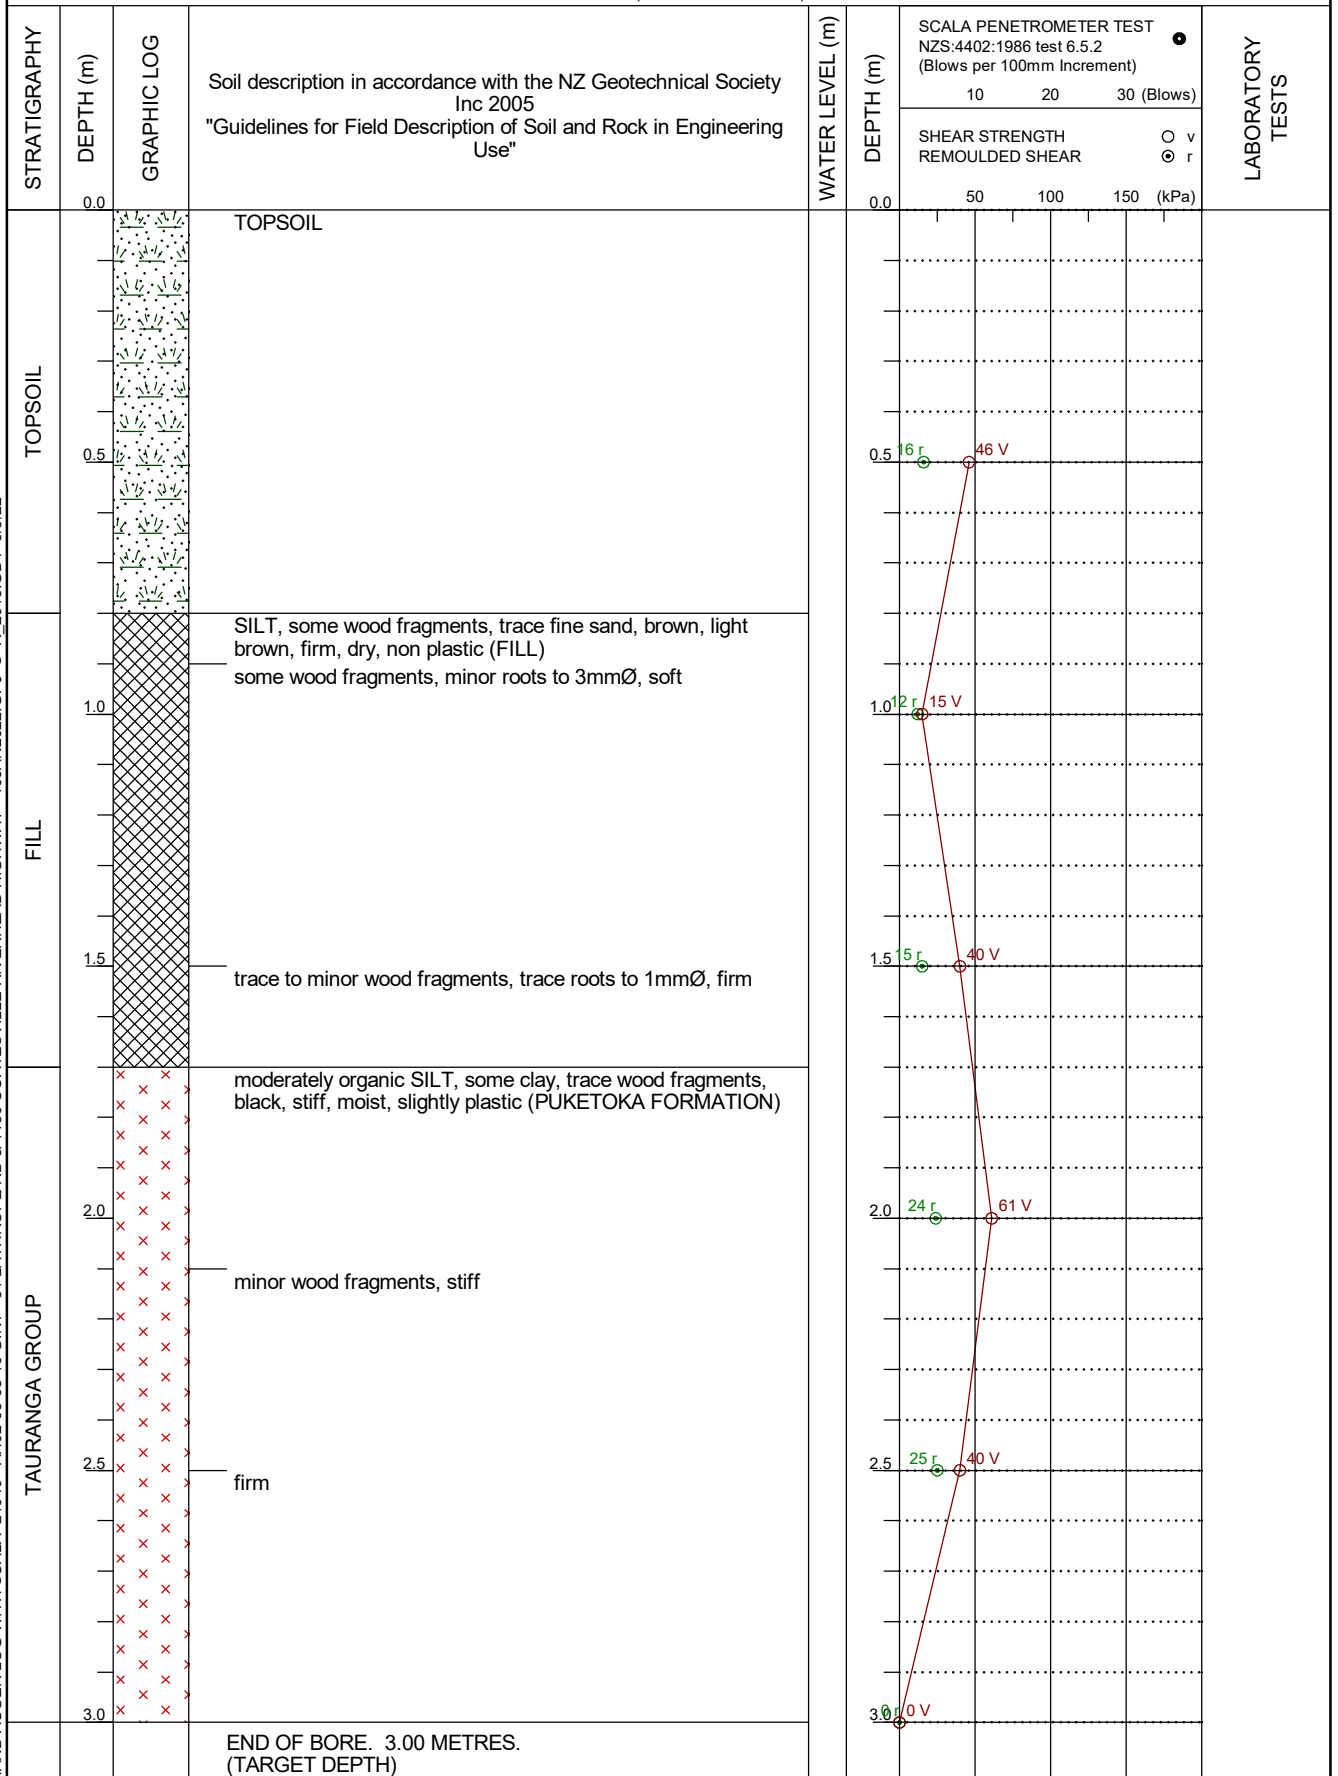
Drill Type: 50mm Hand Auger Project No: 21640 Logged By: JT
 Drilled By: JT Coordinates: Shear Vane No - Calibration Date: GEO403 - 24/02/2021
 Date Started: 17/1/22 Ground Elevation: Surface Conditions: Near Level, Grass
 Date Finished: 17/1/22 Water Level: (NOT ENCOUNTERED)

HAND AUGER LOG WITH SCALA 21640 - AH02-05-08-10 GINT - 51 LATHROPE RD & 1186 COATESVILLE RIVERHEAD HIGHWAY - 10JAN2022 GPJ S+R 2013.GDT 5/5/22

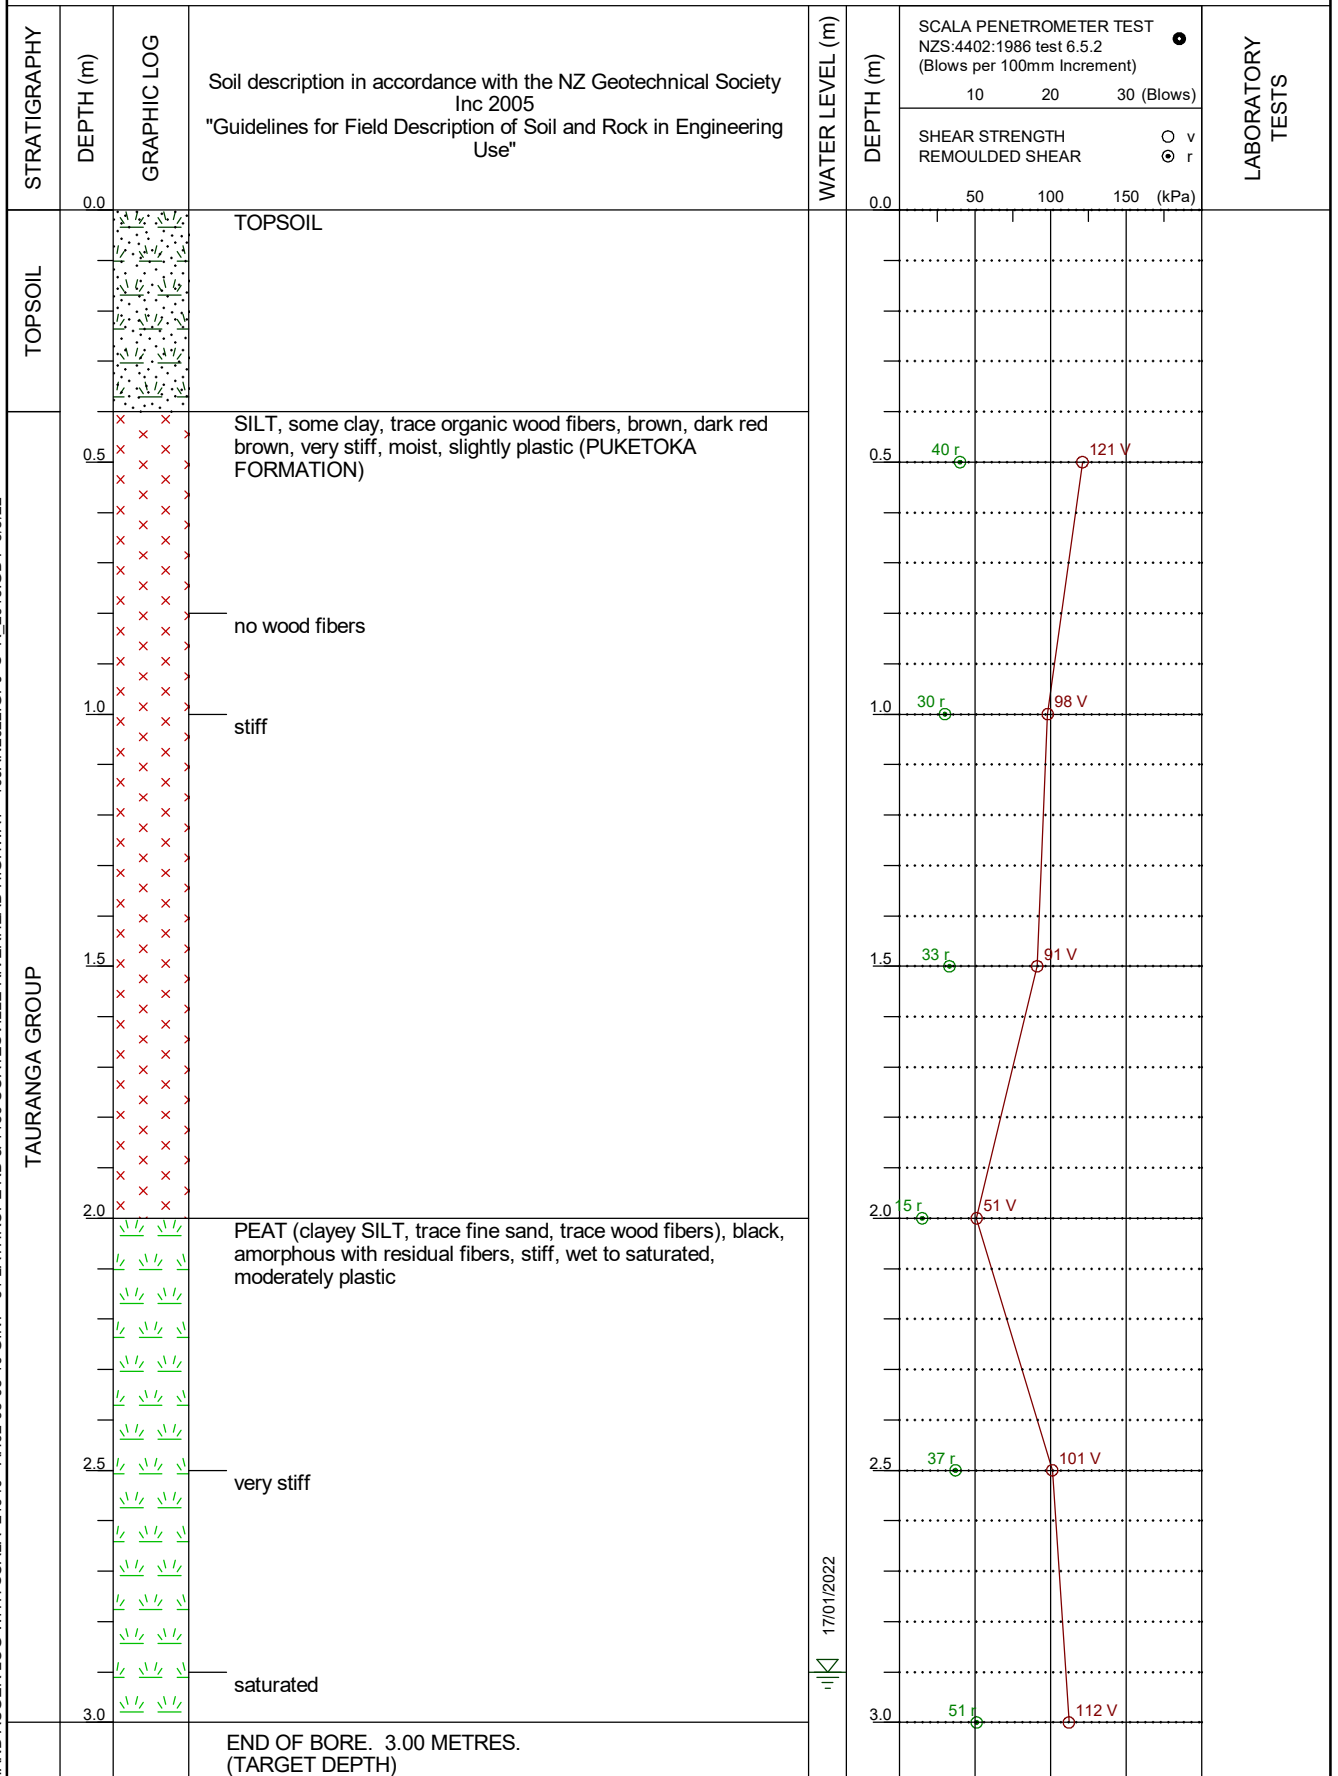
Drill Type: 50mm Hand Auger Project No: 21640 Logged By: JT
 Drilled By: JT Coordinates: Shear Vane No - Calibration Date: GEO403 - 24/02/2021
 Date Started: 17/1/22 Ground Elevation: Surface Conditions: Near Level, Soil
 Date Finished: 17/1/22 Water Level: 2.9m 17/01/2022

HAND AUGER LOG WITH SCALA 21640 - AH02-05-08-10 GINT - 51 LATHROPE RD & 1186 COATESVILLE RIVERHEAD HIGHWAY - 10JAN2022.GPJ S+R_2013.GDT 5/5/22

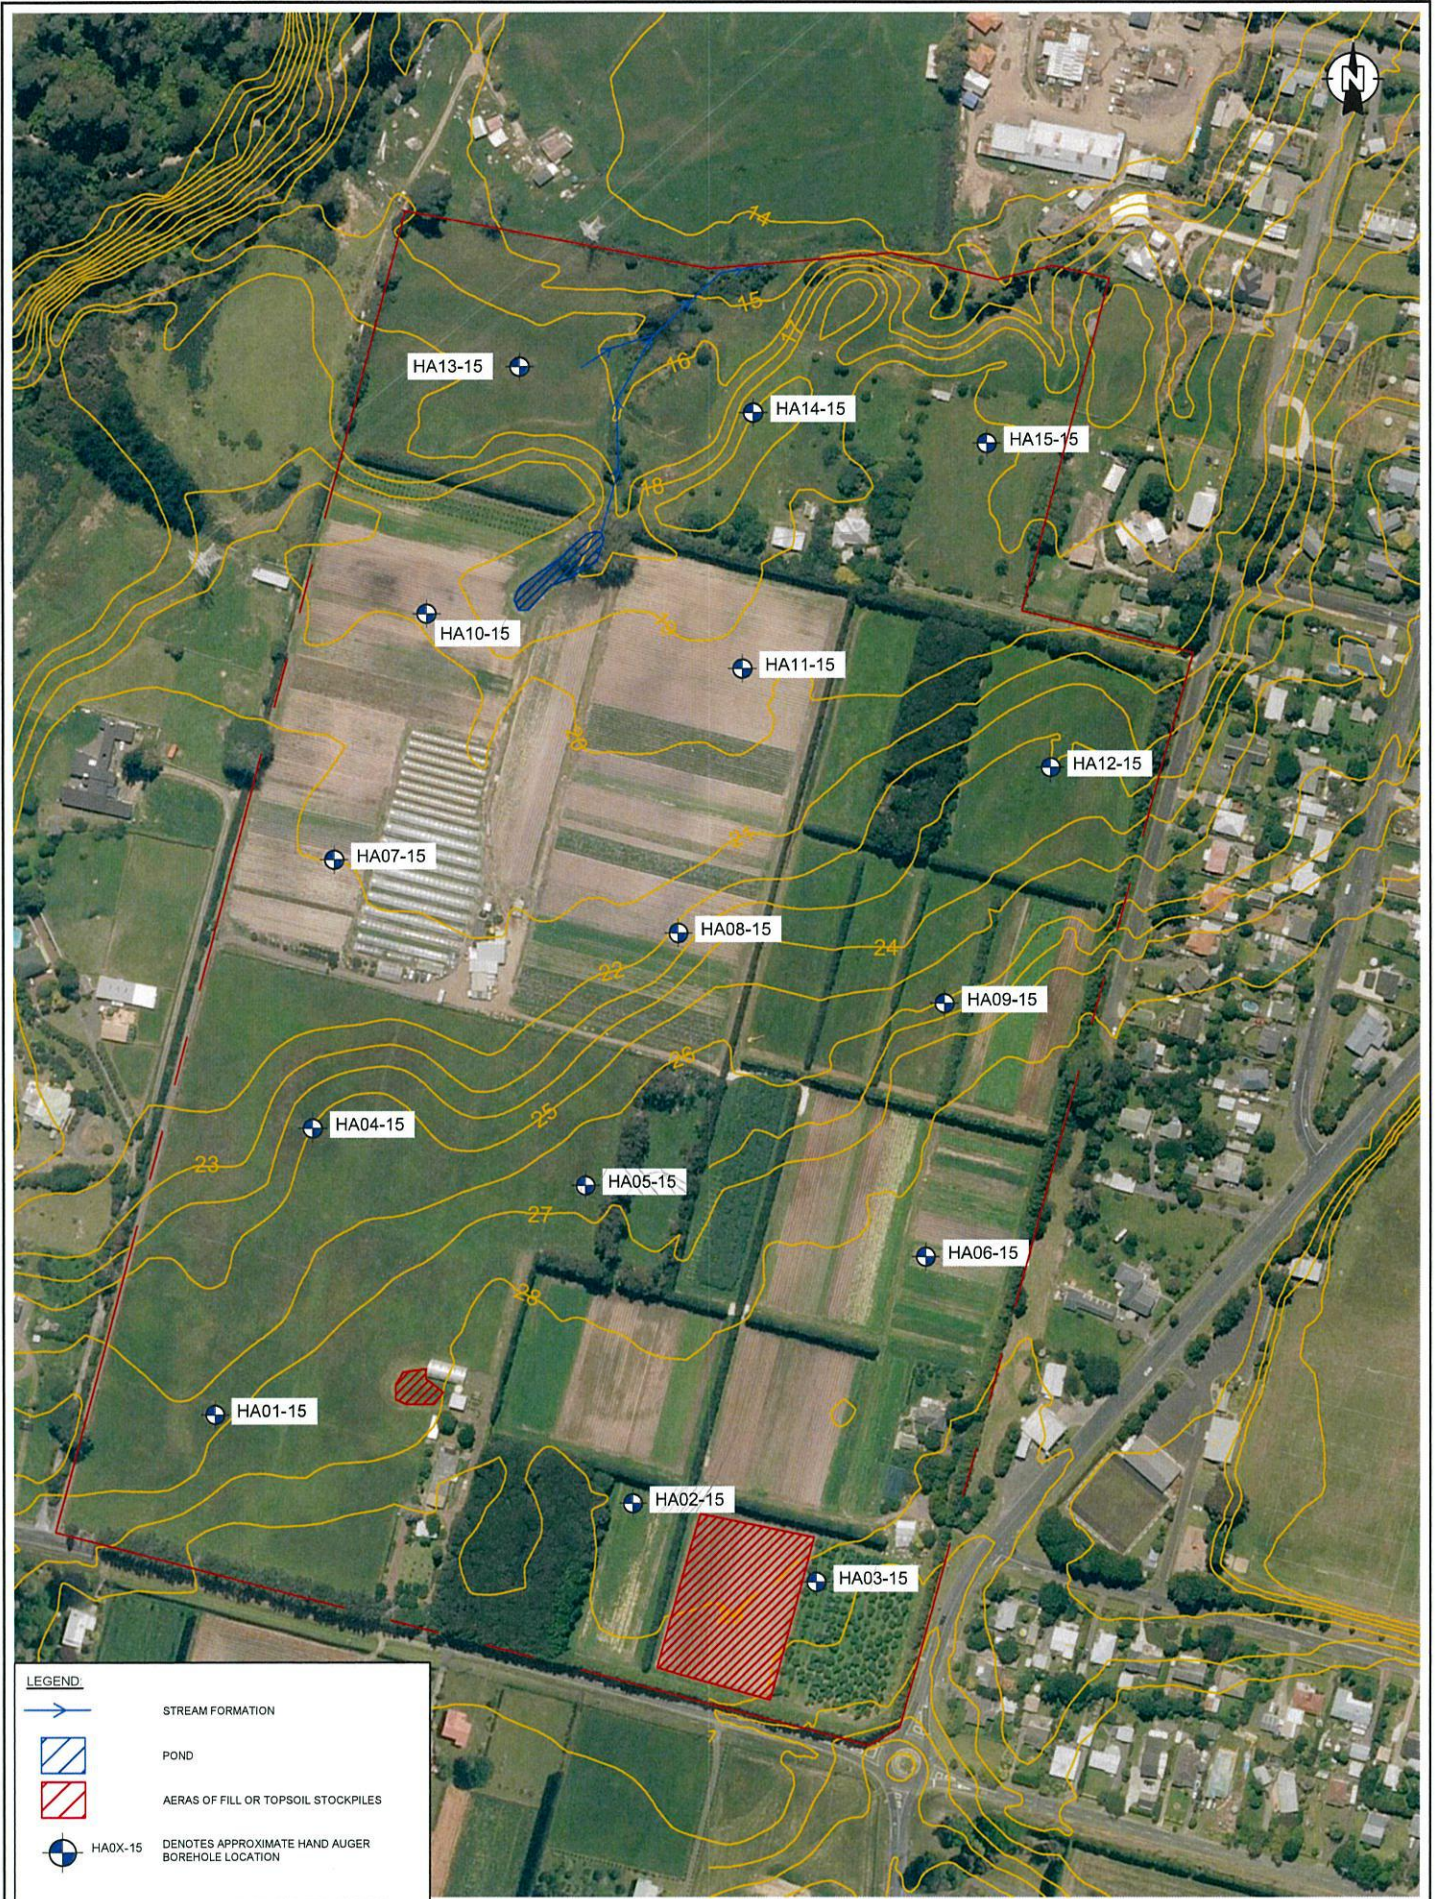
LEGEND

- STREAM FORMATION
- POND
- AREAS OF FILL OR TOPSOIL STOCKPILES
- HA0X-15 DENOTES APPROXIMATE HAND AUGER BOREHOLE LOCATION
- DENOTES APPROXIMATE SITE BOUNDARY

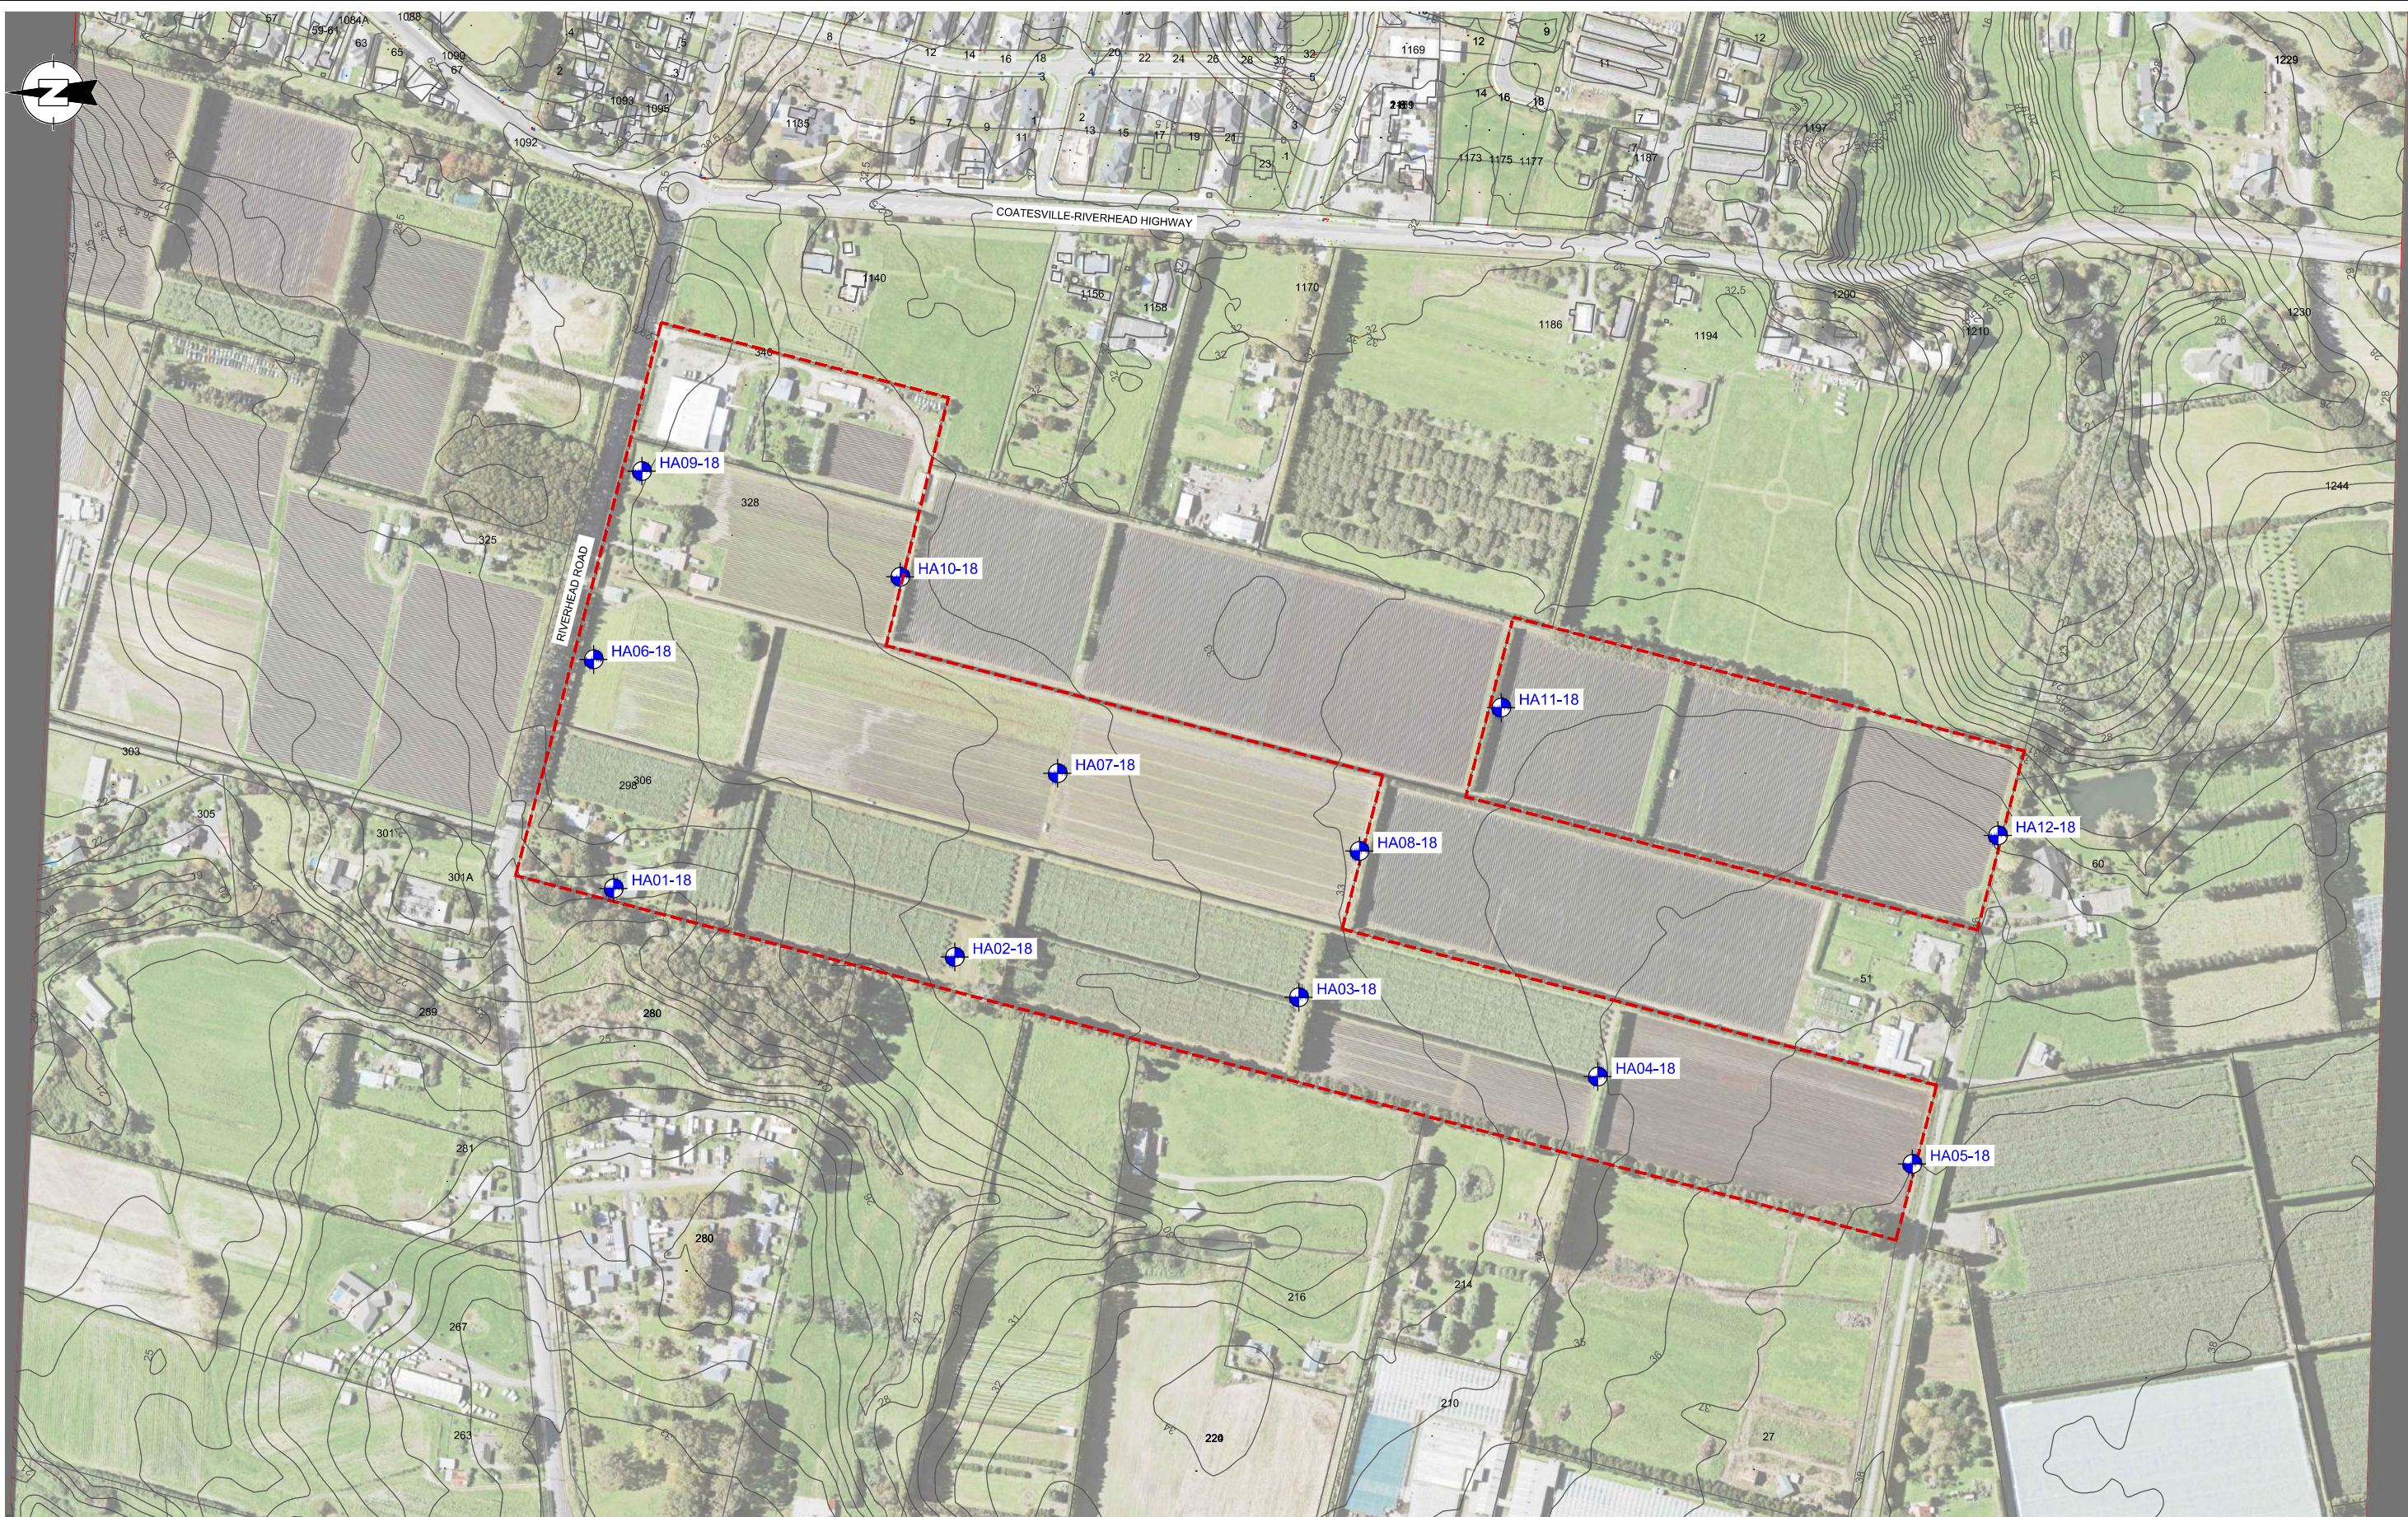
LEGEND:
 HA01-18 HAND AUGER (HA) LOCATION
 SITE BOUNDARY
