Northwest HIF - Trig Road Geotechnical Factual Report

This Factual Report has been prepared in order to present geotechnical information from the preliminary investigation undertaken at Trig Road, Whenuapai.

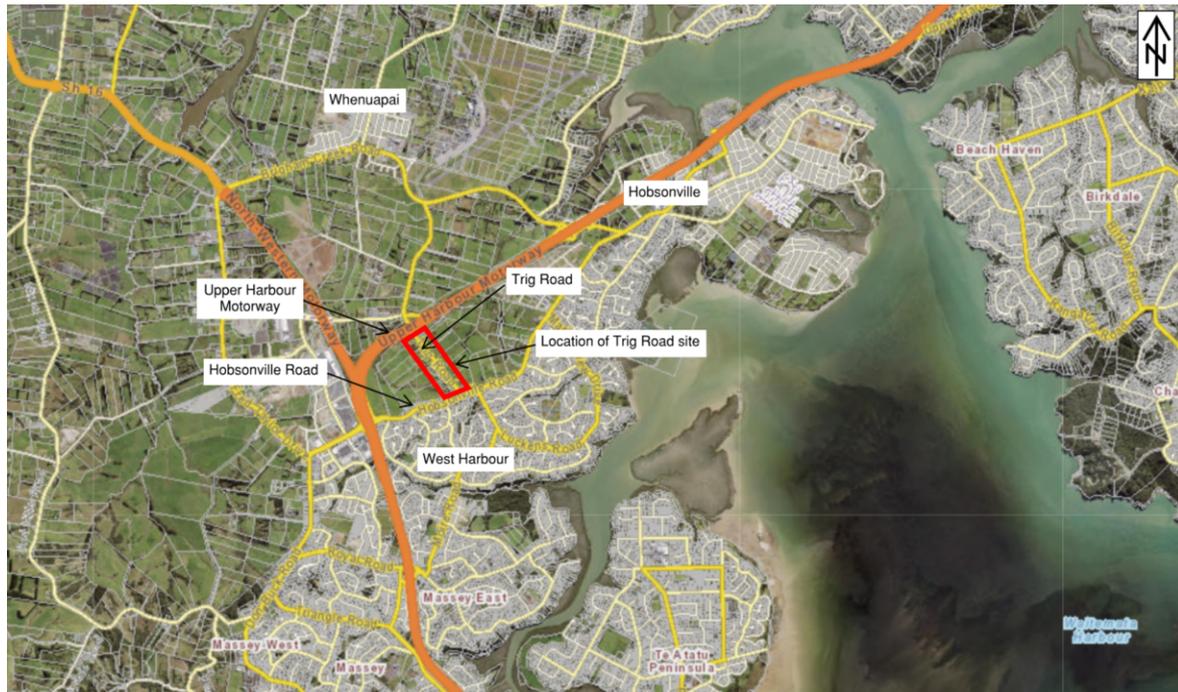
Figure 1: Trig Road Location Plan

The site is located along Trig Road, which trends in a north-west south-east direction from Hobsonville Road in the south to Brigham Creek Road in the north. The proposed Trig Road upgrade extends approximately 850m from Hobsonville Road in the south to Upper Harbour Highway in the North. The site is bound by residential properties to the south and grass paddocks to the east and west. Refer to the Location Plan shown in Figure 1 below. An overall Site Plan is also shown in Appendix 1.

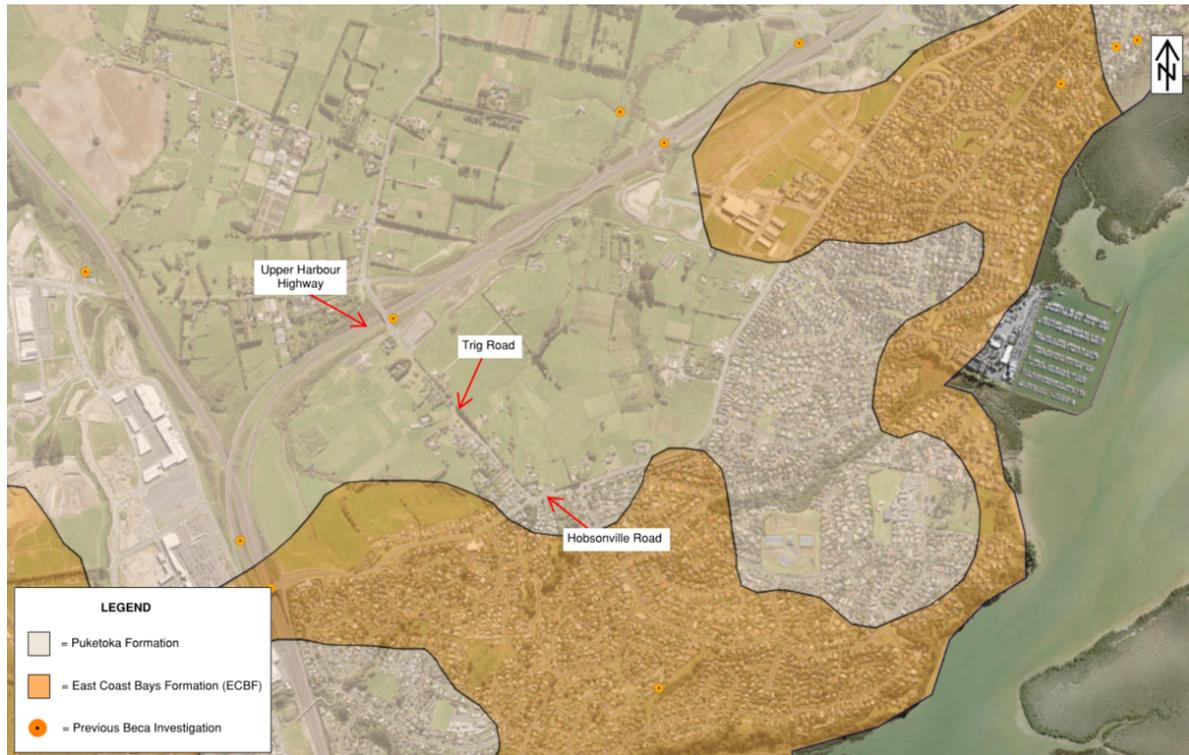
Figure 2: Trig Road Geology (QMaps, 2019)

The published 1:250,000 geological map (QMAP) of the Auckland area (Edbrooke, 2001) indicates that the area comprises two main geological units (Figure 2). Puketoka Formation alluvial deposits belonging to the Tauranga Group and comprising “pumiceous mud, sand and gravel” underly most of the site. Residually weathered soils of the East Coast Bays Formation (ECBF) belonging to the Waitemata Group and comprising “alternating sandstone and mudstone” are shown to the south and southwest of Trig Road.

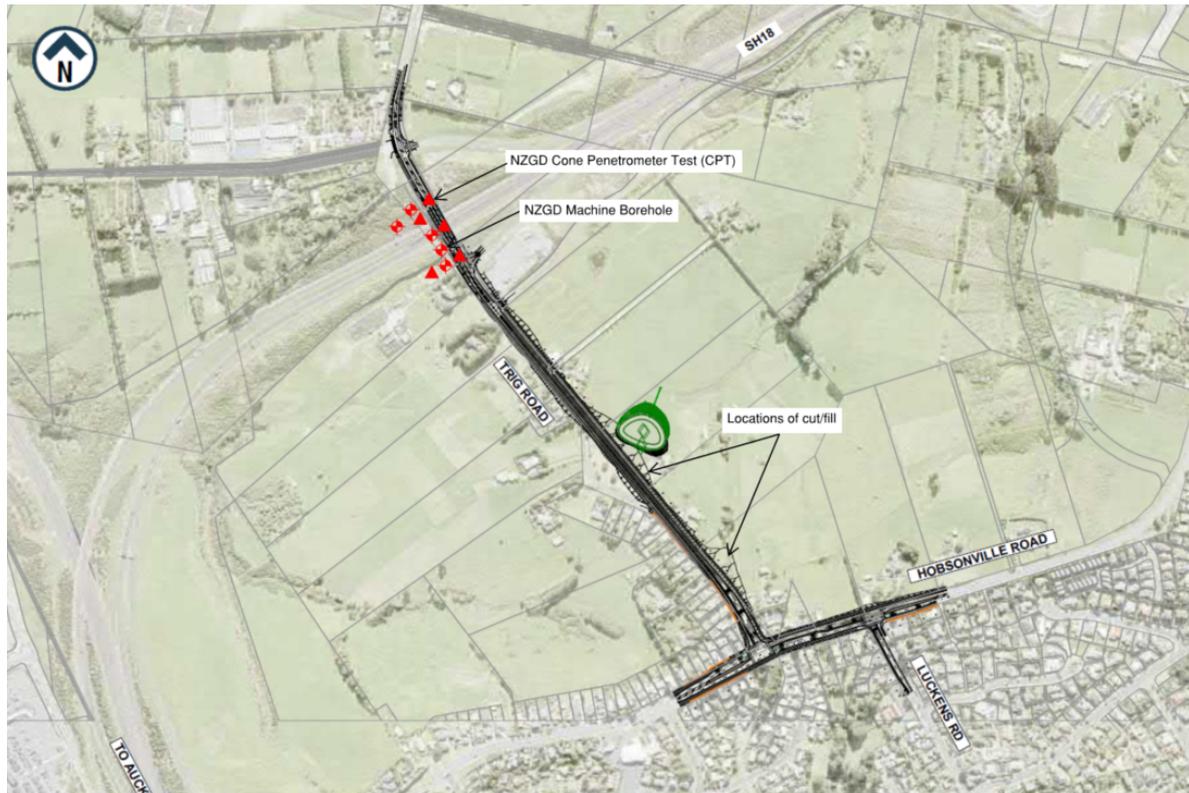
Figure 3 – Trig Road NZGD Investigation Points.

Several geotechnical investigations have been carried out along Upper Harbour Highway. A Beca investigation is shown in our reports database, however the locations of the individual investigation points are a long way from this Trig Road site. The New Zealand Geotechnical Database (NZGD) shows several investigation points at the northern end of the site adjacent to the Upper Harbour Highway (Figure 3). These are summarised below:

- Five machine boreholes and five Cone Penetrometer Tests (CPT's) at the northern end of the site
- Machine boreholes encounter varying amounts of fill ranging from 0.5m to 2.5m thick.
- Puketoka Formation alluvials underly the fill to approximately 5.6m below ground level (bgl) to 15mBGL and overly residual ECBF. The ECBF residual soil varies from approximately 5.6mBGL to 24mBGL and overlies ECBF Rock. ECBF rock varies from approximately 12mBGL to 35.3mBGL.
- CPT results indicate soft soils from ground level to around 8 – 13mBGL with cone resistance of 0 – 2 mPa.
- CPT's reach refusal from around 15 – 23mBGL.

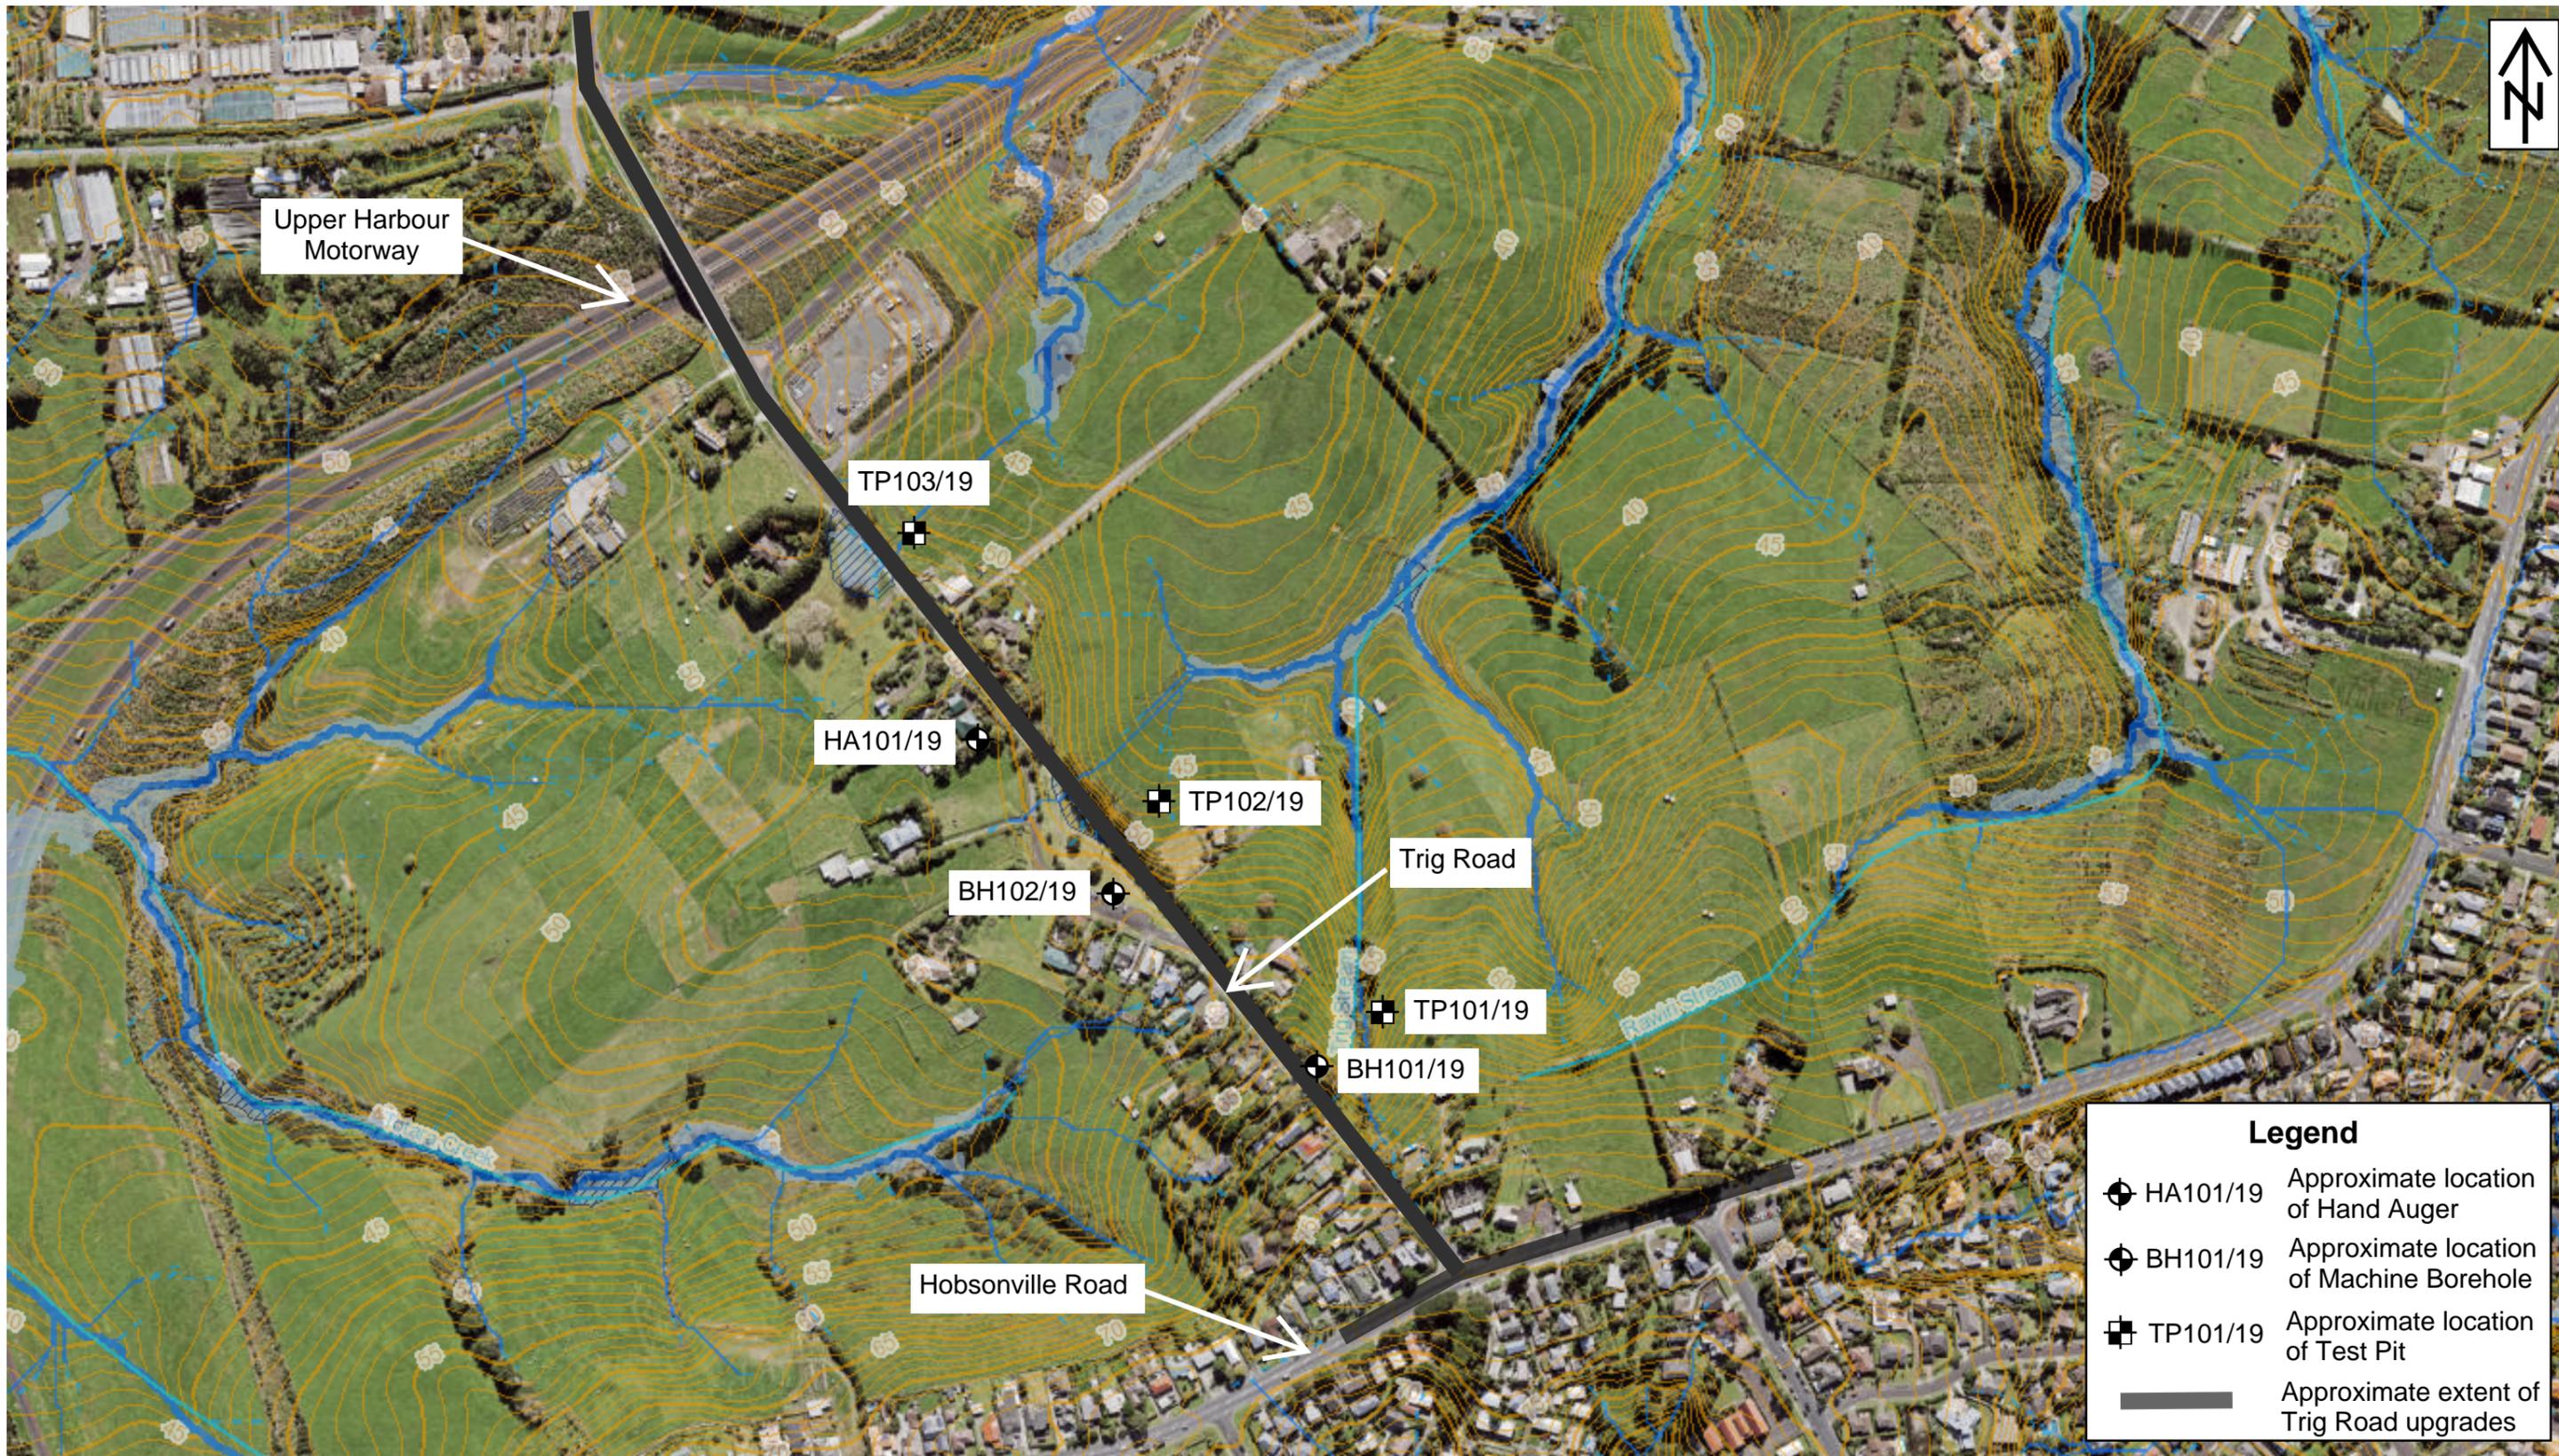
Overall Site Plan

A hand auger was drilled and logged on site by Beca staff. The hand auger location is shown on the Site Plan in Appendix 1, the log and photographs are shown in Appendix 3.

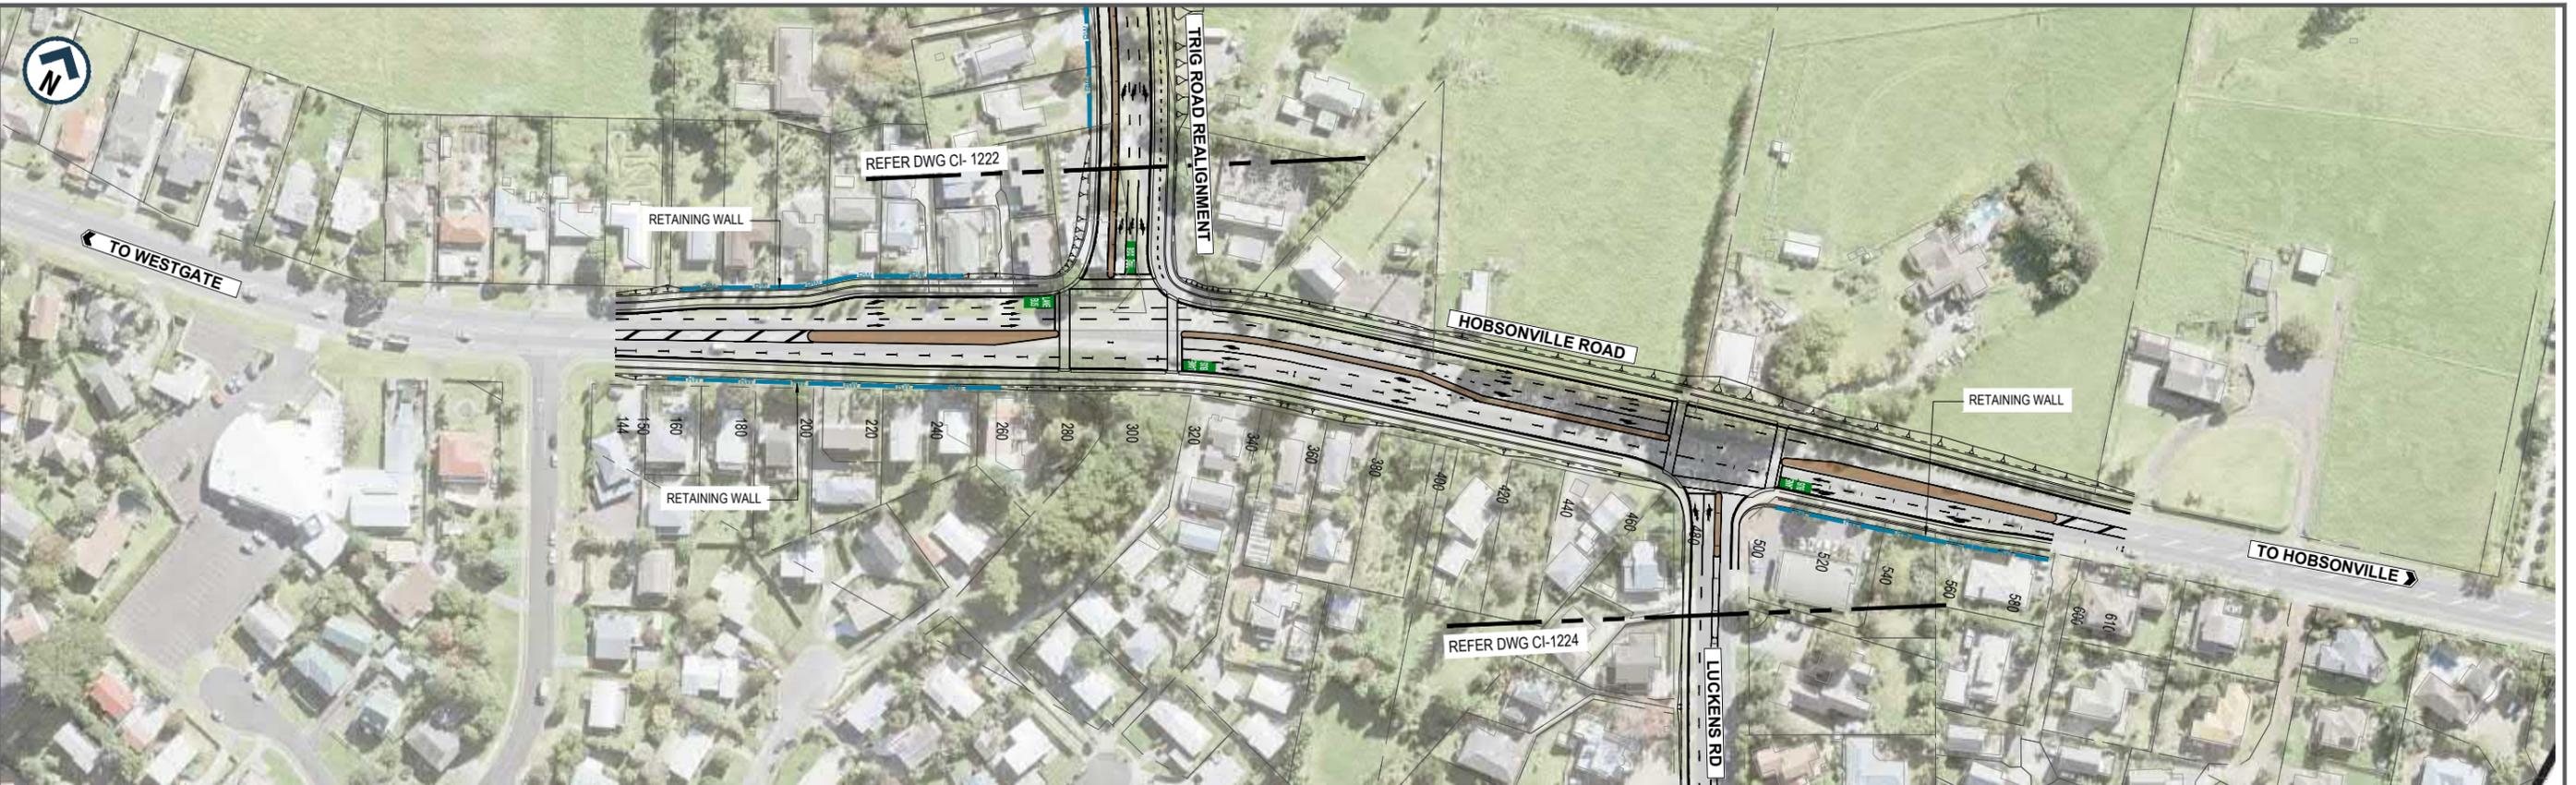
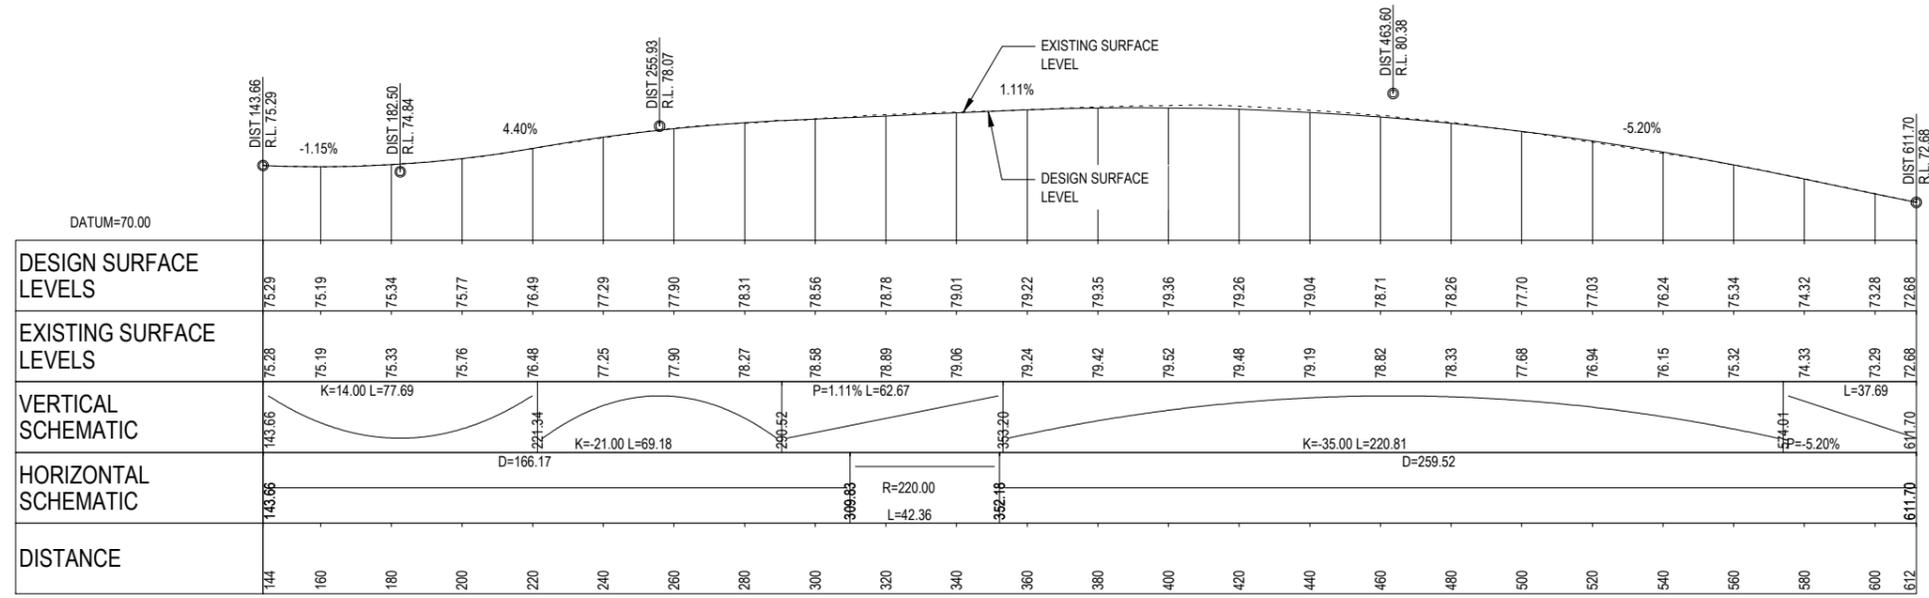
PLAN VIEW: HOBSONVILLE ROAD

LONGITUDINAL SECTION ON CONTROL STRING MCHO
SCALE HORIZ=1:1000 VERT=1:250

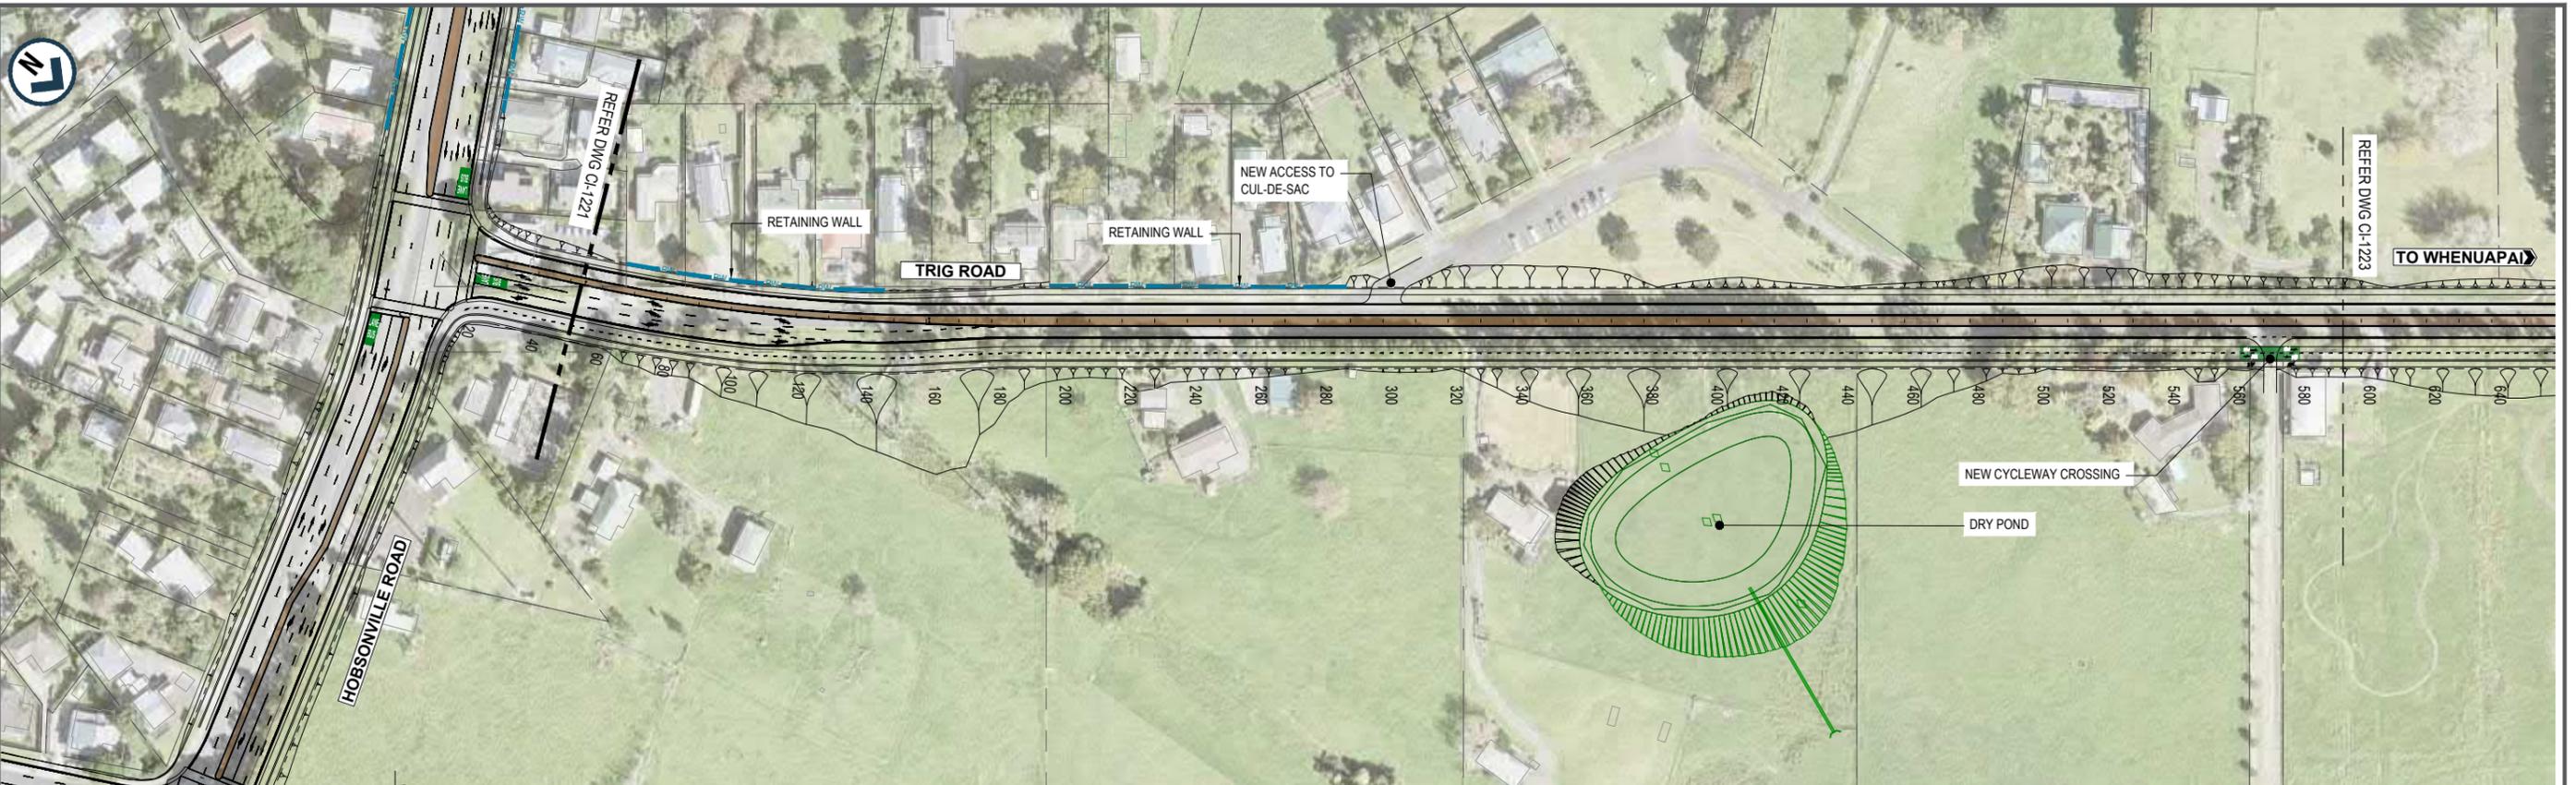
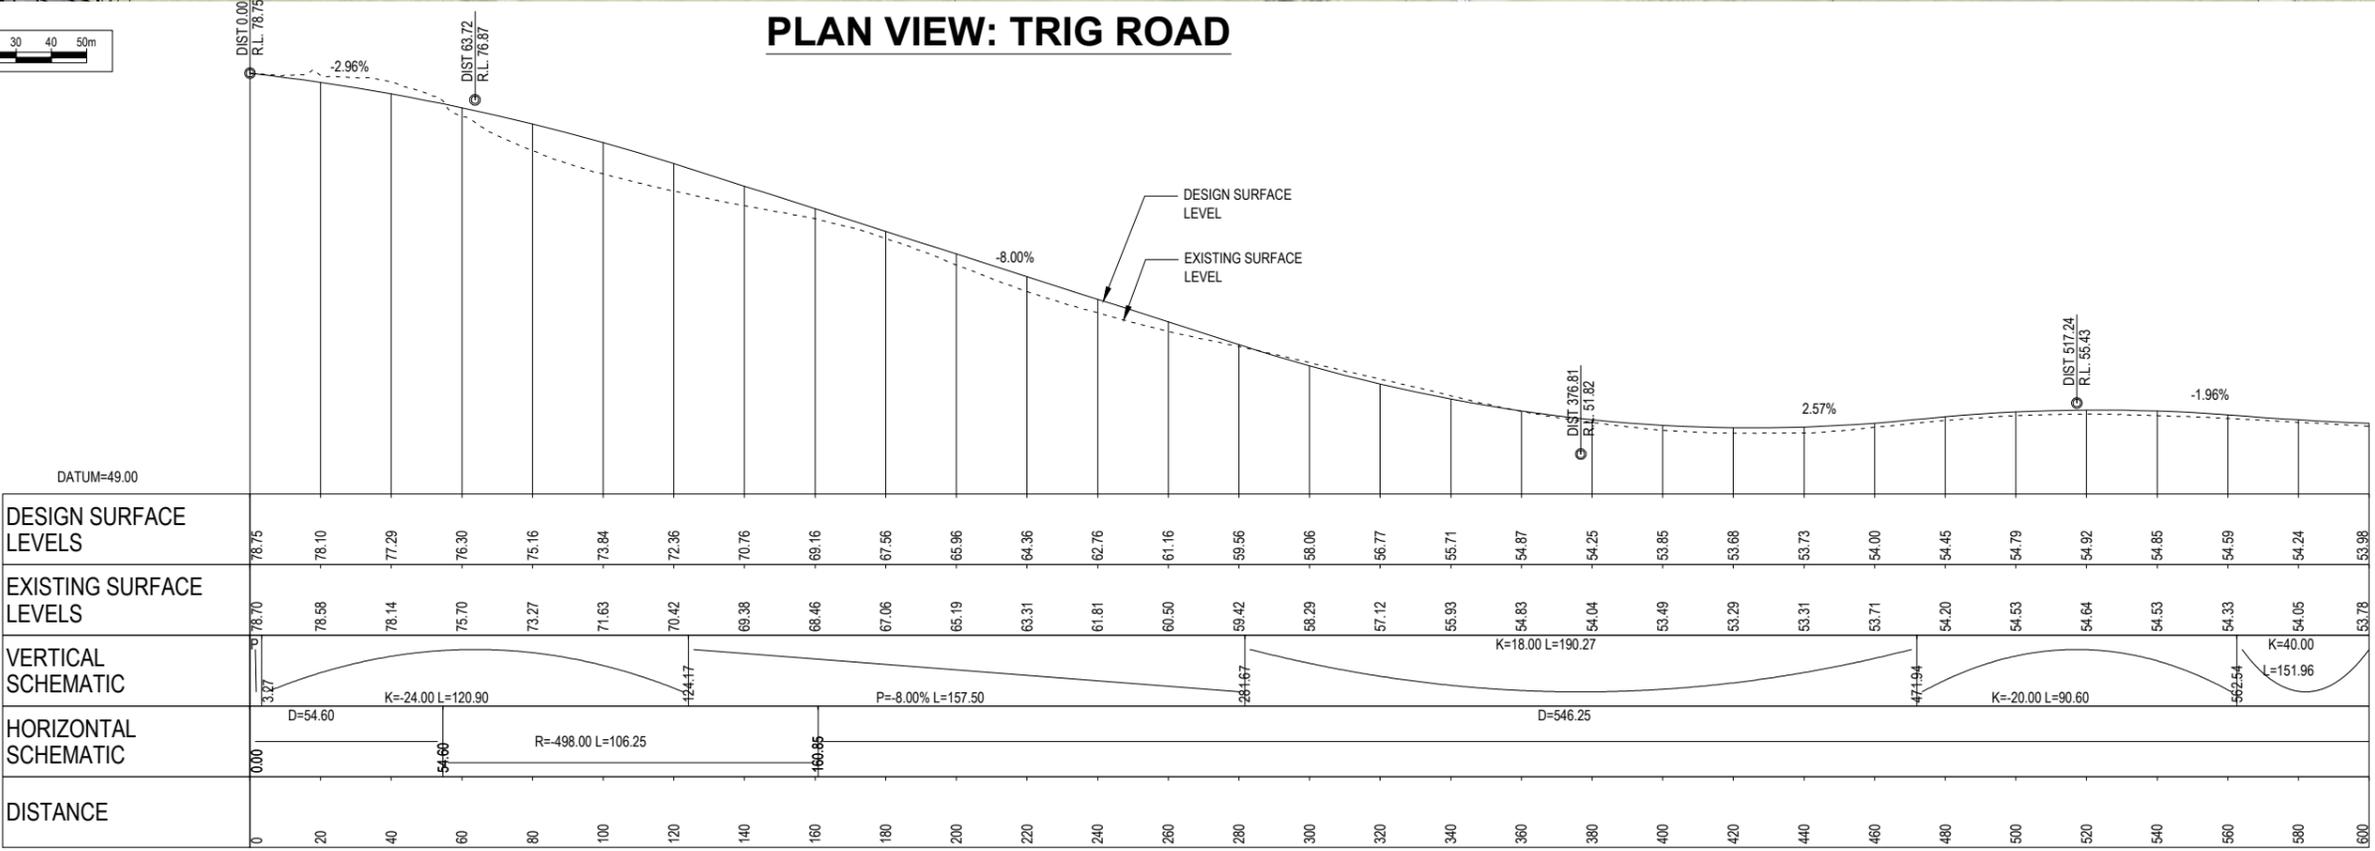
PLAN VIEW: TRIG ROAD

LONGITUDINAL SECTION ON CONTROL STRING MCT0
SCALE HORIZ=1:1000 VERT=1:250

Trig Road runs along a minor north to south trending ridge with slopes within the area considered flat to gently sloping, at less than 5°. Slopes up to 20° occur in localised areas immediately adjacent to the road alignment. Three streams are present within the site and exist on the eastern and western sides of Trig Road and are named Totara Stream, Trig Stream, and Rawiri Stream with various ephemeral water courses feeding into them. The proposed road alignment upgrade involves various cut and fill operations which will require retaining walls to support adjacent properties. Refer to Geometric Plans attached in Appendix 1.

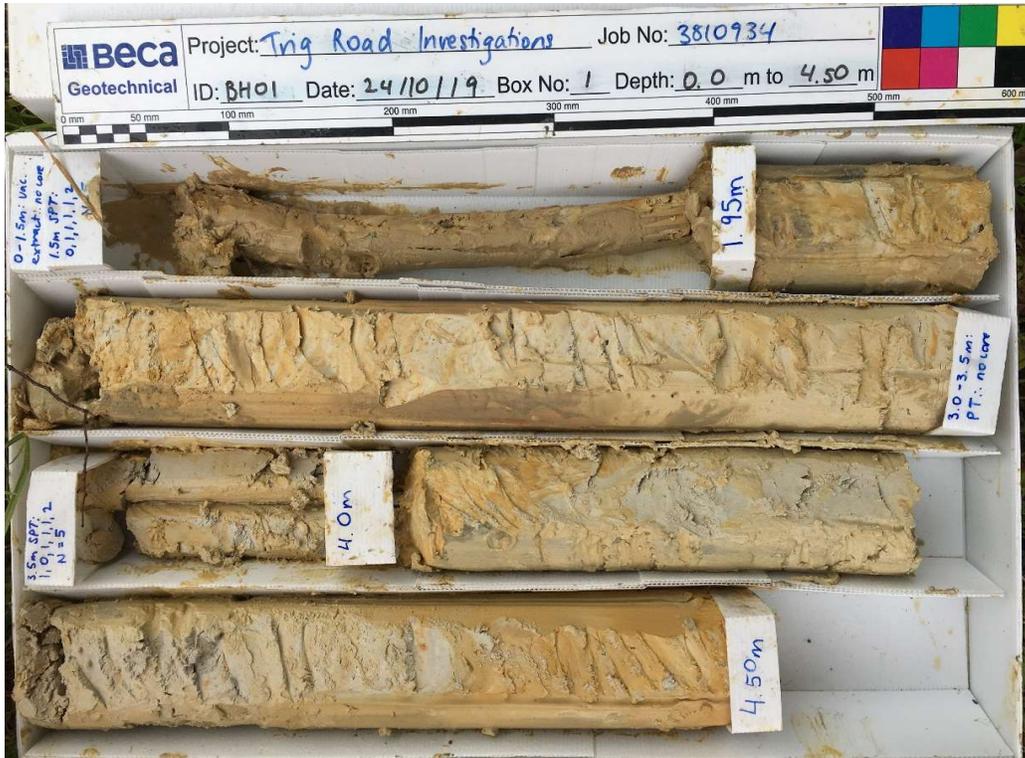
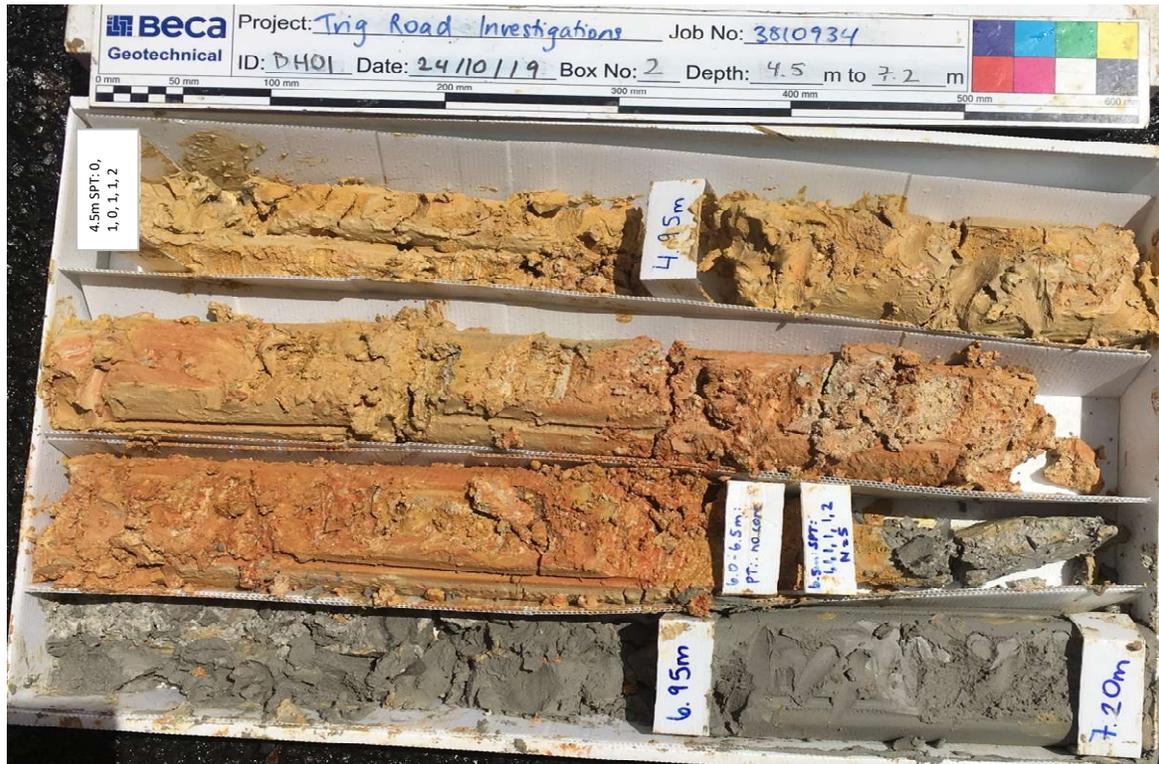
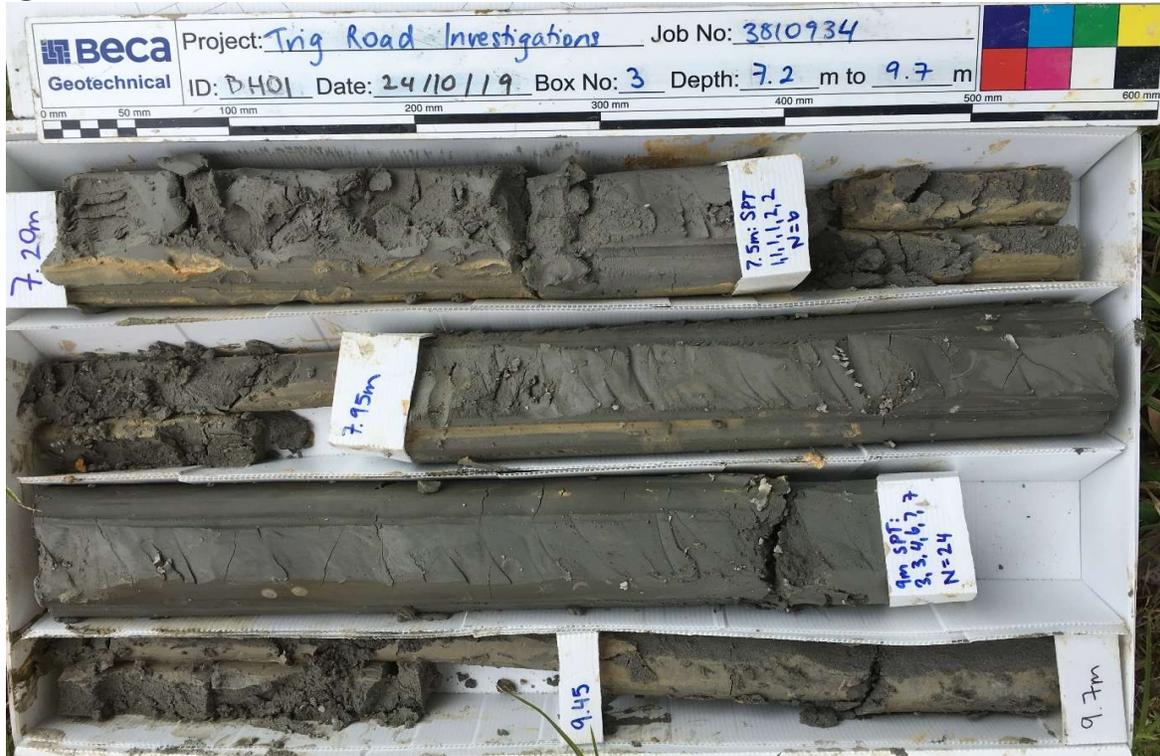
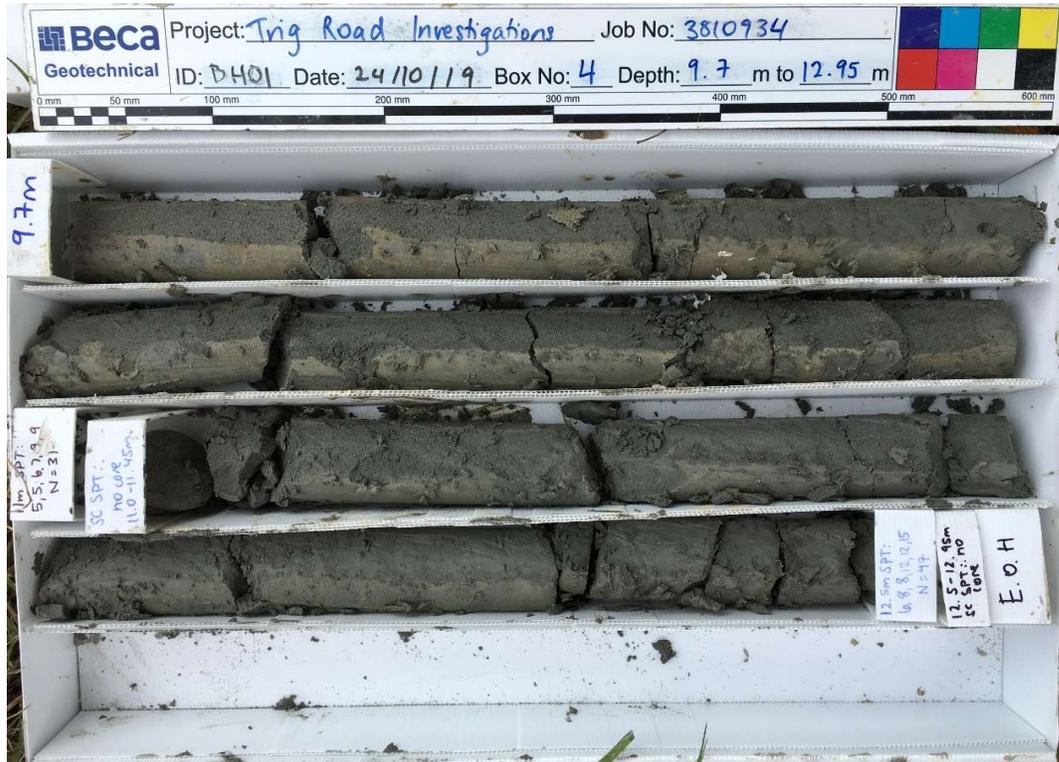
DEPTH: 0.0 to 4.50m

DEPTH: 4.50 to 7.20m

DEPTH: 7.20 to 9.70m

DEPTH: 9.70 to 12.95m

All core samples were logged on site by a Beca Geotechnical Engineer. Machine borehole logs and core photographs are presented in Appendix 2. After the core samples had been logged, they were wrapped in plastic to reduce moisture loss and placed in labelled core boxes before being transferred to the Beca office for storage. Some natural desiccation and degradation of the core samples will occur through time following storage. Upon completion, all boreholes were backfilled with gravel and placed over with a topsoil and grass cover.
