Northwest HIF - Trig Road Geotechnical Factual Report

This Factual Report has been prepared in order to present geotechnical information from the preliminary investigation undertaken at Trig Road, Whenuapai.

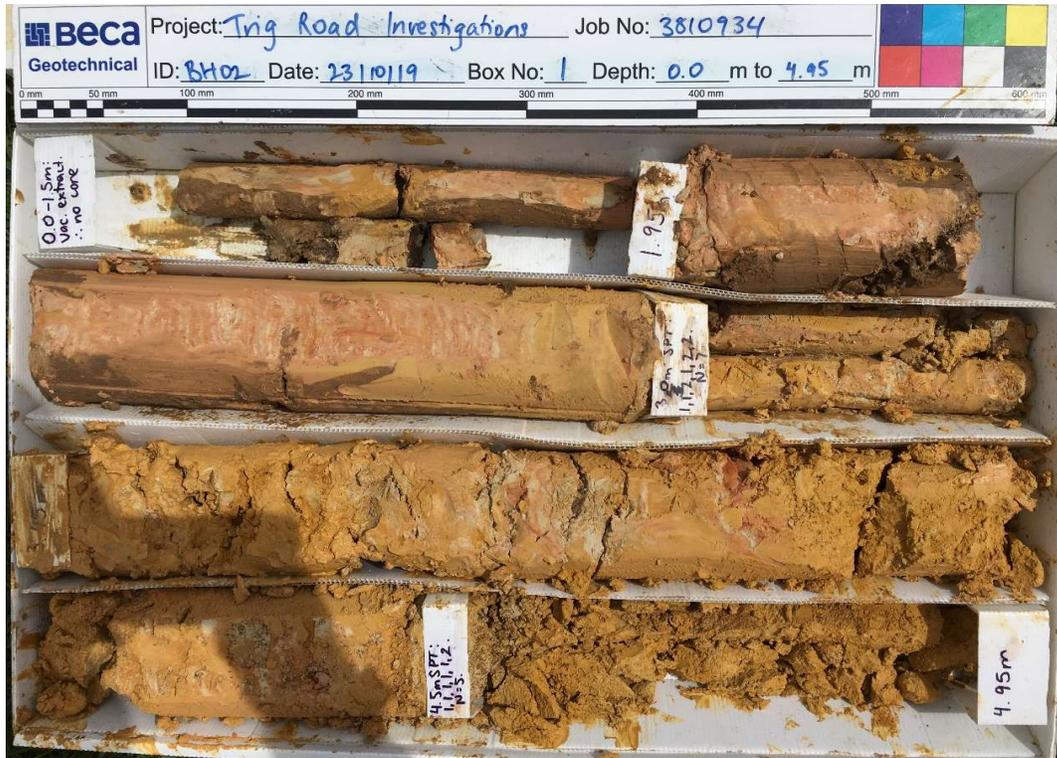
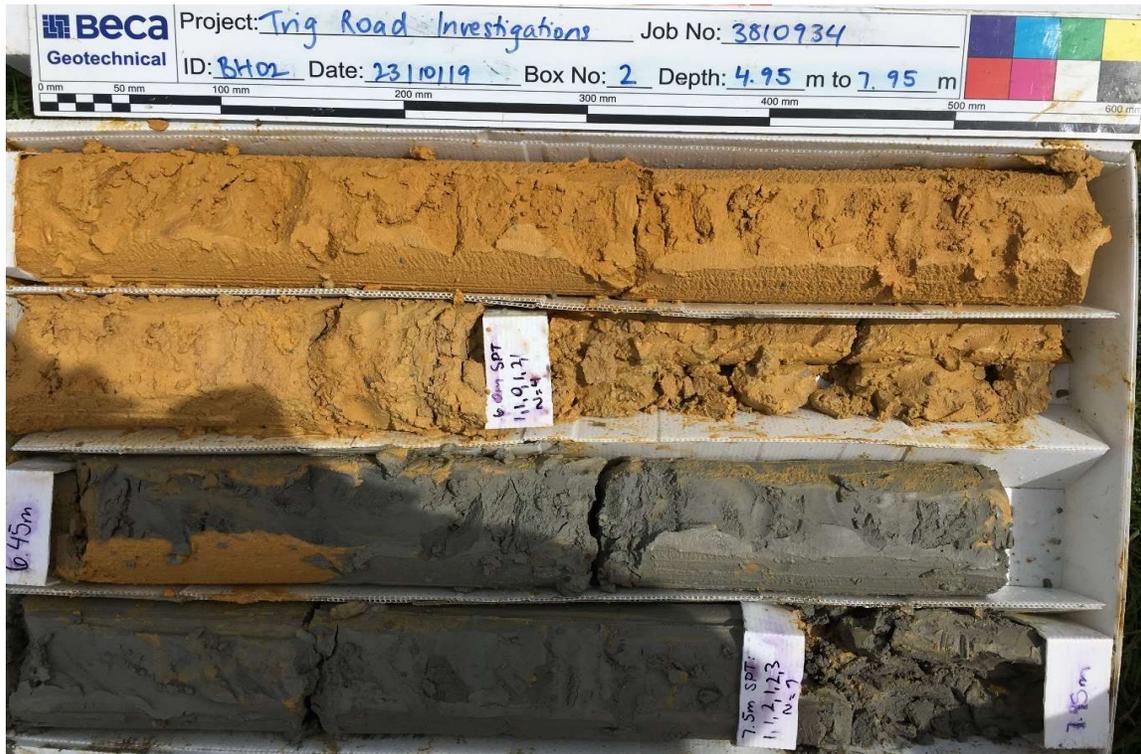
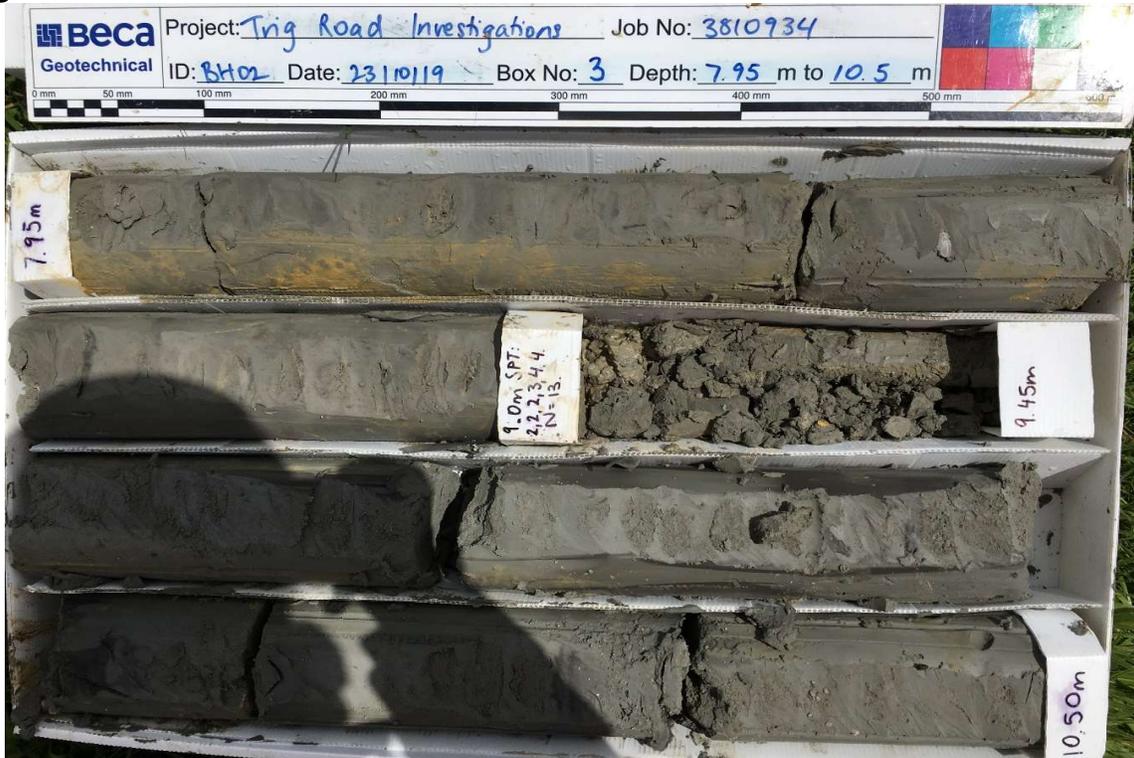
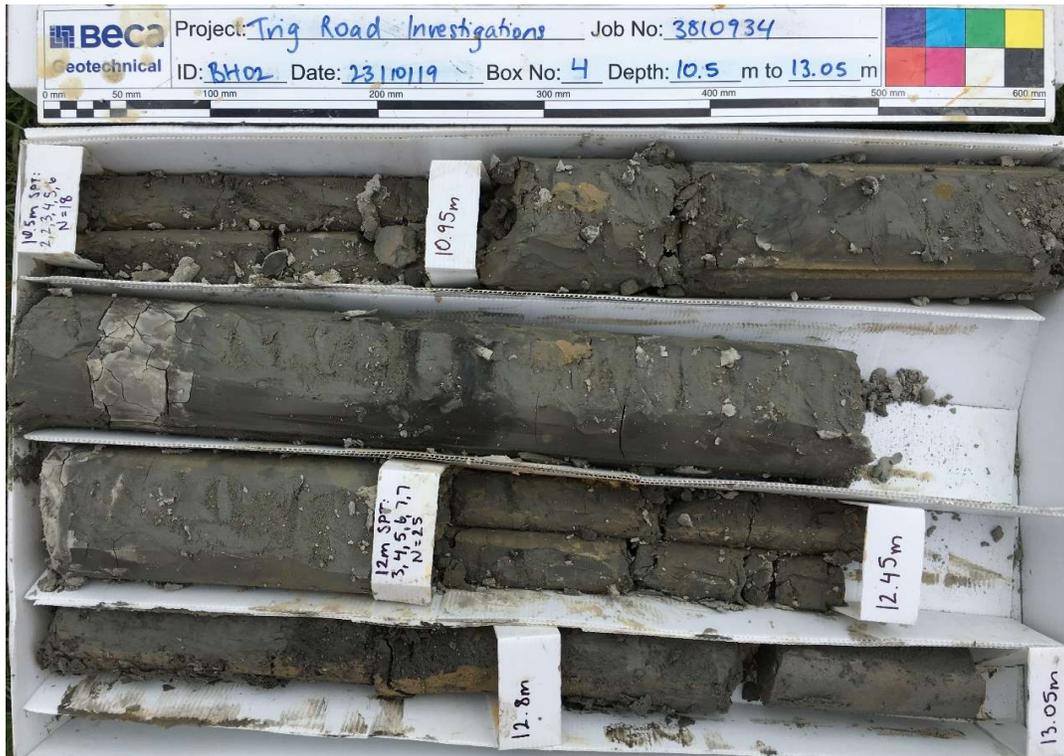
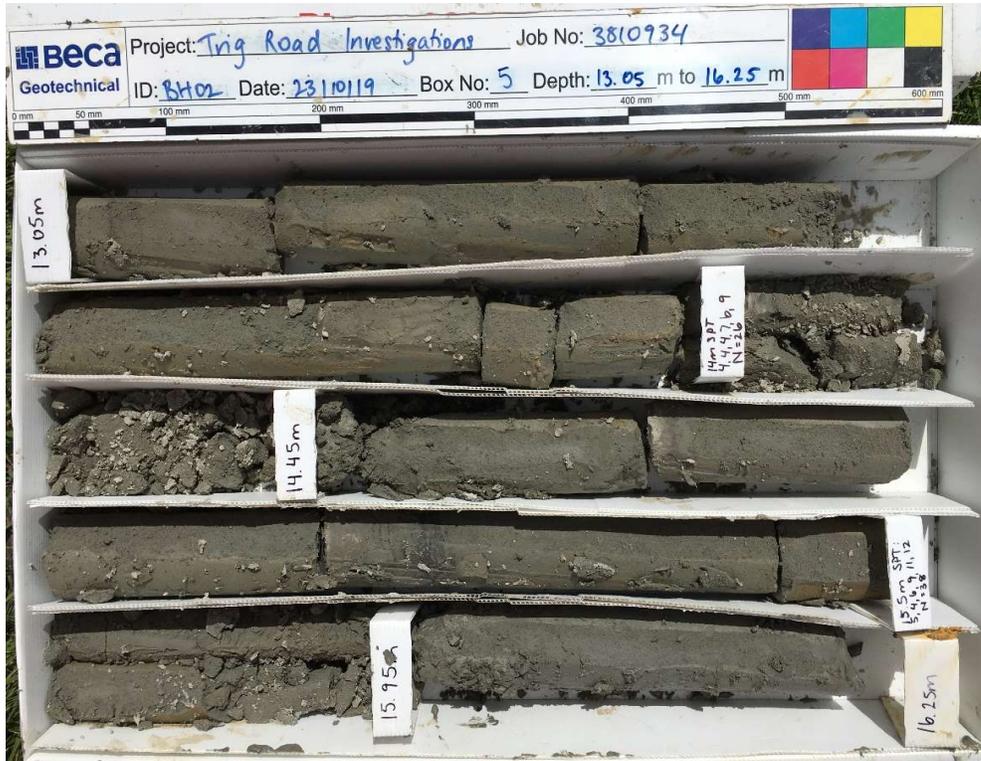
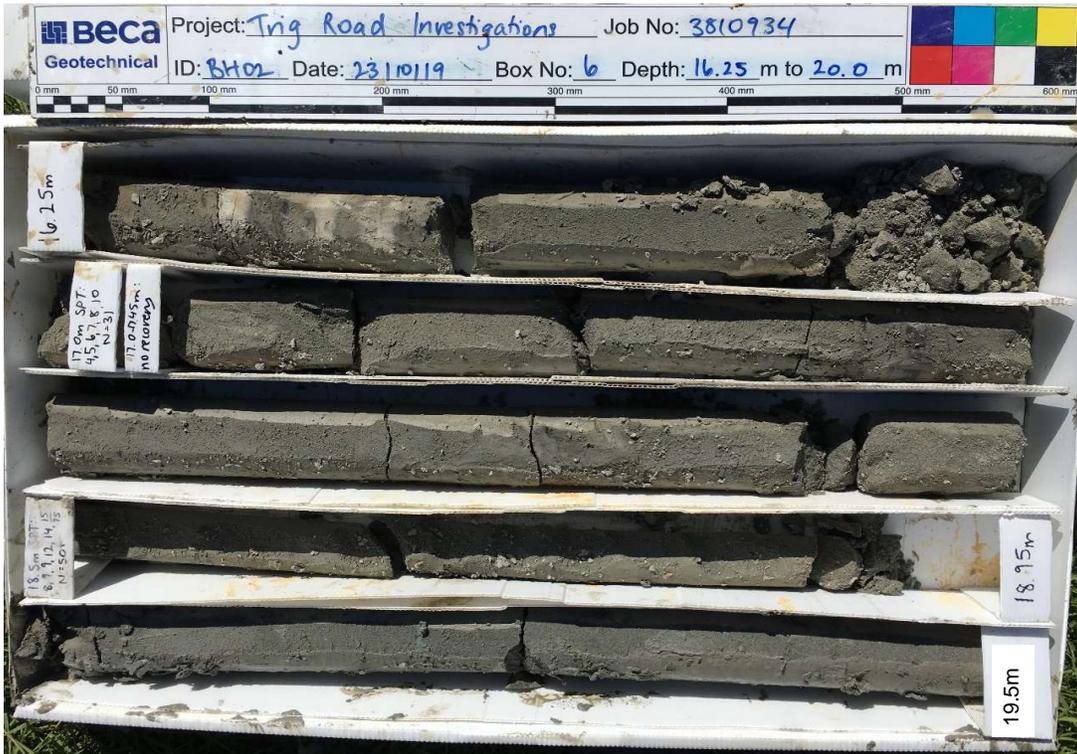
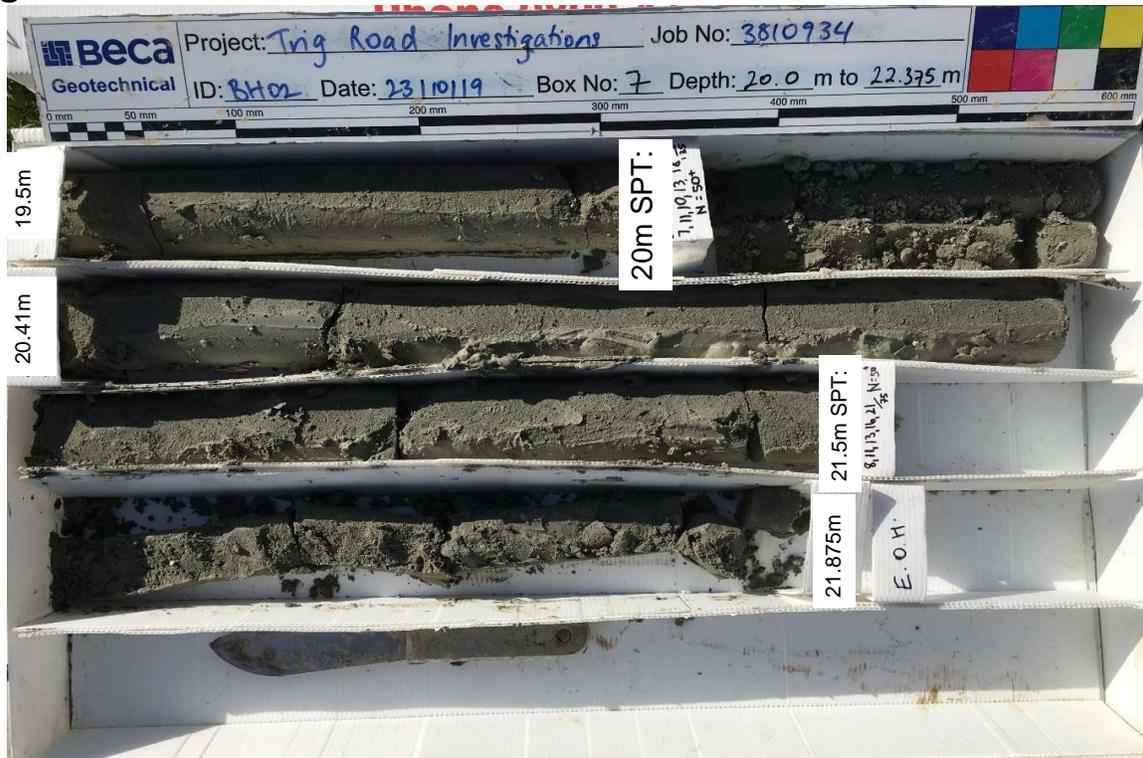
DEPTH: 0.0 to 4.95m

DEPTH: 4.95 to 7.95m

DEPTH: 7.95 to 10.50m

DEPTH: 10.5 to 13.95m

DEPTH: 13.05 to 16.25m

DEPTH: 16.25 to 20.00

DEPTH: 20.0 to 22.375m

All core samples were logged on site by a Beca Geotechnical Engineer. Machine borehole logs and core photographs are presented in Appendix 2. After the core samples had been logged, they were wrapped in plastic to reduce moisture loss and placed in labelled core boxes before being transferred to the Beca office for storage. Some natural desiccation and degradation of the core samples will occur through time following storage. Upon completion, all boreholes were backfilled with gravel and placed over with a topsoil and grass cover.

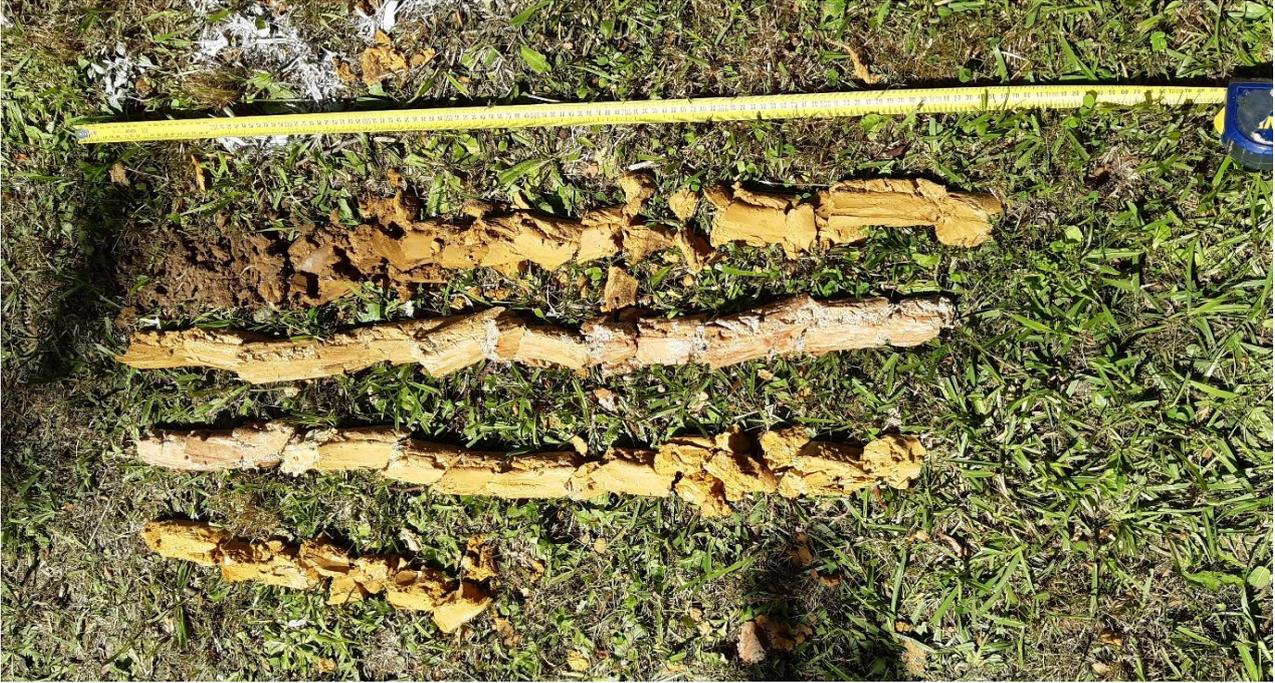
SGA Trig Rd Geotechnical Investigation. HA101/19

Depth: 0.00 m to 3.50 m

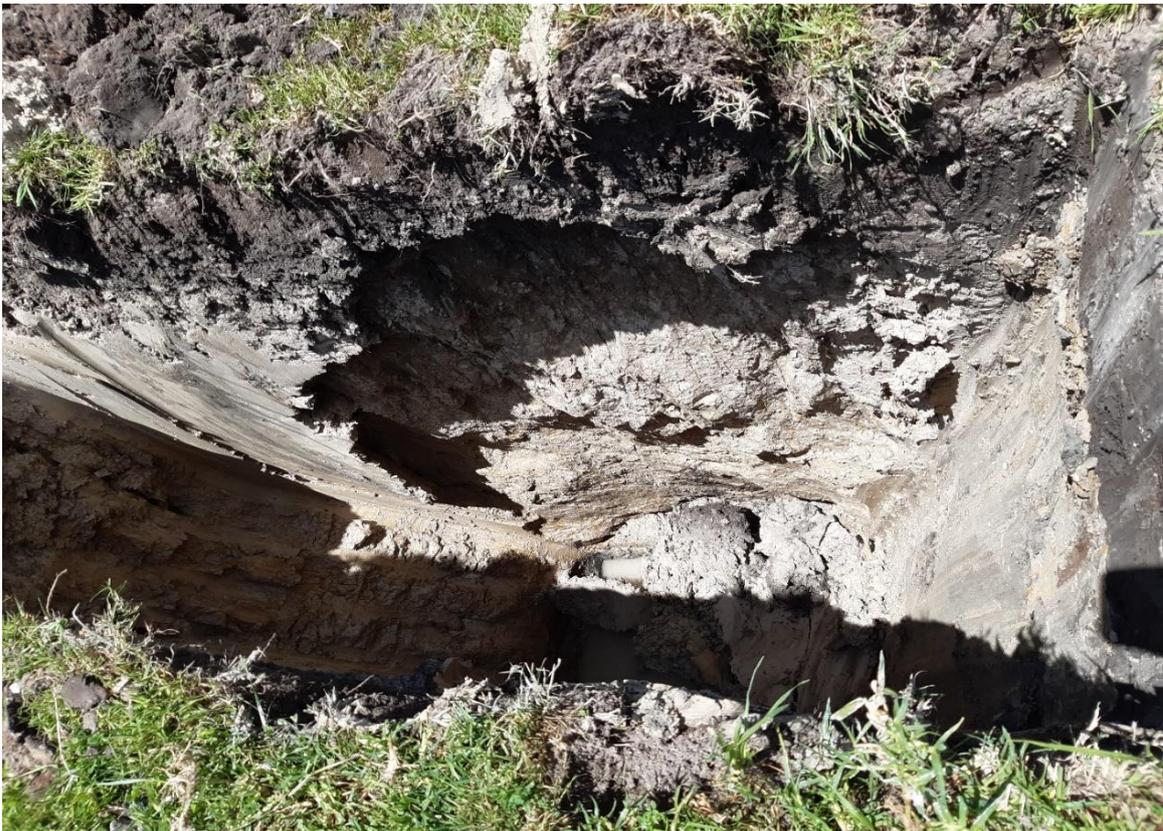
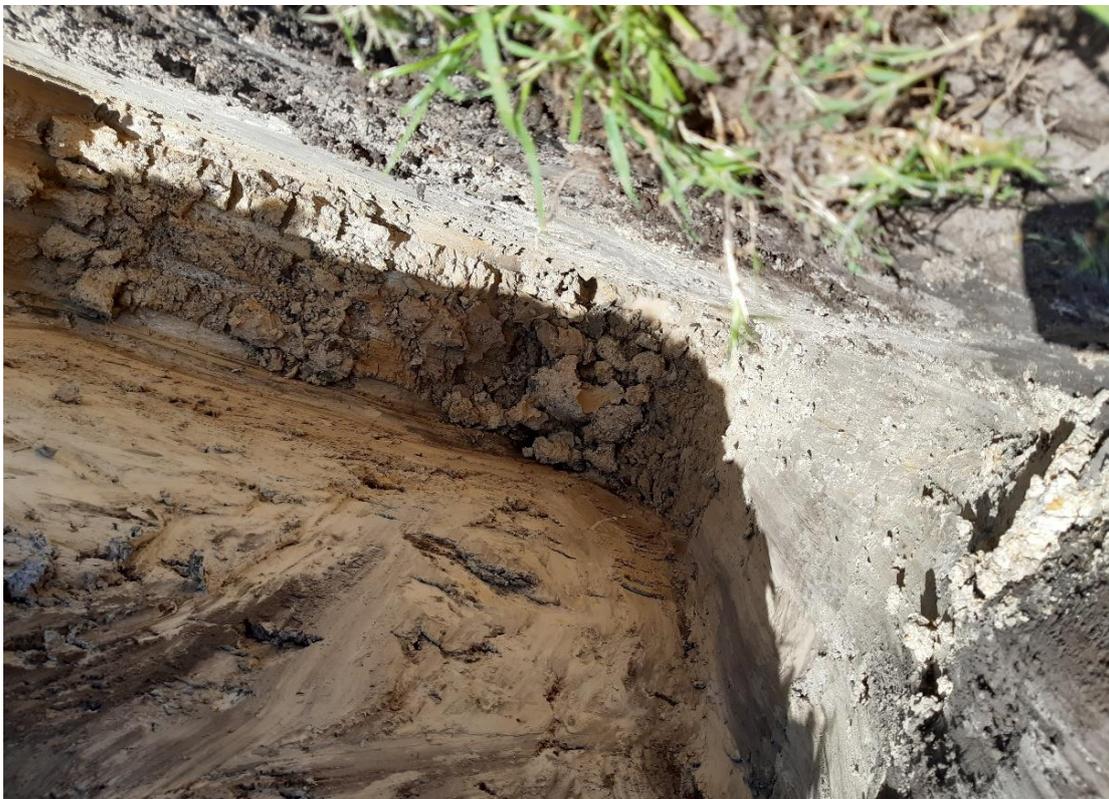
SGA Trig Rd Geotechnical Investigation TP101/19

Depth: 0.00 m to 3.5 m

Test pit 101/19 encountered groundwater at approximately 800mm depth. This test pit is located adjacent to an ephemeral watercourse and groundwater will likely be elevated at this location. Groundwater was measured at 3.0m below ground level in borehole BH101/19, and 2.5m below ground level in borehole BH102/19. Table 4 below summarises these observations

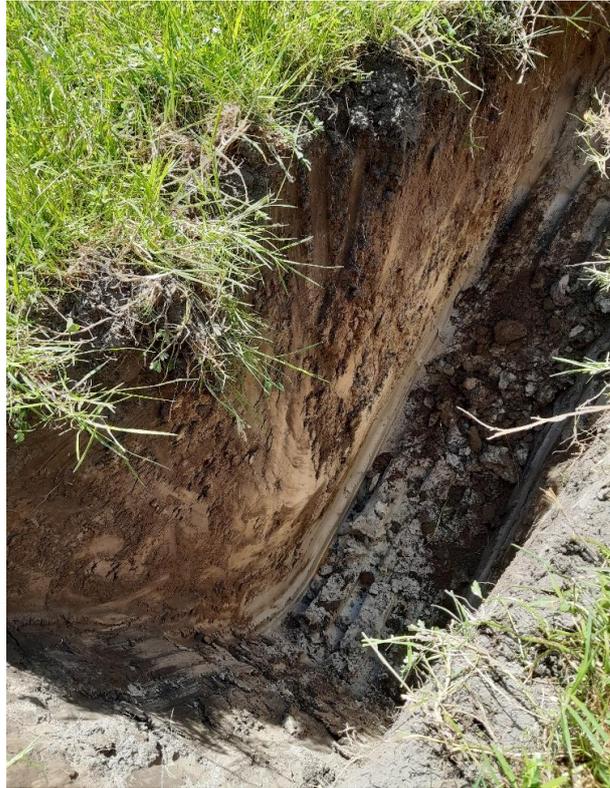
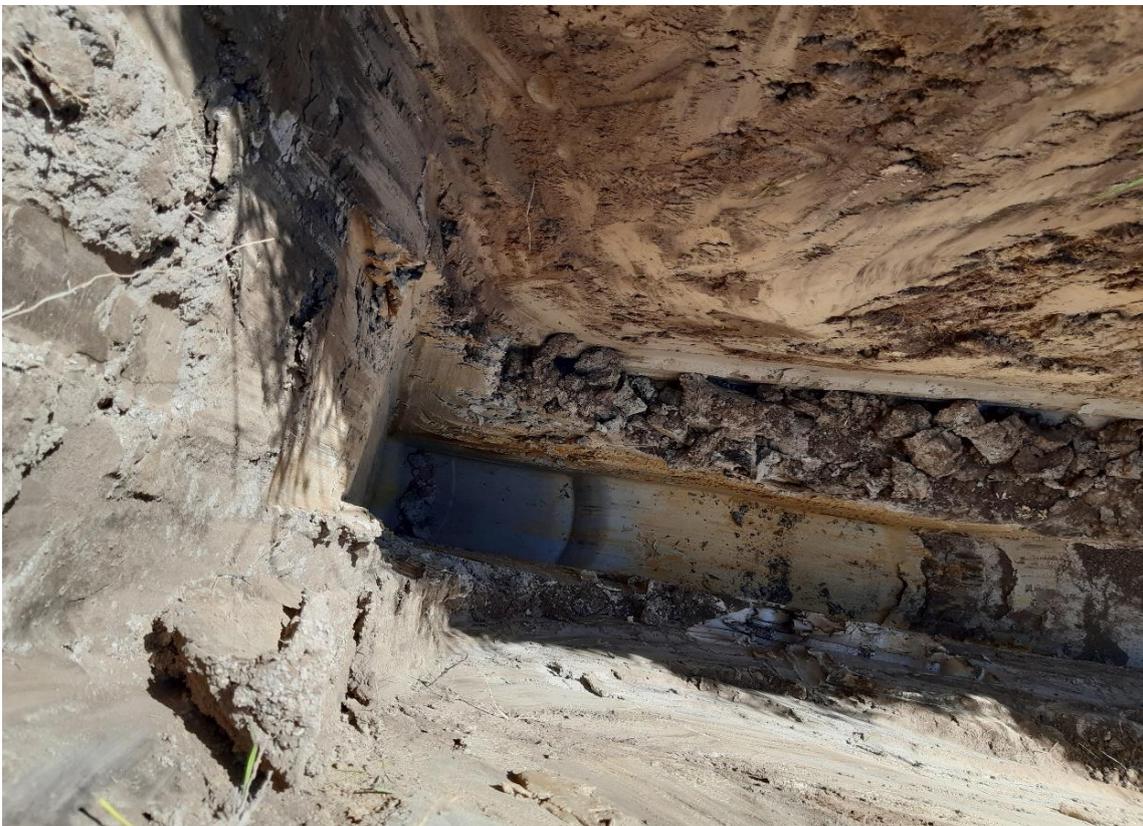
SGA Trig Rd Geotechnical Investigation TP102/19

Depth: 0.00 m to 3.5 m

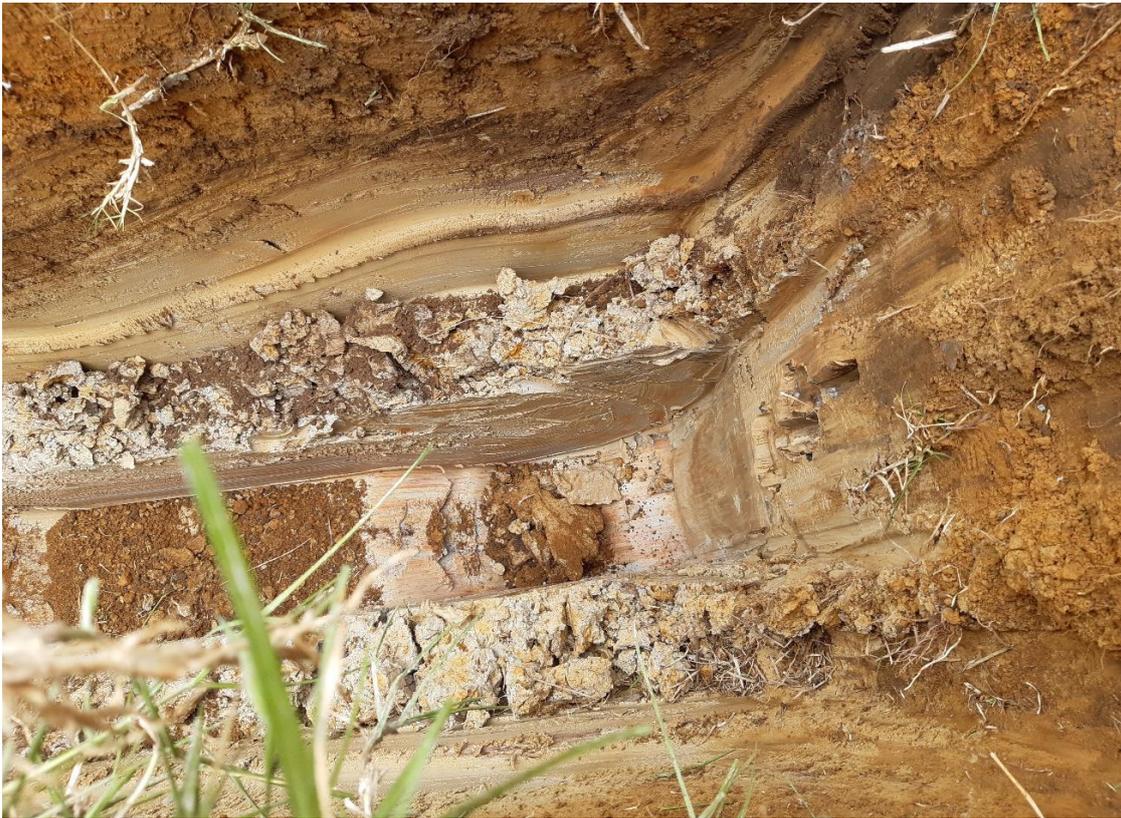
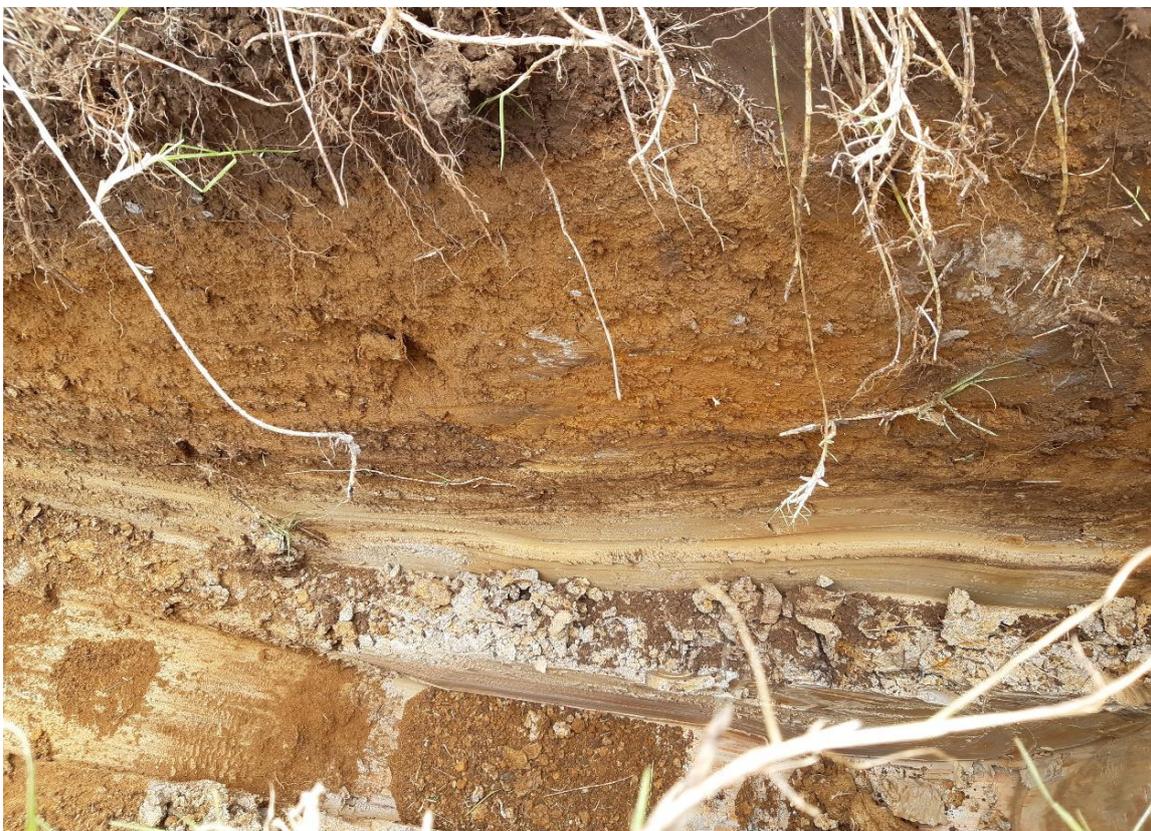
SGA Trig Rd Geotechnical Investigation TP103/19

Depth: 0.00 m to 2.3 m

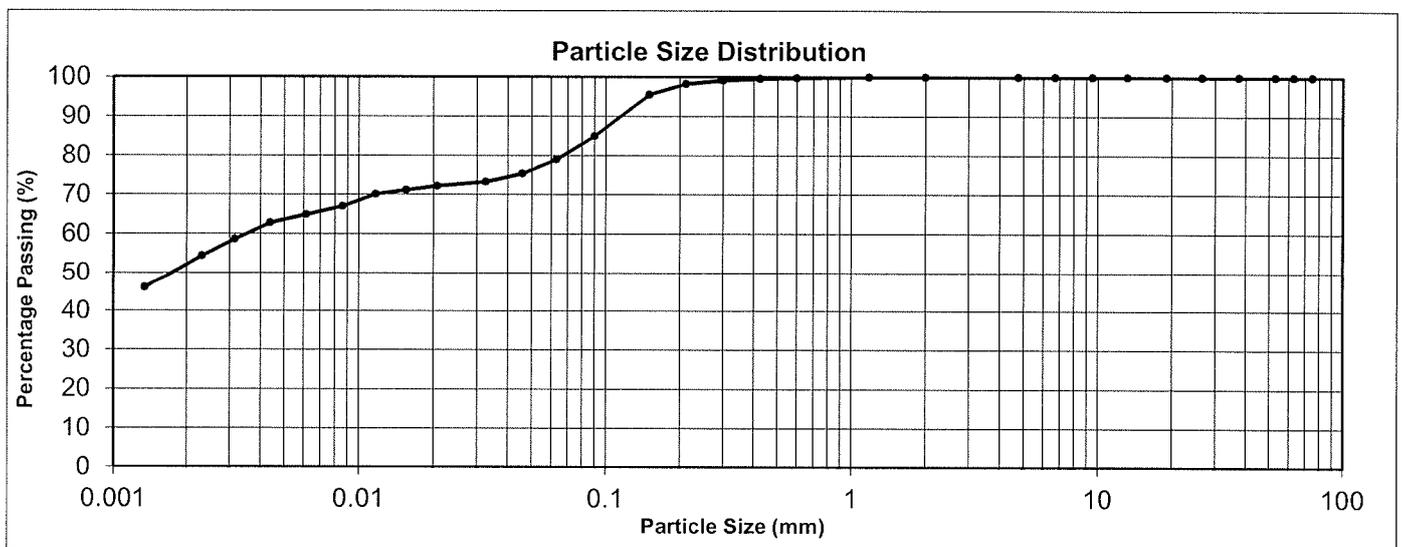
Sample Description: Fine to medium sandy silty CLAY, trace organics; yellowish brown, speckled dark greyish brown; moist, highly plastic.

Test Standard: NZS4402: 1986, Test 2.8.4 **Dispersion:** Sodium hexametaphosphate, pH = 9.0

% Clay	% Silt	% Sand	% Gravel	Max. size:
52	27	21	0	300µm

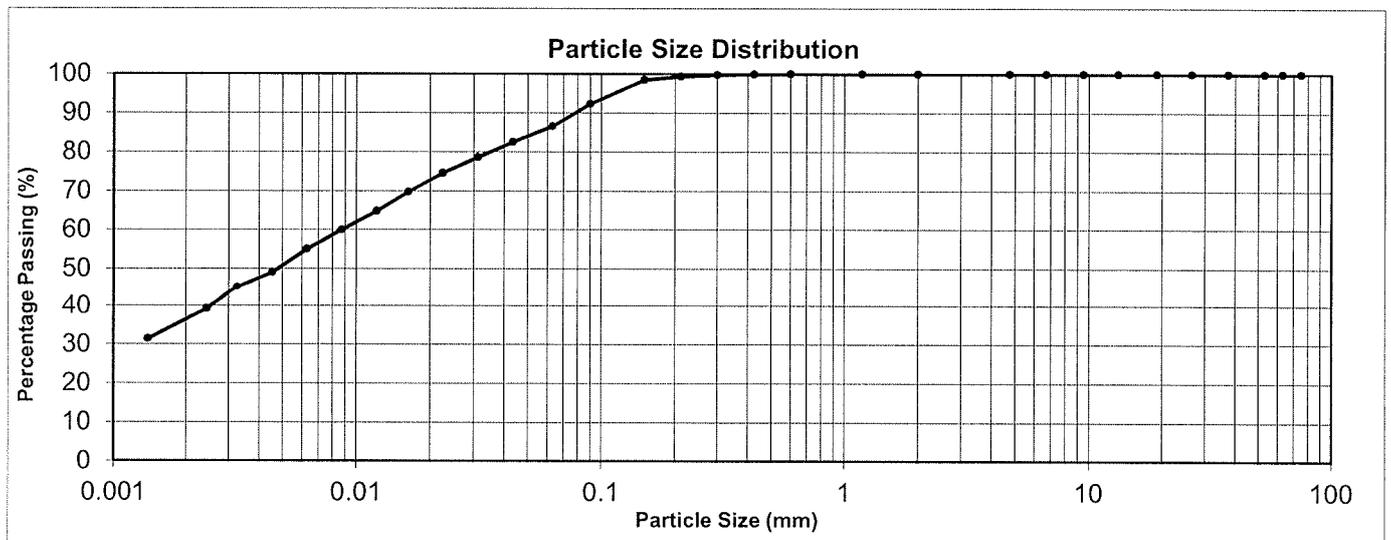
Sample Description: Clayey SILT, some fine sand; orange brown, mottled light blueish grey; moist, highly plastic.

Test Standard: NZS4402: 1986, Test 2.8.4 **Dispersion:** Sodium hexametaphosphate, pH = 9.0

% Clay	% Silt	% Sand	% Gravel	Max. size:
36	51	13	0	212µm

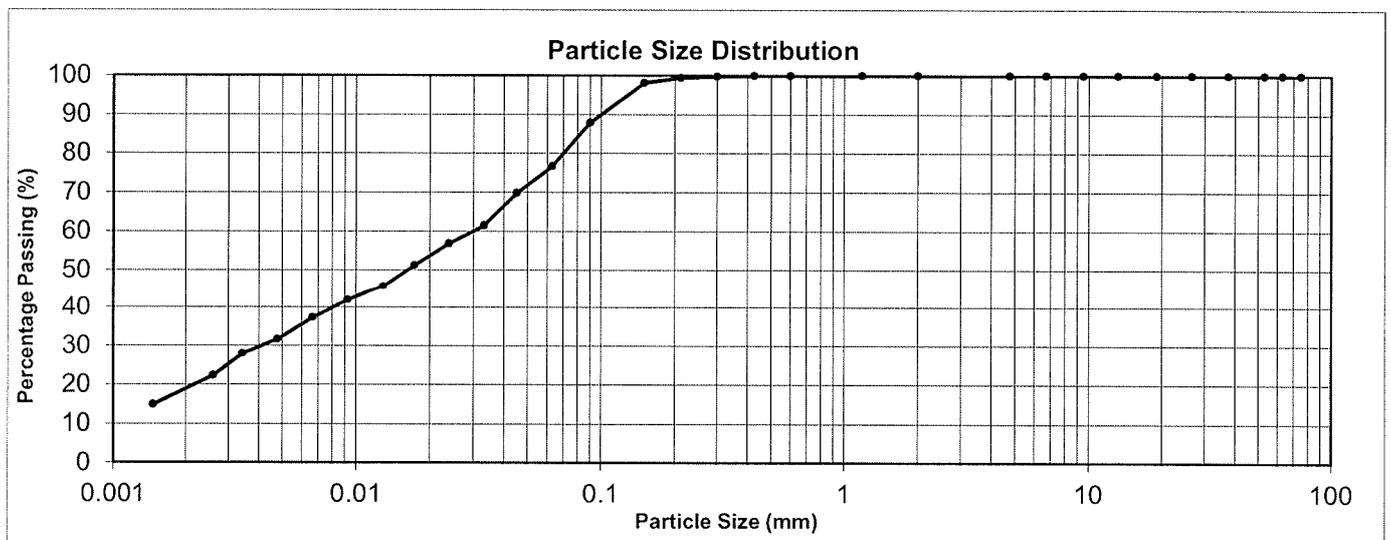
Sample Description: Fine to medium sandy SILT, some clay; greyish brown, speckled orange brown; moist, highly plastic.

Test Standard: NZS4402: 1986, Test 2.8.4 **Dispersion:** Sodium hexametaphosphate, pH = 9.0

% Clay	% Silt	% Sand	% Gravel	Max. size:
18	59	23	0	212µm

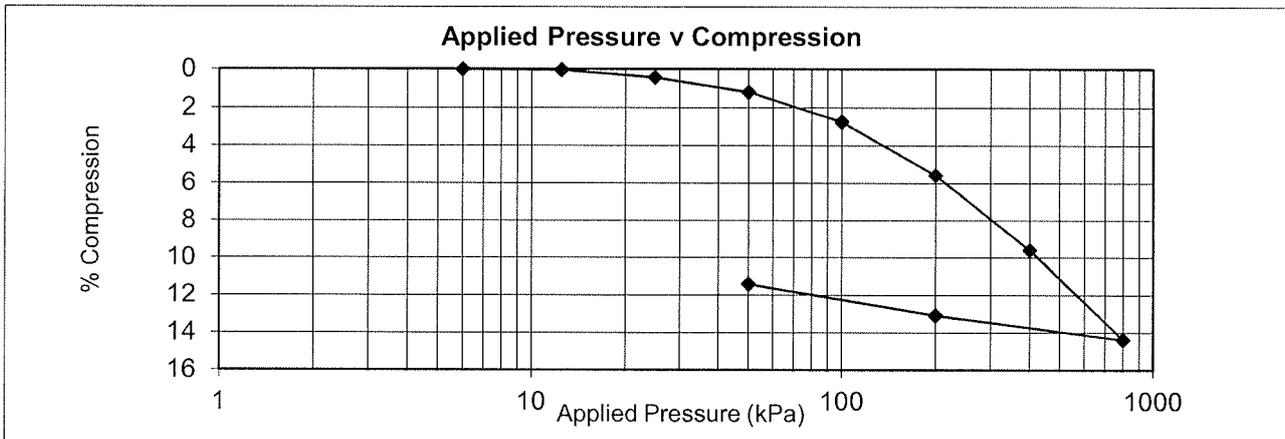
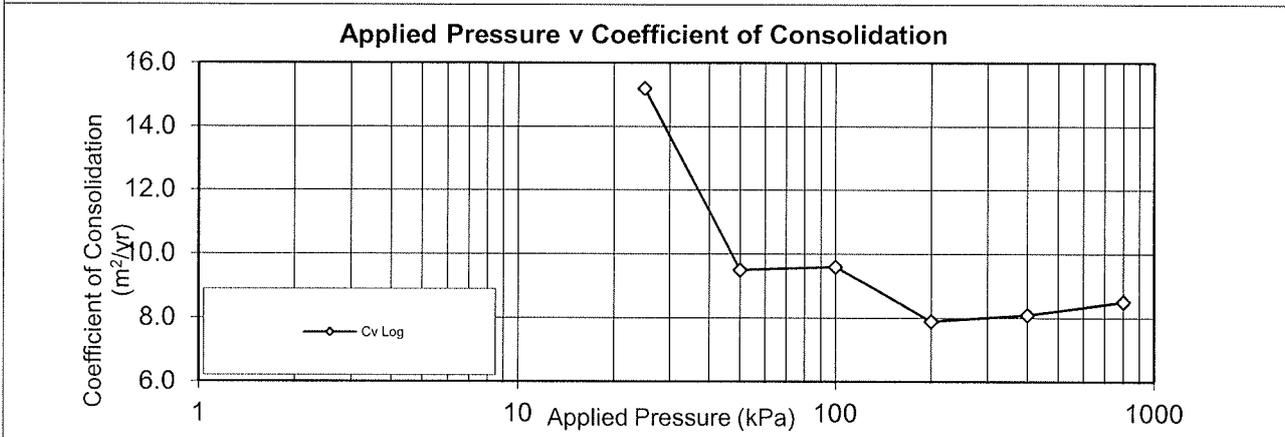
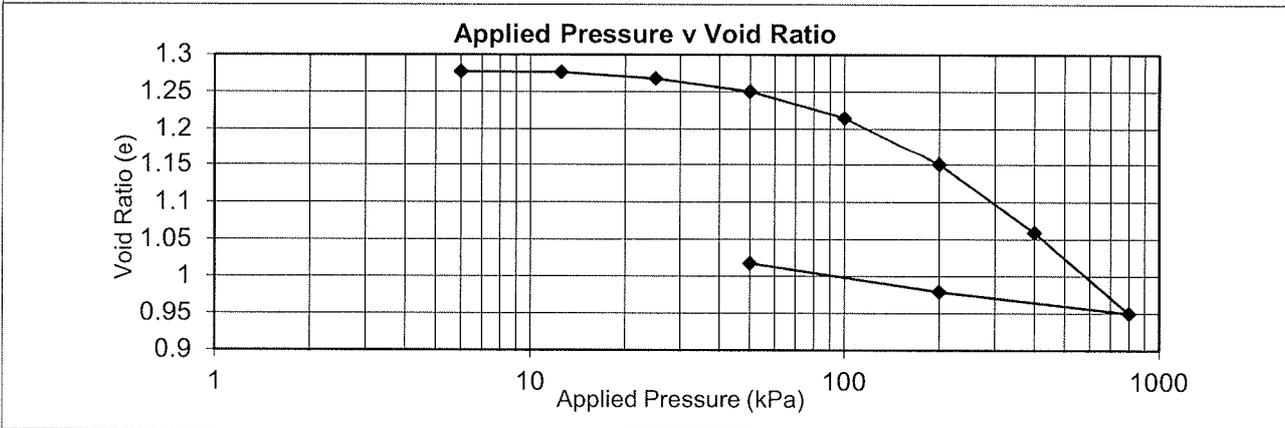
ONE DIMENSIONAL CONSOLIDATION (OEDOMETER) TEST

Sample Description: Clayey SILT, minor sand; bluish grey mottled orange brown; moist, highly plastic.

Test Condition: Inundated at 1 minute interval on initial load sequence

Project: Supporting Group Alliance Client:Auckland Transport Date: 13 December 2019
 Job No: 3810934/1000 Location: - Depth (m): 3.8
 Bore/Test Pit No.: BH101/19 Sample No.: S846 Report No: 2048L:01

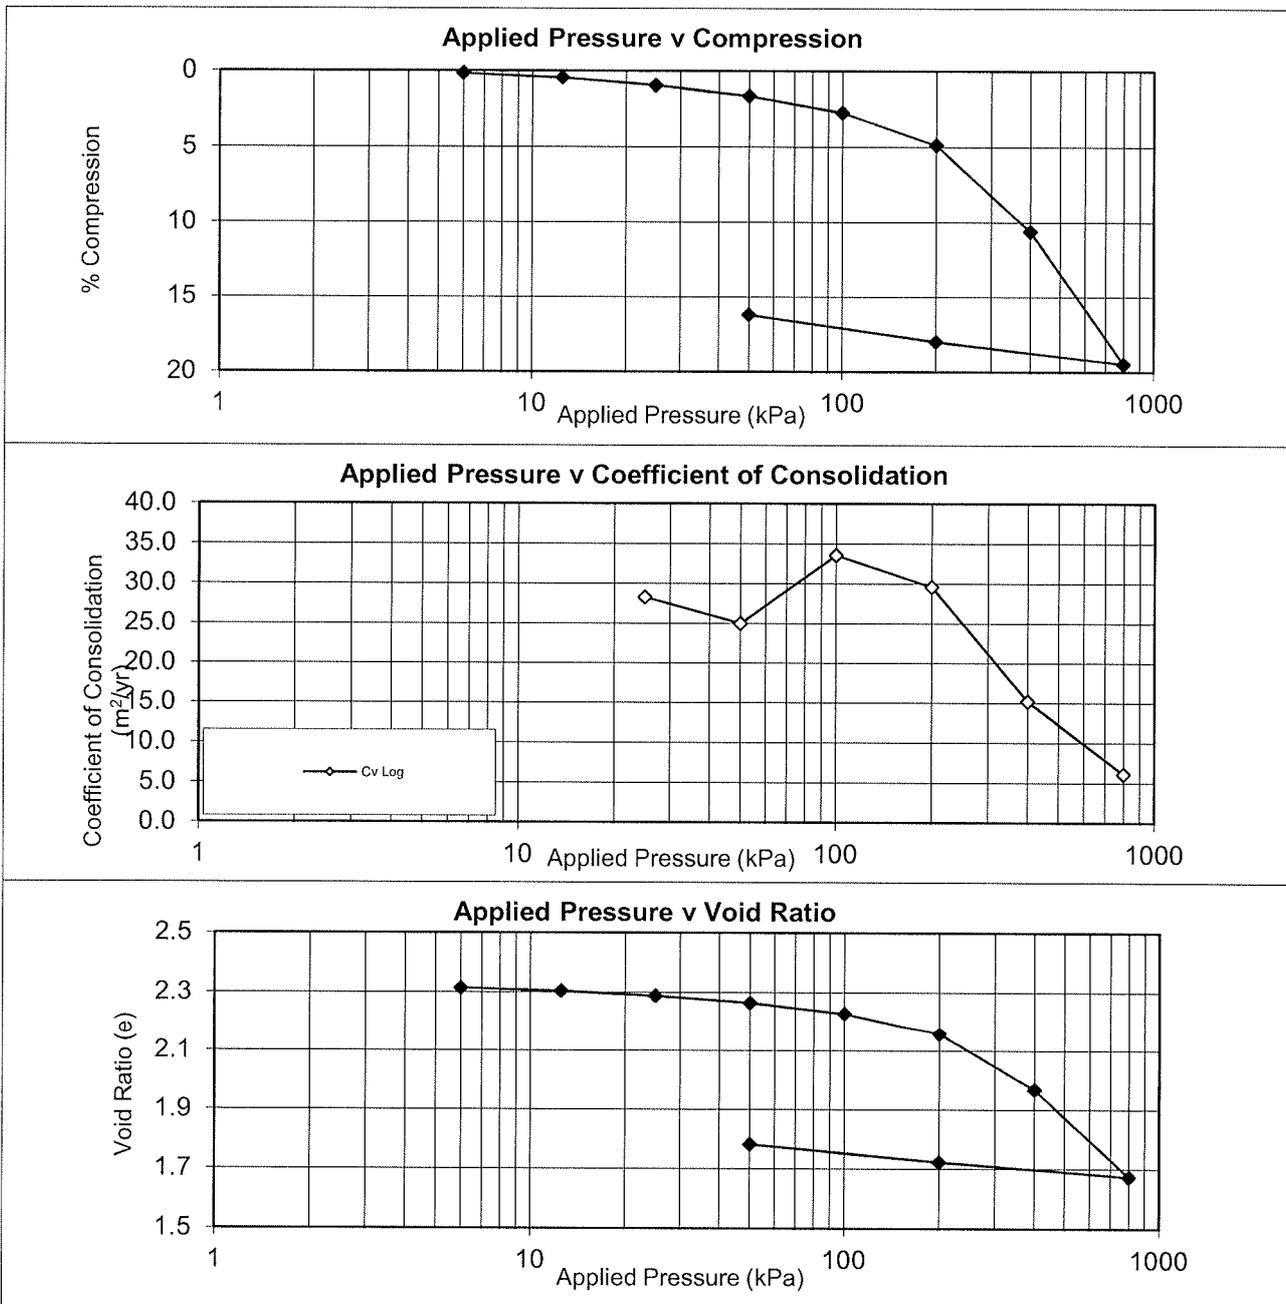
ONE DIMENSIONAL CONSOLIDATION (OEDOMETER) TEST

Sample Description: Clayey SILT, minor sand, trace fine gravel; reddish brown mottled yellowish grey; moist, highly plastic.

Test Condition: Inundated at 1 minute interval on initial load sequence

Project: Supporting Group Alliance Client:Auckland Transport Date: 13 December 2019
 Job No: 3810934/1000 Location: - Depth (m): 6.0
 Bore/Test Pit No.: BH101/19 Sample No.: S847 Report No: 2048L:01
