50 Westney Road, Māngere

**Preliminary Site Investigation (Ground
Contamination)**

ROTOKOHU INVESTMENTS LTD

WWLA1450 | Rev. 1

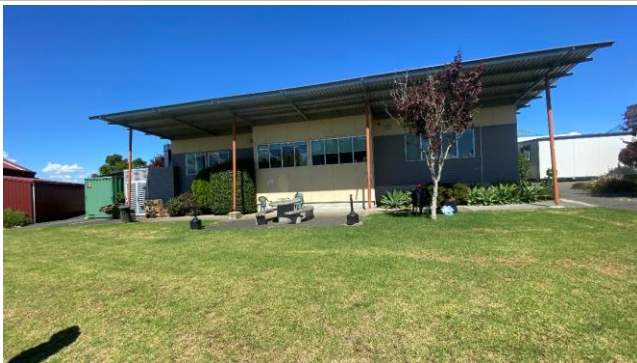
Photograph 1: View of one of the admin buildings, facing southwest.

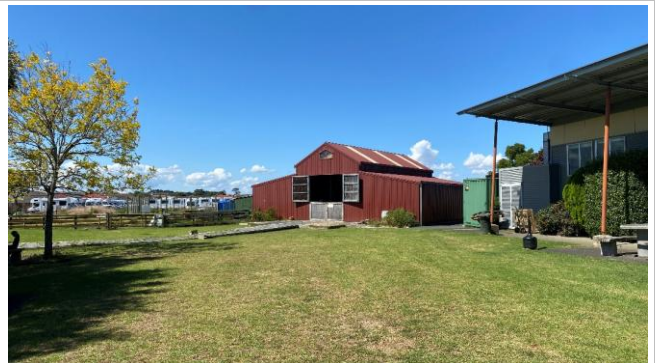
Photograph 2: View of the barn which is currently housing bird cages (temporary aviary) and other small animals, facing south.

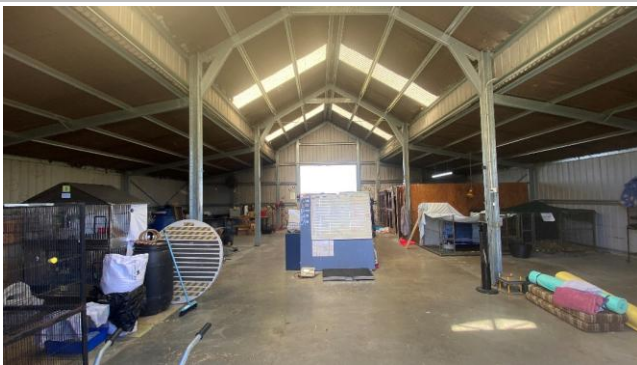
Photograph 3: Inside the barn/temporary aviary.

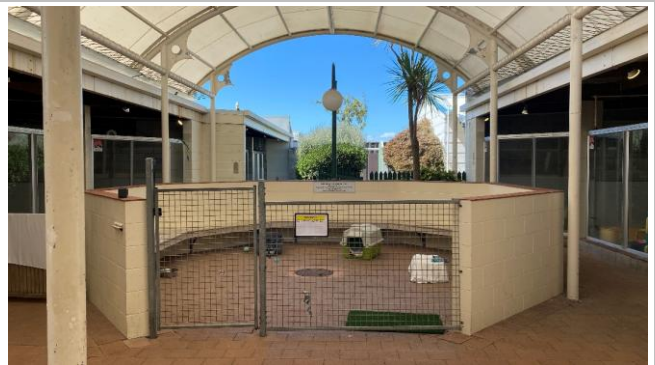
Photograph 4: Dog adoption centre with viewing pens.

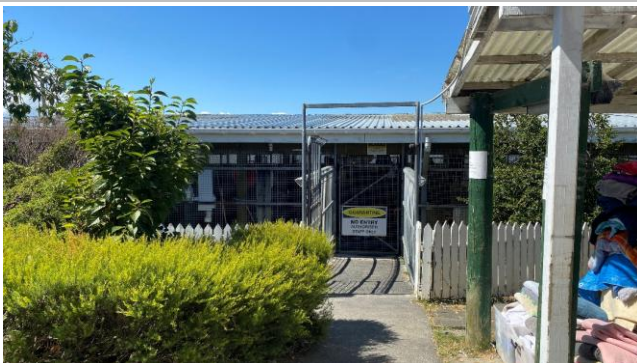
Photograph 5: View of the quarantine facility, facing southeast.

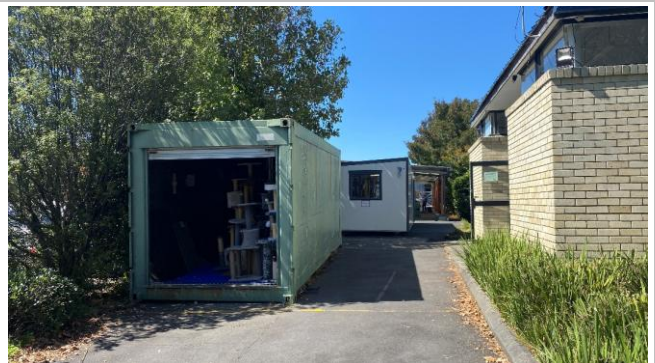
Photograph 6: Storage containers are located across the site.

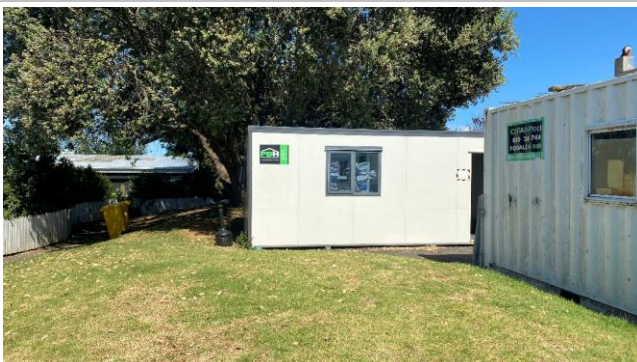
Photograph 7: Temporary Portacom-style buildings were observed as extensions of permanent buildings and as standalone buildings.

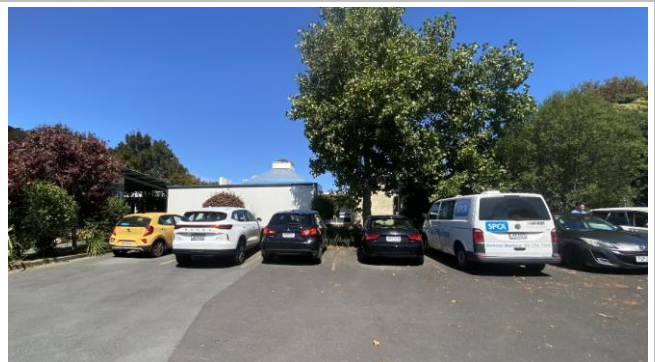
Photograph 8: Carparking around the admin buildings to the west.

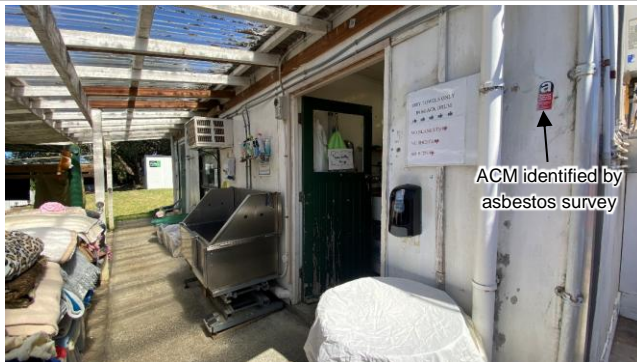
- Concrete block and brick walls.
- Hardboard or cement board cladding and soffits (potentially asbestos-containing material/ ACM in select locations, e.g., the laundry building, where an asbestos survey has identified ACM) (**Photograph 9**).
- Corrugated metal cladding and roofing.
- Prefab concrete panels.
- Concrete and brick floors.
- Timber.
- Glass windows and ranch sliding doors with timber or metal framing.
- Archgola/pergola with metal framing (**Photograph 10**).
- Corrugated and non-corrugated clearlite roofing (**Photograph 9**).

Photograph 9: View of the laundry and ACM as identified during the asbestos survey, facing west.

An asbestos survey has been undertaken but has not been provided to WWLA. Asbestos stickers are present on the identified buildings containing ACM (**Section 3.1, Photograph 9**).

- ACM has been identified on the buildings and is required to be removed in accordance with the Health and Safety at Work (Asbestos) Regulation by a suitably qualified asbestos removalist during demolition of the buildings.

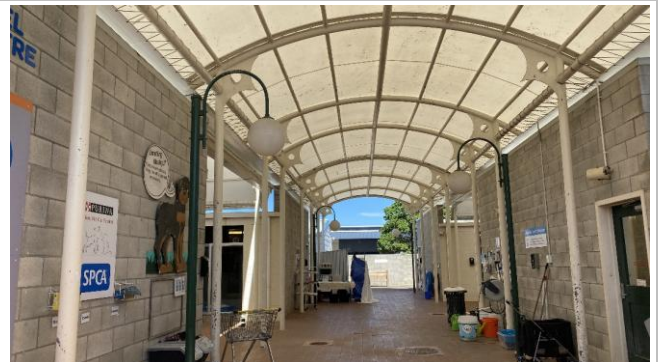
Photograph 10: Archgola/pergola covering a walkway through the adoption centre.

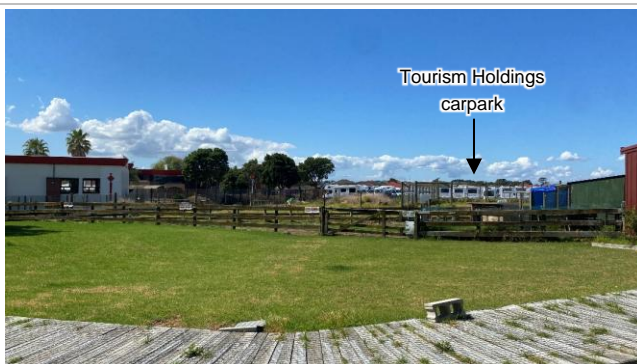
The paddock fences and gates are constructed from timber planks and posts (**Photograph 11**).

A large gravel carpark used by Tourism Holdings (northeastern quarter) and Fly Away (southeastern quarter) for campervan and airport traveller parking, respectively, is located in the eastern half of the site (**Photograph 11**).

Photograph 11: View of the paddocks and yard in the centre of the site with the Tourism Holdings campervan carpark in the background, facing southeast.

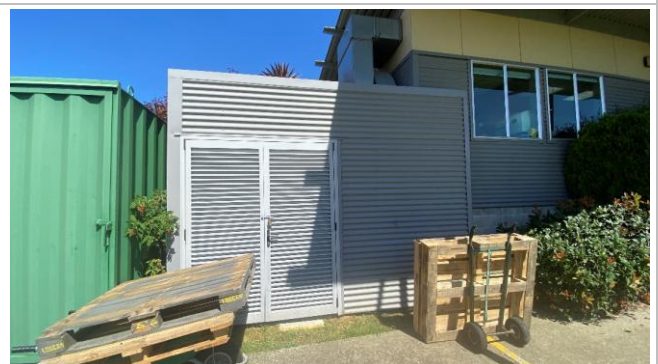
An unmarked locked shed constructed from corrugated metal sheets with vented metal doors is located on the (south)eastern end of the admin building, adjacent to the aviary/barn, and contains a small dangerous goods storage (flammable liquid storage cabinet), milking equipment and a pump, a number of empty fuel cans,

Photograph 12: View of the storage shed housing a dangerous goods cabinet, facing southwest.

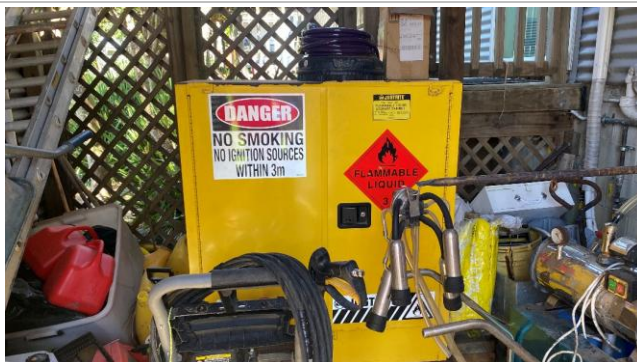
ladders and property maintenance equipment, road cones, Panasonic inverter, water blaster, and various other items (**Photographs 12 to 14**).

Photograph 13: Dangerous goods store (flammable liquid storage cabinet), empty fuel cans, milking equipment and pump, and property maintenance equipment, among other items stored in the shed in Photograph 12.

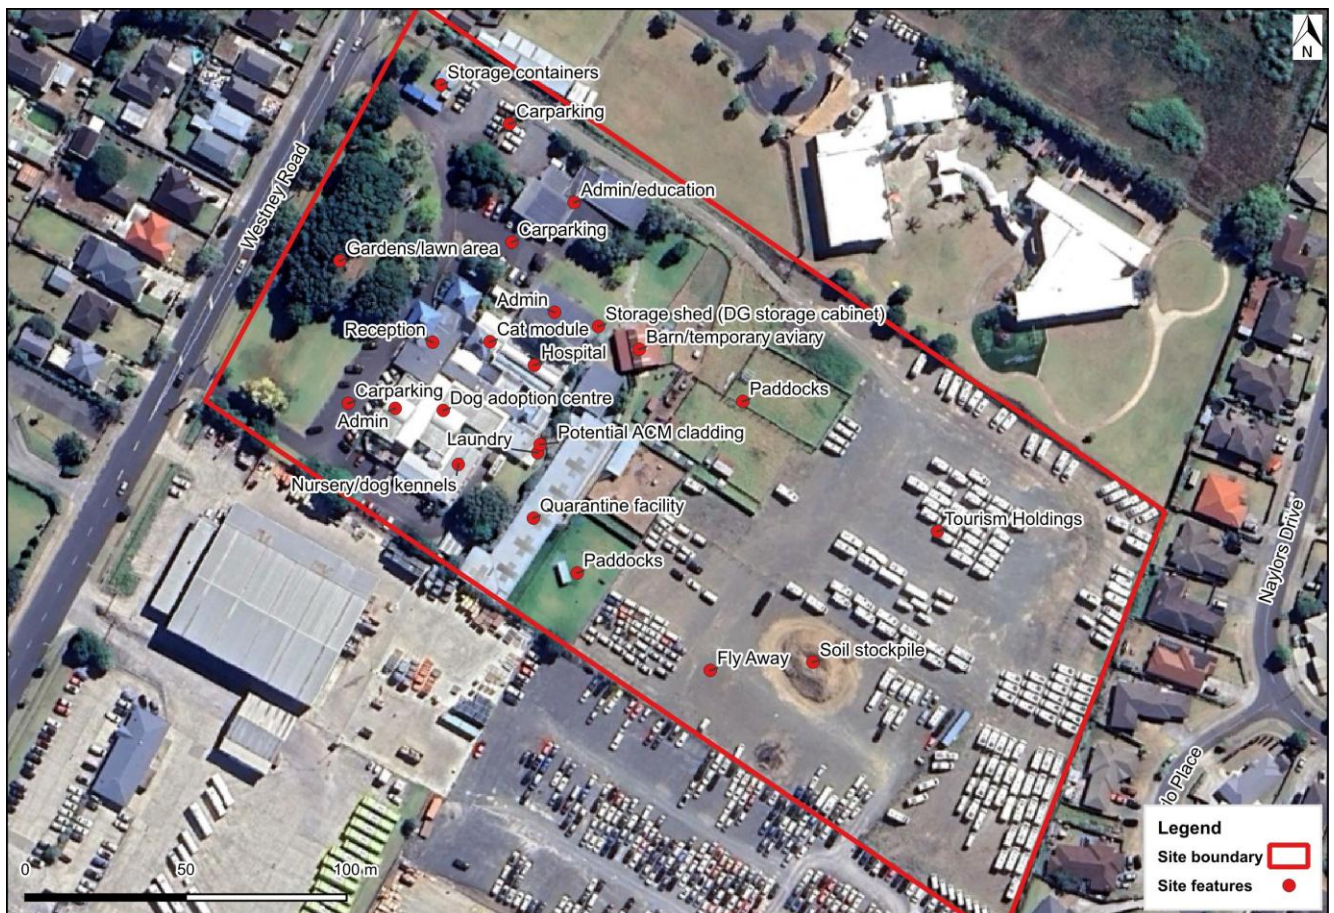
Figure 3. Site features plan (Source: Google Earth Pro, 2025).

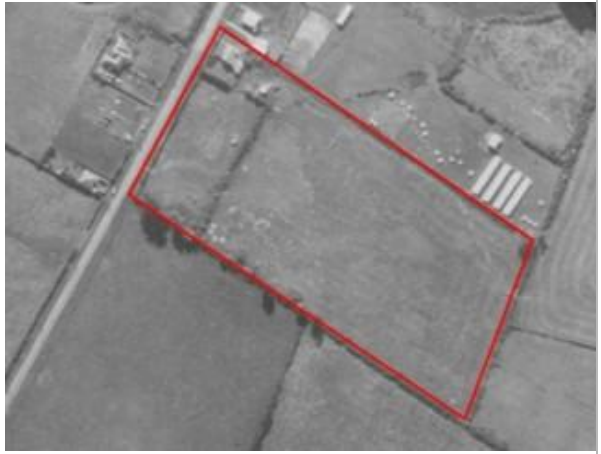
Photograph date (source)	Description	Aerial image (approximate site in red outline)
1939 – 1959 (1939: Retrolens SN139 32/6) (1959: Auckland Council Geomaps) <i>1959 image shown</i>	<p>Structures occur in the northwest of the site, with the balance being used for stock grazing. The site is likely to be part of a wider farm as a farm race runs along the eastern boundary and north across the neighbouring paddock. By the 1959 aerial photograph, the structure near the western corner of the property is no longer observed.</p> <p>The surrounding area is predominantly used for grazing/pastoral land with some rural residential dwellings and associated farm buildings. A group of four rectangular sheds (possibly poultry sheds) occur on the eastern portion of the neighbouring property to the north, adjacent to the eastern corner of the site</p>

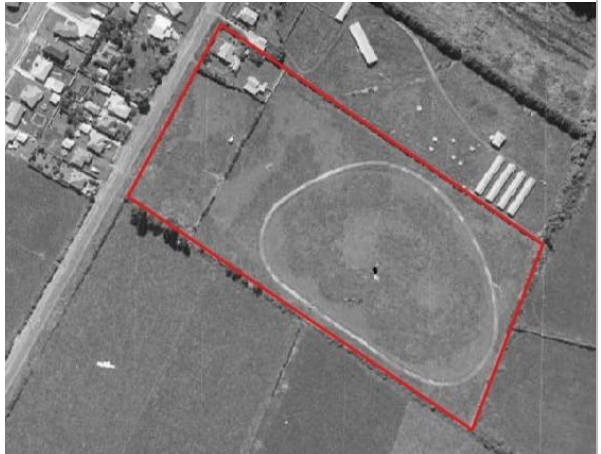
1967 – 1972 Retrolens (1967: SN3015 B/15) (1972: SN3552 4605/13) <i>1972 image shown</i>	<p>The cluster of structures in the northwest remains although one on the boundary has been removed and the land has been reverted back to pasture. A newer possible minor dwelling is observed in the northern corner of the site. A track of some description is observed occupying much of the site.</p> <p>The surrounding land to the northwest of the site and further to the north/northeast has begun to undergo residential redevelopment, although rural residential properties and farmland remains to the west, south and east.</p>

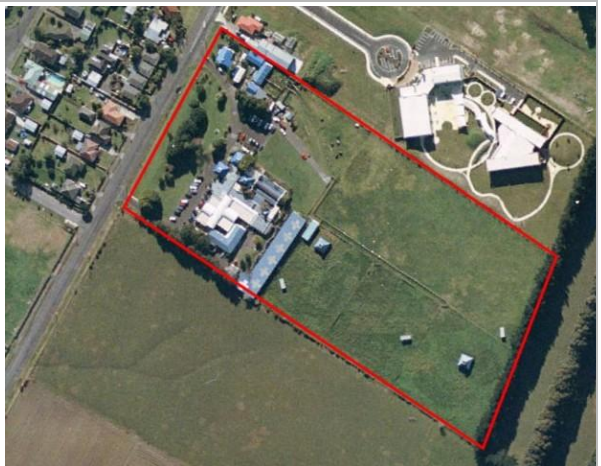
1988 – 2006 (1988: Retrolens SN8772 R/4) (1996 – 2006 AC Geomaps) <i>2001 image shown.</i>	<p>A large complex is under construction in the western portion of the site in the 1988 aerial photograph (complete by the 2006 image), and the eastern portion has been split into six (6) smaller paddocks each with an animal shelter shed. The dwellings/buildings in the northern corner of the site remain until prior to the 1996 aerial photograph when a new larger building and associate smaller buildings/sheds was observed.</p> <p>The adjacent school to the north of the site has been developed with multiple buildings added between 1996 and 2001.</p>

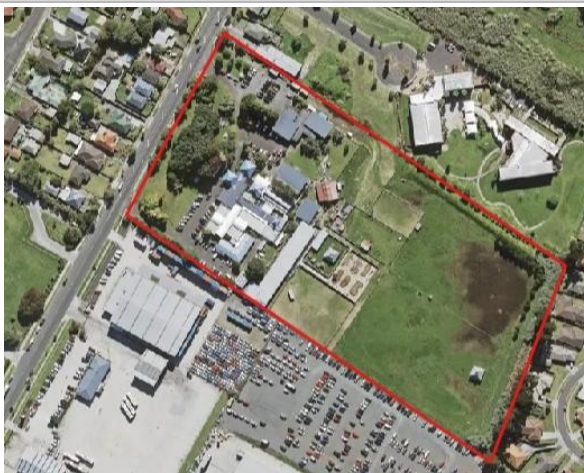
Photograph date (source)	Description	Aerial image (approximate site in red outline)
2008 – 2022 (2008-2016: AC Geomaps) (2017: LINZ) (2022: Google Earth Pro) <i>2017 image shown.</i>	<p>Minor changes have occurred on the site since the 2006 aerial photograph, primarily additions of small sheds/buildings through the centre of the site and in the paddocks. By 2017, the two paddocks in the centre of the site had been split up into smaller paddocks and what appears to be a yard area with two shed/shelters. Evidence of ponding water/flooding is observed in the eastern corner of the site in the 2017 aerial photograph. By 2022, earthworks had commenced along the eastern half of the northern boundary and the eastern boundary.</p> <p>The surrounding area has undergone significant redevelopment to residential properties/subdivisions to the northwest and southeast, with commercial/industrial development to the south.</p>

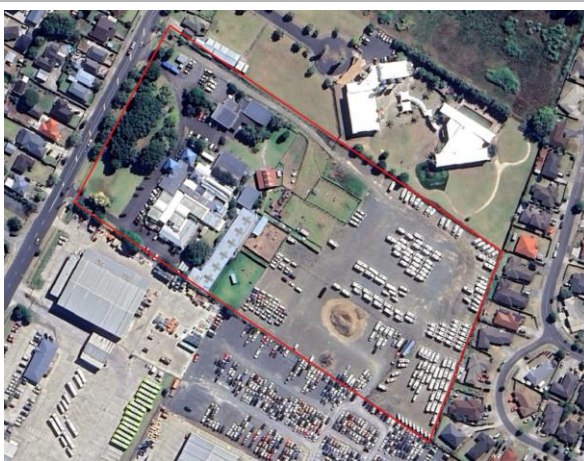
2024 - 2025 (2024: LINZ) (2025: GEP) <i>2024 image shown</i>	<p>By 2024, significant earthworks has occurred over the southern and eastern half of the site, including releveling and the construction of an earthbund. By 2025 the earthbund had been levelled out, and a large gravel carpark occupies much the southern and eastern half of site. A gravel driveway/access road runs along the northern boundary, providing access from Westney Road at the northern corner of the site to the carpark. By March 2025, a soil stockpile was observed in the southern half of the large gravel carpark in the east of the site.</p> <p>The surrounding area remains relatively unchanged since the previous aerial photograph.</p>

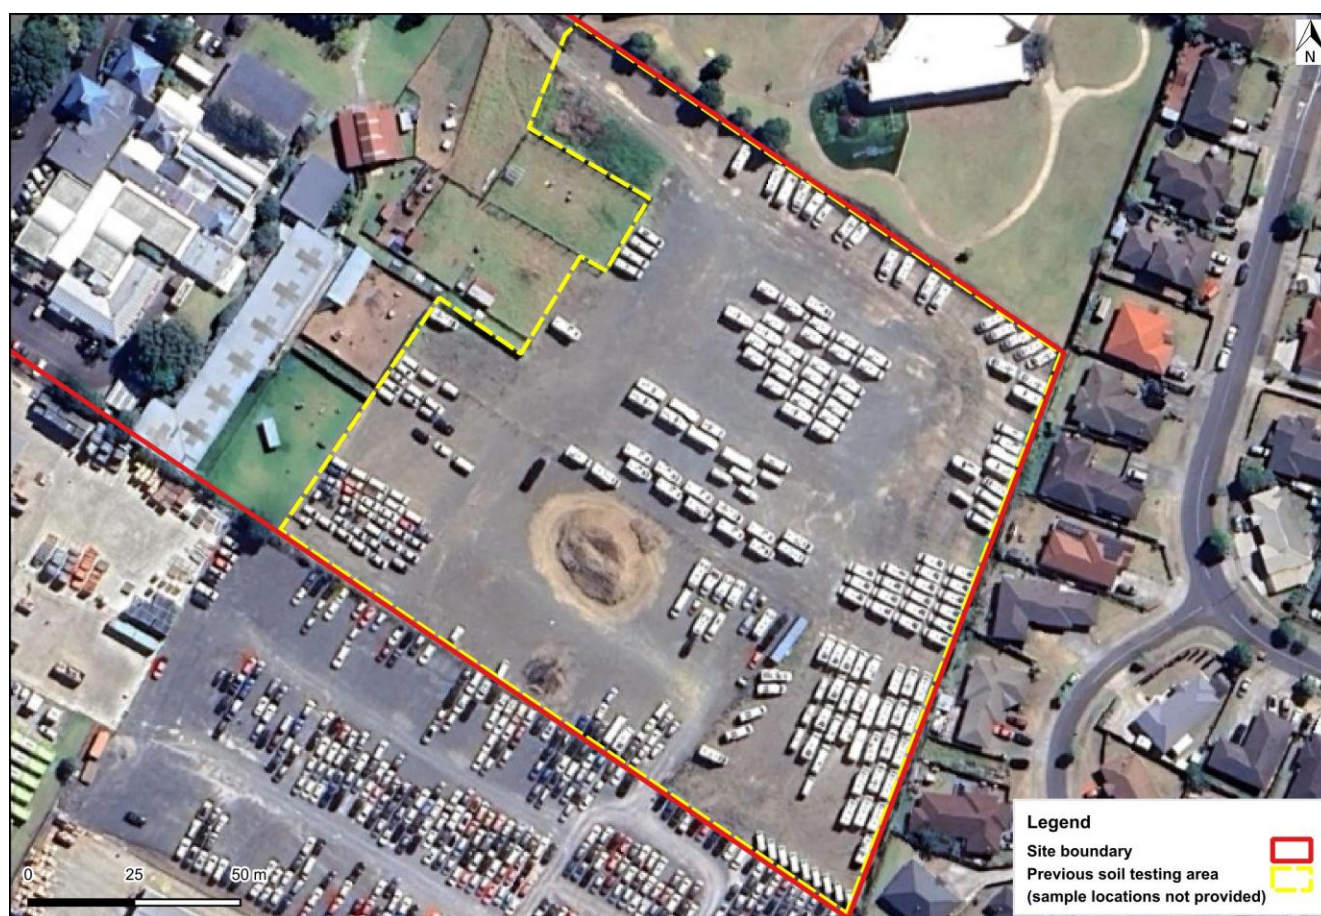
Laboratory transcripts for previous soil testing by Wilkinson Civil Ltd in 2023 for the redevelopment of the eastern half of the site for carparking were provided by the Rotokohu Investments. The results are summarised in **Table 5** and the general area is shown in **Figure 4** below (sample locations not provided). Soil testing shows contaminant levels largely consistent with published background values.

Figure 4. Investigation area of previous soil testing by Wilkinson Civil Ltd in 2023 (source: Google Earth Pro, 2025).
