Combined Preliminary and Detailed Site Investigation

41 - 43 Brigham Creek Road
Whenuapai
Auckland

12.08.2021
18614.000.001_03

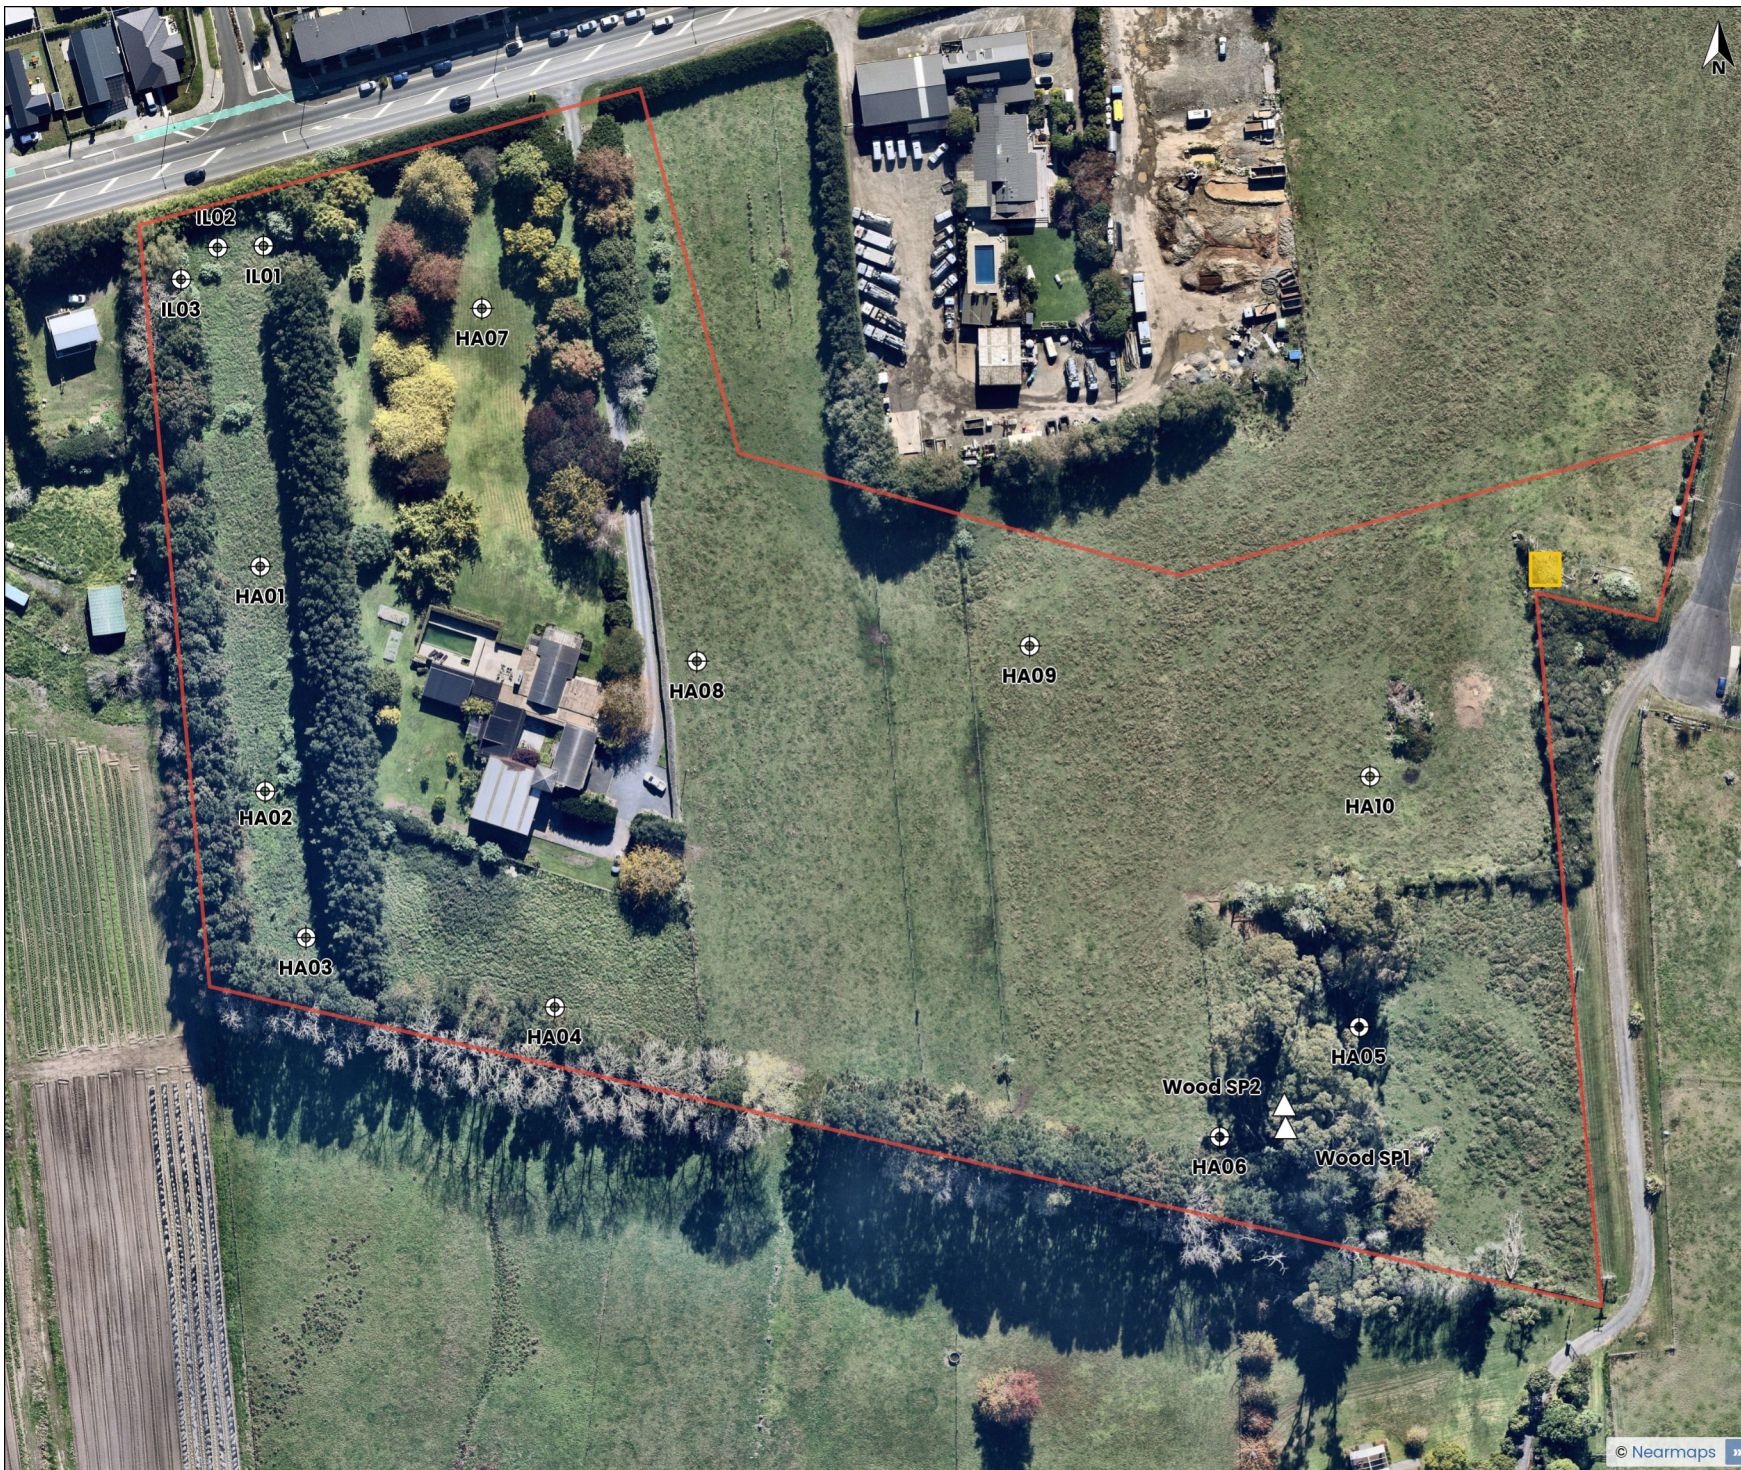
- Legend**
- Site Boundary
 - ⊕ Investigation Locations
 - △ Wood Stockpile Soil Samples
 - Wood Stockpiles - Not Sampled

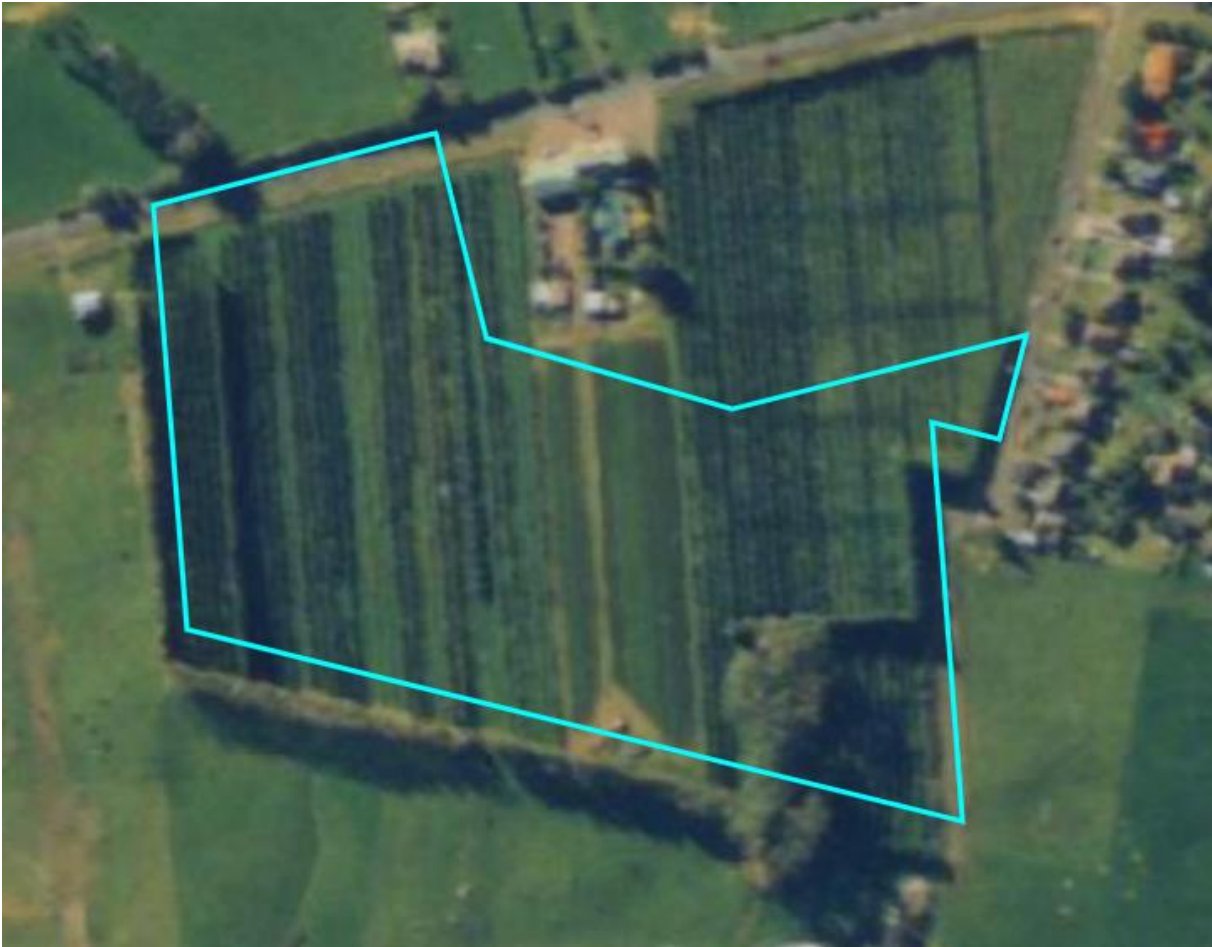
Council's records indicate the site 41-43 Brigham Creek Road, Whenuapai, has been utilised for horticultural activity. This can be seen in the below image:

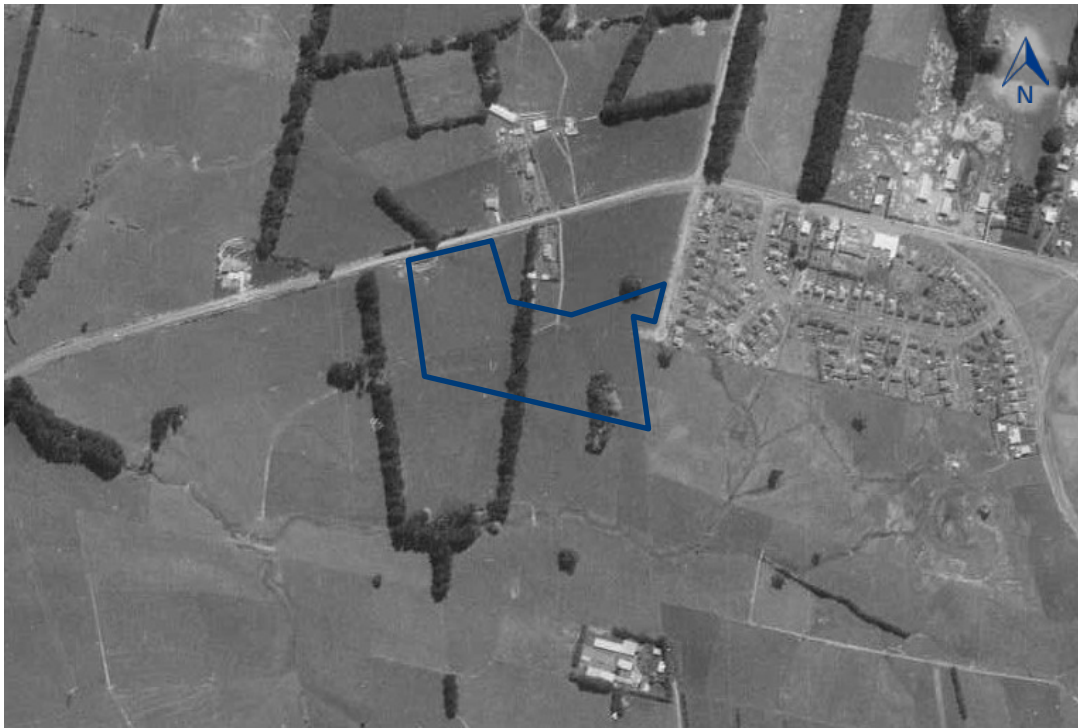
1968 (Retrolens NZ)

1968	No significant changes observed on-site or to the surrounding area.
1972	The pathway from the north has been extended to the southern site boundary. No other significant changes observed on-site or to the surrounding area.
1980	The far northwest of the image shows evidence of horticultural land use, suggesting a shift in land use type within the wider area. No significant changes observed on-site.

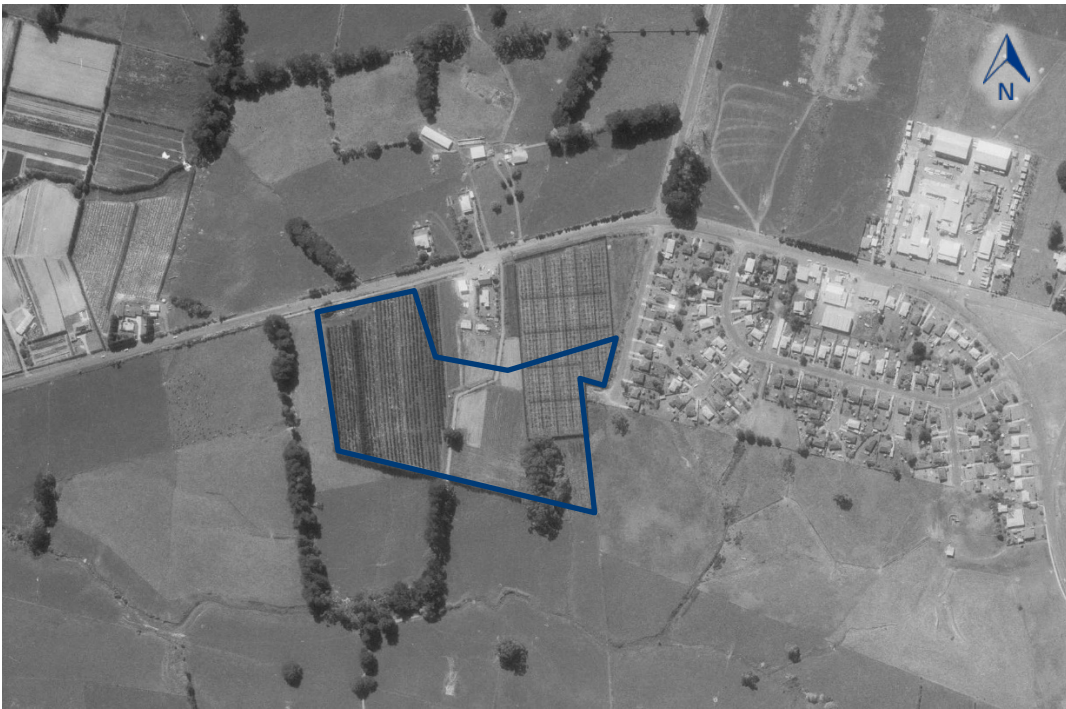
1988 (Auckland Council Geomaps)

Auckland Council's contamination response identified that past land use included HAIL activities (HAIL A10 – Pesticide use; HAIL ID G5 – waste disposal to land). Evidence of historical horticultural land use is provided in the 1988 image, while filling of a depression on-site (northwest corner) can be observed through images from 1961 – 1988 (Appendix 2).

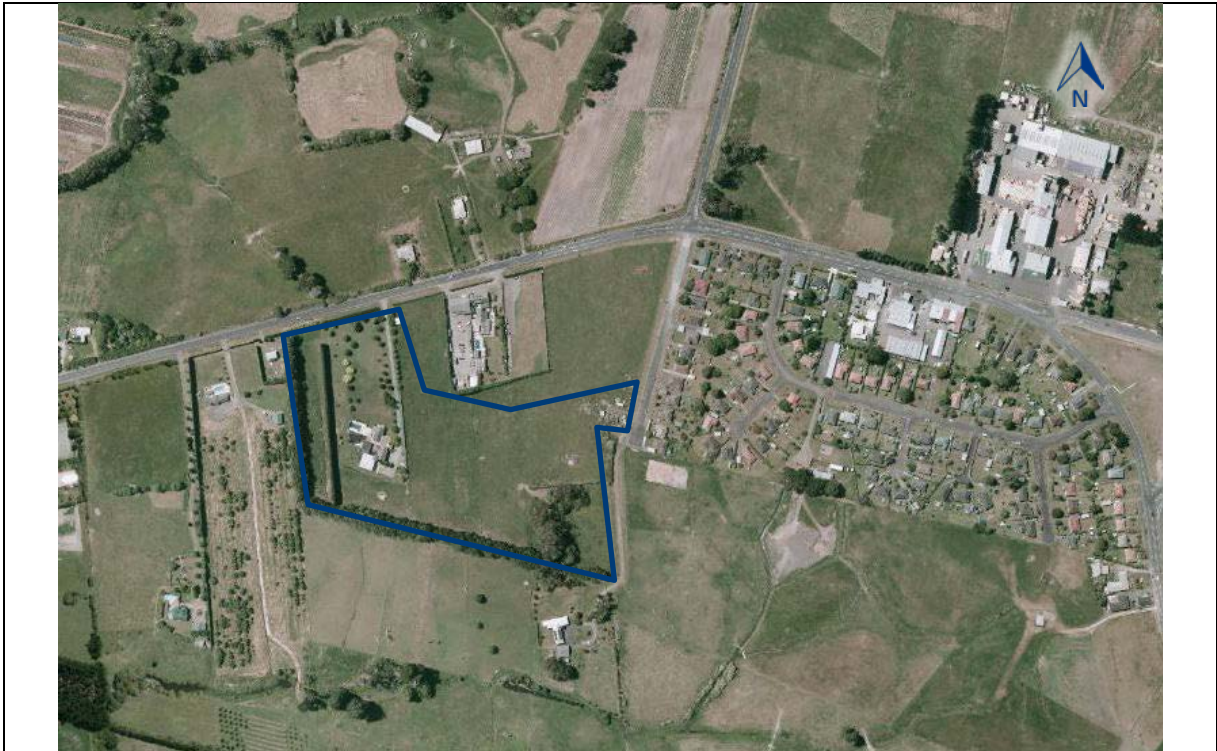
2010/11 (Auckland Council Geomaps)

2010 / 11	The site to the north (45 Brigham Creek Road) has been extended. No other significant changes observed on-site or to the surrounding area.
2015 / 16	There has been an increase in vegetation within the northern portion of the site. Significant earthworks are underway to the north of the site, across Brigham Creek Road.
2017	The property across Brigham Creek Road is undergoing residential redevelopment. No other significant changes observed on-site or to the surrounding area.

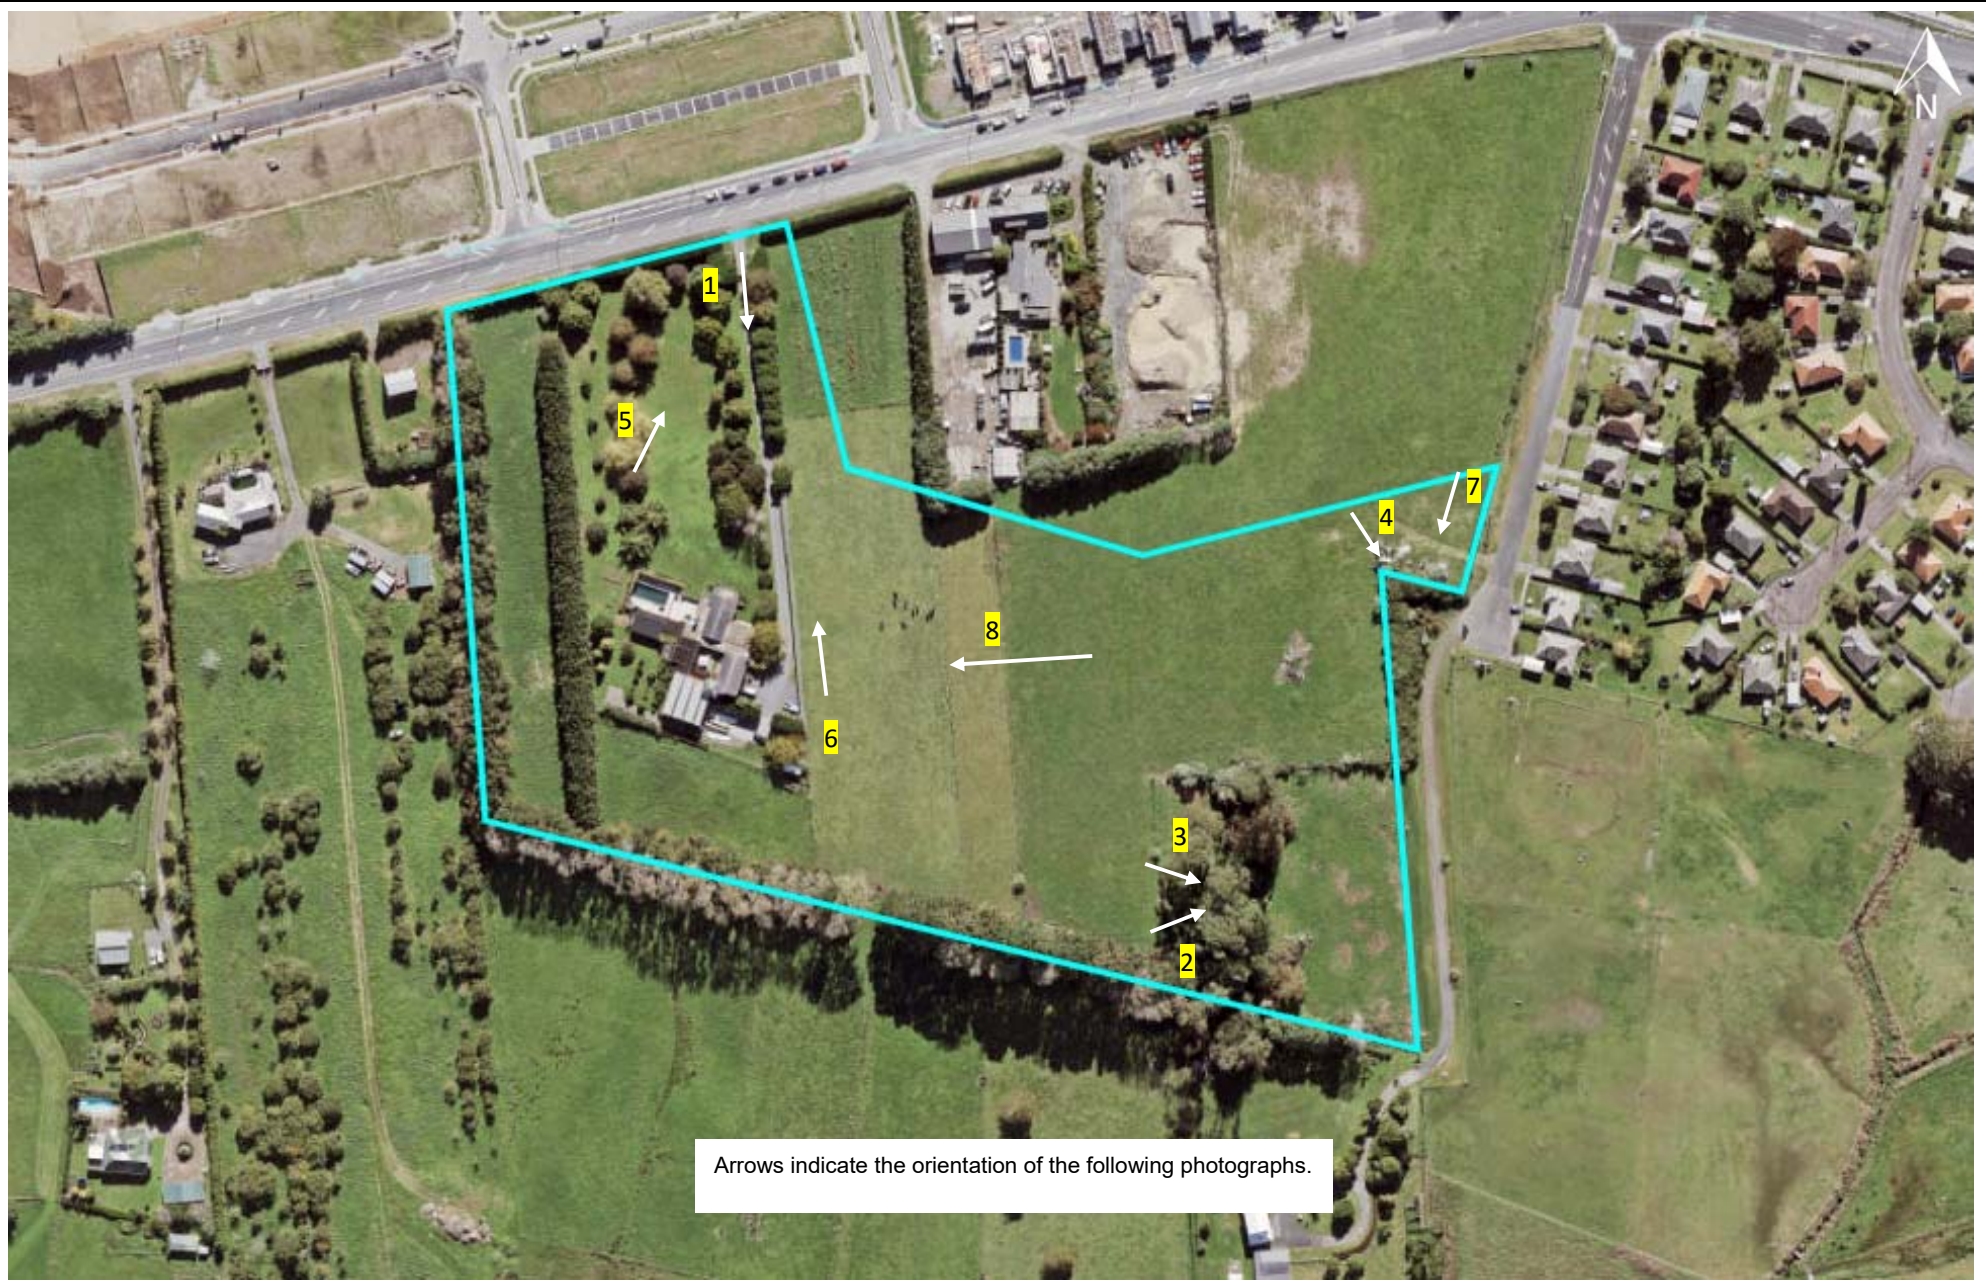
Arrows indicate the orientation of the following photographs.

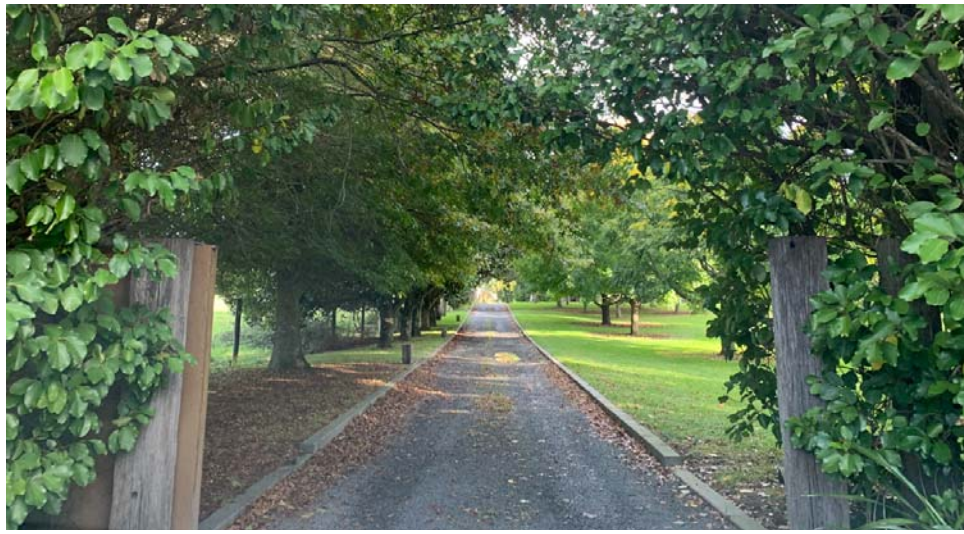
Photograph 1: Residential driveway

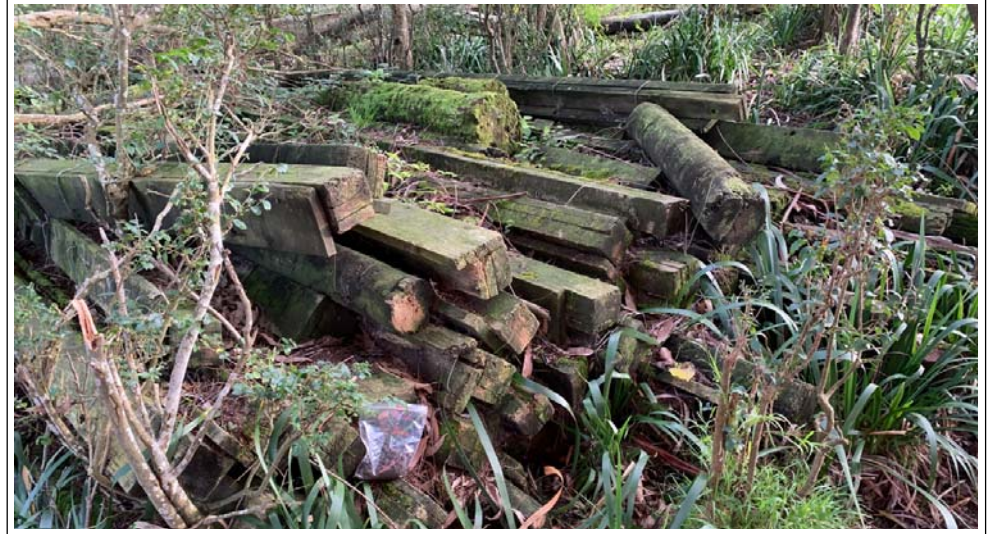
An additional sampling visit was undertaken on 27 April 2021. An environmental scientist attended site, and observed stockpiles containing timber posts. Samples were collected beneath the stockpiles and analysed for contaminants associated with treated timber.

Photograph 2: Wood stockpile 1

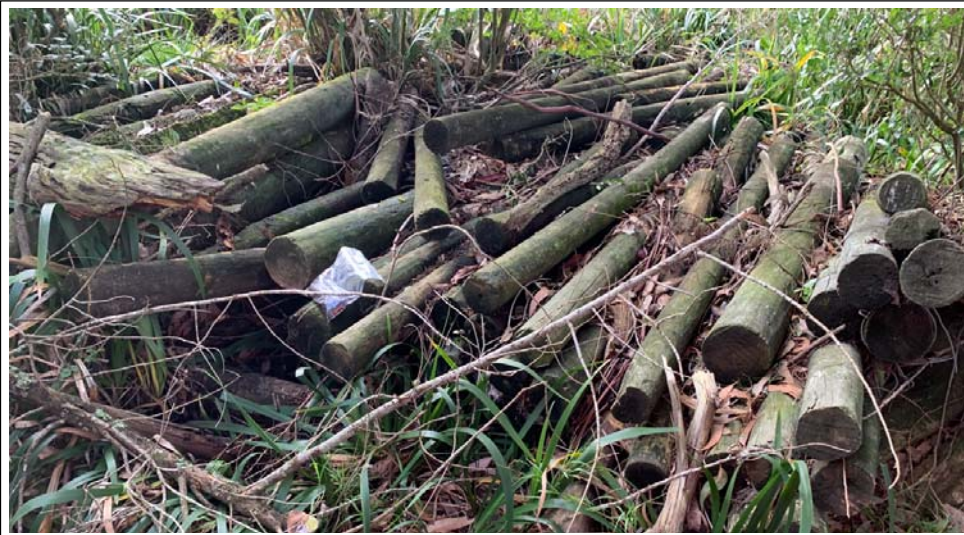
Photograph 3: Wood stockpile 2

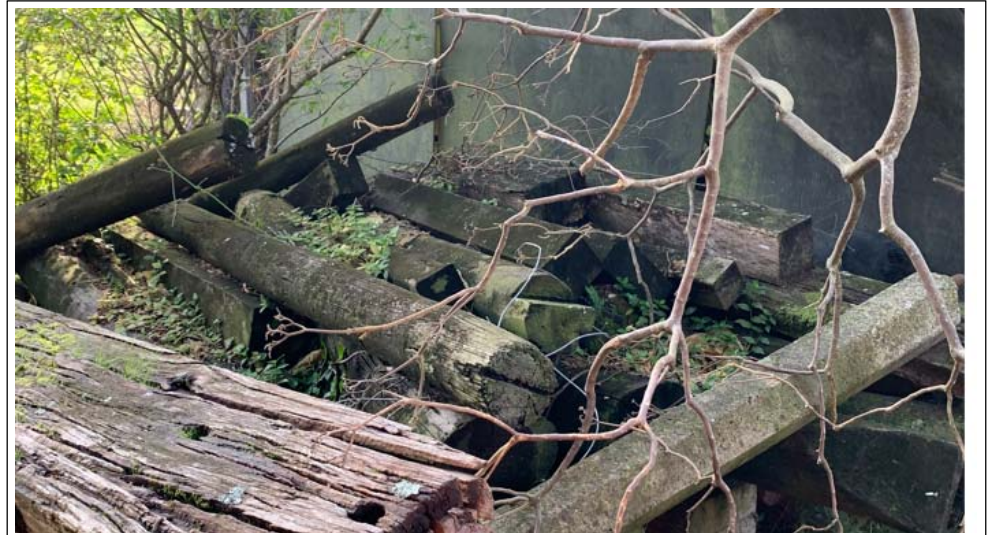
Photograph 4: Wood stockpile 3

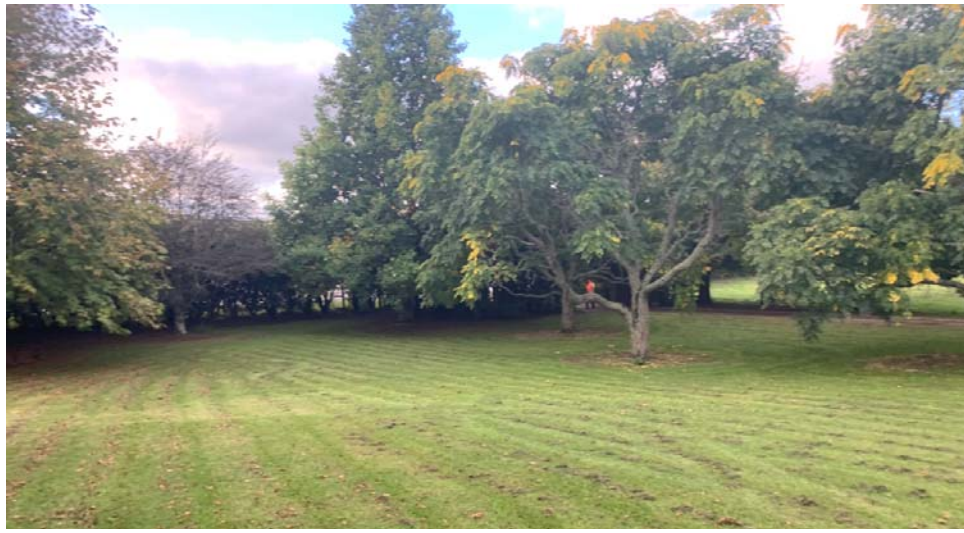
Photograph 5: Paddock north of dwelling

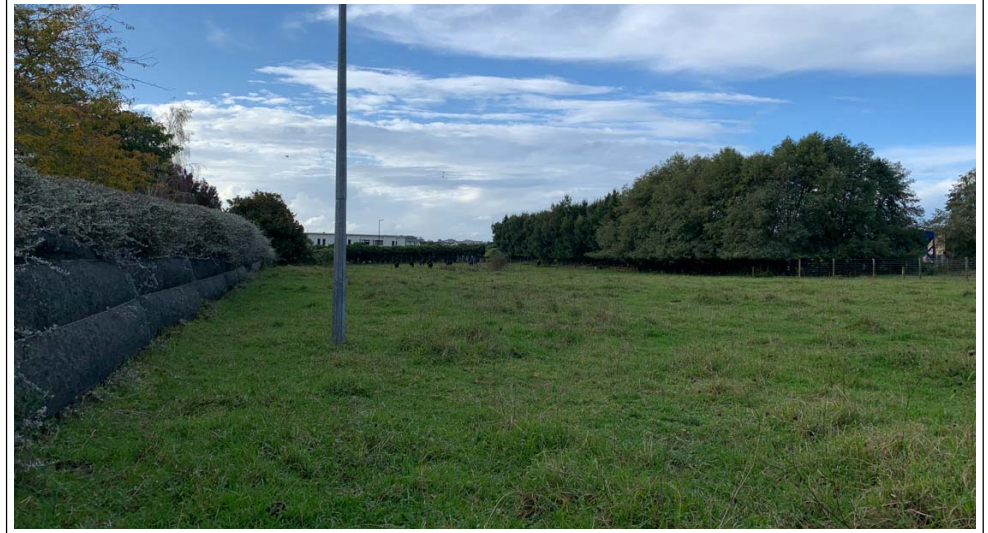
Site Conditions	Comments
Surface Water Appearance	Small areas of pooled water observed – no evidence of contamination (e.g. sheens) observed in this water.
Current Surrounding Land Use	Hydrovac facility to the north, as well as a residential subdivision further to the north (across Brigham Creek Road) and along a portion of the eastern site boundary. The remaining land surrounding the site is rural residential.
Local Sensitive Environments	None observed in the immediate vicinity of the site.
Visible Signs Of Plant Stress	In south-eastern corner of paddock (adjacent to SP04 and HA10 – see Figure 1) were two areas of bare ground suggesting material / soil recently stockpiled here; a stockpile of mostly green waste and some wood (likely untreated) was also observed in this area (refer to photograph 6 in Appendix 3). No evidence of contamination observed (e.g. staining, odours, treated timber, rubbish).

Photograph 6: View north across central paddock.

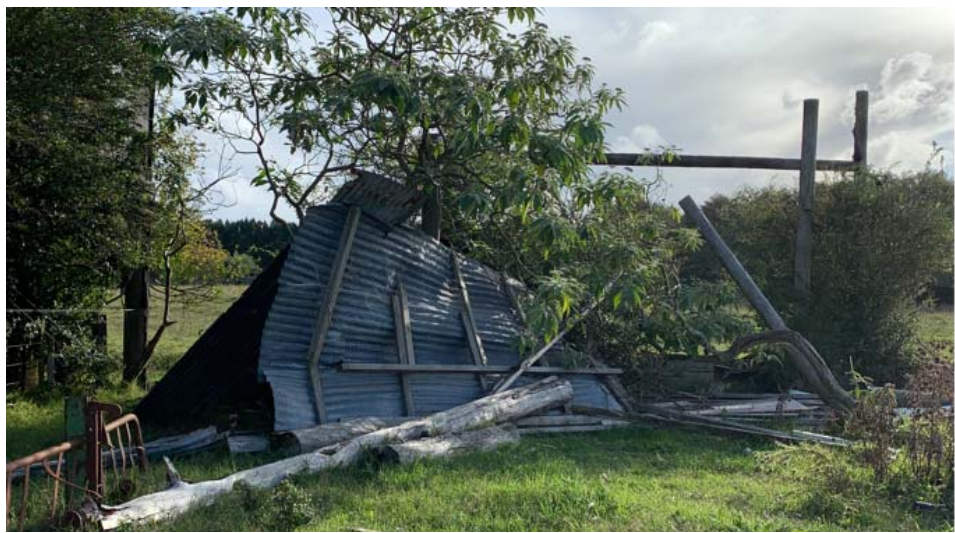
Photograph 7: Dilapidated shed

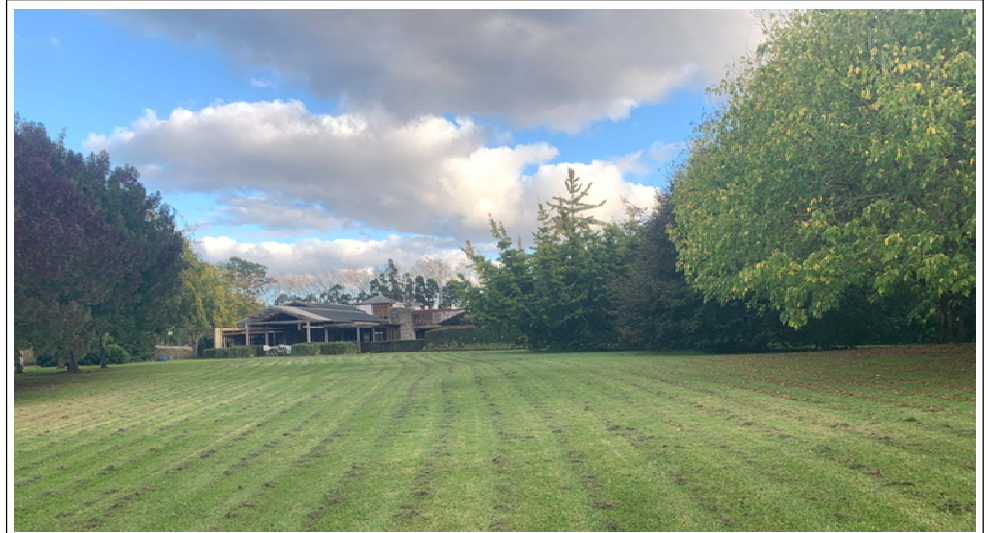
Additional Comments	Dwelling not observed for PACM or lead-painted surfaces due to recent construction

Photograph 8: Dwelling and paddock east of dwelling
