Pukekohe North Substation

Geotechnical Investigation Report

PUKEKOHE NORTH SUBSTATION

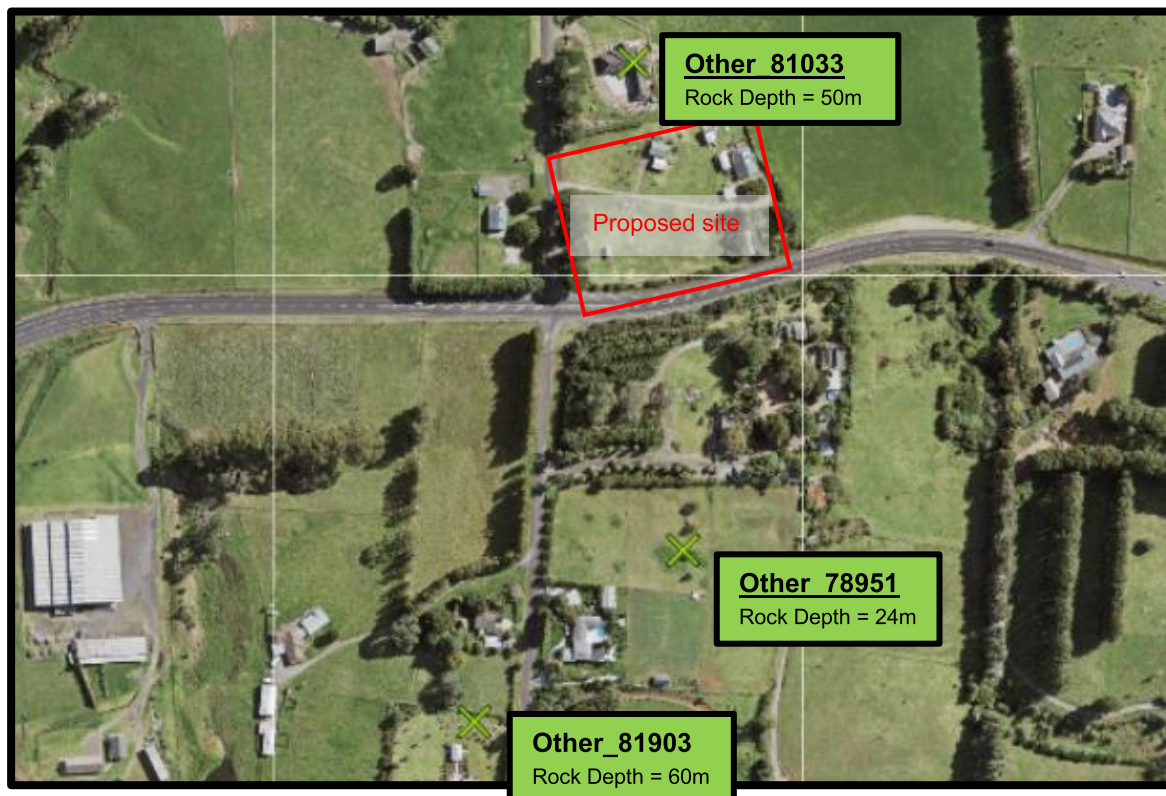
Figure 1: Location of nearby NZGD water bore logs.

Nearby investigation data was sourced using the New Zealand geotechnical database (NZGD). Three water bores were drilled nearby as presented in Figure 1. Material encountered up to 25 metres was similar to that encountered during our investigation. The water bores also reached a depth where East Coast Bays Formation (ECBF) sandstones and mudstones were encountered. Water bore 78951, 81033, and 81903 encountered inferred ECBF rock at 24m, 50m, and 66m respectively, as shown in Figure 1.

Based on the nearby water bore logs sourced from NZGD, which show rock at a depth of 25m to 50m, the seismic site subsoil class is estimated to be D (Deep or soft soil), in accordance with NZS 1170.5 section 3.1.1. This is based on shear wave velocities correlated from the CPT results.

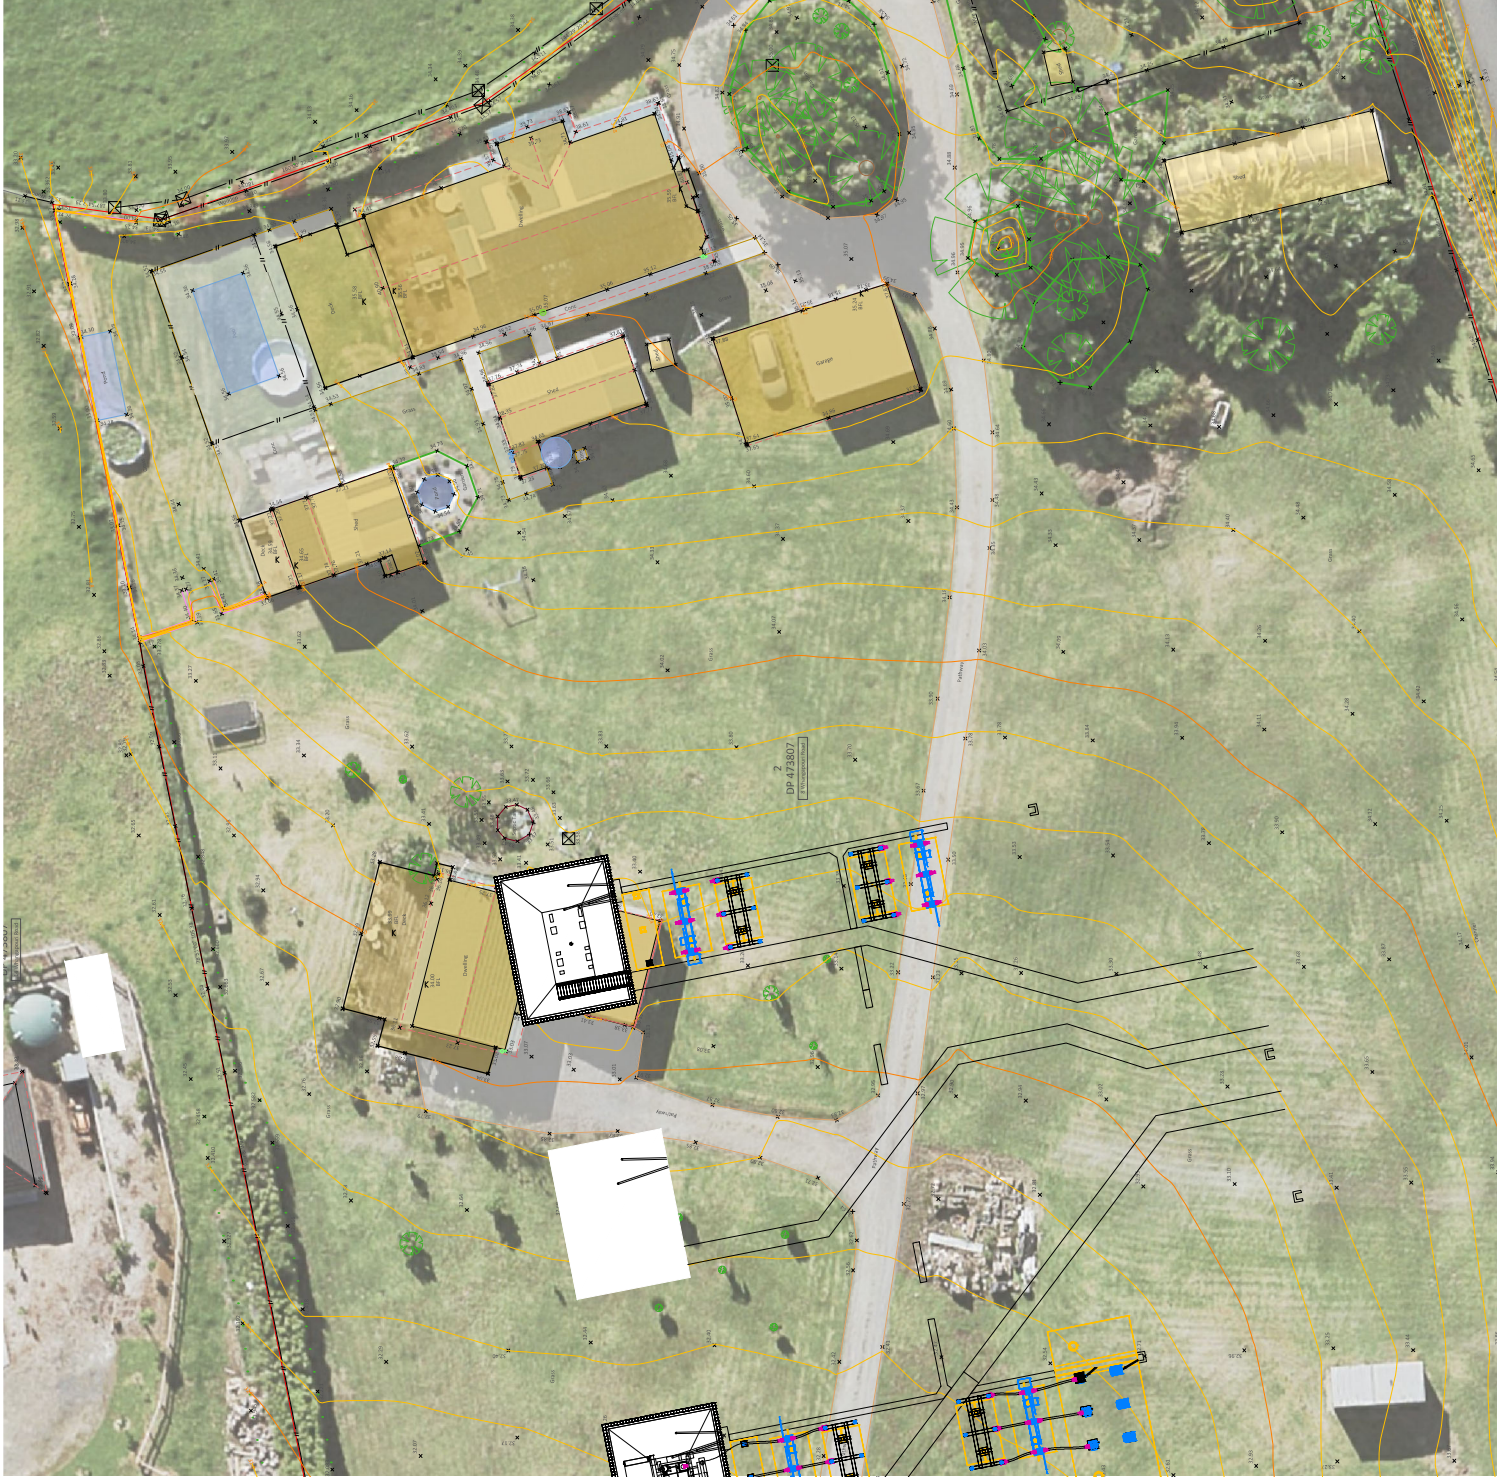
APPENDIX A: SITE PLAN AND DEVELOPMENT PLAN

The proposed Counties Energy Pukekohe North Substation development is shown on the site plan and earthworks plan in Appendix A. Ergo Consulting Limited has indicated that the development proposed for Counties Energy at the site comprises earthworks with up to 1m of cut and fill, retaining walls, three outdoor transformers, a 20m long switch room with a 2m deep basement, outdoor electrical equipment on steel stand and pad foundations and power pole structures. The house currently located near the centre of the northern boundary will be relocated to the south eastern section of the property where the current greenhouse and chicken coop are located.

Test locations are presented in Appendix A on the site plan. The machine borehole log, hand-auger logs and CPT results are presented in appendix B.
